Public Health Assessment

**Physical hazards in the Torch Lake Superfund site and surrounding area
Houghton and Keweenaw Counties, Michigan**

EPA FACILITY ID: MID980901946

**Prepared by
Michigan Department of Community Health**

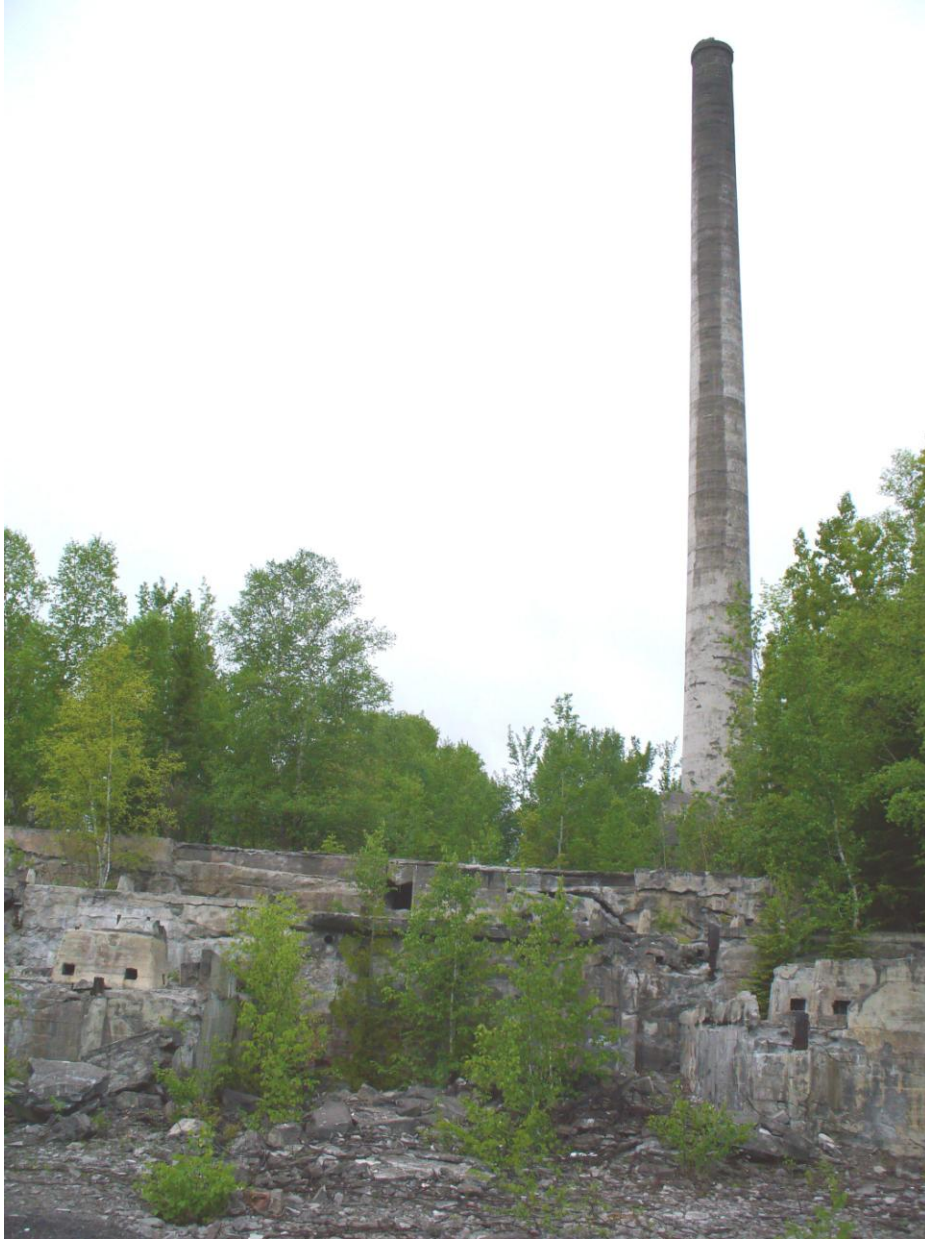
Figure 2. Ruins and stack at former Mohawk stamping mill, Gay (Keweenaw County), Michigan. (Picture taken June 16, 2008. Source: MDCH.)

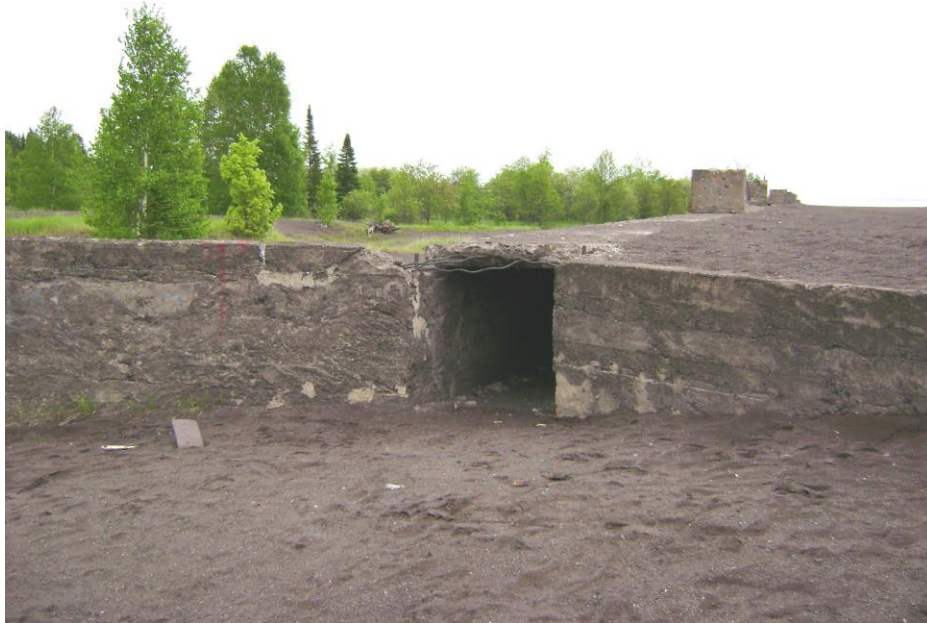
Figure 3. Ruins of conveyor that carried stamp sands to Lake Superior at former Mohawk stamping mill, Gay (Keweenaw County), Michigan. (Picture taken June 16, 2008. Source: MDCH.)

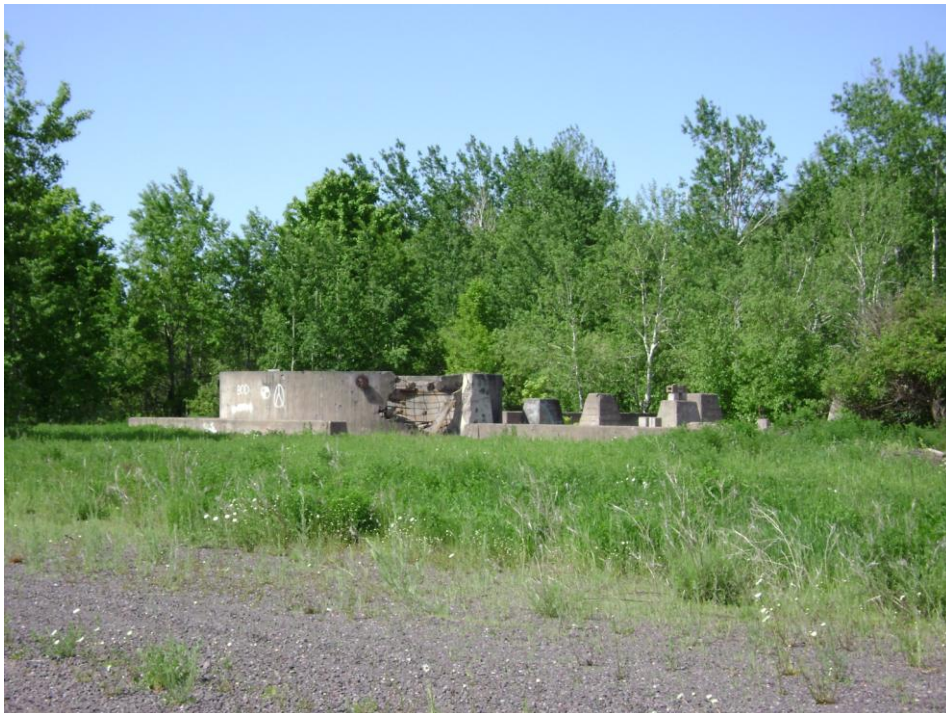
These structures have slip-and-fall hazards. Also, the UST has the potential for an explosion if fuel vapors are present. The exposed dredge likely has sharp edges, its sturdiness is questionable, and people jumping off of it into the lake may misjudge the water's depth. Although a buoy marks the location of the completely sunken dredge, it is unclear how near the water surface the structure is and whether it poses a hazard to swimmers or boaters. Similar to the stack at Gay, people may choose to explore the interior of the stack here, if accessible.

Figure 4. Ruins of Quincy reclamation plant in Mason (Houghton County), Michigan. (Picture taken June 16, 2008. Source: MDCH.)

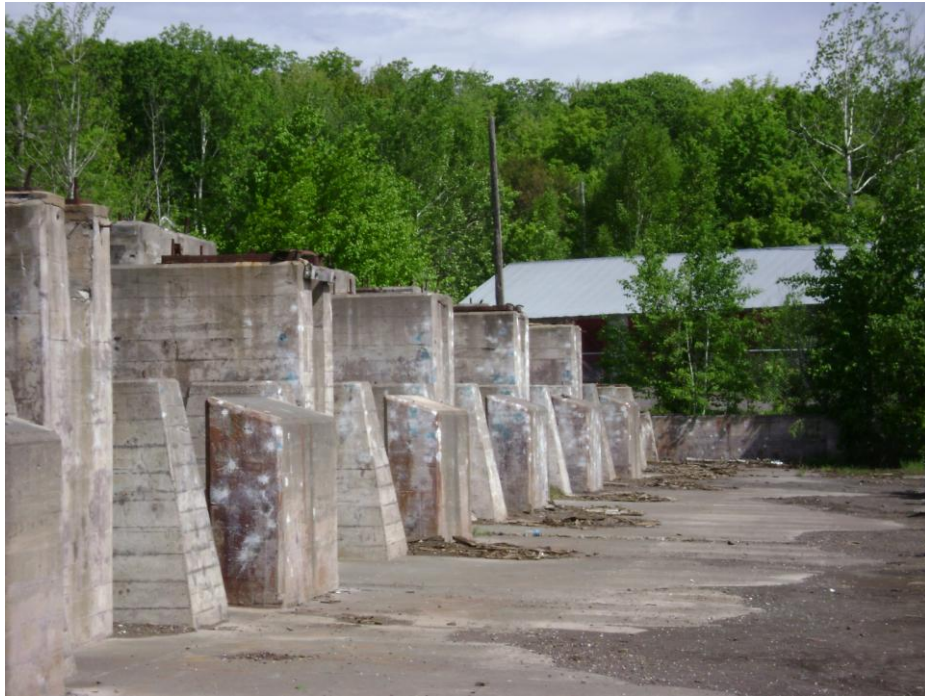
Figure 5. Closer view, with evidence of paintball splatters, of ruins of Quincy reclamation plant in Mason (Houghton County), Michigan. (Picture taken June 16, 2008. Source: MDCH.)

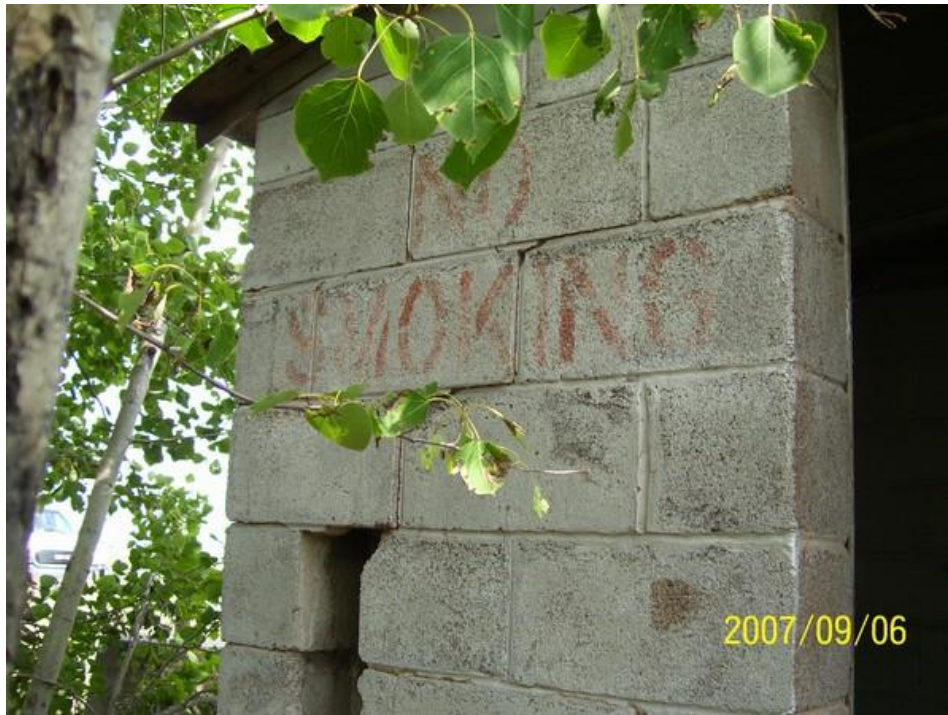
Figure 6. Possible underground storage tank at former Quincy reclamation plant in Mason (Houghton County), Michigan. (Picture taken September 6, 2007. Source: Weston 2007.)

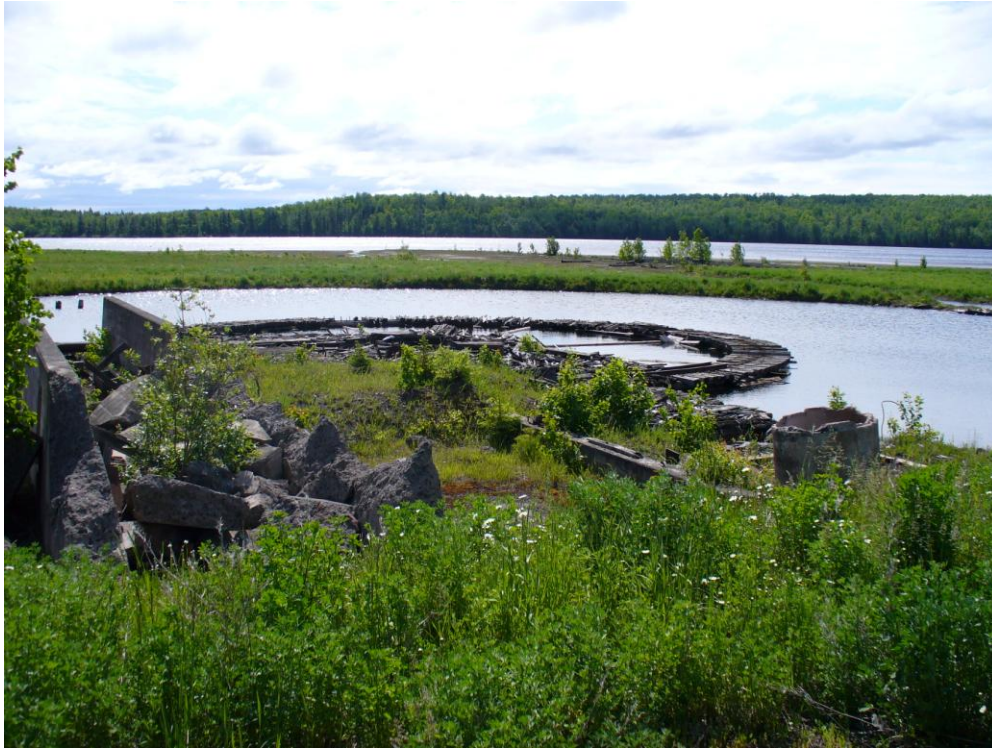
Figure 7. Circular track offshore in Torch Lake at former Quincy reclamation plant in Mason (Houghton County), Michigan. (Picture taken June 16, 2008. Source: MDCH.)

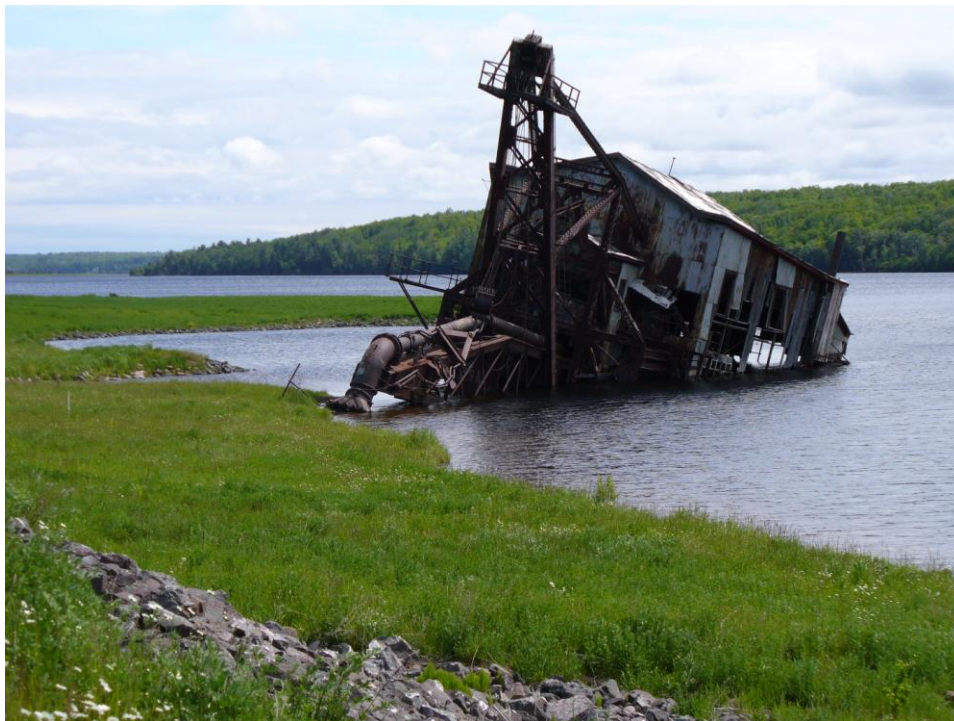
Figure 8. Partially sunken dredge in Torch Lake near former Quincy reclamation plant in Mason (Houghton County), Michigan. (Picture taken June 16, 2008. Source: MDCH.)

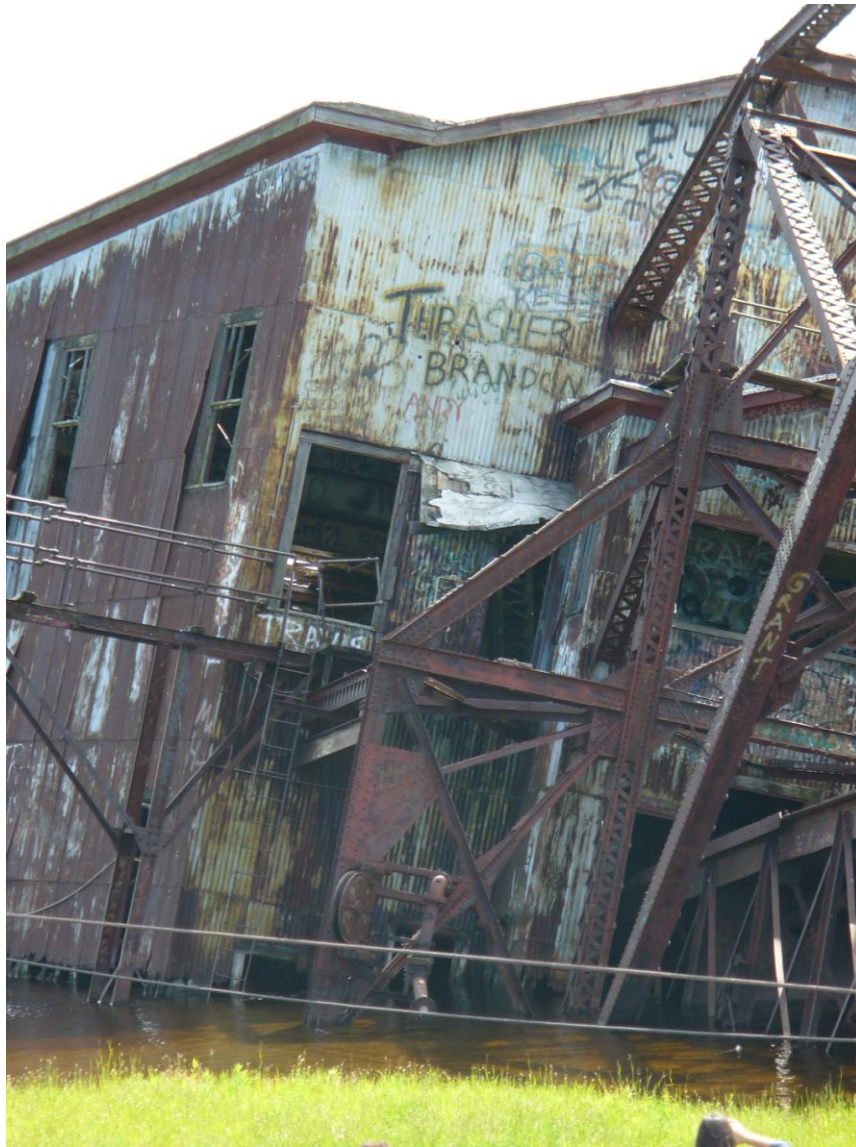
Figure 9. Closer look, with evidence of graffiti, at dredge in Torch Lake near former Quincy reclamation plant in Mason (Houghton County), Michigan. (Picture taken June 16, 2008. Source: MDCH.)

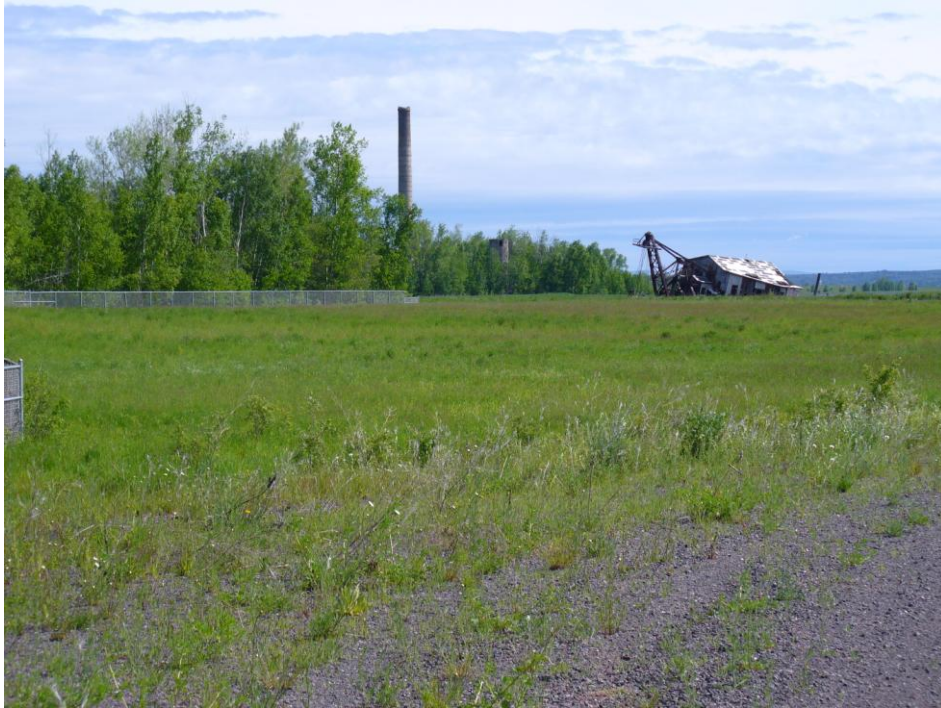
Figure 10. View of stack and partially sunken dredge near former Quincy reclamation plant in Mason (Houghton County), Michigan. (Picture taken June 16, 2008. Source: MDCH.)

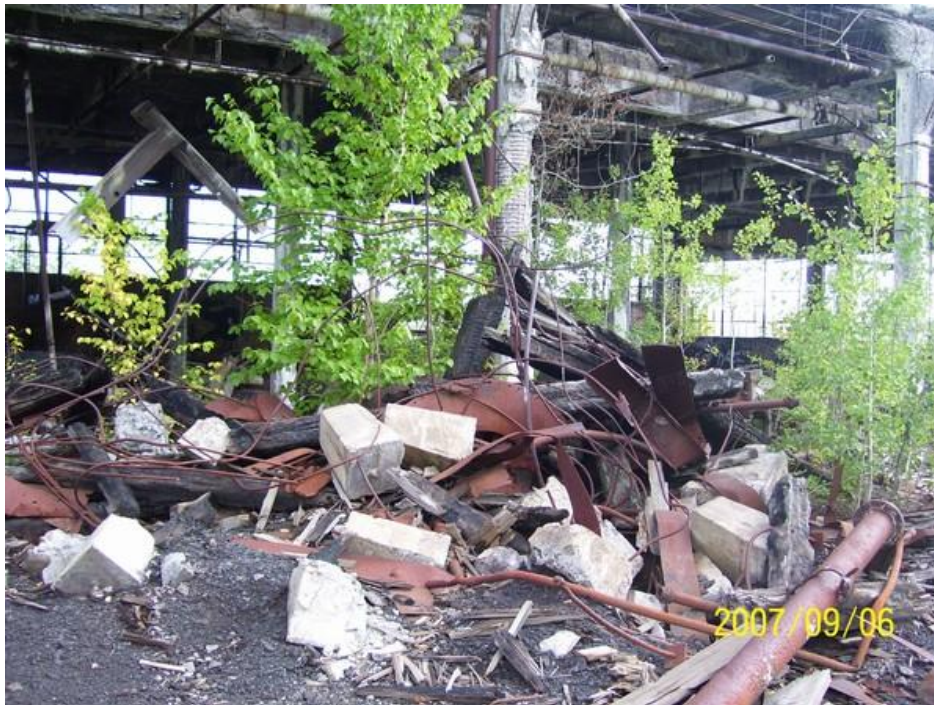
On the west side of M-26 in Mason, slightly north of the former Quincy Reclamation Plant area, is a former industrial building that is no longer in use. MDCH did not stop here during the site visit in 2008, but MDEQ pointed out the structure. The property is not part of the Torch Lake Superfund site. Along with the building, the property also contains exposed foundation materials and debris (Figure 11), empty drums, and suspected ACM (Figure 12). There reportedly is evidence of trespassing and vandalism (Weston 2007).

There are numerous safety hazards at this site: debris could cause tripping, sheet metal and cables may have sharp edges, and the integrity of the structure is questionable. The proximity of the property to M-26 may attract looters seeking scrap metal to sell.

Figure 11. Debris at “Building in Mason,” west of former Quincy Reclamation Plant area (across M-26) in Mason (Houghton County), Michigan. (Picture taken September 6, 2007. Source: Weston 2007.)

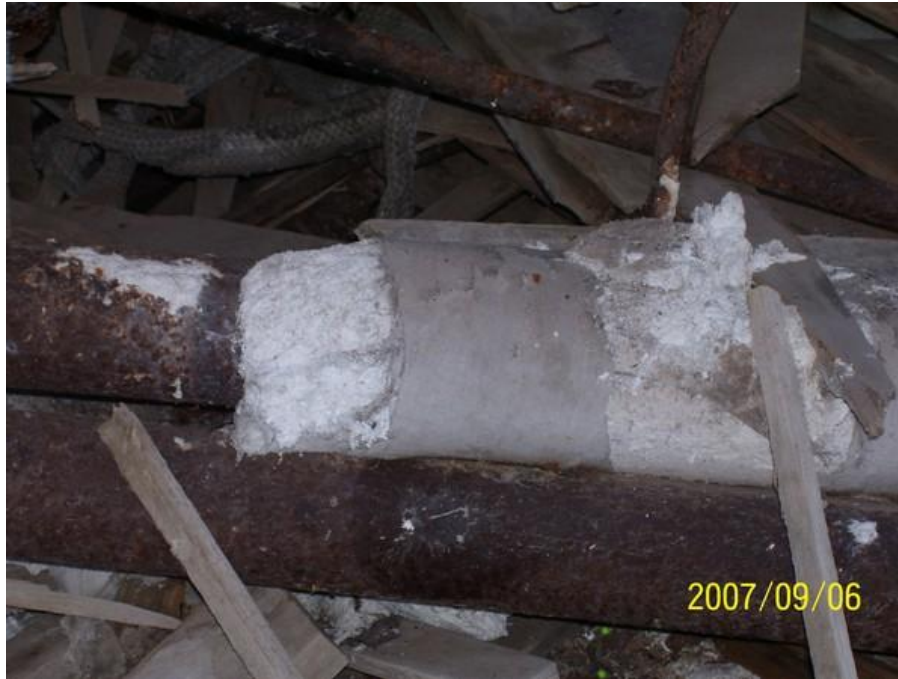
shown); ACM is discussed further in the *Chemical Hazards Associated with Physical Structures* section.

Figure 12. Suspected asbestos-containing material at “Building in Mason,” west of former Quincy Reclamation Plant area (across M-26) in Mason (Houghton County), Michigan. (Picture taken September 6, 2007. Source: Weston2007.)

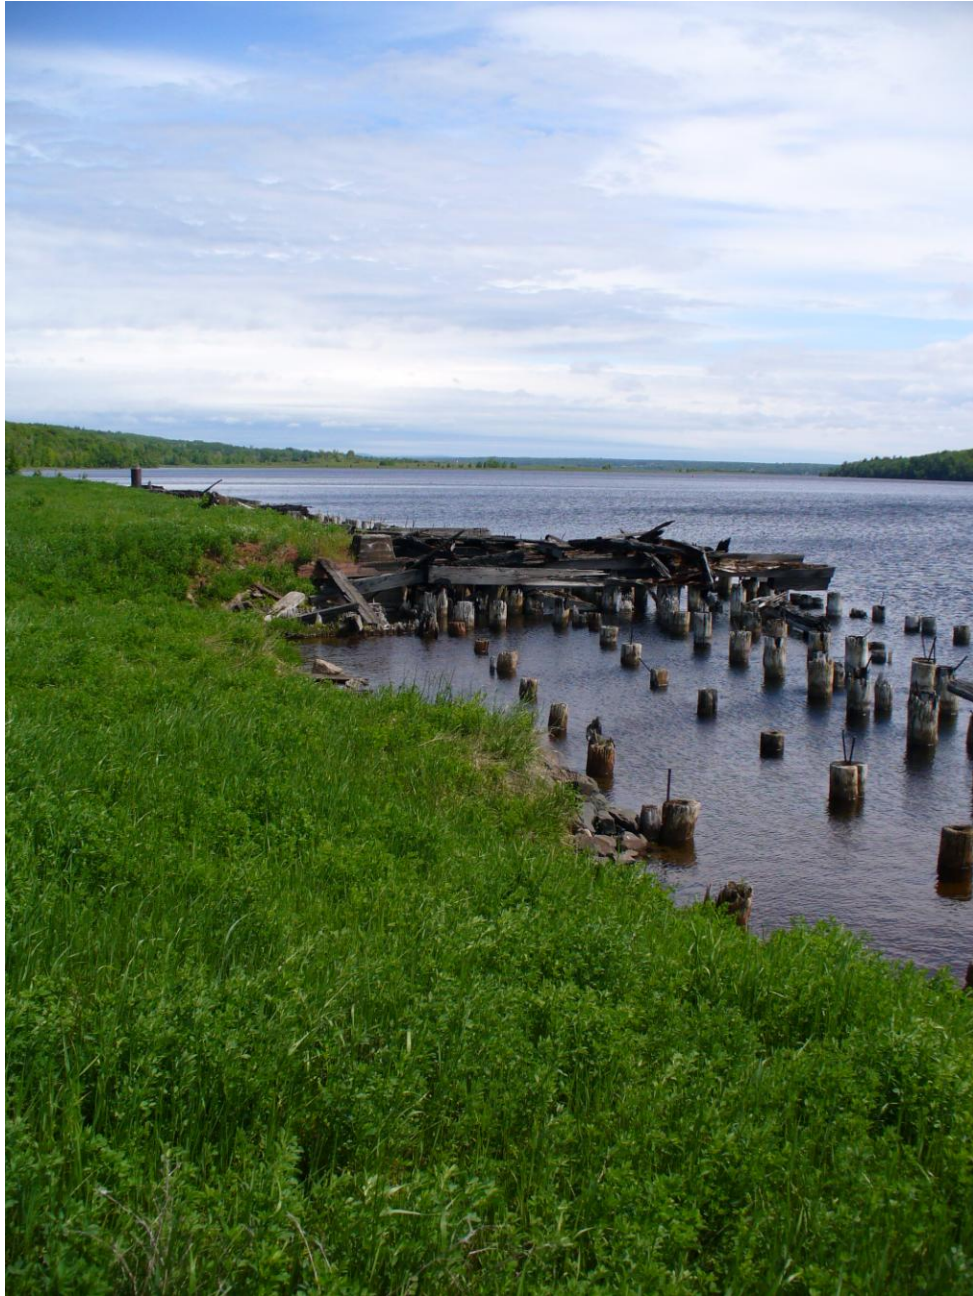
The pilings present a hazard to boaters and personal watercraft (“jetski”) users who may be unaware of their presence and not see them soon enough to avoid them.

Figure 13. Remnants of coal docks along Torch Lake shoreline between Mason and Hubbell (Houghton County), Michigan. (Picture taken June 16, 2008. Source: MDCH.)

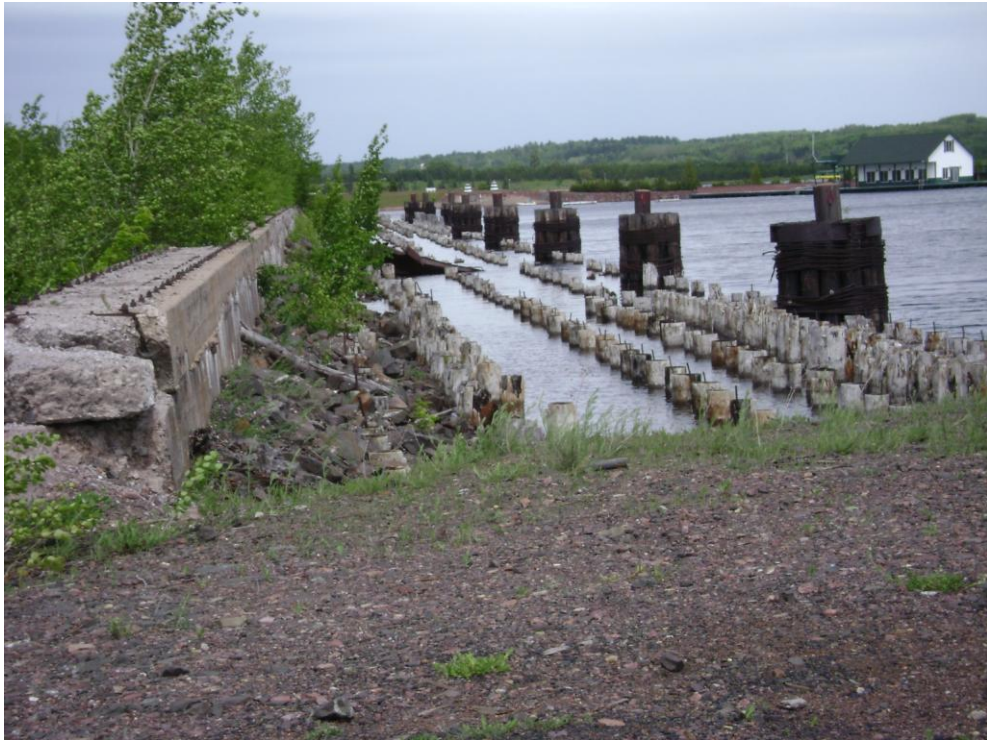
Figure 14. Remnants of coal docks along Torch Lake shoreline north of Hubbell (Houghton County), Michigan. (Picture taken June 16, 2008. Source: MDCH.)

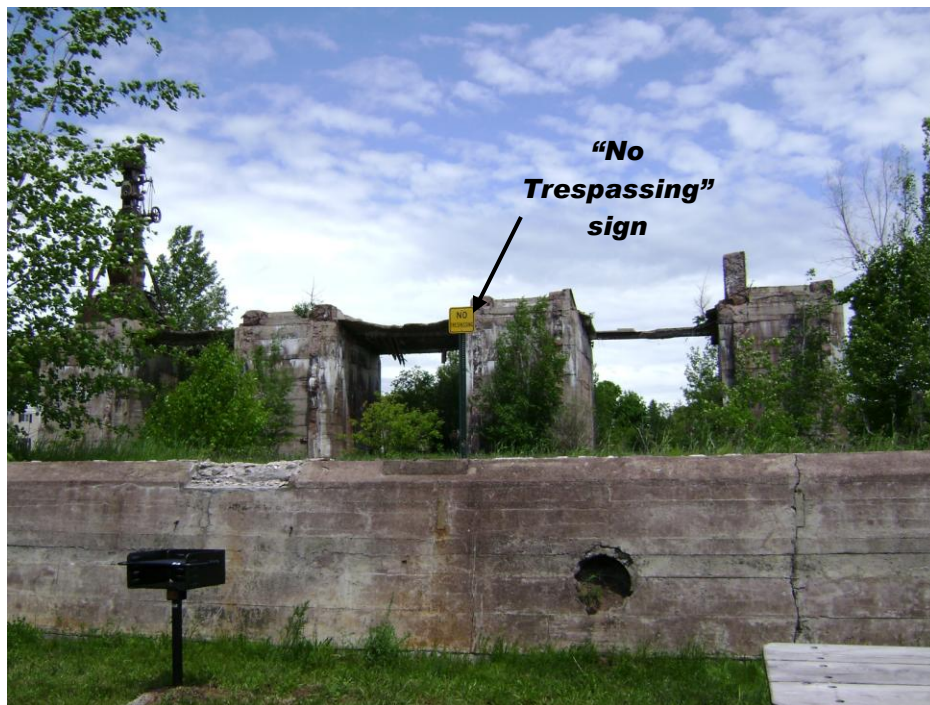
Figure 16. Wall with “No Trespassing” sign separating playground/picnic area from former Ahmeek stamping mill ruins in Tamarack City/Hubbell (Houghton County), Michigan. (Picture taken June 16, 2008. Source: MDCH.)

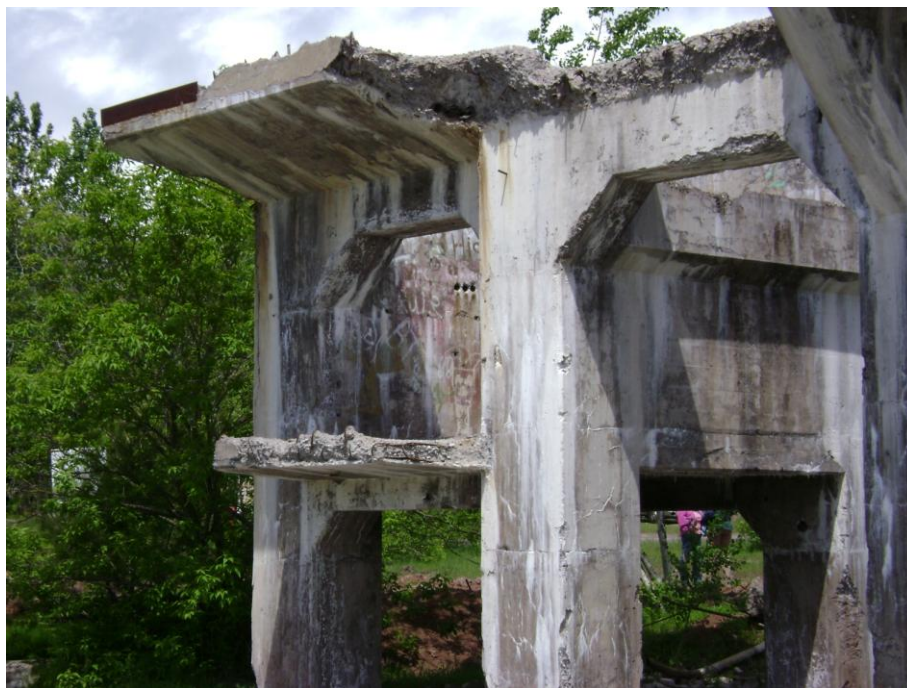
The ruins present a falling hazard, as it is evident people have climbed on them (Figure 17). The dumping area presents a trip-and-fall hazard, and it is not known what might have been dumped there other than what is shown in Figure 18.

Figure 17. Evidence of graffiti at former Ahmeek stamping mill ruins in Tamarack City/Hubbell (Houghton County), Michigan. (Picture taken June 16, 2008. Source: MDCH.)

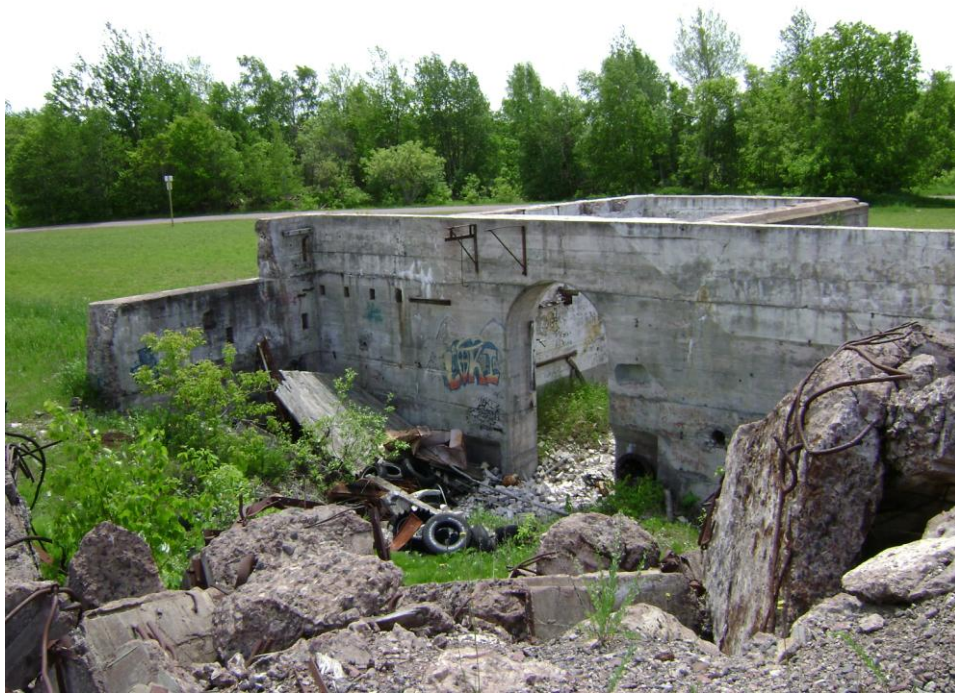
Figure 18. Evidence of graffiti and dumping at former Ahmeek stamping mill ruins in Tamarack City/Hubbell (Houghton County), Michigan. (Picture taken June 16, 2008. Source: MDCH.)

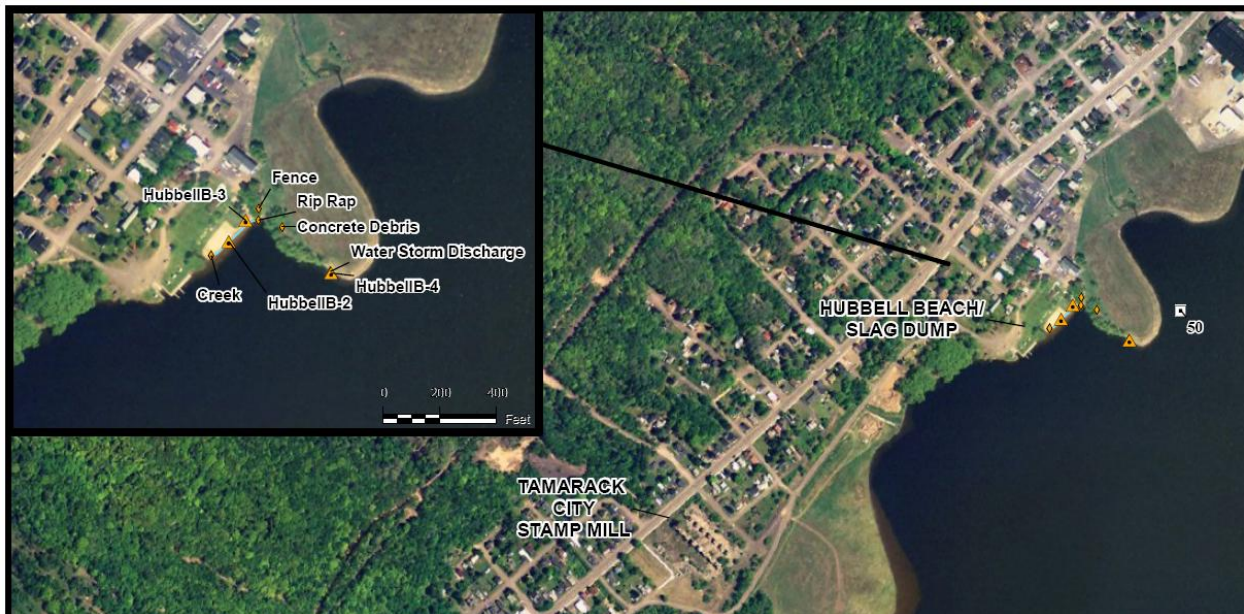
At the very least, the presence of visible waste is a nuisance. The waste in the former dump has not been fully characterized (A. Keranen, MDEQ RD, personal communication, 2011), thus there may be physical or chemical hazards posed by the items in that area. If untreated sewage is entering the lake, that can pose a biological hazard to persons using the beach and lake.

Figure 19. Overview of public beach and former slag dump in Hubbell (Houghton County), Michigan. (Symbols indicate environmental sampling locations, not discussed here. Source: Weston 2007.)

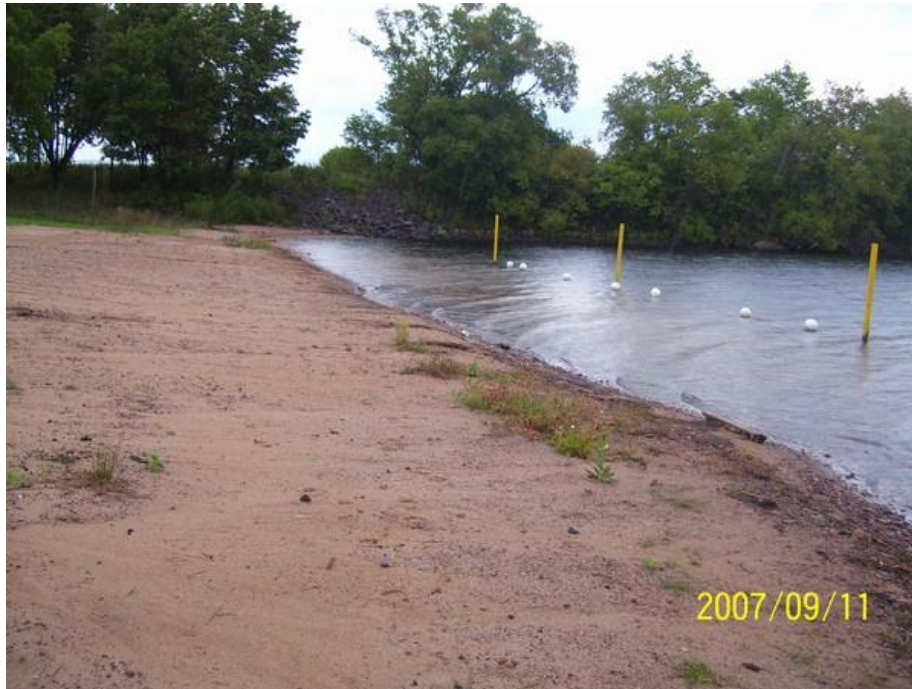
Figure 20. Public beach on Torch Lake at Hubbell (Houghton County), Michigan, looking north at former slag dump. (Picture taken September 11, 2007. Source: Weston 2007.)

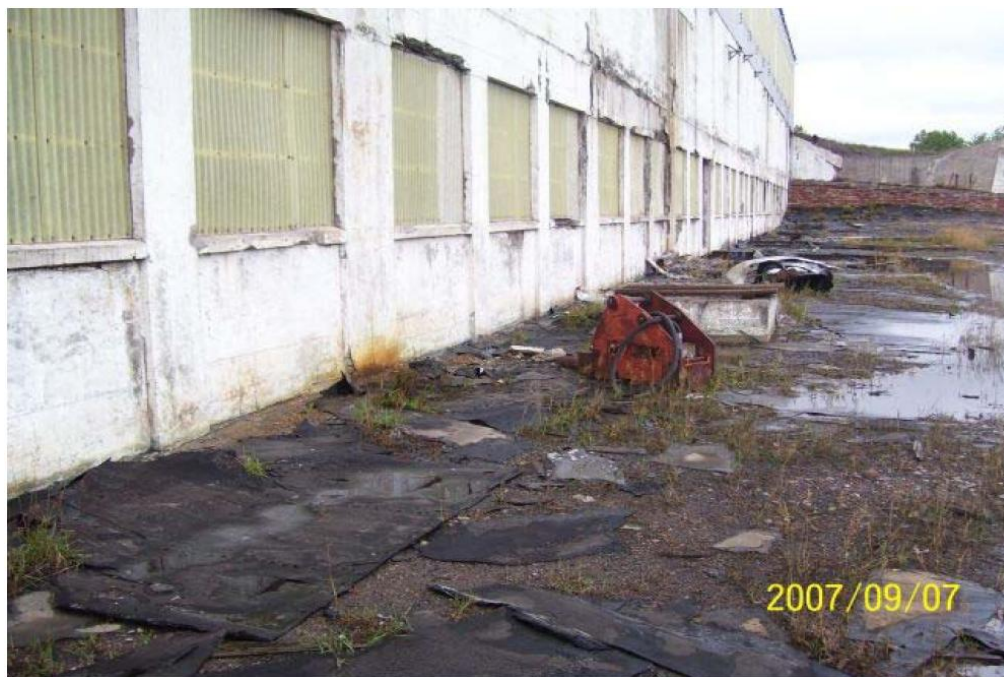
Since people are dumping residential trash at this location, it is reasonable to expect that other trespassers may be coming to the site. The old building and debris on the site may pose physical hazards (sharp edges, slip-and-fall), and mining-related or household waste could pose chemical hazards.

Figure 21. Mineral Building in Hubbell (Houghton County), Michigan. (Picture taken September 7, 2007. Source: Weston 2007.)

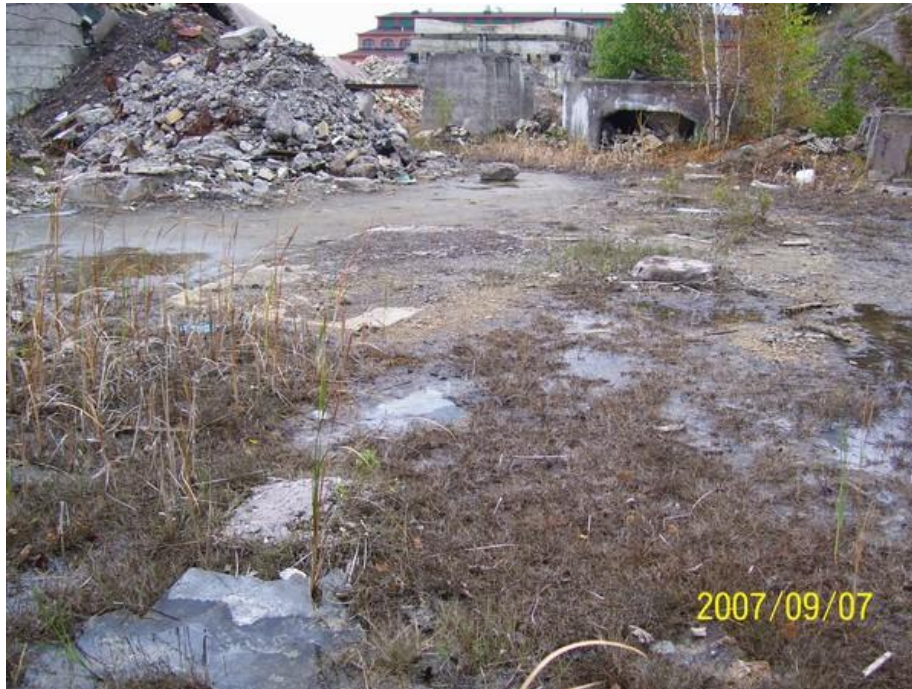
Figure 22. Debris at Mineral Building in Hubbell (Houghton County), Michigan. (Picture taken September 7, 2007. Source: Weston 2007.)

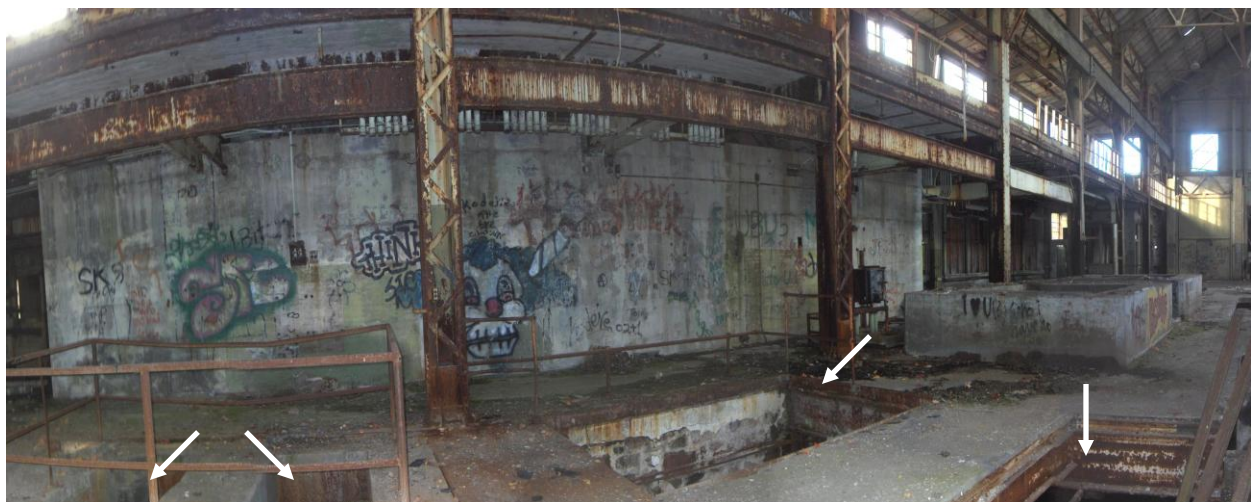
There are several deep open pits inside the plant, some with fall protection but others without (Figure 23). Partially submerged drums were observed in some of the pits. There are sediments in the pits that have been shown to contain polychlorinated biphenyls (PCBs; MDEQ, unpublished data, 2008). ACM has been reported at this property, both in and outside the building (http://www.epaossc.org/site/site_profile.aspx?site_id=5961). Thus, there are physical as well as chemical hazards present at the former C & H Power Plant. The EPA Emergency Removal branch currently is involved in addressing the hazards at this site. MDCH is evaluating possible public health implications in a separate health consultation.

Figure 23. Interior of former Calumet and Hecla Power Plant showing graffiti and floor pits (white arrows), Lake Linden (Houghton County), Michigan. (Photo date unknown. Source: MDNRE.)
