Public Health Assessment

Physical hazards in the Torch Lake Superfund site and surrounding areas

Houghton and Keweenaw Counties, Michigan

**Prepared by the
Michigan Department of Community Health**

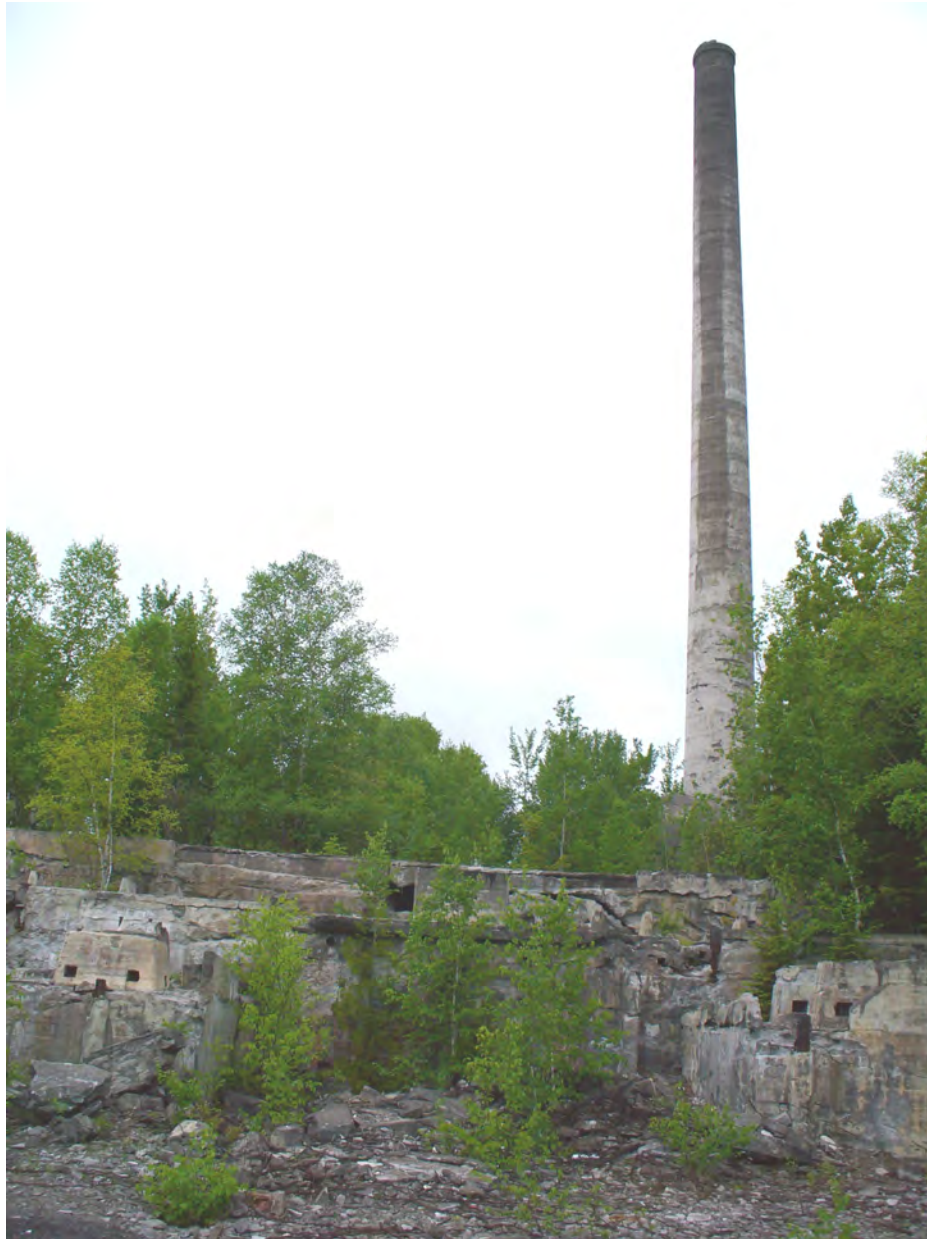
deposited the stampsands into Lake Superior, and various piles of rubble remain. People may attempt to explore the interior of the stack (Figure 2) at its base and the interior of the underground structure of the conveyor (Figure 3). The stability of these structures is unknown. Also, there appears to be asbestos-containing material (ACM) near several rubble piles (not shown); ACM is discussed further in the *Chemical Hazards Associated with Physical Structures* section.

Figure 2. Ruins and stack at former Mohawk stamping mill, Gay (Keweenaw County), Michigan. (Picture taken June 16, 2008. Source: MDCH.)

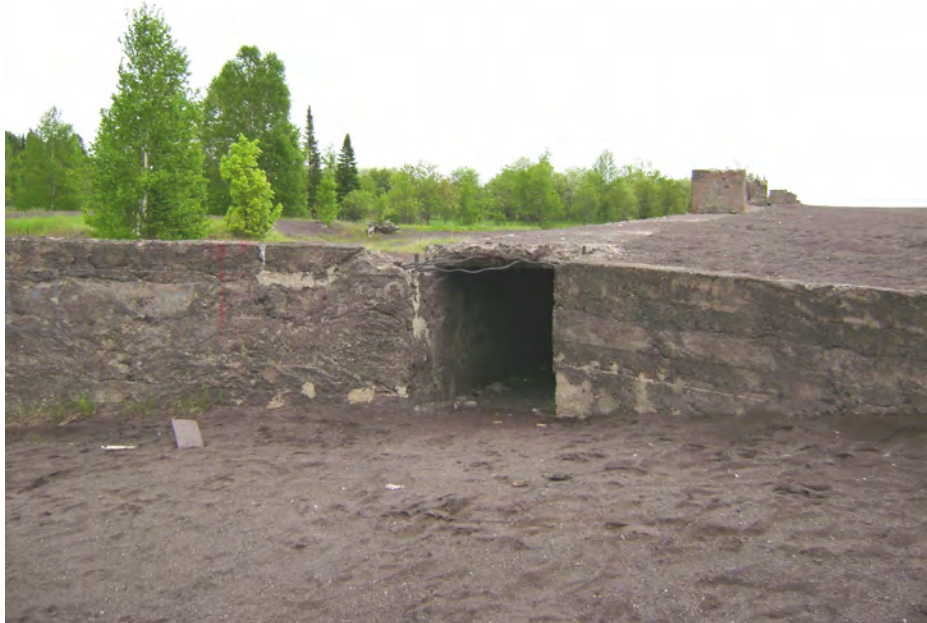
Figure 3. Ruins of conveyor that carried stamp sands to Lake Superior at former Mohawk stamping mill, Gay (Keweenaw County), Michigan. (Picture taken June 16, 2008. Source: MDCH.)

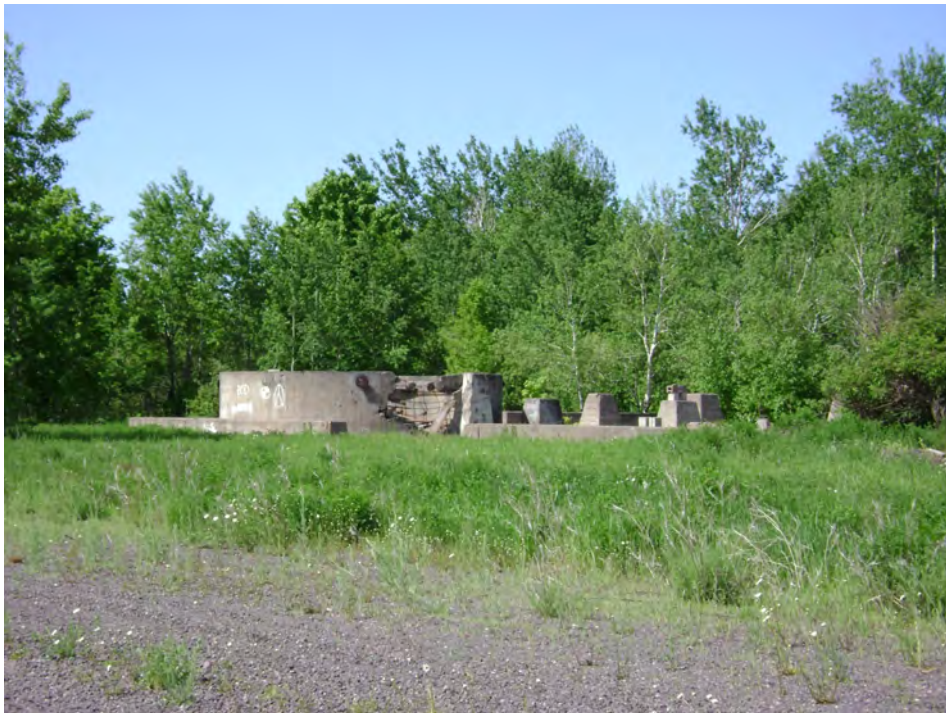
These structures have slip-and-fall hazards. Also, the UST has the potential for an explosion if fuel vapors are present. The exposed dredge likely has sharp edges, its sturdiness is questionable, and people jumping off of it into the lake may misjudge the water's depth. Although a buoy marks the location of the completely sunken dredge, it is unclear how near the water surface the structure is and whether it poses a hazard to swimmers or boaters. Similar to the stack at Gay, people may choose to explore the interior of the stack here, if accessible.

Figure 4. Ruins of Quincy reclamation plant in Mason (Houghton County), Michigan. (Picture taken June 16, 2008. Source: MDCH.)

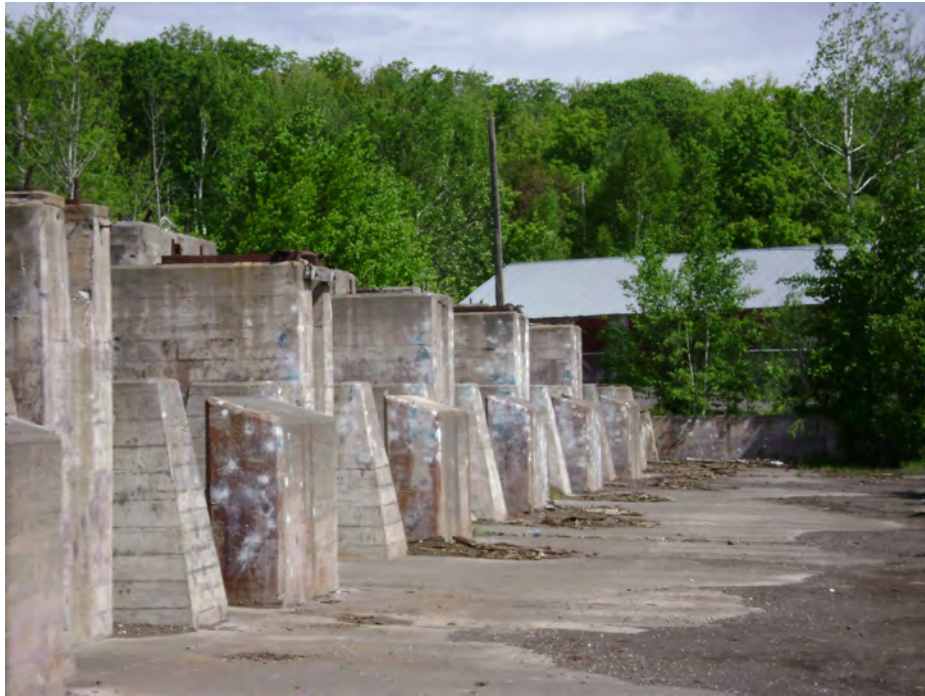
Figure 5. Closer view, with evidence of paintball splatters, of ruins of Quincy reclamation plant in Mason (Houghton County), Michigan. (Picture taken June 16, 2008. Source: MDCH.)

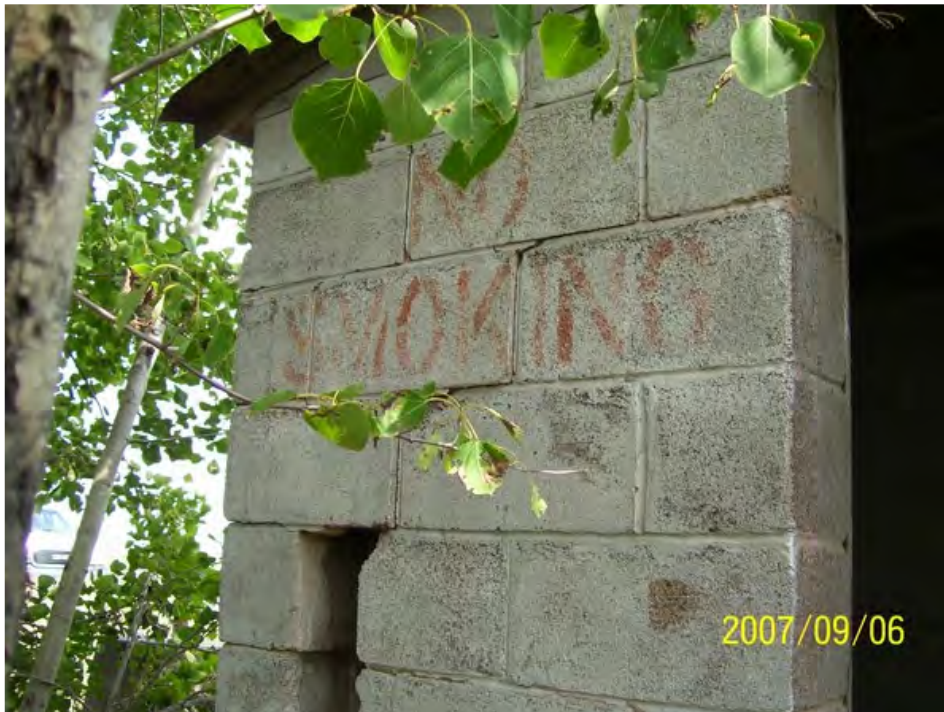
Figure 6. Possible underground storage tank at former Quincy reclamation plant in Mason (Houghton County), Michigan. (Picture taken September 6, 2007. Source: Weston 2007.)

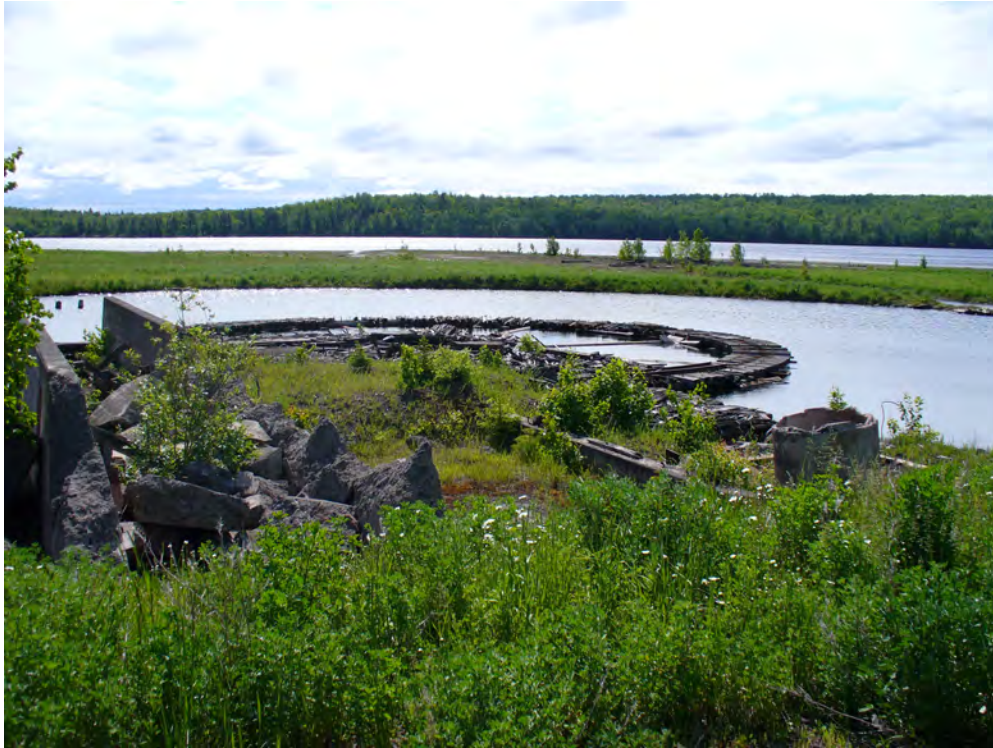
Figure 7. Circular track offshore in Torch Lake at former Quincy reclamation plant in Mason (Houghton County), Michigan. (Picture taken June 16, 2008. Source: MDCH.)

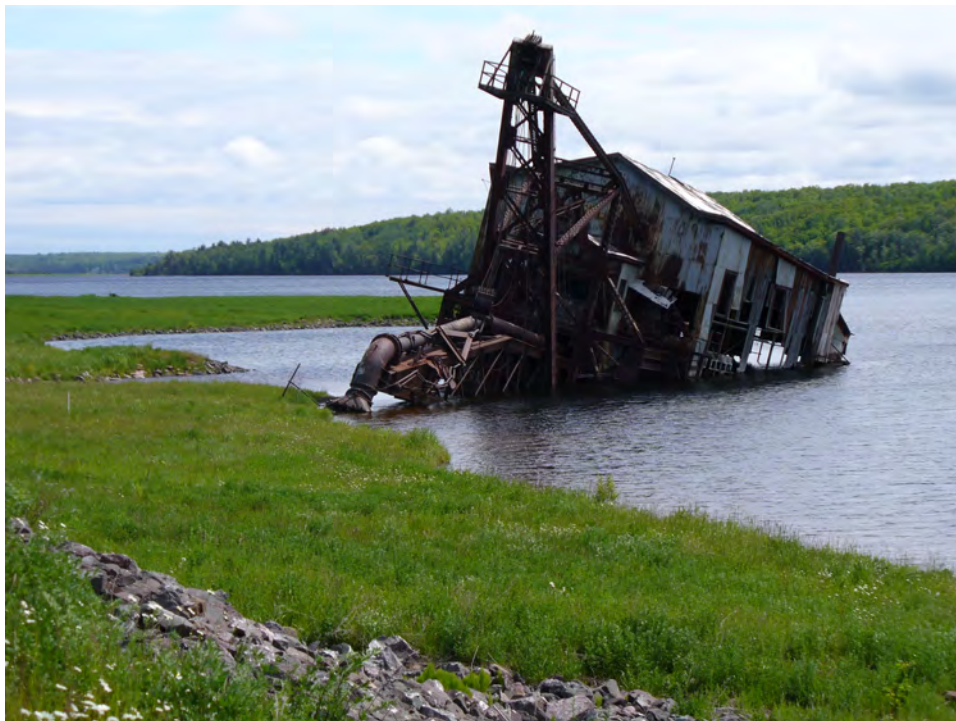
Figure 8. Partially sunken dredge in Torch Lake near former Quincy reclamation plant in Mason (Houghton County), Michigan. (Picture taken June 16, 2008. Source: MDCH.)

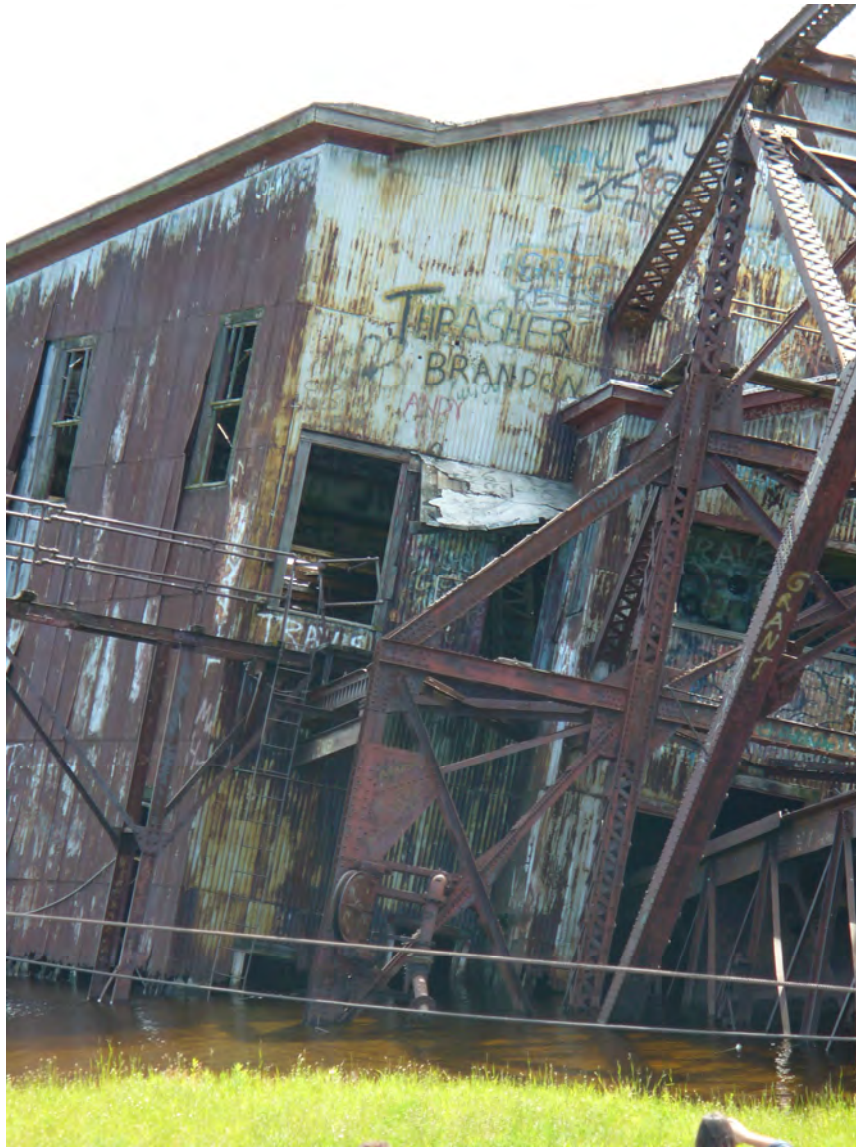
Figure 9. Closer look, with evidence of graffiti, at dredge in Torch Lake near former Quincy reclamation plant in Mason (Houghton County), Michigan. (Picture taken June 16, 2008. Source: MDCH.)

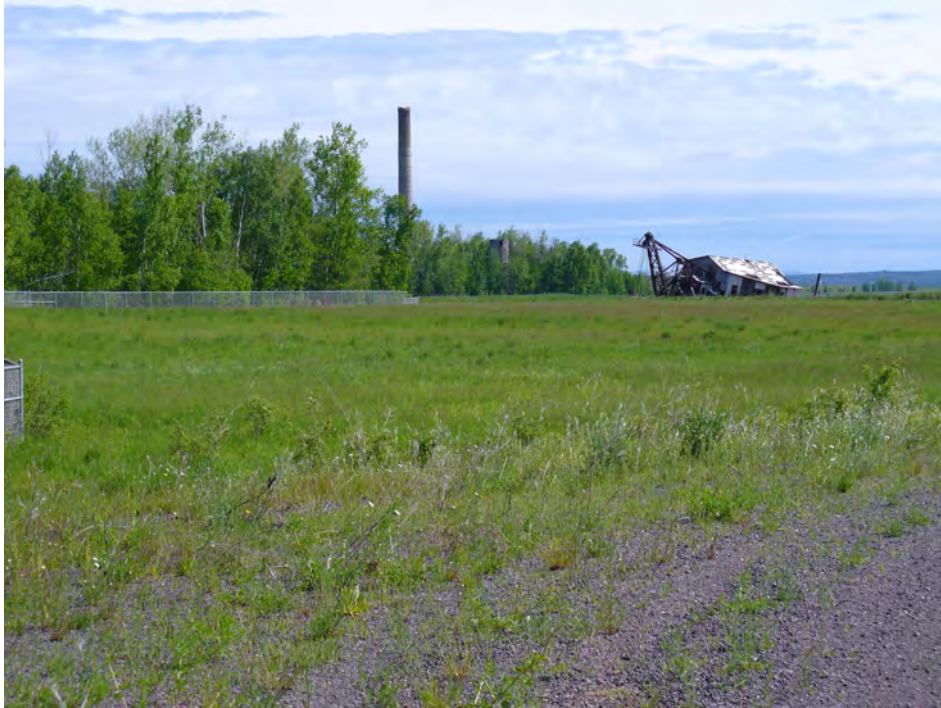
Figure 10. View of stack and partially sunken dredge near former Quincy reclamation plant in Mason (Houghton County), Michigan. (Picture taken June 16, 2008. Source: MDCH.)

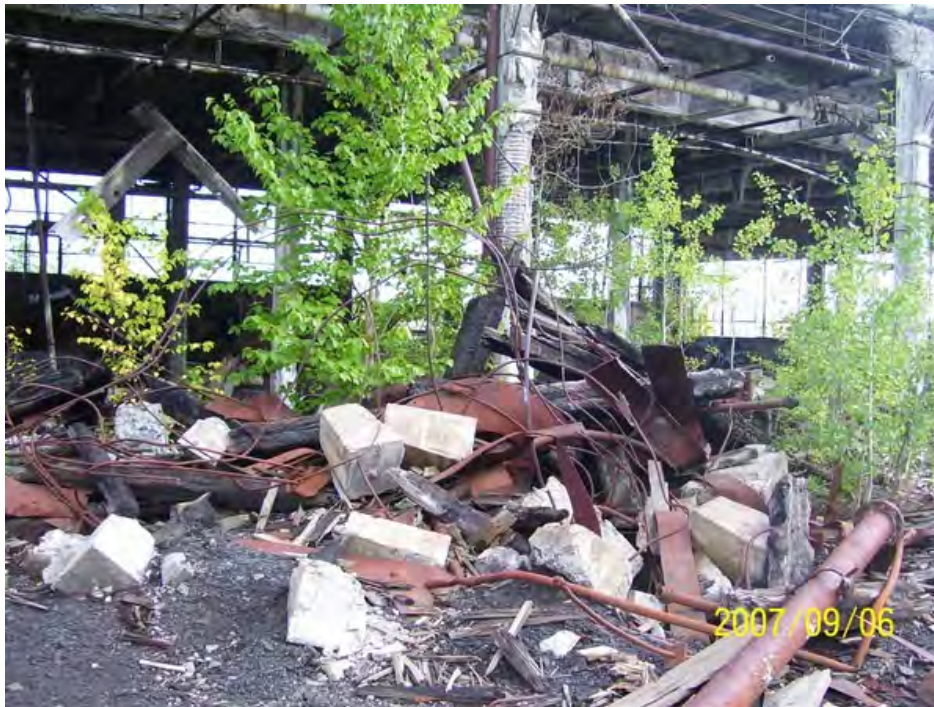
On the west side of M-26 in Mason, slightly north of the former Quincy Reclamation Plant area, is a former industrial building that is no longer in use. MDCH did not stop here during the site visit in 2008, but MDEQ pointed out the structure. The property is not part of the Torch Lake Superfund site. Along with the building, the property also contains exposed foundation materials and debris (Figure 11), empty drums, and suspected ACM (Figure 12). There reportedly is evidence of trespassing and vandalism (Weston 2007).

There are numerous safety hazards at this site: debris could cause tripping, sheet metal and cables may have sharp edges, and the integrity of the structure is questionable. The proximity of the property to M-26 may attract looters seeking scrap metal to sell.

Figure 11. Debris at “Building in Mason,” west of former Quincy Reclamation Plant area (across M-26) in Mason (Houghton County), Michigan. (Picture taken September 6, 2007. Source: Weston 2007.)

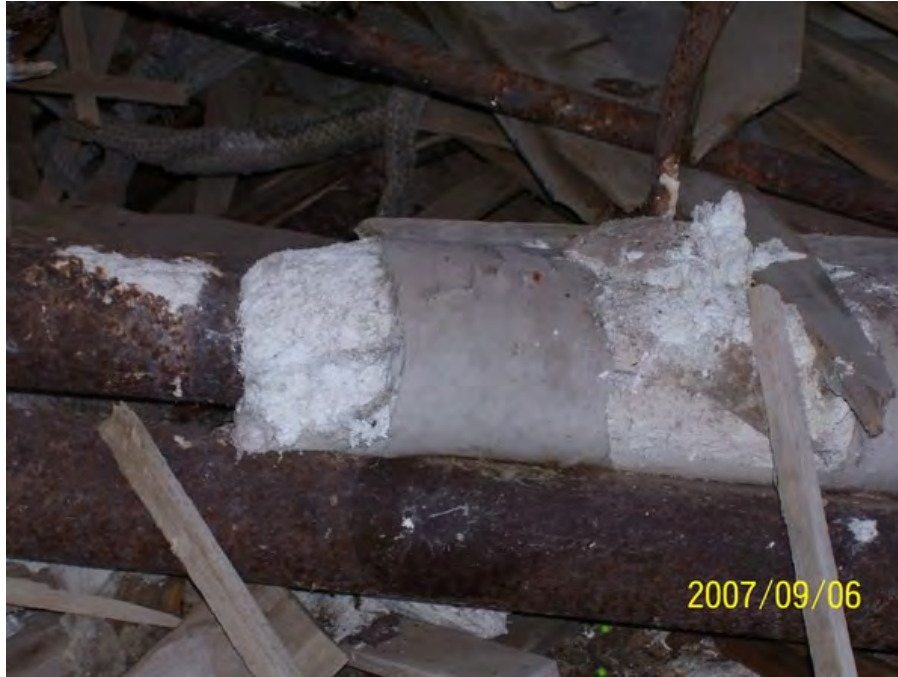
Figure 12. Suspected asbestos-containing material at “Building in Mason,” west of former Quincy Reclamation Plant area (across M-26) in Mason (Houghton County), Michigan. (Picture taken September 6, 2007. Source: Weston2007.)

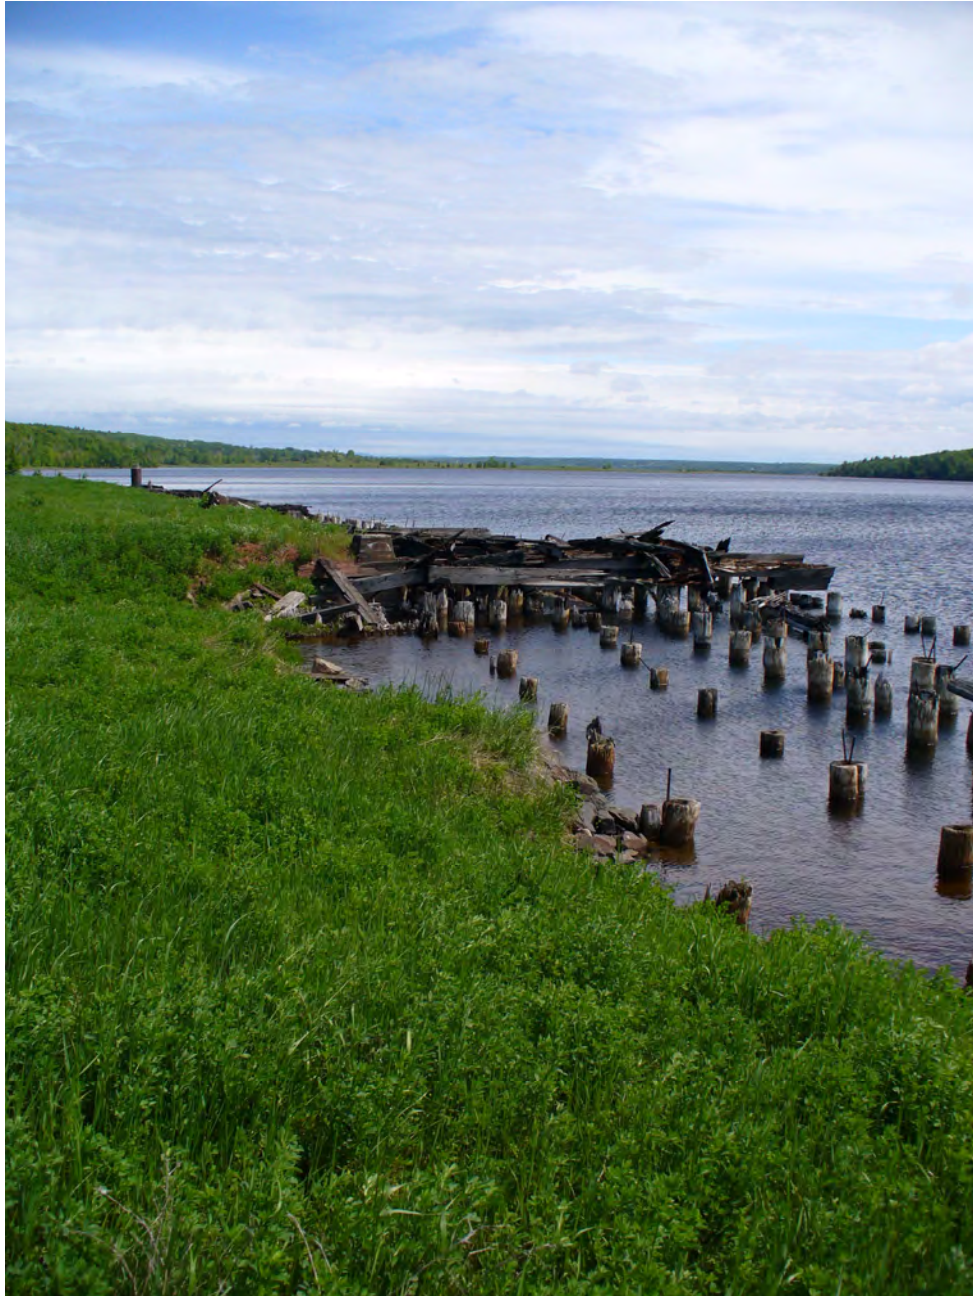
The pilings present a hazard to boaters and personal watercraft (“jetski”) users who may be unaware of their presence and not see them soon enough to avoid them.

Figure 13. Remnants of coal docks along Torch Lake shoreline between Mason and Hubbell (Houghton County), Michigan. (Picture taken June 16, 2008. Source: MDCH.)

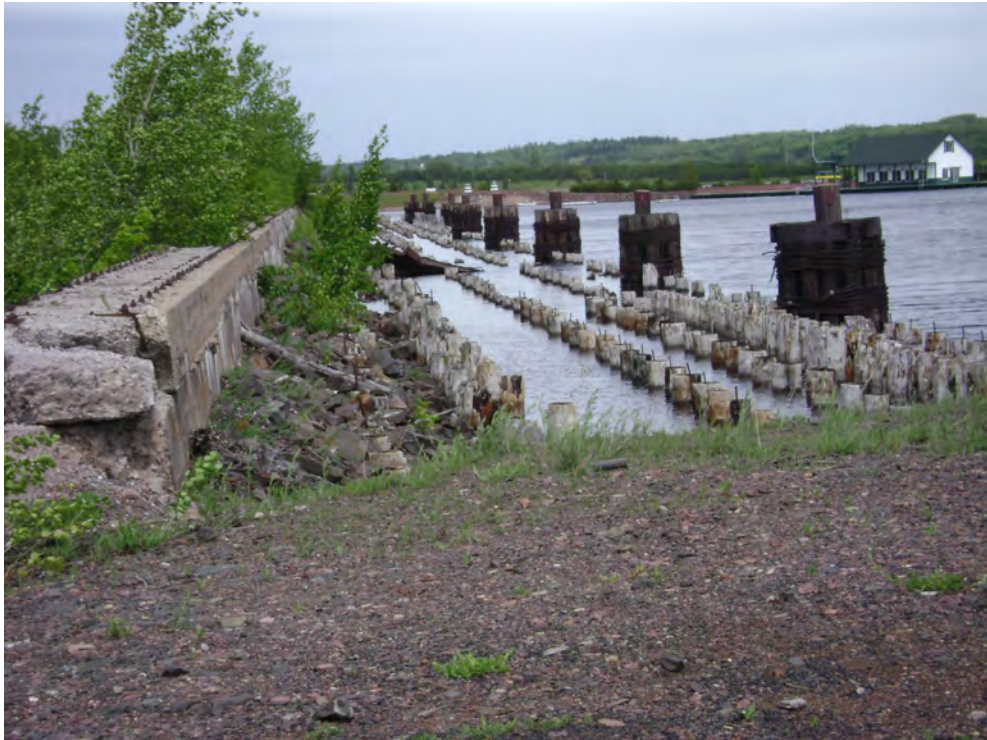
Figure 14. Remnants of coal docks along Torch Lake shoreline north of Hubbell (Houghton County), Michigan. (Picture taken June 16, 2008. Source: MDCH.)

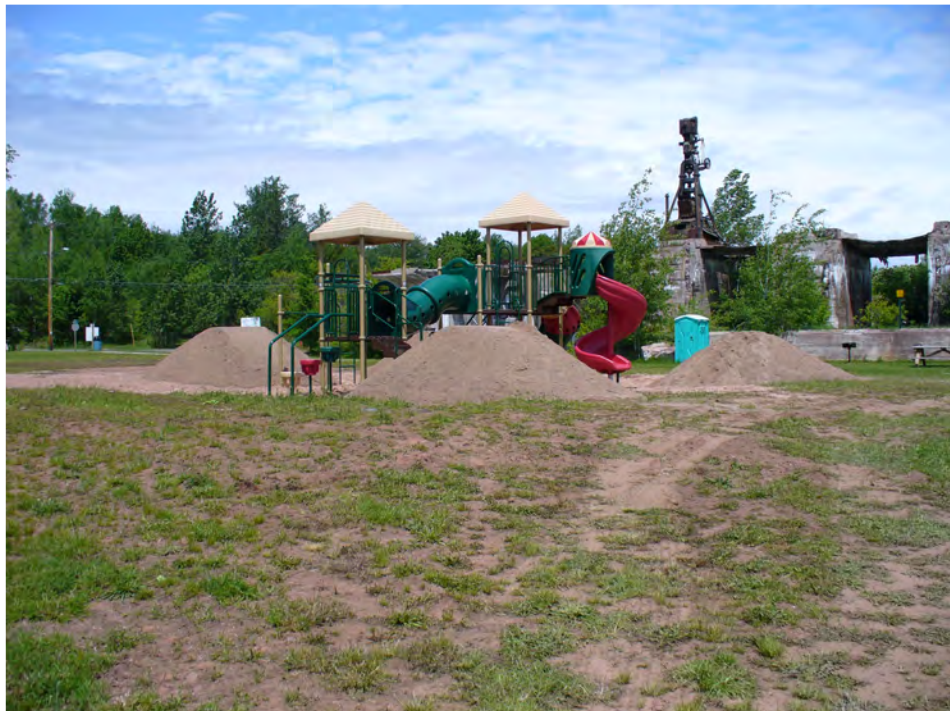
The former Ahmeek stamp mill in Tamarack City (also known as the “Tamarack City stamp mill” ruins) is adjacent to a playground (Figure 15). Although there is a small “No Trespassing” sign between the two areas (Figure 16), there is no access restriction between the playground and the ruins. There is evidence of graffiti (Figures 17 and 18) and dumping (Figure 18) at the site.

Figure 16. Wall with “No Trespassing” sign separating playground/picnic area from former Ahmeek stamping mill ruins in Tamarack City/Hubbell (Houghton County), Michigan. (Picture taken June 16, 2008. Source: MDCH.)

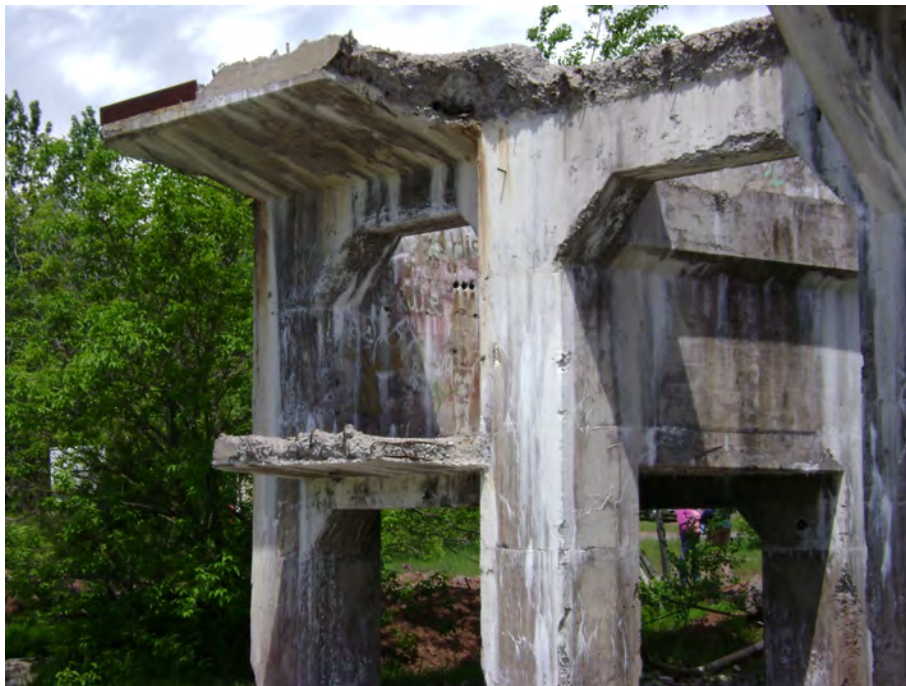
The ruins present a falling hazard, as it is evident people have climbed on them (Figure 17). The dumping area presents a trip-and-fall hazard, and it is not known what might have been dumped there other than what is shown in Figure 18.

Figure 17. Evidence of graffiti at former Ahmeek stamping mill ruins in Tamarack City/Hubbell (Houghton County), Michigan. (Picture taken June 16, 2008. Source: MDCH.)

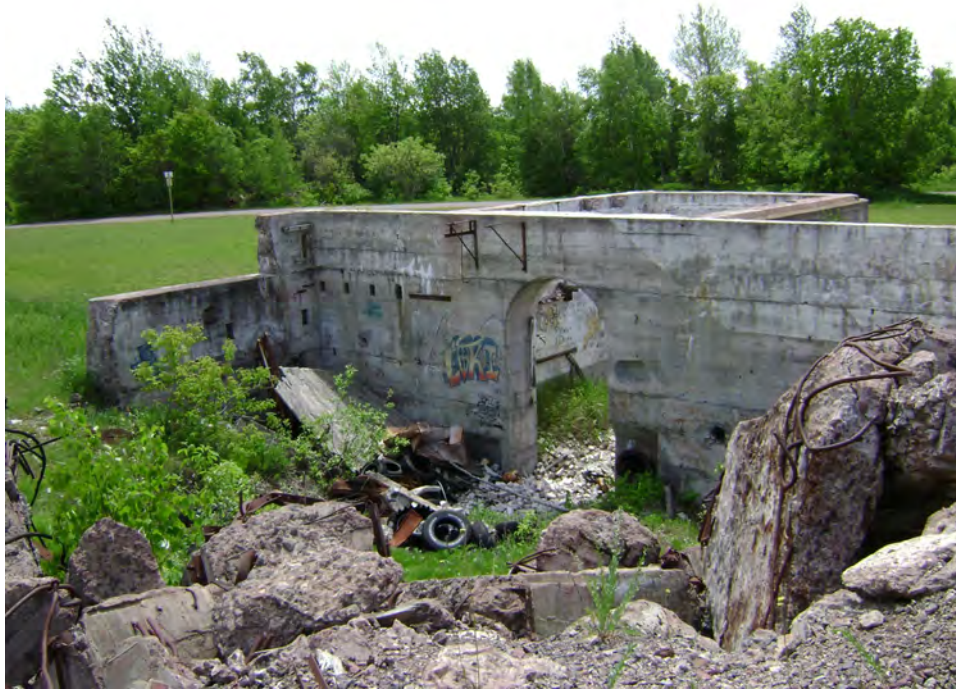
Figure 18. Evidence of graffiti and dumping at former Ahmeek stamping mill ruins in Tamarack City/Hubbell (Houghton County), Michigan. (Picture taken June 16, 2008. Source: MDCH.)

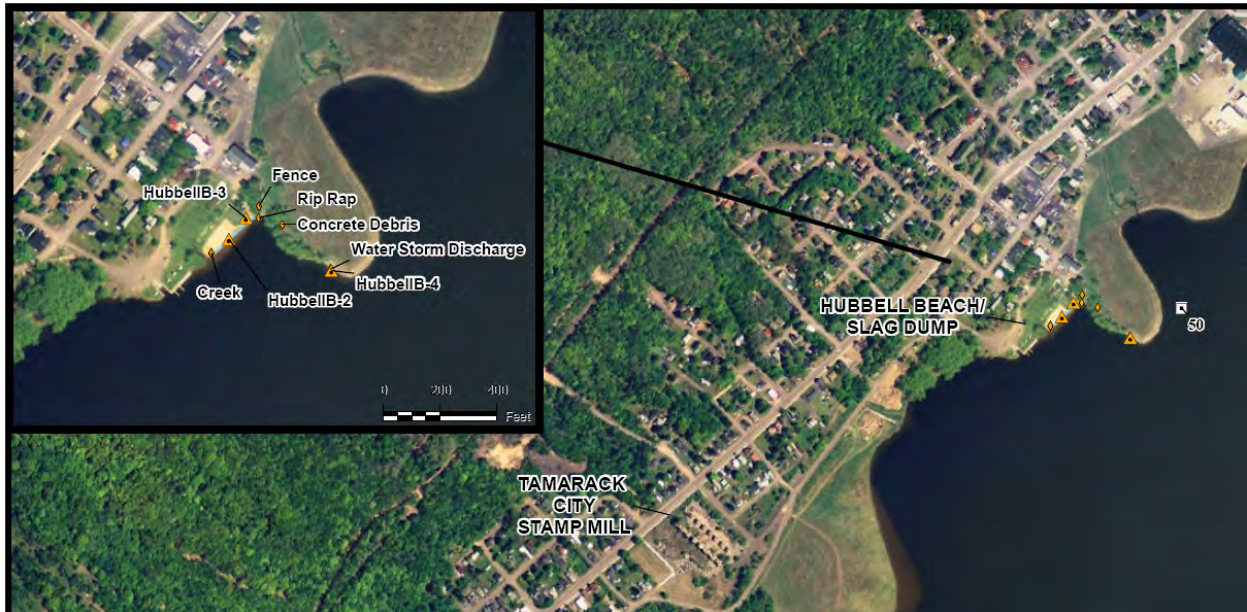
There is a township park in Hubbell that includes a boat launch, docks, a playground, and a swimming beach on the shore of Torch Lake. Immediately northeast of the beach, also on the shore, is a former dump where slag and other wastes were deposited (Figures 19 and 20). The dump has a vegetative cover, but the cover is not intact. There are reports of swimmers and divers seeing old appliances and batteries on the lake bottom near the swimming beach (A. Keranen, MDEQ RRD, personal communication, 2010). Weston (2007) reports direct discharges of residential sewage from local homes via piping to the northeast lobe of the beach (i.e., the former dump area.) There is also a pipe that discharges from the dump into the lake (identified as “Water Storm Discharge” in Figure 19; A. Keranen, MDEQ RRD, personal communication, 2011).

Figure 20. Public beach on Torch Lake at Hubbell (Houghton County), Michigan, looking north at former slag dump. (Picture taken September 11, 2007. Source: Weston 2007.)

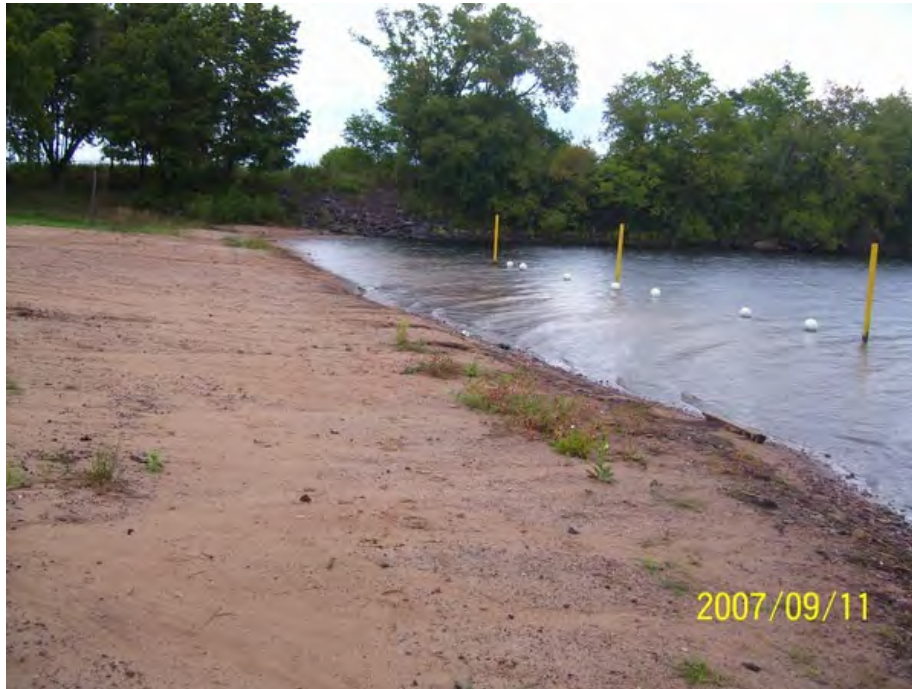
At the very least, the presence of visible waste is a nuisance. The waste in the former dump has not been fully characterized (A. Keranen, MDEQ RRD, personal communication, 2011), thus there may be physical or chemical hazards posed by the items in that area. If untreated sewage is entering the lake, that can pose a biological hazard to persons using the beach and lake.

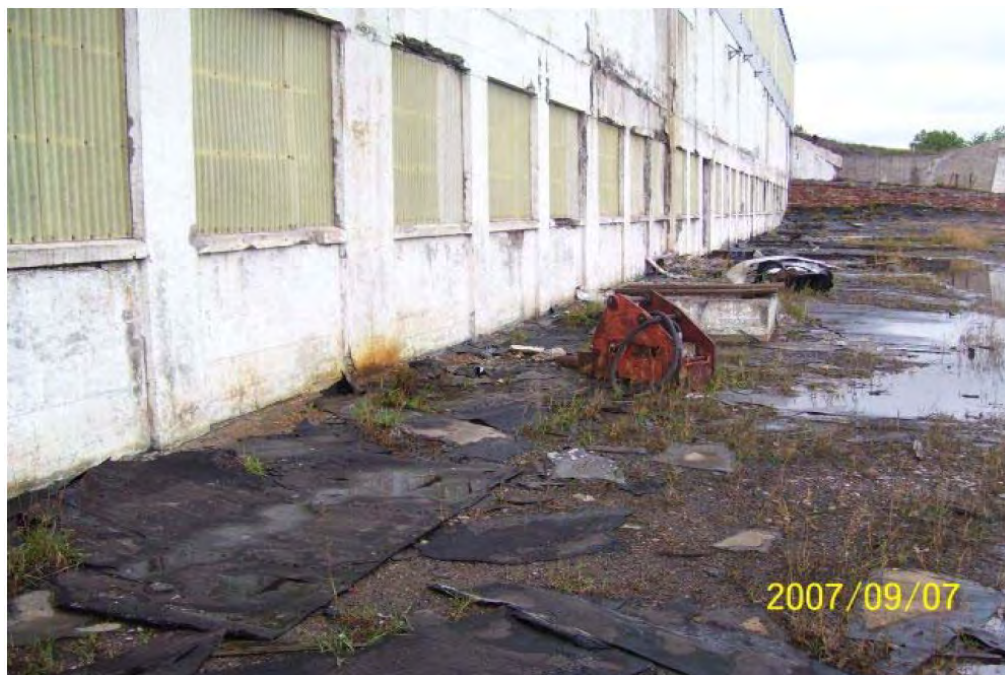
Since people are dumping residential trash at this location, it is reasonable to expect that other trespassers may be coming to the site. The old building and debris on the site may pose physical hazards (sharp edges, slip-and-fall), and mining-related or household waste could pose chemical hazards.

Figure 21. Mineral Building in Hubbell (Houghton County), Michigan. (Picture taken September 7, 2007. Source: Weston 2007.)

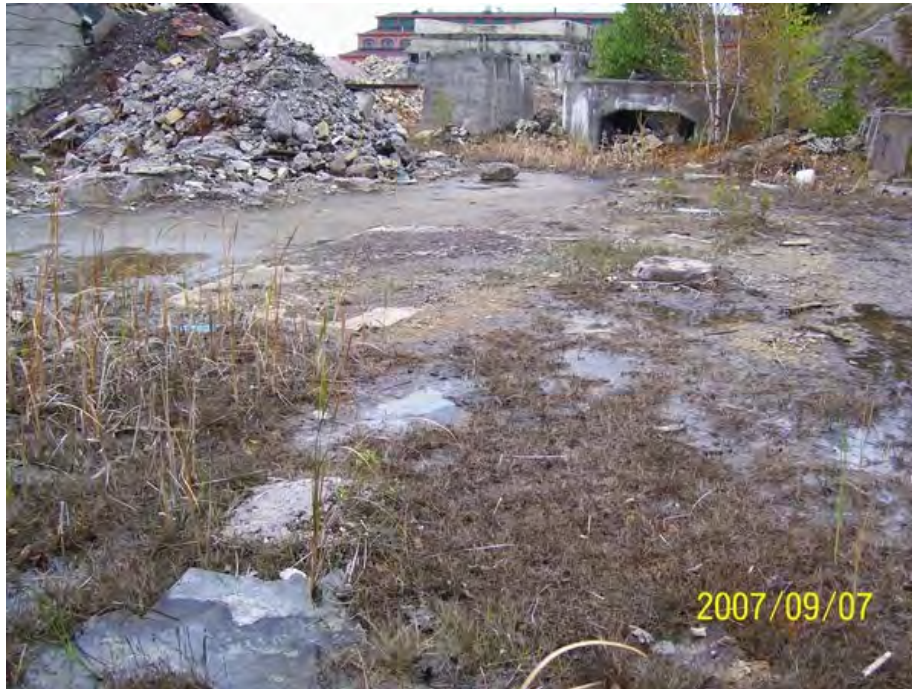
Figure 22. Debris at Mineral Building in Hubbell (Houghton County), Michigan. (Picture taken September 7, 2007. Source: Weston 2007.)

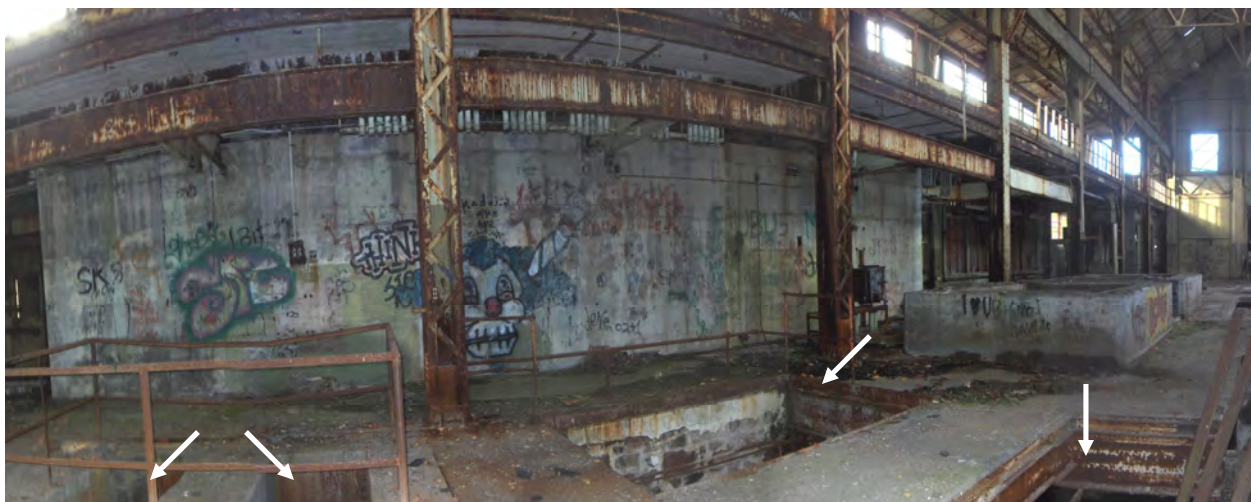
There are several deep open pits inside the plant, some with fall protection but others without (Figure 23). Partially submerged drums were observed in some of the pits. There are sediments in the pits that have been shown to contain polychlorinated biphenyls (PCBs; MDEQ, unpublished data, 2008). ACM has been reported at this property, both in and outside the building (http://www.epaos.org/site/site_profile.aspx?site_id=5961). Thus, there are physical as well as chemical hazards present at the former C & H Power Plant. The EPA Emergency Removal branch currently is involved in addressing the hazards at this site. MDCH is evaluating possible public health implications in a separate health consultation.

Figure 23. Interior of former Calumet and Hecla Power Plant showing graffiti and floor pits (white arrows), Lake Linden (Houghton County), Michigan. (Photo date unknown. Source: MDEQ.)
