Infrastructure Protection and Rehabilitation Response to High Lake Levels

MDOT OR21-013

March 2022 (Final)

Primary Author:

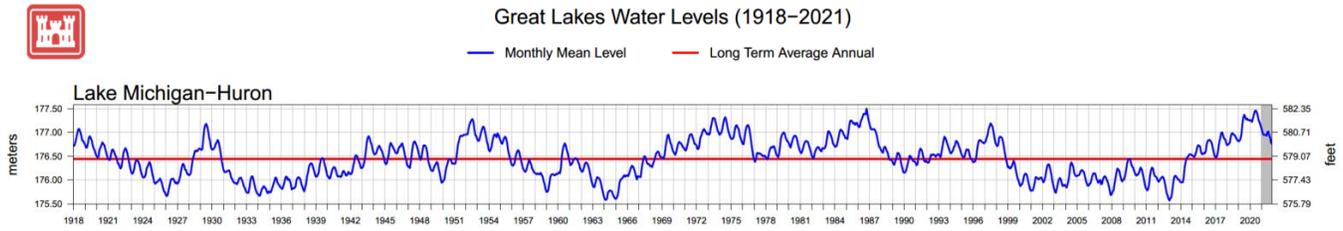
Figure 0-1. Historic lake level variability for Lake Michigan – Huron. Source: USACE Detroit District, 2021.²

4 - 6.5 feet, depending on the lake. An example of these long-term trends for lakes Michigan-Huron is shown in Figure 0-1.

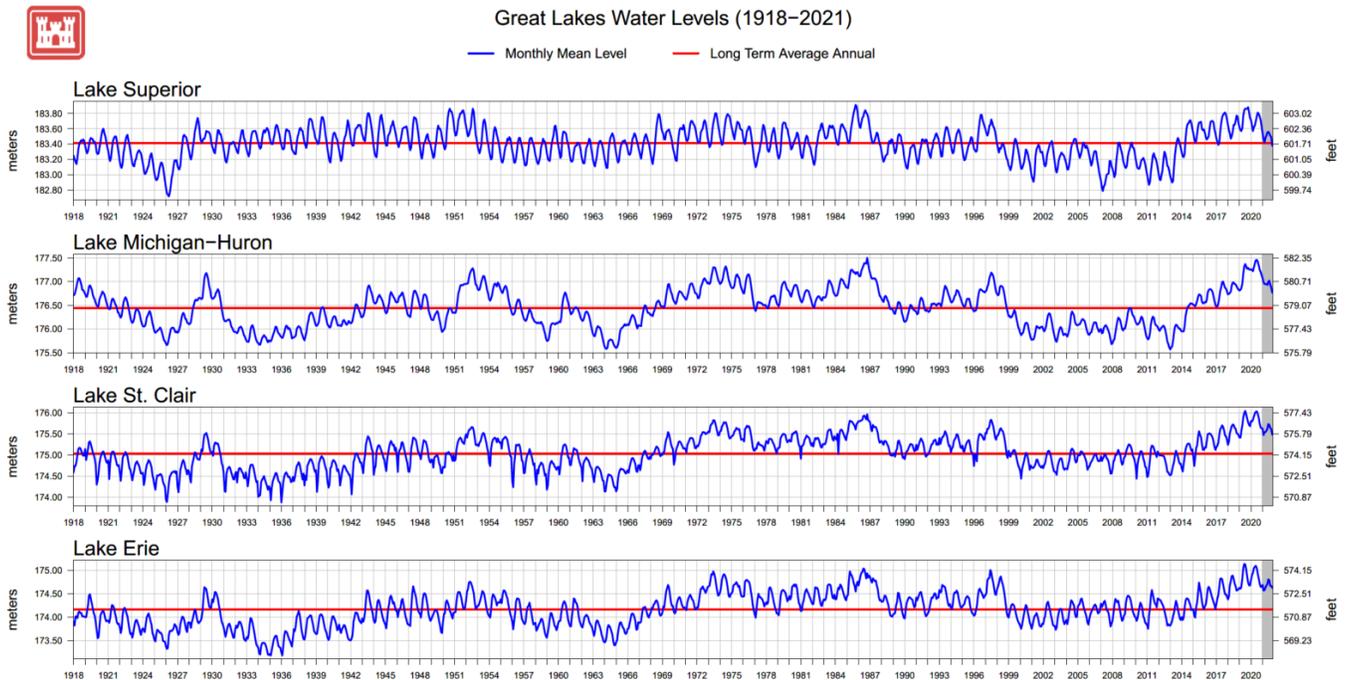
Figure 2-1. Historic lake level variability for Lakes Superior, Michigan – Huron, St. Clair, and Erie. Source: USACE Detroit District, 2021a.⁸

The Great Lakes water levels naturally show significant variability, both seasonally and across years or decades. Annual swings are relatively predictable, with higher water levels in summer and lower water levels in winter. However, these annual fluctuations in water levels are significantly smaller than the fluctuations seen across years or decades (by approximately one third) (Hanrahan et al., 2010). The total water level fluctuation between times of high lake levels and low lake levels across the period of record (going back to the early 1900s) is approximately 4– 6.5 feet, depending on the lake. These long-term trends are shown in Figure 2-1.

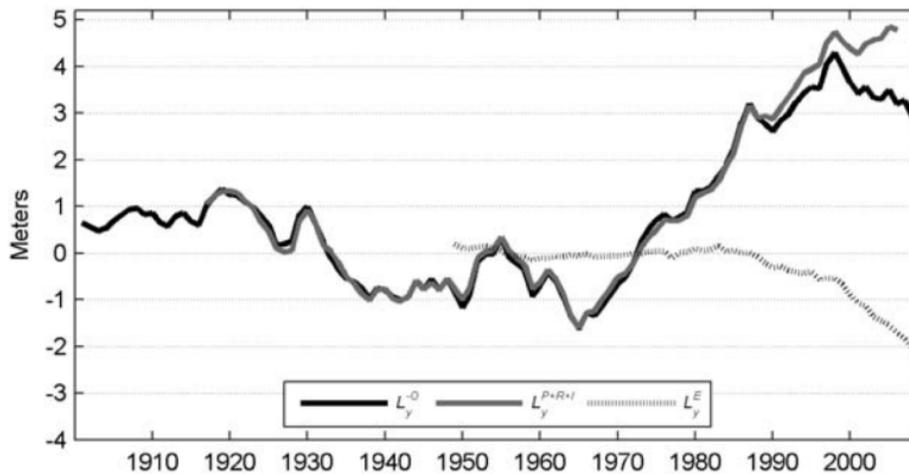
Figure 2-2. Outflow removed lake level curve (black) closely followed the precipitation driven components of net basin supply curve (gray; includes overlake precipitation, runoff, and inflows) prior to the mid-1980s, after which the lake level trends decreased, following the evaporation curve (dotted). Source: Hanrahan et al., 2010.

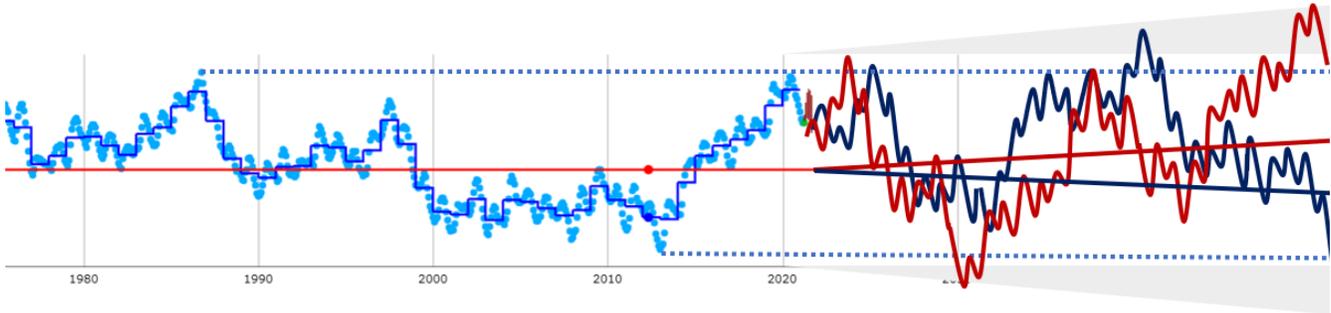
Figure 2-3. Schematic depiction of potential variability around an increasing long-term lake level average and a decreasing long-term lake level average. Base graphic source: Great Lakes Water Level Dashboard, NOAA/GLERL.

demonstrates that even if long term lake levels trends downward, MDOT will likely see years of high water, that may even result in peaks above those in the historical record.

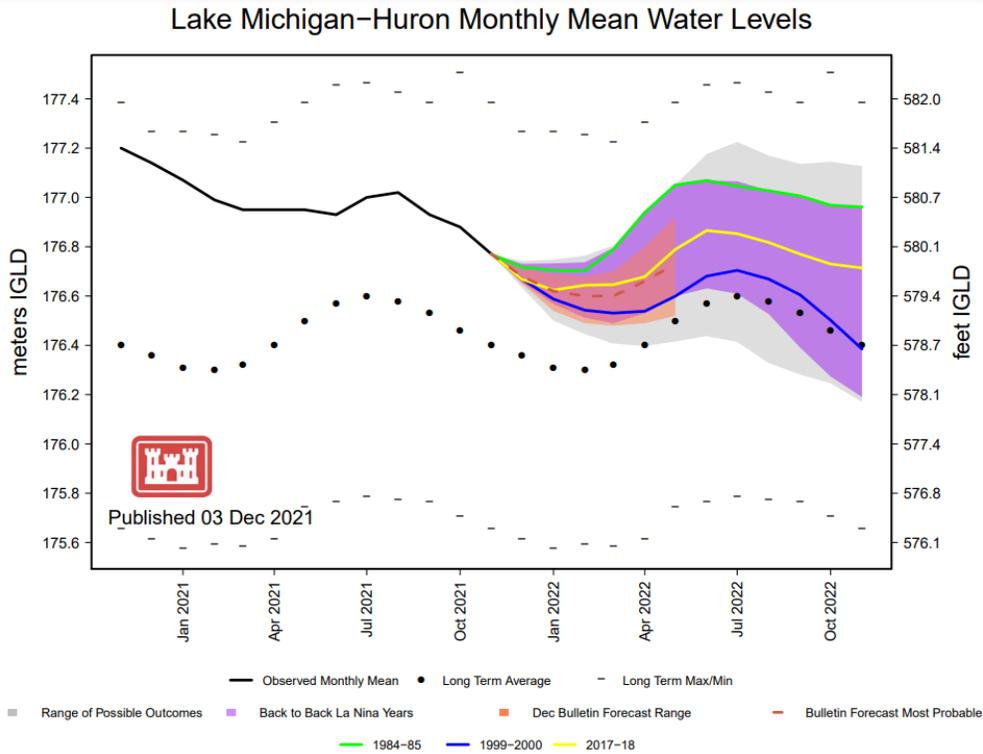
Figure 2-4. USACE October 2021 experimental forecast for Lakes Michigan-Huron. Source: USACE Detroit District, 2021b.

Also of note is the USACE Great Lakes Water Level Future Scenarios forecast. In addition to the available mid- to end-of-century long term trends available in the literature, NOAA/GLERL and the USACE have developed an unofficial (or experimental) forecast, which is updated monthly (USACE Detroit District, 2021a; Gronewold et al., 2017; USACE Detroit District, 2018). These forecasts were specifically developed to help hydropower authorities with decision support relating to flows along the Niagara and St. Lawrence rivers. While they don't provide estimates across the lifespan on MDOT assets, they are a useful ongoing resource for MDOT for monitoring and management. Figure 2-4 shows an example of the forecast for Lake Michigan, which shows approximately 2.7 feet of uncertainty in water level range of possible outcomes over the next year.

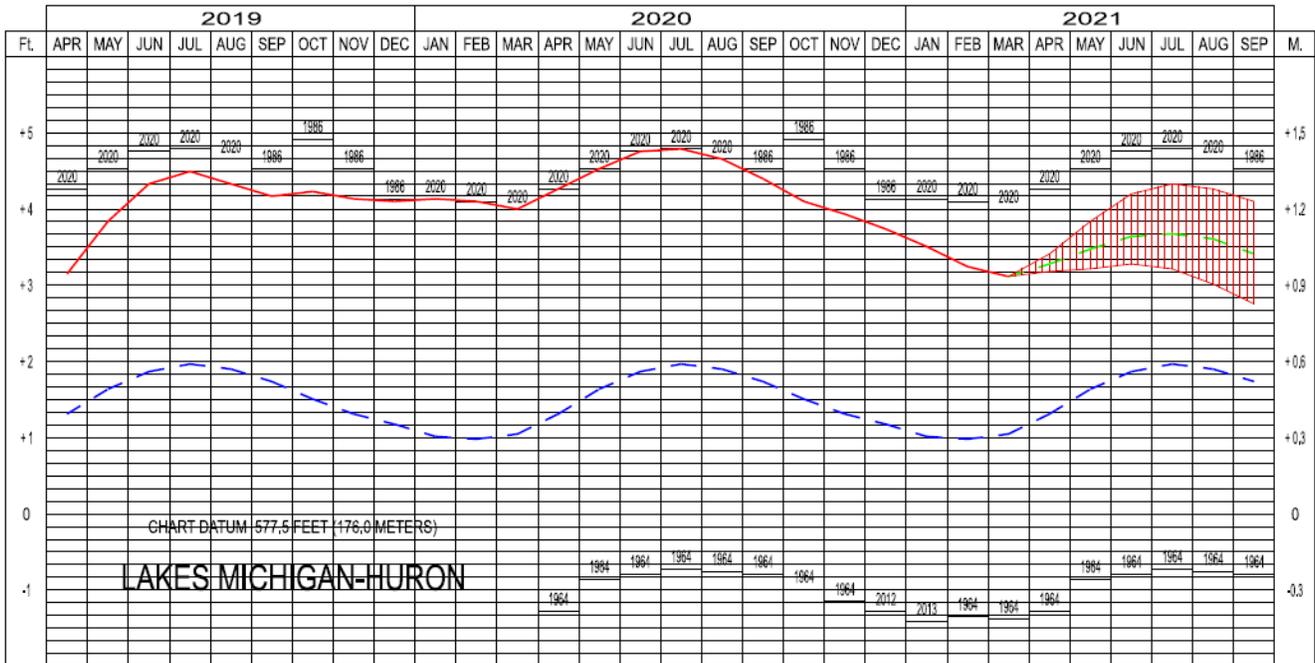
LAKES MICHIGAN-HURON WATER LEVELS - APRIL 2021

Figure 2-5. USACE April 2021 regulatory forecast for Lakes Michigan-Huron. Source: USACE Detroit District, 2021a.

Additionally, USACE publishes monthly updates to their regulatory water level predictions, in coordination with Canada. These predictions are limited to a six month outlook, but do take into consideration climate predictions. As shown in Figure 2-5, both the average prediction and 95 percent confidence interval are provided.

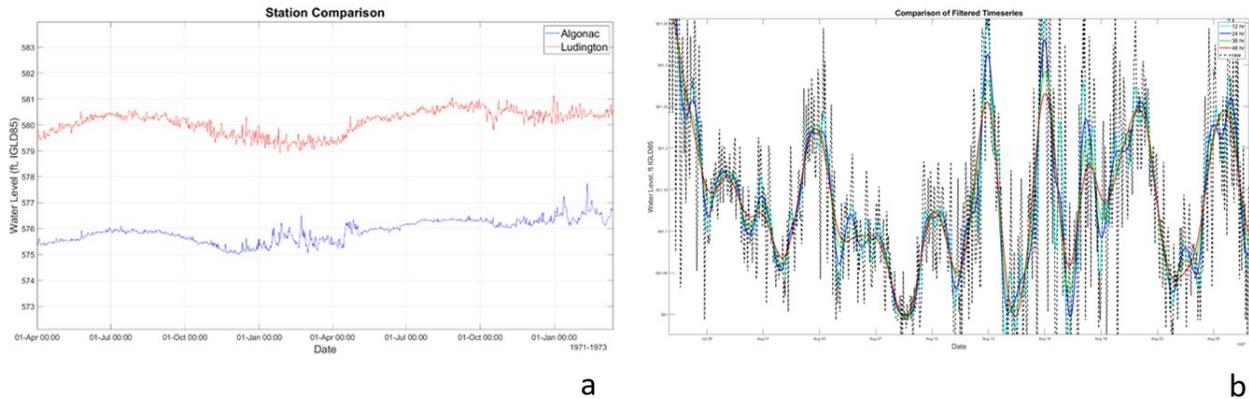
Figure 3-2. a) Algonac and Ludington timeseries comparison; b) comparison of filtered timeseries.

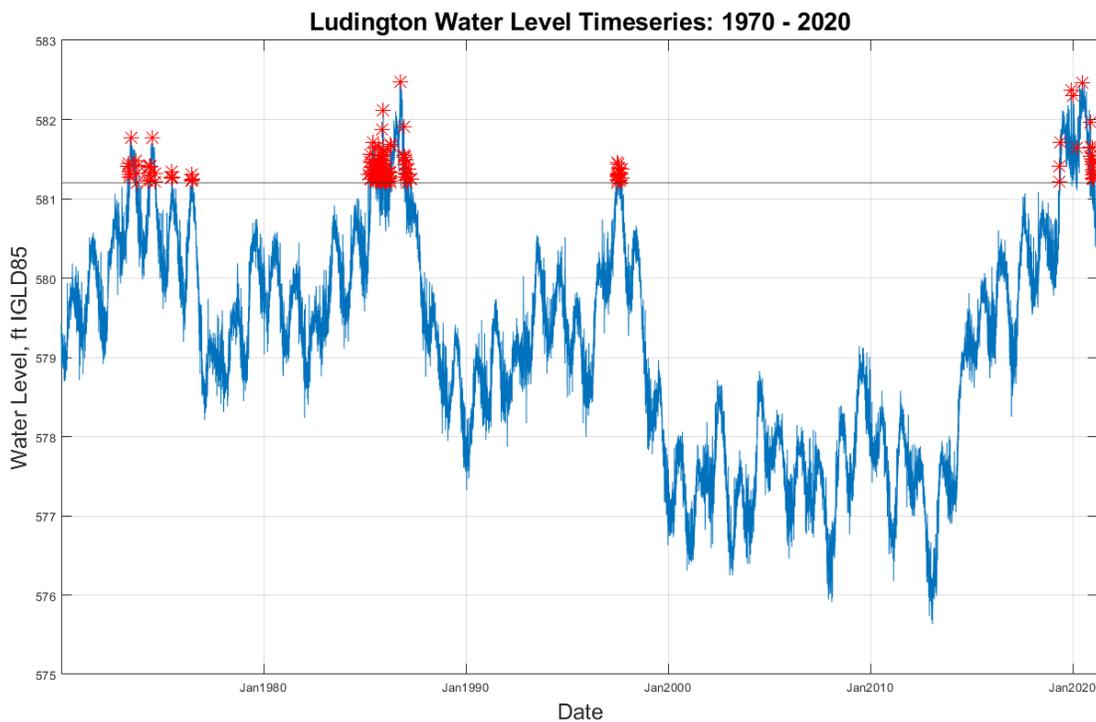
Figure 3-3. Ludington timeseries and Edge of Pavement incidence of exceedance.

After data processing, the Peak-Over-Threshold method was used to identify exceedance occurrences throughout the water level timeseries, an example of which is shown in Figure 3-3. This is a method to model extreme values in a dataset and establishes a threshold to identify values that exceed this threshold. The Peak-Over-Threshold method identifies the peak at the center of the exceedance. An event is defined by an up crossing past the defined threshold and closed by a down crossing below the threshold. The duration is then computed at each peak. The time and date of both the initial up cross past the threshold and the final

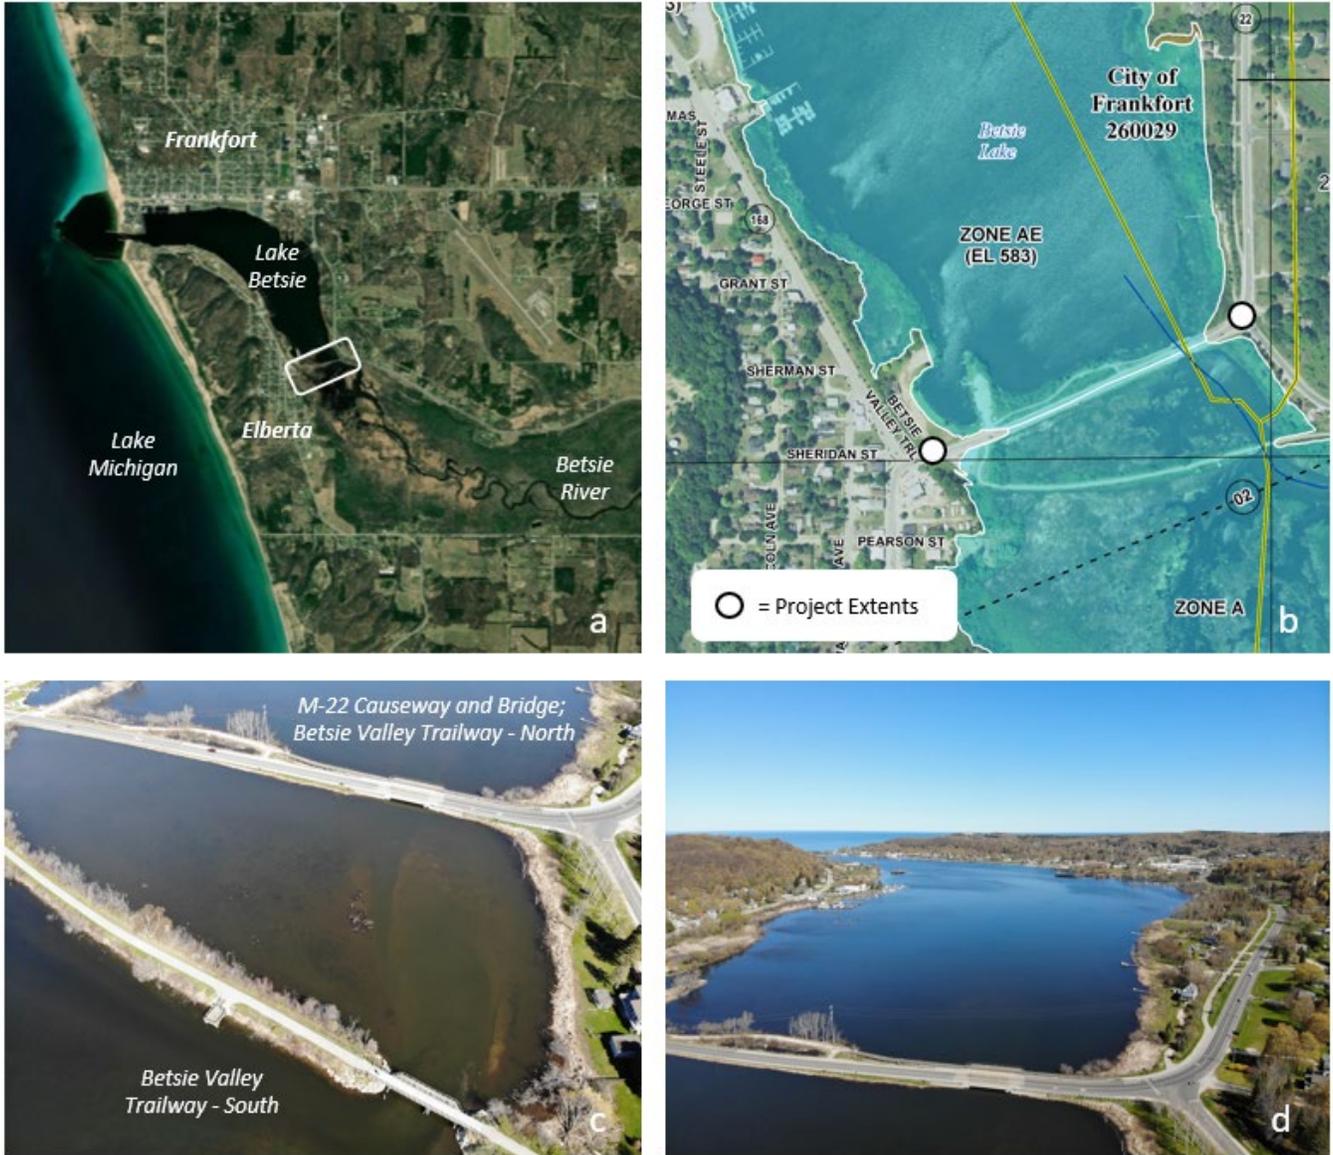
Figure 4-1. Overview of M-22 Elberta/Frankfort site and surrounding context. a) Region aerial photograph depicting relation of Betsie River, Betsie Lake, and Lake Michigan (not to scale). b) FEMA flood map showing AE and A flood zones in relation to project extents, c) the larger Betsie Valley Trailway bridge opening to the south of the site, d) aerial overview of site and surrounding context, looking toward Lake Michigan.

The M-22 (Lake Street/Frankfort Avenue) causeway and bridge over Betsie Lake is a key point of connection between downtown Elberta (to the south) and Frankfort (to the north). The Bestie River flows into Betsie Lake, which then empties into Lake Michigan. As Betsie Lake is somewhat protected, it is not categorized as a Coastal High Hazard Area (Zone V or VE on FEMA flood maps) for wave impacts, and as such is expected to see wave heights less than 3 feet. Anecdotally, the area frequently sees wind driven run-up during high water levels that can exacerbate flooding during periods of long-term inundation. Upstream, Bestie River has a large intact natural floodplain, which moderates downstream flooding seen due to rainfall runoff (Figure 4-1, insets a, d). However, the assets are still in a 1 percent AEP flood zone, with the causeway acting as the boundary between FEMA's AE and A floodway designations (Figure 4-1, inset b).

wider) than the M-22 bridge, and therefore the M-22 bridge is the limiting factor for downstream riverine flow (Figure 4-1, inset c).

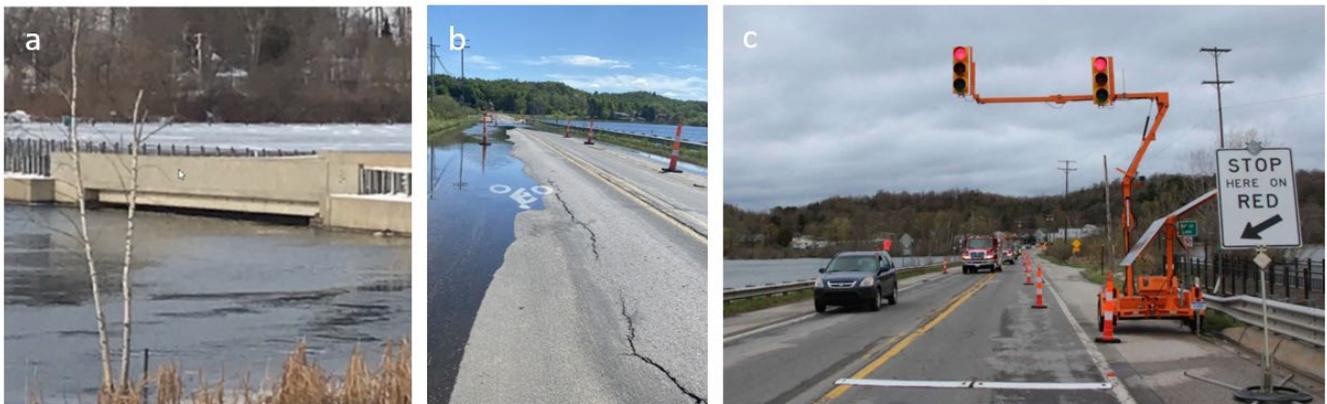
Shorter, wind-driven events cause both lanes to be closed occasionally throughout the inundation period. In the spring through fall of 2020, overtopping occurred frequently and forced MDOT to install a permanent signed detour. Wind driven events would fluctuate, and could last 15-minutes, an hour, or as long as a week. As the bridge is higher than the causeway, the roadway over the bridge never flooded, though water levels were elevated above the bottom of beams for an extended period (Figure 4-2, inset a).

Figure 4-2. Photographs during the 2019 and 2020 high water. a) elevated winter water levels near the bottom of bridge beams. b) water extending across the causeway, c) signalled one-way traffic due to partial lane flooding.

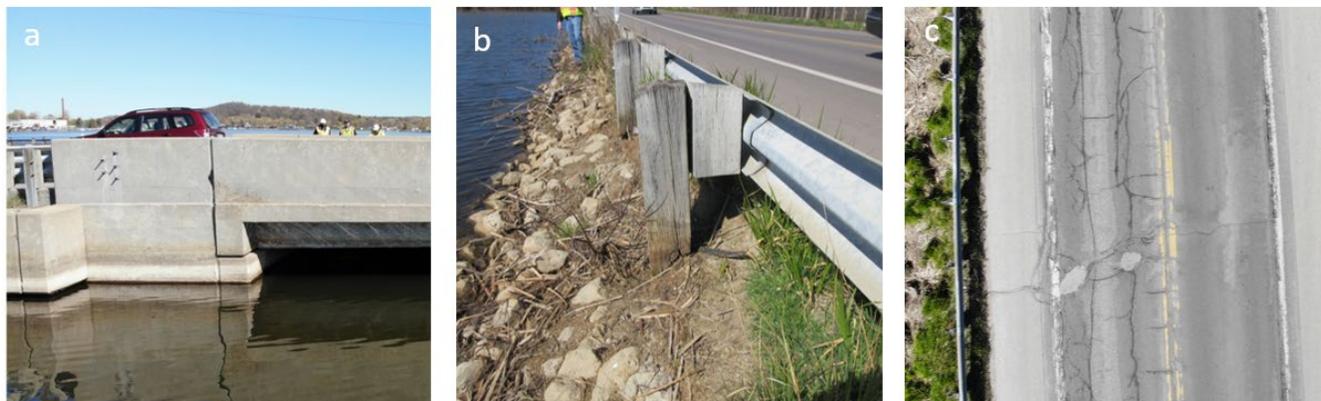
Damage to date includes scour to the bridge and pavement degradation. The pavement experienced bad ruts from traffic and a prolonged saturated sub-base. While the region was able to skim coat the ruts and topcoat the area that usually floods, there are still areas that show bad cracking and ruts (to the point where the crown is crushed down) (Figure 4-3, inset c). Additionally, water overtopping the road has washed out around guard posts and long-term saturation is rotting the posts. This is most visible on the southern side of the causeway (Figure 4-3, inset b). Now that washout has begun, rainwater is exacerbating the erosion. When looking at the bridge, there are high-water marks on the bottom of the beam (Figure 4-3,

inset a). The bridge is categorized as “scour critical,” and while the most recent underwater inspection report found no undermining of the footings, one major storm event could easily change this.¹⁵

Figure 4-3. Damage as captured in May 2021. a) high water mark on bottom of bridge beams. b) debris from high water and rotting of guardrail posts, c) ruts and cracking on pavement.

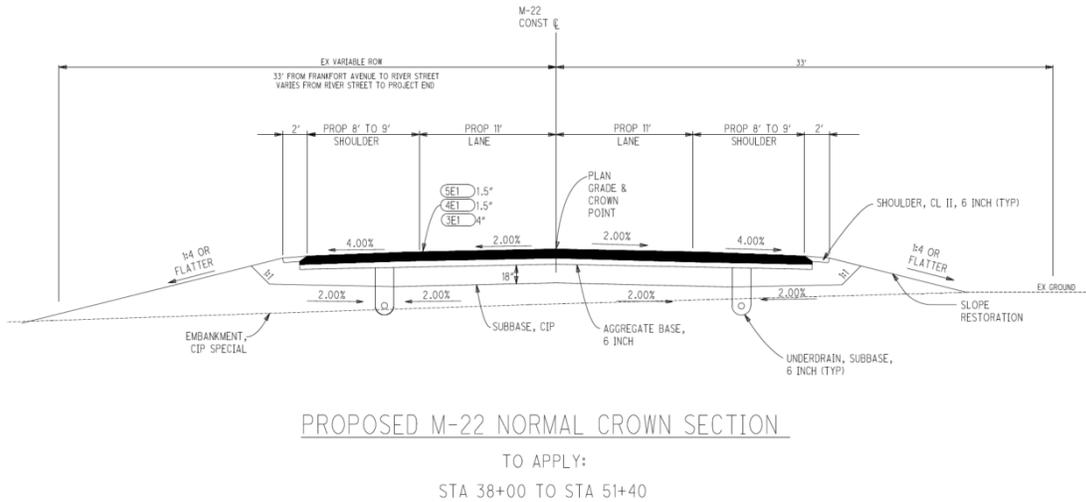
Figure 4-4. Schematic causeway crown section for M-22 Elberta/Frankfort

From review of the FEMA Flood Insurance Rate Map (FIRM) and Flood Insurance Study (FIS) data, as well as historic lake levels for this area, it was determined to use a critical design elevation of 583.1 NAVD88 which equates to be slightly above the FEMA BFE of 583 feet NAVD88. Also, to comply with the MDOT criteria, a minimum of 2 feet of freeboard was provided from this surface to the proposed bottom of beam elevation for the new structure. To limit the overall impact to the intersecting roadways and drives along the corridor, the projects termini and length were limited to be between the Betsie Valley Trailway entrance and River Road. The design proposes to raise the road a minimum of 18 inches to a maximum of about 3 feet to provide additional freeboard. From reviewing prior years' traffic data along with the current traffic, not much growth is expected for this area and consequently, the proposed roadway typical section is the same as the existing section (Figure 4-4). A calculation for the pavement buildup assuming the current traffic indicated that 7 inches of asphalt over 6 inches of aggregate will be sufficient. See *Appendix E: M-22 Elberta/Frankfort Expanded Documentation* for the schematic drawings and for a summary of the design criteria used for the roadway design.

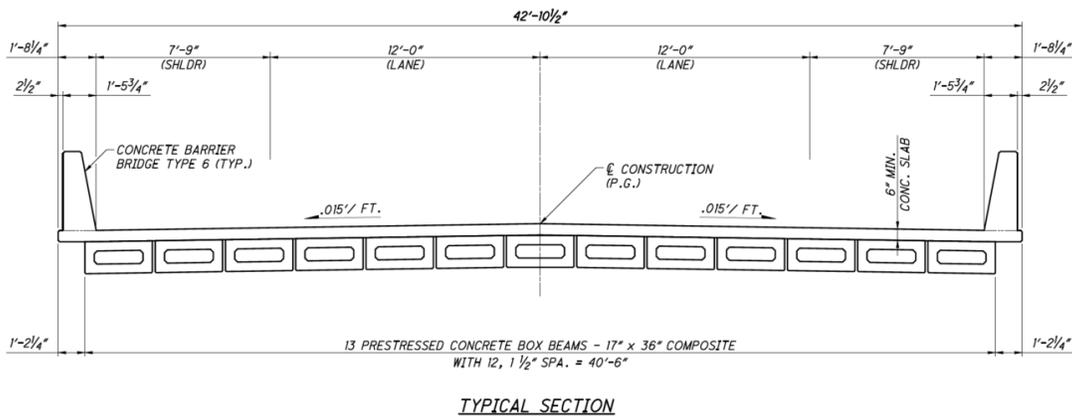
Figure 4-5. Schematic bridge section for M-22 Elberta/Frankfort

The existing bridge was constructed in 1995 and is currently in fair condition according to the most recent inspection report. Therefore, it was assumed that the substructure will still have another 50 to 75 years of life expectancy and will be re-used for the proposed improvements. A similar superstructure is proposed to replace the existing bridge superstructure and consists of a 6-inch concrete deck on 17 inches x 36 inches prestressed concrete box beams (Figure 4-5).

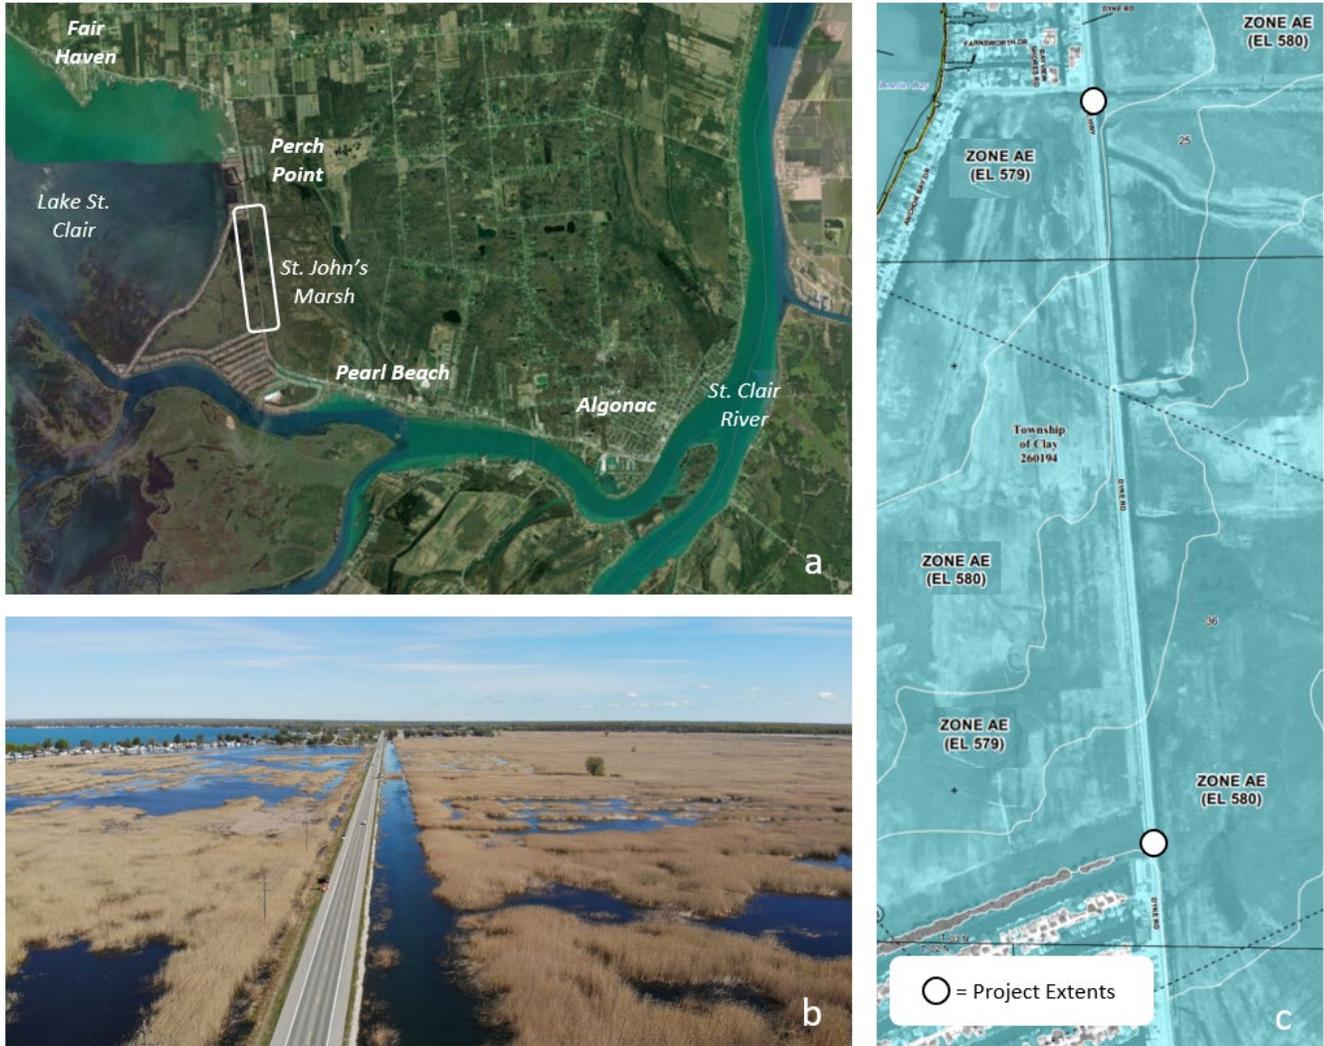
Figure 4-6. Overview of M-29 St. John's Marsh site and surrounding context. a) Region aerial photograph depicting relation of St. Clair River, Lake St. Clair, and St. John's Marsh (not to scale). b) FEMA flood map showing 580 NAVD88 and 579 NAVD88 AE flood zones in relation to project extents, c) aerial overview of site and surrounding context, looking north toward Perch Point.

M-29 St. John's Marsh roadway connects Algonac and Pearl Beach area to the southwest with Perch Point and Fairhaven to the northeast. The roadway runs through the marsh that is part of the natural delta as the St. Clair River flows into Lake St. Clair (Figure 4-6, inset a, b). Similar to M-22, the site is somewhat protected, and so not categorized as a Coastal High Hazard Area (Zone V or VE on FEMA flood maps) for wave impacts. However, whole area is within FEMA's AE zone, with the BFE alternating between 579 and 580 feet NAVD88 (representing a 1 percent or greater change of flooding to the BFE each year) (Figure 4-6, inset c).

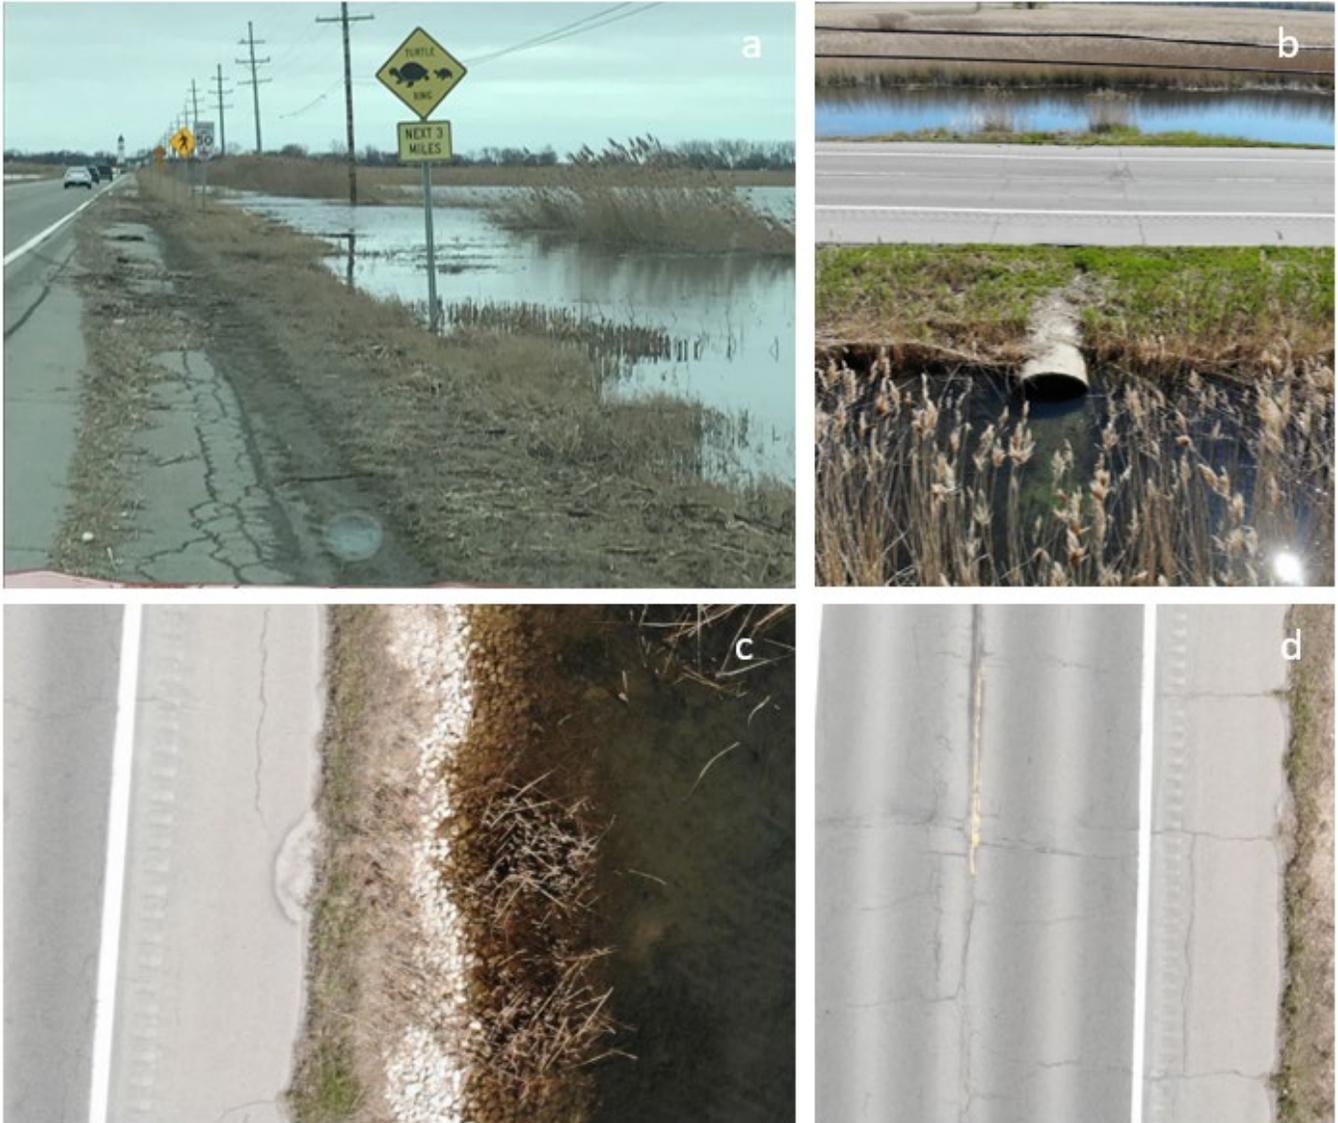
Figure 4-7. Historic flooding and current condition of roadway. a) debris showing extent of high water that has since receded (as well as an unapproved “turtle crossing” sign), b) a pipe culvert, one of the two culverts along the 5,800 feet considered, c) evidence of muskrat damage on the shoulder, d) typical cracking and rutting of this section of roadway.

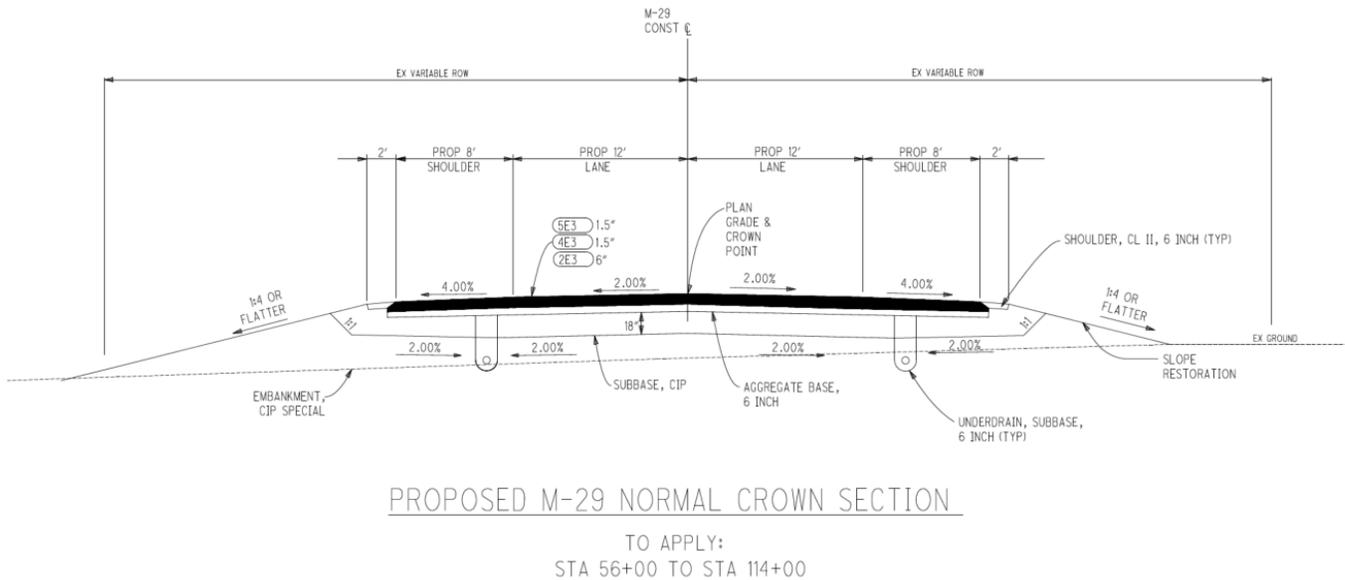
Figure 4-8. Schematic crown section for M-29 St. John's Marsh.

embankment areas of the roadway and may need to be raised as well. From reviewing recent traffic data, not much growth is expected for this area. Therefore, the proposed roadway typical section is the same as the existing section which appears to comply with all MDOT criteria (Figure 4-8). A calculation for the pavement buildup assuming the current traffic indicated that 9 inches of asphalt over 6 inches of aggregate will be sufficient. See *Appendix F: M-29 St. John's Marsh Expanded Documentation* for the schematic drawings and for a summary of the design criteria used for the roadway design.

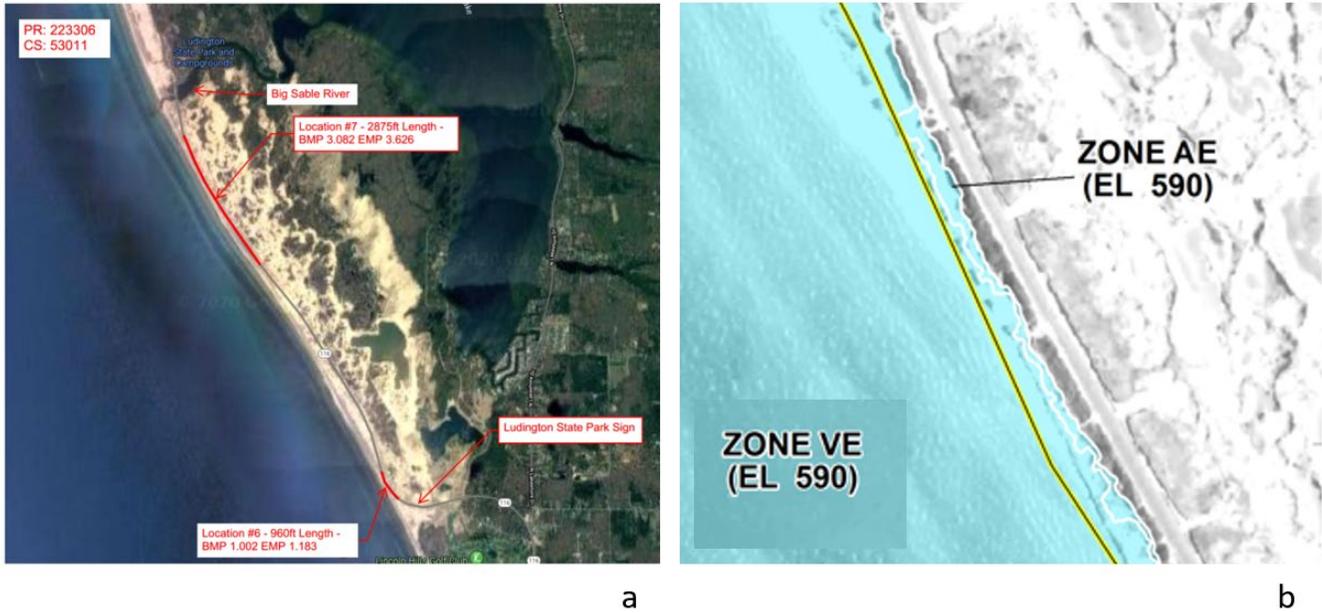
M-116 between Ludington State Park and Piney Ridge Road runs effectively north-south near the shore of Lake Michigan. This portion of M-116 is approximately 3 miles long, 60 to 400 feet east of the shoreline, and approximately 10 feet higher than the typical lake elevation. The route is the only access to Ludington State Park and the associated recreational facilities in the area, with the beach and campgrounds just past the Big Sable River to the north. Two key areas along this larger stretch of particular concern, 2,875 feet in the north, and 960 feet in the south (Figure 4-9, inset a). While the roadway itself is not within a FEMA flood zone, the adjacent dunes are partially within both VE (waves >3 feet) and AE flood zones (Figure 4-9, inset b).

Figure 4-9. Site context for M-116. a) aerial showing two areas of interest b) close up of FEMA flood map showing adjacency of VE and AE zones to the dunes and roadway.

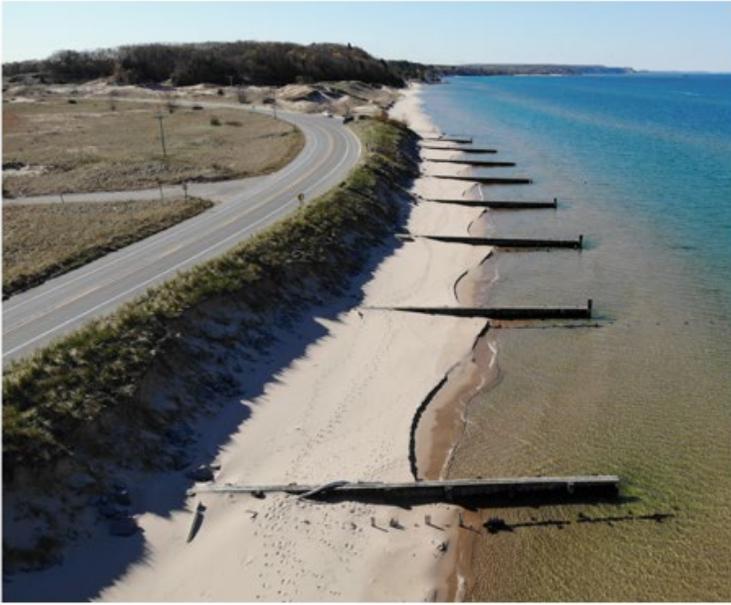
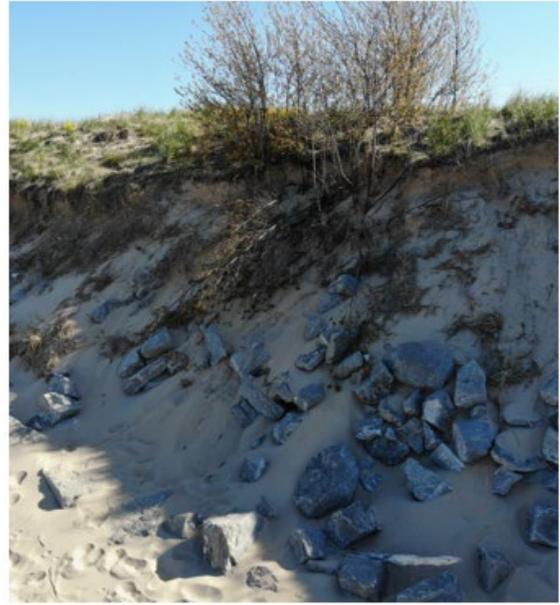
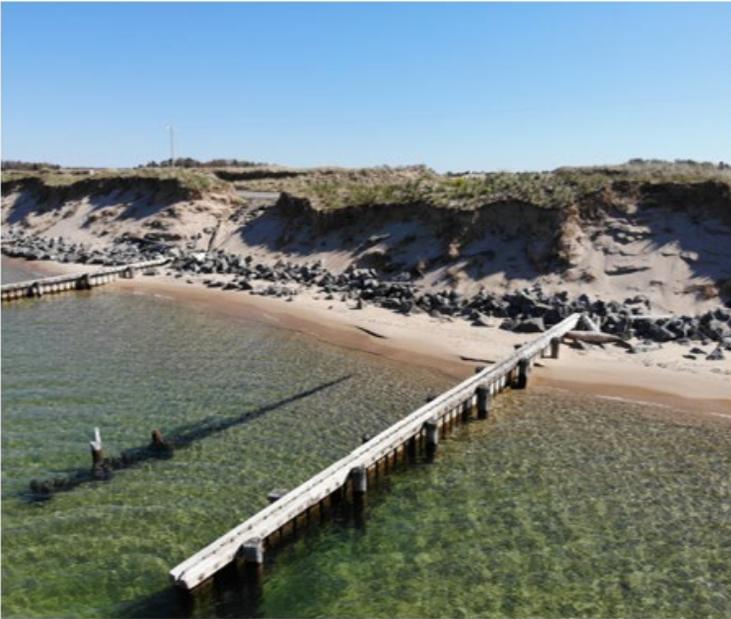
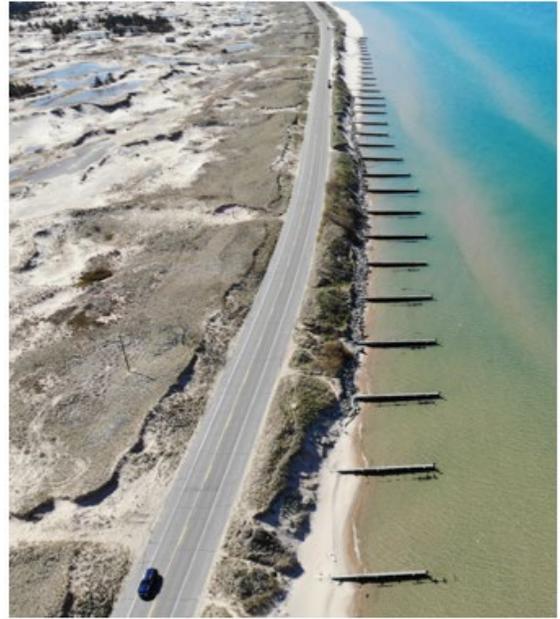
Beach and dune erosion has reduced the width of the beach between the lake and the road and has exposed groins along the shoreline (Figure 4-10, inset a, d). Based on regional interviews, groins had been installed at two points in time along this stretch. The first was in 1953 (now quite dilapidated), and a second series was installed in 1986 during the last cycle of high water (Figure 4-10, inset c). Additionally in 1986, stone was placed along the base or side of the then current slope (Figure 4-10, inset b). Since the 1980s, these groins and stones had since been covered by sand, only to again be uncovered in 2019 and 2020. During the 2019 and 2020 seasons, the State Geotechnical Engineer performed monitoring on this site, however no road closures were experienced.

Figure 4-10. Imagery of past mitigation measures at M-116. a) groins in the south b) rip rap in the south c) groins in the north, with both 1953 installation (underwater) and 1986 installations visible d) groins in the north.

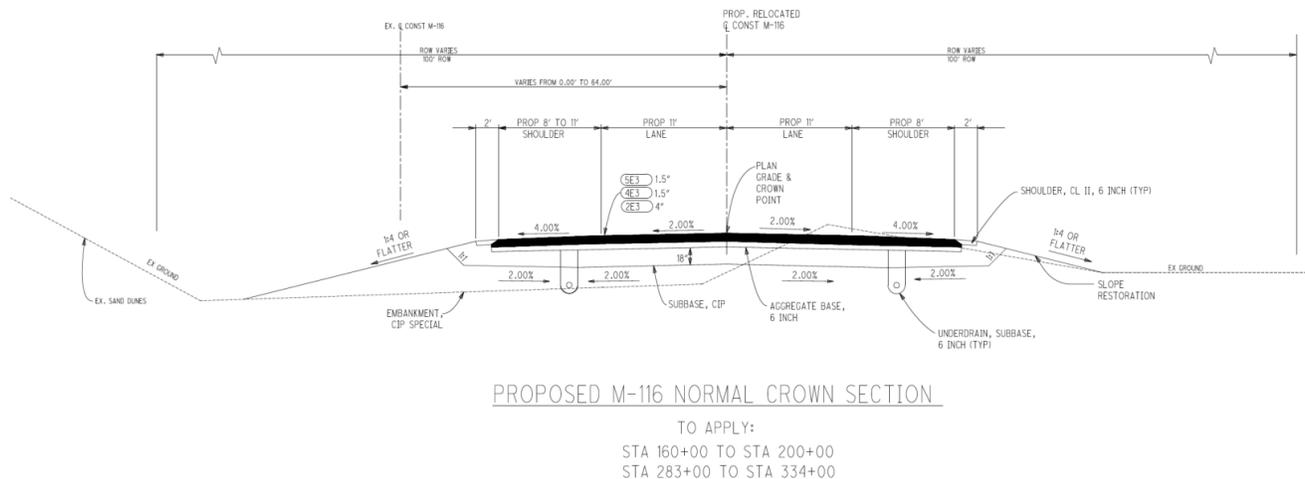
Figure 4-11. Proposed M-116 Ludington State Park typical roadway section.

From reviewing the recent traffic data, it was noted that the traffic tends to be seasonal, and not much growth is expected for this area. Therefore, the proposed roadway typical section is the same as the existing section which complies with all MDOT roadway criteria (Figure 4-11). A calculation for the pavement buildup assuming the current traffic indicated that 7 inches of asphalt over 6 inches of aggregate will be sufficient. See *Appendix G: M-116 Ludington State Park Expanded Documentation* for the schematic drawings.

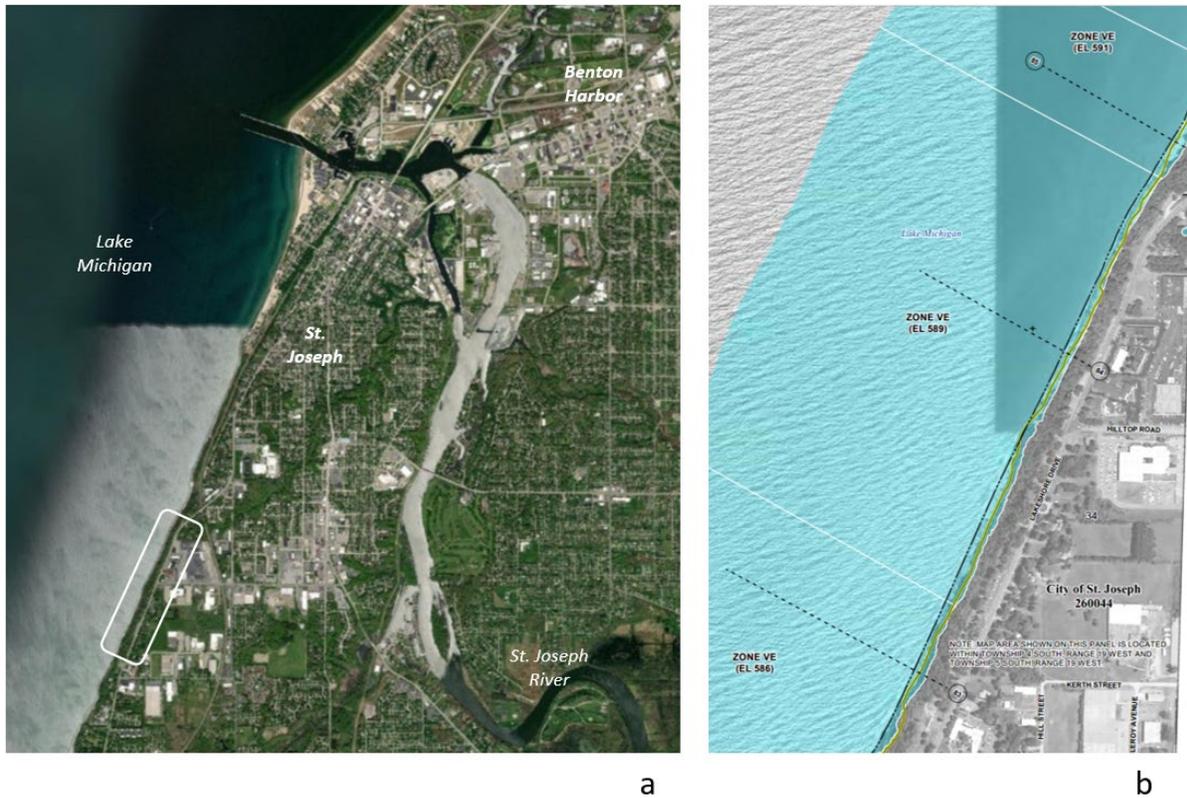
Figure 4-12. I-94BL Site overview, including a) site map showing the relation of the jetties at the mouth of the St. Joseph River to area of interest, and b) FEMA VE flood zone in relation to the toe of slope.

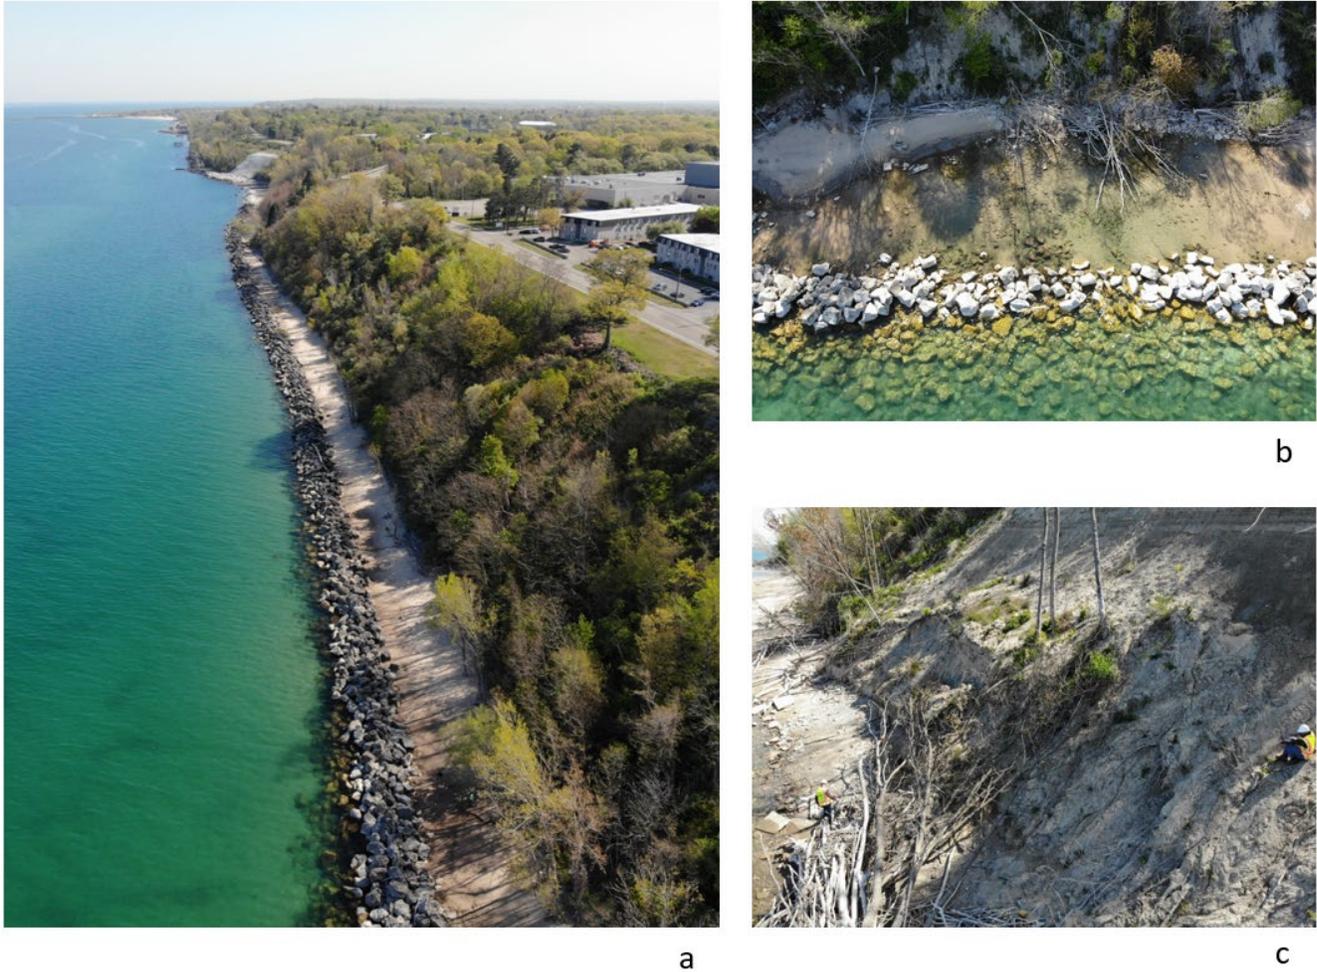
water landside of existing mitigation measures (inset b) and loss of vegetation (inset c). A summary of additional site overview metrics is presented in Table 4-20.

Figure 4-13. Drone imagery of I-94 BL St. Joseph, May 2021, showing a) the roadway in relation to the bluff and existing mitigation measures, b) existing state of rip-rap mitigation measures, and c) evidence of slope failure.

anticipated that the most effective solution for mitigating erosion at I-94BL St Joseph will be a combination of beach nourishment and shoreline protection, some of which has been previously planned by MDOT. Arcadis notes that doing nothing may be an acceptable alternative because although shorelines comprising cohesive materials are prone to small, localized slope failures that are generally induced by undermining, shorelines comprising cohesive materials are less prone to major, catastrophic failures (like the failure at Petoskey) than non-cohesive shorelines.

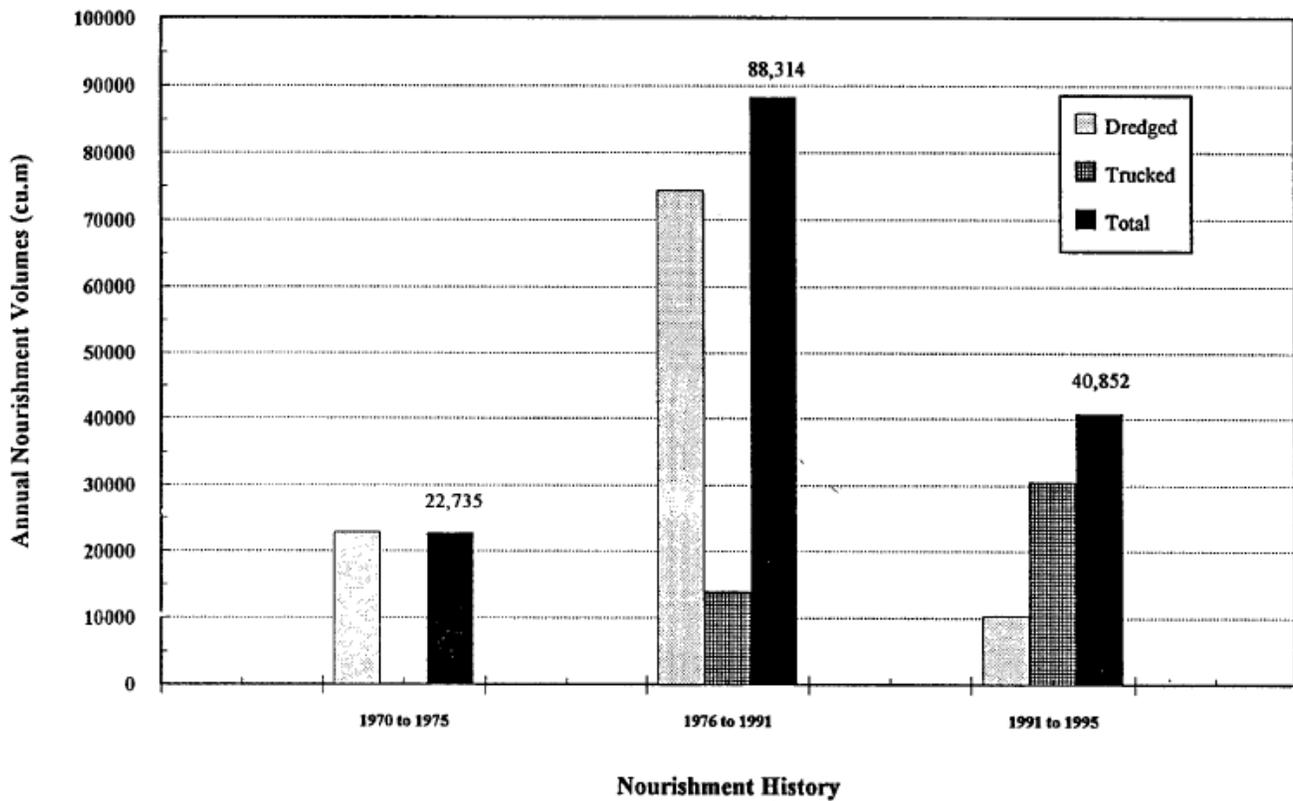
Figure 4-14. Summary of average annual beach nourishment volumes from 1970 to 1995 (from Nairn, et al., 1997).

- As much as 50 percent of the sand placed on the beach just south of the jetties ends up back in the navigation channel from which it was dredged.
