Infrastructure Protection and Rehabilitation Response to High Lake Levels

MDOT OR21-013

March 2022 (Final)

Primary Author:

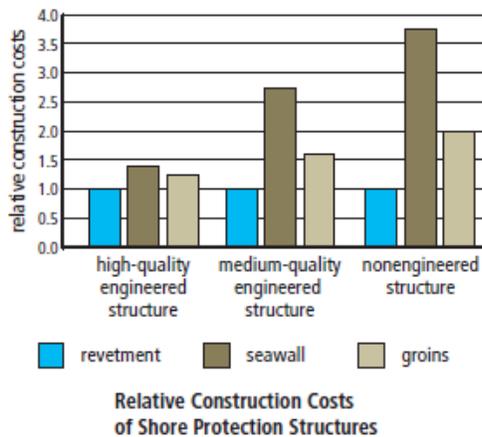
Figure 4-15. Relative cost of seawalls and groins, as compared to riprap revetments (from: Keillor, and White, 2003)

Shoreline protection structures could be constructed, for example, riprap revetment, seawalls, groins, nearshore stone breakwaters, or protected headlands. As shown in Figure 4-15, seawalls and groins are generally more costly than riprap revetments, and we should note that groins are becoming less common erosion mitigation solutions because they can disrupt longshore transport patterns, much like the jetties at St. Joseph. Shabica, et al. (2011) reinforce this concern with groins noting that “Toward the end of the 20th century, coastal scientists and engineers, recognizing the reduced effectiveness of groins on sediment-starved coasts, began designing and constructing nearshore stone breakwaters and headlands.”

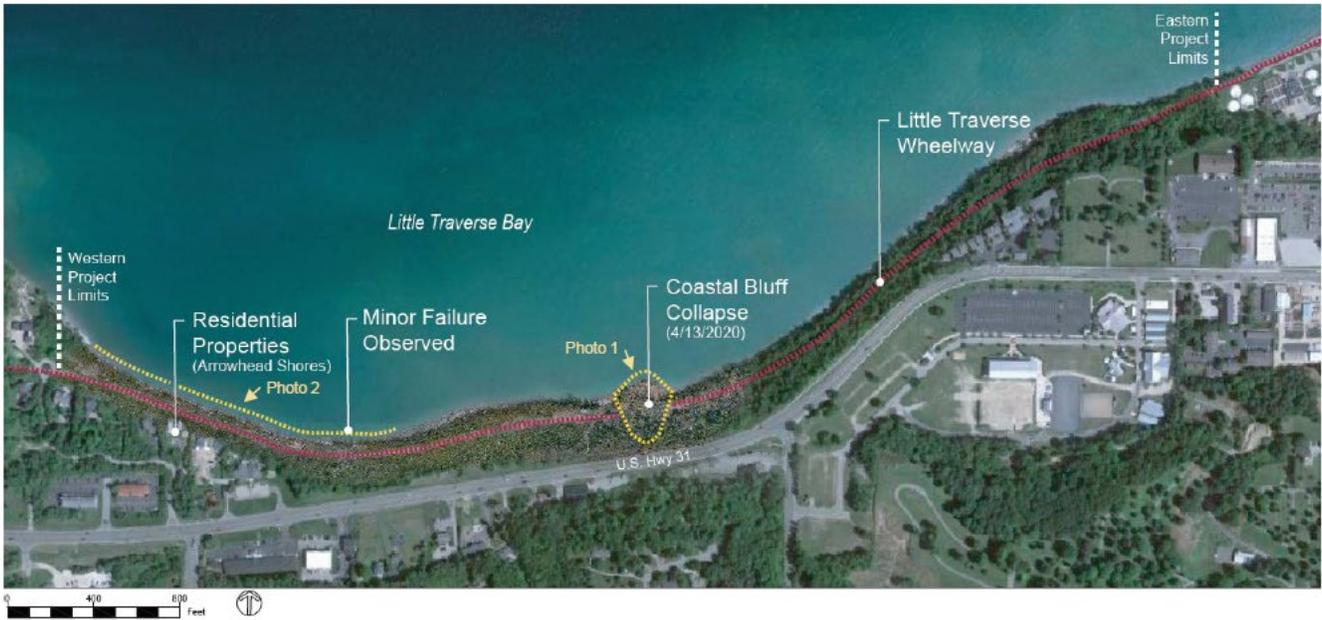
On April 13, 2020, a section of the coastal bluff near western Petoskey, Michigan, and adjacent to Little Traverse Bay catastrophically failed into the bay. At the crest of the failed bluff is US-31, and mid-slope between US-31 and the bay is the Little Traverse Wheelway, a paved bicycle and pedestrian path. The April 2020 failure did not damage the highway; however, the failure destroyed approximately 150 feet of the Little Traverse Wheelway. Figure 4-16 shows an aerial view of the catastrophic 2020 slope failure, and Figure 4-17 shows drone imagery of the large failure (inset a) and an adjacent, smaller failure (inset b).

Figure 4-16. Aerial view of the catastrophic 2020 slope failure near western Petoskey, Michigan (from Baird, 2020)

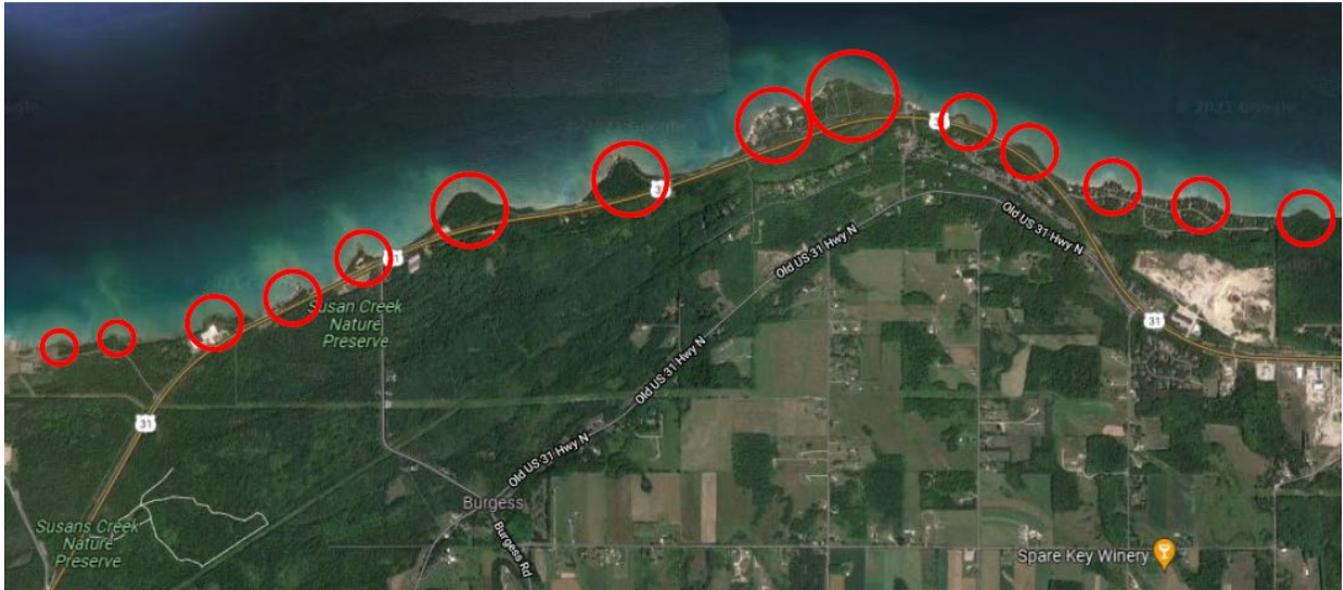
- 1) Previous slope failures in the area.** The Baird report cites a major coastal bluff failure circa 1913 in the same vicinity as the catastrophic 2020 slope failure. The exact location of the 1913 failure is unknown. However, Eppler Road that runs north-south and is just east of the 2020 failure was formerly known as “Washout Road,” in reference to the major 1913 slide. In addition to the major 1913 slope failure, local newspaper articles describe other major slope/bluff failures in the vicinity in 1916, 1957, 1959, and 1985. Aerial imagery of the Susan Creek Nature Preserve just west of Bay Shore, Michigan, shows coastal geomorphological features that appear to be like the post-failure geometry of the catastrophic 2020 Petoskey bluff failure. The presence of these features coupled with recent major slope failures indicate that the coastal bluffs on the south shore of Little Traverse Bay are sensitive to slope instability and may be marginally stable. Figure 4-18 shows many V-shaped land protrusions into Little Traverse Bay west of Bay Shore, Michigan, that may be evidence of previous slope/bluff failures on the southern shore of Little Traverse Bay.

Figure 4-18. V-shaped land protrusions into Little Traverse Bay west of Bay Shore, Michigan, that may be evidence of previous slope/bluff failures on the southern shore of Little Traverse Bay (image modified from Google).
