RESEARCH SPOTLIGHT

REPORT NAME: Concrete Deterioration of Prestressed Bridge Beams

RESEARCH REPORT NUMBER: SPR-1703

Remedies for concrete bridge beam deterioration

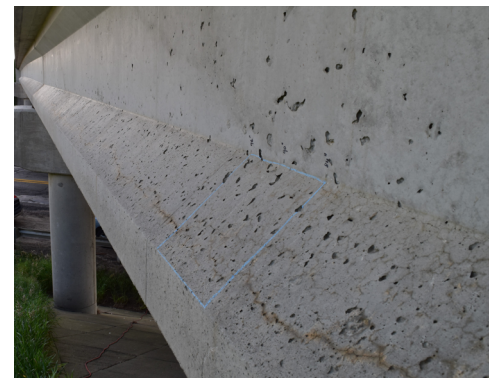
Longitudinal and alligator cracking may be caused by alkali-aggregate reactivity and generally occurs on beams exposed to direct sunlight.

This particular type of deterioration generally results in longitudinal or alligator cracking along a fascia beam’s bottom flange. As current bridge inspection procedures do not include documenting the condition of fascia beams, MDOT did not have a standardized process for recording and tracking the deterioration.
