Road Safety Audit Report

M-22/M-72

Traverse City, Grand Traverse/Leelanau Counties

MDOT Job No. 204066

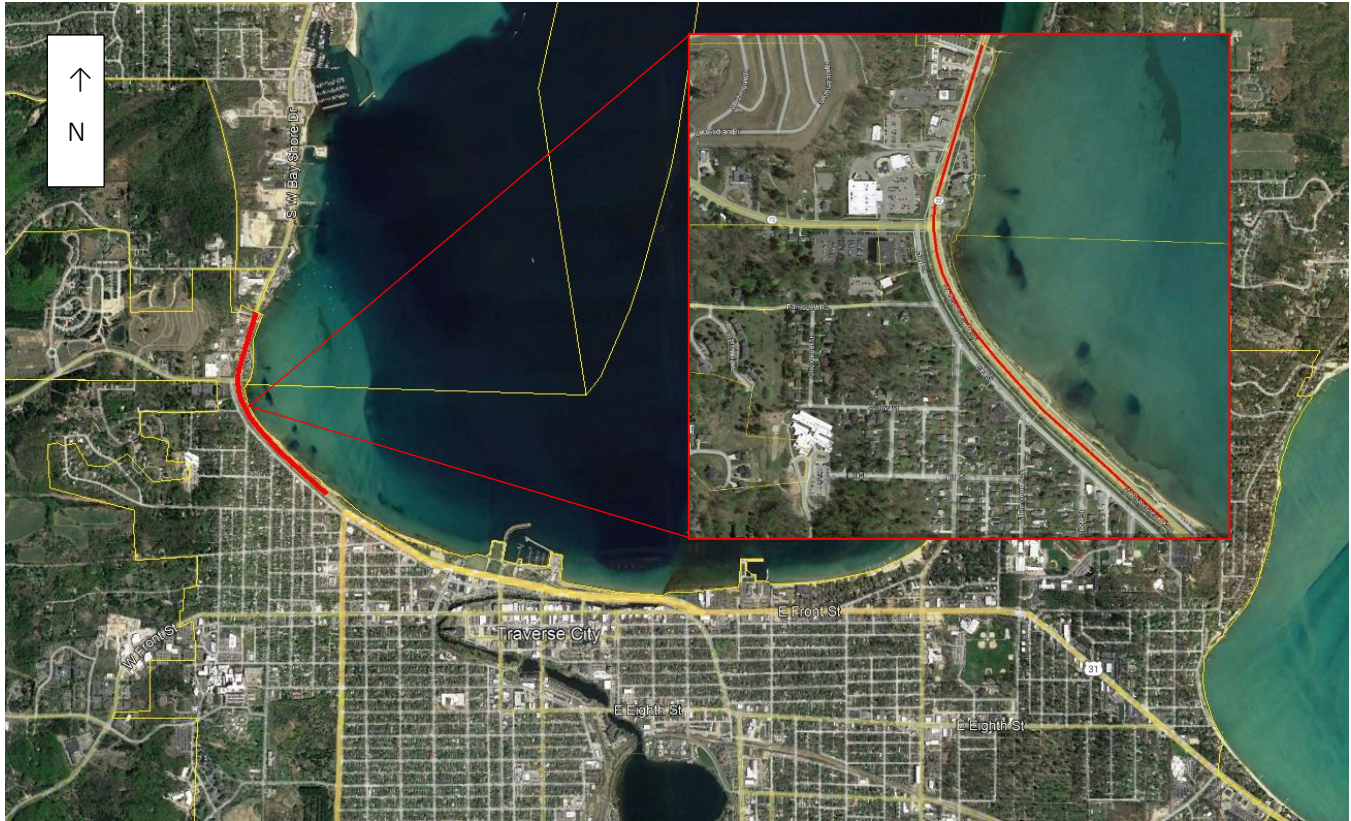
Figure 1 – RSA Study Area

This RSA was requested by the Michigan Department of Transportation (MDOT) Traverse City Transportation Service Center (TSC). This segment of M-22/M-72 from 500 feet west of US-31 to 1,200 feet north of M-72 is planned for reconstruction. The RSA is intended to provide MDOT and the consultant designer with an independent review of safety concerns and design elements that may be considered to enhance safety with this project, or in the future. The subject roadway segment, intersections, and approximate limits that were investigated for this RSA are described in Table 1. The RSA study area is shown on Figure 1.

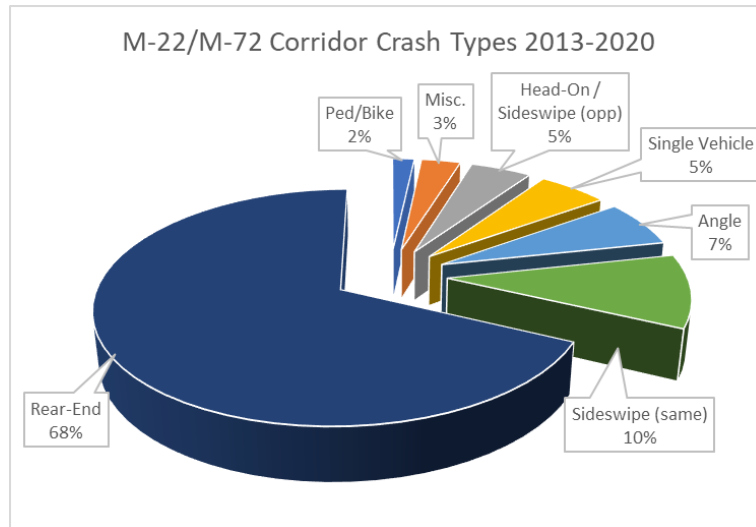
Figure 2 – M-22/M-72 Corridor Crash History by Type

Crashes involving a pedestrian/bicycle as well as all serious injury crashes were further evaluated by Fishbeck. Crash data from 2013 thru 2020 (excluding animal crashes) were obtained from Michigan Traffic Crash Facts, which references the Michigan State Police database. During this period, three crashes involving a bicycle and one involving a pedestrian occurred, resulting in one A-level serious injury, one B-level minor injury, one C-level possible injury, and one property damage only (PDO) crash. In addition to the bicycle crash that resulted in A-level injury, one vehicle head-on left-turn crash occurred at the US-31 intersection that resulted in A-level injury. The US-31 intersection is outside the limits of this RSA; however, the crash is noteworthy. Zero fatalities have been recorded on this corridor. Approximately 89% of all crashes resulted in PDO severity.

Two of the four pedestrian/bicycle crashes occurred at mid-block marked pedestrian crossings in July 2017 and July 2018. Both crashes involved a truck stopping for a bicycle crossing M-22/M-72, blocking view of the

crosswalk, and a driver in the other lane continuing through the crosswalk, striking the cyclist. One crash resulted in the cyclist being propelled and crashing to the pavement, incurring several broken bones and internal injury according to the police report. An MDOT press release indicates that the existing HAWK signalized crossing of M-22/M-72 near Elmwood Avenue was installed in 2019. Installation of the HAWK signalized crossing of M-22/M-72 can be expected to provide significant safety enhancement as compared to the previous marked/signed crossings.

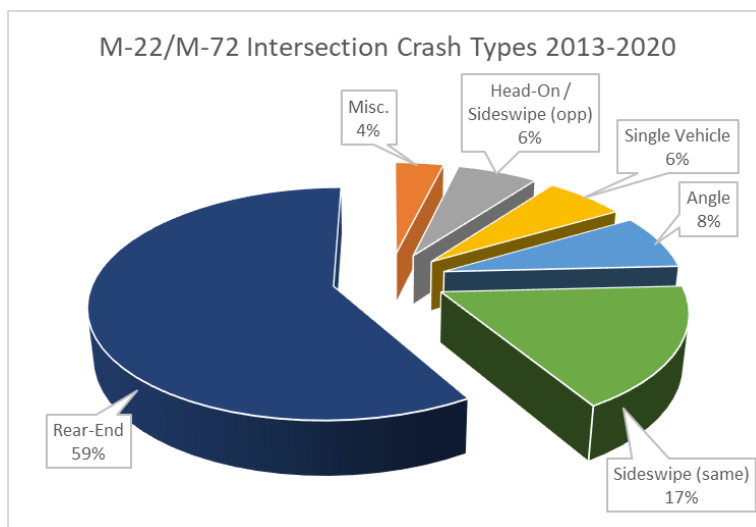
Figure 3 – M-22/M-72 Intersection Crash History by Type

Historical crashes at the M-22/M-72 intersection were also evaluated in greater detail, including those occurring in the vicinity of Bay Street. During the 2013-2020 timeframe, 157 total crashes were recorded in this area with zero fatal or A-level serious injury crashes. Similar to the overall study corridor, the predominant crash types at this intersection are rear-end and sideswipe (same direction) crashes. This correlates with anecdotal knowledge of vehicle delays and congestion, especially as experienced during the peak summer months. Angle, head-on (left-turn), and sideswipe (opposite) crashes comprise approximately 14% of crash occurrence at this location. The recent signal modernization can be expected to provide safety enhancement by reducing delays and queues which may encourage risky maneuvers. Additionally, improved left-turn operation can be expected to reduce angle and head-on (left-turn) crash occurrence, which tend to result in more severe outcomes.

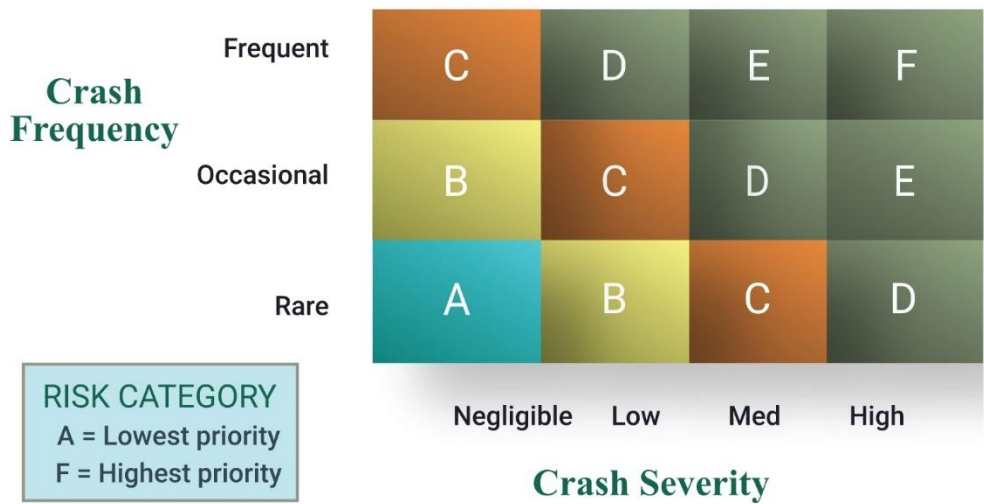
Figure 4 – RSA Relative Risk Factor Matrix

Each list of suggested safety concerns provided in the following subsections is presented according to location and risk categorization. A safety concern that has the potential to result in crashes that could have a generally high severity (potential to result in death or incapacitating injury) on a more frequent basis may be categorized as an “E or F” (highest relative risk). On the contrary, a safety concern that has the potential to result in crashes that would have a generally low severity (property damage only) on a less frequent basis may be categorized as an “A or B” (lowest relative risk). The relative risk factor matrix is illustrated on Figure 4 below.

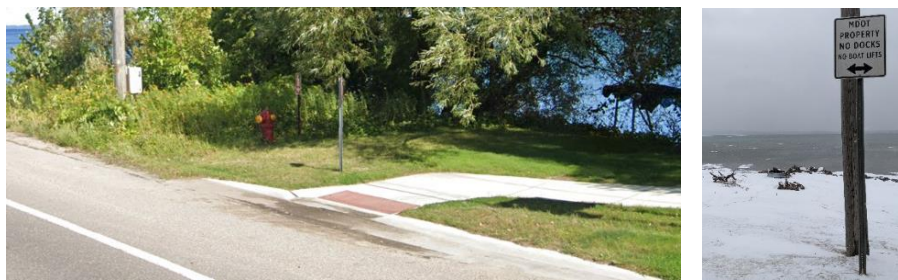
There is also no receiving curb cut/ramp on the west side of M-22 at the Holiday gas station. Additionally, sidewalk (paved area) on the west side of M-22 in front of Harrington's restaurant runs immediately adjacent to the back of curb, providing no buffer to the travelled way. When the sidewalk is at the back of curb, MDOT would typically require a 6-foot sidewalk to provide additional buffer from the road. The existing sidewalk width here appears less than 6-feet. The sidewalk in front of Harrington's also does not connect to the adjacent property to the north. There is a worn path indicating pedestrian usage in the approximately 15' sidewalk gap.

Risk Analysis: Gaps in the non-motorized network and absence of marked/signed crossings of M-22 may lead to vehicle-pedestrian crashes with severe outcome. This concern is exacerbated during nighttime conditions when visibility is reduced (lighting improvements are discussed in a subsequent section).

Figure 5 – Sidewalk Ends into M-22 (left) Firepit in MDOT ROW (right)

Suggestions: Gaps in the existing non-motorized network should be closed. This may require shore stabilization along the bay to provide adequate space for continuous sidewalk/path; however, curbing the east side of M-22 and eliminating the wide paved shoulder may mitigate this impact. If sidewalk on the east side cannot be continued to the north, the sidewalk should be terminated into the commercial building, not into an unmarked crossing of M-22. Pedestrian refuge islands (permanent or seasonal) and a marked/signed crossing should be considered on this 3-lane section to connect land uses that would generate pedestrian activity across M-22.

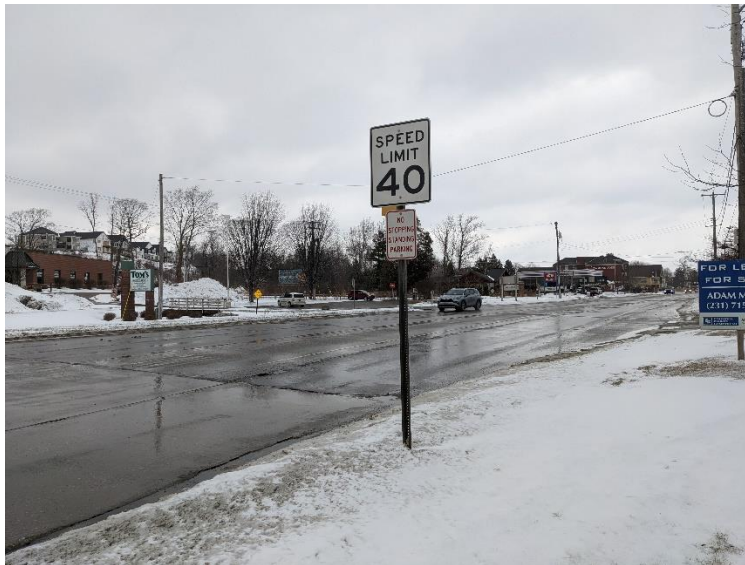
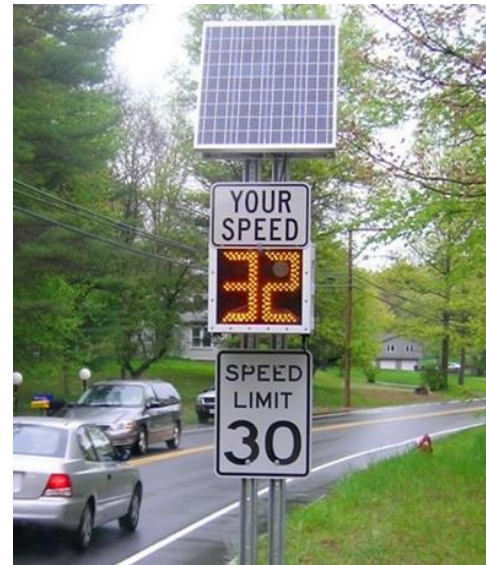
Observations: The posted speed limit on M-22 north of M-72 increases from 35 mph to 40 mph. During site observations, speeds were not measured; however, the RSA Team observed speeds that appeared to be between 40 and 45 mph. Stakeholder input and anecdotal knowledge indicate that northbound drivers often accelerate north of the M-72 intersection, and that southbound traffic retains higher speeds approaching M-72 from the north even as the speed limit is reduced. Observed speeds may be relative to lower traffic volumes during the off-peak season but are always of concern. During the peak summer months, vehicular congestion and pedestrian activity are higher and increased speeds would adversely impact both vehicular and pedestrian safety. During winter months, higher speeds can result in loss of control and roadway departure.

Figure 6 – M-22 Posted Speed (left) Dynamic Speed Sign (right)

1. Current and future design efforts for M-22 north of M-72 may consider modifying the design speed; however, this is unlikely given the function and classification of the facility. Narrowing of the roadway to replace wide paved shoulder with curb and gutter may have a positive impact to reduce vehicle speeds. Narrowing of the roadway via modification of the median immediately north of M-72 is also discussed in following sections.
2. Dynamic speed signs to display the speed limit in contrast to actual vehicle speeds may also encourage speed reduction, in combination with focused speed enforcement.

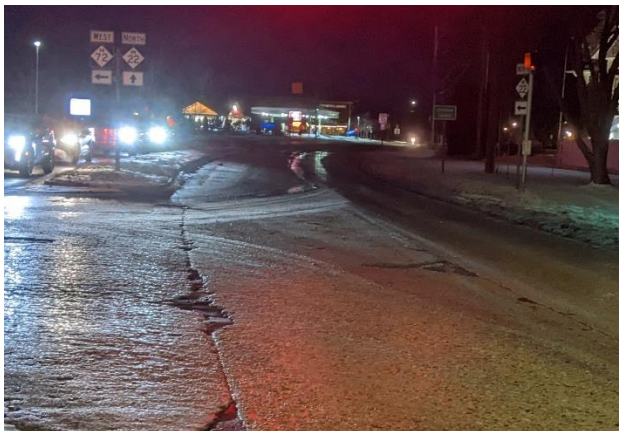
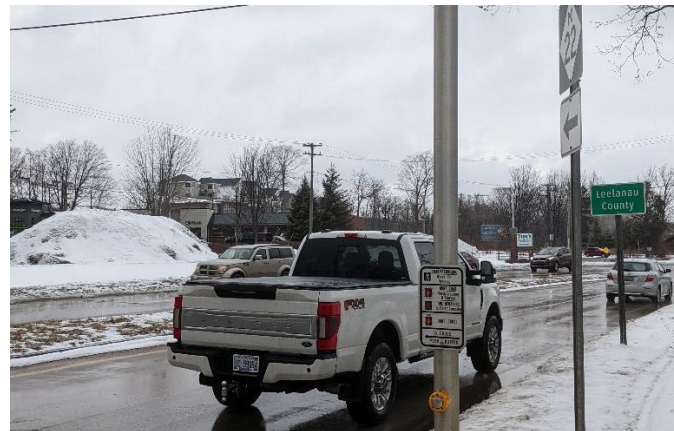
Risk Analysis: Inability to perceive the transition between the 4-lane boulevard and 3-lane section may result in sideswipe crashes. Single vehicle fixed object crashes may also result from limited conspicuity of the small median island north of M-72 in both the NB and SB directions. Both of these vehicle crash types are likely result in property damage only severity. Pedestrian activity in this area would correlate to a higher risk factor that is addressed in the previous section on pedestrian facilities.

Figure 7 – Dark Area (left) Narrow Median (right)

1. Install additional lighting immediately north of the M-22/M-72 intersection.
2. Install delineators, refresh pavement markings, and/or paint the island curb to increase visibility for proper lane use and fixed object location.

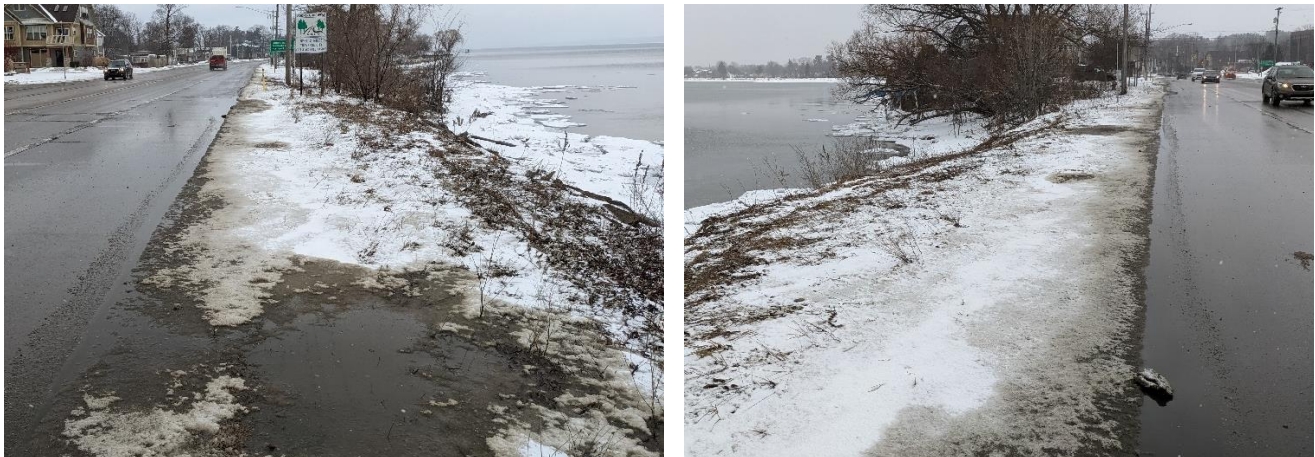
Observations: Along the east (bay) side of M-22 north of M-72, the distance between the travelled way and the shoreline varies. North of the existing office/commercial uses located just north of M-72, the shoreline is very close to the roadway at some points. Given the changing roadway alignment, lane transitions, lighting needs, vehicle speeds, and winter weather conditions, this proximity is of concern for lane departure crashes. A NB lane departure crash could result in a vehicle leaving the roadway and not being able to recover on the roadside slope before hitting large rocks or entering the water.

Figure 8 – Buffer to Rock/Water Looking N (left) Looking S (right)

1. Eliminate the wide shoulder on the east (bay) side of M-22 north of M-72. Install curb and gutter. Narrowing the roadway may have a positive impact to reducing vehicle speeds and better delineate the travelled way.
2. Install guardrail if roadside slopes cannot be mitigated and/or where the distance from the travelled way to the rocks/water cannot be increased.
3. Install reflective delineators and refresh pavement markings to highlight the edge of the roadway.

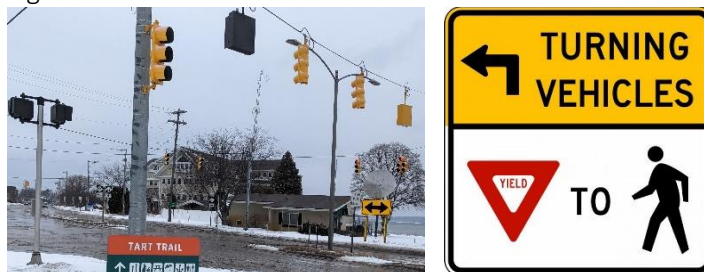
Stakeholder input and anecdotal knowledge indicate that cyclists on the TART trail tend to ride thru this crossing. A walking/running pedestrian may have greater ability to stop, wait, or maneuver to have a “near miss” as opposed to a pedestrian-vehicle crash. Cyclists approaching the intersection at higher speeds would also be less likely to be observed by a turning vehicle and are therefore more likely to be struck while crossing M-72.

Figure 9 – TART Trail M-72 Crossing (left) Yield to Pedestrian Sign (right)

1. Install permanent “No Turn on Red” signage on right-turn movements that conflict with pedestrian crossings, particularly on the SB approach of M-22 conflicting with the TART crossing.
2. Install a “Turning Vehicles Yield to Pedestrians” sign to notify turning vehicles to yield to crossing pedestrians, particularly in association with the NB permissive left-turn flashing yellow arrow.
3. Install a Leading Pedestrian Interval (LPI) to allow pedestrians/cyclists to enter the crosswalk during the all-red phase, prior to any vehicular movements. LPI can be considered for all crosswalks or installed specifically for the TART crossing the west leg of M-72. An LPI would slightly decrease vehicular green time when a pedestrian call is placed; however, the potential safety benefit may outweigh this minor operational impact.

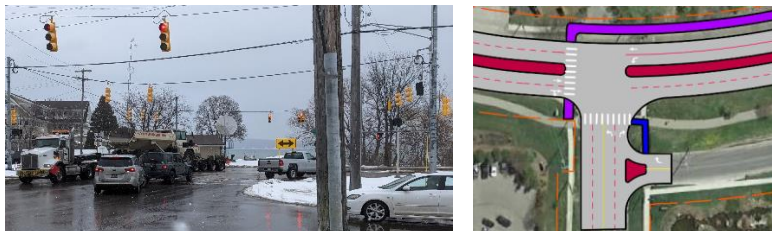
The most frequent turning maneuver observed at this location was from SB M-22 to EB Bay Street. Bay Street provides the first entry point to the local Traverse City street network for traffic arriving from the north. This “S” turn maneuver requires drivers to observe, perceive, and react to multiple conflict points, including the TART trail crossing of M-72. Although the advanced signal heads provide a gap to allow movements from Bay Street to M-72, vehicles are often queued EB on M-72 to turn right onto M-22/M-72.

Figure 10 – EB M-72 at Bay Street/M-22 Conflicts (left) WSP Turn Restriction Concept (right)

At a minimum, the RSA Team suggests that left-turn restrictions to/from Bay Street at M-72 and the potential impacts be investigated. This would require a physical channelizing island and regulatory signs. The RSA Team and stakeholders also discussed concerns relative to TART trail crossing safety with a roundabout at this location. WSP operational reviews indicated a roundabout would need to have multiple lanes; therefore, additional safety measures should be considered for the TART trail crossing if a roundabout is selected as the preferred alternative.

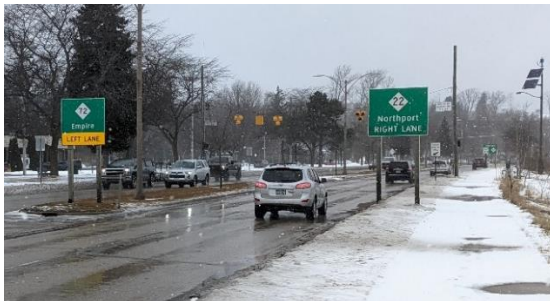
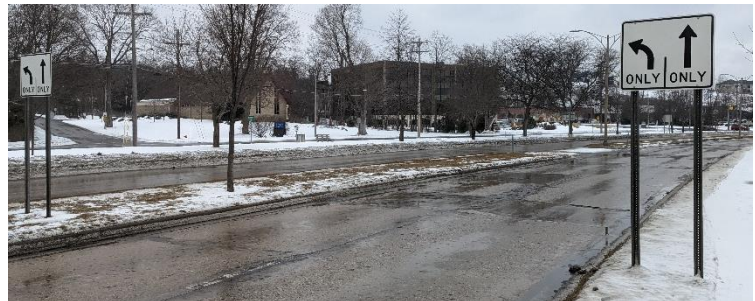
Vehicles were observed making last-minute lane changes or travelling thru the intersection from the median lane despite lane control signs, pavement markings, and upstream route/guide signage. The RSA Team reviewed upstream lane use and route/guide signage on NB M-22/M-72 to determine if drivers are being informed of the downstream lane drop prior to arriving at the M-22/M-72 intersection. There is existing signage, approximately 150' from the intersection, and pavement markings indicating that the median lane becomes a left-turn lane. Additionally, there are lane use signs for M-72 (left lane) and M-22 (right lane) approximately 1600' in advance of the M-22/M-72 intersection. The RSA Team identified significant upstream signage, which should be adequate to communicate proper lane selection and positioning in advance of the decision point. Future design should review the location and spacing of these signs with respect to the HAWK crossing; however, additional signage is therefore not recommended as a mitigation measure for this issue.

Risk Analysis: Vehicles travelling NB thru the intersection from the median lane may sideswipe vehicles in the outside lane. Vehicles stopping or abruptly maneuvering from the median lane to the outside lane may cause rear-end collisions. These crash types typically result in property damage only.

Figure 11 – NB Lane Drop Guide (left) and Lane Use (right) Signage

1. Narrow the receiving lane to eliminate the perception that two NB lanes are carried thru the intersection.
2. Create a more deliberate and conspicuous median that is longer and wider than existing. Redevelopment of the parcel(s) and access reconfiguration on the east side of M-22/M-72 at this intersection should be considered that would narrow the travelled way without limiting property access.
3. Offset the NB left-turn lane to the median and add hatching between lanes to more clearly separate the NB left-turn movement from the NB thru lane.

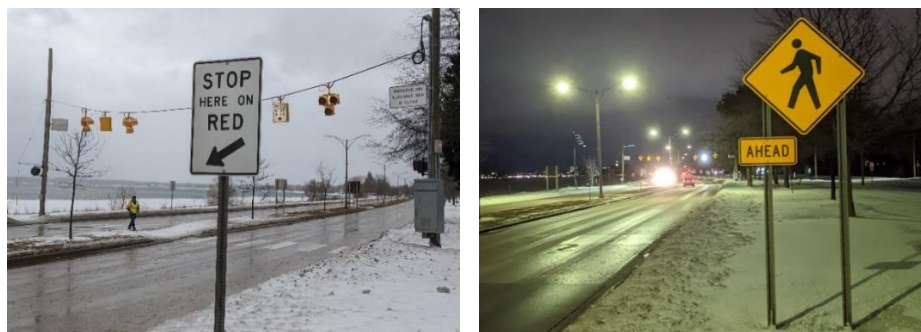
The HAWK signal heads are fairly visible during daylight; however, drivers do not always expect an operating signal at a mid-block location. At nighttime, the signal heads are less visible and the crossing is not conspicuous. There is street lighting in the median along M-22/M-72 including a streetlight within 50 feet of the crosswalk. Unless activated by a pedestrian, the signal is dark during daylight and nighttime hours. Upstream pedestrian crossing warning signs are in place on the outside of each bound, but they are slightly worn and the retro-reflectivity appears to be faded. Investigation of historical press releases indicates that the HAWK signal was installed in 2019. The previously existing crossing and warning signage may have been retained/salvaged. Special emphasis crosswalk markings are in place at the crosswalk providing greater visibility to motorists.

Figure 12 – HAWK Signal Visibility and Signage Day (left) Night (right)

1. Install retroreflective backplates on the HAWK signals to increase visibility and enhance conspicuity of the crossing location for approaching vehicles.
2. Replace existing pedestrian crossing advanced warning signs with new signs and include vertical reflective strips on the sign posts. Install complementary left-side warning signs on the median.

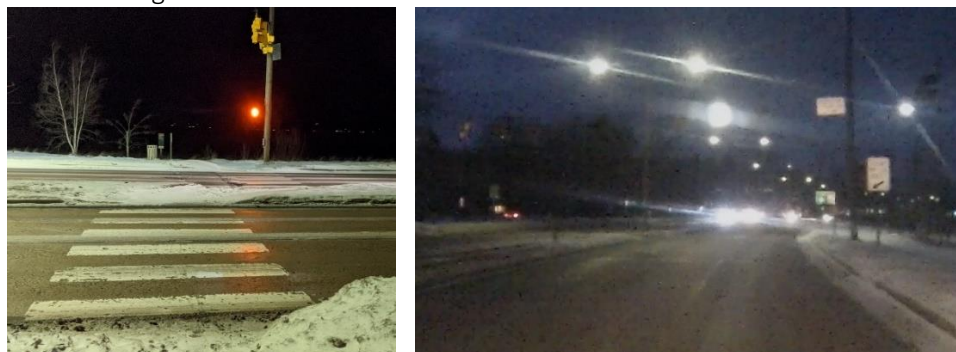
Figure 13 – Night HAWK Crosswalk Visibility (left) NB Light Glare at HAWK (right)

1. Install additional lighting to increase nighttime visibility of pedestrians/bicyclists waiting to enter the roadway at the crosswalk approaches to M-22/M-72. This may include relocation of the existing bench/lighted area on the bay side.
2. When this roadway is reconstructed, review the location of the existing light pole immediately north of the crossing. Install lighting that casts onto the roadway and crosswalk but does not inhibit visibility of the signal heads. Signal backplates suggested in the prior section may also partially mitigate this issue.
3. Consider alternative lighting for the crosswalk including overhead crosswalk case sign options or relocating lighting at this location to the outside of the roadway to cast on the crosswalk and each approach.

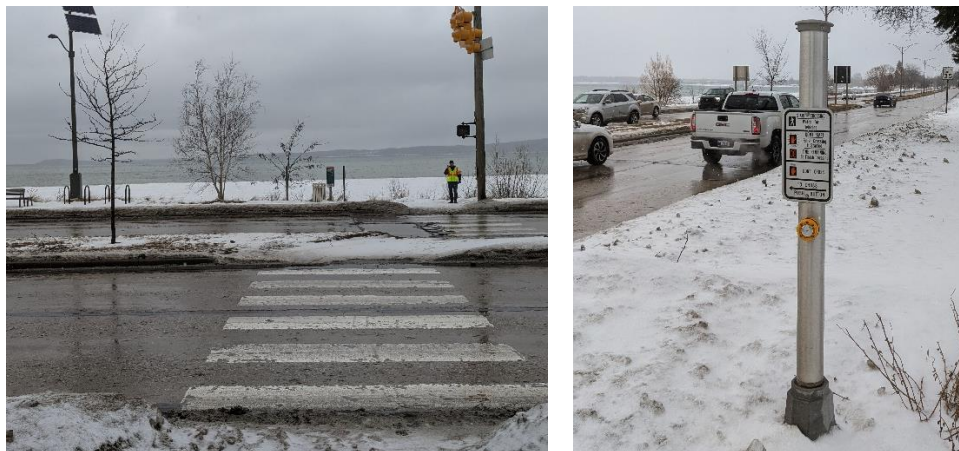
Figure 14 – HAWK Crossing Offset (left) Pushbutton and Sign (right)

1. Reconfigure the crosswalk to have a direct alignment thru the median and crossing both bounds, eliminating the offset.
2. Install alternative signage (i.e. R10-3 or R10-3a) on the pushbutton pedestal to heighten the message to pedestrians to activate the HAWK signal.
3. Install passive pedestrian detection at the crossing to activate the HAWK signal.

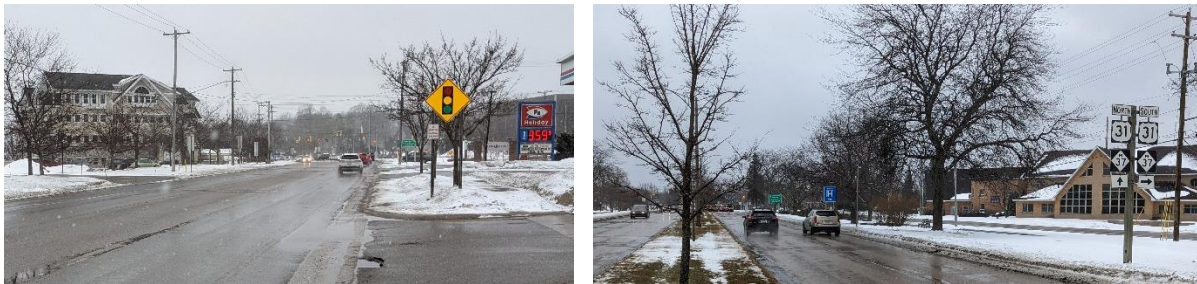
Observations: Sign retro-reflectivity was not measured; however, the general observation by the RSA Team along the corridor was that sign visibility could be improved, especially at night. Some signs appeared faded and given the complexity of vehicular and non-motorized movements along this corridor, the importance of these messages is heightened. Although the RSA Team is not aware of the installation timeline and age of signage along this corridor, weather conditions along the bay may contribute to premature degradation of sign quality.

Figure 15 – Corridor Signage N of M-72 (left) NW of US-31 (right)

1. Replace all corridor signage. The messages on current signing are appropriate; however, the visibility can be improved.
2. Install vertical reflective strips on the sign support posts where messaging is particularly important.

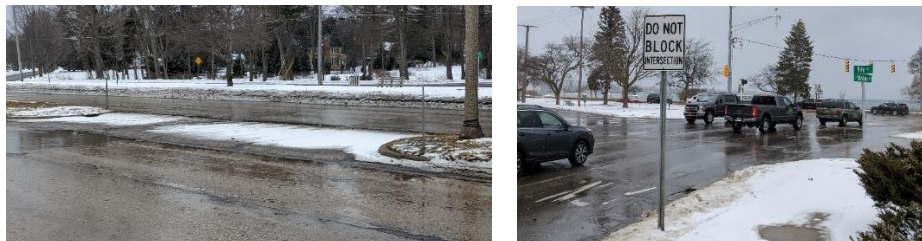
Figure 16 – Median Crossover (left) US-31/Bay Street Conflicts (right)

1. Close the bidirectional median breaks on M-22/M-72 within the study limits.
2. Stabilize the shoreline and restore the West End Beach public parking lot near US-31.
3. Modify the West End Beach parking lot to eliminate the utilizing the parking lot as a portion of the TART trail.
4. Investigate the operational and safety issues relative to Bay Street documented at the M-22/M-72 intersection relative to the US-31 intersection.
