GORDIE HOWE INTERNATIONAL Bridge

Historic Properties documentation project

KOVACS BAR
6986 W. Jefferson Avenue
Detroit, Michigan 48209
HISTORICAL DOCUMENTATION

KOVACS BAR (Kilian Hotel /Simpson Hotel)

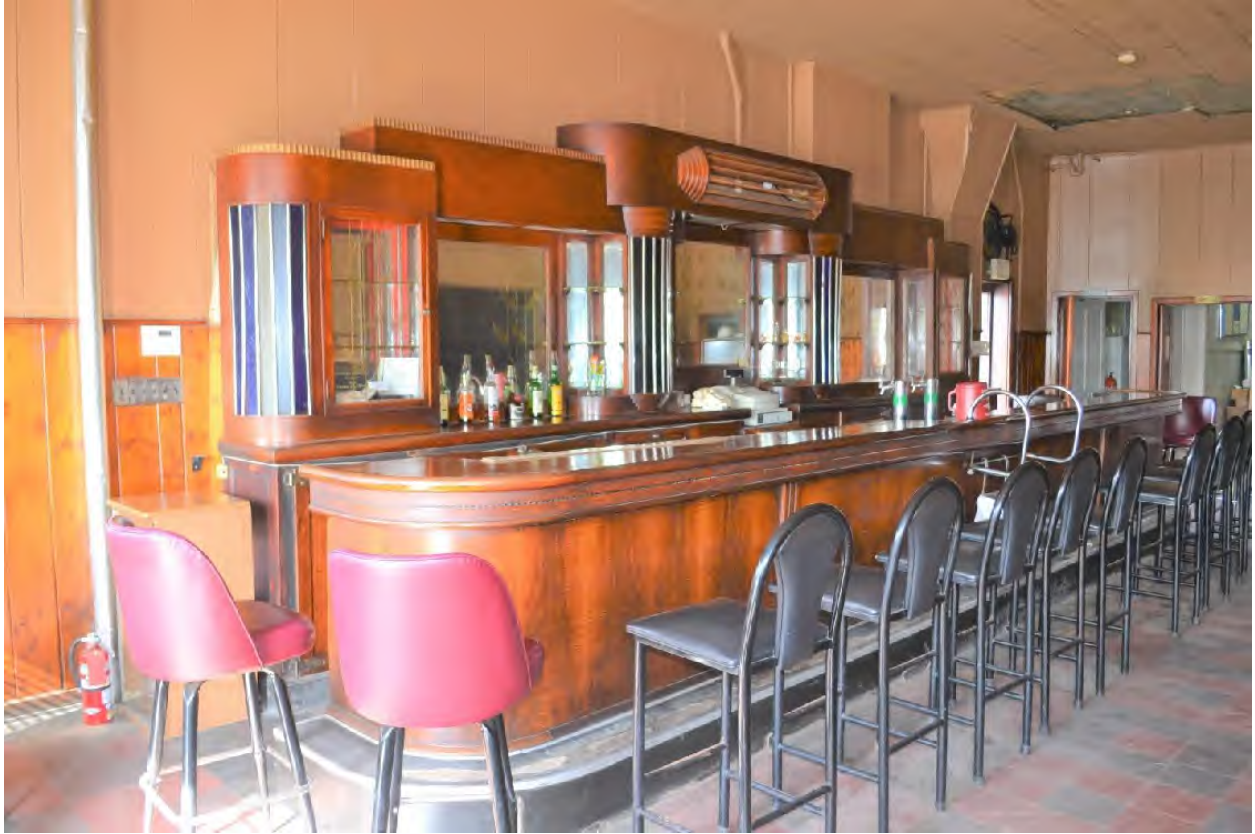
Figure 9: The Art Deco bar and back bar at Kovacs; note also the maple-finish knotty pine paneling. (MDOT/Baldwin September 15, 2015)

In circa 1936 Michael Kovacs remodeled the exterior and interior to visually unify and modernize the property. The West Jefferson Avenue frontage was clad in porcelain enamel panels – cream on a dark green base – with small windows lighting the barroom and dining rooms. Inside a new Art Deco Bar and back bar were installed and the old-time bead board wainscoting was replaced with maple-finish knotty pine paneling (covering approximately six feet of the 15-foot tall walls). He also installed large Art Deco milk glass pendant lighting – although only one fixture was still in place by 2015.

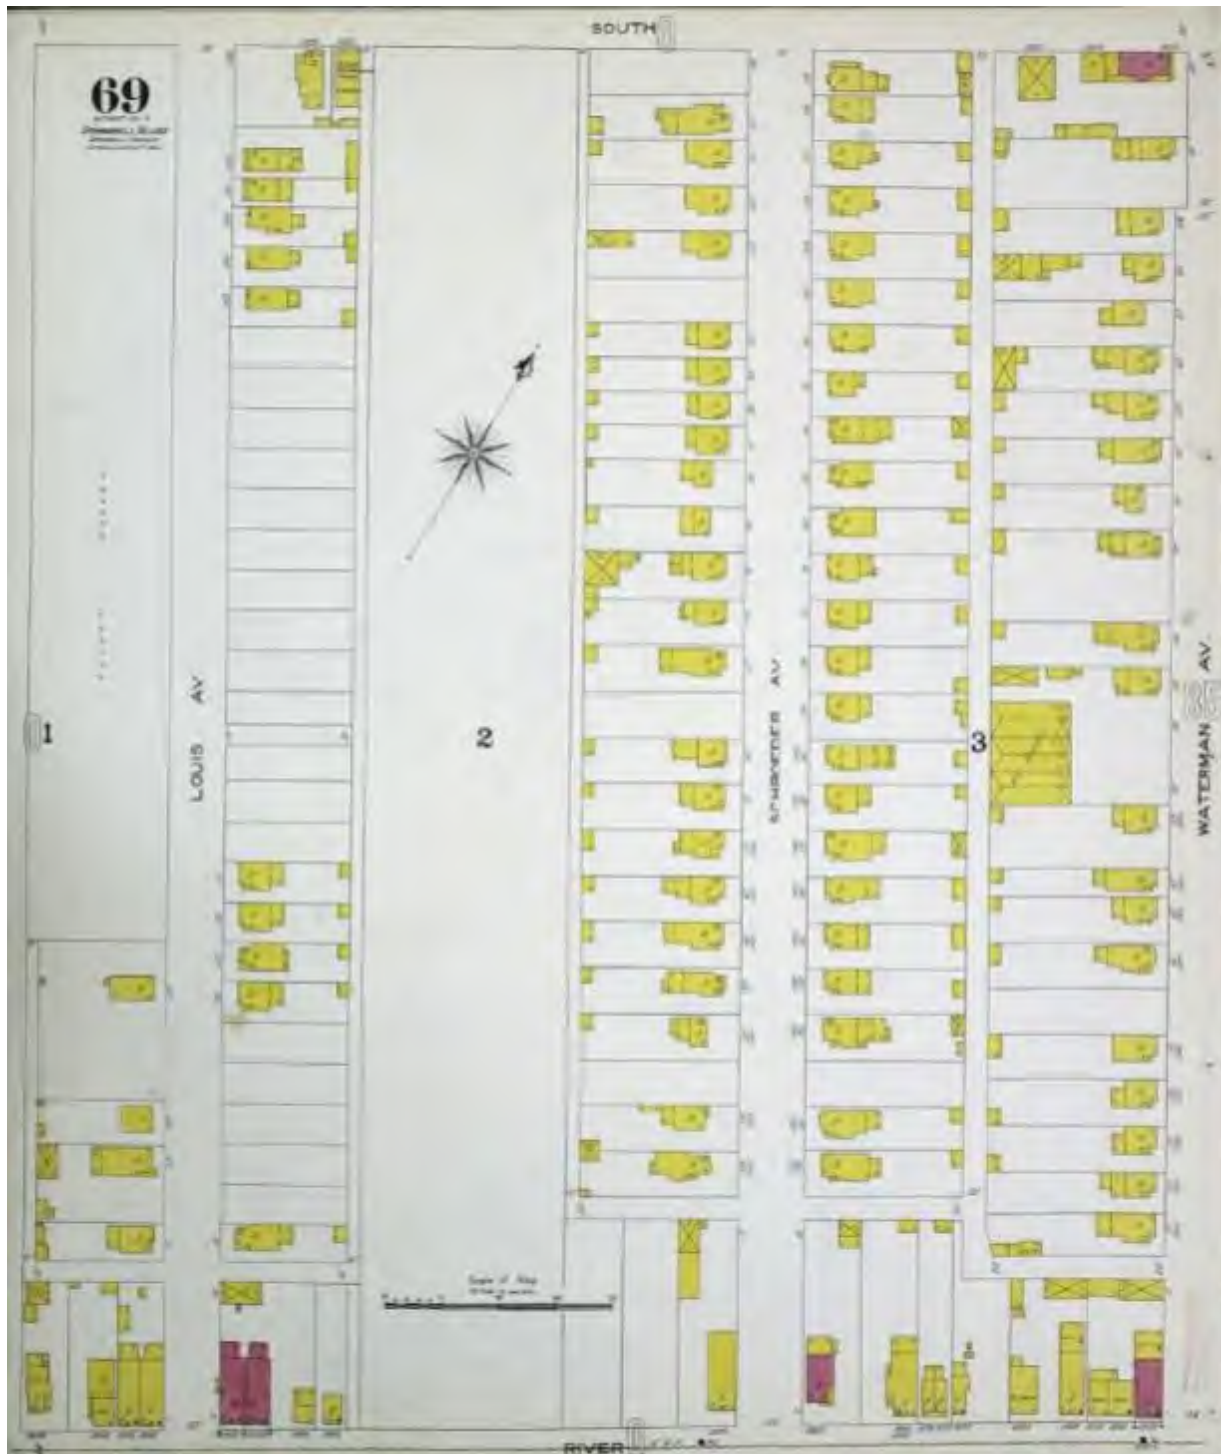
Figure 14: The subject building (owned then by Fidel Jehle) is the magenta shaded building on the lower left of this 1897 *Sanborn Fire Insurance Map*; the shading indicates the building is solid brick. The building at the northwest corner – owned by Fidel Jehle’s brother-in-law Louis Schmit, was of frame construction but essentially matched the Kovacs Building in massing (*Sanborn Fire Insurance Map*, Detroit, Volume 5, Sheet 69, 1897, <https://www.loc.gov/resource/g4114dm.g03985189705/?sp=70>)

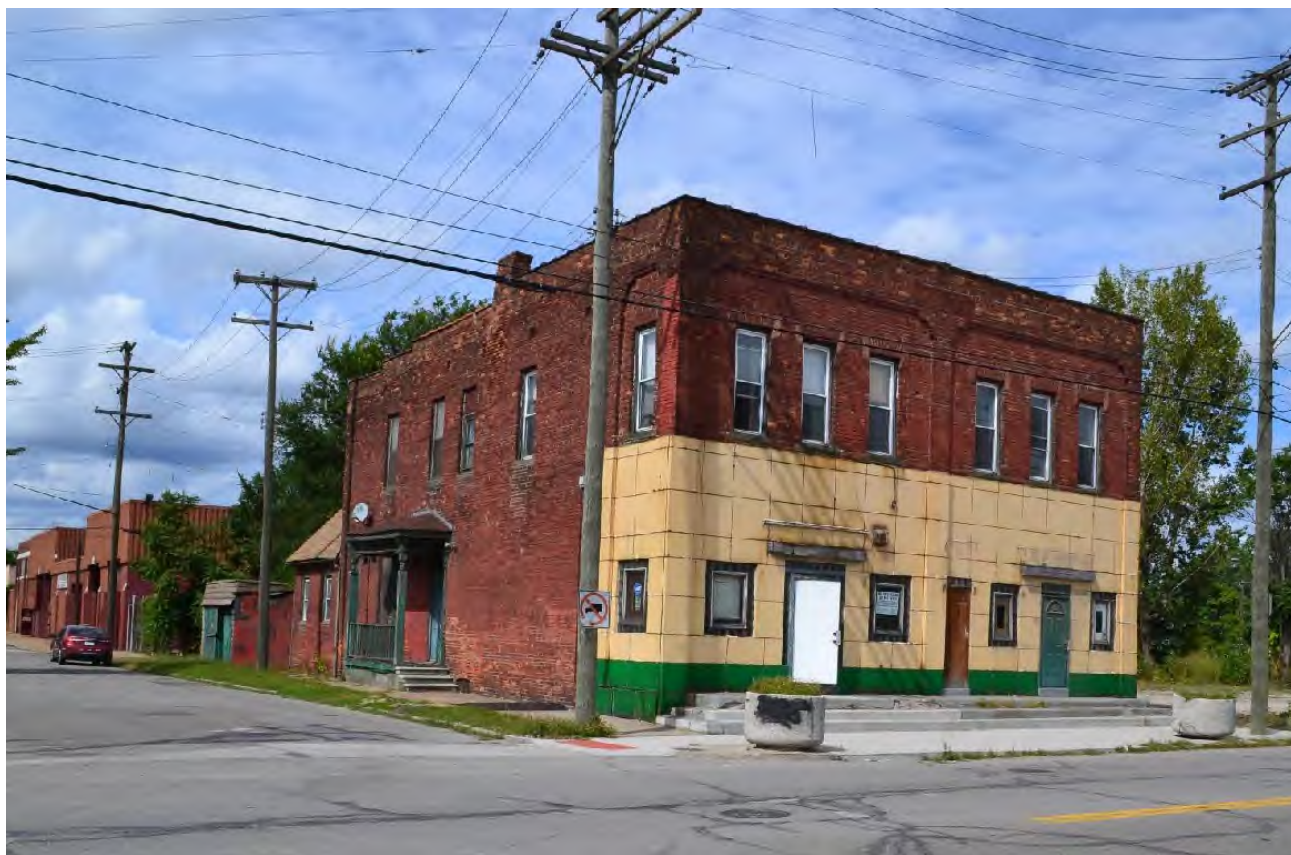
Photo 1: Looking northeast, showing the main (south) elevation and west (Post Street side elevation).

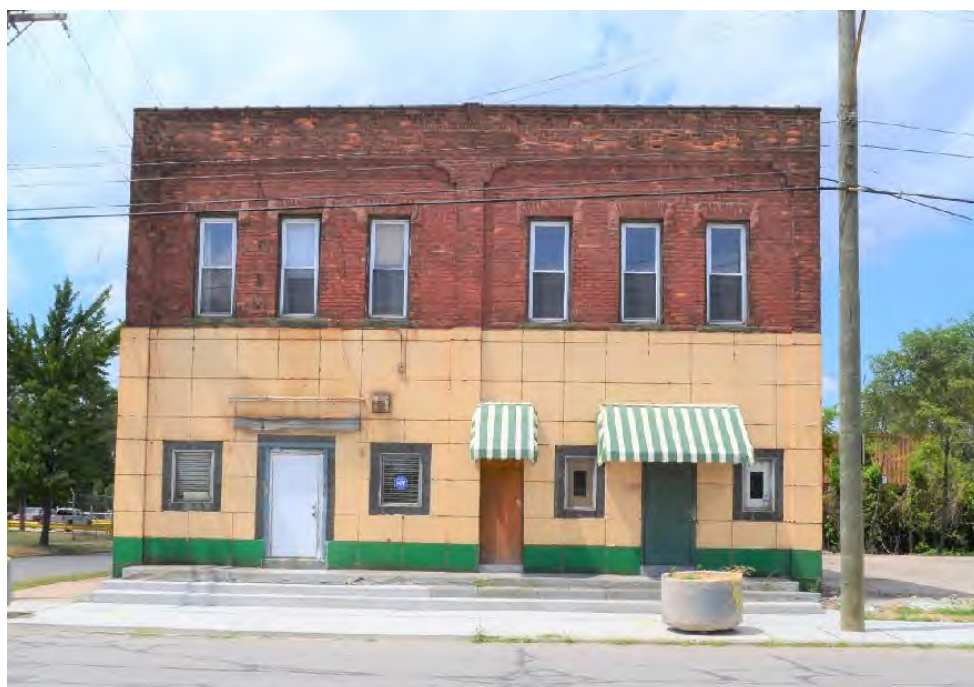
Photo 3 (detail): Looking north, view shows window on right side of the bar entrance / west storefront. The patterned glass block detail is repeated on the door side lights (but not transom light), window on left side of the door, and a side window at the southwest corner of the west elevation. The patterned glass block detail is also used on the windows flanking the dining room / east storefront doorway.

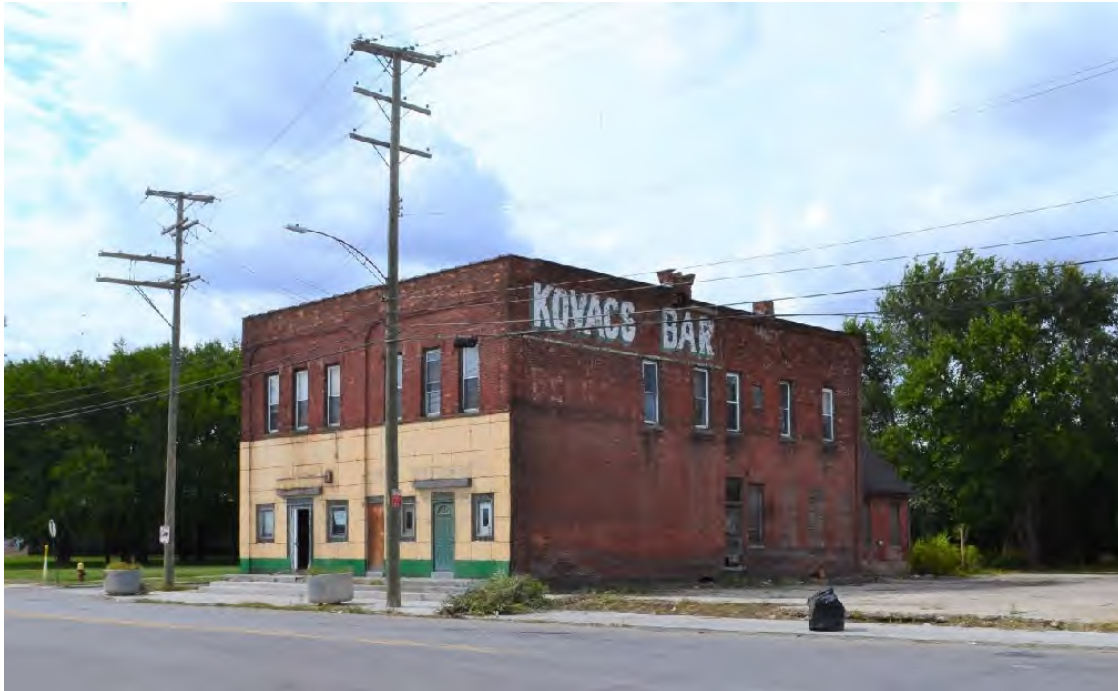
Photo 4: Looking northwest, view shows the South and east elevations of the building. The east elevation had been obscured for several decades by a one-story light industrial building. The building, erected in the early 1920s, was demolished in early July 2016.

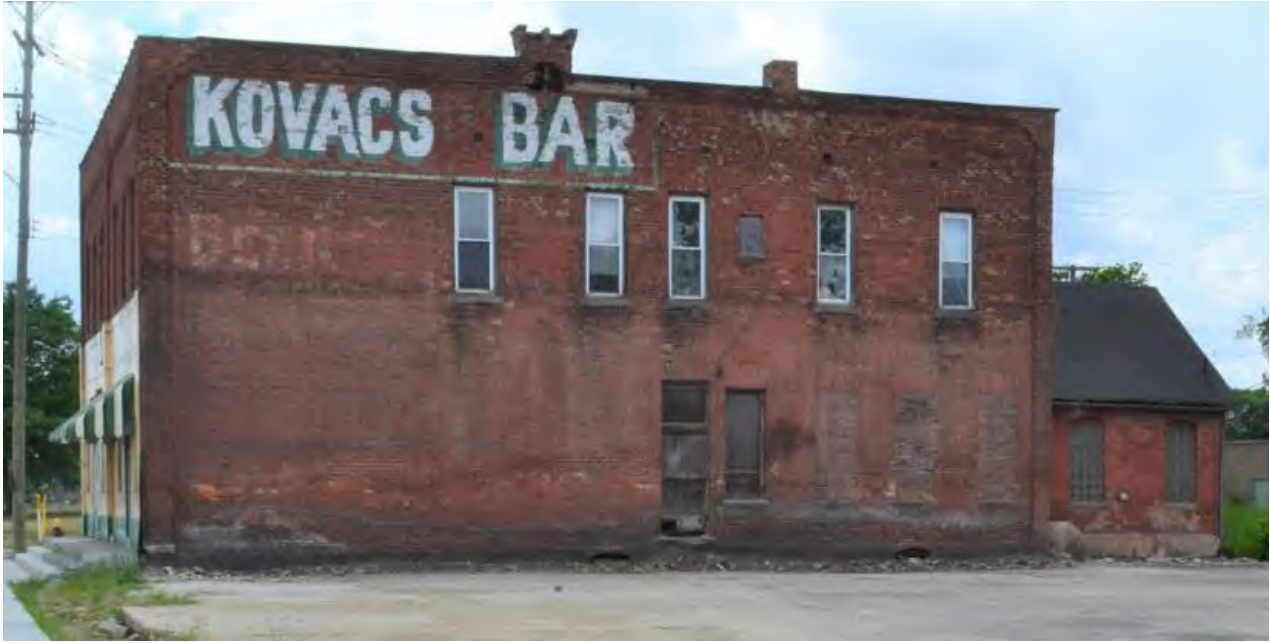
Photo 5 (July 14, 2016): looking west, view shows the east elevation, which until a few days earlier, had been obscured by a one-story light industrial building, built in the early 1920s. The side door and windows of the east storefront's east elevation were infilled at the time the industrial building was erected. This side lot was used for a seasonal beer garden operated by Martin Kilian in the late 19th and early 20th century. Beer gardens were a popular feature of many ethnic German taverns.

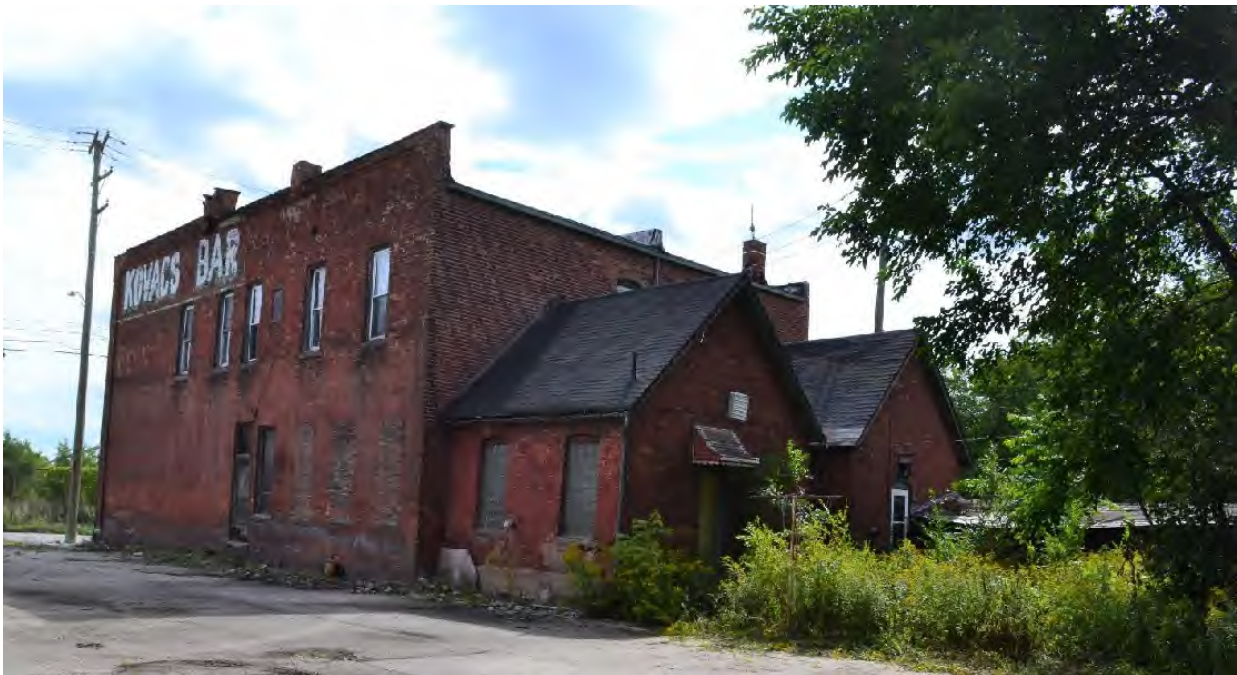
Photo 6: Looking southwest, view shows the east and north elevations, including one-story additions, of the Kovacs Building. The addition at the foreground (with glass block window infill) housed the laundry and women's restrooms. The gabled additions were added after 1896 and before 1910.

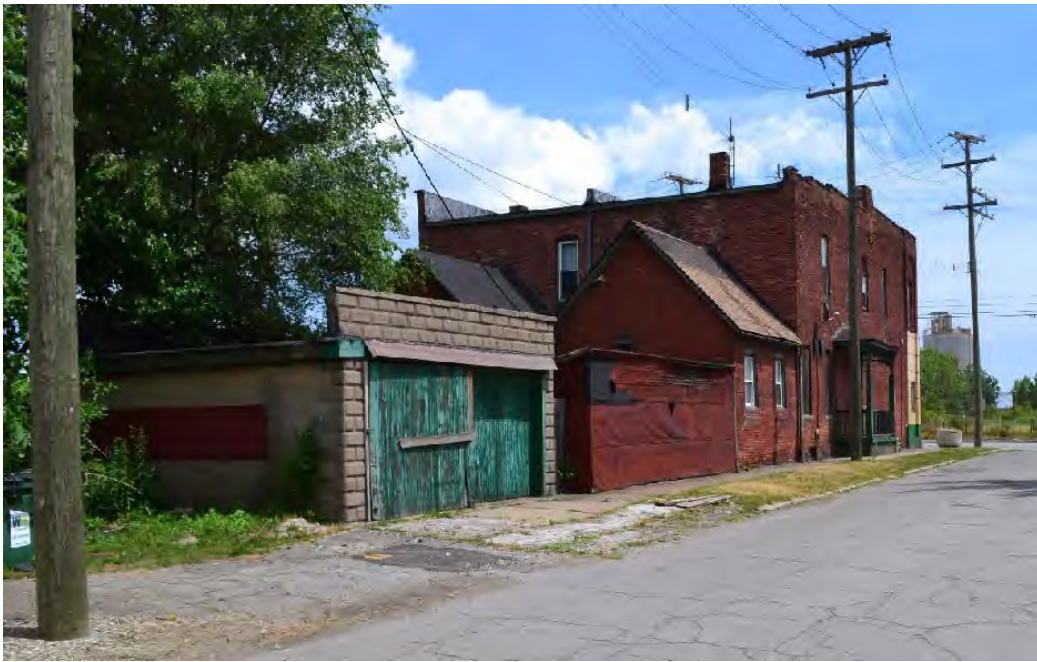
Photo 10 (July 14, 2016): looking southeast, view shows the Post Street side of the property, including the two-car, one-story garage, shed, and the north (rear) and west (side) elevations of the building. The one-story gabled addition housed the Kovacs Bar kitchen.

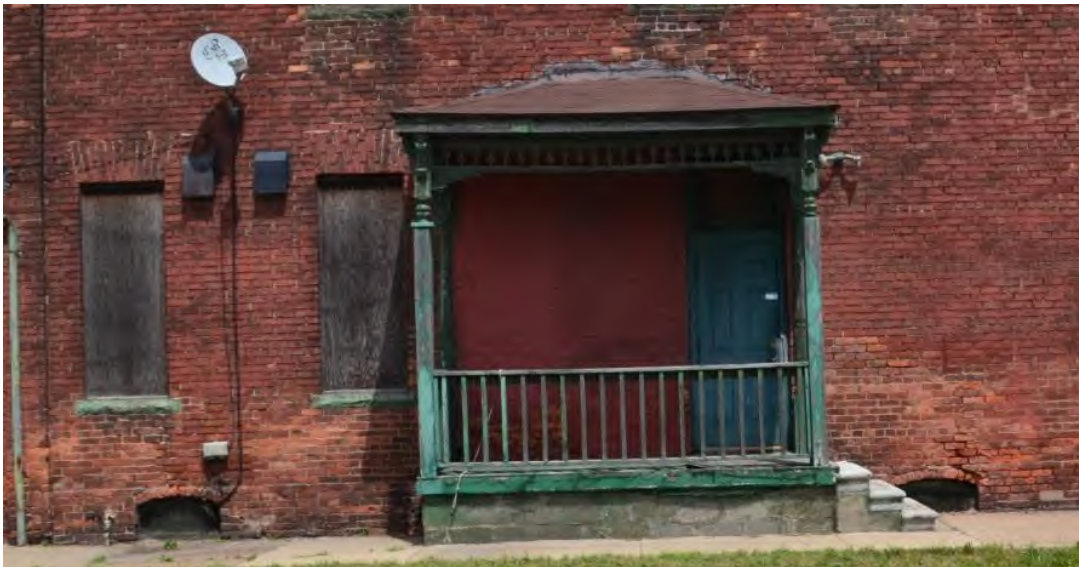
Photo 11 (detail, July 14, 2016): looking east, view shows the Victorian porch— dating to 1889-1891— on the west elevation of the west storefront. The non-original steel security door accessed the barroom, behind the plywood-covered window to the left of the porch was the men's restroom, behind the other plywood-covered window was an employee's restroom.

The west elevation parapet stepped down from the center chimney back to the building end, which terminated in a brick pilaster. A wood Victorian porch, dating to the building's construction, featuring turned posts, open cornice and simple railing projected from the wall, protecting the side entrance into the bar. North of the porch was a pair of window openings covered in wood panels, the upper floor fenestration consisted of four window openings clustered in the middle of the wall plane that lit the apartments within. As with the south elevation, second story windows were one-over-one replacement sash. Window openings on both levels featured the typical rough-faced stone sills and two-course soldiered brick lintels but lacked the stone shoulders found on the south/front elevation. The opening at the center window of the second floor carried wood panel infill and a smaller aluminum frame window lighting an apartment bathroom.

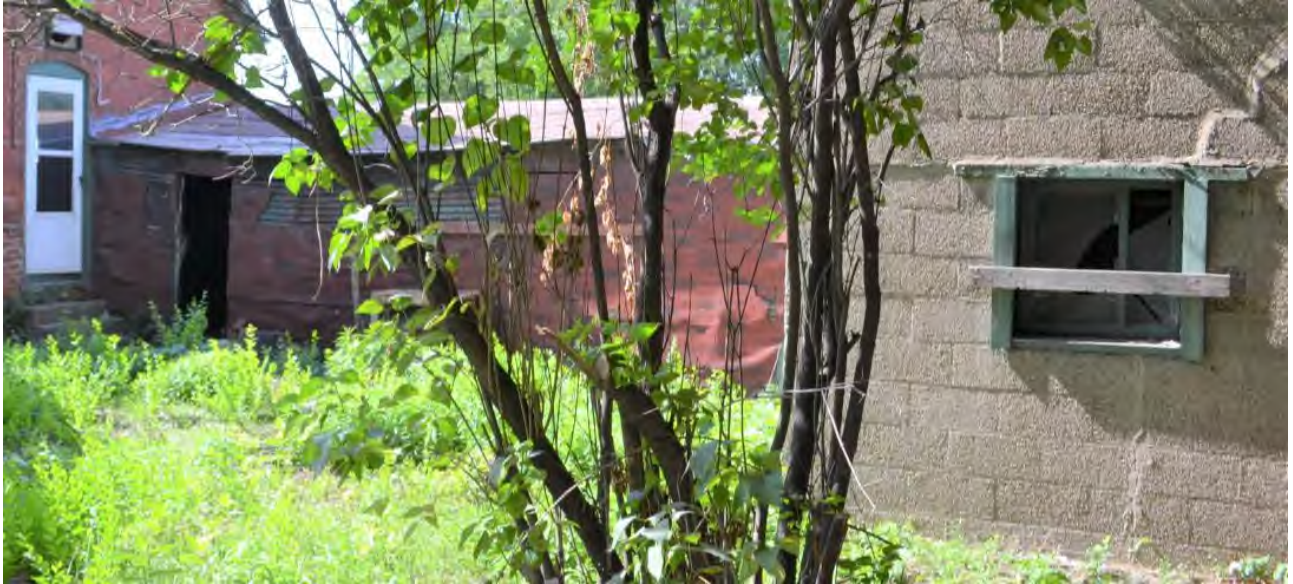
Photo 12 (detail, September 15, 2015): Looking west, southwest, showing the one-story wood-frame shed between the building and garage. Brick-look asphalt siding covers the clapboard cladding. At right is portion of the east (back) wall of the garage.

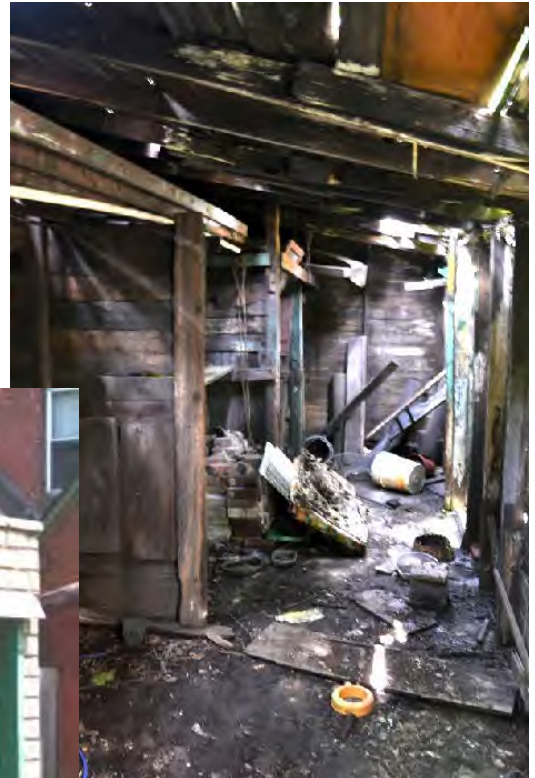
Right, Photo 13: looking north, a view of the shed interior. Used for decades for storage, the shed dates to circa 1900-1910. The shed was likely associated with a two-story barn that predated the current garage.

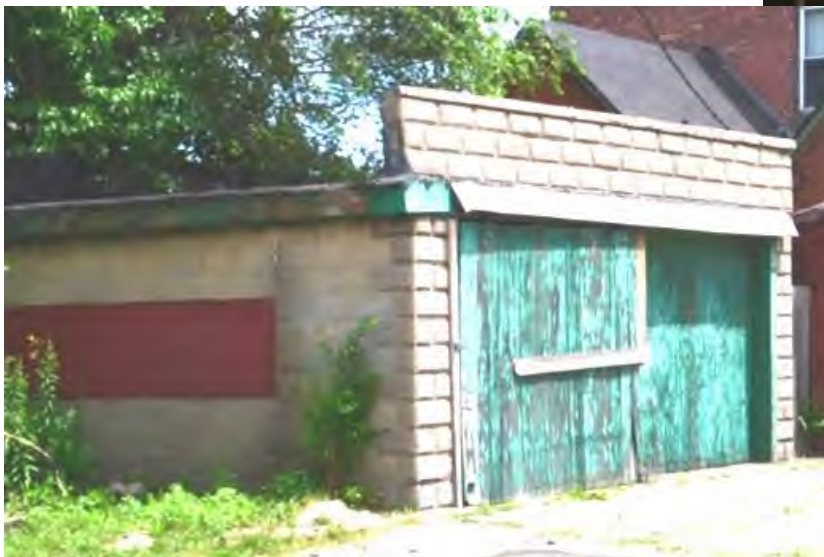
Below, Photo 14 (detail, July 14, 2016): Looking southeast, showing the west elevation and a portion of the north elevation of the garage. The garage—built c. 1940- replaced the original two-story carriage barn.

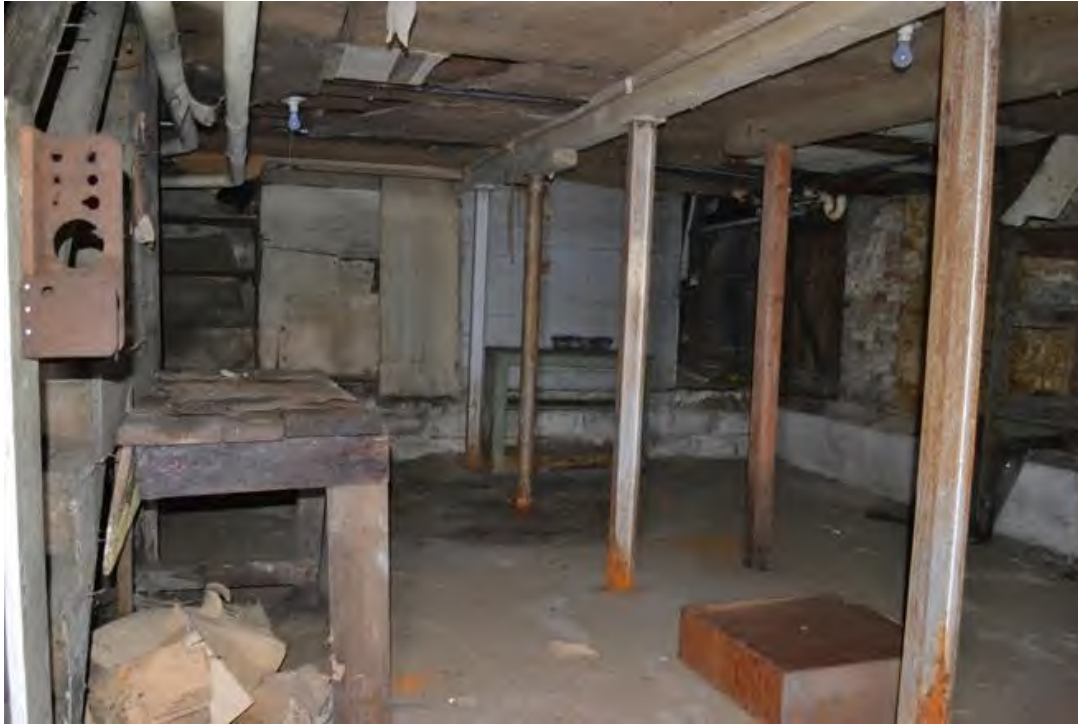
Photo 15: East basement, looking north. Most of the east basement is beyond the partition wall. At the far left (next to the work bench) are stairs to the first-floor dining room/east storefront. Note the non-original wood and steel posts.

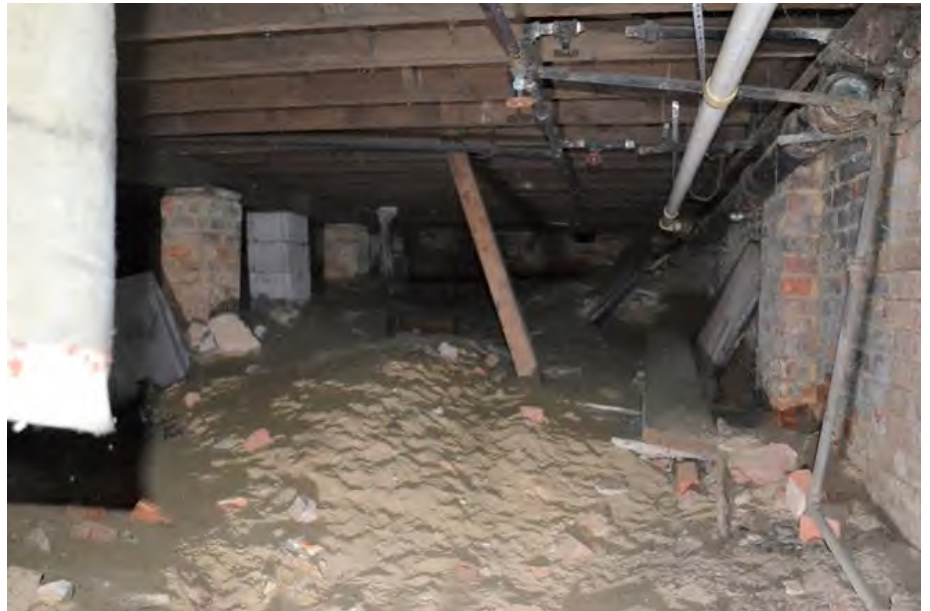
Photo 16: East basement, looking north. View shows the dirt and debris-filled north 2/3rds of the east basement. At left original brick and a replacement block posts support the floor beam

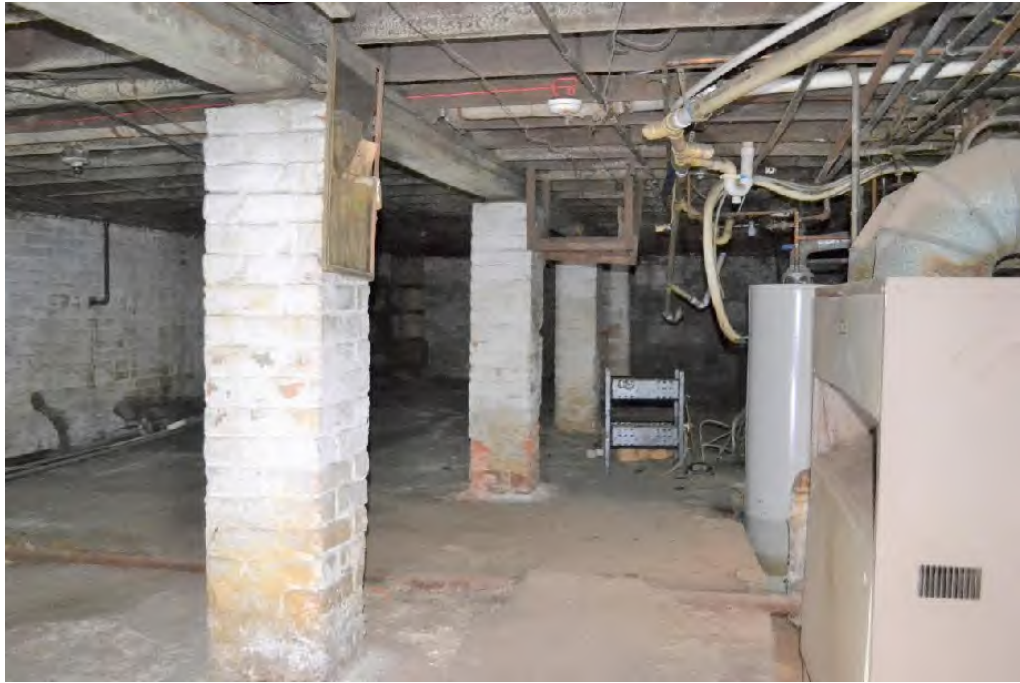
Photo 19: West basement, looking south. View from stairs (near north end of the basement). At the left is the central load bearing wall separating the west and east storefronts. Along mid frame are original brick posts supporting the floor beam. At right is the building furnace and a water heater (serving the first floor), the units were set in a shallow pit to accommodate their height. The floor, including the pit, were concrete finished.

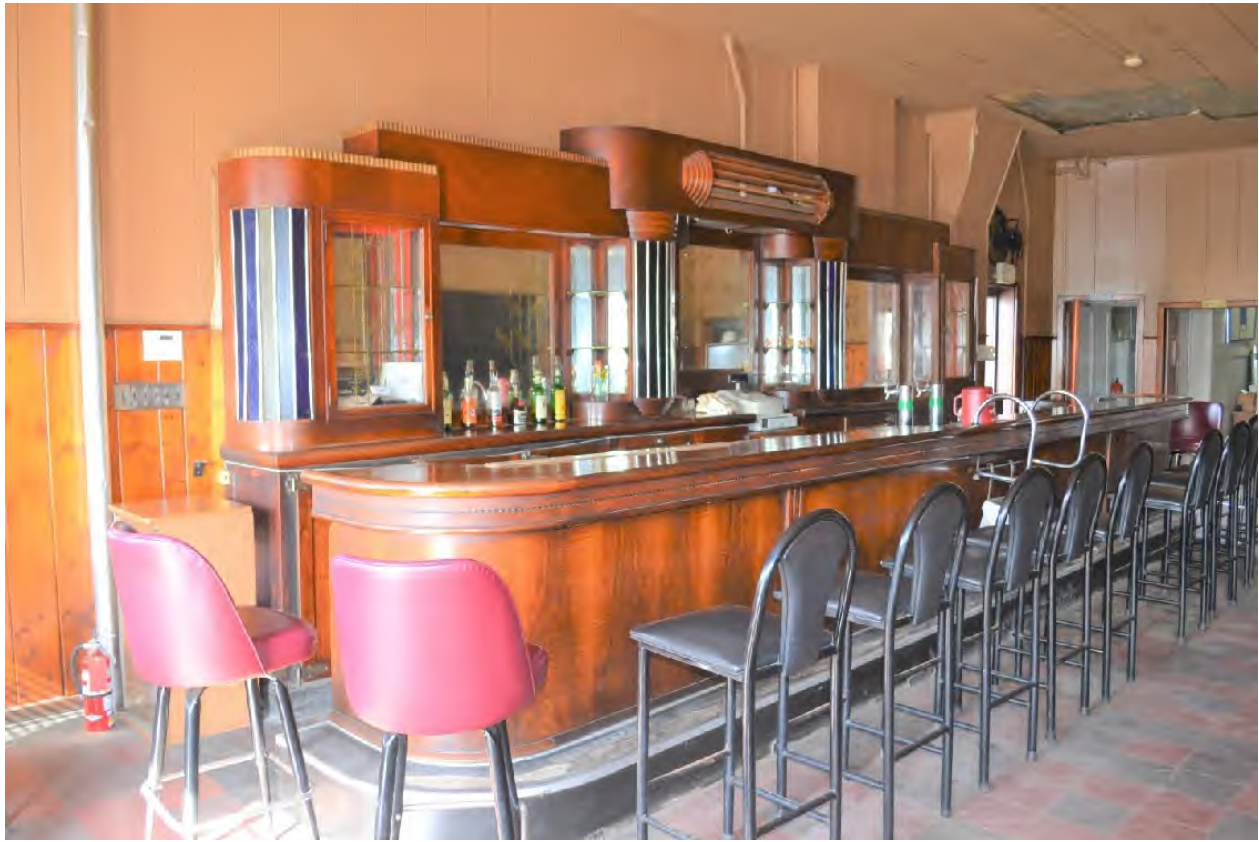
Photo 24 (September 15, 2015): looking northwest, the Art Moderne/ Art-Deco bar and back bar installed by Michael Kovacs in the 1930s.

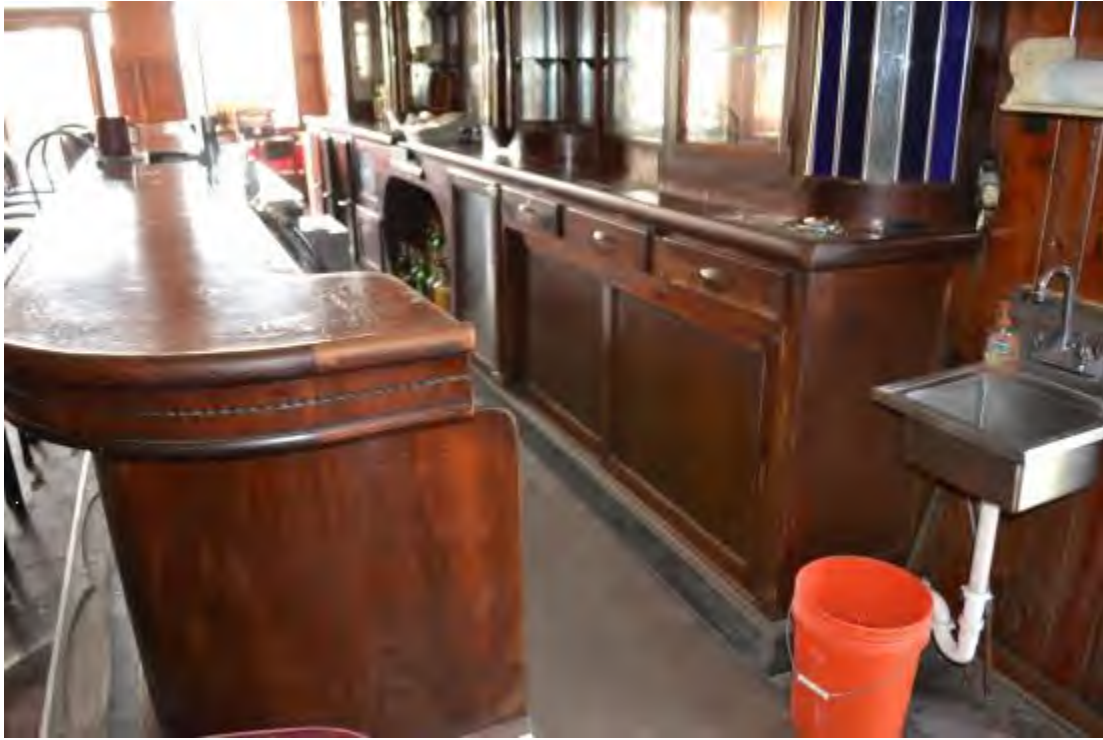
Photo 26 (September 15, 2015): Looking south, southwest, lower section of the back bar. Mechanical refrigeration for the unit was added during his tenure.

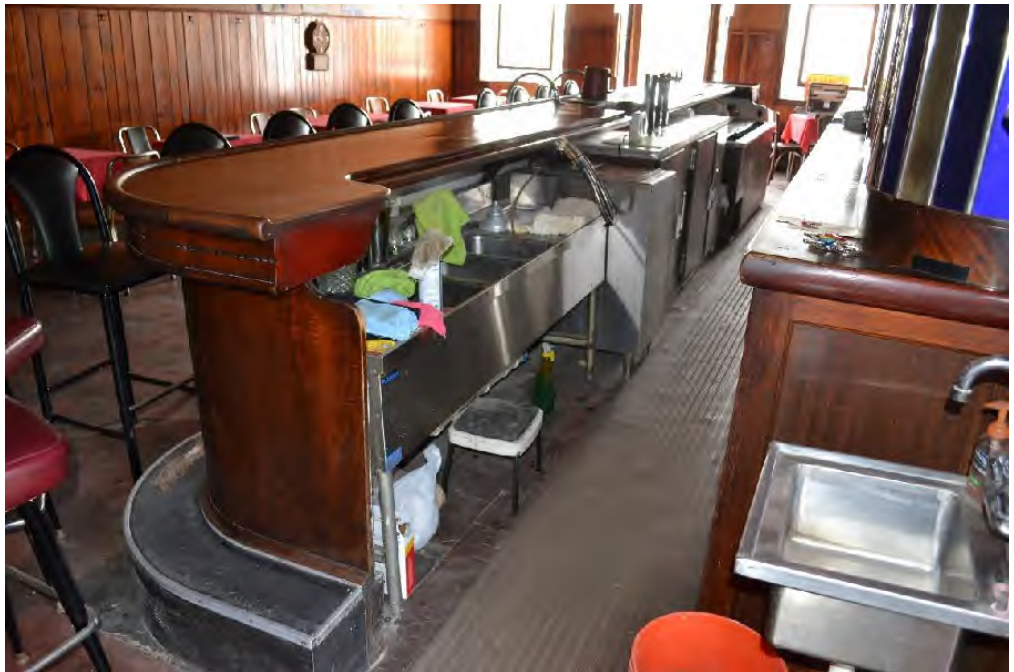
Photo 27 (September 15, 2015): looking south-southeast, view showing the under-bar array of sinks and coolers. At the right is the bartender's/server's hand sink.

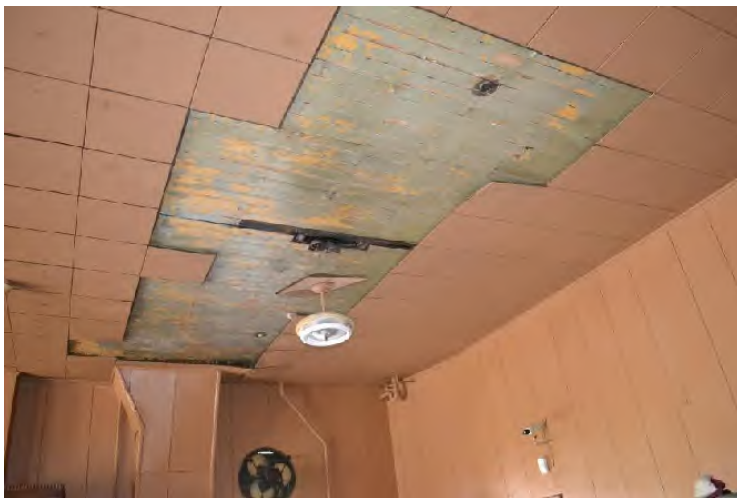
Photo 31 (detail, September 15, 2015): looking north, view of the original plank ceiling (barroom) where acoustic tiles are missing; although two different colors of paint are present it might be assumed the ceiling carried decorative tin cladding. The fluorescent fixture replaced an Art Deco milk glass pendant fixture that was typical of the décor during the Kovacs years. **Above right, Photo 32, (detail, September 15, 2015):**

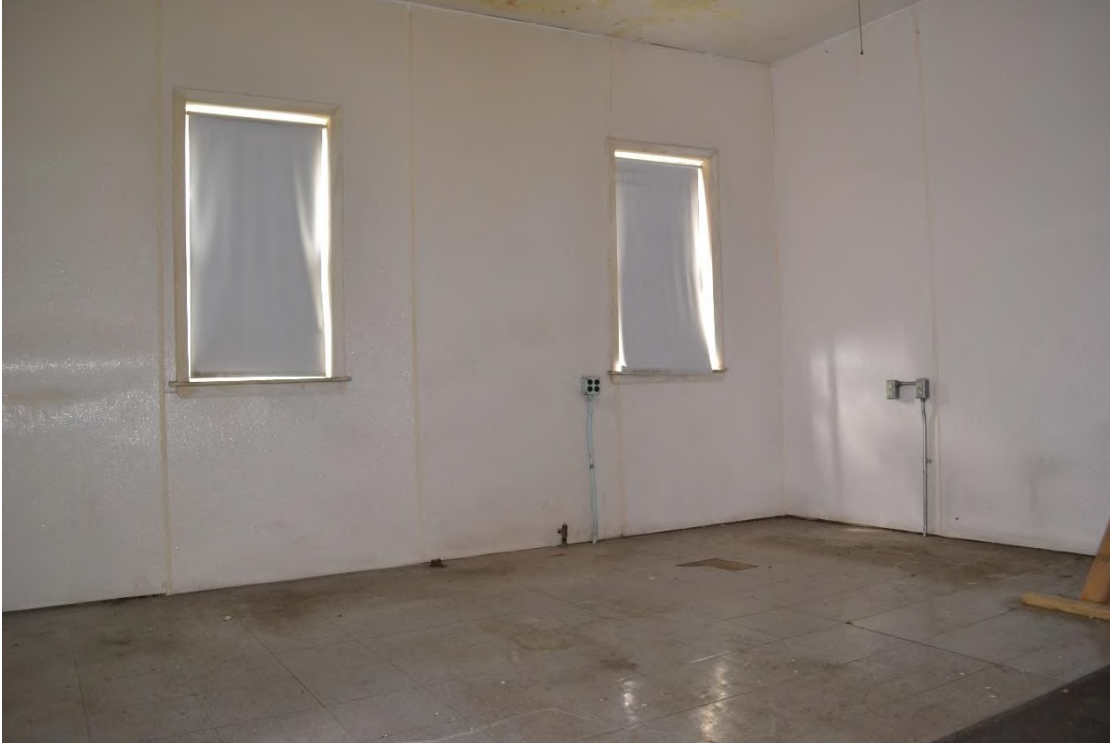
Above: Photo 41: Looking northwest, view of the west addition / bar kitchen. The walls are clad in restaurant-grade sanitary paneling.

The one room west addition housed the bar's kitchen and scullery services; the walls were covered in modern, easy-clean plastic wall panels. The west elevation carried two window openings on the west wall with one-over-one replacement sash.
