ROAD SAFETY AUDIT

US-31 (REYNOLDS RD
TO SULLIVAN RD)

CITIES OF INTERLOCHEN AND GRAWN,
MICHIGAN

Cincar Consulting Group, LLC

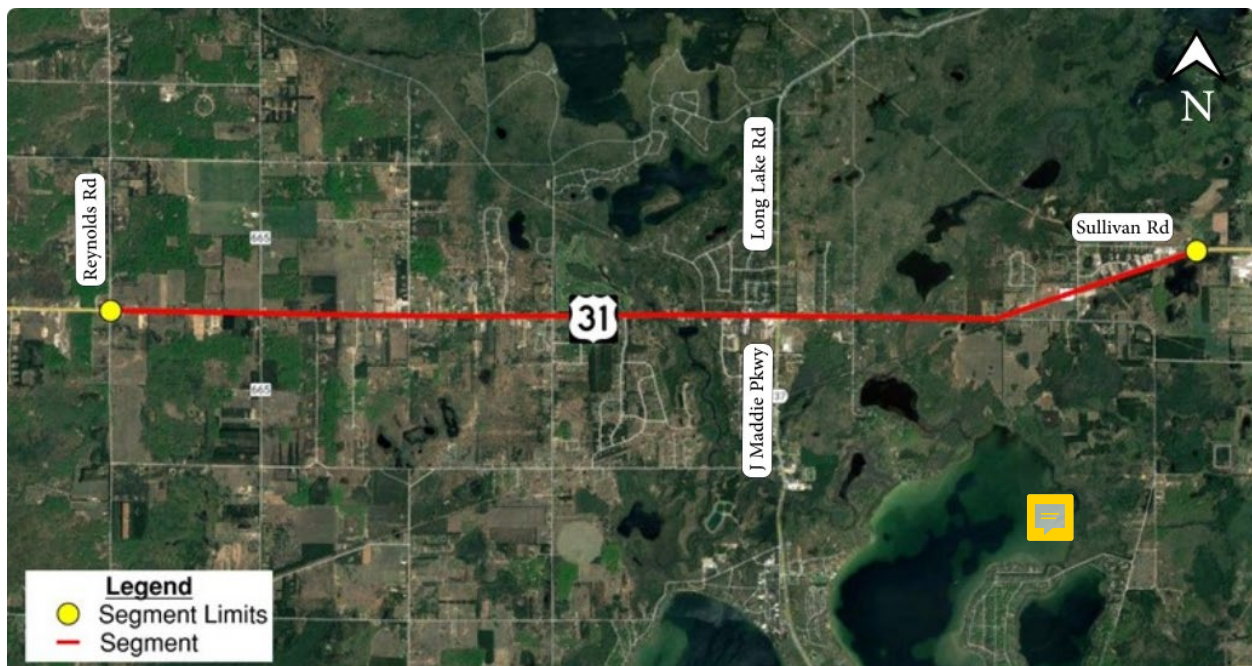
Figure 2: US-31 Road Safety Audit Limits

The objective of the study was to review the corridor for any safety issues that could be mitigated in the future design project. The project limits are shown in **Figure 2**. US-31 is a minor arterial linking Benzie County on the west to the cities of Interlochen and Grawn and eventually to Traverse City. J Maddie Parkway/Long Lake Road splits the corridor with about 10,862 AADT (2020) from Reynolds Road to J Maddie Parkway/Long Lake Road and 14,730 AADT (2020) from J Maddie Parkway/Long Lake Road to Sullivan Road. The project limits are about 8.39 miles in length.

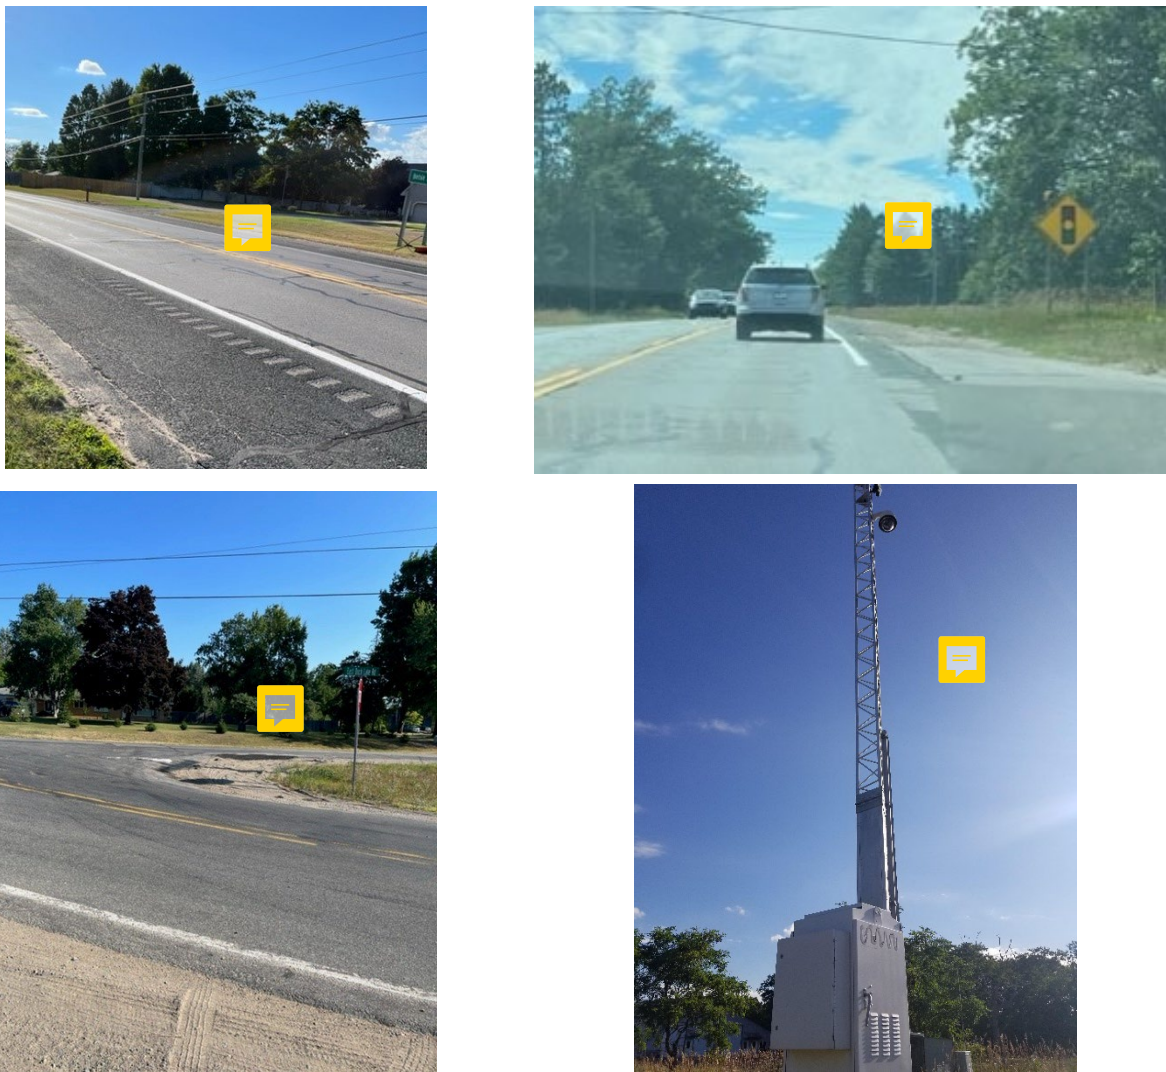
Figure 3: US-31 Existing Roadway Characteristics

The project segment is approximate 8.39 miles between Reynolds Rd and Sullivan Rd in Grawn and Interlochen County (**Figure 2**). US-31 is a two-lane section, with one lane in each direction, continuous center rumble strips for the majority of the corridor, shoulder rumble strips between Betsie River Rd and Gonder Rd, and a wide shoulder throughout the length of the corridor. Several driveways also exist throughout the length of the corridor. There is only one signalized intersection at J Maddie Pkwy that is present along the corridor and advanced warning flashers have been installed. Numerous stop-controlled access points exist along the corridor and some are heavily skewed. An ITS tower between Betsie River and Round Lake Rd was observed to monitor weather conditions along US-31. **Figure 3** shows some of the existing roadway characteristics. The US-31 corridor has a posted speed limit of 55 MPH.

There is one signalized intersection and 19 unsignalized intersections within the project limits. The following list goes from West to East:

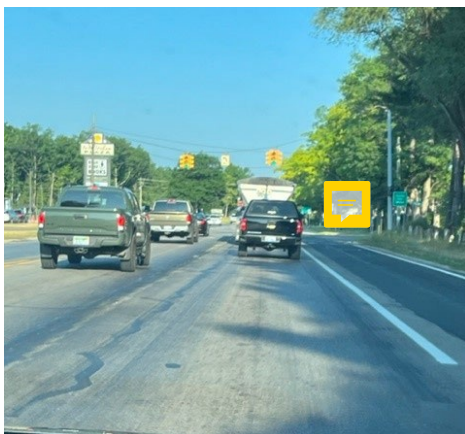
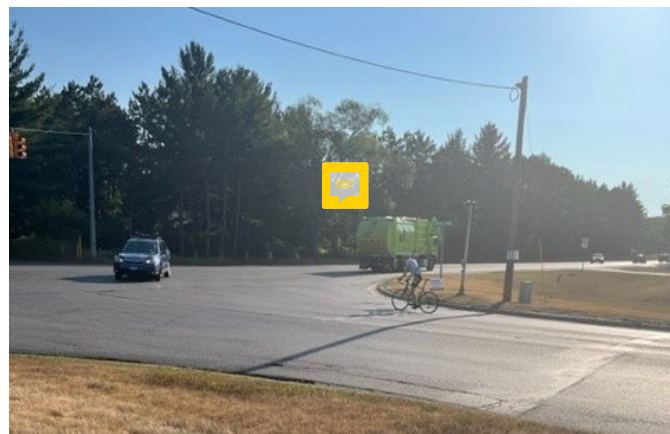
Figure 4: Roadway Users

The primary mode of travel throughout the corridor is passenger vehicles. The corridor has an approximate AADT of 10,862 vehicles (west of J Maddie Pkwy) and 14,730 vehicles (east of J Maddie Pkwy). Additional modes of travel include cycling. See **Figure 4** pictures for roadway users. A local transit route uses US-31 with a stop in the SW parking lot at J Maddie Pkwy. Several cyclists were observed utilizing the shoulders and crossing at intersections.

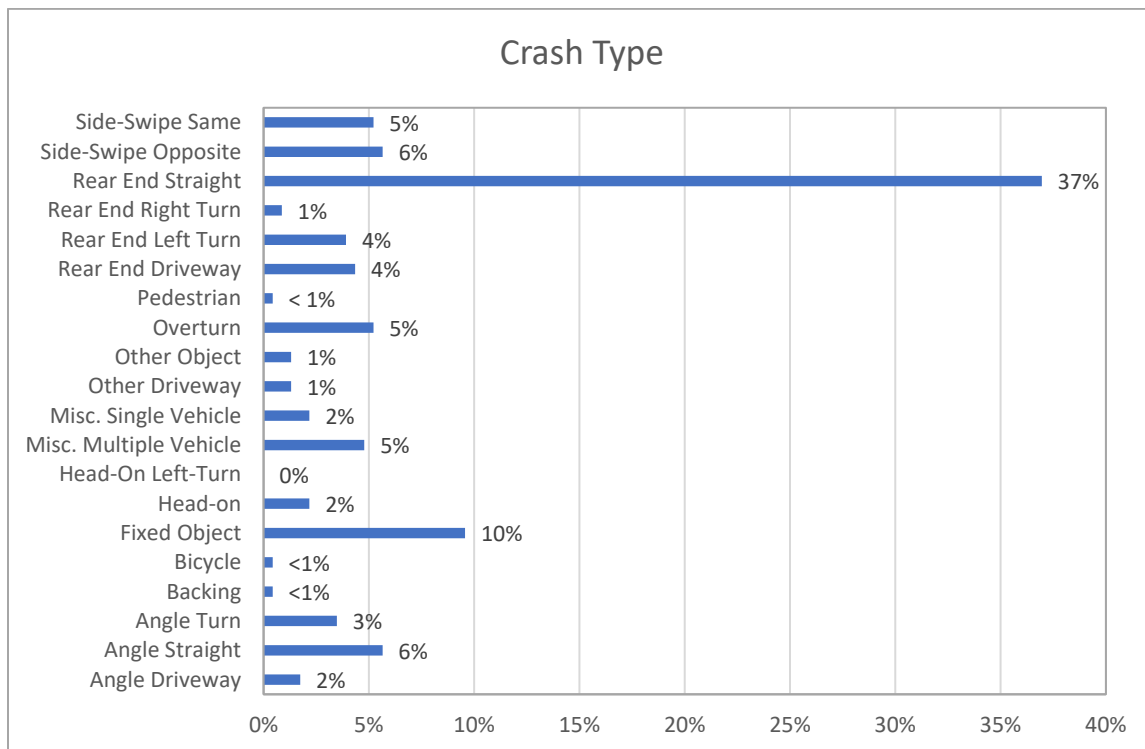
Figure 5: Crash Type

There were 230 crashes during the analysis period, of which 46% (106 total) were rear-end collisions, 11% (25 total) were angle crashes, and 6% (13 total) were sideswipe same-direction crashes. The remainder of the crashes consisted of single motor vehicle, head-on, sideswipe opposite direction, head-on, and other crashes.

Crash types are summarized in **Figure 5**. The proportion of rear-end straight crashes is similar to other Grand Traverse County US-Route crash averages.

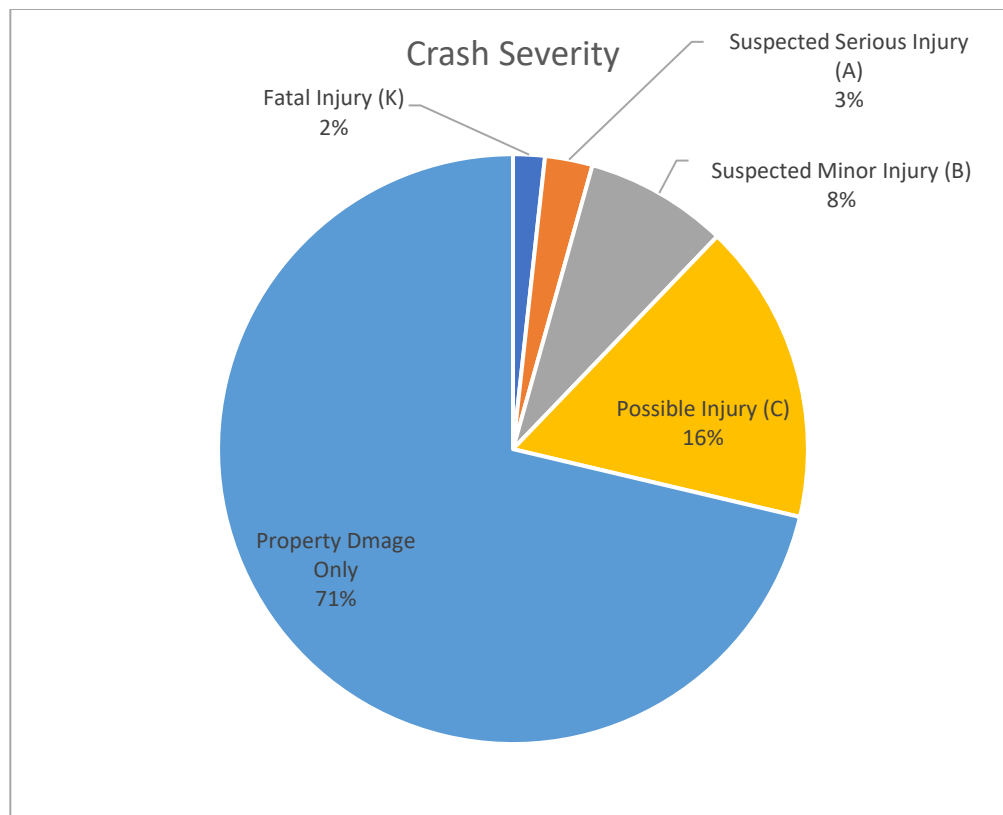
Figure 6: Crash Severity

Out of the 230 total crashes, 66 crashes (29%) resulted in some type of injury. Four crashes (2%) resulted in Fatal (Type K) injuries and six crashes (3%) resulted in Type A injuries. A breakdown of crashes by severity is shown in **Figure 6**. The proportion of Fatal (Type K), Type A, and Type B injuries is approximately 7% higher when compared to other Grand Traverse County US-Route averages. The proportion of Type C injuries is approximately 4% higher and the proportion of crashes with some type of injury is approximately 11% higher when compared to other Grand Traverse County US-Route crash averages.

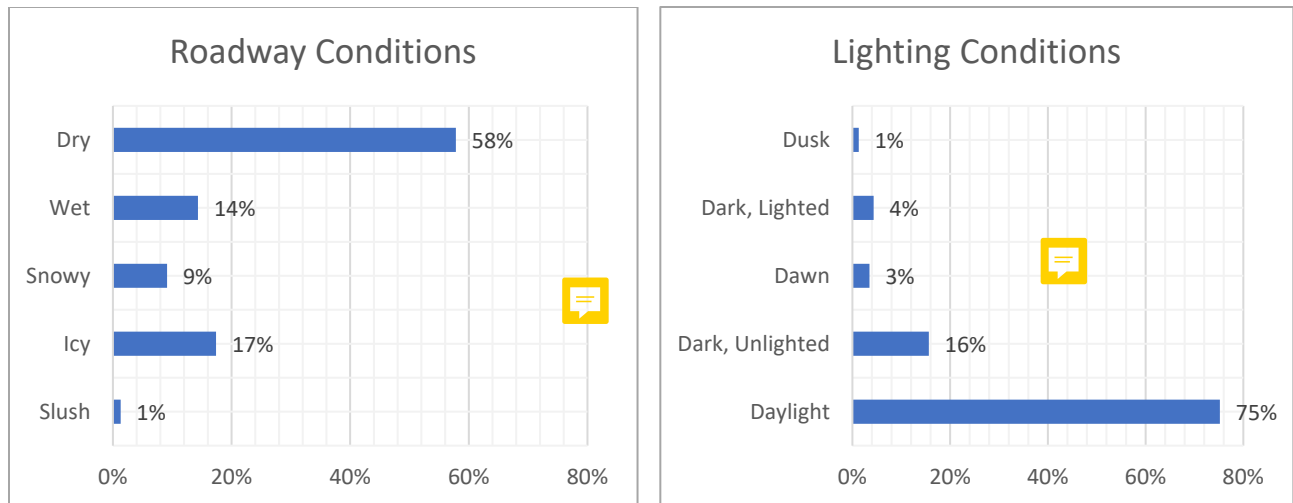
Figure 7: Crashes by Roadway and Lighting Conditions

The varying roadway and lighting conditions at the time of a crash are shown in **Figure 7**. The proportion of crashes occurring in dry roadway conditions is approximately 6% lower when compared to other Grand Traverse County US-Route crash averages. The proportion of crashes occurring in icy road conditions is approximately 10% higher when compared to other Grand Traverse County US-Route crash averages. The proportion of crashes occurring during daylight along US-31 is similar to other Grand Traverse County US-Routes crash averages.

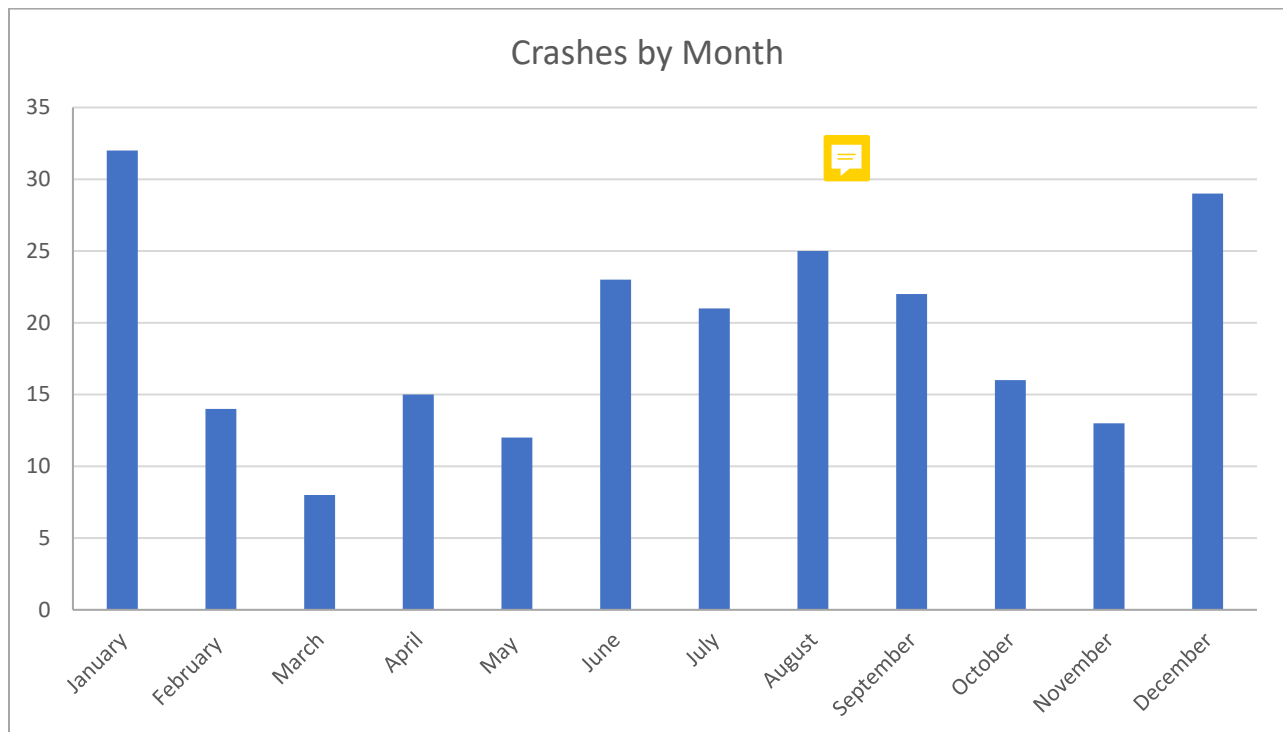
Figure 8: Crashes by Month

The crashes along US-31 were broken down by month and are displayed in **Figure 8**. The highest proportion of crashes occurred in January and December. The proportion of crashes in January is approximately 4.4% higher when compared to Grand Traverse County monthly percentages for the same five-year time period.

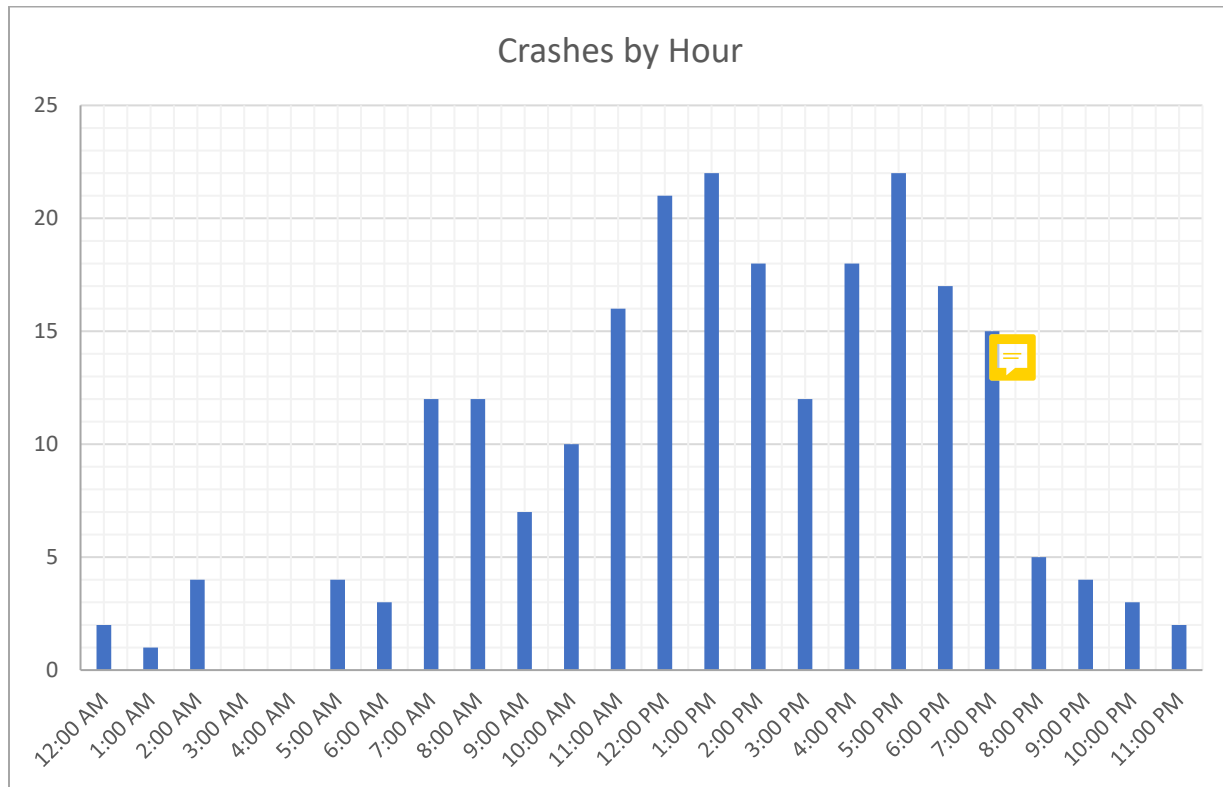
Figure 9: Crashes by Hour

The crashes along the US-31 corridor were broken down by hour of the day and are shown in **Figure 9**. The highest proportion of crashes along the corridor occur during the midday and PM peak periods from 11:00 AM to 2:00 PM and 4:00 PM to 7:00 PM.

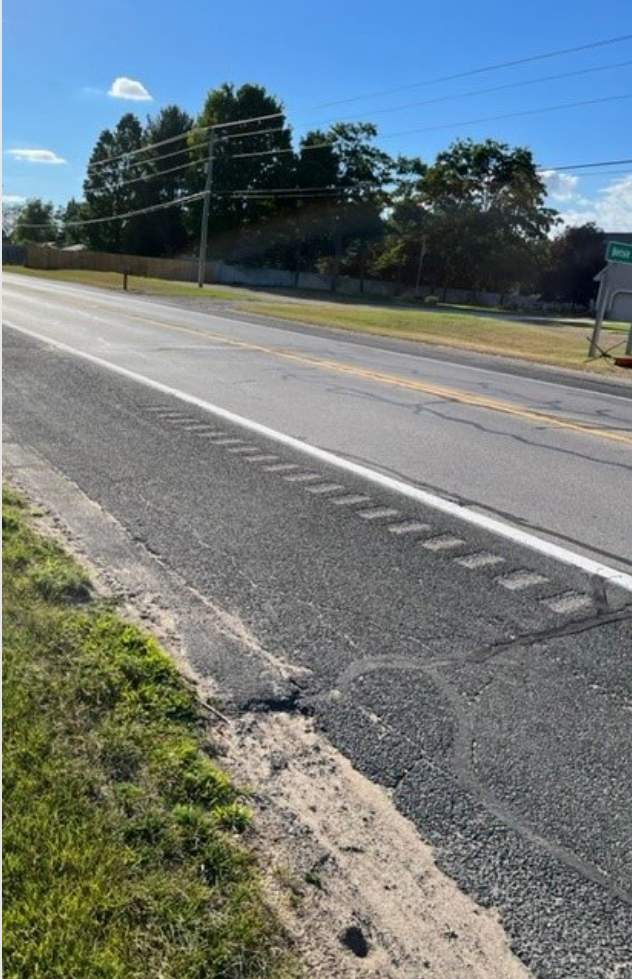
Existing Safety Measures	
<p>Center rumble strips (side rumbles between Betsie River Rd and Gonder Rd)</p> <p>Corridor pavement markings visible</p>

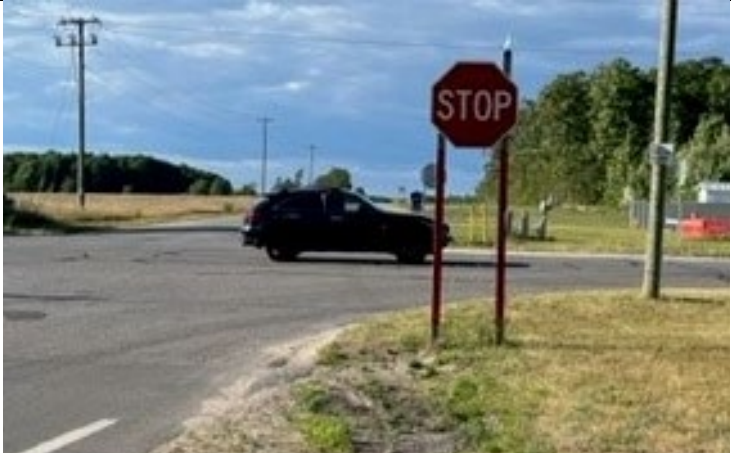
<p>Local intersections</p> <ul style="list-style-type: none"> • Streetlights • Advanced signage • Dual stop signs with reflectors

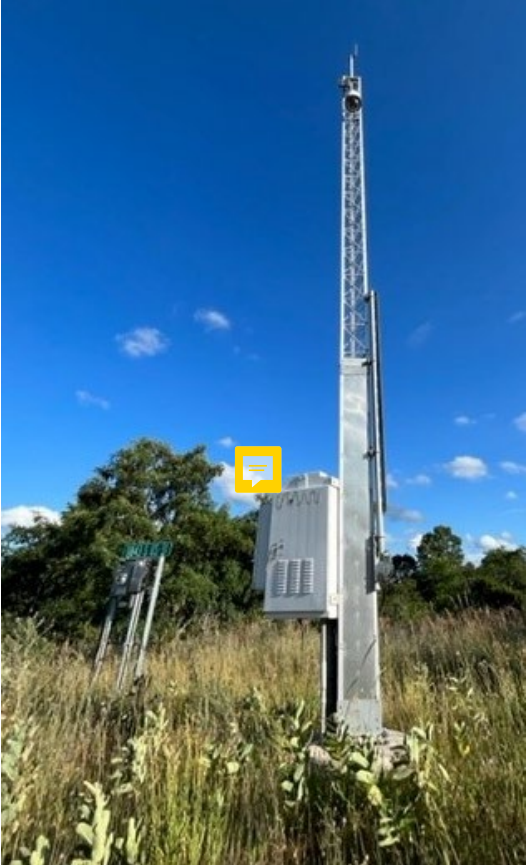
Existing Safety Measures	
<p>Advanced warning flashers at J Maddie Pkwy and Fire Station (pre-empt)</p>	 
<p>ESS – ITS tower to monitor weather conditions. Two pavement pucks present.</p>

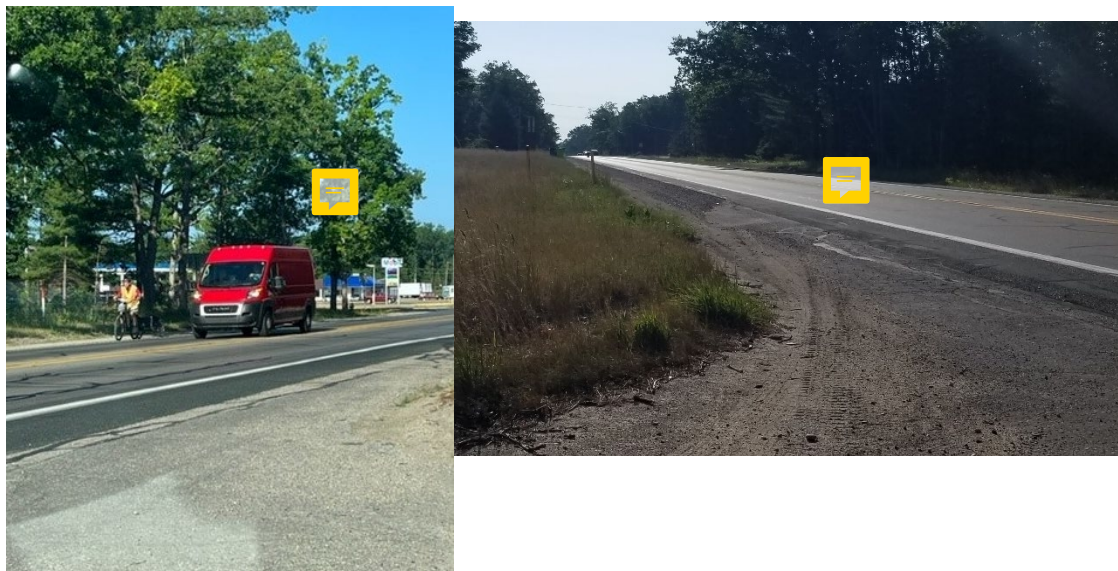
Figure 10: Corridor Wide Examples

The US-31 corridor runs east/west which creates sun glare/blind in the morning and evening hours of travel. There is only one lane in each direction with no passing lanes. Crossroads and driveways are spaced throughout the corridor, which results in left-turn movements. The lack of turn lanes has resulted in a higher percentage of rear-end crashes, vehicles passing on the right (gravel shoulder), and using the existing right-turn only lanes as by-pass lanes. Queuing was also noticeable on EB US-31 at Tonawanda Rd. The lack of available gaps eastbound during the AM and westbound during the PM is causing drivers to be more aggressive in completing turning movements.

Gravel shoulders are present along the corridor. A height difference between the pavement and the gravel shoulder was noticed as well as highly varied slopes. Both traits could decrease the driver's ability to recover if they run off the road. Several cyclists along the corridor were observed utilizing gravel shoulders. An example of this can be seen in **Figure 10**.

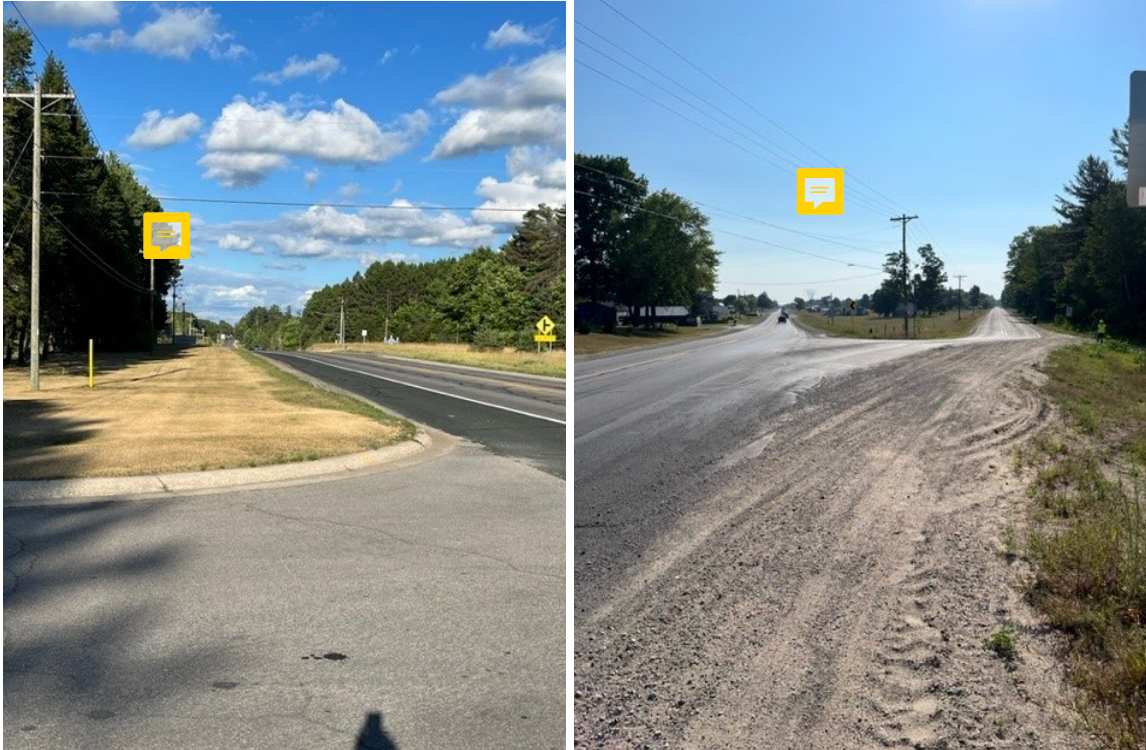
Figure 11: Vertical/Horizontal Curve Examples

- **Duck Lake Road:** this roadway connects to US-31 on the outer part of a horizontal curve creating a skew. During the field visits, drivers were observed exiting US-31 EB at a high rate of speed and either utilizing the wide gravel shoulder or entering the oncoming WB lane on Duck Lake Road. An example of this can be seen on the right of **Figure 11**. The skew connection also makes it difficult to make turns onto WB US-31 from Duck Lake Road. A near miss was observed at this intersection.

- Sullivan Road: also connects to US-31 in a horizontal curve. Due to the lower volume along this roadway not as many crashes were recorded at the intersection.

Due to the higher traffic volumes on Duck Lake Road and the behaviors that were observed, the RSA team members assigned the crash frequency as **occasional**. The crash types associated with curves include angle and rear-end crashes combined with increased speed and were thus assigned a **high** severity. The final risk rating is E.

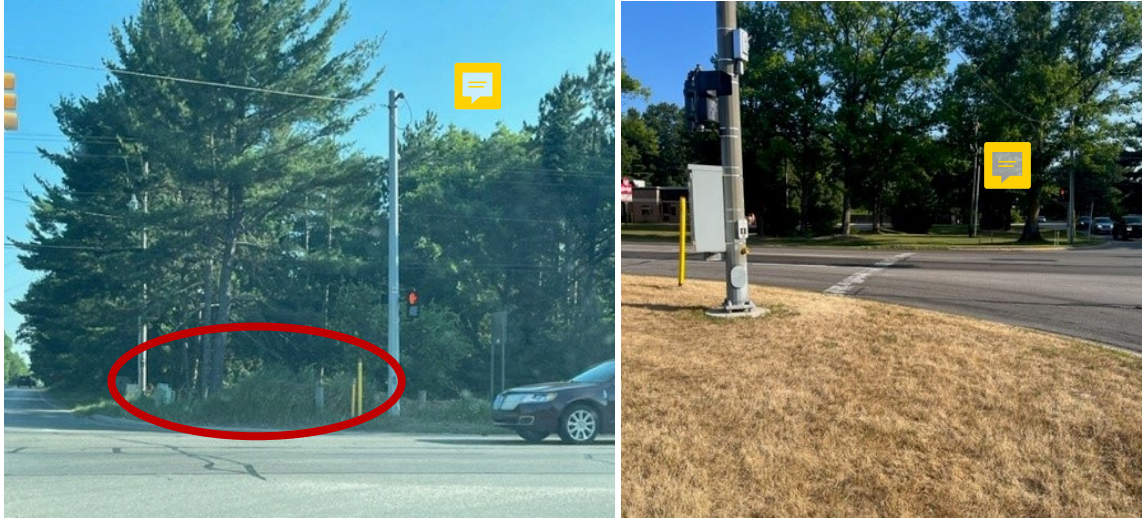
Figure 13: Safety issues at US-31 and J Maddy Parkway

The US-31 at J Maddy Parkway intersection is the only signalized intersection within the study area corridor limits. The signalized intersection contains several safety concerns.

The overgrown vegetation in the northeastern quadrant restricts sight distance posing a risk for turning vehicles. Vehicles were observed traveling through the intersection during yellow and all-red signal time to complete their movements. It was observed that some of the northbound and southbound left turners had to wait two signal cycles before completing the left-turn due to the lack of available gaps in opposing traffic. Vehicles, including asphalt trucks, were observed traveling through the intersection at high speeds. The pavement markings within the intersection were also worn and difficult to detect and the intersection does not currently include crosswalks or ramps for pedestrians. **Figure 13** illustrates some of these issues such as the overgrown vegetation and lack of crosswalk and ramp features at the intersection.

- **Improve visibility of the clear zone/ROW in all quadrants:** It is recommended that vegetation be removed in all quadrants to improve visibility for both drivers and allow adequate space for pedestrians.

- **Address access management of existing and future driveways near the intersection:** It is recommended to follow an access management plan when access requests are submitted for new or existing developments. Proper access management will help to minimize the number of conflict points near the intersection.

- **Enhance traffic signal:** The signal at the intersection could be modernized to a box span to provide good visibility to the signal heads. Backplates could also be incorporated to provide enhanced visibility of the signal heads. Clearance intervals and current cycle lengths can be evaluated to determine any necessary adjustments. Also, a left-turn phasing warrant analysis can be completed to determine any changes to the left-turn phasing on all four approaches.

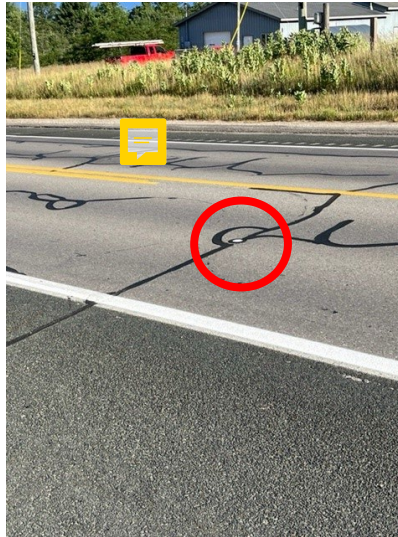
Figure 15: Existing ITS sensor (puck) along US-31

The icy roadway conditions during the winter months pose safety concerns along the US-31 corridor. An existing ITS Environmental Sensor Station (ESS) site that monitors the weather conditions has two pucks in the roadway, where both are located on US-31 between Betsie River Road and Gonder Road. Large trees on the southside of US-31 shade the roadway and may contribute to the ice not melting on the roadway. The highest number of crashes associated with icy, wet, and snowy roadway conditions are located a half mile to the west and a half mile to the east of the US-31 and J Maddy Parkway intersection.

Upon review of the data and observations the RSA team members assigned the crash frequency as **occasional**. Crashes associated with roadway conditions were higher at the US-31 at J Maddy Parkway intersection, but no other high concentration locations were identified from the crash analysis. The final risk rating is D.

- **ITS ESS Site and advanced warning signs:** Utilize the existing two sensors and add advanced warning signs (LED border or flasher) to alert drivers of the downstream roadway conditions
- **Clear pine trees** in the area to eliminate or reduce the shaded area along the roadway
- **Add delineators** on shoulders to prevent vehicles from veering off the roadway
