## Daily Field Log

Site Name: Former Wurtsmith AFB  
 Date: 08/23/2021  
 Project Number: 605414613  
 Field Staff: J. Morse

<b>Project Name:</b> Wurtsmith RI EGLE Oversight	<b>Site Location:</b> Oscoda, MI	<b>Project No.</b> 60514613
---	-------------------------------------	--------------------------------

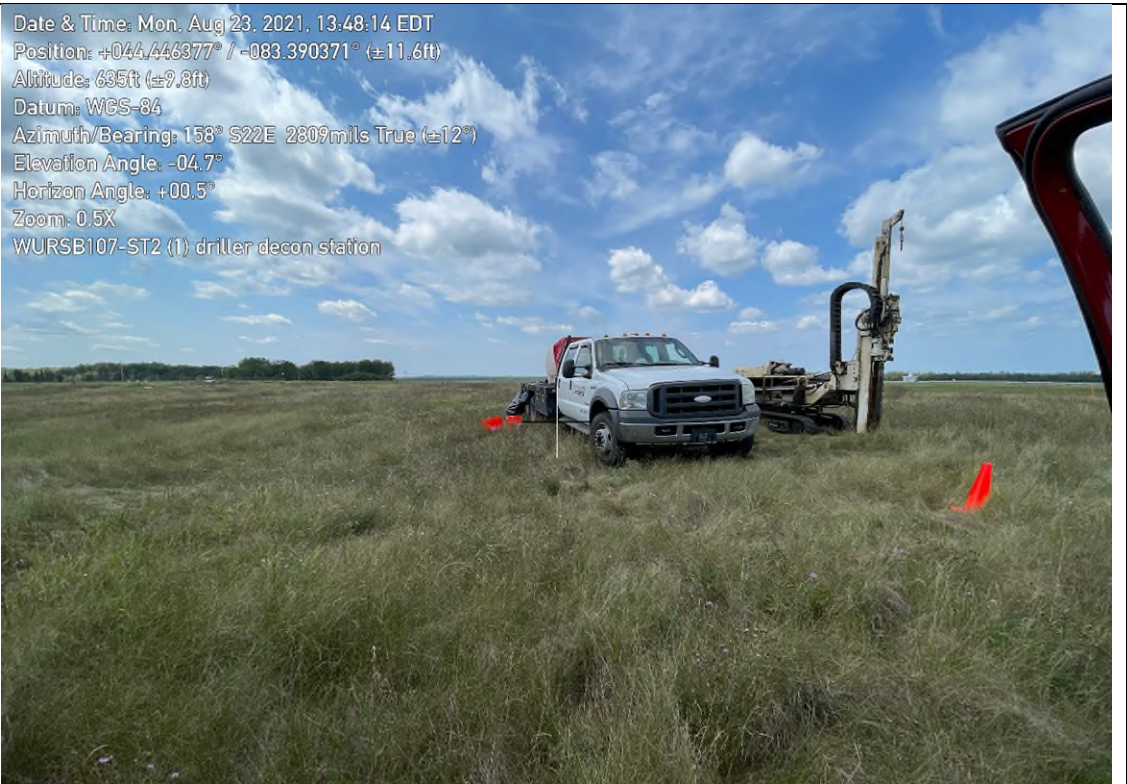
1350	Observed drillers have a separate decon station. Informed by Aerostar that WURSB107-ST2 has already been characterized and sampled down to 5' bgs w/ hand augers.
1435	Work stopped. Drillers lost rod drive head down-hole. They're attempting to retrieve tooling. Drillers do not have a replacement. Note water table was not encountered.
1500	Driller unable to retrieve tooling down hole.

<b>Photo No.</b> <b>7</b>	<b>Date:</b> 08/23/21	<p>Date &amp; Time: Mon, Aug 23, 2021, 13:48:14 EDT                  Position: +044.446377° / -083.390371° (±11.6ft)                  Altitude: 635ft (±9.8ft)                  Datum: WGS-84                  Azimuth/Bearing: 158° S22E 2809mils True (±12°)                  Elevation Angle: -04.7°                  Horizon Angle: +00.5°                  Zoom: 0.5X                  WURSB107-ST2 (1) driller decon station</p>
<b>Direction Photo Taken:</b> South		
<b>Description:</b> WURSB107-ST2 (1) driller decontamination station

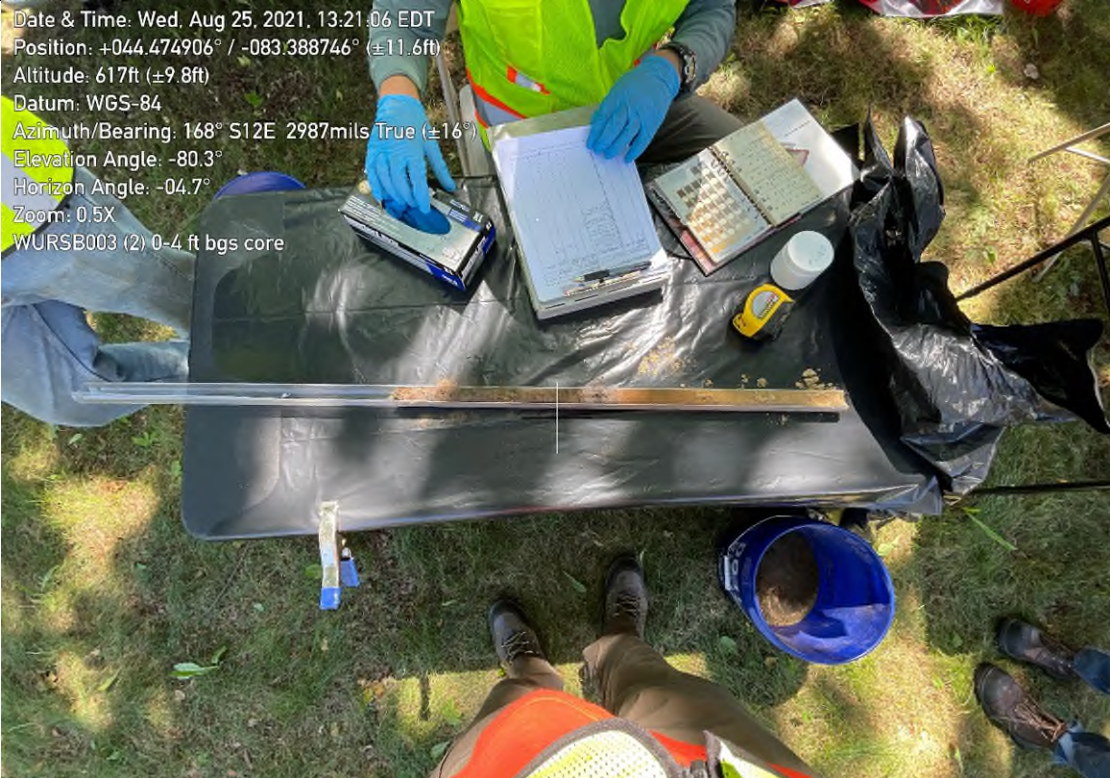
<b>Direction Photo Taken:</b> South		
<b>Description:</b> WURSB003 (2) 0-4 ft bgs core

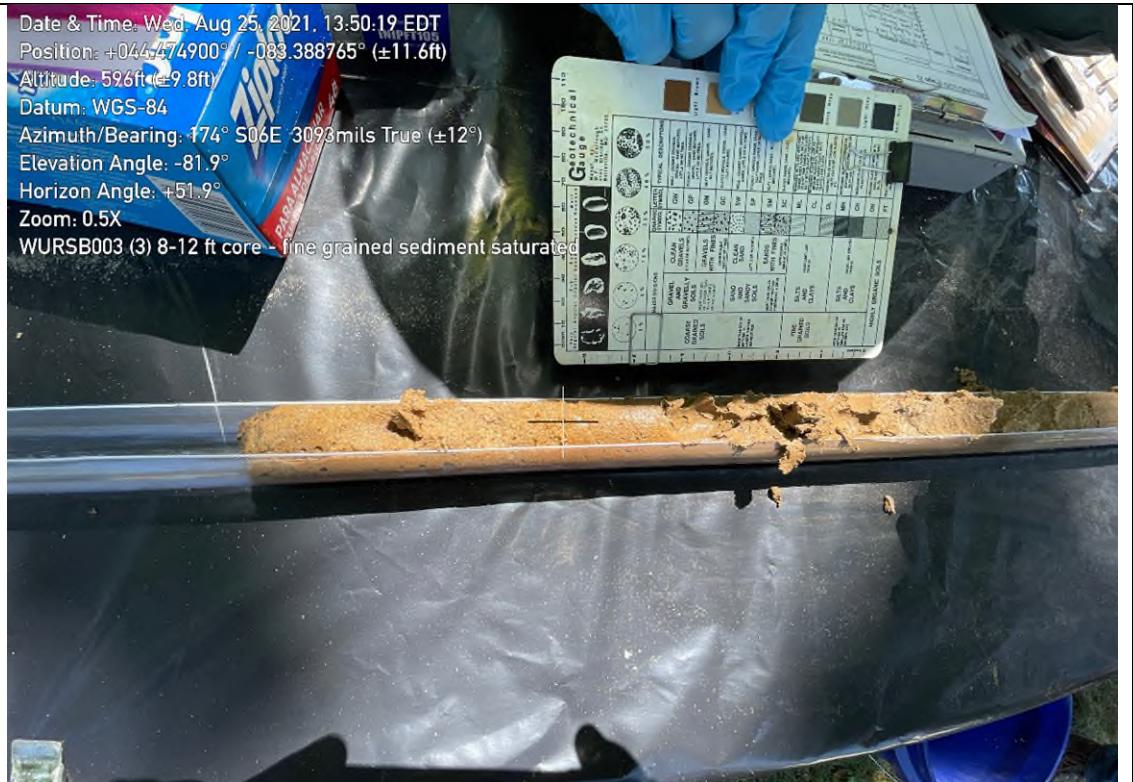
<b>Photo No.</b> <b>15</b>	<b>Date:</b> 08/25/21
<b>Direction Photo Taken:</b>  South	
<b>Description:</b>  WURSB003 (3) 8-12 ft core – fine grained sediment saturated

13:55	Interval 8.0-12.0 ft bgs saturated at 8.0 ft bgs, <del>more silt and clay found in 8.0-12.0' than other</del> <sup>JW</sup> locations. / fine-grained sediments.

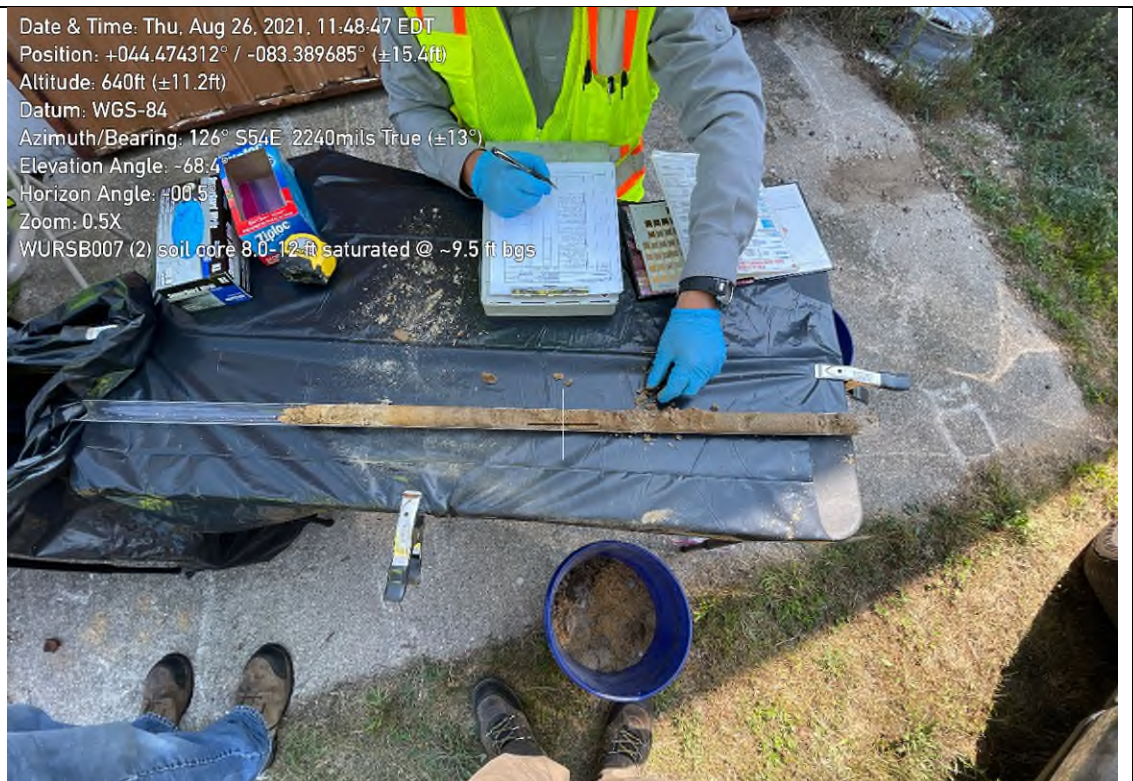
<b>Photo No.</b> <b>18</b>	<b>Date:</b> 08/26/21
<b>Direction Photo Taken:</b>  Southeast	
<b>Description:</b>  WURSB007 (2) soil core 8.0 – 12.0 ft saturated at ~9.5 ft bgs

11:32	0.5-2.0 ft interval sampled (WURSB007). EGLE split sample collected. Sample IDs: SB2108261132JM (EGLE), WUR13532 (0.5-2.0) (Air Force)
11:54	EGLE split sample collected @ WURSB007 → 7.0-9.0 ft Sample IDs: SB2108261154JM (EGLE), WUR13535 (7.0-9.0) (Air Force). Observed saturated sediment @ approximately 9.5 ft bgs. *

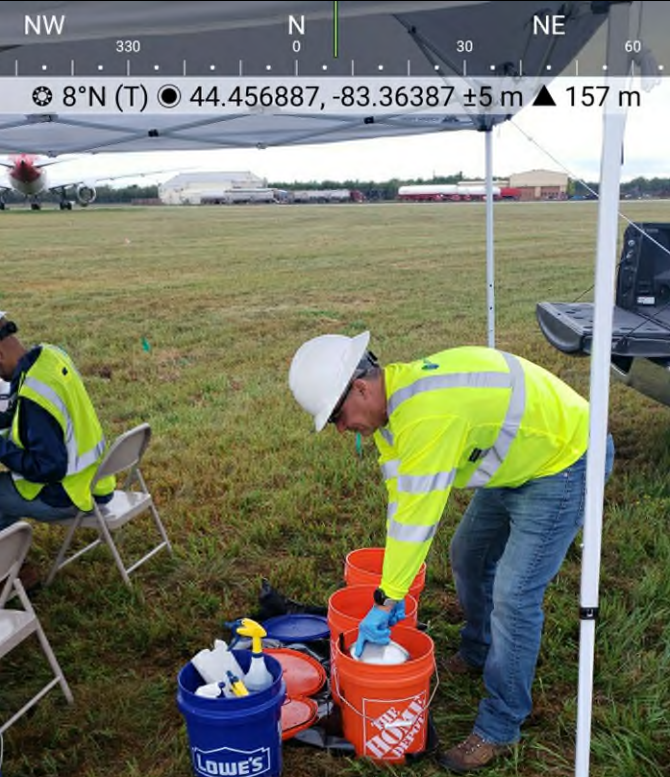
<b>Photo No.</b> <b>24</b>	<b>Date:</b> 08/28/21

<b>Direction Photo Taken:</b> North		
<b>Description:</b> WURSB065 – observed decontamination procedure by Aerostar

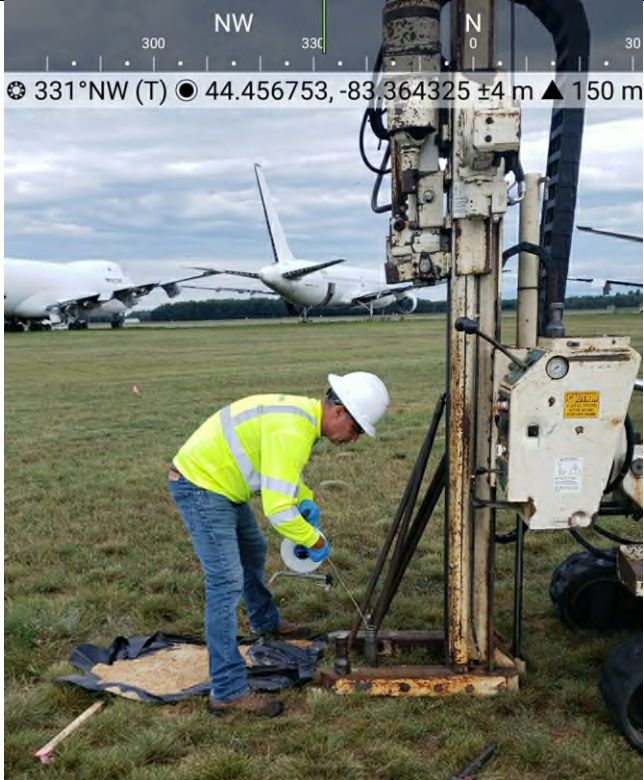
<b>Photo No.</b> <b>25</b>	<b>Date:</b> 08/28/21

<b>Direction Photo Taken:</b> Northwest		
<b>Description:</b> WURSB066 – Aerostar measured water level reading of 15.3 ft bgs

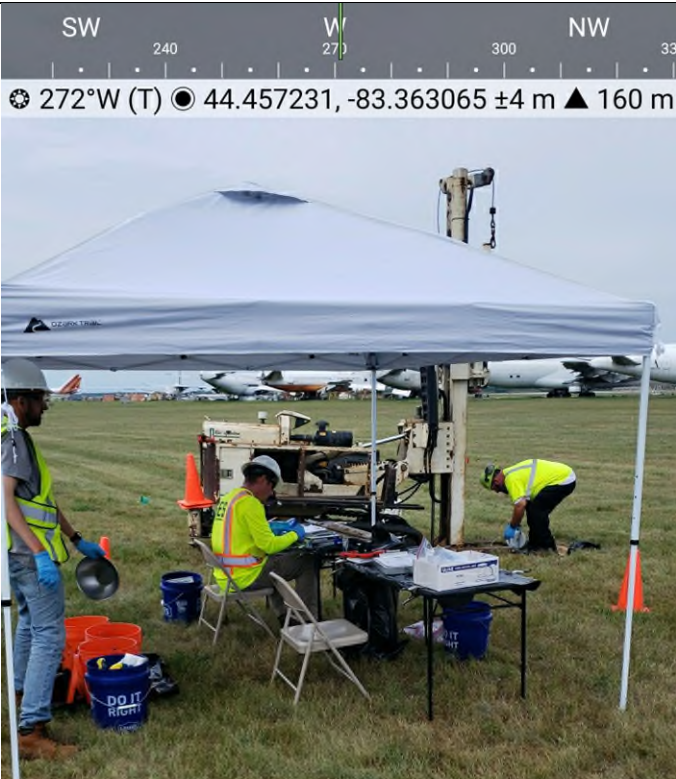
<b>Photo No.</b> <b>26</b>	<b>Date:</b> 08/28/21

<b>Direction Photo Taken:</b> West		
<b>Description:</b> WURSB064 – Driller measured water level reading at 15.4 ft bgs
