# Air Force Civil Engineer Center

## Wurtsmith Restoration Advisory Board Meeting

24 April 2019  
Matt Marrs  
AFCEC/CIB

## Hydrogeology Near Former Wurtsmith AFB

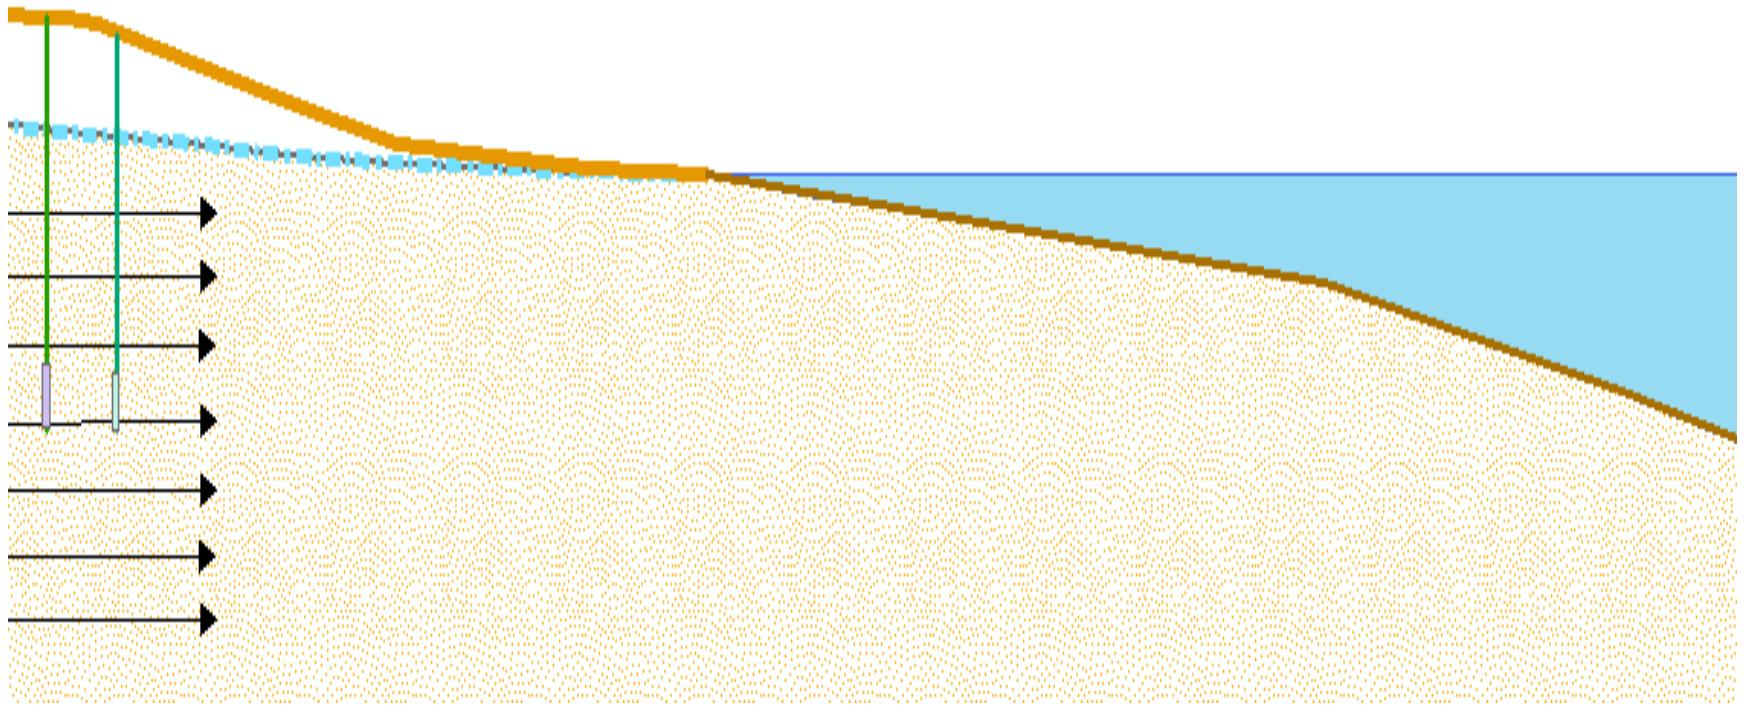
# Groundwater-Surface Water Interface – Conceptual Site Model

- What is GSI?
  - GSI is the location where groundwater enters (vents) to a surface water body.

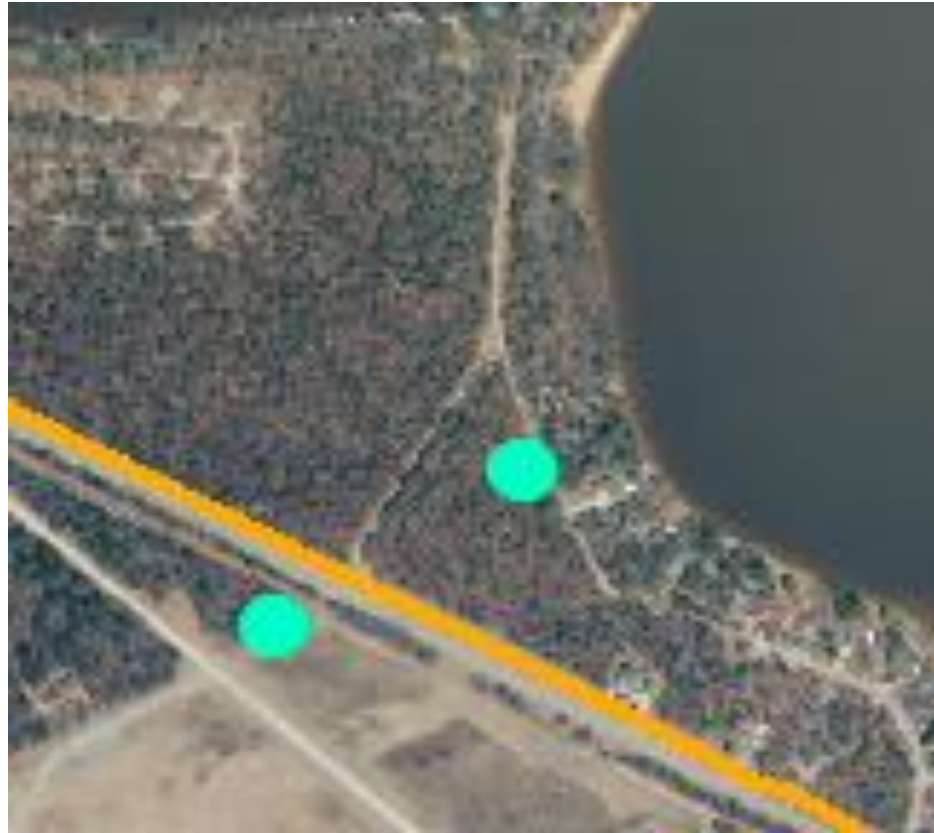
- Horizontal flow direction
- Groundwater concentrations above the GSI criteria
  - 12 parts per trillion for PFOS

**Example of Monitoring Wells Used for Horizontal Flow Determination**

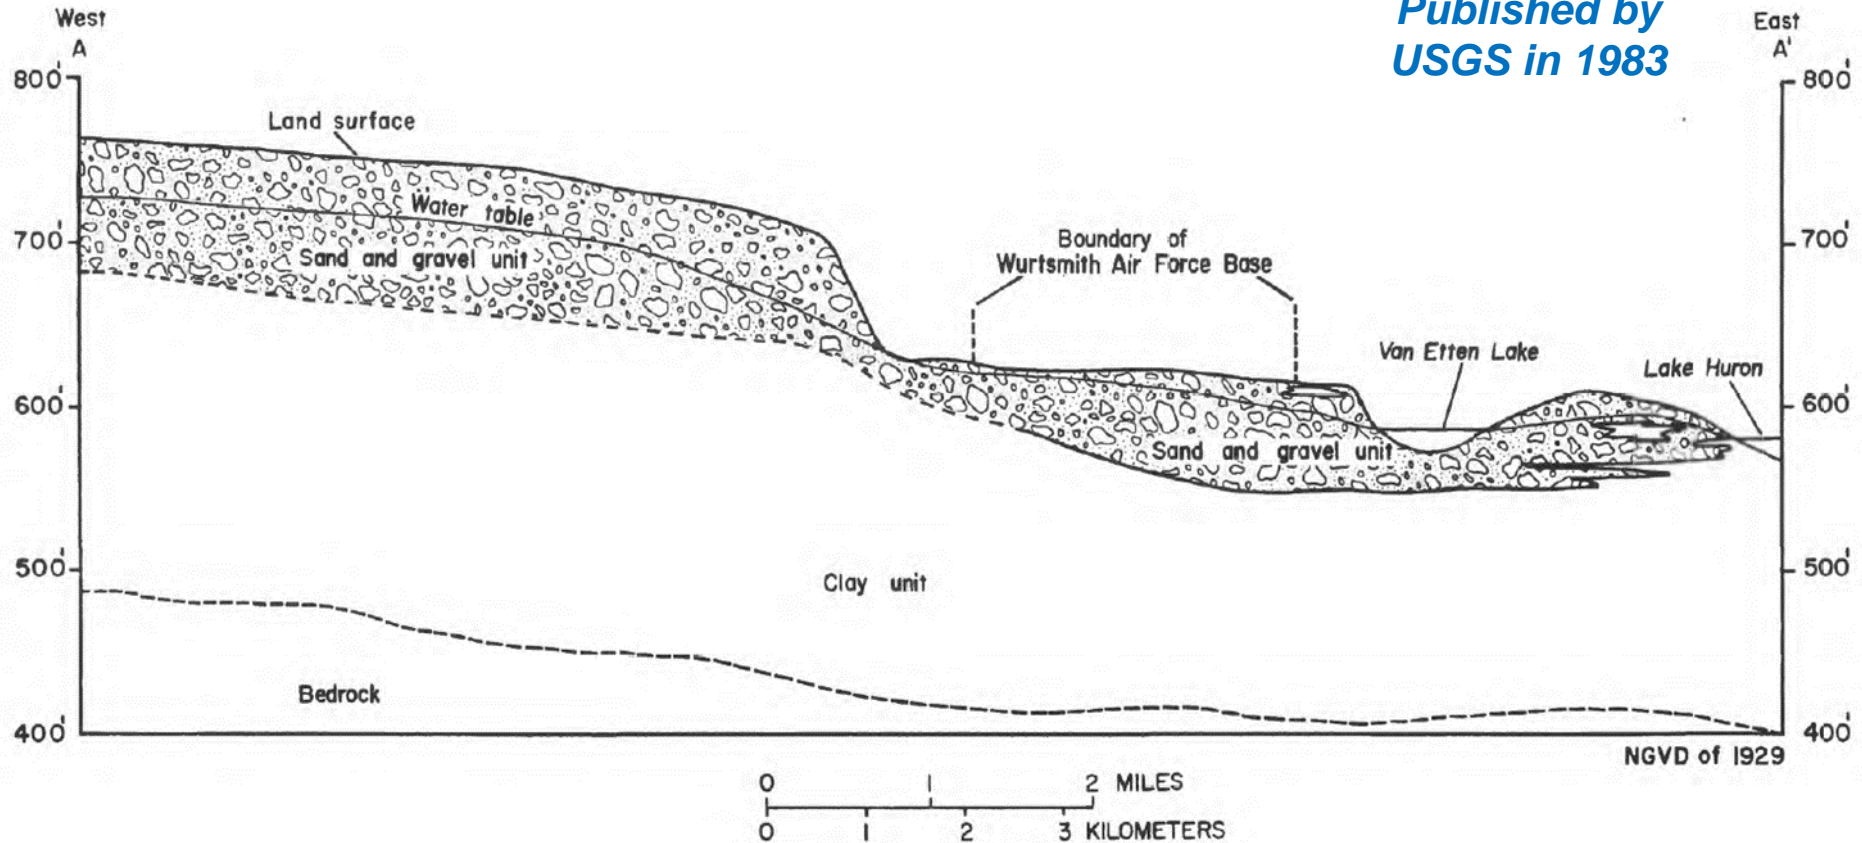
# Subsurface Geology near Former Wurtsmith AFB

Figure 5.--Generalized geohydrologic section showing relation of sand and gravel unit to clay unit. Line of section shown in figure 4.

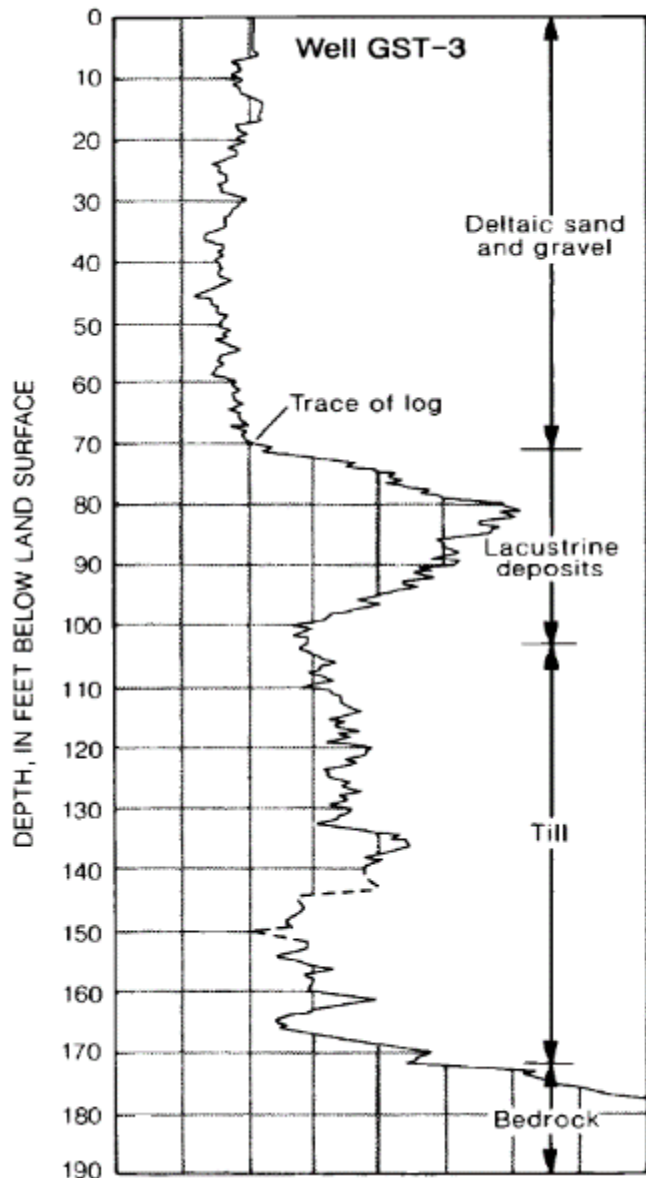
# Wurtsmith RAB Geophysical Log for Well GST-3

- **Total Dissolved Solids (TDS) >7000  $\mu\text{S}/\text{cm}$**
- **Water level 10 feet higher than water level in surficial aquifer**

Figure 8. - Gamma-ray log of well GST-3 showing stratigraphic breaks between geologic units. (Modified from Cummings and Twenter, 1983, fig. 54.)

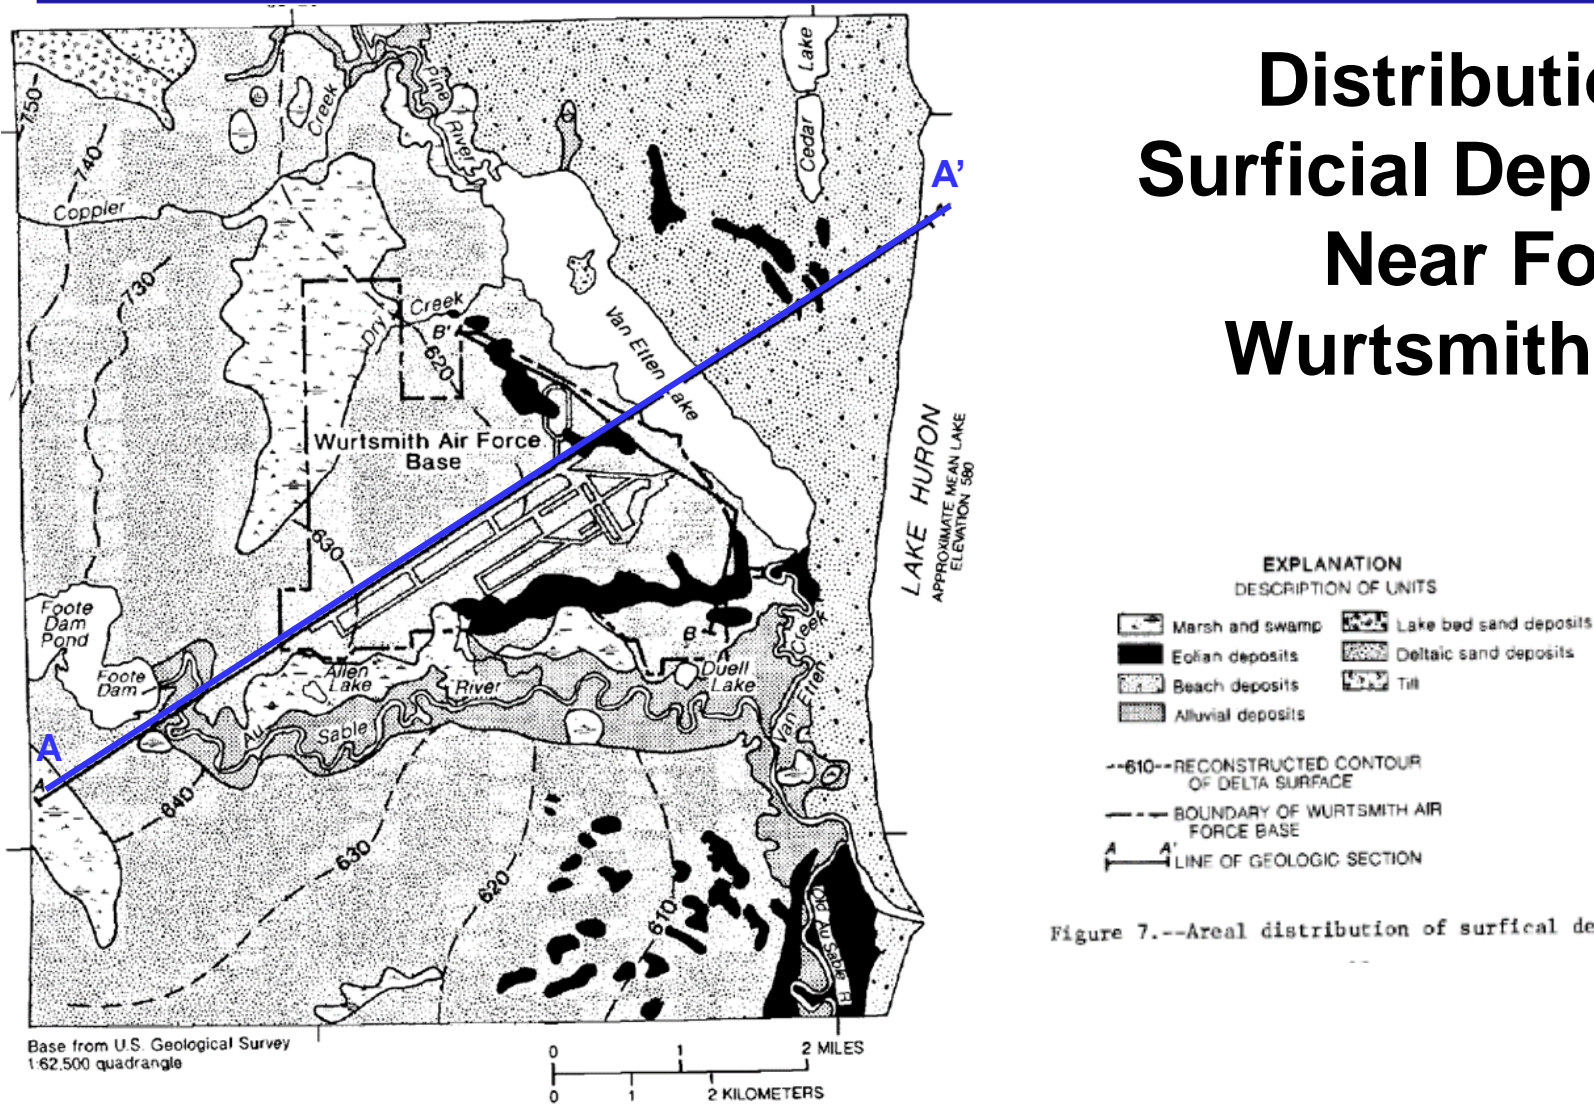
## Distribution of Surficial Deposits Near Former Wurtsmith AFB

Figure 7.--Areal distribution of surficial deposits.

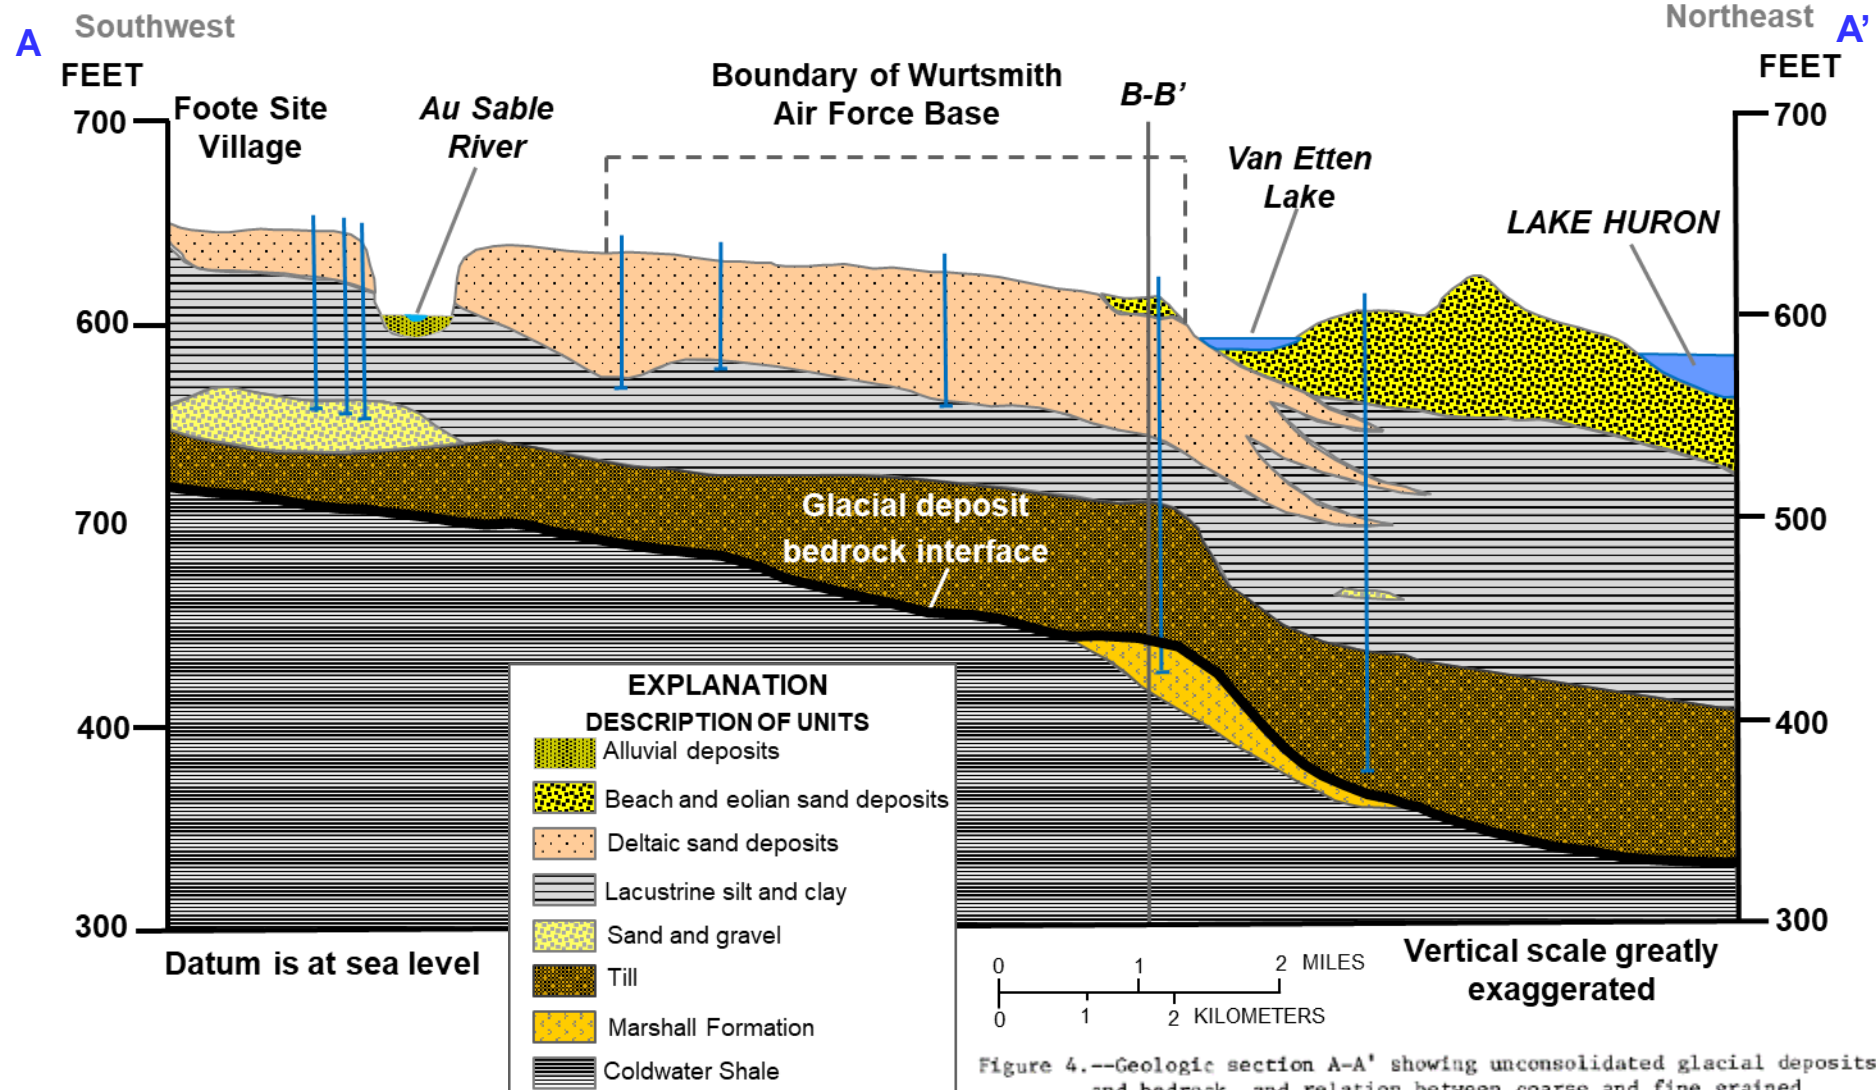
# Geologic Section A-A'

Figure 4.--Geologic section A-A' showing unconsolidated glacial deposits and bedrock, and relation between coarse and fine grained glacial deposits in the study area. (Line of section shown on fig. 7.) (Digitized)

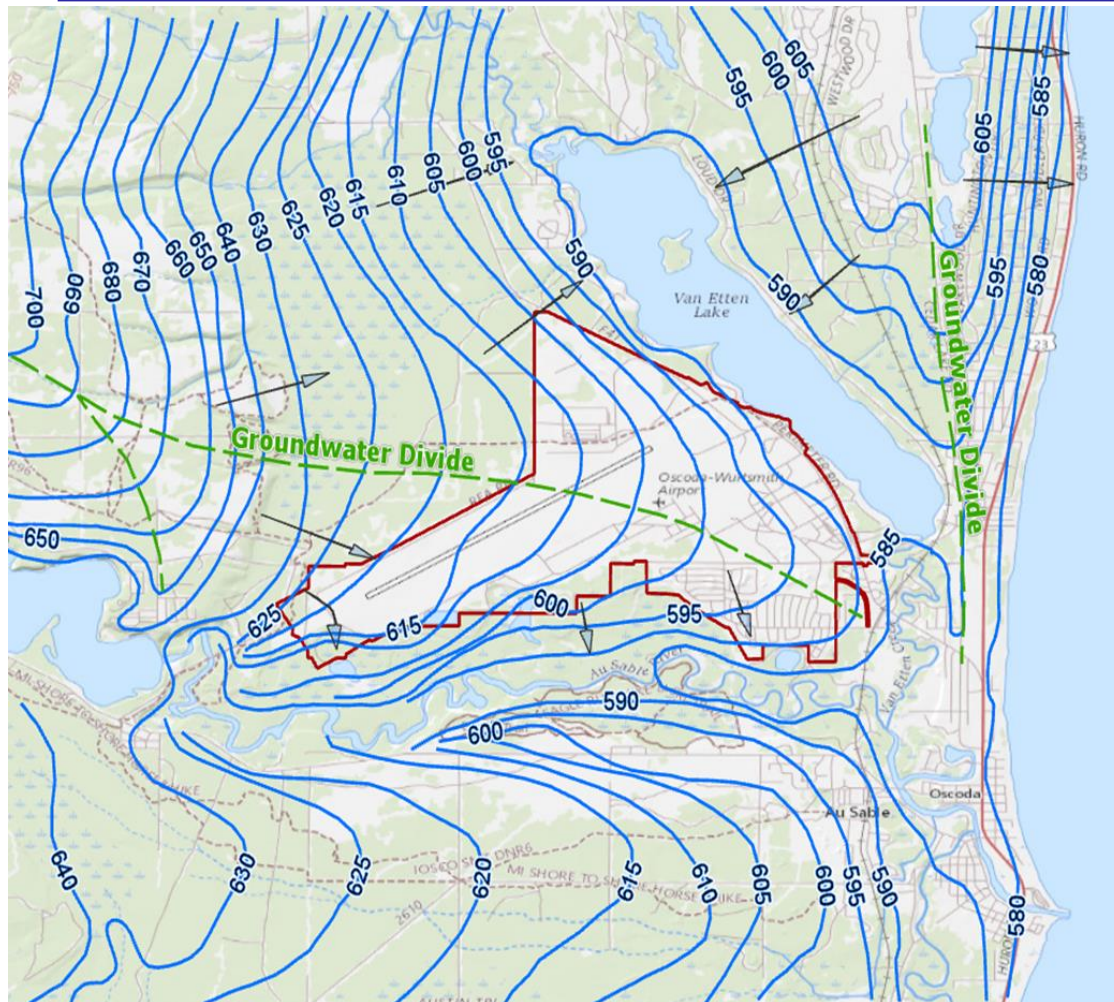
**USGS generalized  
groundwater flow in  
vicinity of Former  
Wurtsmith AFB  
(published in 1990  
report)**

Figure 11.--Generalized water table and direction of ground-water flow in study area. (Modified from Stark and others, 1983, fig. 6.) (Digitized)

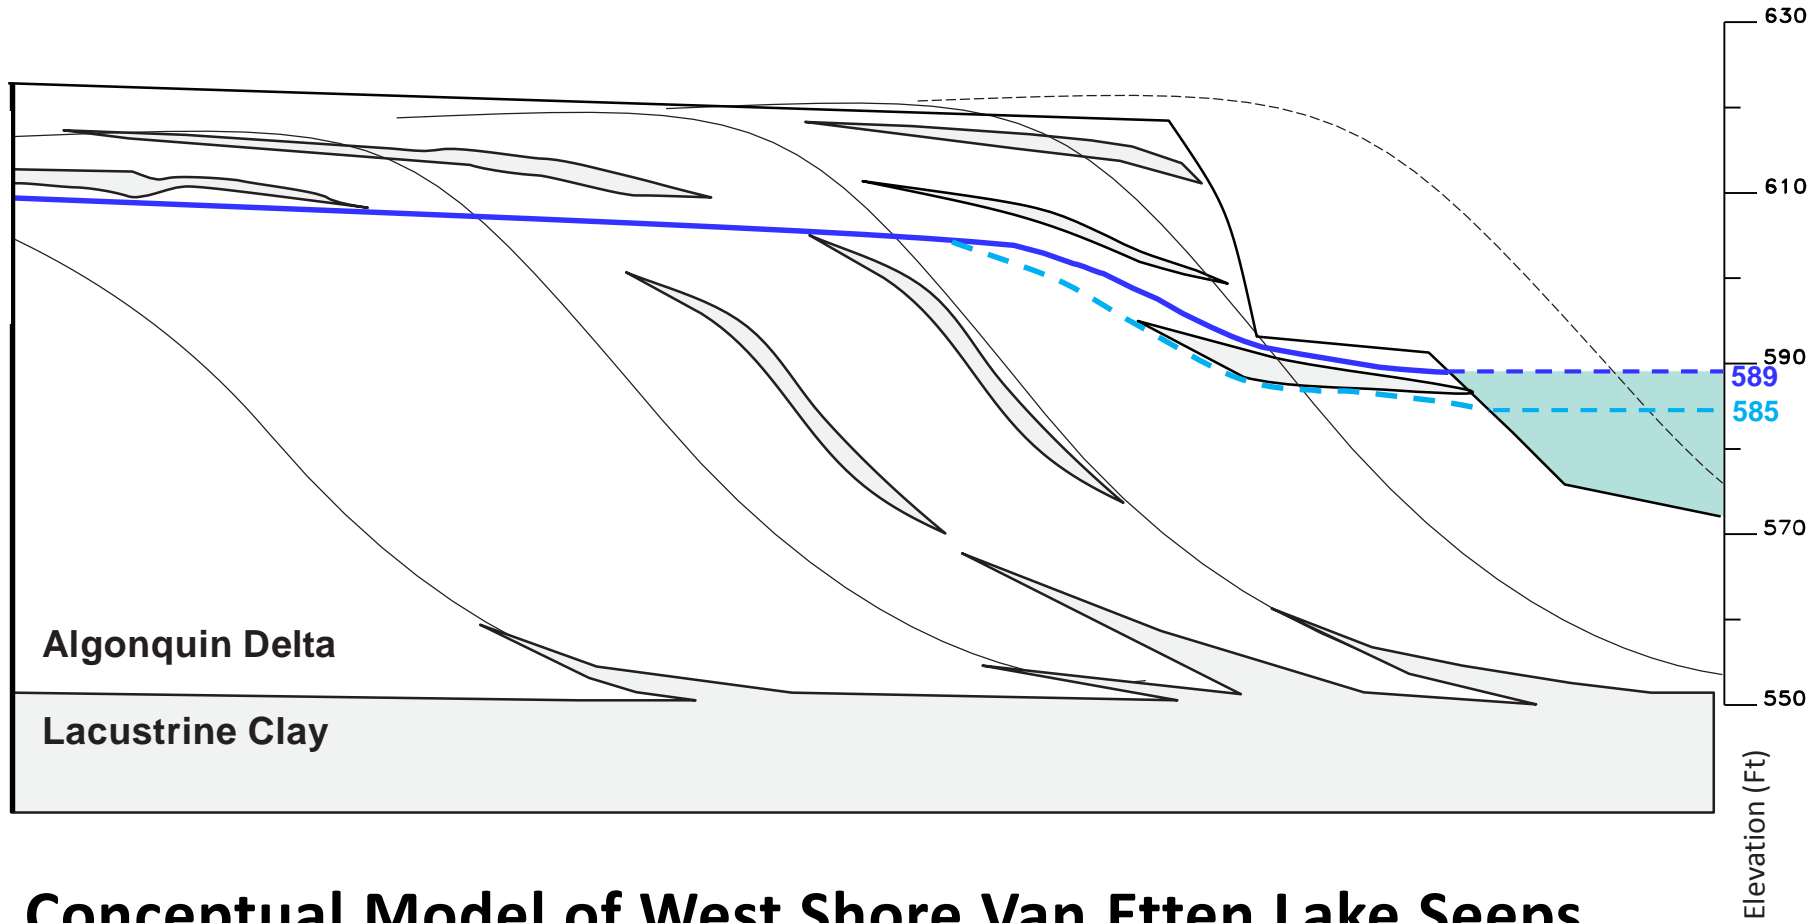
# Conceptual Model Showing Fine Grain Layers Causing Seeps During Seasonal Lowering of Van Etten Lake

## Conceptual Model of West Shore Van Etten Lake Seeps

- d) Seasonal water level controls on Van Etten Lake expose seeps that are caused by finer grain layers within the deltaic deposits**
  - e) Alluvial deposits in the ancestral Au Sable River would need better definition to understand groundwater flow through those deposits**
