| <b>Anderson LF</b><br>LOCATION ID 63000005<br>50250 Eight Mile Road<br>NORTHVILLE TOWNSHIP, OAKLAND COUNTY<br>T01N R08E SECTION 31 | | |
| <b>Site Map</b> | | |

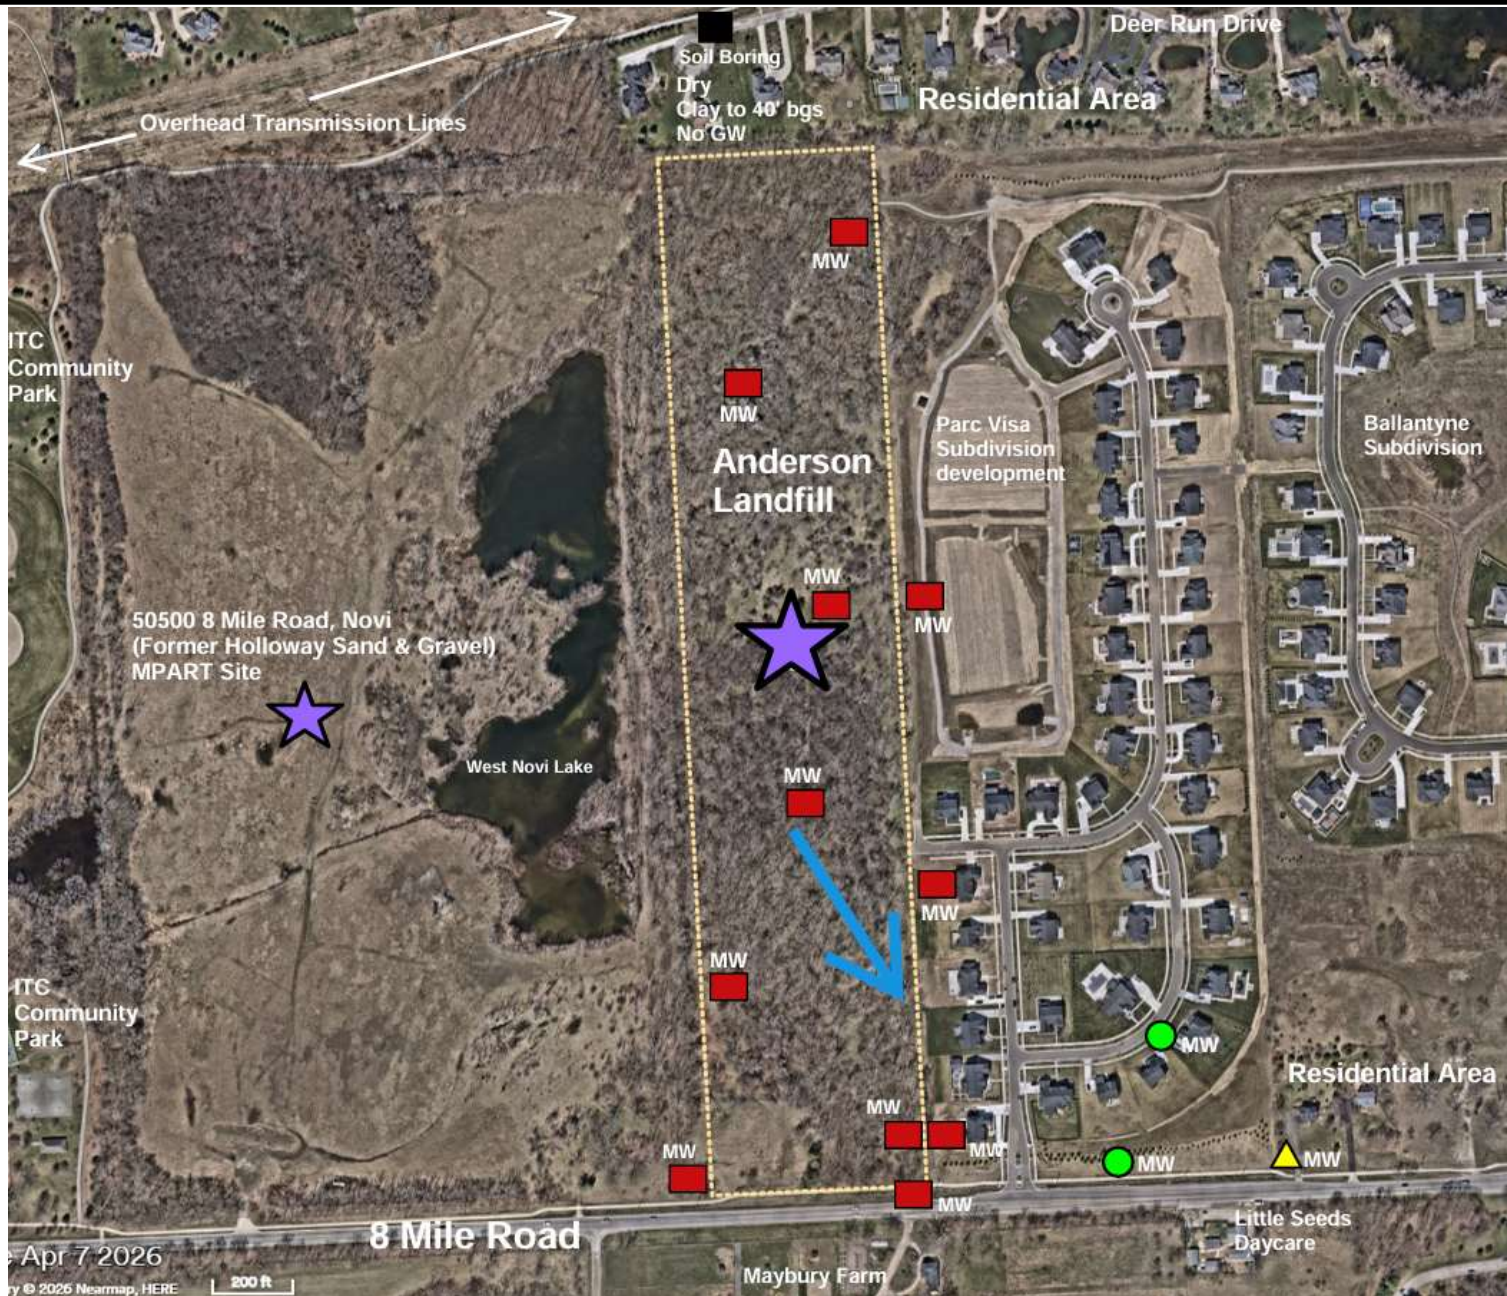
| Remediation and<br>Redevelopment<br>Division | | <b>FIGURE 1</b> |

- Green indicates PFAS compounds are non-detect
- ▲ Yellow indicates one or more of the PFAS Substances detected below criteria
- Red indicates PFAS compounds exceed criteria
- ➔ Groundwater flow direction
- ★ MPART Site
- MW - Monitoring Well
