Combined Condition Assessment

Ann Arbor Trail Magnet School

7635 Chatham, Detroit, Michigan

February 2017

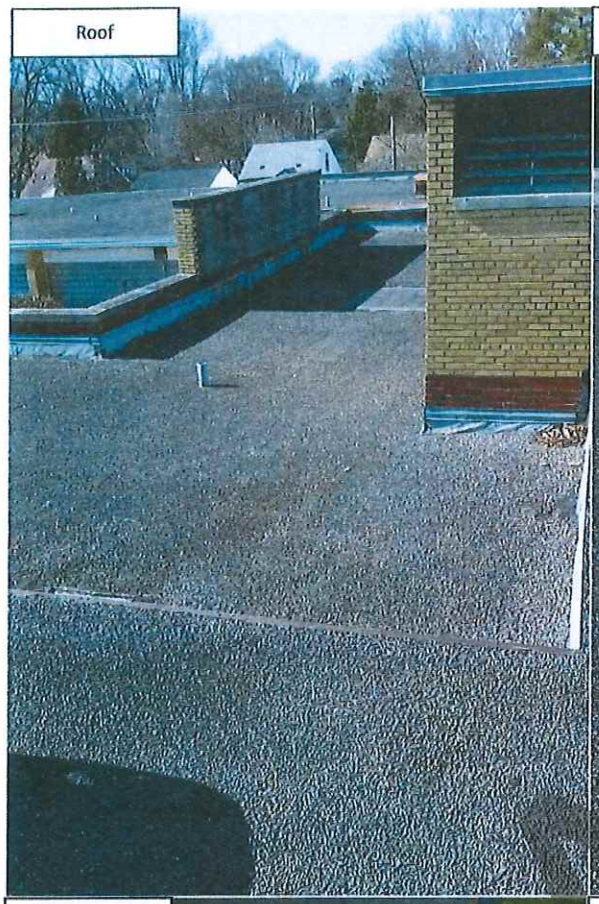
Roof

- The original construction date is 1946.
- The building is brick multi-story with a coal-tar, built-up roof system and a portable classroom on the site.
- Rooftop ponded water was noted on the day of the site visit.
