Combined Condition Assessment

Robert Burns Elementary

14350 Terry Street, Detroit, Michigan

February 2017

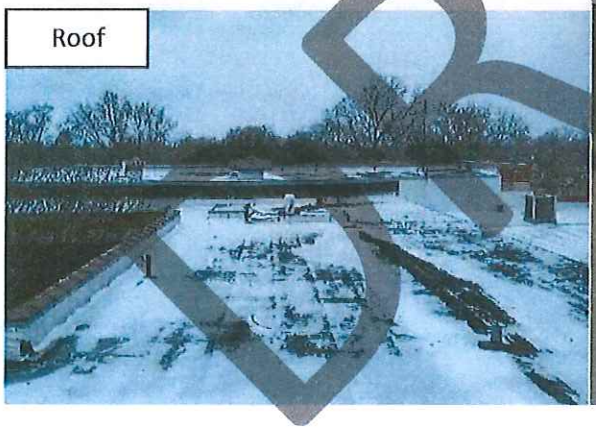
Roof Leak
