# Appendix B: Facility Conditions Index Report

# Combined Condition Assessment

## *Detroit Institute of Technology at Cody*

February 2017

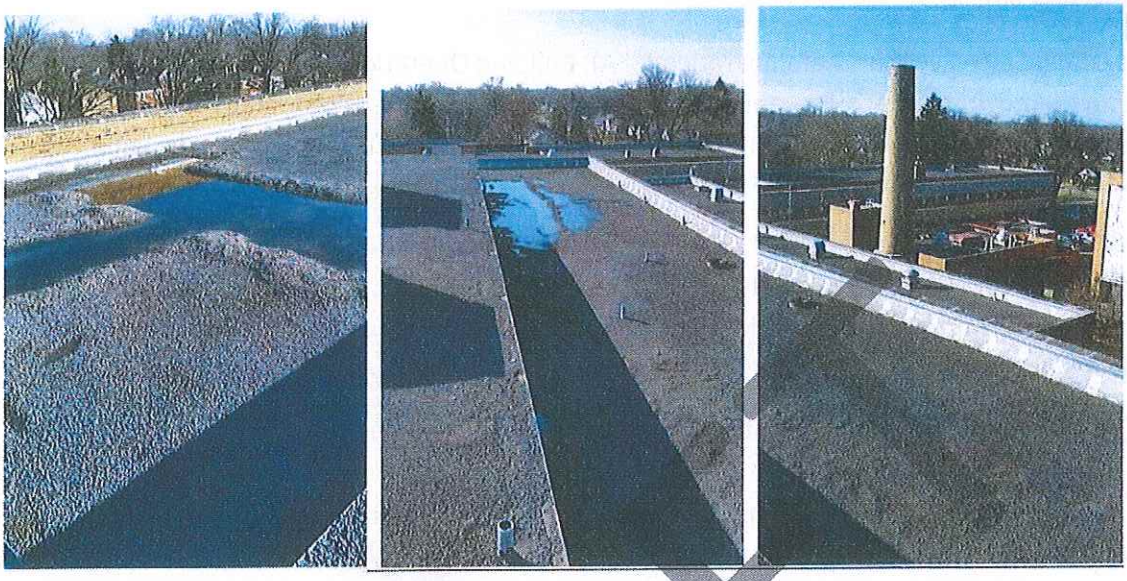
## Building Roof

- The site was originally constructed in 1947.
- The exterior is brick with a built-up, bituminous roof system.
- Significant water ponding on the roof was noted on the day of the inspection along with evidence of past or present roof and/or piping leaks.

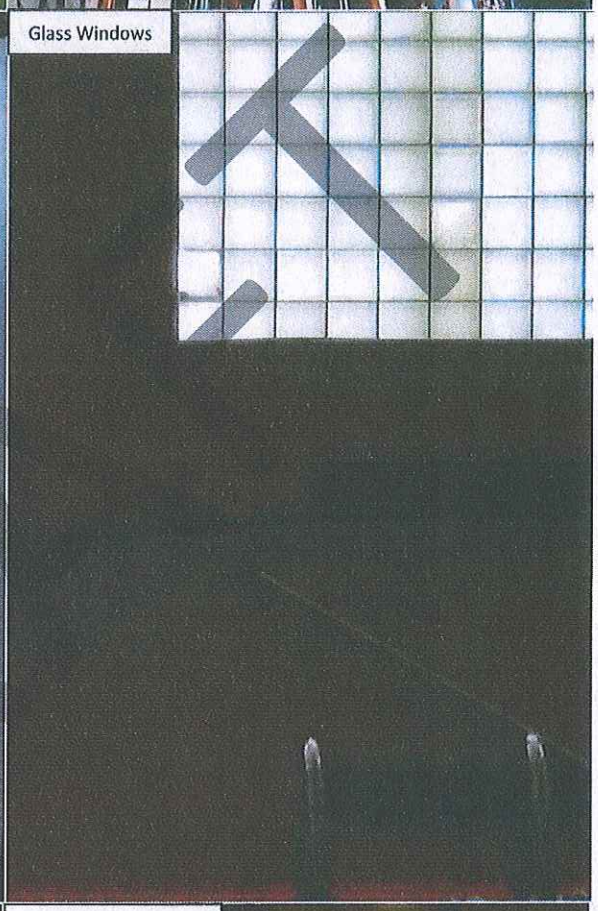
Glass Windows

| | | 4 | 3 | 2 | 1 | 0 | COMMENTS / RECOMMENDED ACTION |
|---|---|---|---|---|---|---|---|
| | Exterior Finish | | | 2 | | | Several glass block were broken on the |

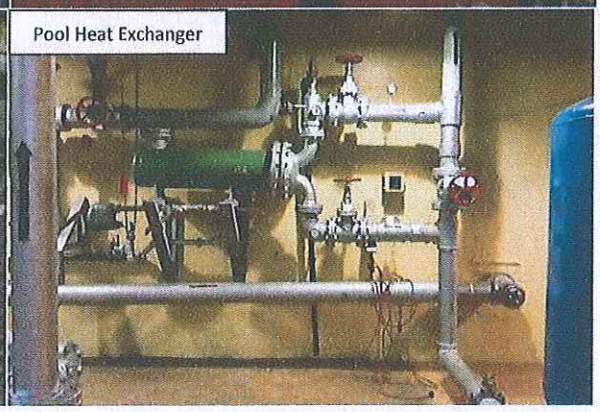
Pool Heat Exchanger

| | | | 4 | 3 | 2 | 1 | 0 | COMMENTS / RECOMMENDED ACTION |
|---|---|---|---|---|---|---|---|---|
| | Vent and Pool Heater | | | | 2 | | | Repairs being made leaks |

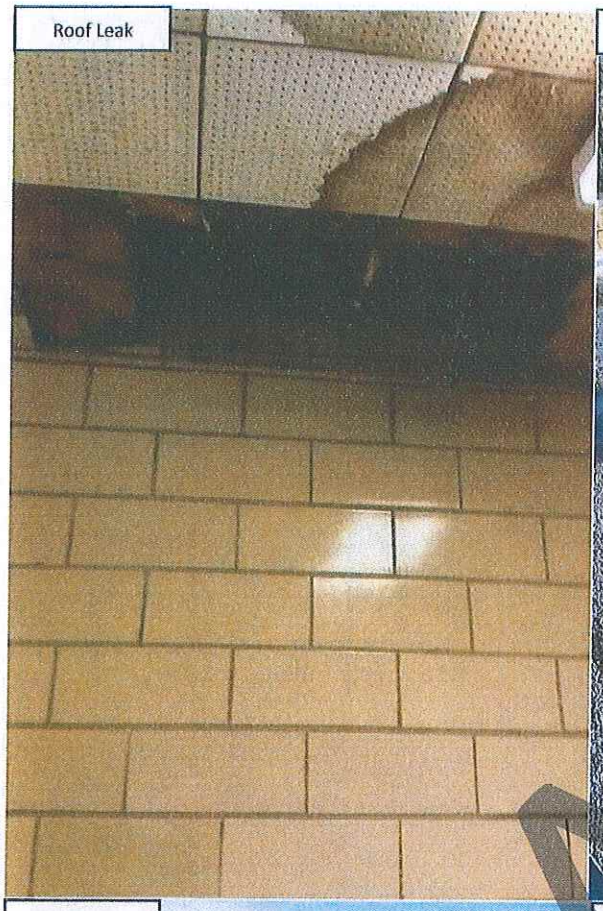
Roof Leak

| | | 4 | 3 | 2 | 1 | 0 | COMMENTS / RECOMMENDED ACTION |
|---|---|---|---|---|---|---|---|
| | Roof Equipment Curbing | | | 2 | | | Roof is in need of repair |

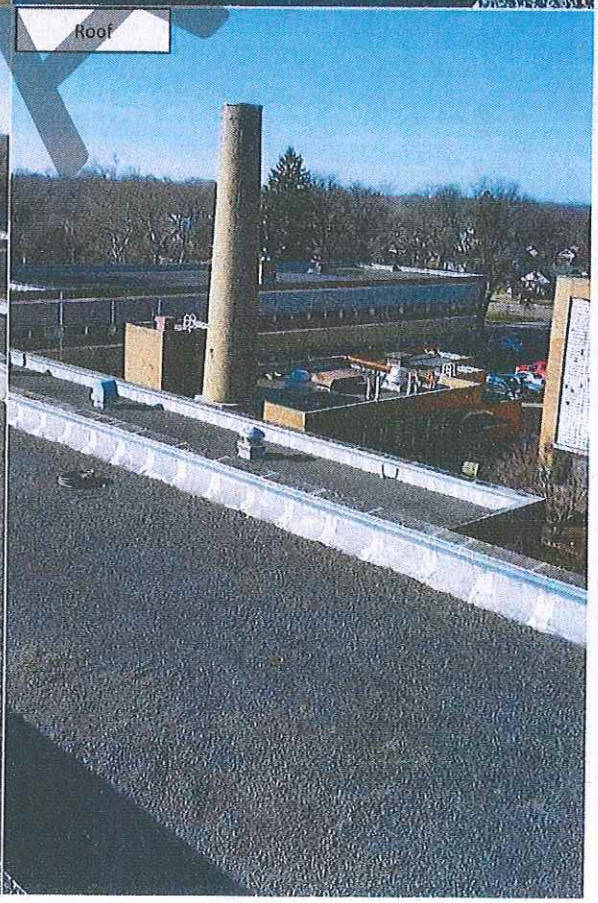
Roof

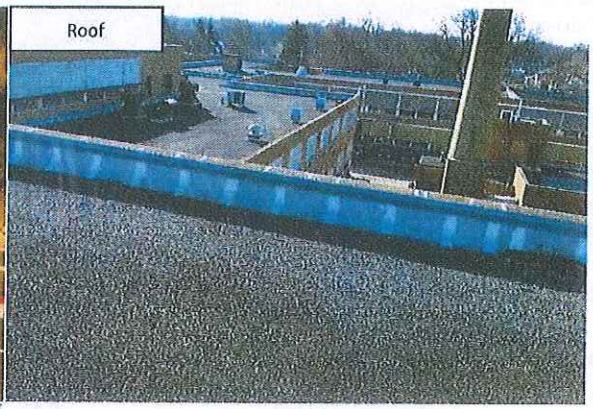
Roof Leak
