Combined Condition Assessment

Dream Academy

1995 Union Street, Benton Harbor, Michigan

February 2017

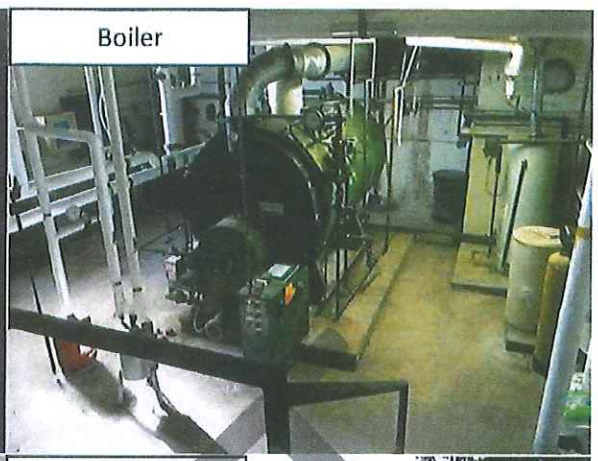
Boiler Nameplate
Stone Johnston Corp.
300 Pine St. Ferrysburg, MI 49409
Catalog No.
Date

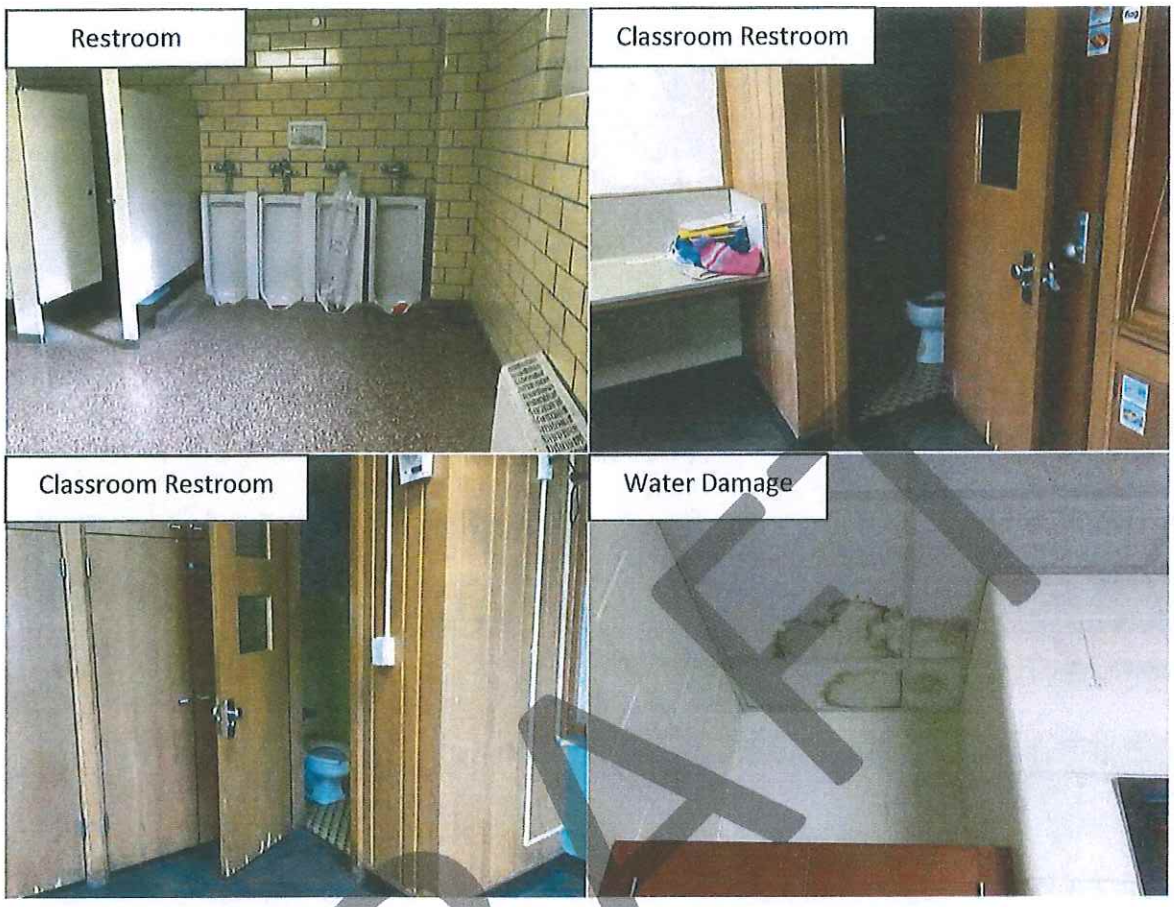
Restroom
Classroom Restroom
Classroom Restroom
Water Damage
