Combined Condition Assessment

Henry Ford High School

20000 Evergreen Road, Detroit, Michigan

February 2017

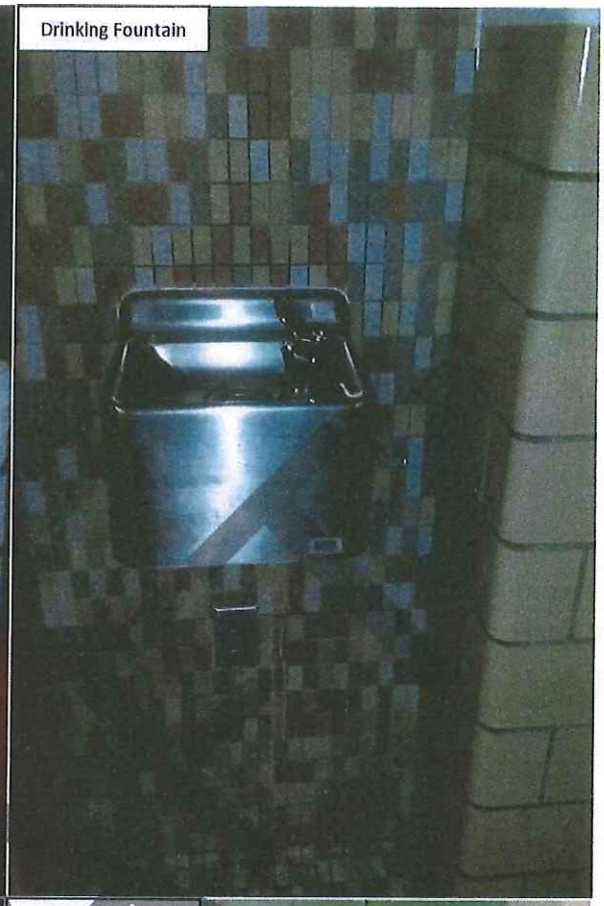
Drinking Fountain
