Combined Condition Assessment

Osborn Schools

11600 East 7 Mile Road, Detroit, Michigan

February 2017

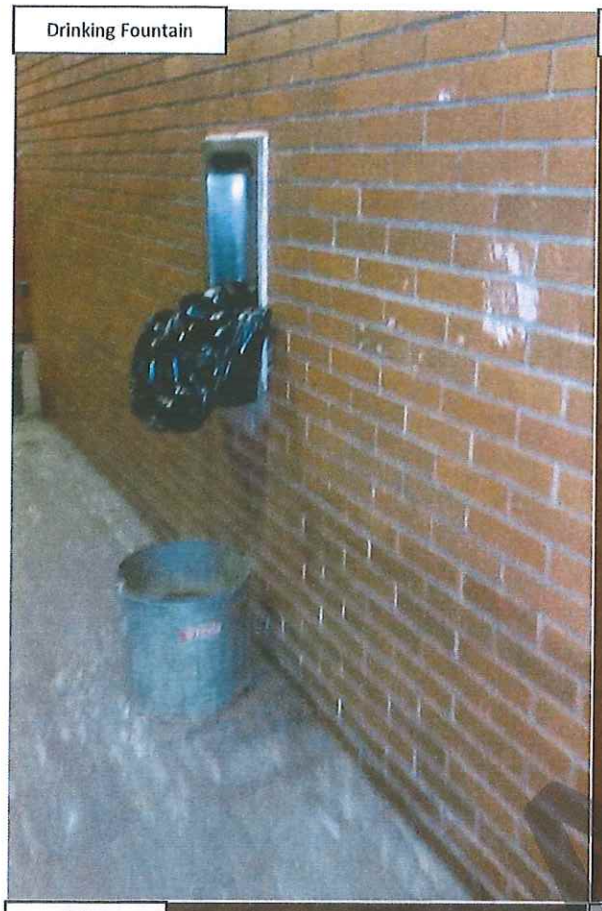
Drinking Fountain

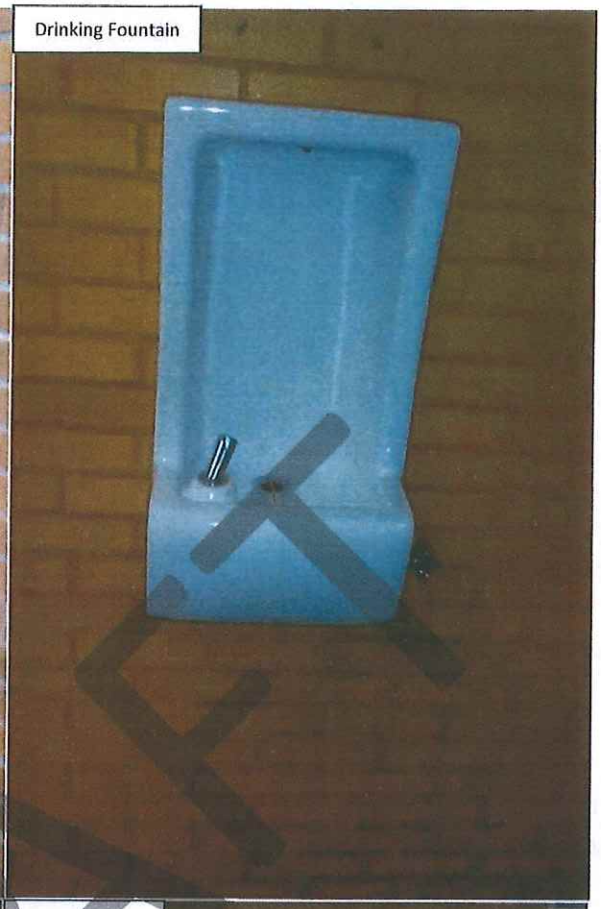
Drinking Fountain

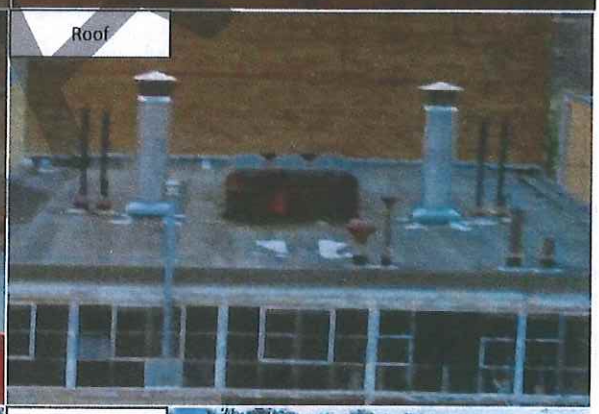
Roof

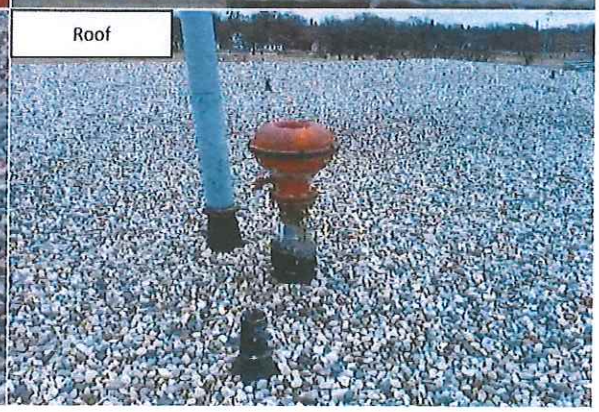
Roof
