Appendix B: Facility Conditions Index Report

Combined Condition Assessment

Osborn Schools

11600 East 7 Mile Road, Detroit, Michigan

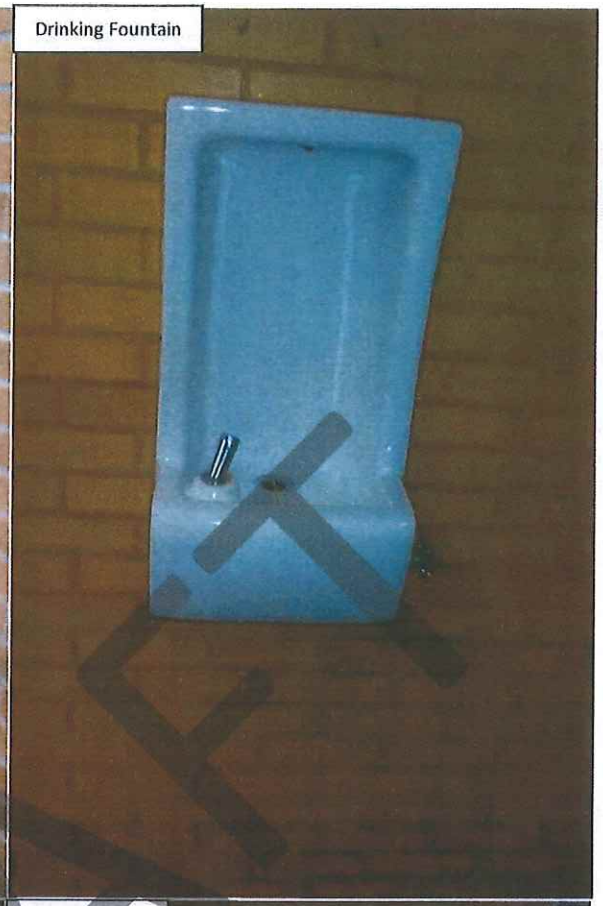
Drinking Fountain

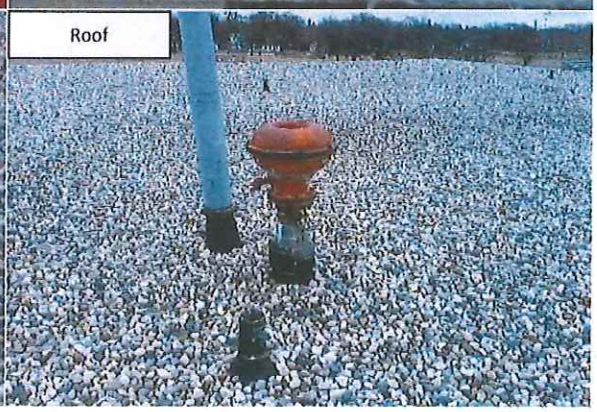
Roof

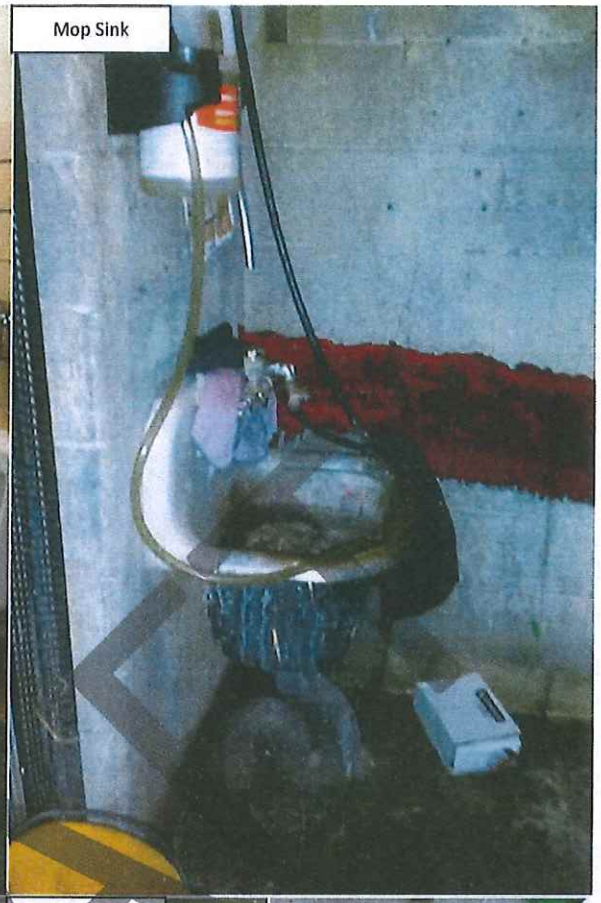
Mop Sink

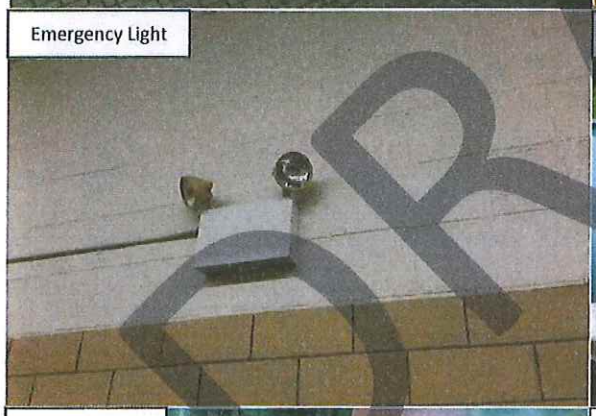
Emergency Light

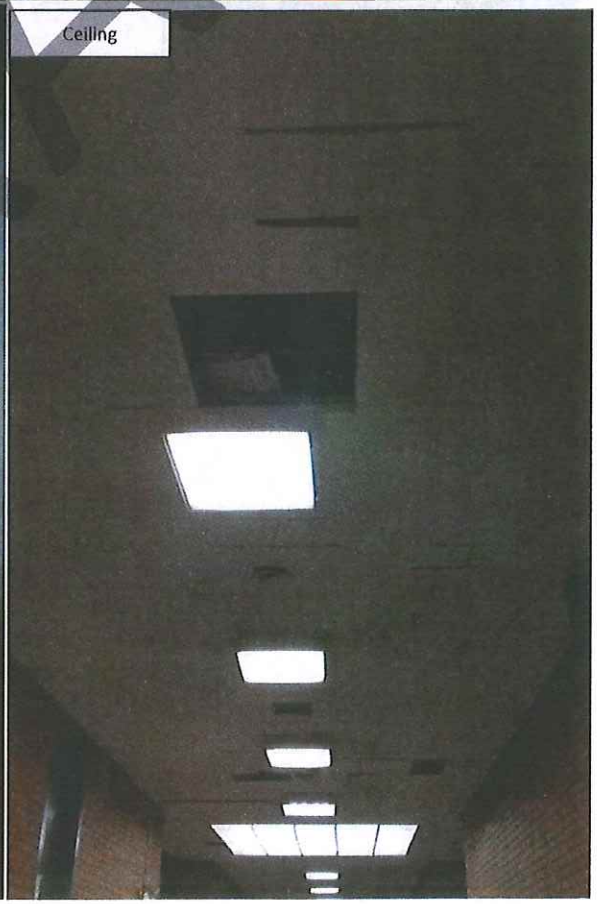
Ceiling

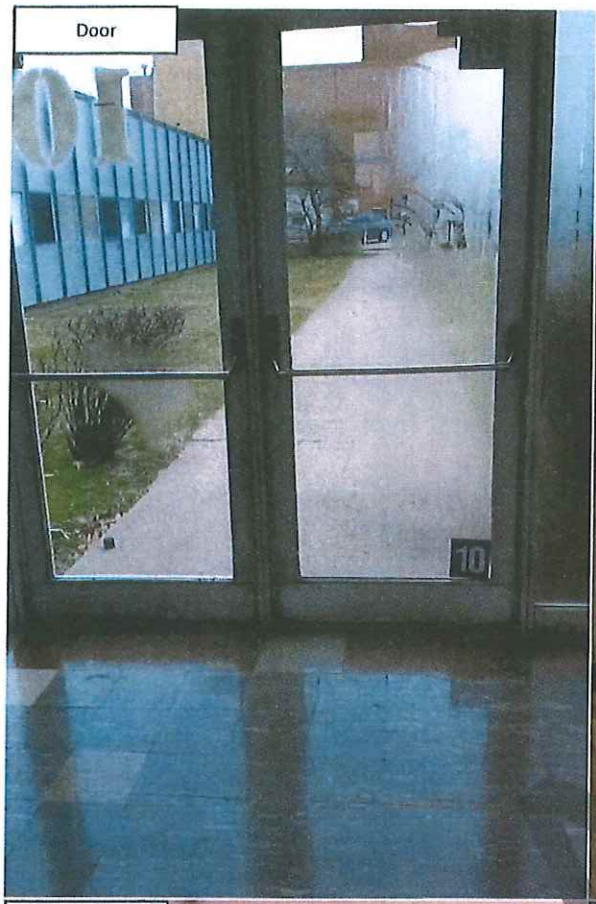
Door

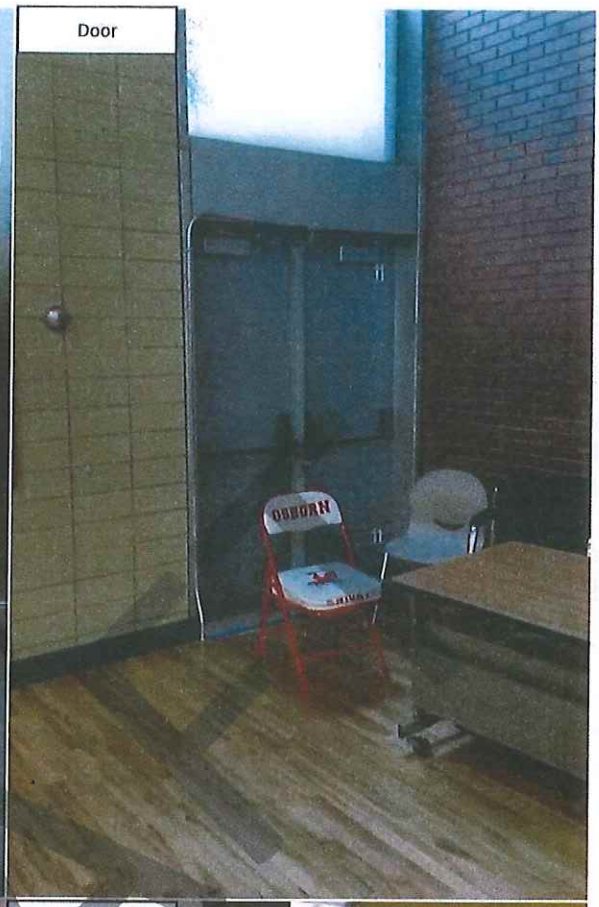
Door

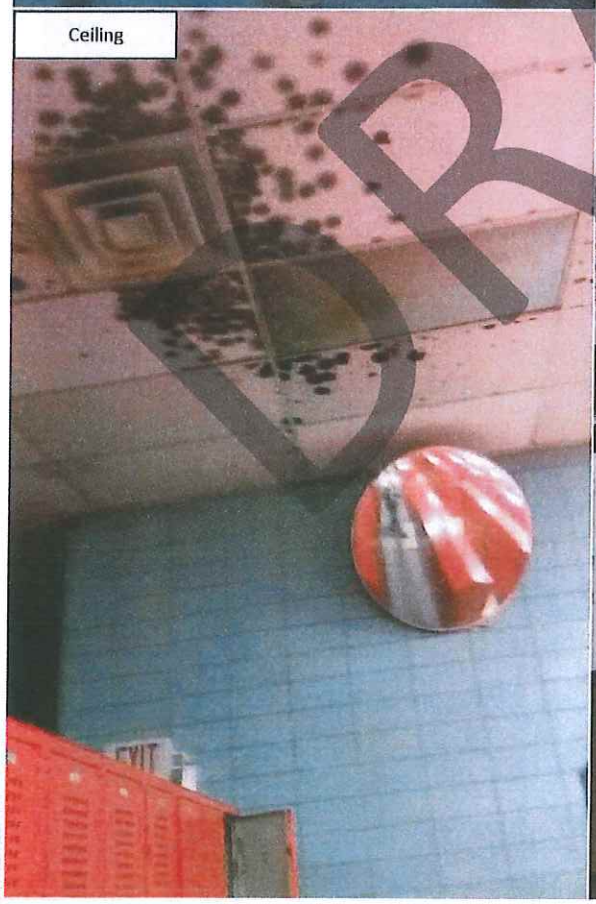
Ceiling

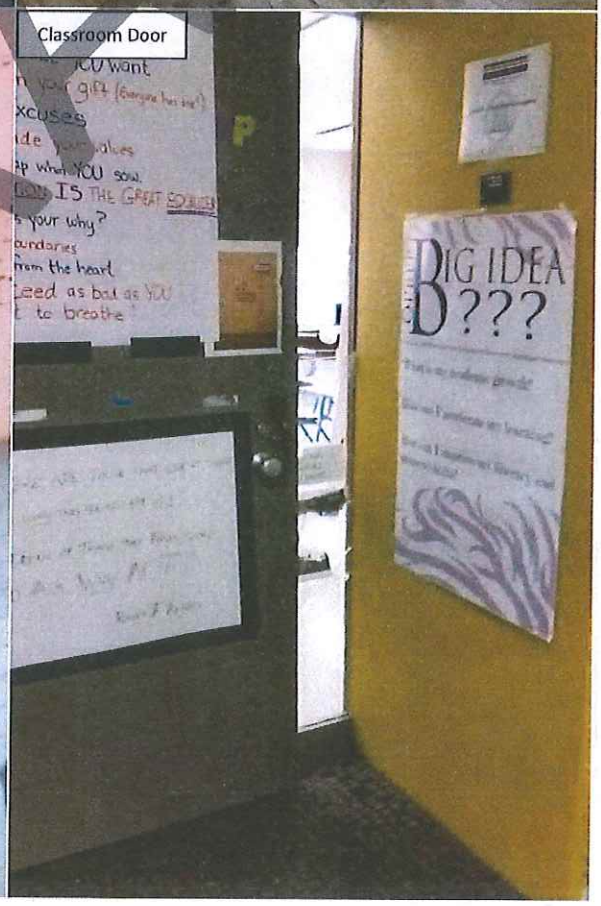
Classroom Door
