Appendix B: Facility Conditions Index Report

Combined Condition Assessment

Pershing High School

February 2017

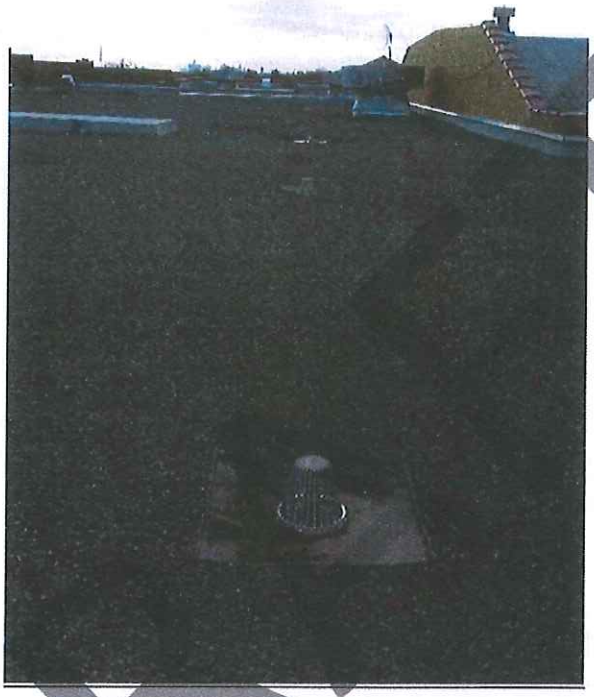
Building Roof

- The original construction date is 1929.
- The building is multi-story with a coal-tar, built-up roof system.
- Water heaters appear to be newer.
