Combined Condition Assessment

Sampson Webber Leadership Academy

4700 Tireman Street, Detroit, Michigan

February 2017

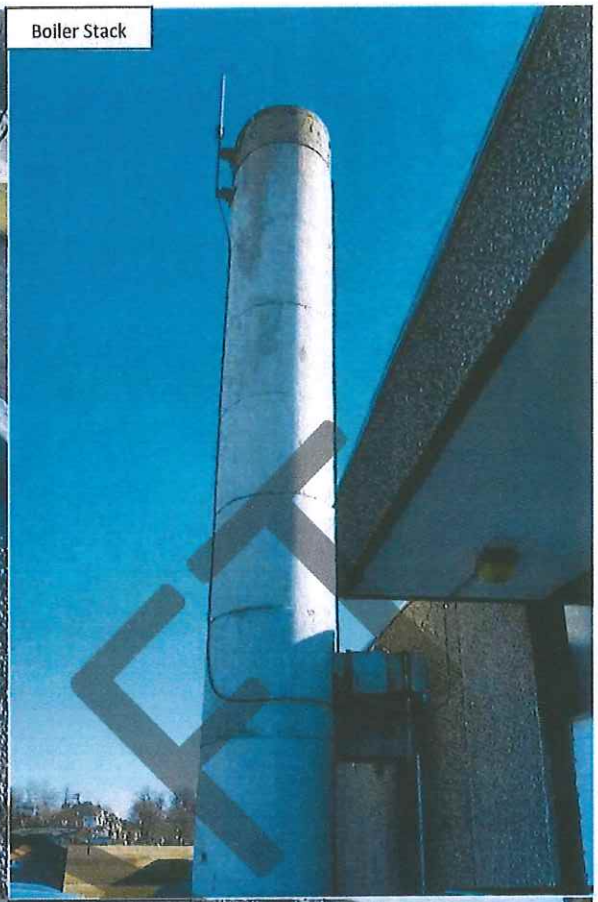
Roof

- The original construction date is 1964.
- The building is multi-story with a coal-tar, built-up roof.
- It was noted the roof is need of repair; ponding water was present at the site visit.
