PERFORMANCE OF HOT-POURED AND COLD-APPLIED JOINT SEALERS

Research Laboratory Division
Office of Testing and Research
Research Project R-62 G-116
Research Report No. R-493

Michigan State Highway Department
Lansing, February 1965

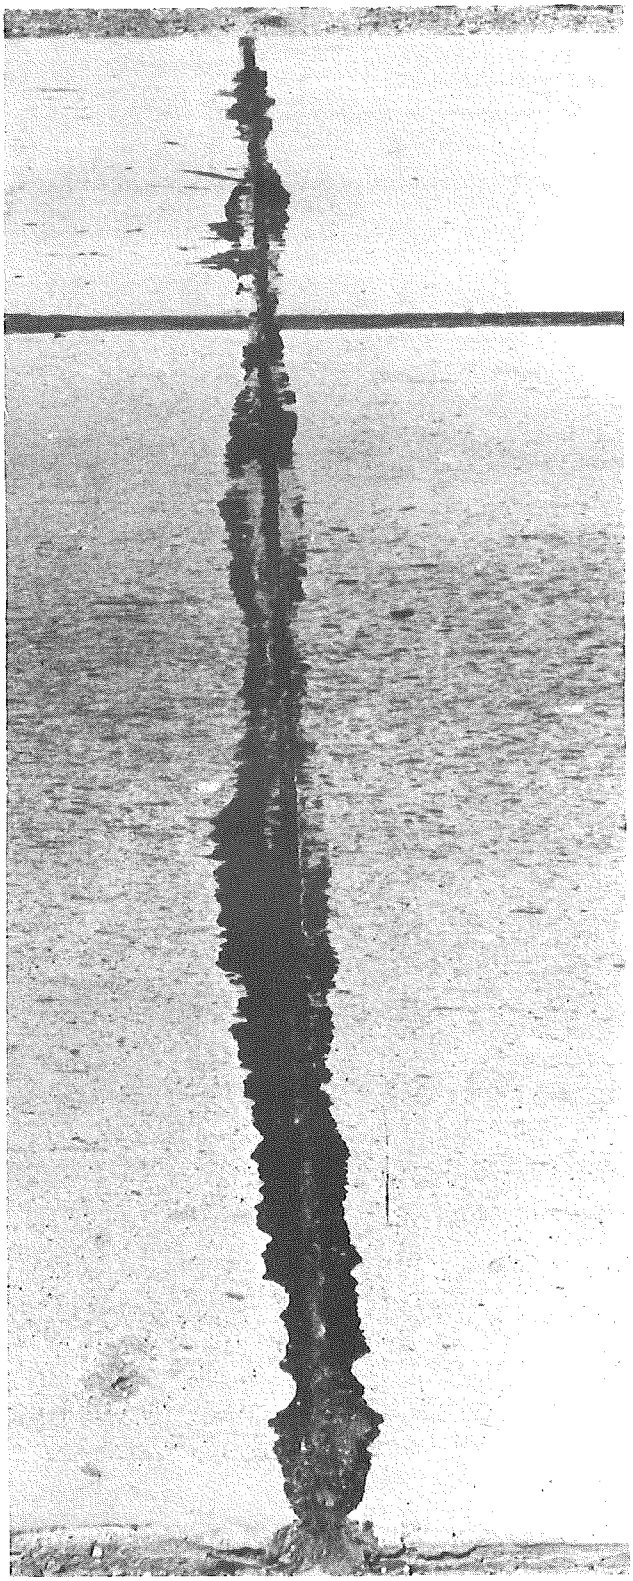
The condition of five brands of regular hot-pour, rubber-asphalt sealer at the end of 2-1/2 years is shown in Figs. 1 through 5. All these examples show loss of sealer adhesion to the joint faces and penetration by stones and dirt in varying degrees, with the material pictured in Fig. 5 showing up best in this regard. Good adhesion can be easily recognized by the "necking down" of the sealer in the joint space, manifested by a light colored dust or powdery film that collects in the depression. Extrusion of sealer, on the other hand, means infiltration of foreign material at some time in the cyclic change of joint width.

Figure 1. Considerable penetration by stones and almost total loss of adhesion after 2-1/2 years of service: Naugatuck Chemical regular (SS-S-164) hot-pour, rubber-asphalt sealer (Sta. 562+75).

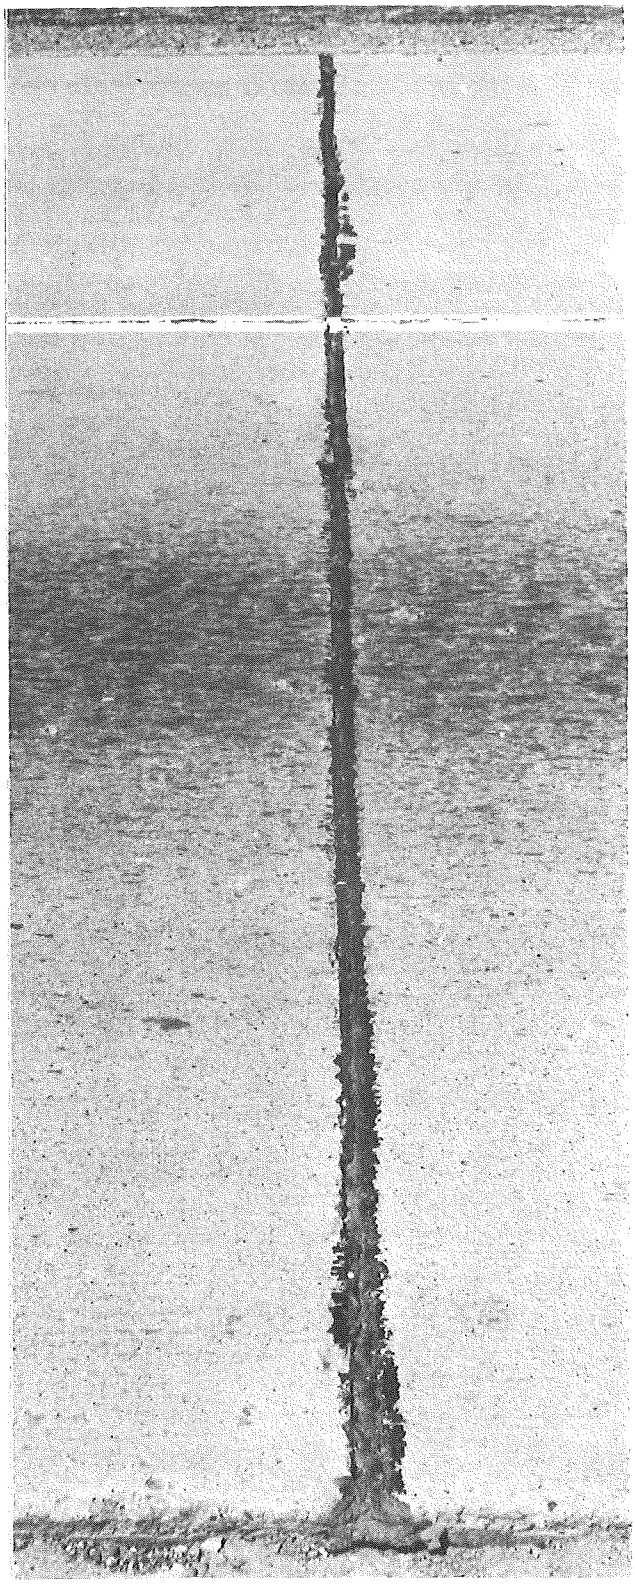
Figure 2. Complete failure (both cohesive and adhesive) and marked lack of resilience after 2-1/2 years of service: Philip Carey regular (SS-S-164) hot-pour, rubber-asphalt sealer (Sta. 586+88).

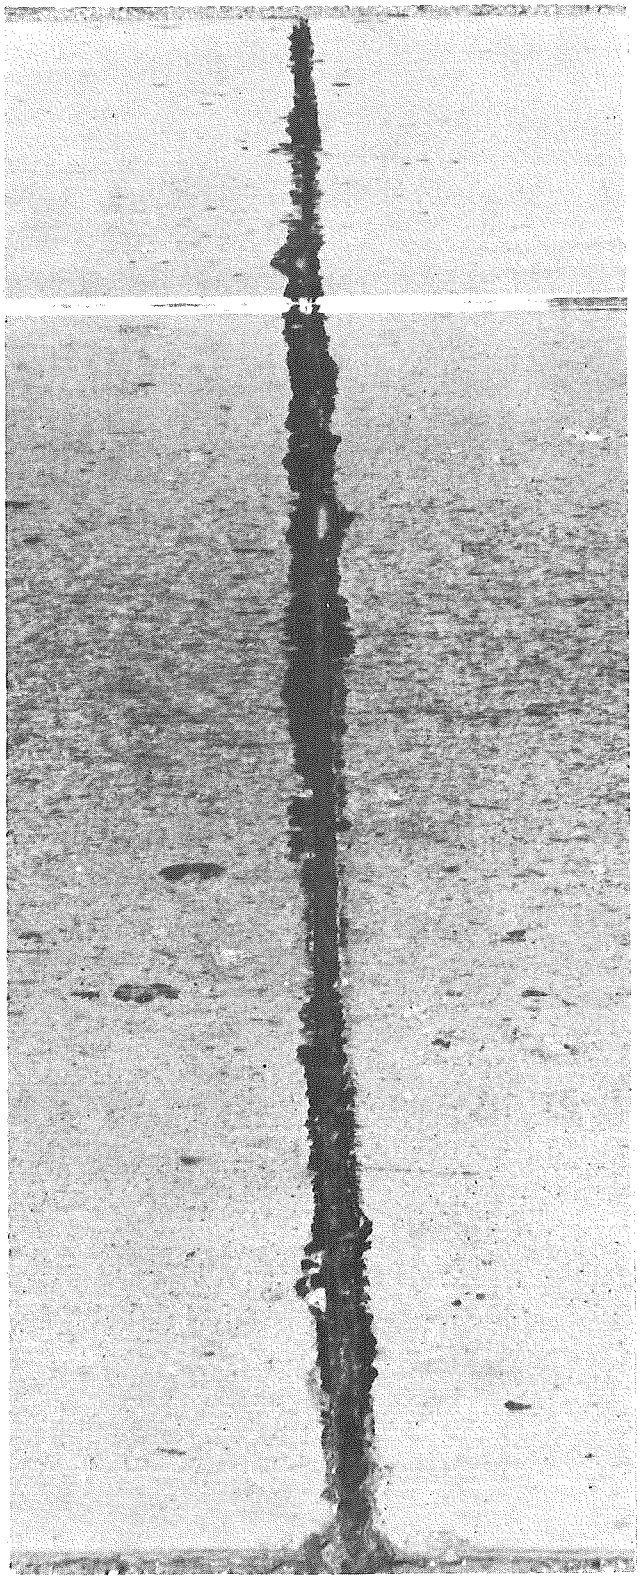
Figure 3. Very little adhesion and considerable penetration at pavement edge after 2-1/2 years of service: Presstite-Keystone regular (SS-S-164) hot-pour, rubber-asphalt sealer (Sta. 608+89).

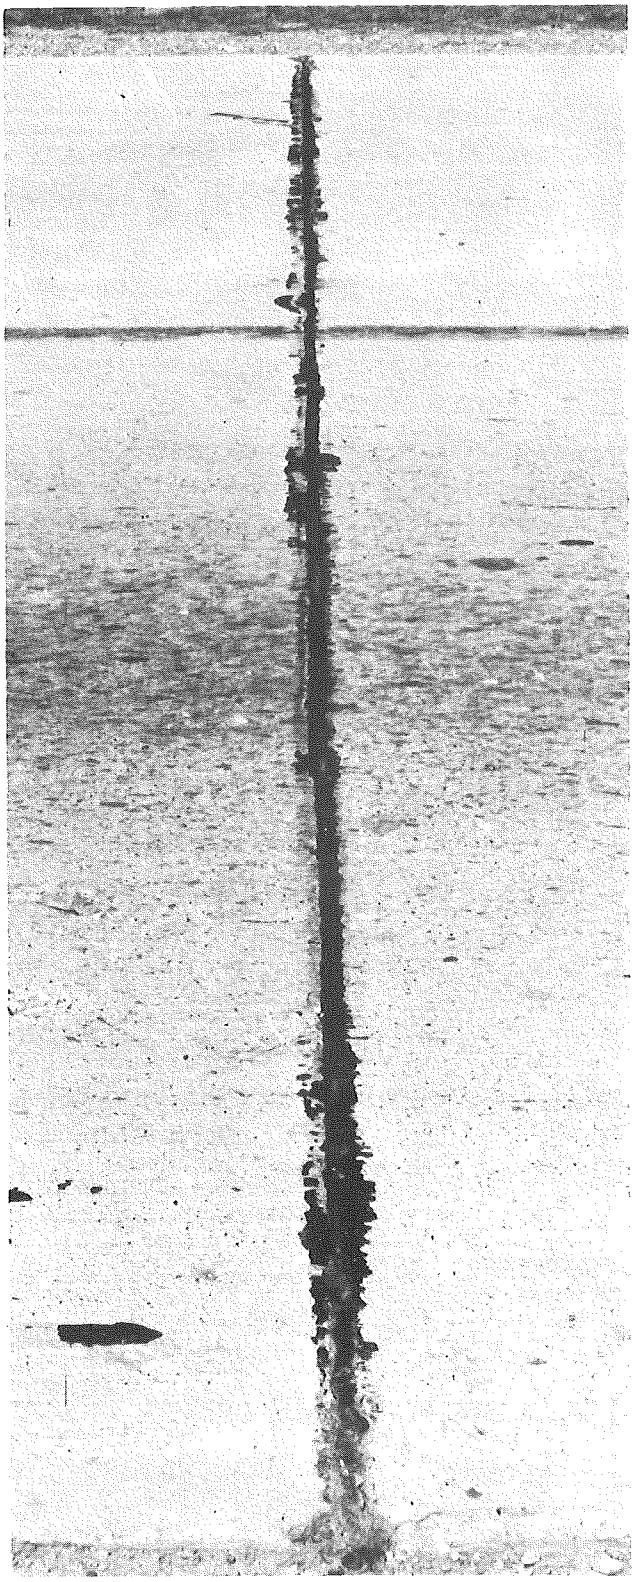
Figure 4. Almost total loss of adhesion after 2-1/2 years of service: Presstite-Keystone regular (SS-S-164) hot-pour, rubber-asphalt sealer (Sta. 641+01).

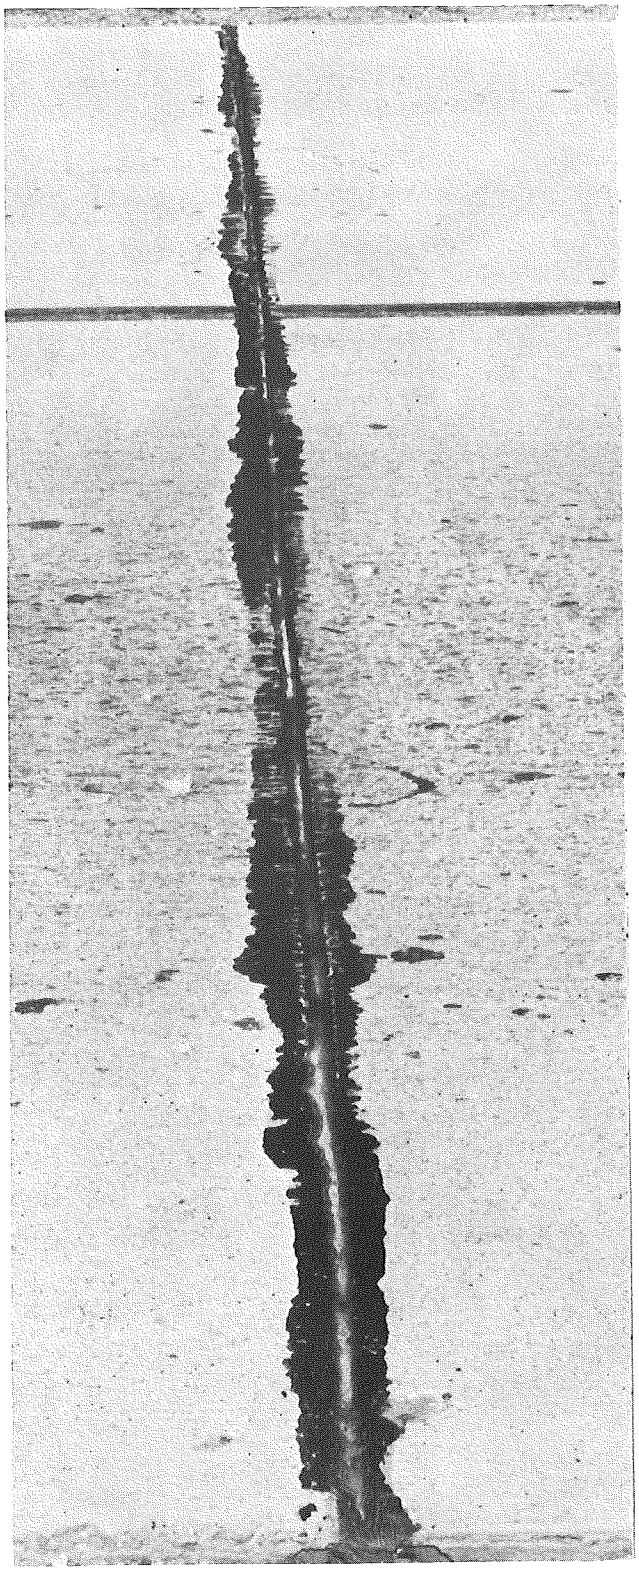
Figure 5. Necking down (light-colored depression) after 2-1/2 years of service, indicating good adhesion along most of the joint: Allied Materials regular (SS-S-164) hot-pour, rubber-asphalt sealer (Sta. 668+40).

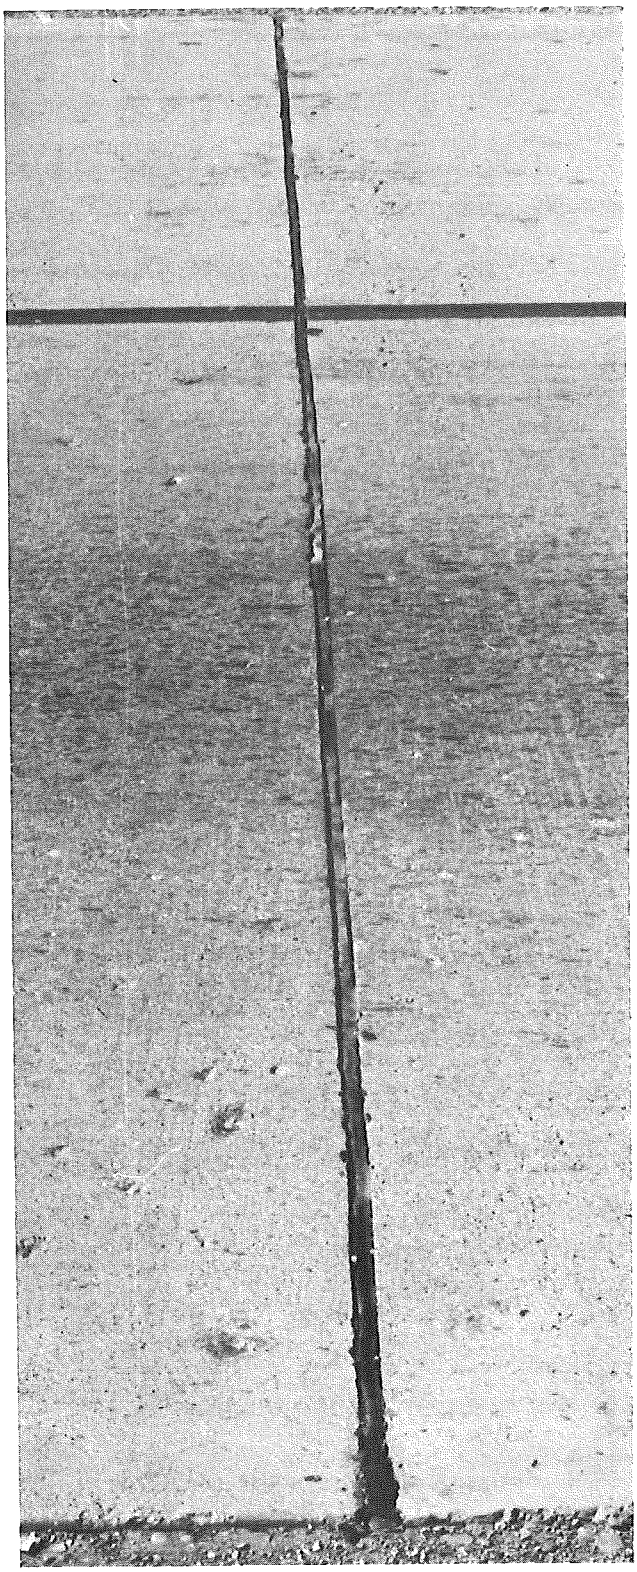
Three makes of two-component, cold-applied sealers in the same project are shown in Figs. 6, 7, and 8. The first, PRC (Fig. 6), was of a tough, rubbery consistency that exhibited excellent resistance to penetration, but the force required to extend it was so great that the sealer pulled completely away from the joint faces during cold weather. The second, Allied Materials 9015 H, was a two-component, machine-applied material that lost its resiliency fairly early and also failed in adhesion. The third material, a special two-component, hand-mixed compound prepared by Servicised Products, performed little better than the single-component, mastic type that had failed so badly in transverse joints; it was easily penetrated by stones and failed in both cohesion and adhesion. Fig. 9 shows a typical example of the failure of single-component, mastic-type, cold-applied sealer. Loss of cohesion is extreme and the material affords practically no protection for the joint space against the infiltration of foreign materials.

Figure 6. Complete loss of adhesion, but good resistance to penetration by larger stones, after 2-1/2 years of service: Products Research (PRC) two-component, cold-applied sealer (Sta. 436+51).

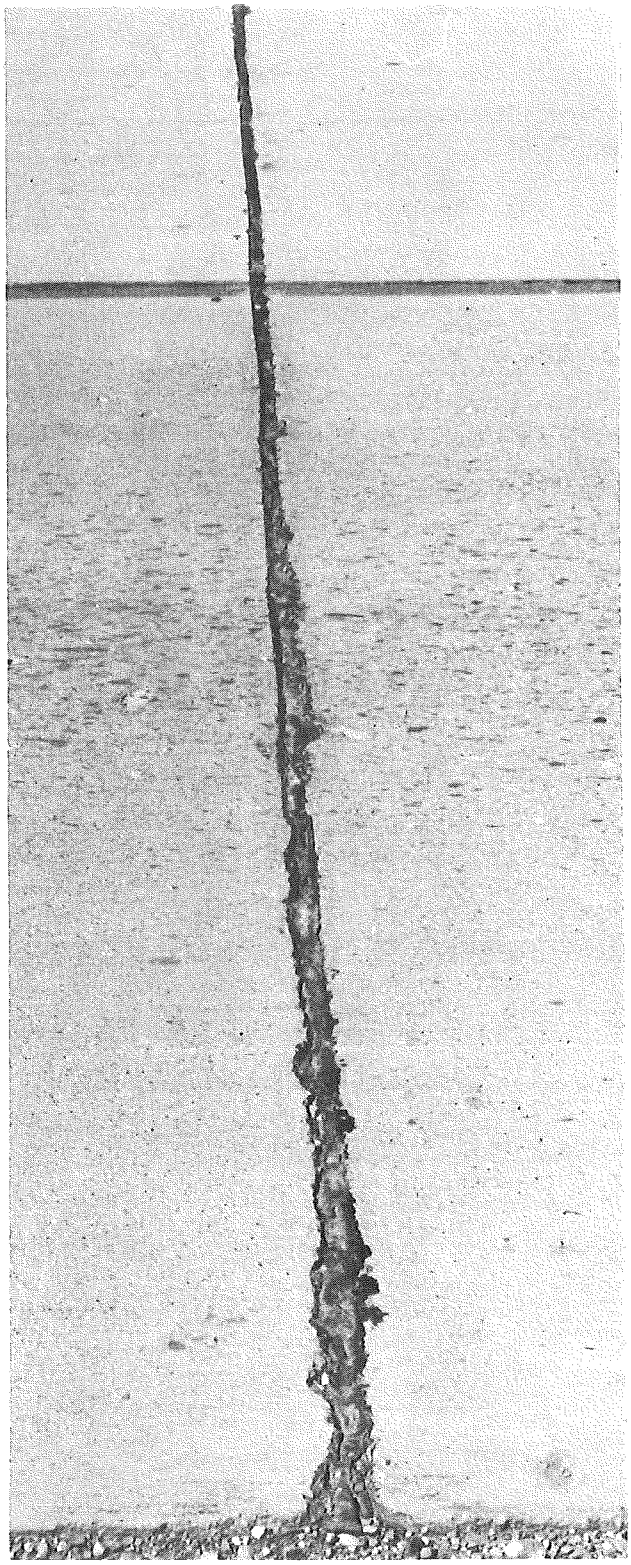
Figure 7. Total adhesion failure and poor resilience after 2-1/2 years of service: Allied Materials 9015 H two-component, cold-applied sealer (Sta. 468+02).

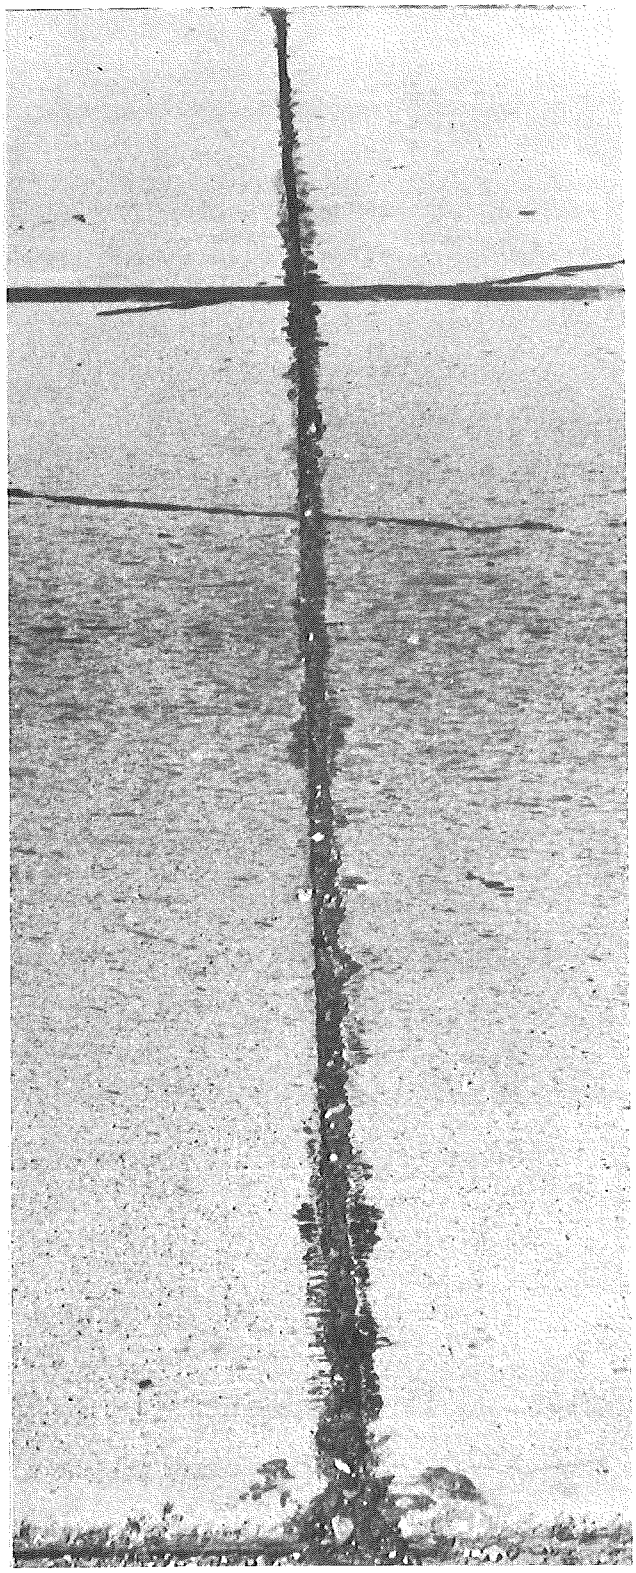
Figure 8. Very poor adhesion and cohesion and little resistance to penetration after 2-1/2 years of service: Servicised two-component, cold-applied sealer (Sta. 480+42).

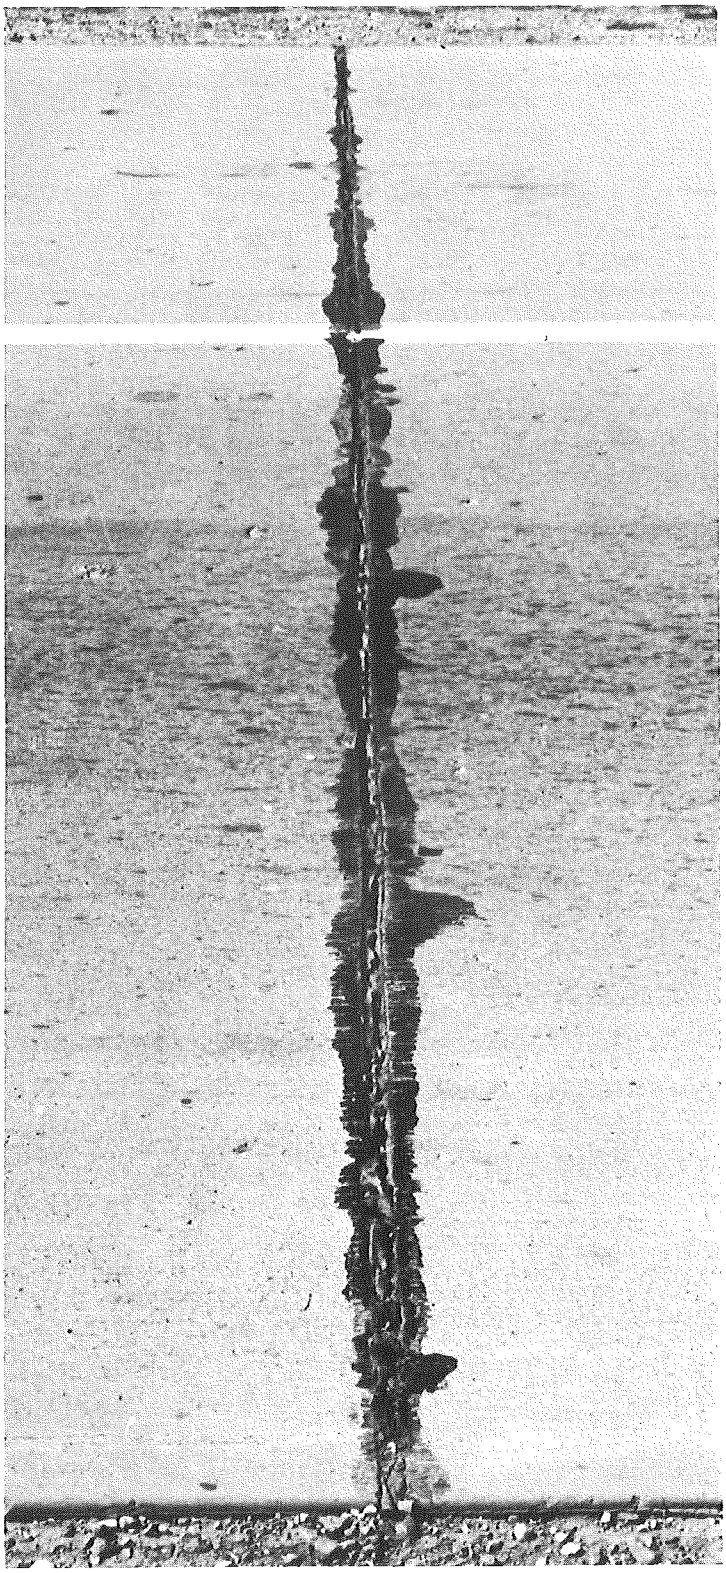
Figure 9. Total failure in cohesion and very little resistance to penetration after 2-1/2 years of service: Presstite-Keystone single-component, mastic sealer (Sta. 420+55).
