Delaminations

Bridge: 5002 SB Lane: 1 Image Name: 1_4833000_57440_2171.tif

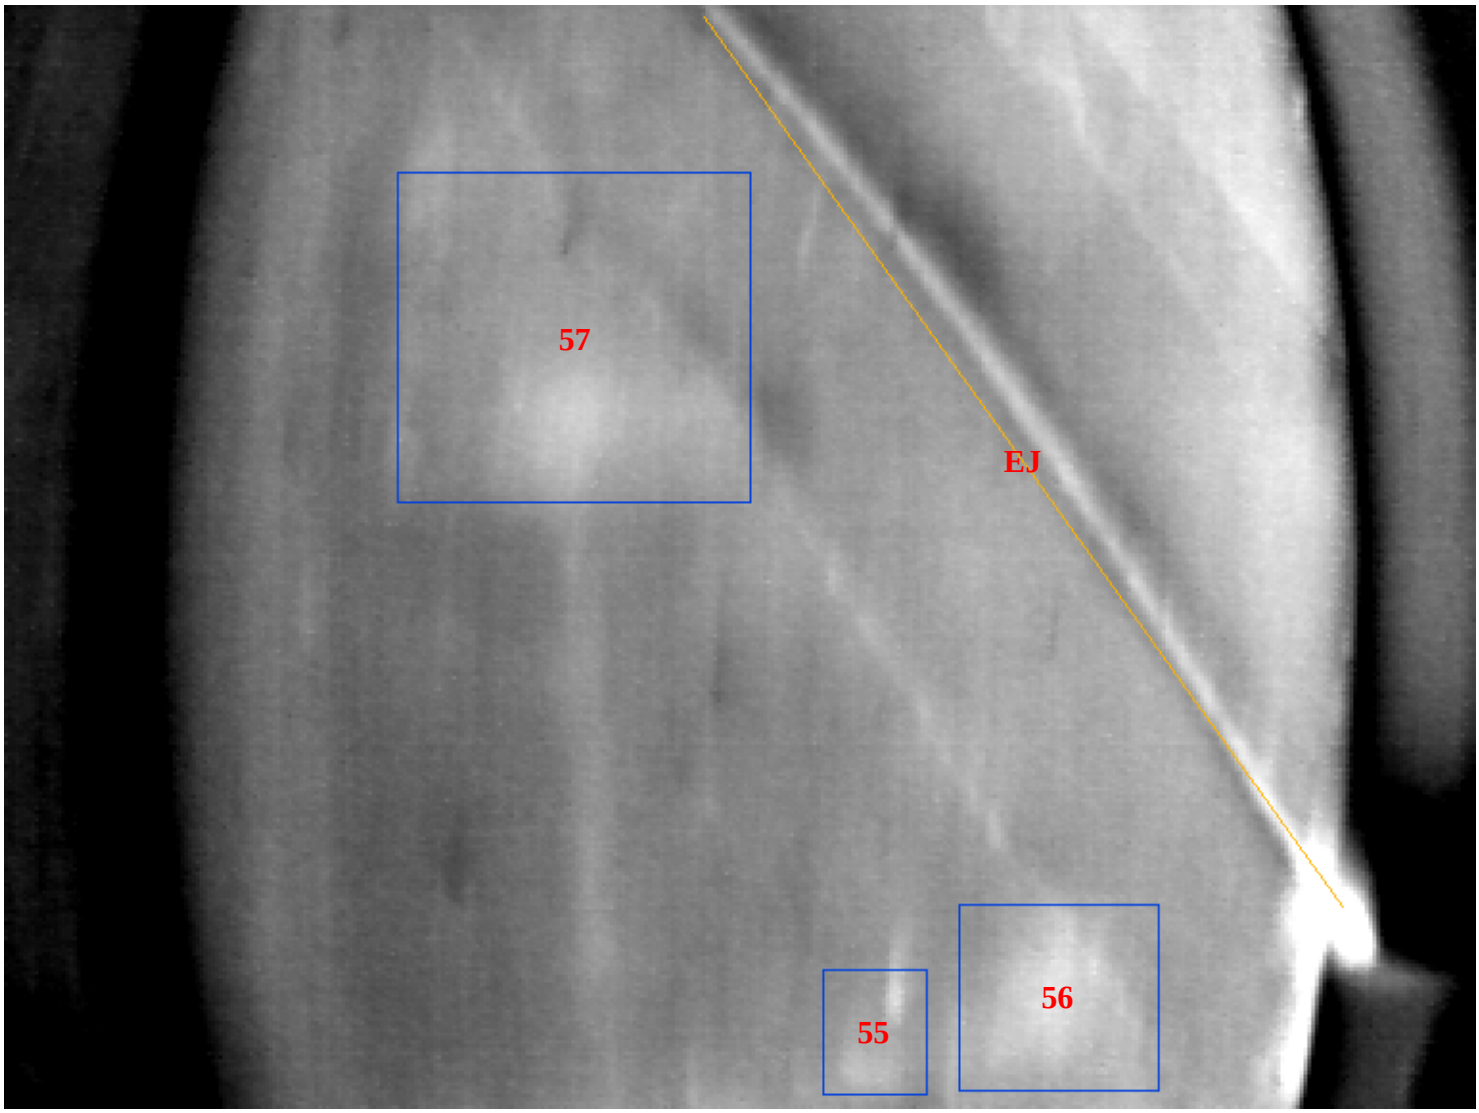
Defect #	55	56	EJ	57
Feet from Start	117.51	117.83	122.85	124.00
Feet from Right	5.71	3.96	4.31	8.58
Defect Size	1.24 sq ft	3.52 sq ft	NA	10.93 sq ft
Length x Width (ft)	1.18 x 1.00	1.76 x 1.91	NA	3.10 x 3.37
Type	Delam	Delam	Joint	Delam

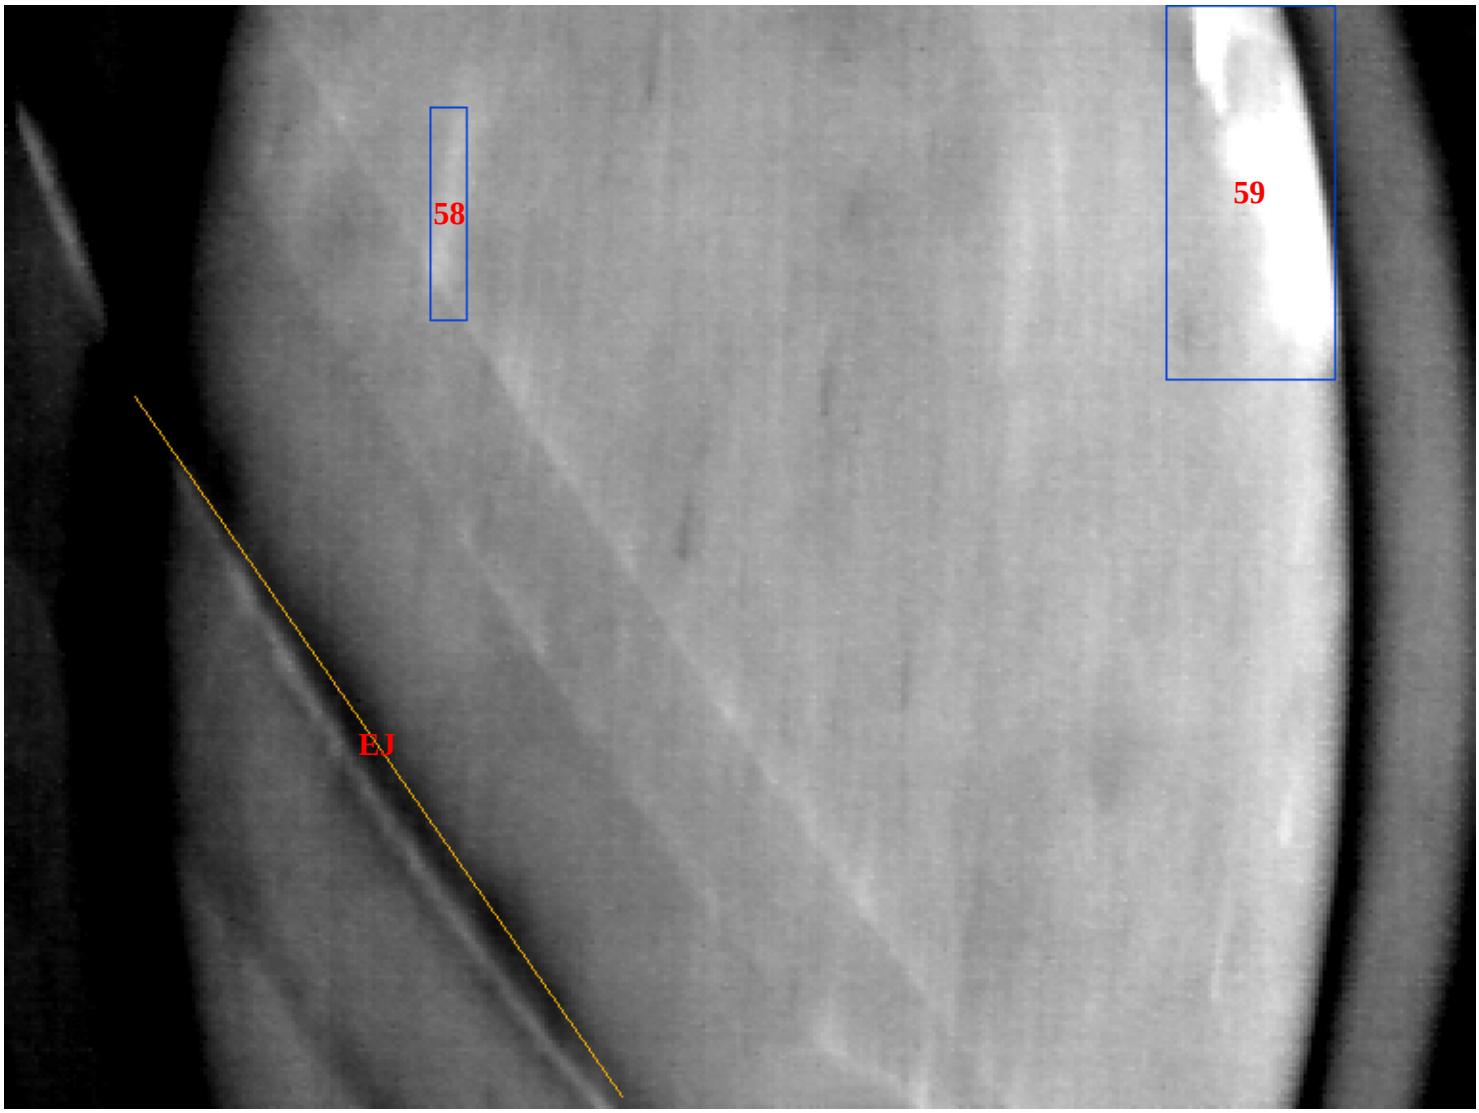
Bridge: 5002 SB Lane: 1 Image Name: 1_5052000_57440_2171.tif

Defect #	EJ	58	59
Feet from Start	130.67	135.64	135.85
Feet from Right	10.45	9.77	2.14
Defect Size	NA	0.77 sq ft	5.96 sq ft
Length x Width (ft)	NA	2.01 x 0.36	3.51 x 1.62
Type	Joint	Delam	Delam

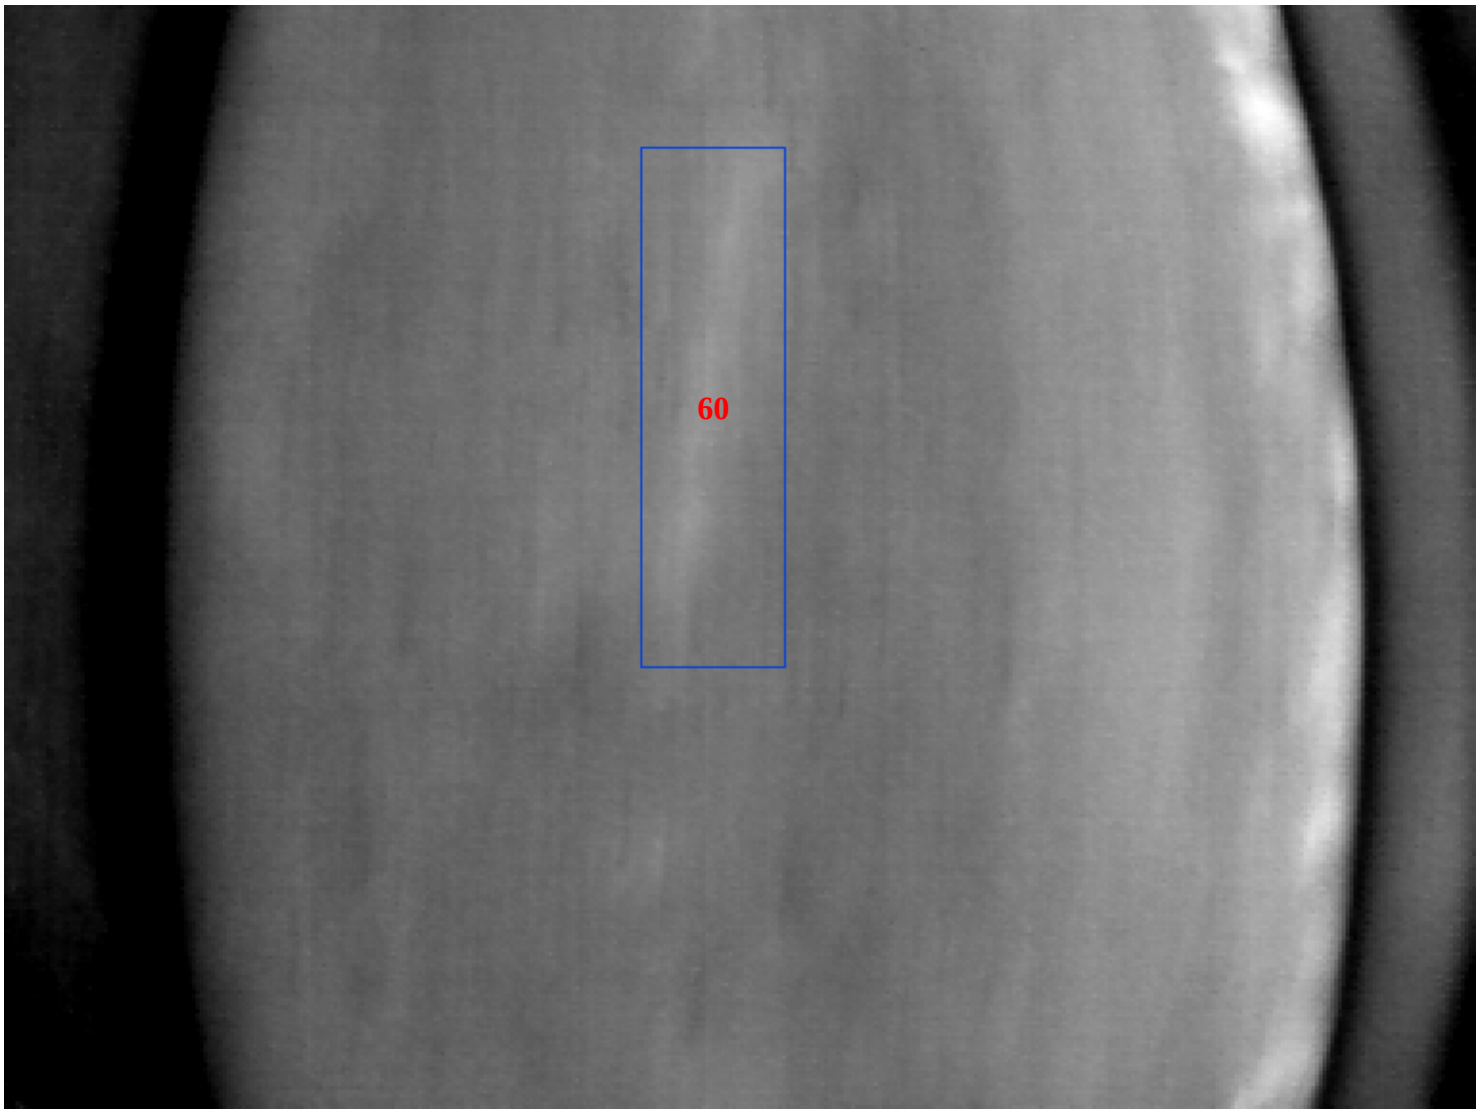
Bridge: 5002 SB Lane: 1 Image Name: 1_5265000_57824_2165.tif

Defect #	60
Feet from Start	144.09
Feet from Right	7.26
Defect Size	7.06 sq ft
Length x Width (ft)	4.87 x 1.39
Type	Delam

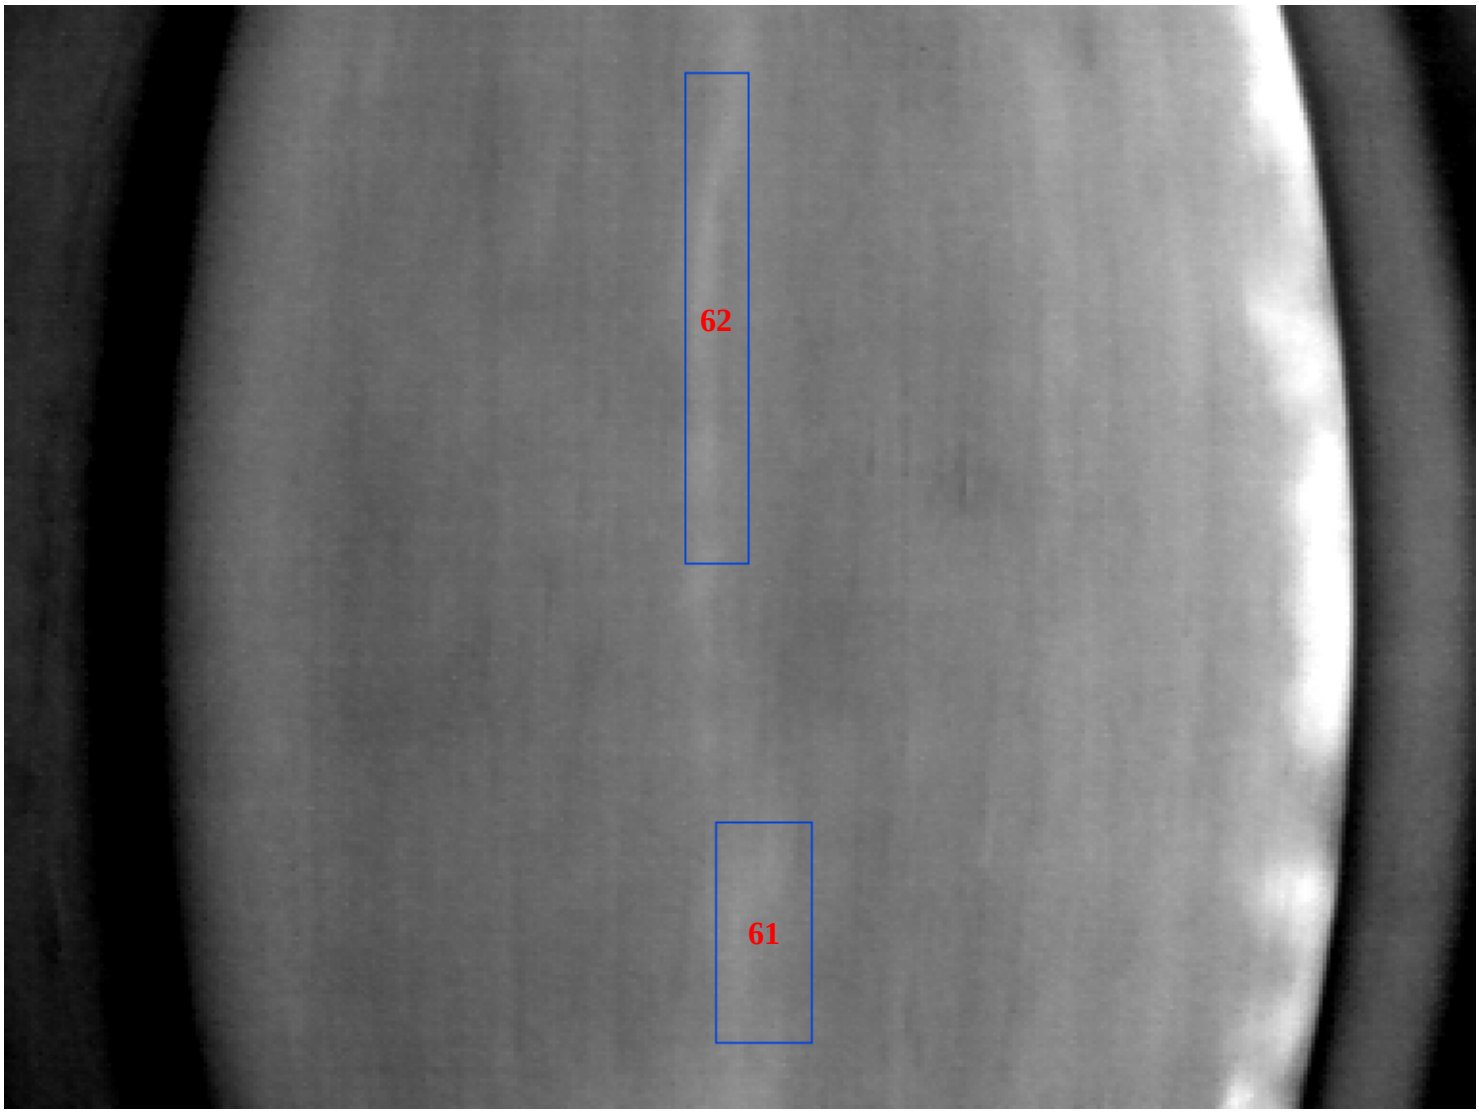
Bridge: 5002 SB Lane: 1 Image Name: 1_5481000_57824_2165.tif

Defect #	61	62
Feet from Start	149.59	155.33
Feet from Right	6.77	7.22
Defect Size	2.02 sq ft	2.99 sq ft
Length x Width (ft)	2.08 x 0.93	4.60 x 0.62
Type	Delam	Delam

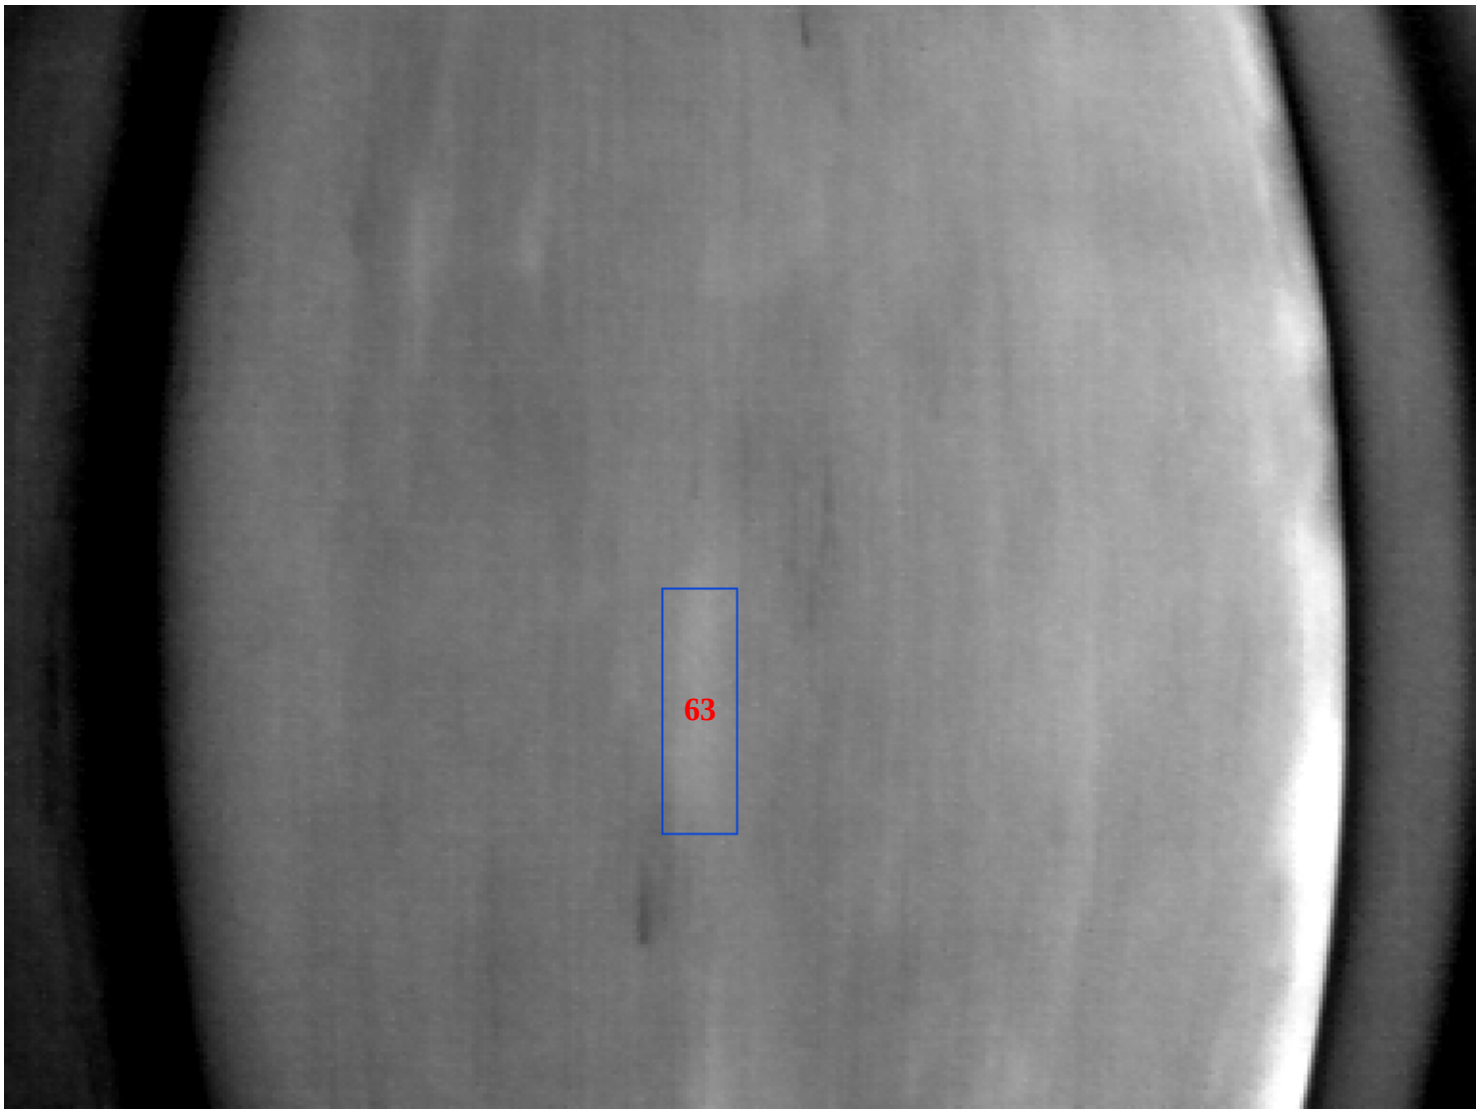
Bridge: 5002 SB Lane: 1 Image Name: 1_5698000_57824_2165.tif

Defect #	63
Feet from Start	162.12
Feet from Right	7.38
Defect Size	1.76 sq ft
Length x Width (ft)	2.31 x 0.73
Type	Delam

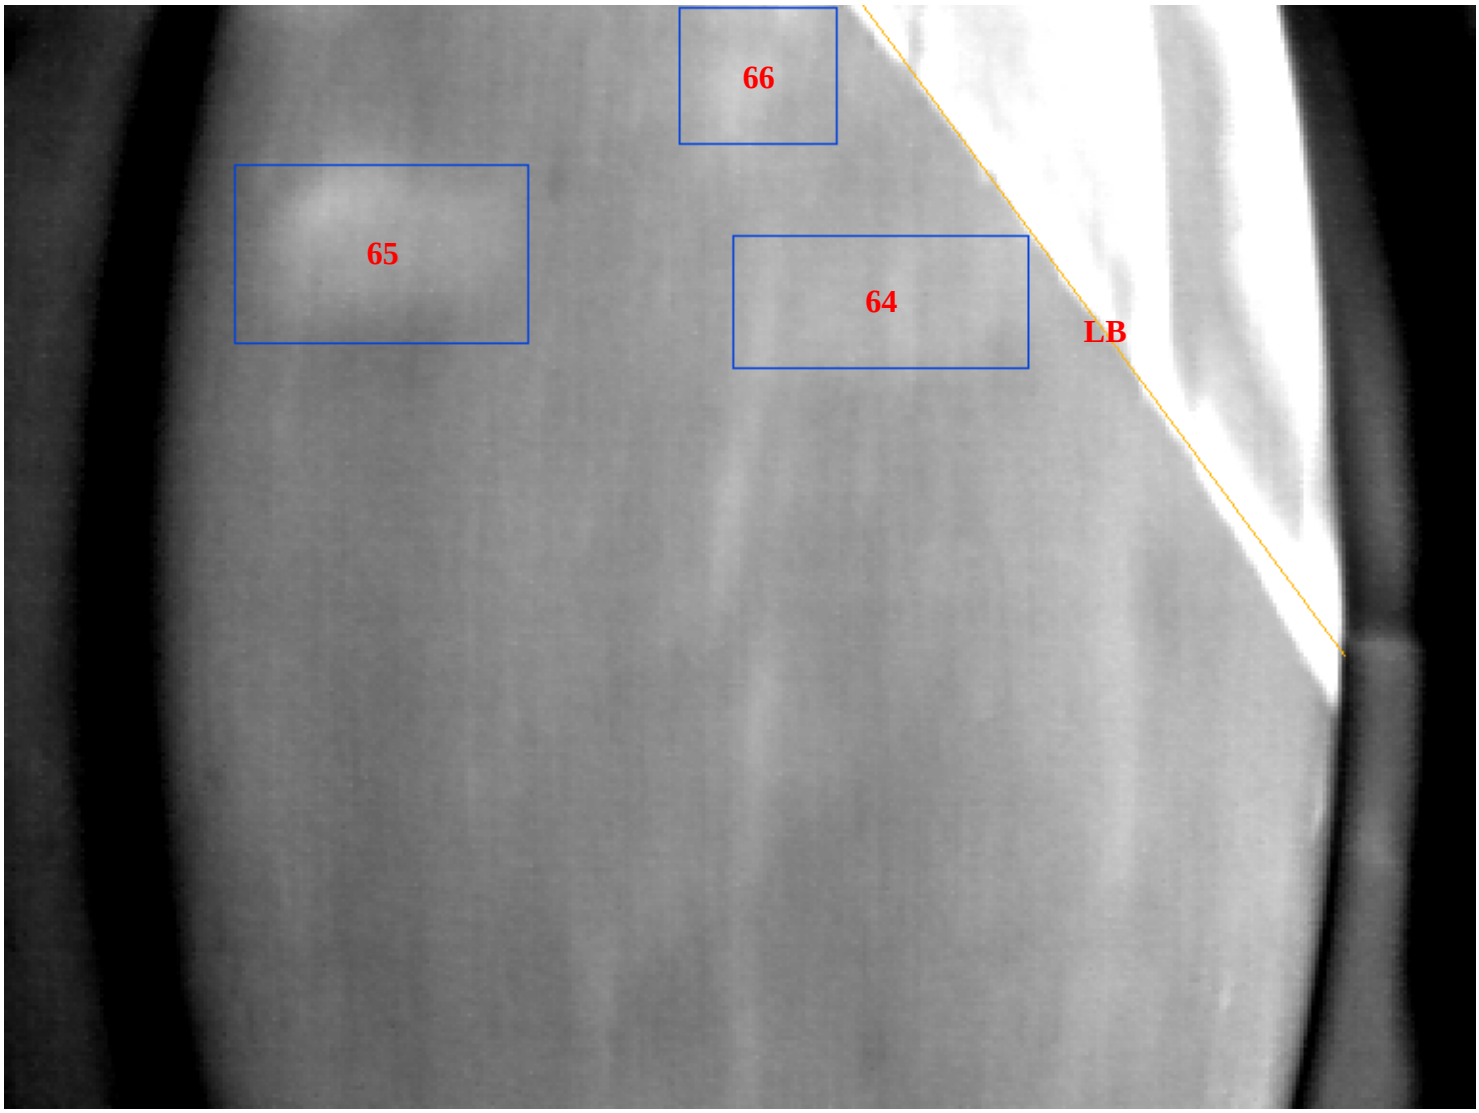
Bridge: 5002 SB Lane: 1 Image Name: 1_5915000_57824_2165.tif

Defect #	LB	64	65	66
Feet from Start	176.14	176.40	176.85	178.51
Feet from Right	3.55	5.66	10.41	6.83
Defect Size	NA	3.71 sq ft	4.95 sq ft	2.04 sq ft
Length x Width (ft)	NA	1.25 x 2.83	1.68 x 2.81	1.29 x 1.51
Type	Lane Bound	Delam	Delam	Delam

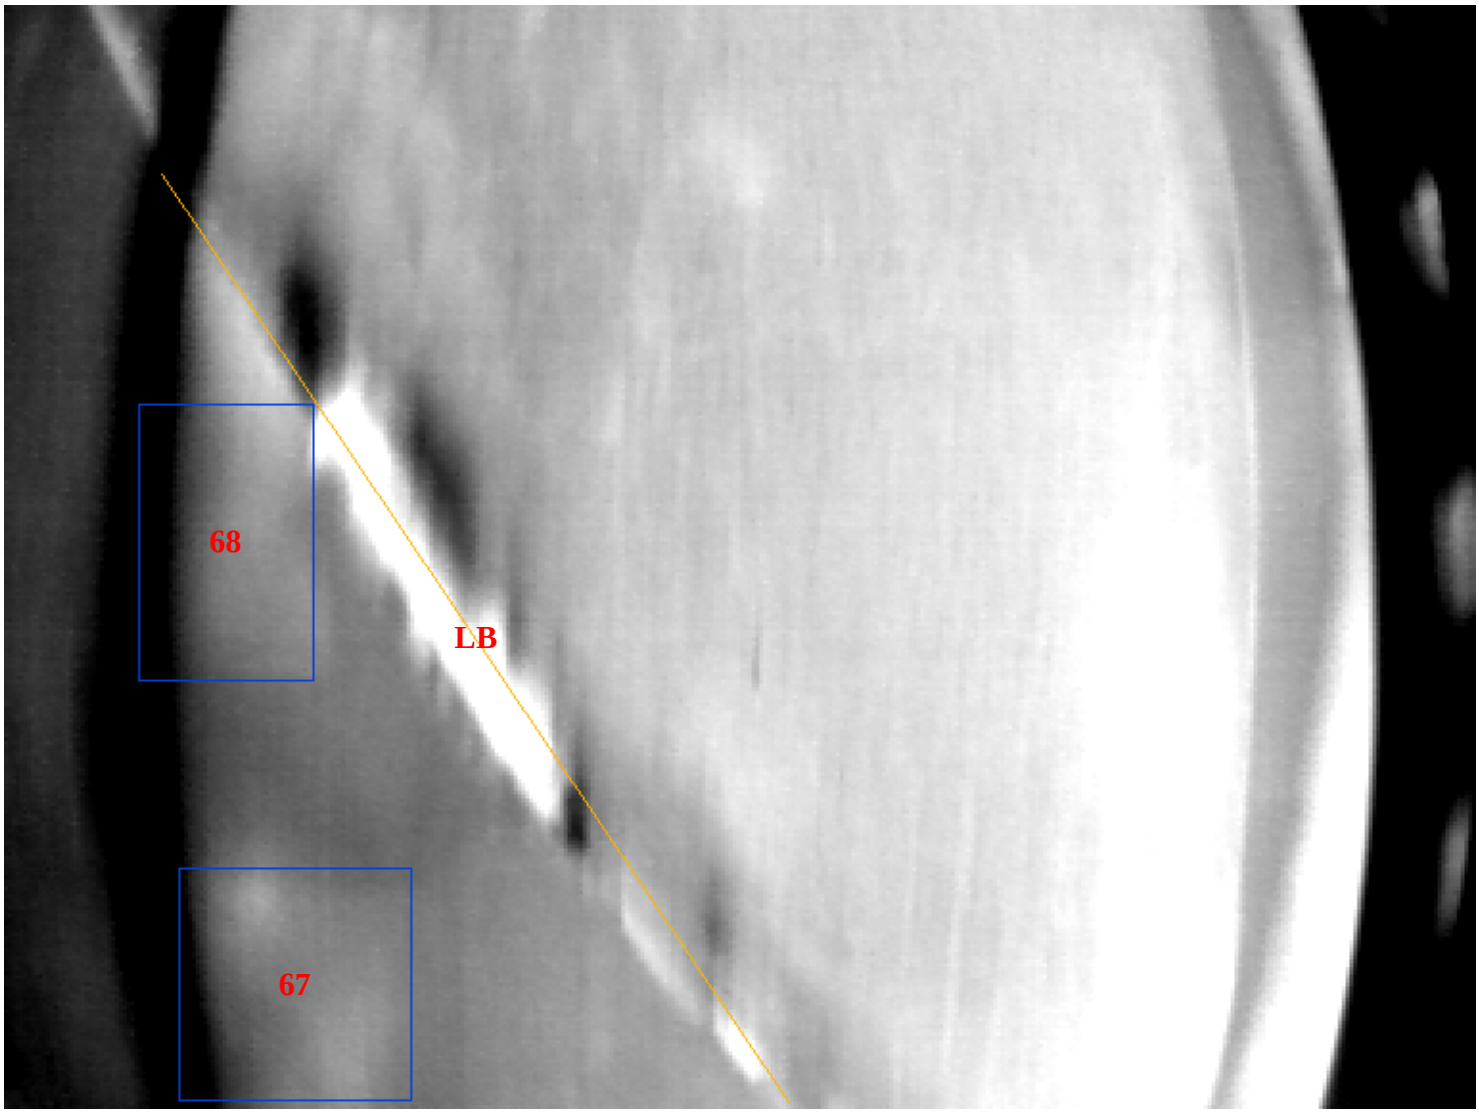
Bridge: 5002 SB Lane: 1 Image Name: 1_6130000_57824_2165.tif

Defect #	67	LB	68
Feet from Start	180.38	183.63	184.51
Feet from Right	11.23	9.52	11.89
Defect Size	5.08 sq ft	NA	4.56 sq ft
Length x Width (ft)	2.19 x 2.22	NA	2.60 x 1.68
Type	Delam	Lane Bound	Delam

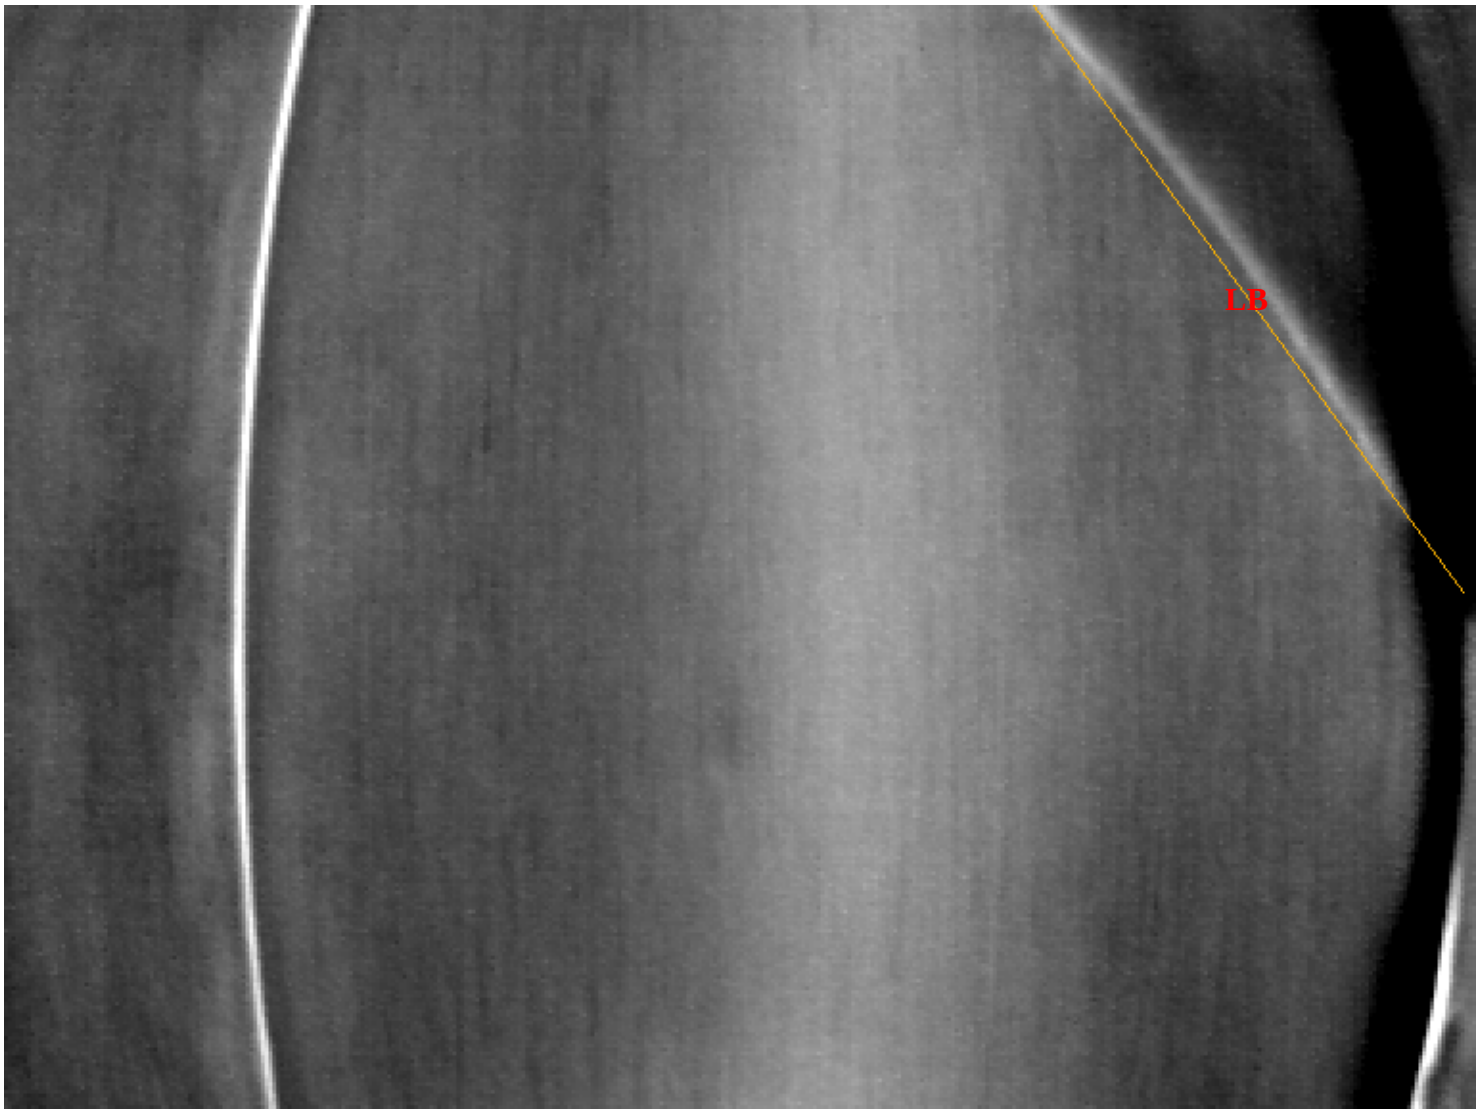
Bridge: 5002 SB Lane: 2 Image Name: 2_2364000_64569_2175.tif

Defect #	LB
Feet from Start	2.88
Feet from Right	16.17
Defect Size	NA
Length x Width (ft)	NA
Type	Lane Bound

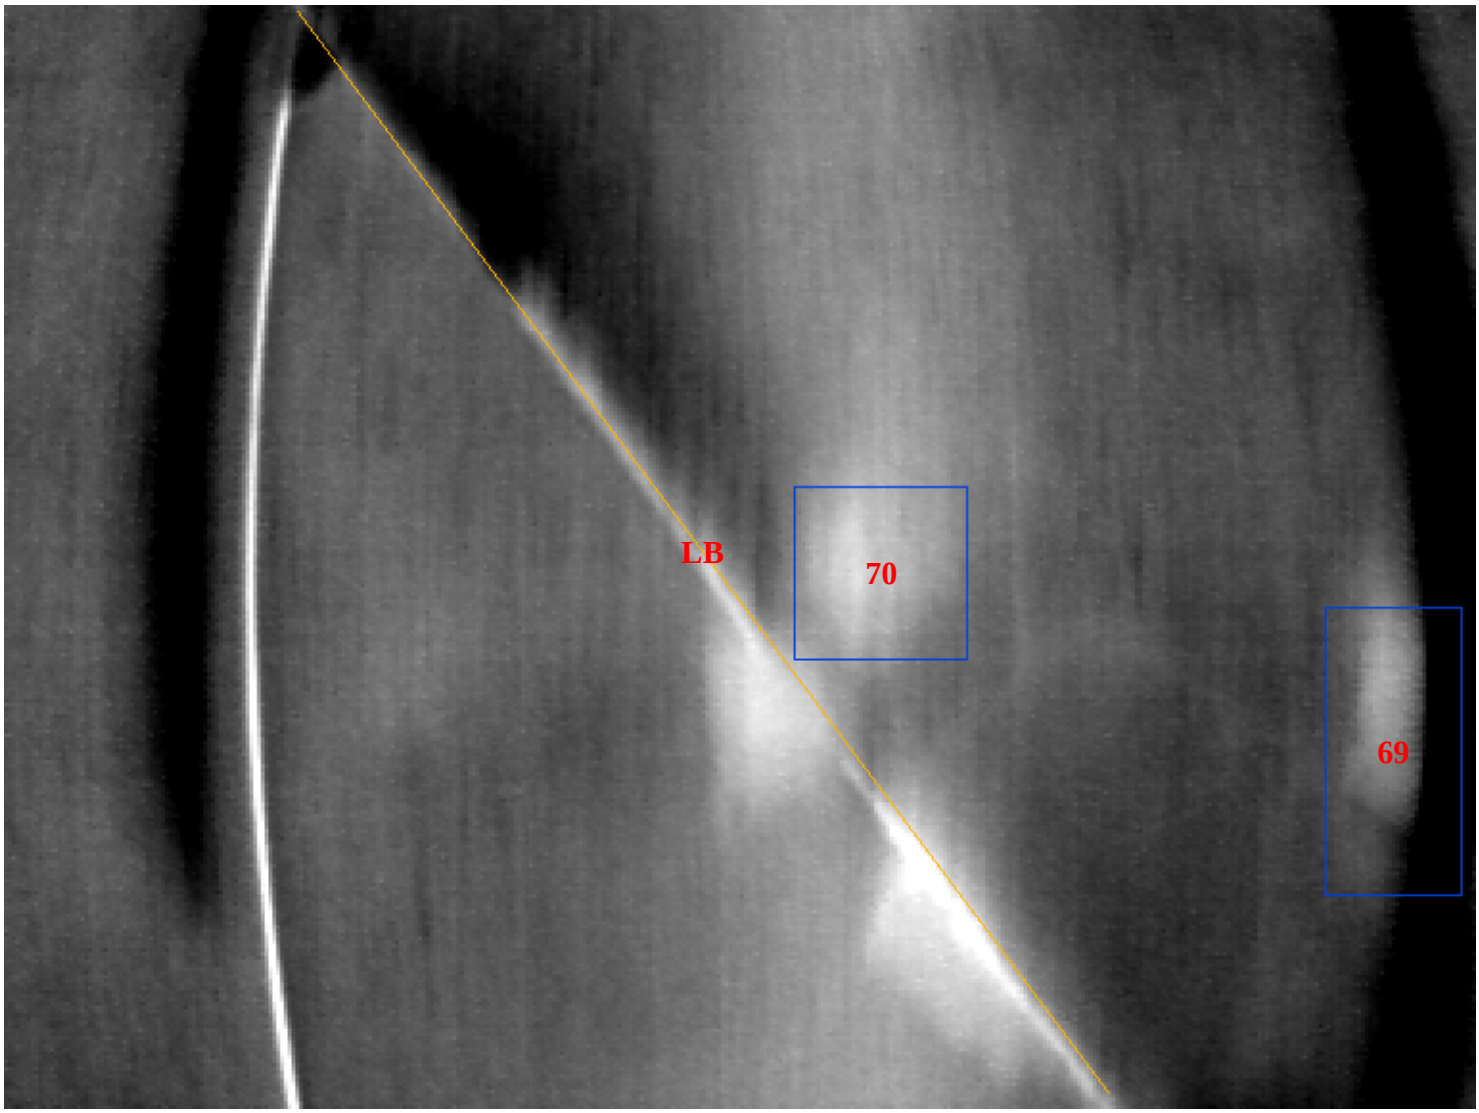
Bridge: 5002 SB Lane: 2 Image Name: 2_2554000_64569_2175.tif

Defect #	69	70	LB
Feet from Start	8.87	10.54	10.74
Feet from Right	14.78	19.66	21.36
Defect Size	3.71 sq ft	2.83 sq ft	NA
Length x Width (ft)	2.70 x 1.31	1.63 x 1.66	NA
Type	Delam	Delam	Lane Bound

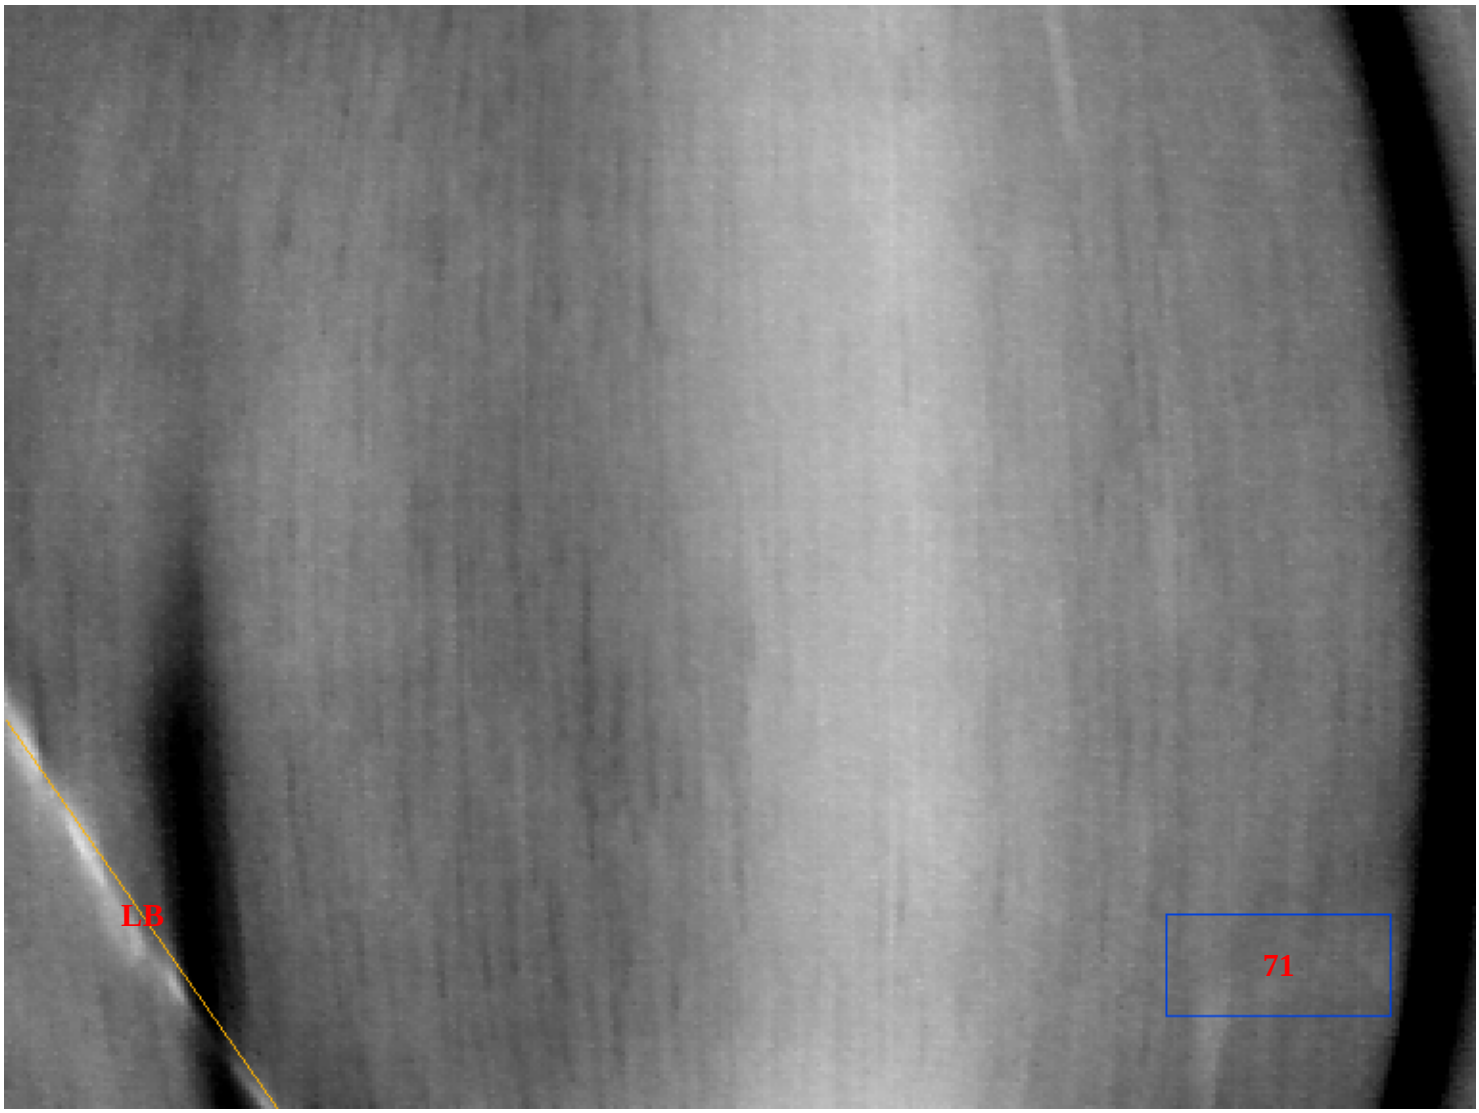
Bridge: 5002 SB Lane: 2 Image Name: 2_2748000_64569_2175.tif

Defect #	71	LB
Feet from Start	17.31	17.80
Feet from Right	15.88	26.70
Defect Size	2.18 sq ft	NA
Length x Width (ft)	0.97 x 2.15	NA
Type	Delam	Lane Bound

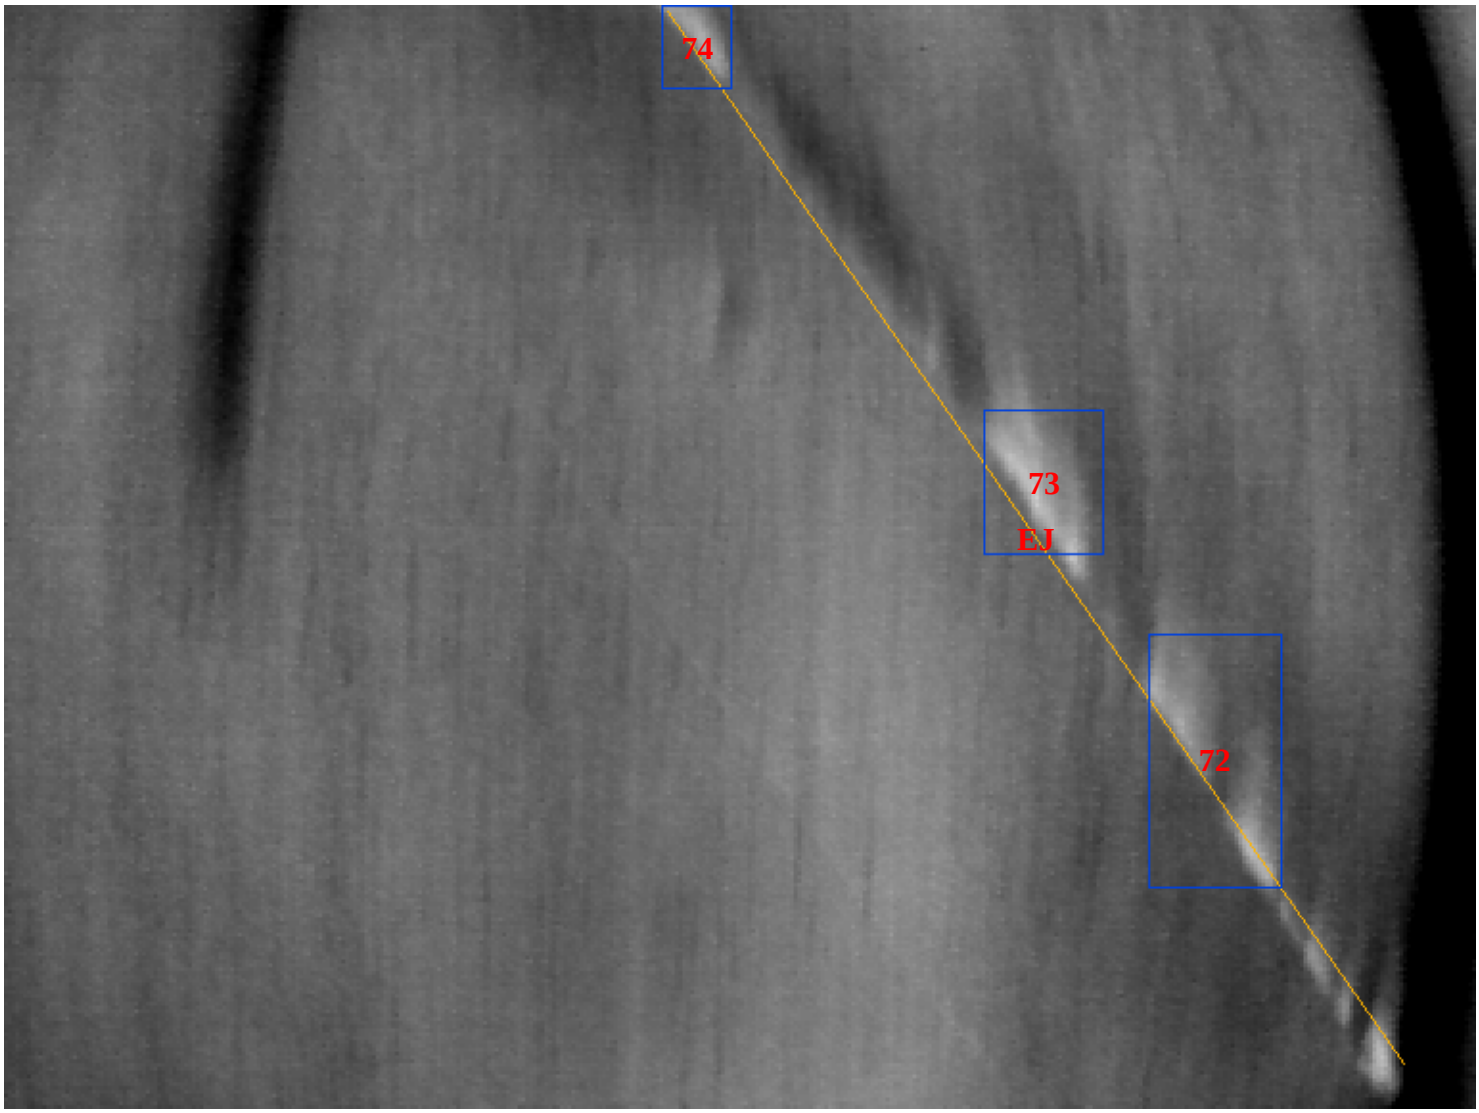
Bridge: 5002 SB Lane: 2 Image Name: 2_3336000_64346_2169.tif

Defect #	72	EJ	73	74
Feet from Start	50.79	52.88	53.39	57.46
Feet from Right	16.48	18.19	18.11	21.41
Defect Size	3.18 sq ft	NA	1.64 sq ft	0.56 sq ft
Length x Width (ft)	2.38 x 1.28	NA	1.36 x 1.15	0.79 x 0.67
Type	Delam	Joint	Delam	Delam

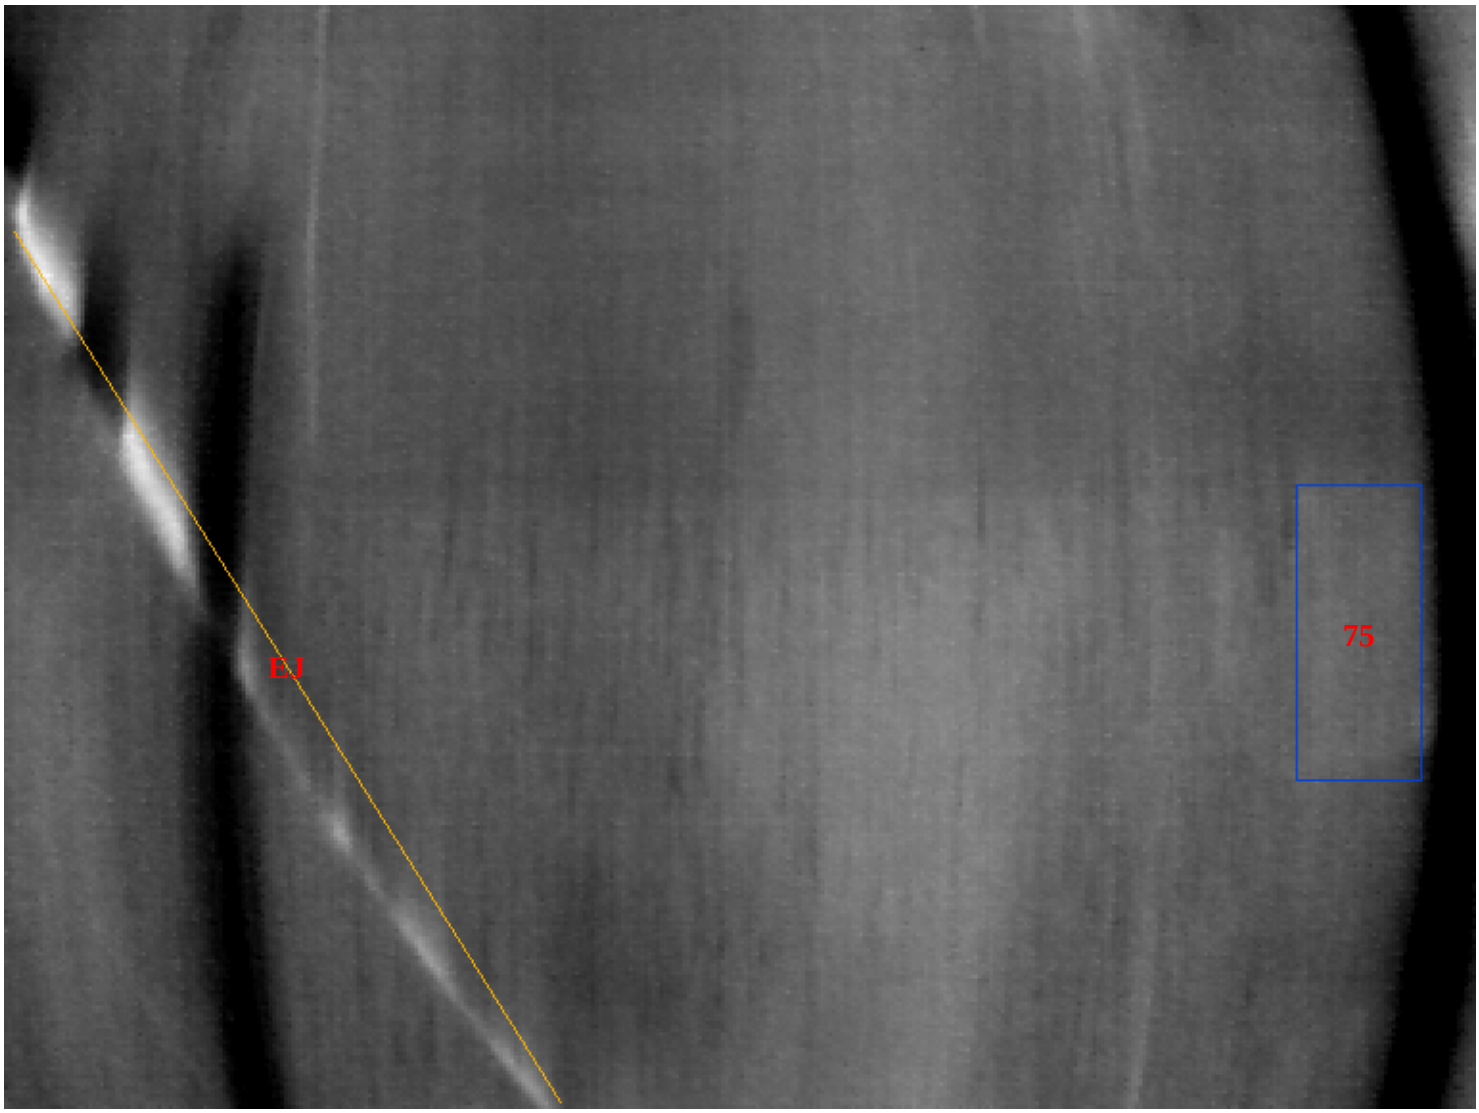
Bridge: 5002 SB Lane: 2 Image Name: 2_3526000_64346_2169.tif

Defect #	EJ	75
Feet from Start	61.86	62.17
Feet from Right	25.31	15.11
Defect Size	NA	3.49 sq ft
Length x Width (ft)	NA	2.78 x 1.20
Type	Joint	Delam

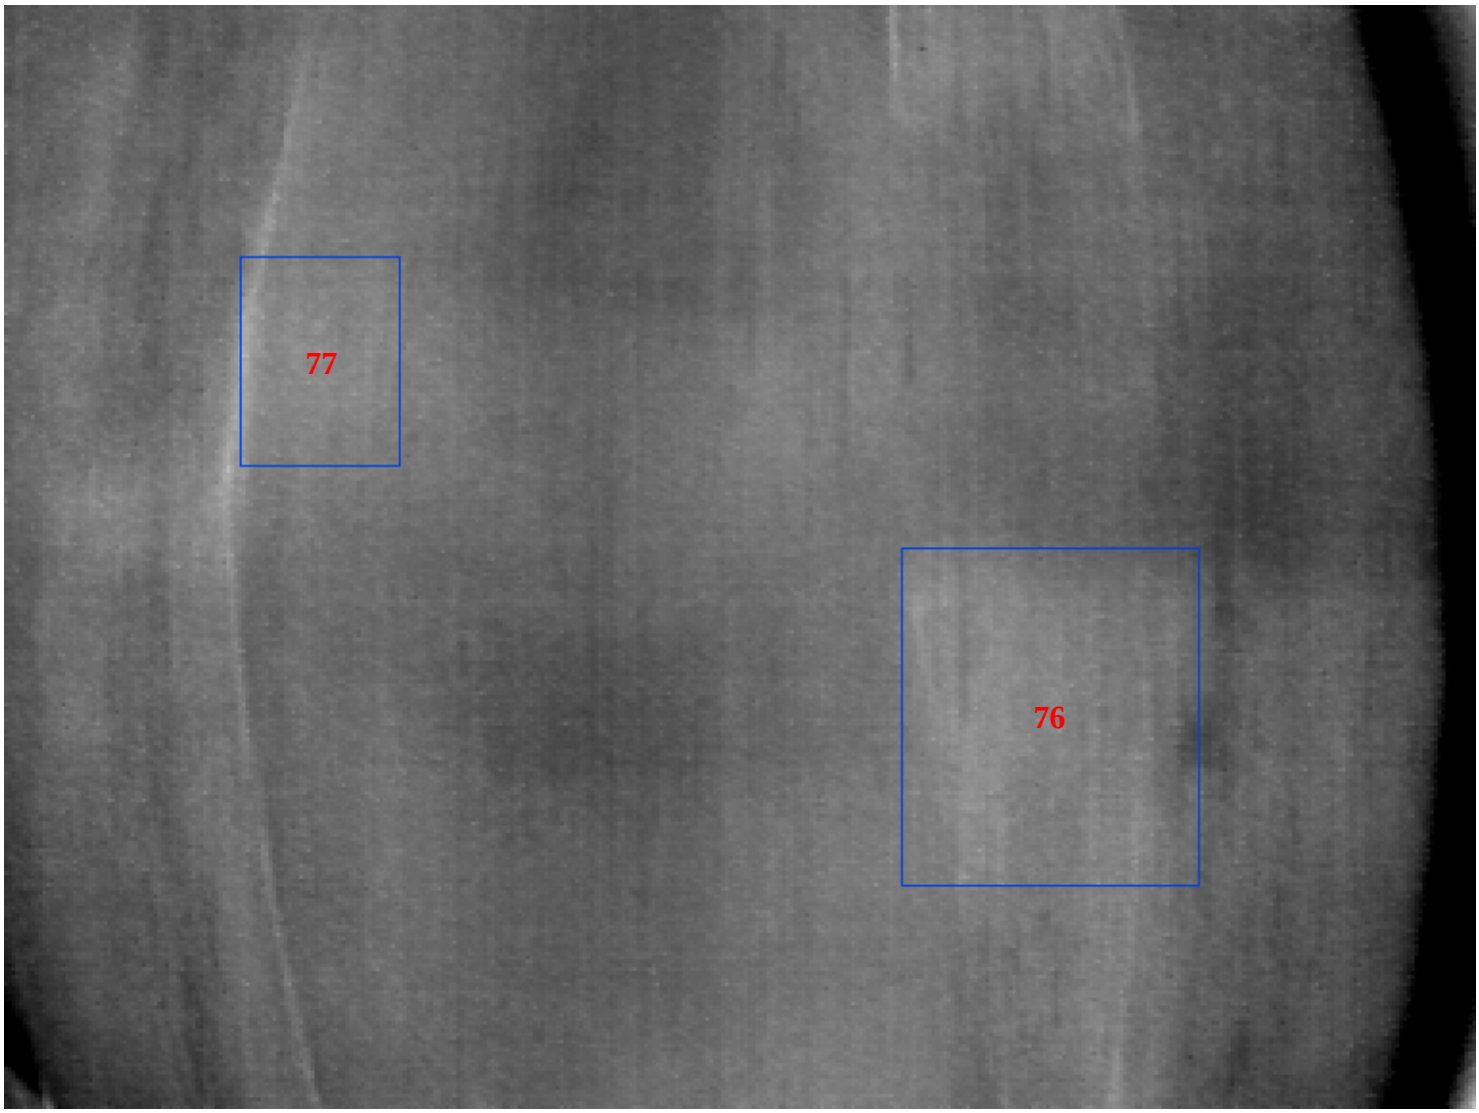
Bridge: 5002 SB Lane: 2 Image Name: 2_3719000_64346_2169.tif

Defect #	76	77
Feet from Start	71.74	75.06
Feet from Right	18.05	24.99
Defect Size	9.43 sq ft	3.16 sq ft
Length x Width (ft)	3.17 x 2.84	1.97 x 1.53
Type	Delam	Delam
