Delaminations

Bridge: 5002 SB Lane: 1 Image Name: 1_4833000_57440_2171.tif

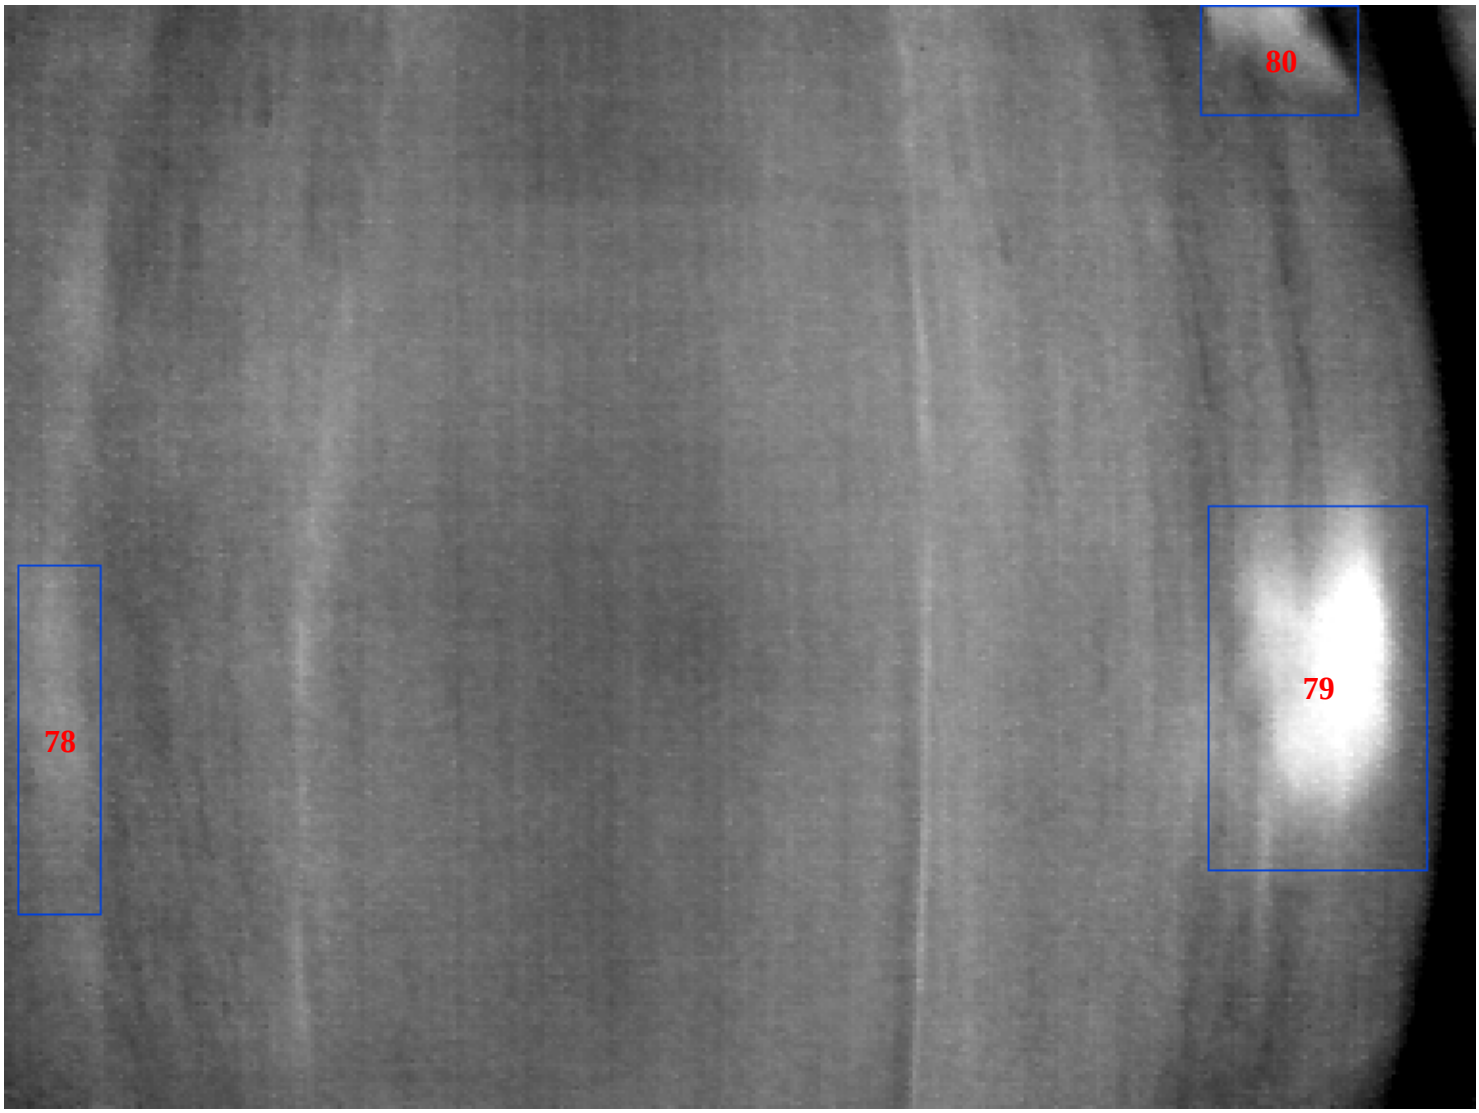
Bridge: 5002 SB Lane: 2 Image Name: 2_3909000_64346_2169.tif

Defect #	78	79	80
Feet from Start	81.71	82.19	88.06
Feet from Right	27.47	15.50	15.87
Defect Size	2.75 sq ft	7.50 sq ft	1.64 sq ft
Length x Width (ft)	3.28 x 0.80	3.42 x 2.10	1.04 x 1.51
Type	Delam	Delam	Delam
