Delaminations

Bridge: 5002 SB Lane: 2 Image Name: 2_4106000_64366_2164.tif

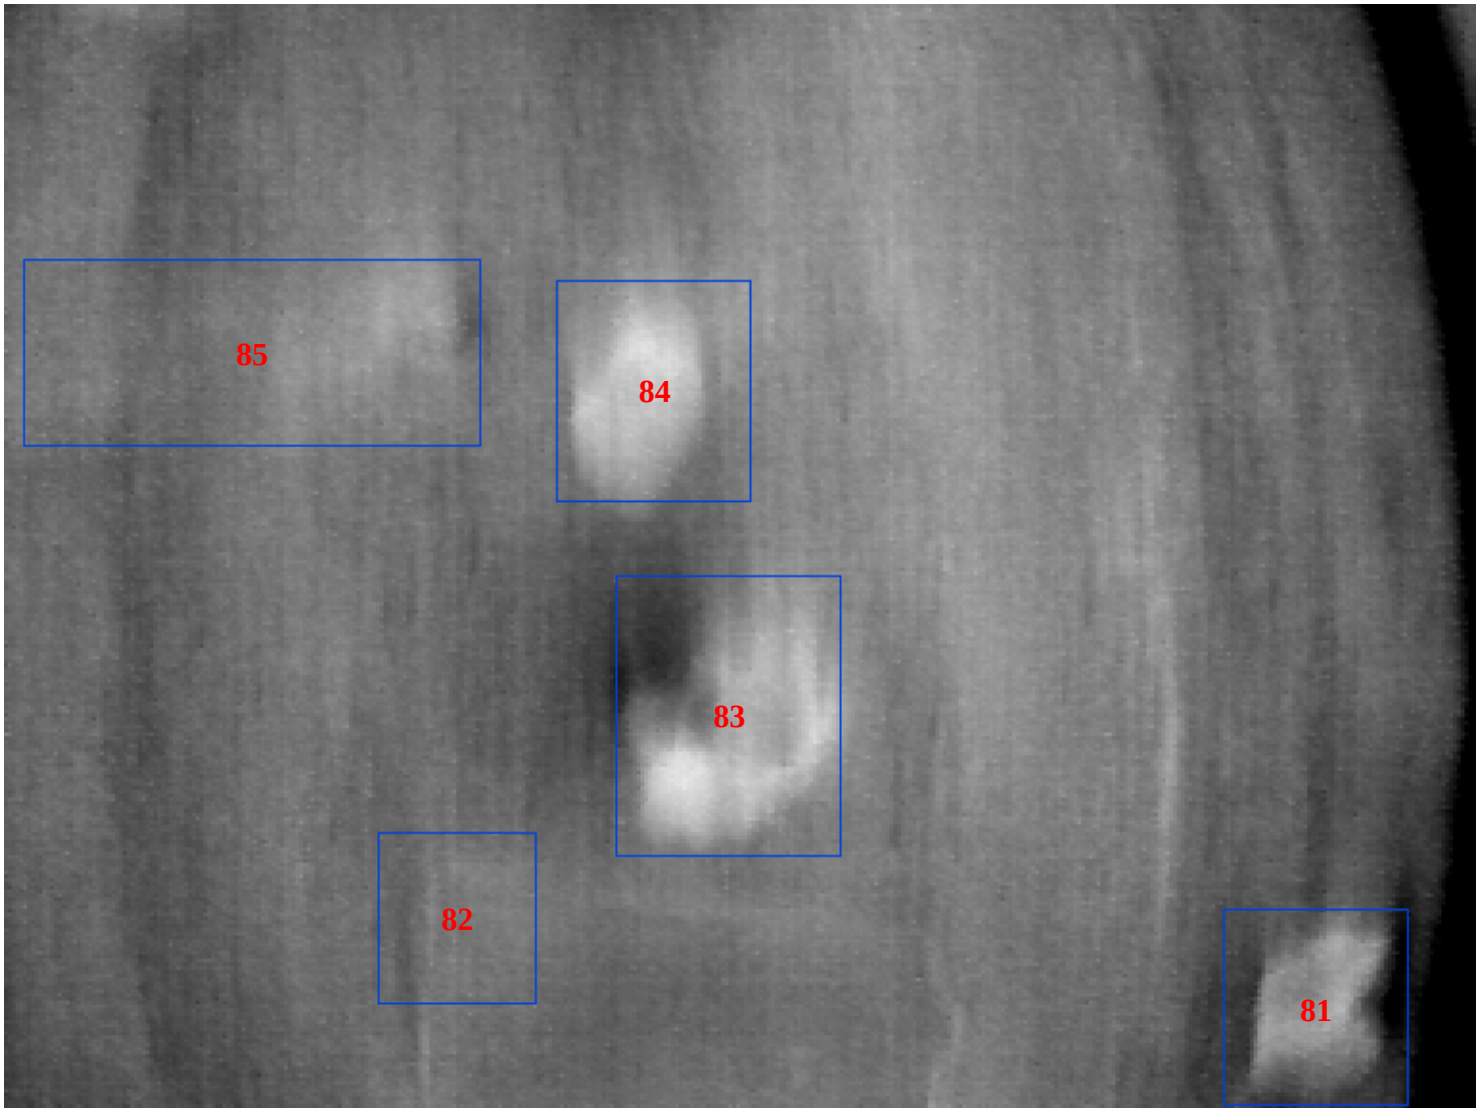
Defect #	81	82	83	84	85
Feet from Start	89.77	90.60	92.49	95.53	95.88
Feet from Right	15.52	23.69	21.11	21.82	25.64
Defect Size	3.41 sq ft	2.55 sq ft	5.93 sq ft	4.04 sq ft	8.00 sq ft
Length x Width (ft)	1.84 x 1.77	1.61 x 1.51	2.63 x 2.15	2.08 x 1.86	1.76 x 4.36
Type	Delam	Delam	Delam	Delam	Delam

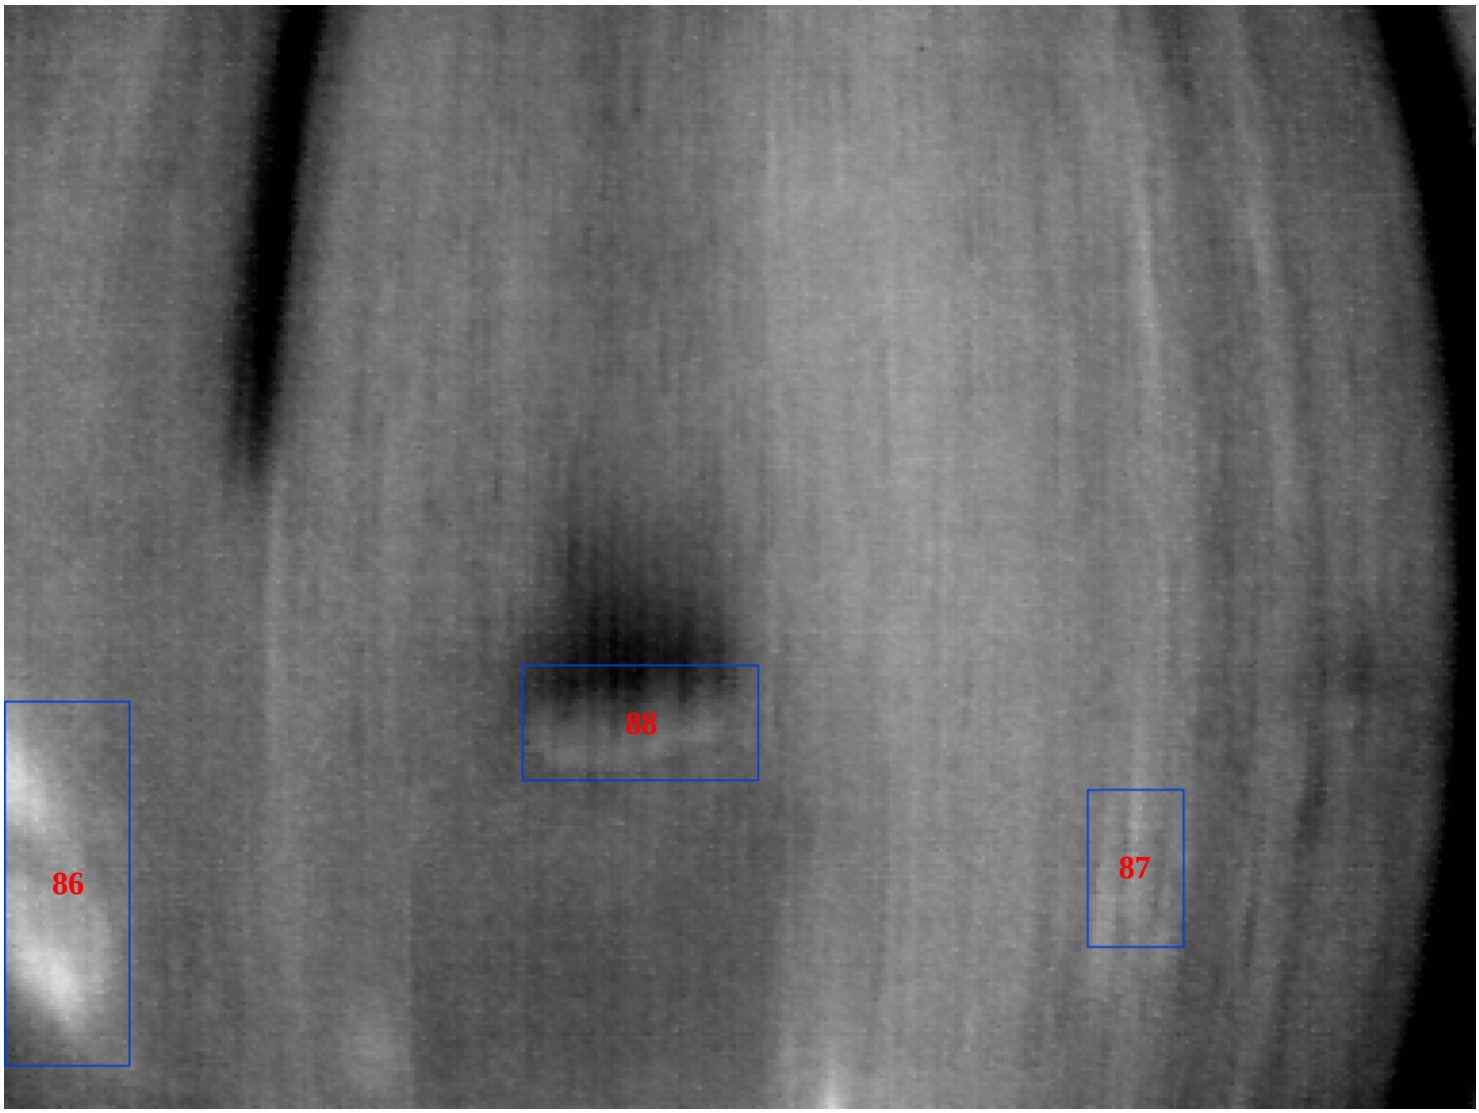
Bridge: 5002 SB Lane: 2 Image Name: 2_4303000_64366_2164.tif

Defect #	86	87	88
Feet from Start	101.50	101.64	103.00
Feet from Right	27.40	17.24	21.95
Defect Size	4.31 sq ft	1.45 sq ft	2.58 sq ft
Length x Width (ft)	3.42 x 1.20	1.49 x 0.93	1.09 x 2.26
Type	Delam	Delam	Delam

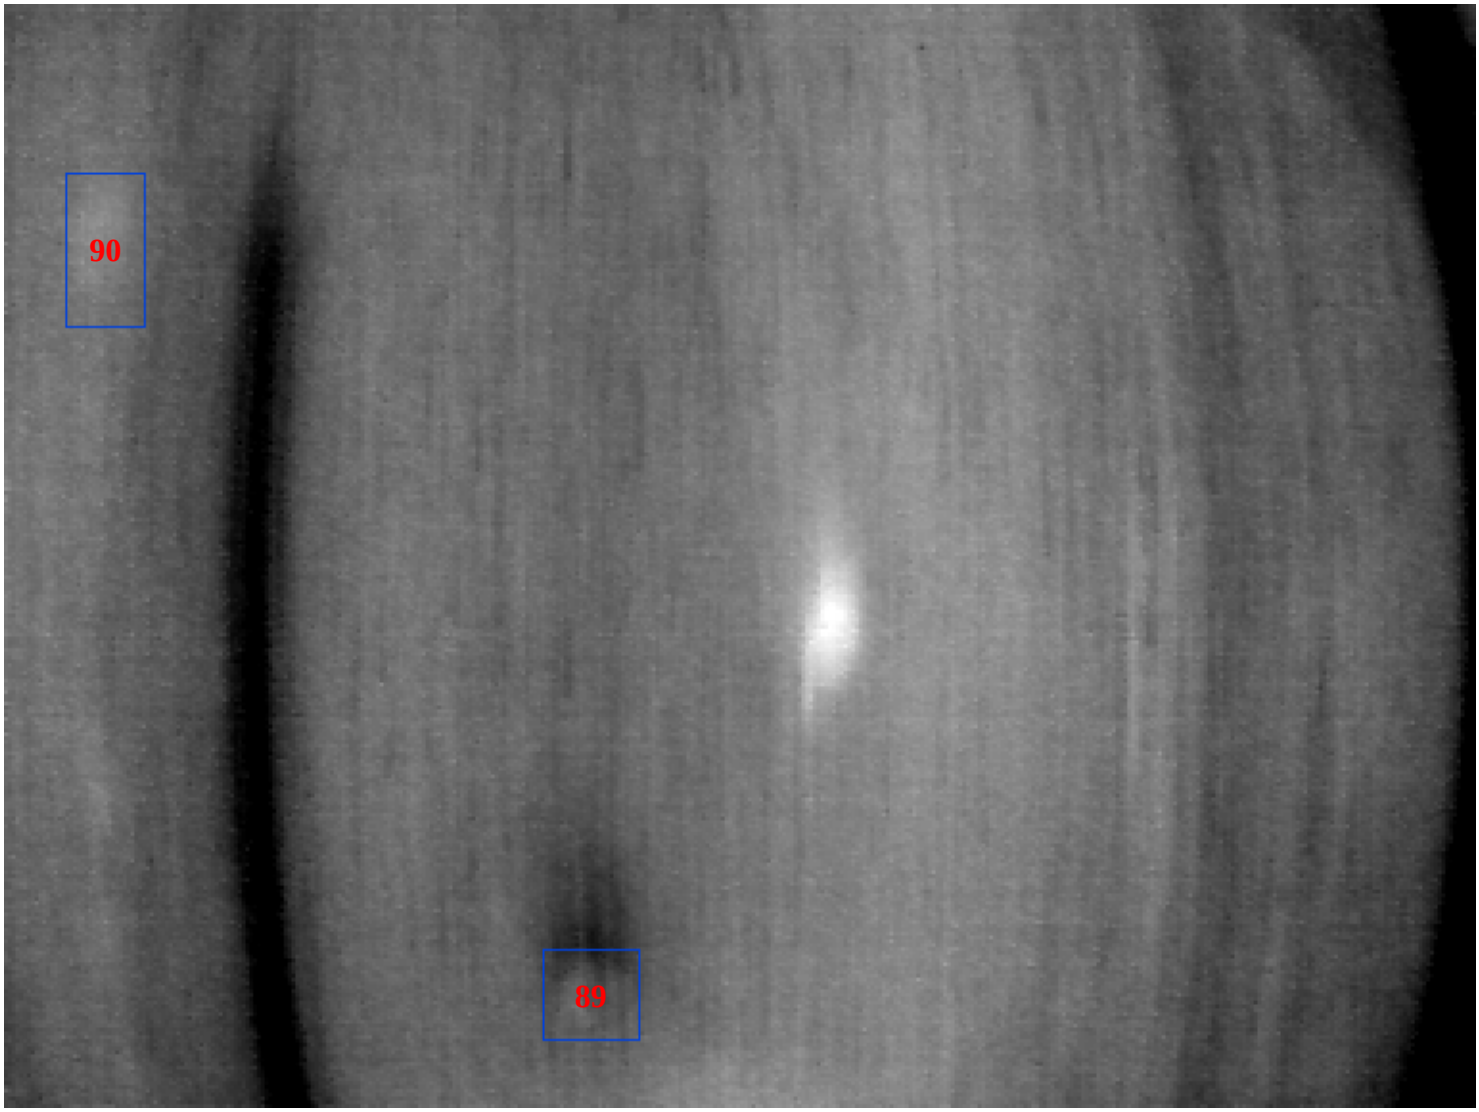
Bridge: 5002 SB Lane: 2 Image Name: 2_4495000_64366_2164.tif

Defect #	89	90
Feet from Start	110.75	117.71
Feet from Right	22.41	27.03
Defect Size	0.84 sq ft	1.16 sq ft
Length x Width (ft)	0.86 x 0.93	1.45 x 0.77
Type	Delam	Delam

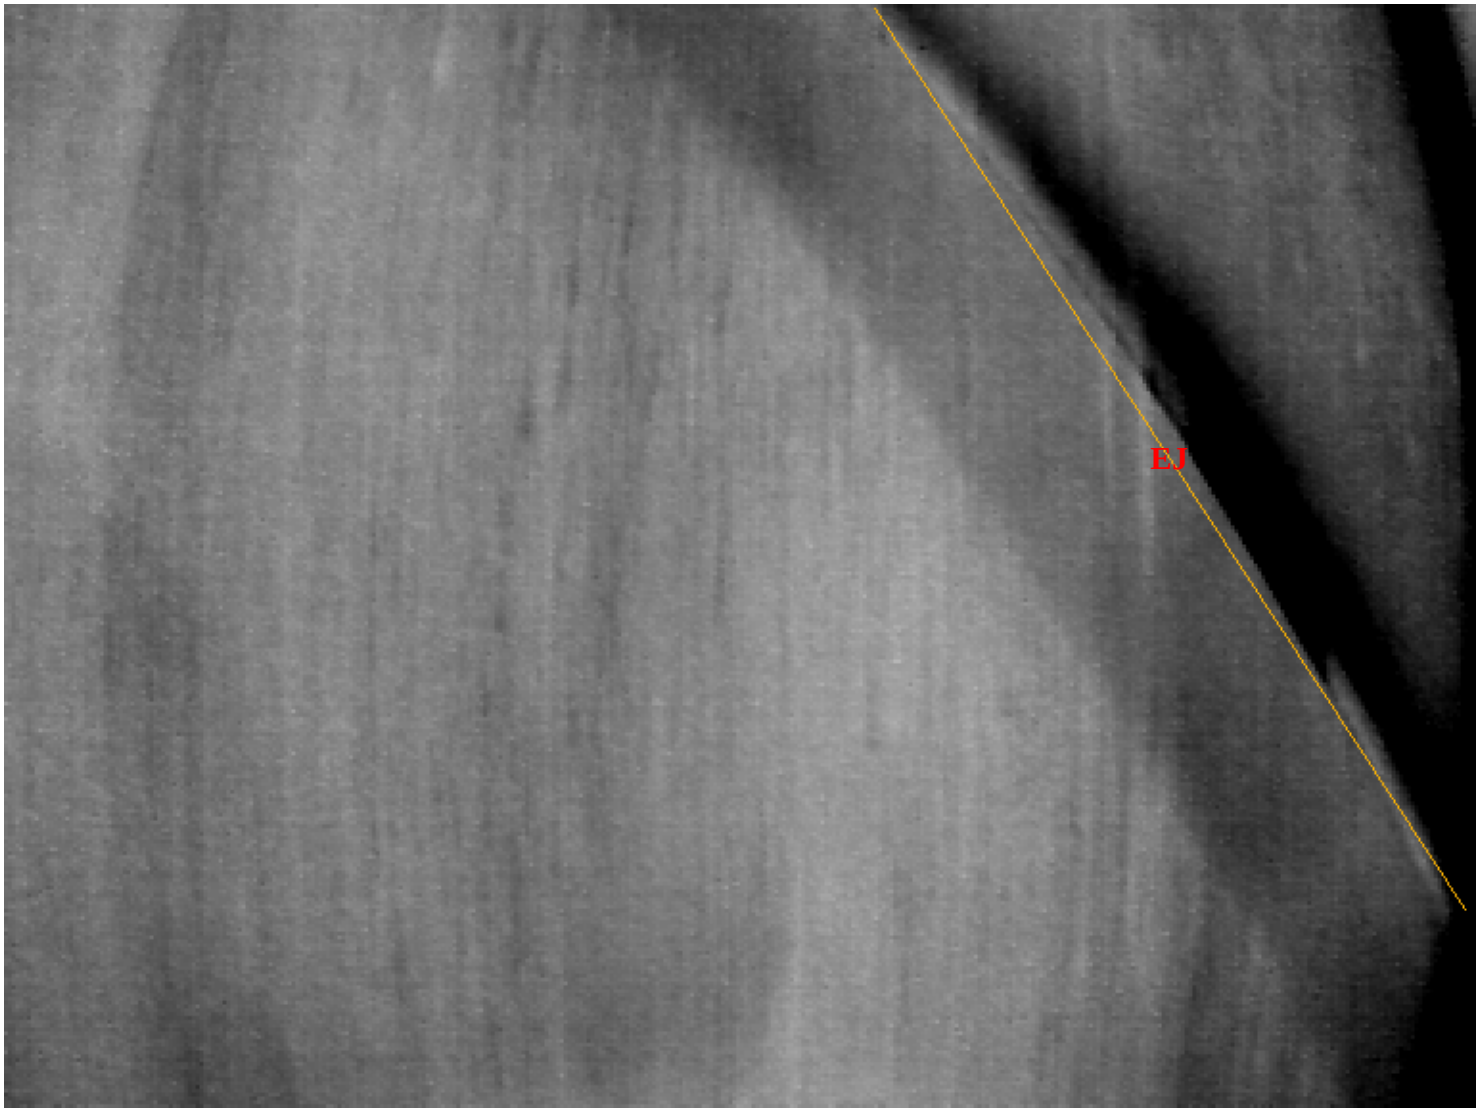
Bridge: 5002 SB Lane: 2 Image Name: 2_4684000_64366_2164.tif

Defect #	EJ
Feet from Start	125.90
Feet from Right	16.92
Defect Size	NA
Length x Width (ft)	NA
Type	Joint

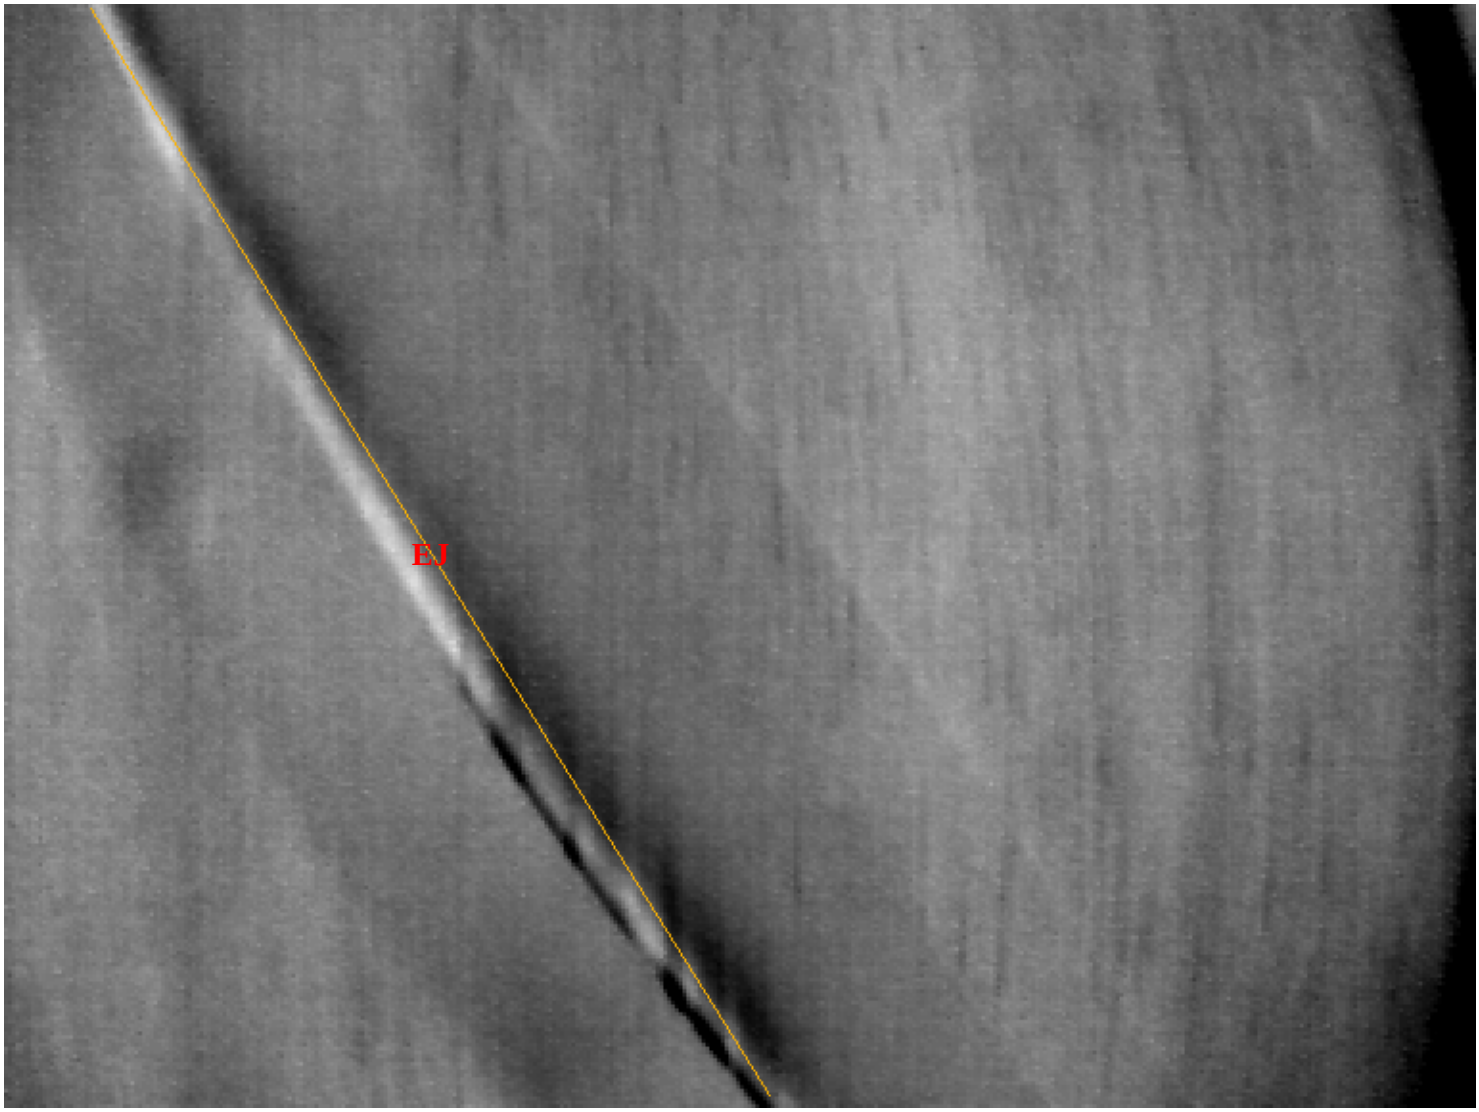
Bridge: 5002 SB Lane: 2 Image Name: 2_4876000_64366_2164.tif

Defect #	EJ
Feet from Start	135.33
Feet from Right	23.95
Defect Size	NA
Length x Width (ft)	NA
Type	Joint

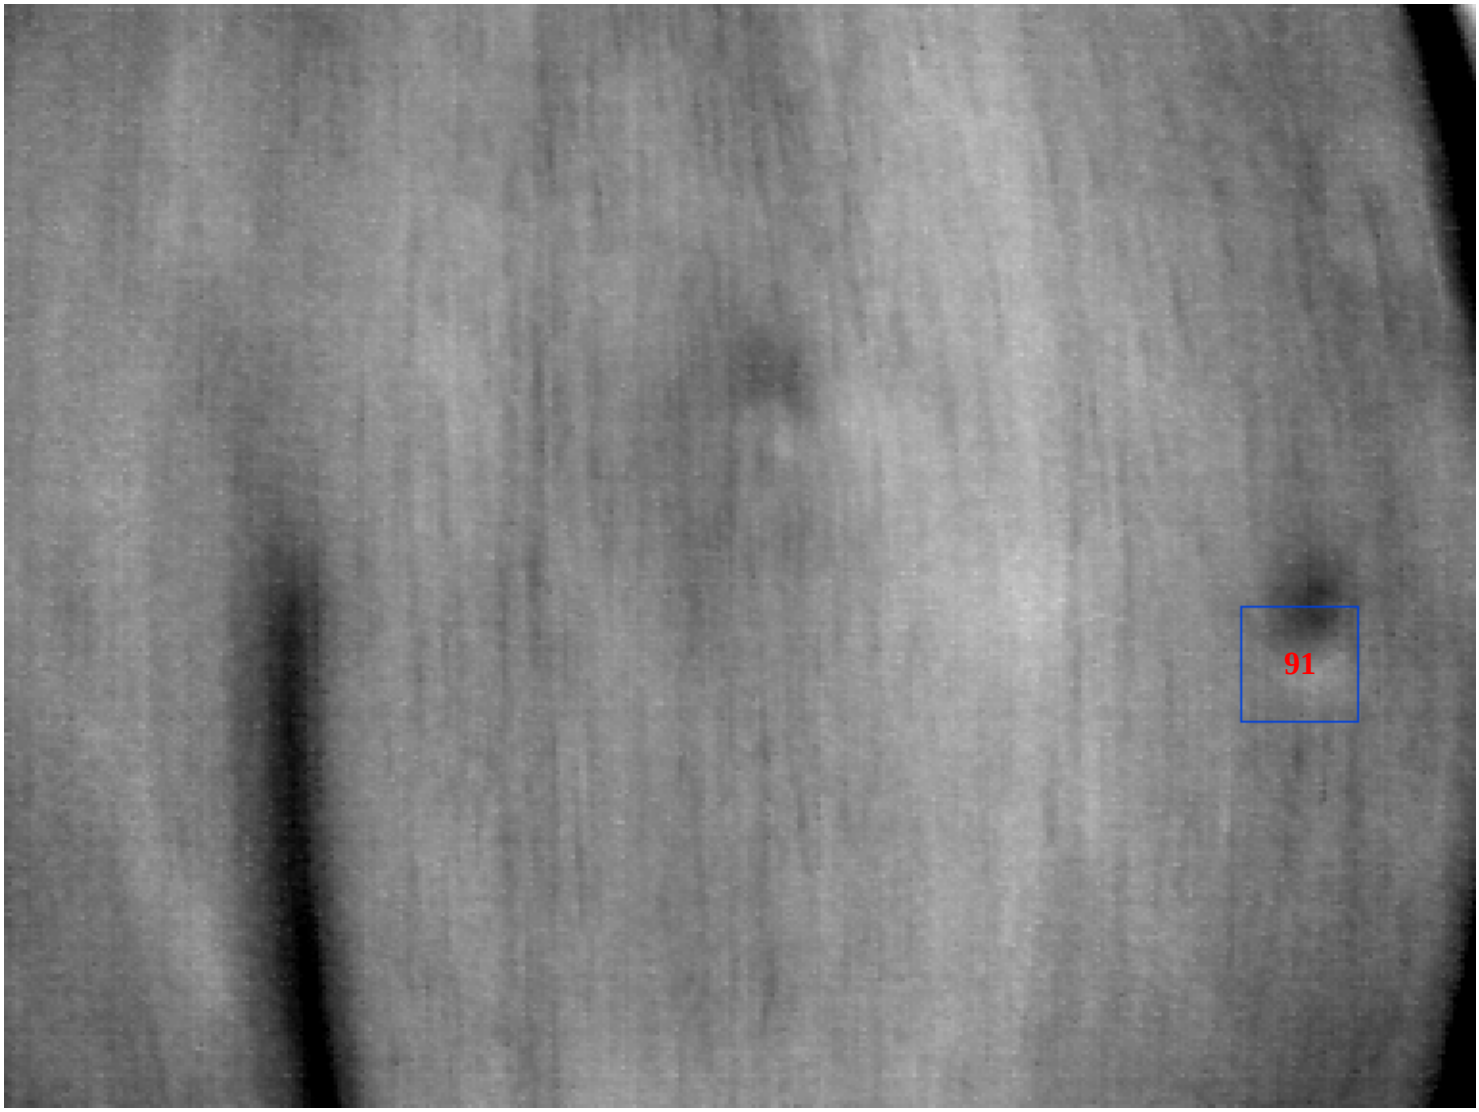
Bridge: 5002 SB Lane: 2 Image Name: 2_5458000_64225_2160.tif

Defect #	91
Feet from Start	165.42
Feet from Right	15.68
Defect Size	1.29 sq ft
Length x Width (ft)	1.09 x 1.13
Type	Delam

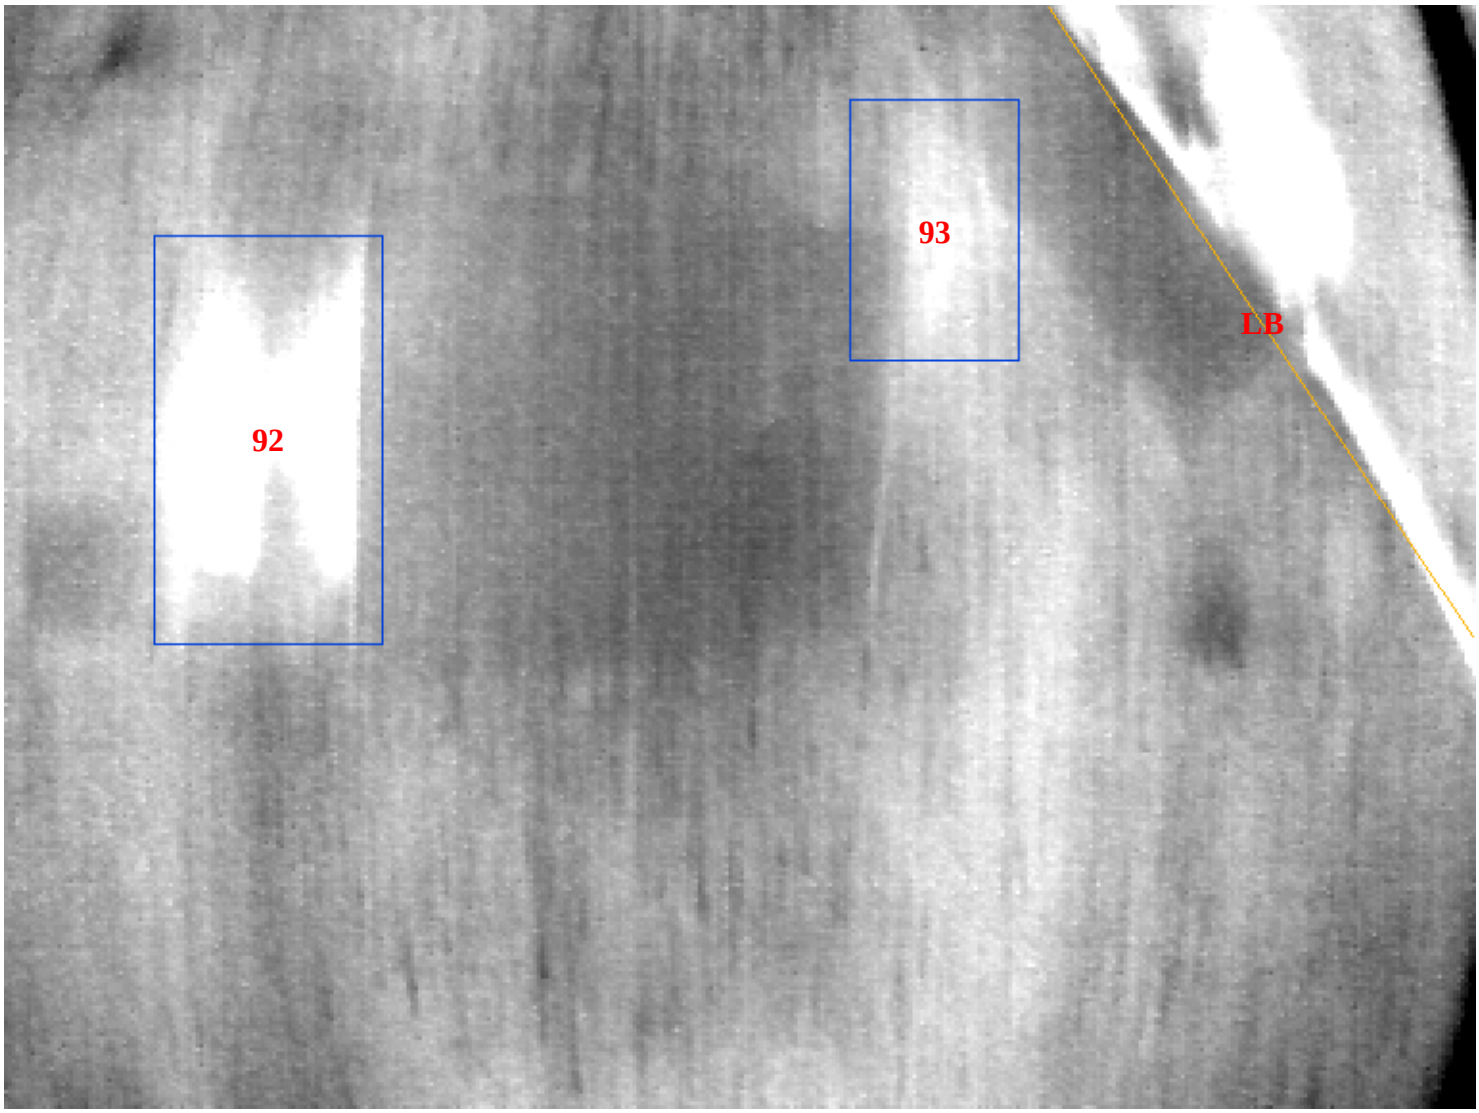
Bridge: 5002 SB Lane: 2 Image Name: 2_5653000_64225_2160.tif

Defect #	92	LB	93
Feet from Start	177.97	179.08	179.93
Feet from Right	25.48	16.05	19.15
Defect Size	8.77 sq ft	NA	4.17 sq ft
Length x Width (ft)	3.83 x 2.19	NA	2.45 x 1.62
Type	Delam	Lane Bound	Delam

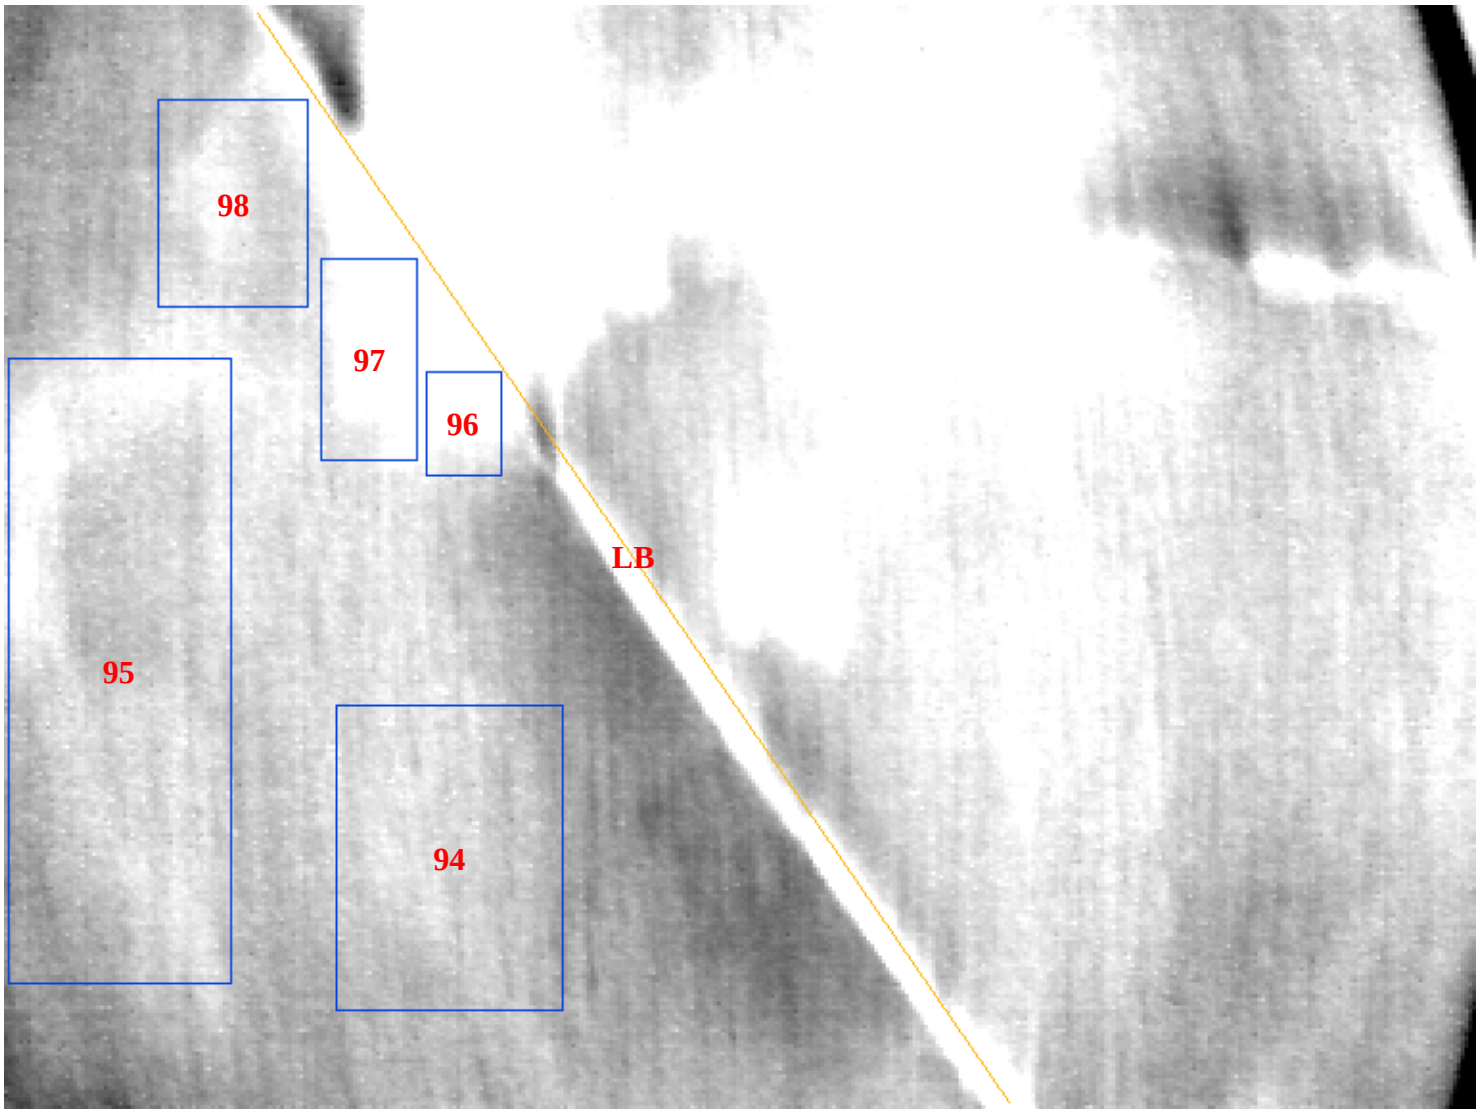
Bridge: 5002 SB Lane: 2 Image Name: 2_5849000_64225_2160.tif

Defect #	94	95	LB	96	97	98
Feet from Start	184.55	186.30	187.36	188.61	189.21	190.67
Feet from Right	23.76	26.90	22.02	23.63	24.53	25.82
Defect Size	6.50 sq ft	13.07 sq ft	NA	0.75 sq ft	1.85 sq ft	2.94 sq ft
Length x Width (ft)	2.87 x 2.17	5.86 x 2.13	NA	0.99 x 0.73	1.90 x 0.93	1.95 x 1.44
Type	Delam	Delam	Lane Bound	Delam	Delam	Delam

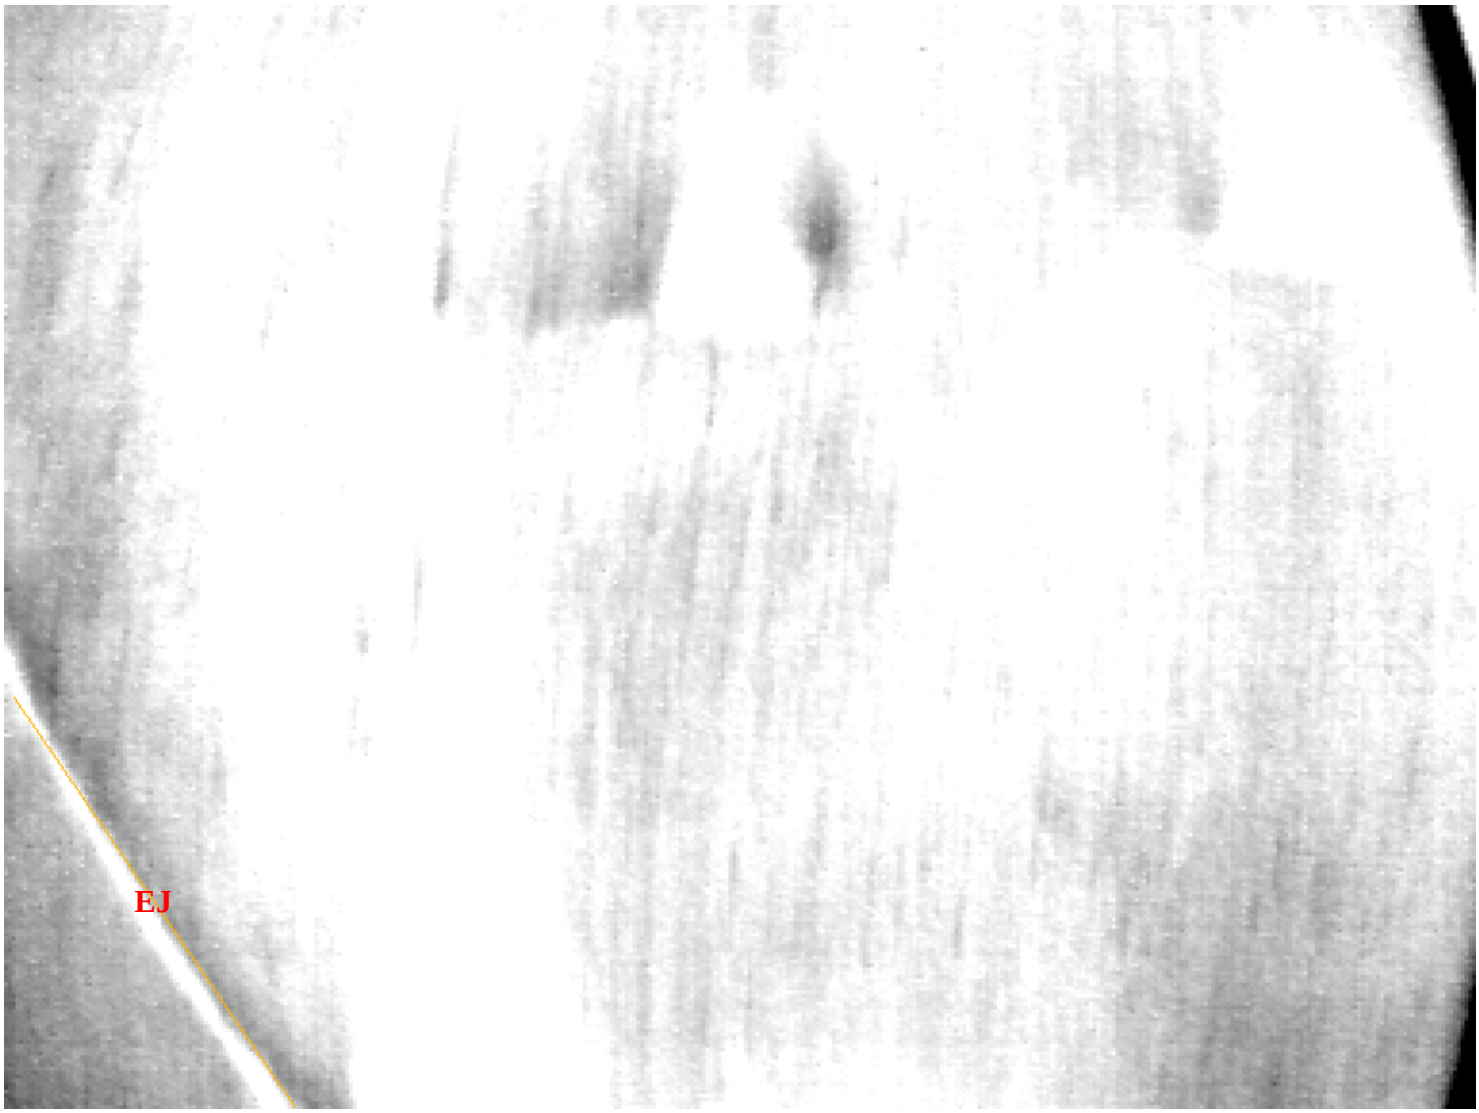
Bridge: 5002 SB Lane: 2 Image Name: 2_6047000_64144_2157.tif

Defect #	EJ
Feet from Start	194.73
Feet from Right	26.58
Defect Size	NA
Length x Width (ft)	NA
Type	Joint

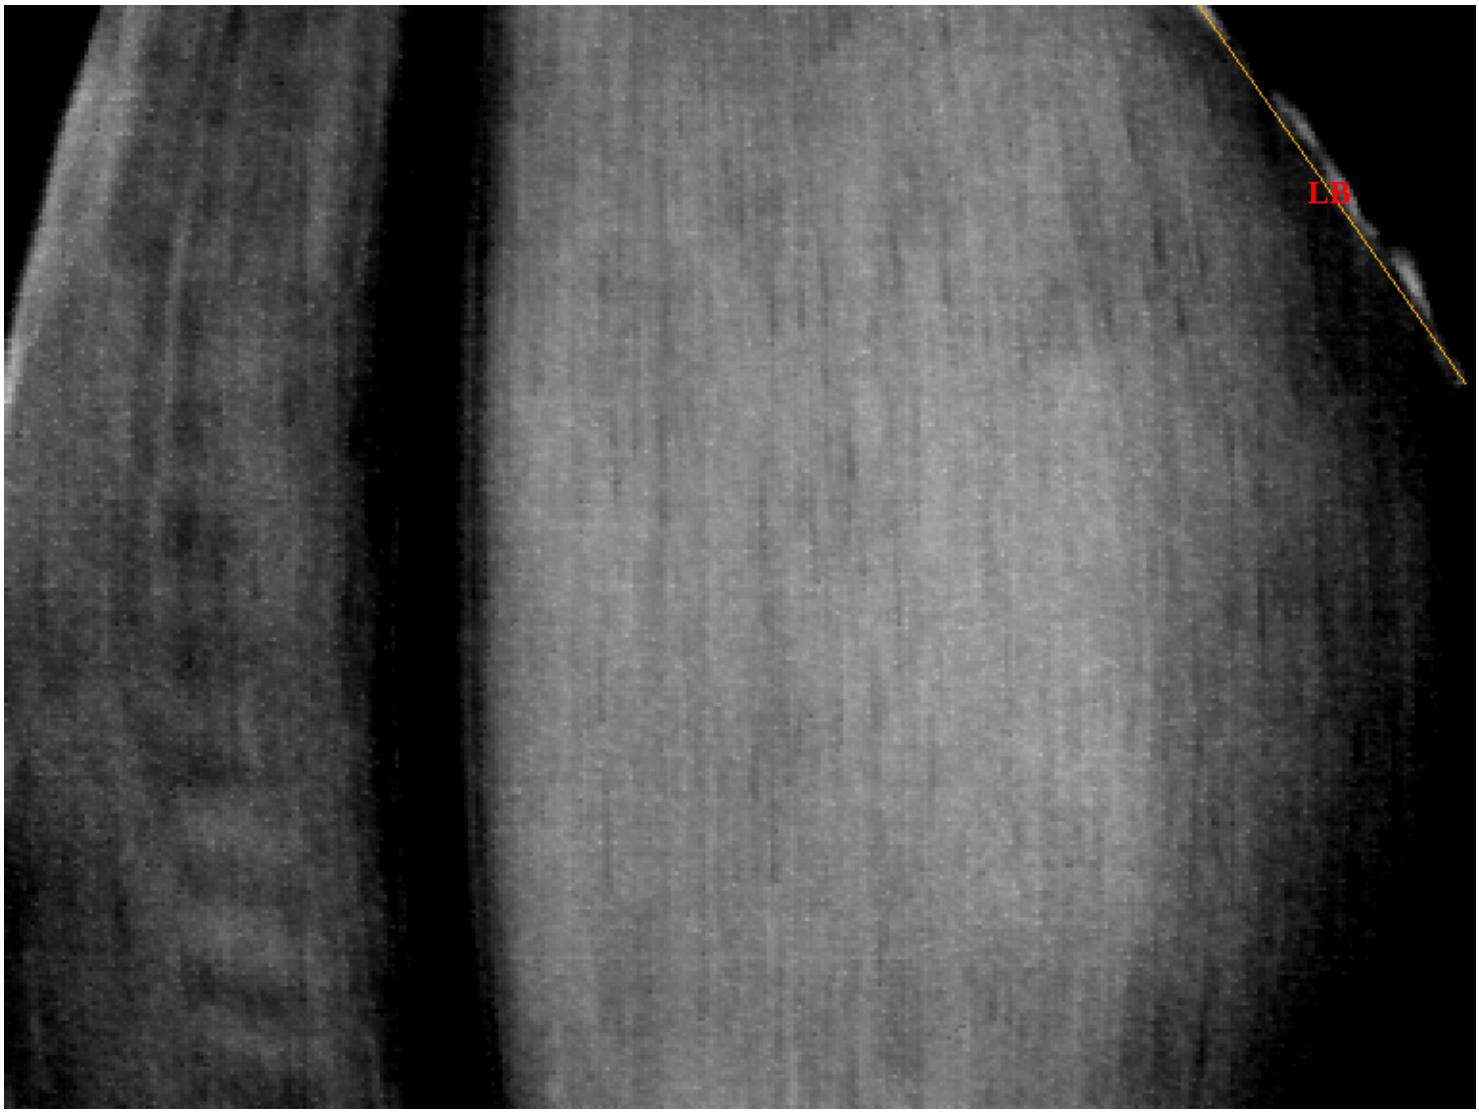
Bridge: 5002 SB Lane: 3 Image Name: 3_2301000_59910_2183.tif

Defect #	LB
Feet from Start	1.89
Feet from Right	29.38
Defect Size	NA
Length x Width (ft)	NA
Type	Lane Bound

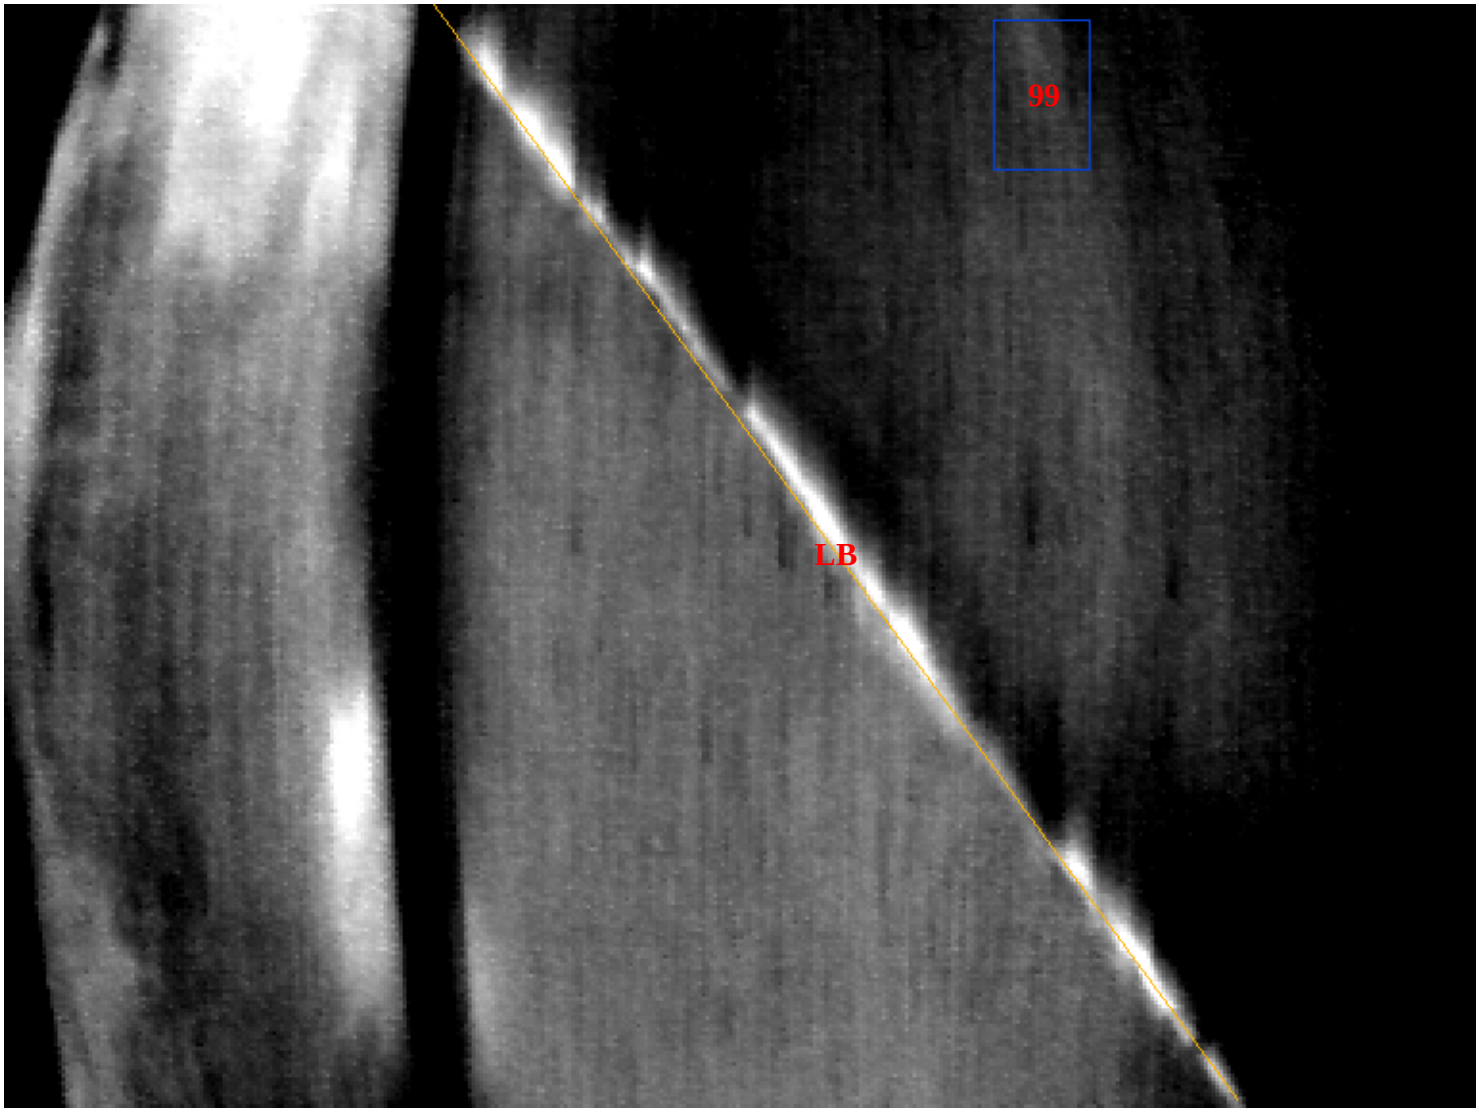
Bridge: 5002 SB Lane: 3 Image Name: 3_2516000_59910_2183.tif

Defect #	LB	99
Feet from Start	9.27	13.54
Feet from Right	34.10	32.13
Defect Size	NA	1.38 sq ft
Length x Width (ft)	NA	1.41 x 0.93
Type	Lane Bound	Delam

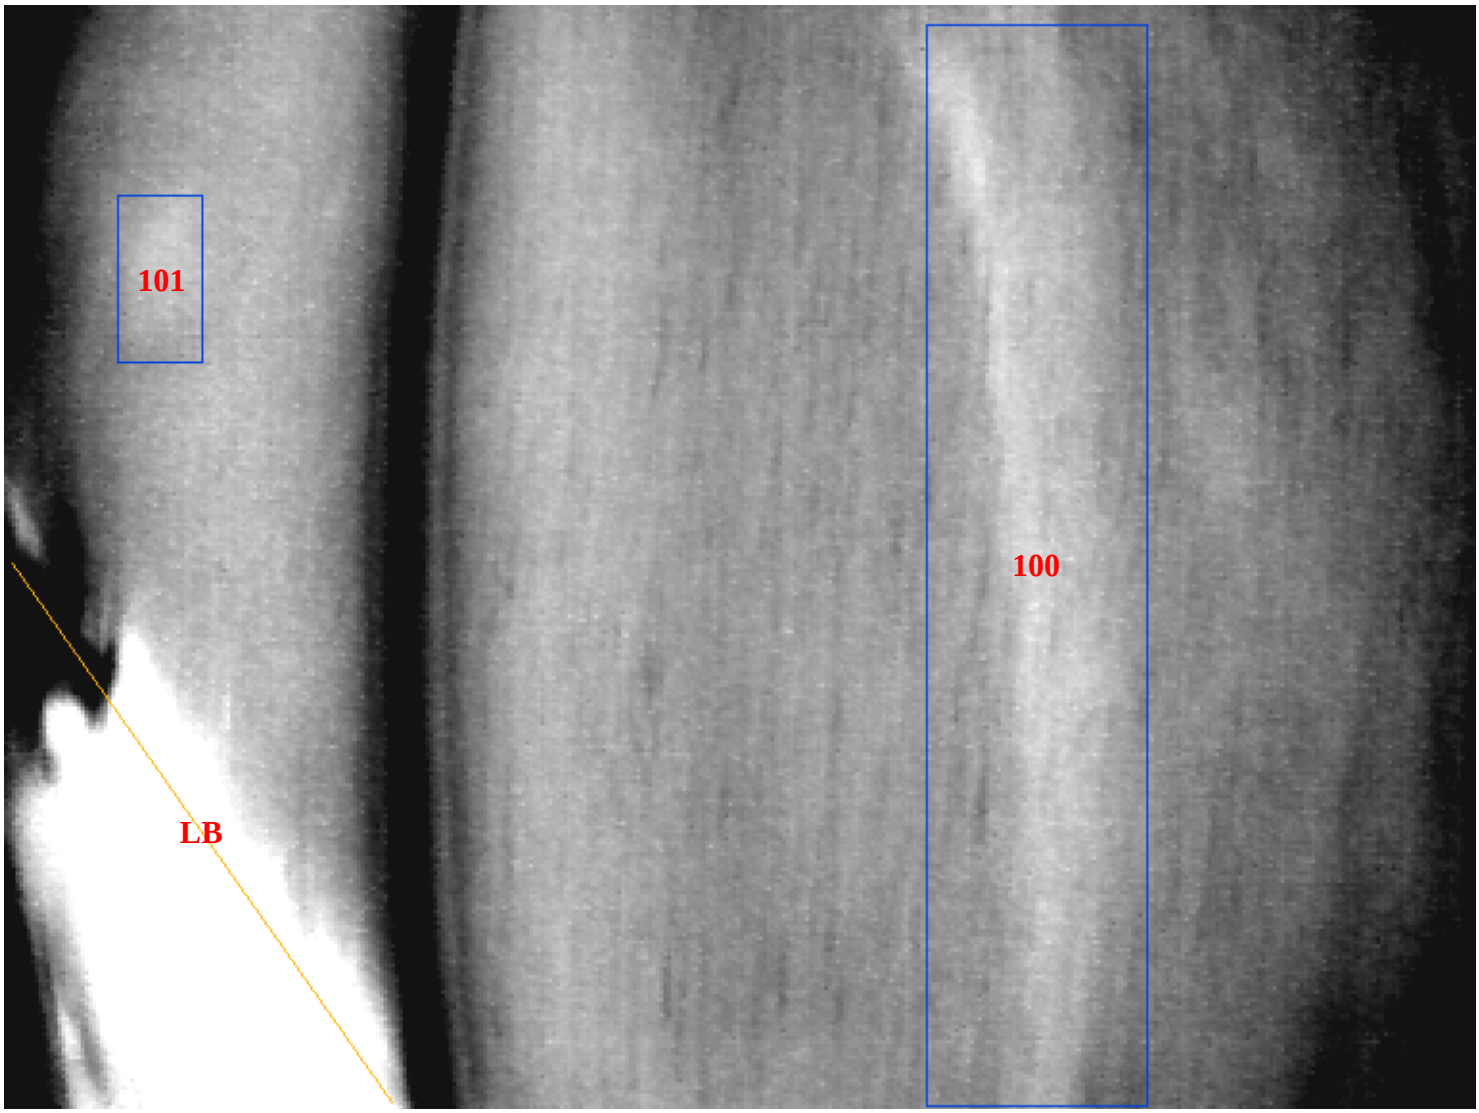
Bridge: 5002 SB Lane: 3 Image Name: 3_2720000_60316_2181.tif

Defect #	LB	100	101
Feet from Start	16.91	19.40	22.08
Feet from Right	40.12	32.17	40.51
Defect Size	NA	22.39 sq ft	1.35 sq ft
Length x Width (ft)	NA	10.12 x 2.11	1.58 x 0.82
Type	Lane Bound	Delam	Delam

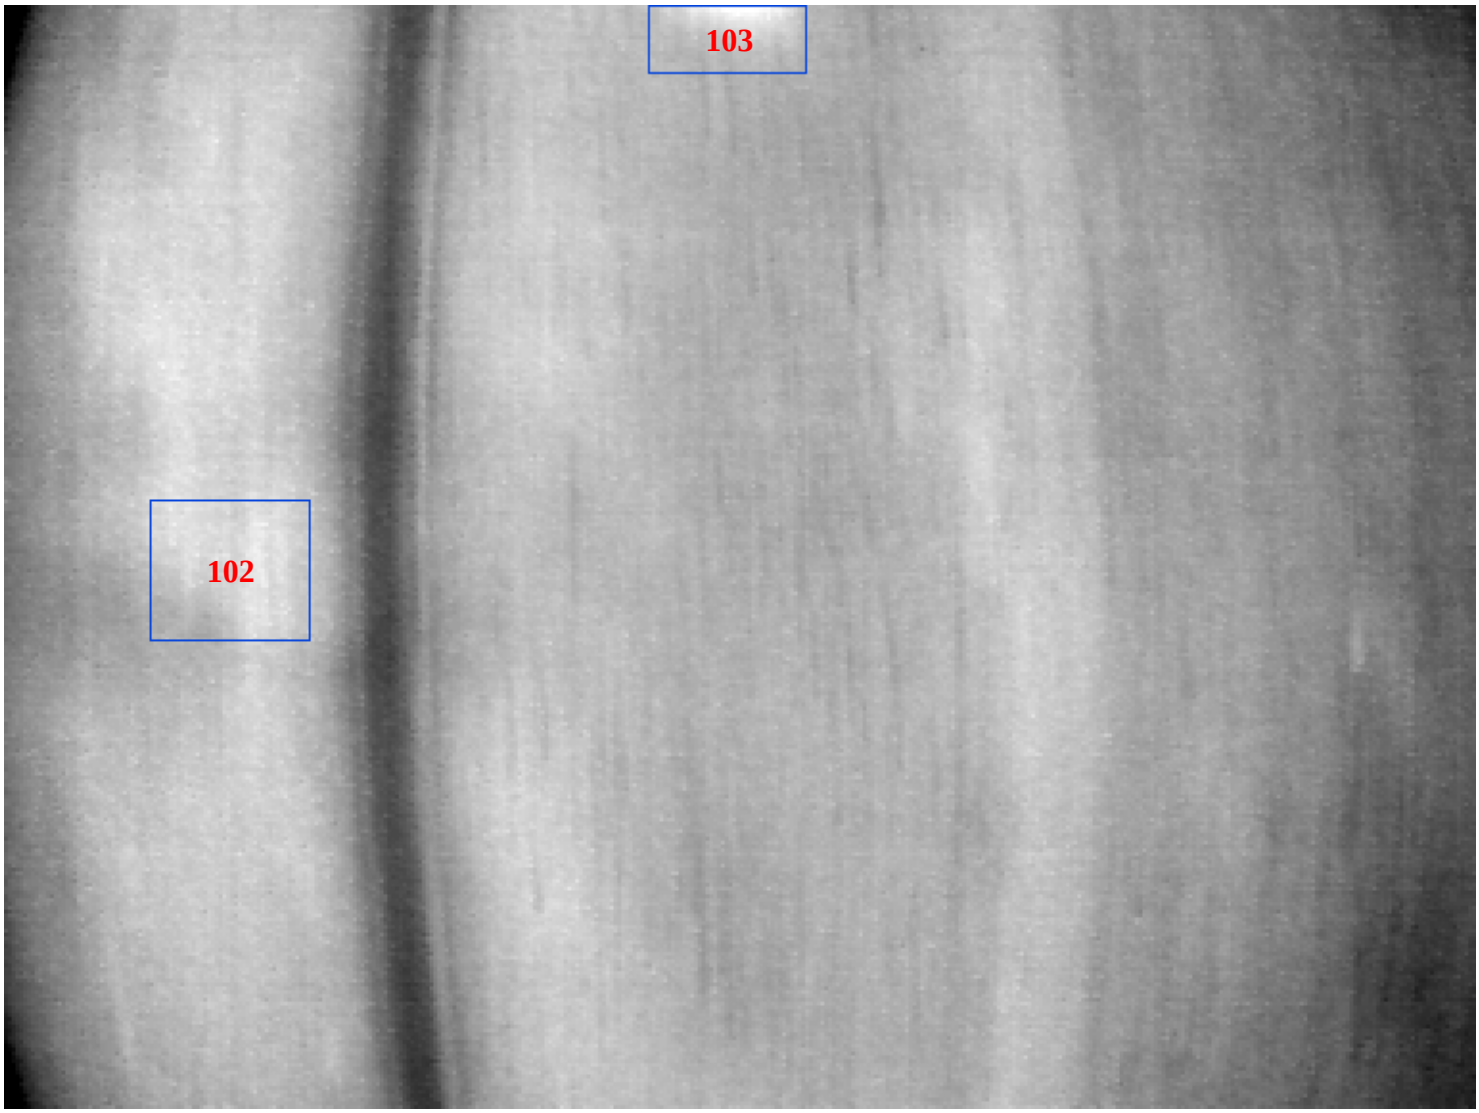
Bridge: 5002 SB Lane: 3 Image Name: 3_2922000_60316_2181.tif

Defect #	102	103
Feet from Start	29.51	34.47
Feet from Right	39.85	35.12
Defect Size	2.12 sq ft	1.02 sq ft
Length x Width (ft)	1.33 x 1.53	0.64 x 1.51
Type	Delam	Delam
