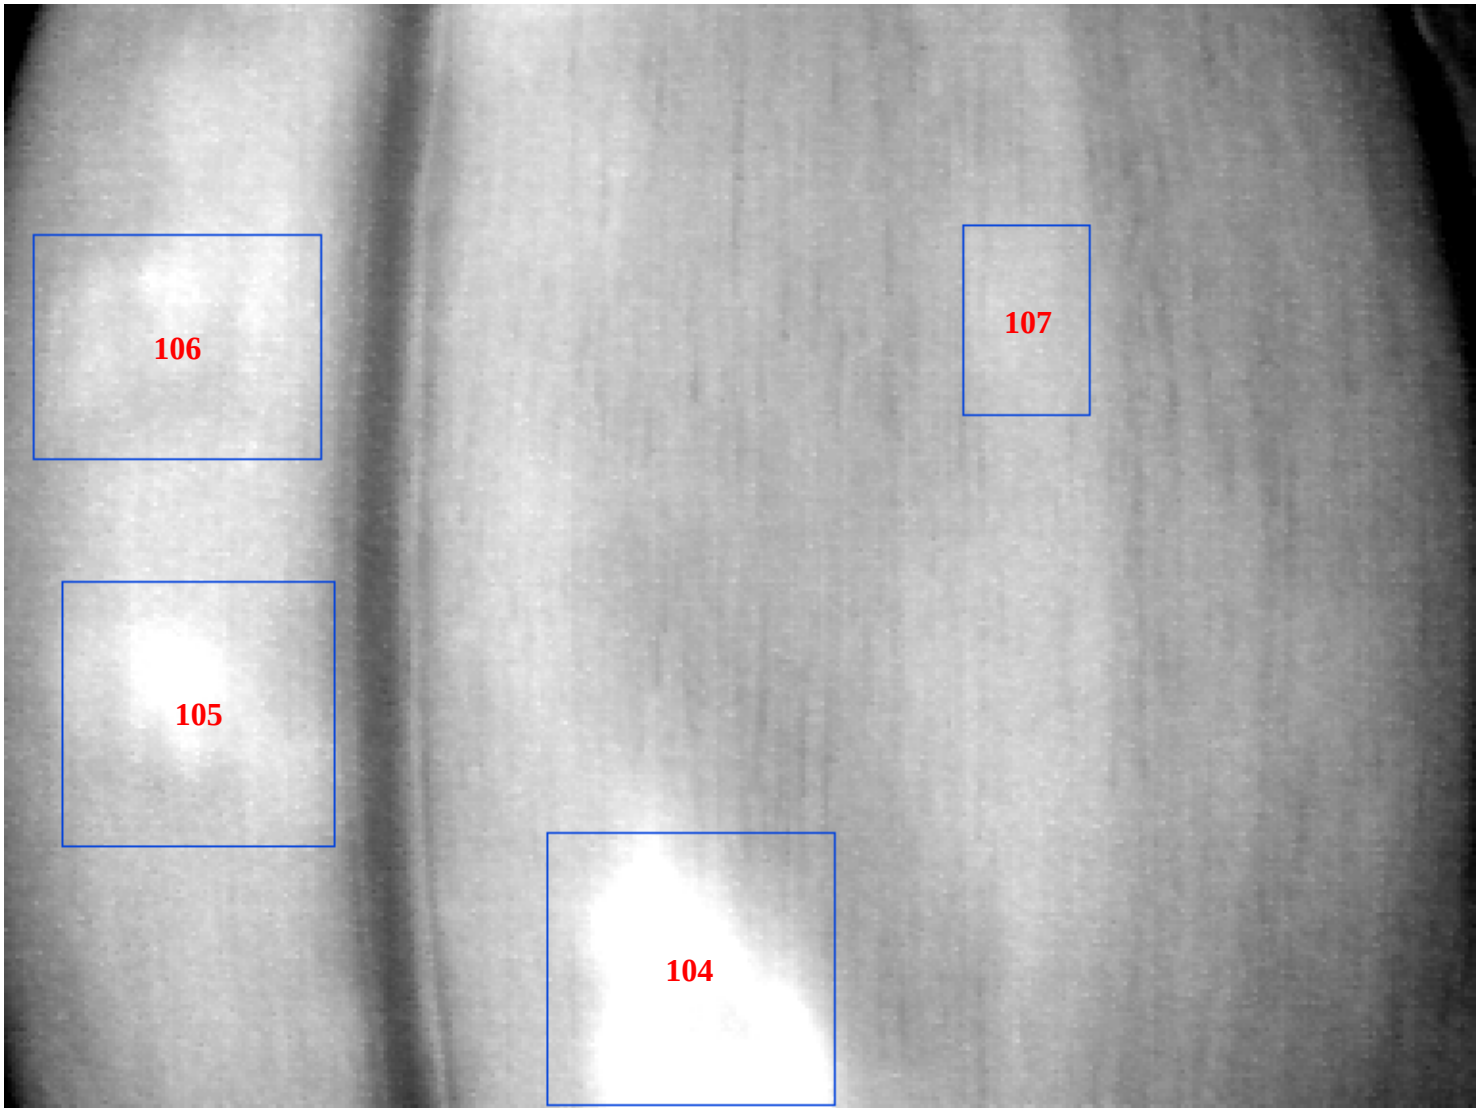
Bridge: 5002 SB Lane: 3 Image Name: 3_3134000_60316_2181.tif

| Defect # | 104 | 105 | 106 | 107 |
| Feet from Start | 36.43 | 38.81 | 42.24 | 42.50 |
| Feet from Right | 35.46 | 40.15 | 40.35 | 32.27 |
| Defect Size | 7.38 sq ft | 6.79 sq ft | 6.09 sq ft | 2.29 sq ft |
| Length x Width (ft) | 2.56 x 2.75 | 2.49 x 2.61 | 2.11 x 2.75 | 1.79 x 1.22 |
| Type | Delam | Delam | Delam | Delam |

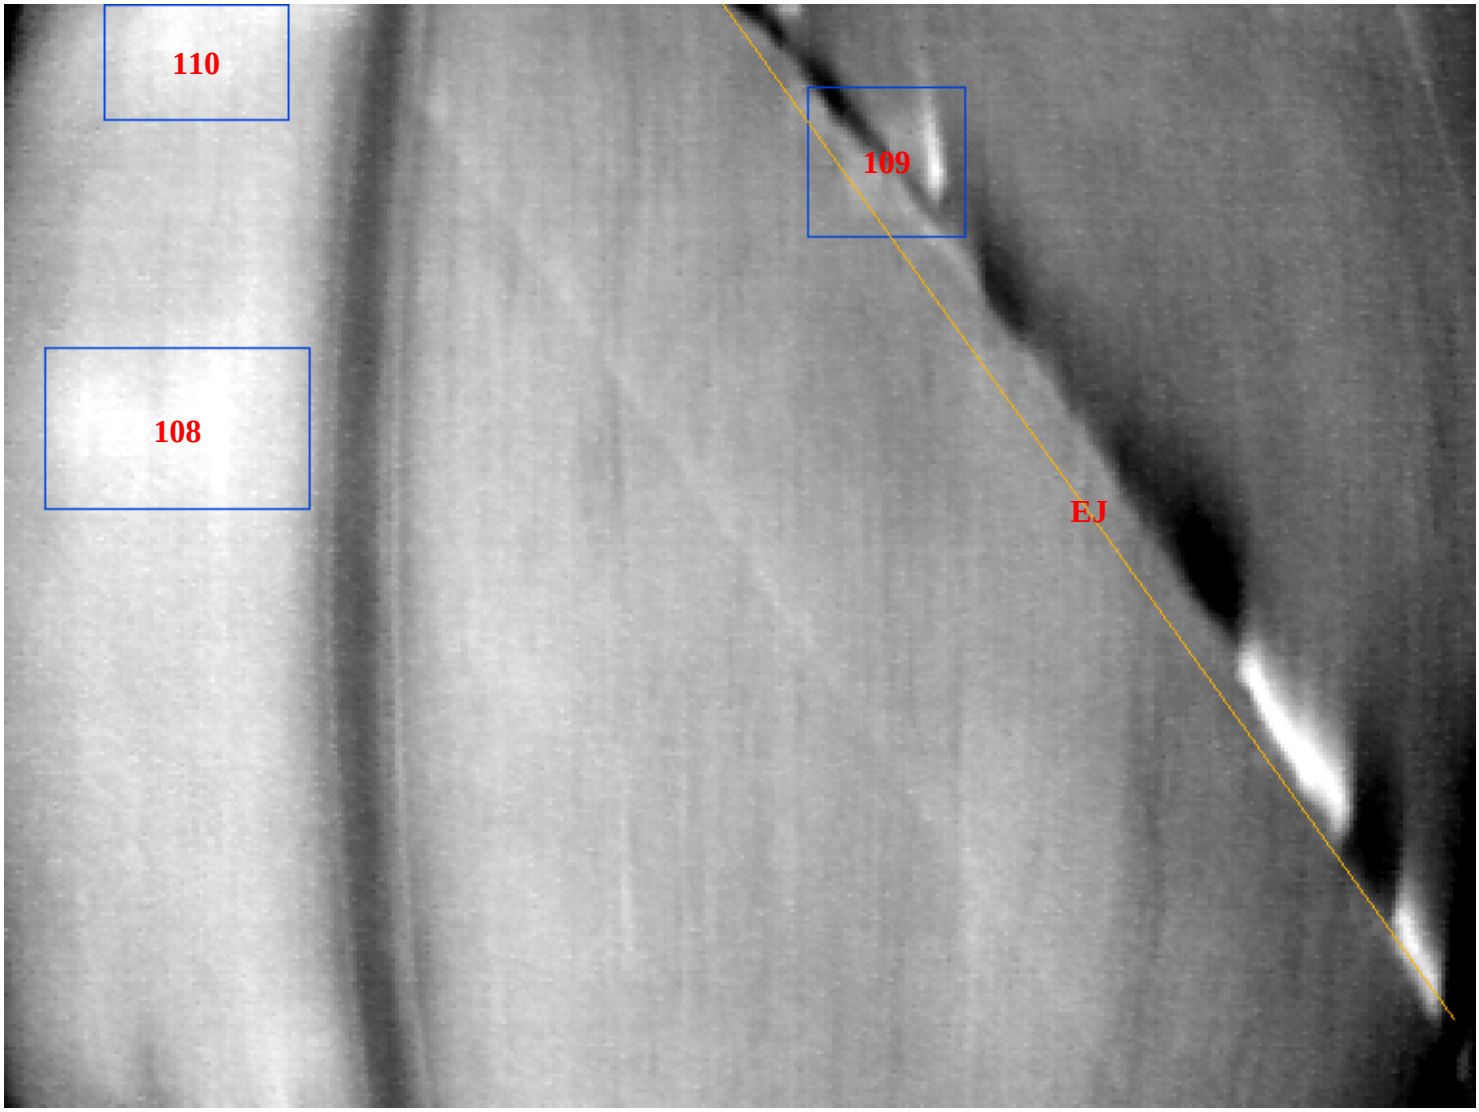
Bridge: 5002 SB Lane: 3 Image Name: 3_3339000_60316_2181.tif

| Defect # | EJ | 108 | 109 | 110 |
| Feet from Start | 51.02 | 51.79 | 54.28 | 55.21 |
| Feet from Right | 31.69 | 40.35 | 33.61 | 40.17 |
| Defect Size | NA | 4.04 sq ft | 2.24 sq ft | 2.02 sq ft |
| Length x Width (ft) | NA | 1.52 x 2.53 | 1.41 x 1.51 | 1.09 x 1.77 |
| Type | Joint | Delam | Delam | Delam |

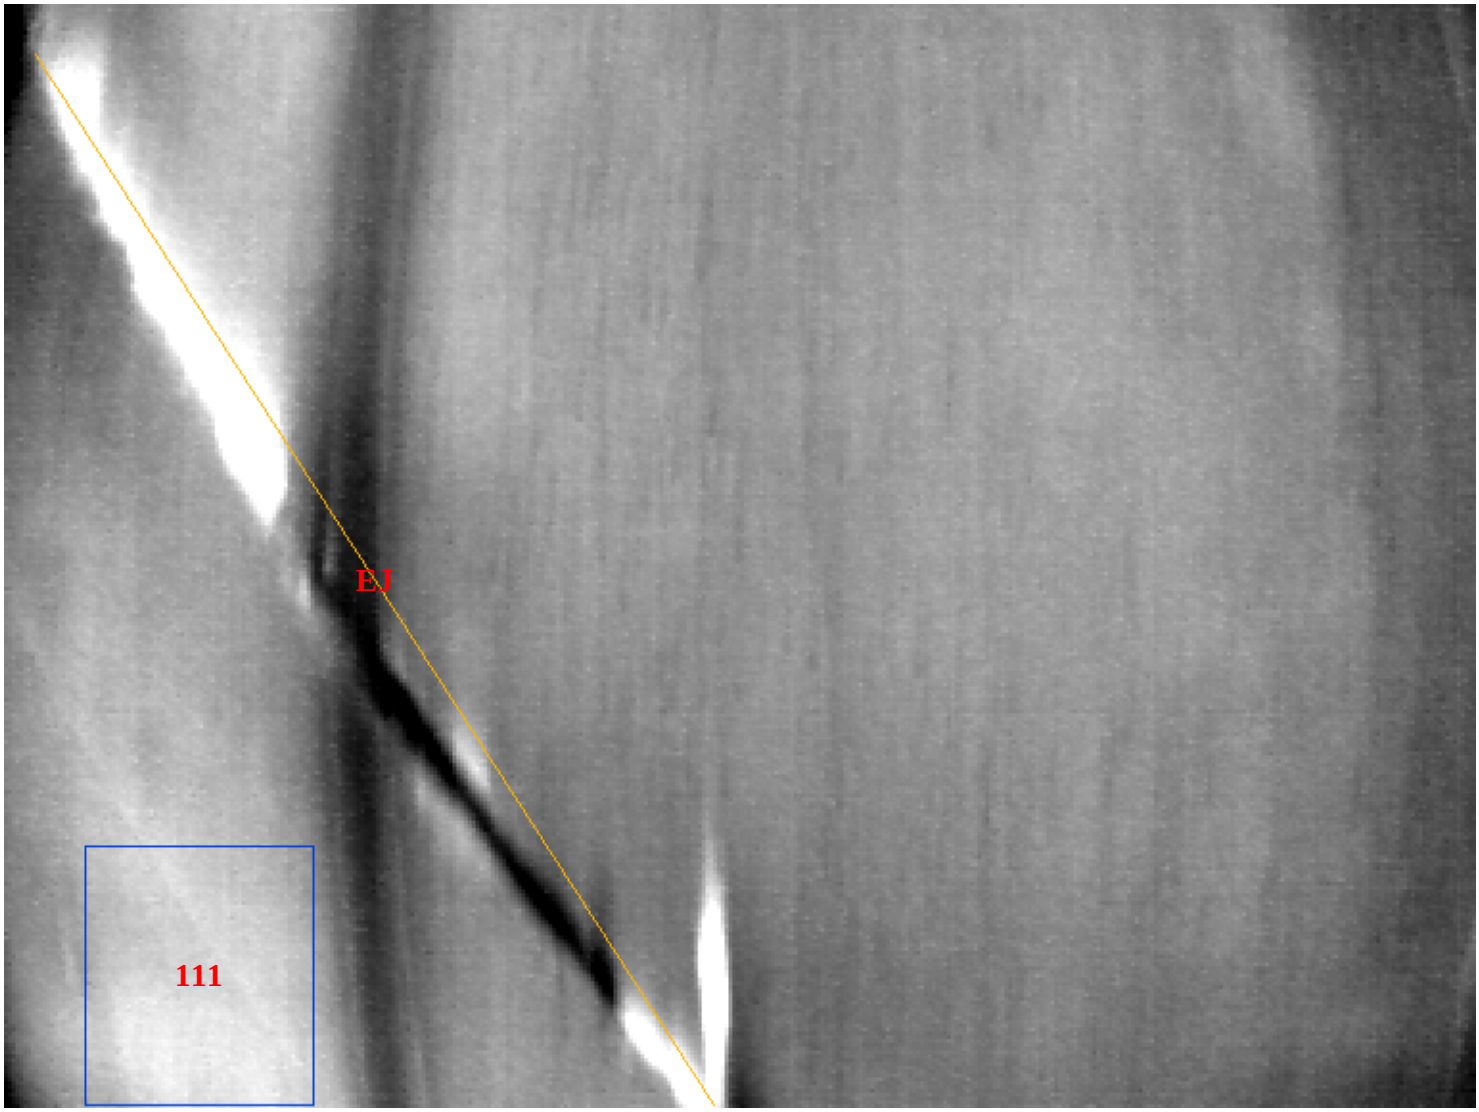
Bridge: 5002 SB Lane: 3 Image Name: 3_3549000_60316_2181.tif

| Defect # | 111 | EJ |
| Feet from Start | 57.23 | 60.94 |
| Feet from Right | 40.14 | 38.48 |
| Defect Size | 5.58 sq ft | NA |
| Length x Width (ft) | 2.44 x 2.19 | NA |
| Type | Delam | Joint |

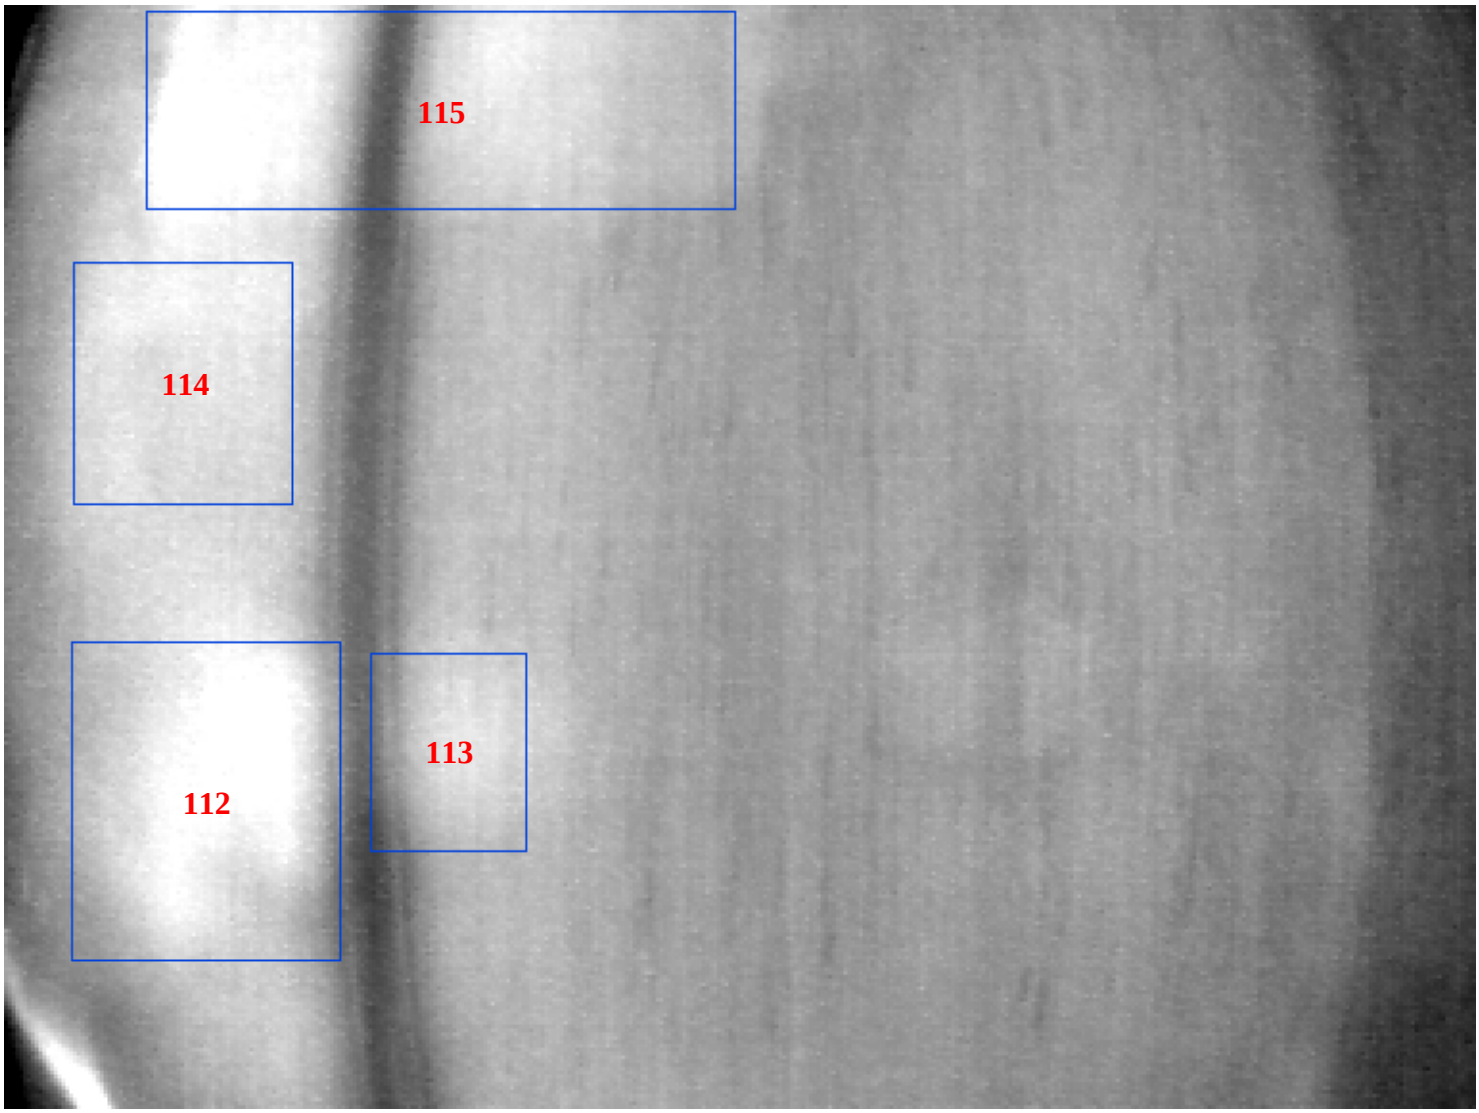
Bridge: 5002 SB Lane: 3 Image Name: 3_3754000_60660_2174.tif

| Defect # | 112 | 113 | 114 | 115 |
| Feet from Start | 69.23 | 69.69 | 73.14 | 75.69 |
| Feet from Right | 40.08 | 37.77 | 40.30 | 37.84 |
| Defect Size | 8.04 sq ft | 2.91 sq ft | 4.99 sq ft | 10.94 sq ft |
| Length x Width (ft) | 2.99 x 2.57 | 1.86 x 1.49 | 2.27 x 2.10 | 1.86 x 5.61 |
| Type | Delam | Delam | Delam | Delam |

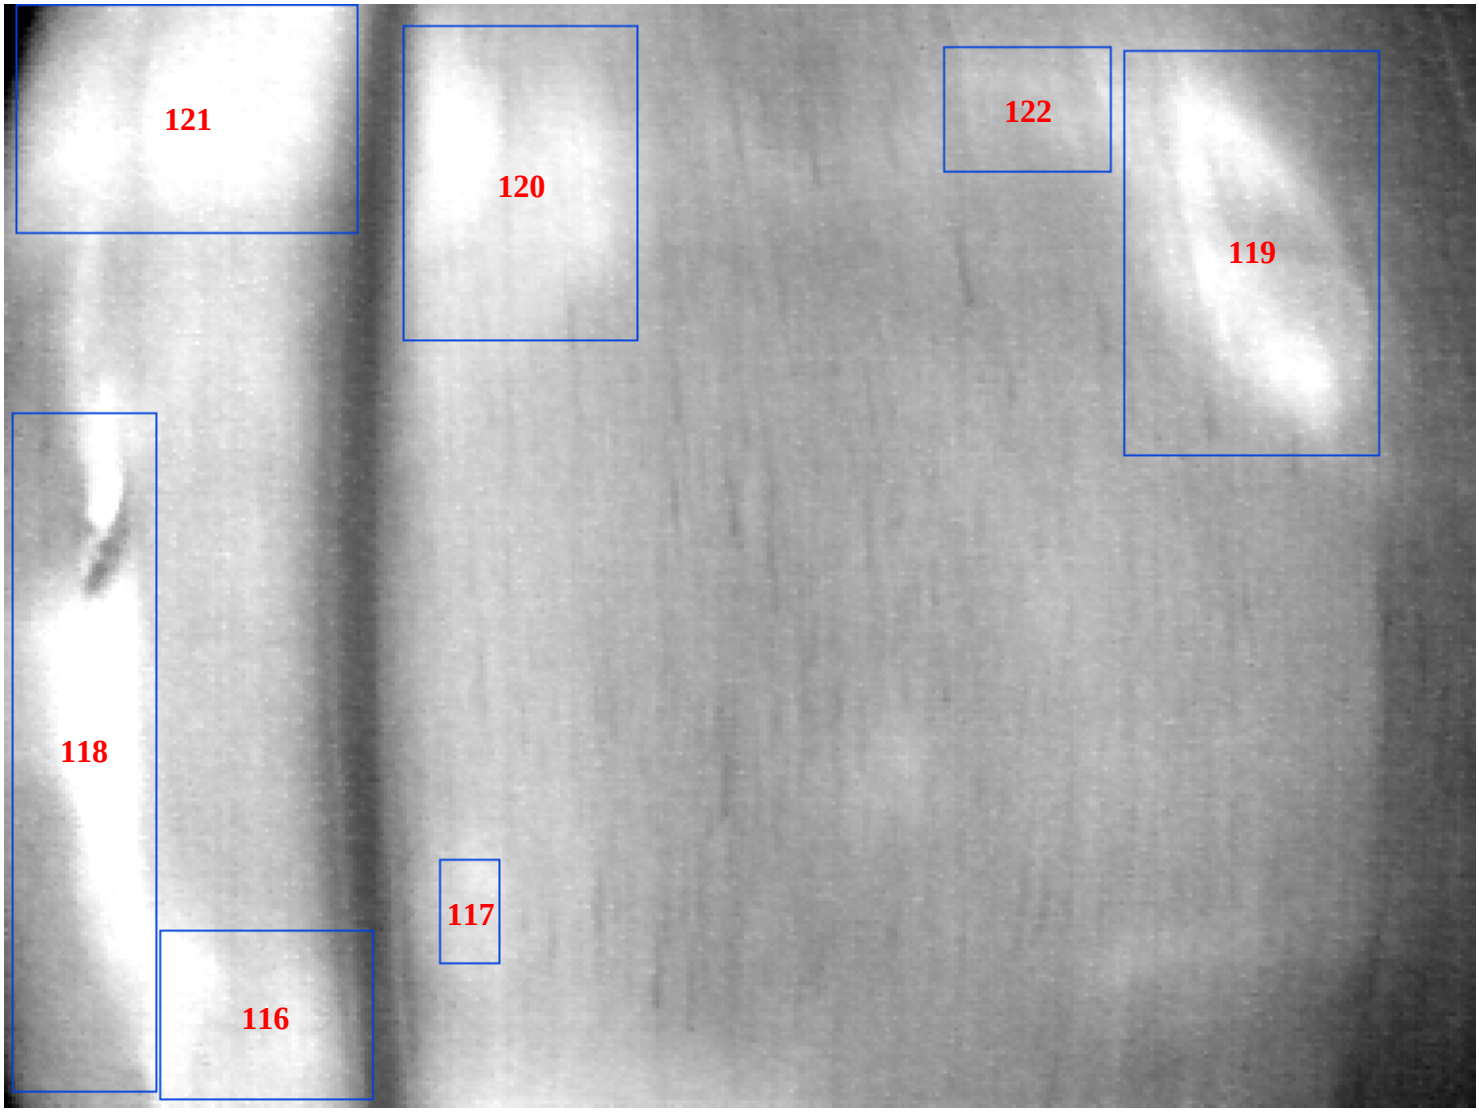
Bridge: 5002 SB Lane: 3 Image Name: 3_3958000_60660_2174.tif

| Defect # | 116 | 117 | 118 | 119 | 120 | 121 | 122 |
| Feet from Start | 77.54 | 78.50 | 79.99 | 84.66 | 85.31 | 85.91 | 86.00 |
| Feet from Right | 39.50 | 37.57 | 41.23 | 30.13 | 37.09 | 40.26 | 32.27 |
| Defect Size | 3.41 sq ft | 0.60 sq ft | 9.22 sq ft | 9.70 sq ft | 6.93 sq ft | 7.34 sq ft | 1.98 sq ft |
| Length x Width (ft) | 1.59 x 2.04 | 0.99 x 0.58 | 6.36 x 1.39 | 3.80 x 2.44 | 2.96 x 2.24 | 2.15 x 3.26 | 1.18 x 1.60 |
| Type | Delam | Delam | Delam | Delam | Delam | Delam | Delam |

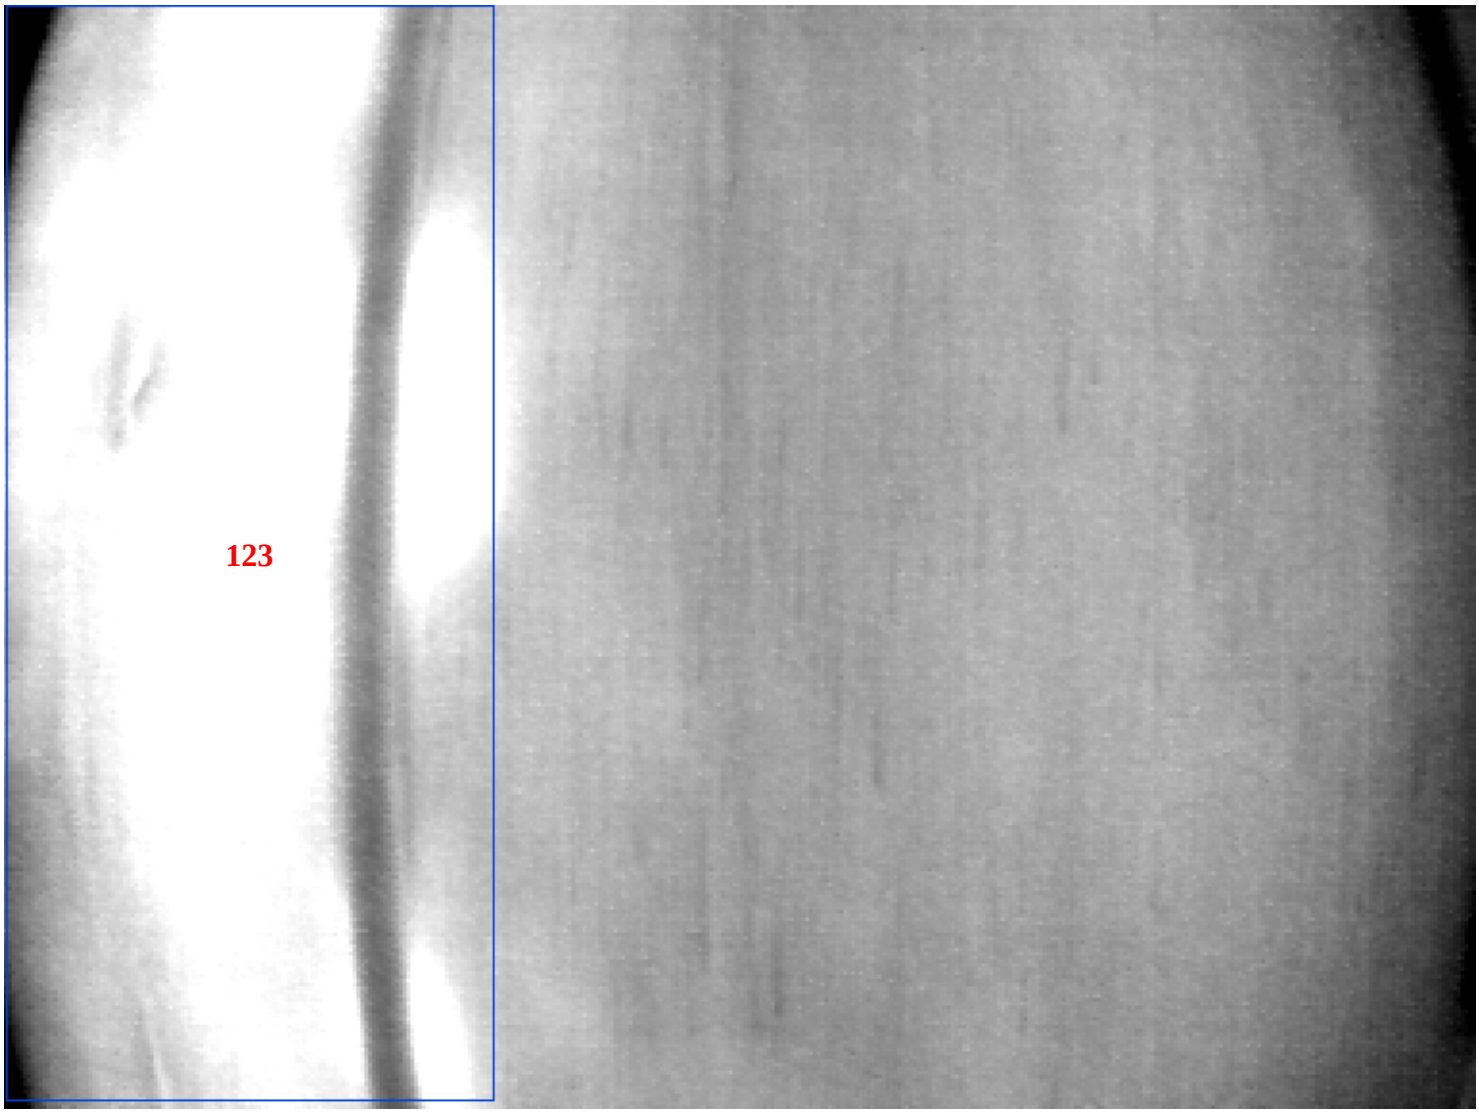
Bridge: 5002 SB Lane: 3 Image Name: 3_4159000_60660_2174.tif

| Defect # | 123 |
| Feet from Start | 92.02 |
| Feet from Right | 39.66 |
| Defect Size | 49.83 sq ft |
| Length x Width (ft) | 10.24 x 4.65 |
| Type | Delam |

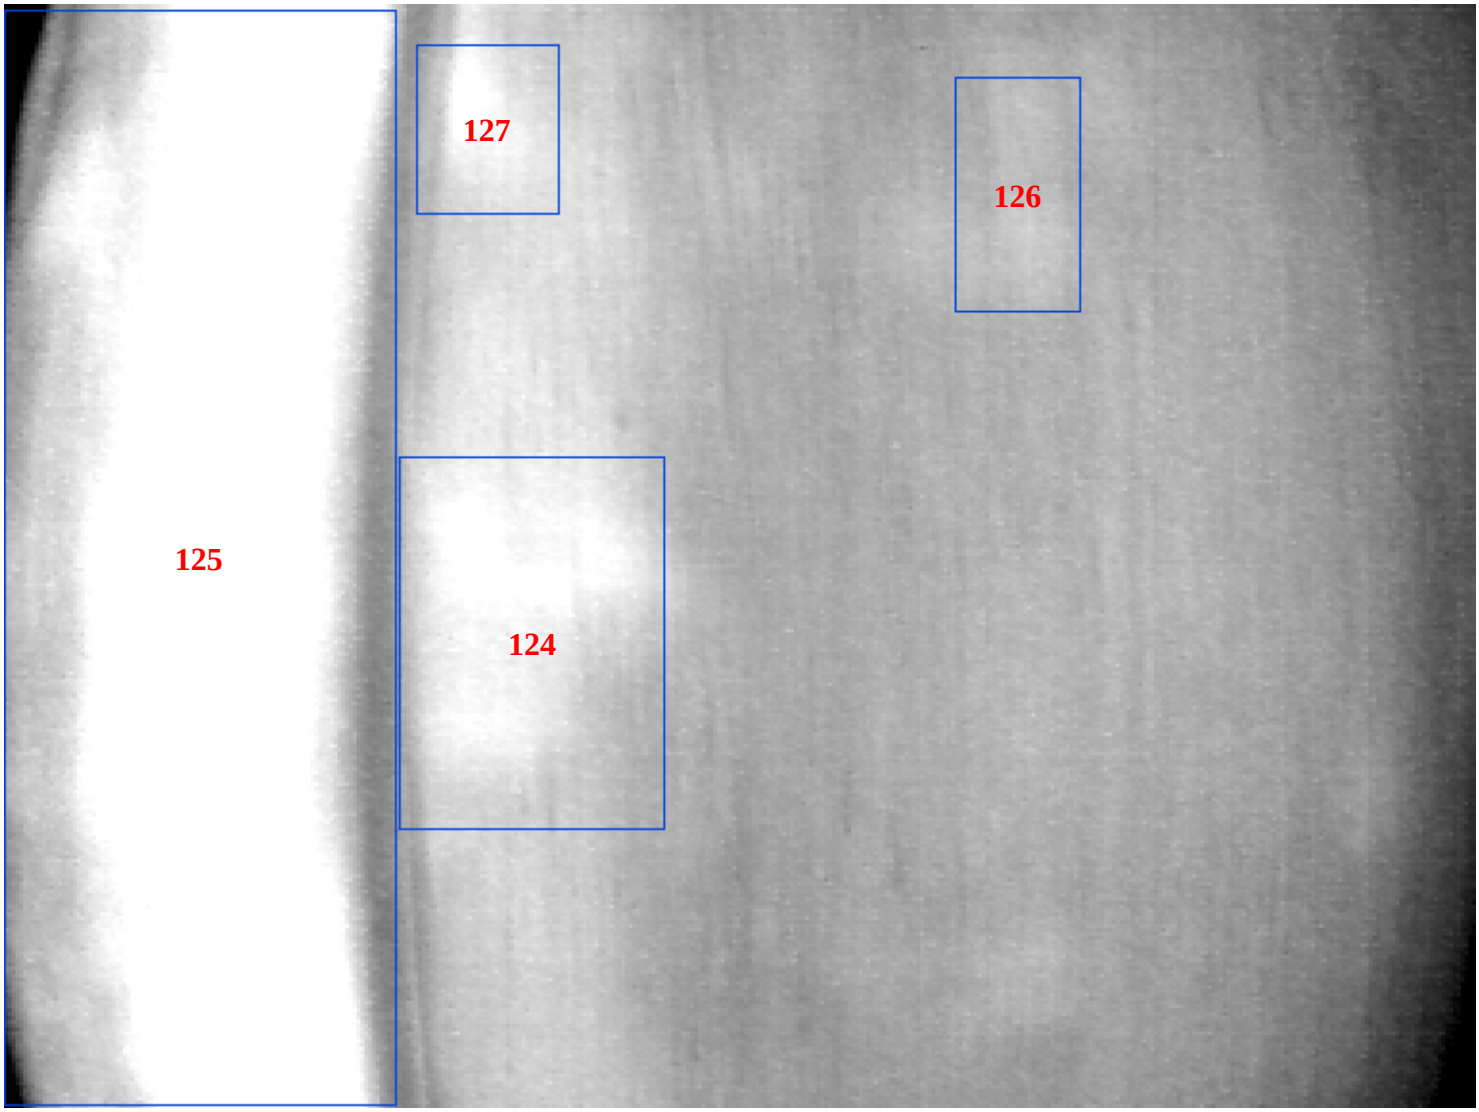
Bridge: 5002 SB Lane: 3 Image Name: 3_4366000_60660_2174.tif

| Defect # | 124 | 125 | 126 | 127 |
| Feet from Start | 101.64 | 102.43 | 105.83 | 106.44 |
| Feet from Right | 36.98 | 40.13 | 32.36 | 37.40 |
| Defect Size | 9.26 sq ft | 40.06 sq ft | 2.77 sq ft | 2.28 sq ft |
| Length x Width (ft) | 3.49 x 2.53 | 10.24 x 3.74 | 2.20 x 1.20 | 1.59 x 1.37 |
| Type | Delam | Delam | Delam | Delam |

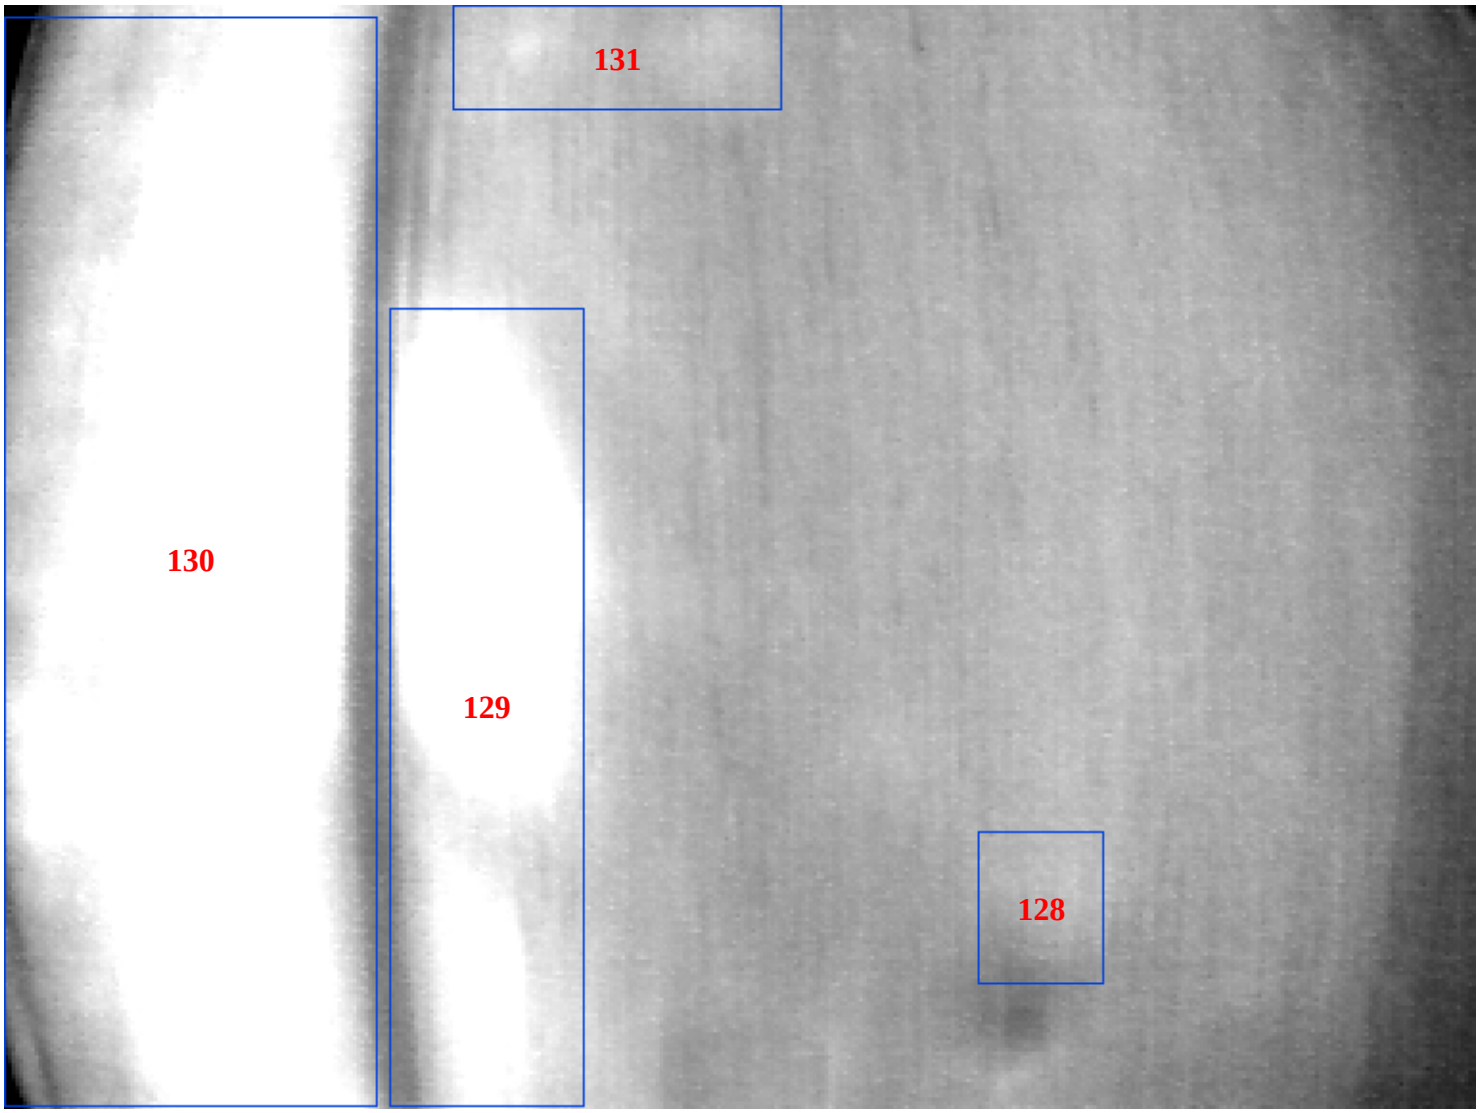
Bridge: 5002 SB Lane: 3 Image Name: 3_4572000_60660_2174.tif

| Defect # | 128 | 129 | 130 | 131 |
| Feet from Start | 109.59 | 111.46 | 112.82 | 117.53 |
| Feet from Right | 32.14 | 37.41 | 40.22 | 36.17 |
| Defect Size | 1.80 sq ft | 14.53 sq ft | 37.90 sq ft | 3.23 sq ft |
| Length x Width (ft) | 1.43 x 1.20 | 7.47 x 1.86 | 10.19 x 3.55 | 0.99 x 3.14 |
| Type | Delam | Delam | Delam | Delam |

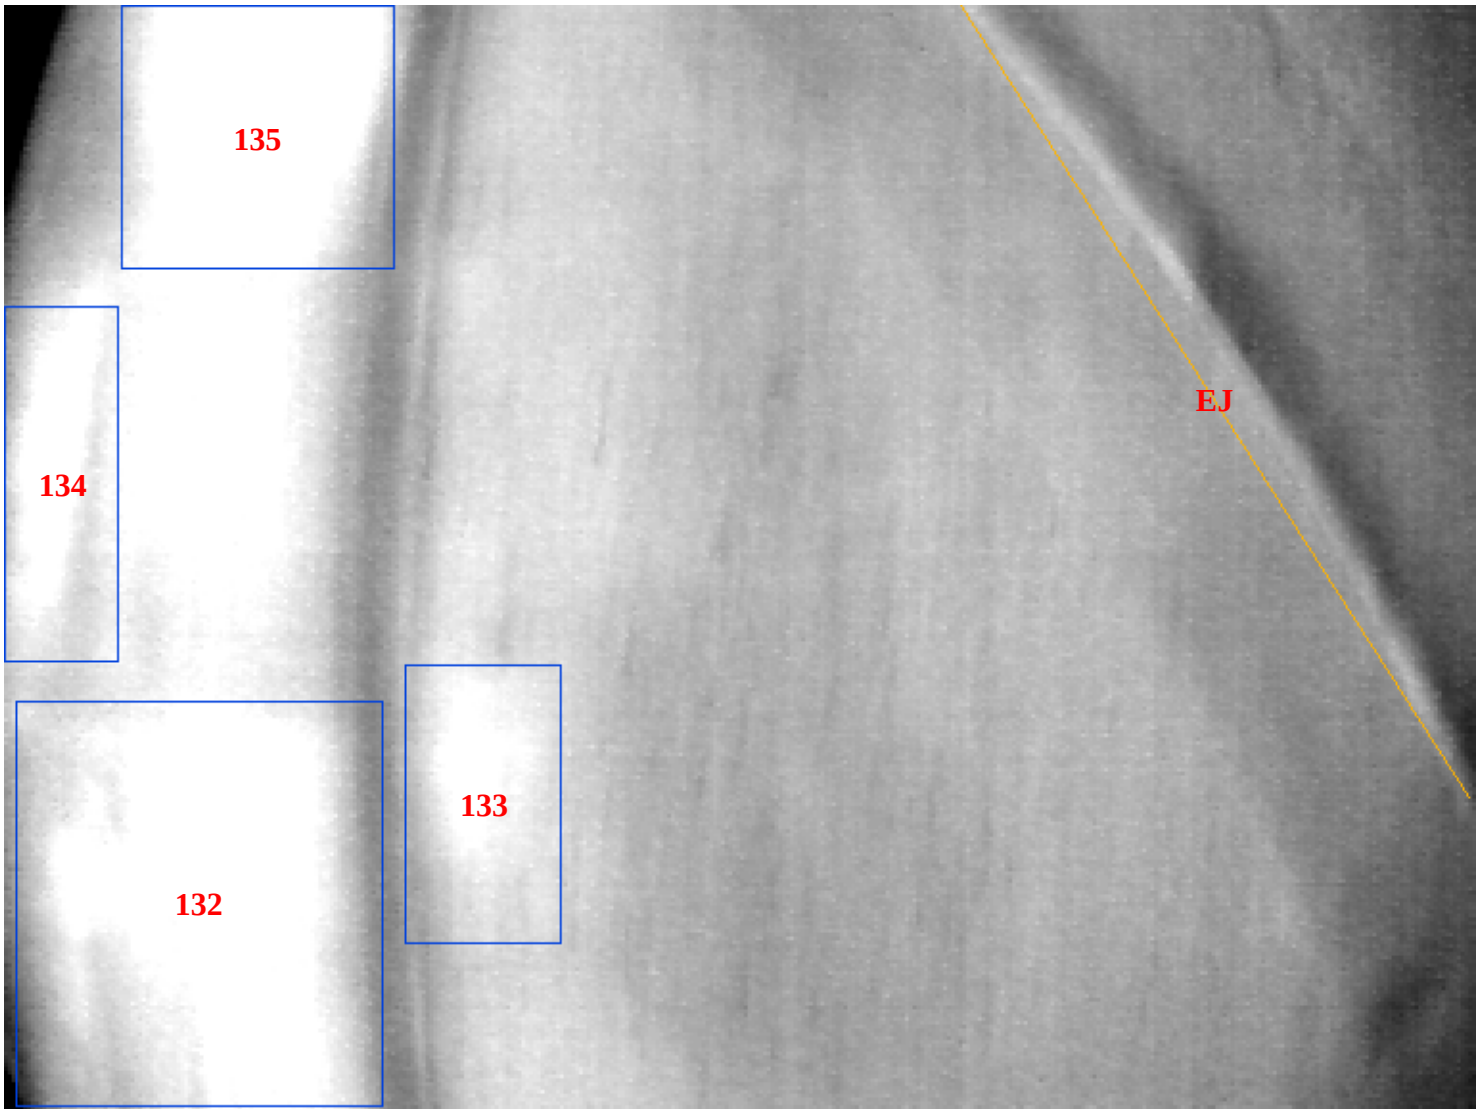
Bridge: 5002 SB Lane: 3 Image Name: 3_4780000_60964_2162.tif

| Defect # | 132 | 133 | 134 | EJ | 135 |
| Feet from Start | 120.19 | 121.12 | 124.11 | 124.89 | 127.35 |
| Feet from Right | 40.14 | 37.44 | 41.45 | 30.49 | 39.58 |
| Defect Size | 13.91 sq ft | 4.09 sq ft | 3.81 sq ft | NA | 6.74 sq ft |
| Length x Width (ft) | 3.80 x 3.50 | 2.61 x 1.49 | 3.33 x 1.09 | NA | 2.47 x 2.61 |
| Type | Delam | Delam | Delam | Joint | Delam |

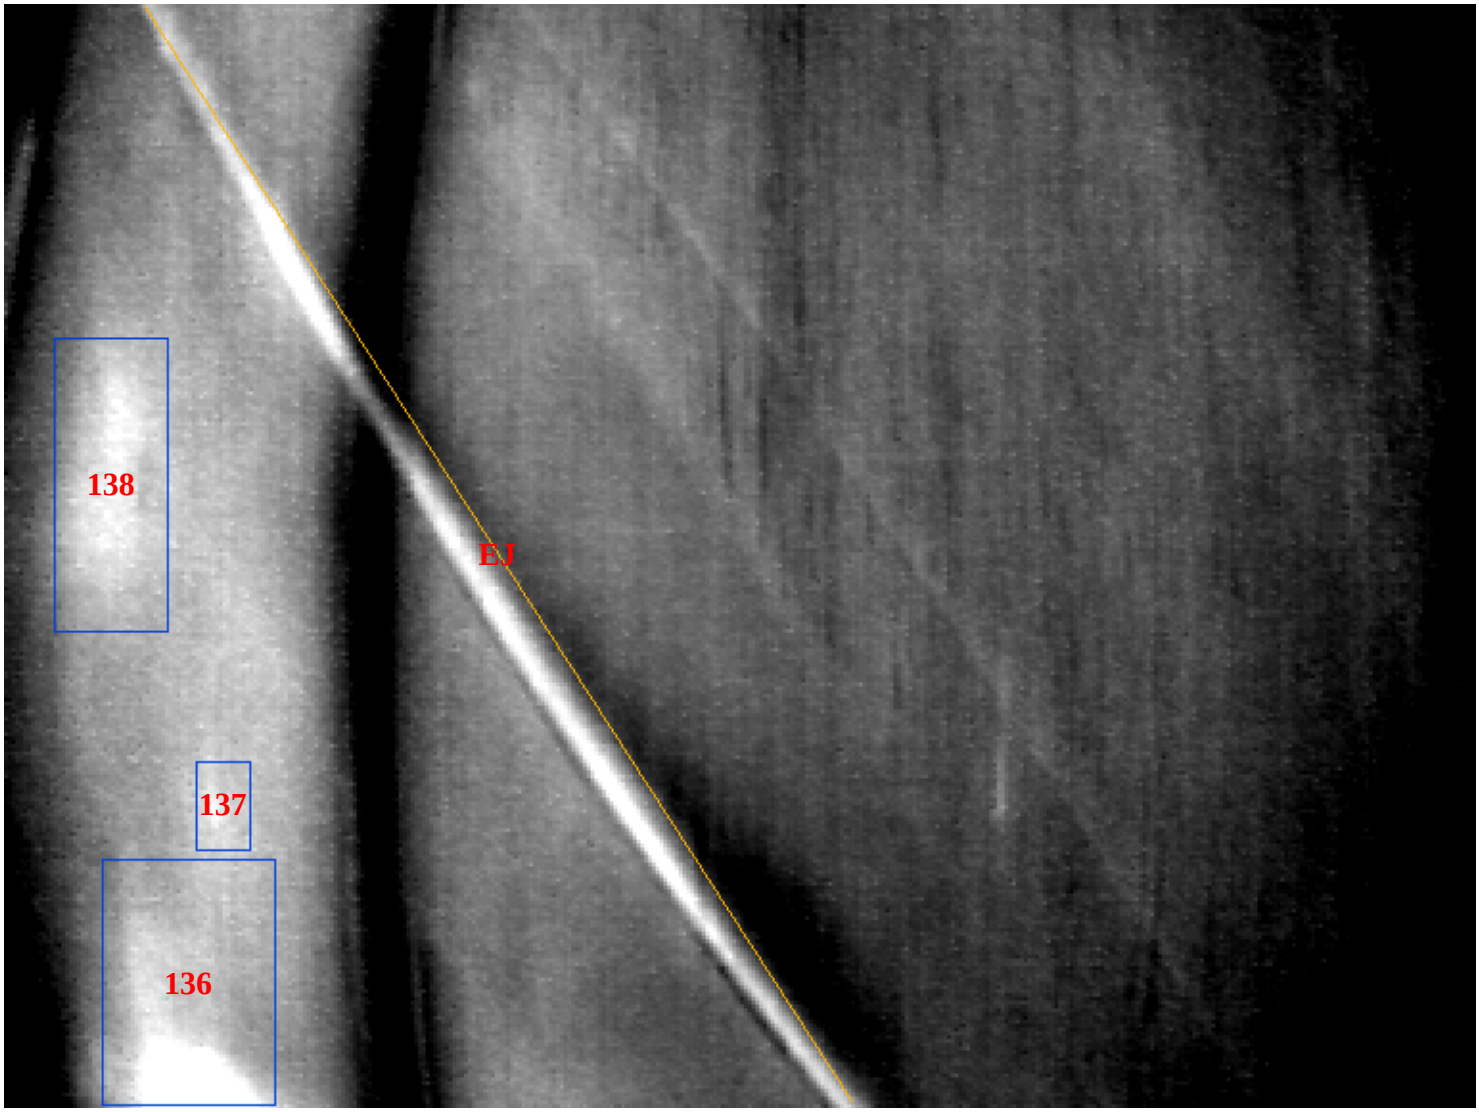
Bridge: 5002 SB Lane: 3 Image Name: 3_4983000_60964_2162.tif

| Defect # | 136 | 137 | EJ | 138 |
| Feet from Start | 129.76 | 131.41 | 133.77 | 134.41 |
| Feet from Right | 40.24 | 39.91 | 37.31 | 40.98 |
| Defect Size | 4.01 sq ft | 0.47 sq ft | NA | 3.16 sq ft |
| Length x Width (ft) | 2.31 x 1.66 | 0.84 x 0.53 | NA | 2.76 x 1.09 |
| Type | Delam | Delam | Joint | Delam |

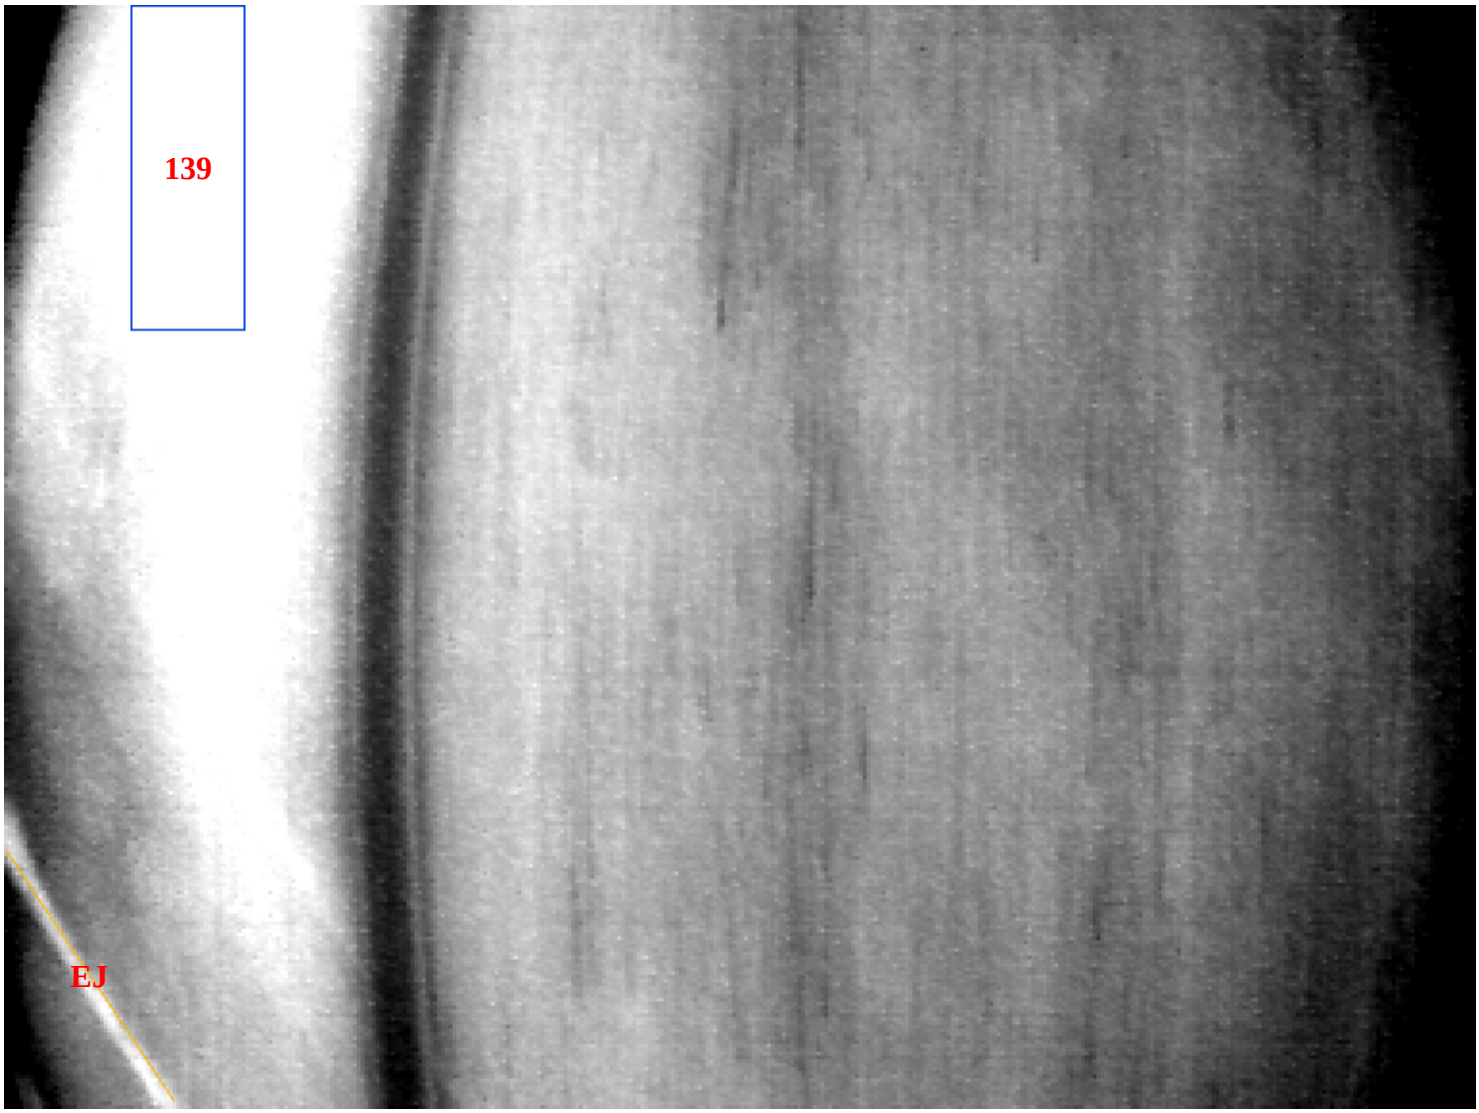
Bridge: 5002 SB Lane: 3 Image Name: 3_5183000_60964_2162.tif

| Defect # | EJ | 139 |
| Feet from Start | 140.00 | 147.54 |
| Feet from Right | 41.19 | 40.25 |
| Defect Size | NA | 3.48 sq ft |
| Length x Width (ft) | NA | 3.04 x 1.09 |
| Type | Joint | Delam |

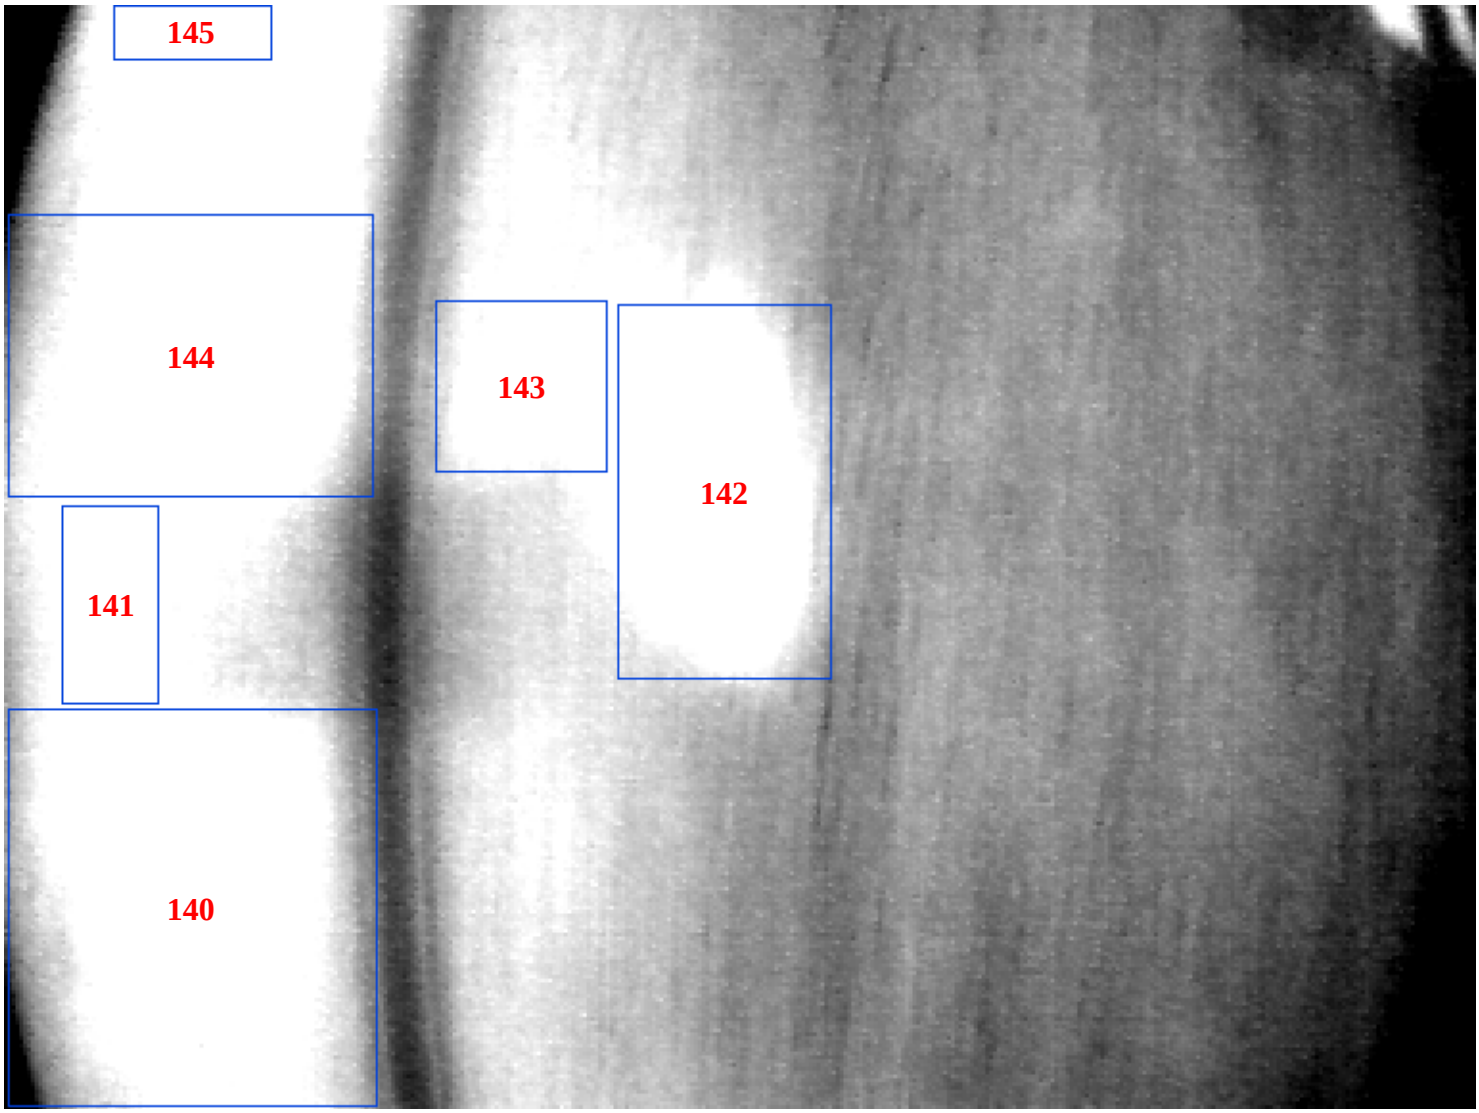
Bridge: 5002 SB Lane: 3 Image Name: 3_5383000_60964_2162.tif

| Defect # | 140 | 141 | 142 | 143 | 144 | 145 |
| Feet from Start | 150.79 | 153.62 | 154.67 | 155.66 | 155.95 | 158.96 |
| Feet from Right | 40.20 | 40.99 | 35.15 | 37.08 | 40.22 | 40.20 |
| Defect Size | 13.71 sq ft | 1.81 sq ft | 7.50 sq ft | 2.77 sq ft | 9.66 sq ft | 0.82 sq ft |
| Length x Width (ft) | 3.73 x 3.52 | 1.86 x 0.93 | 3.51 x 2.04 | 1.61 x 1.64 | 2.65 x 3.48 | 0.52 x 1.51 |
| Type | Delam | Delam | Delam | Delam | Delam | Delam |

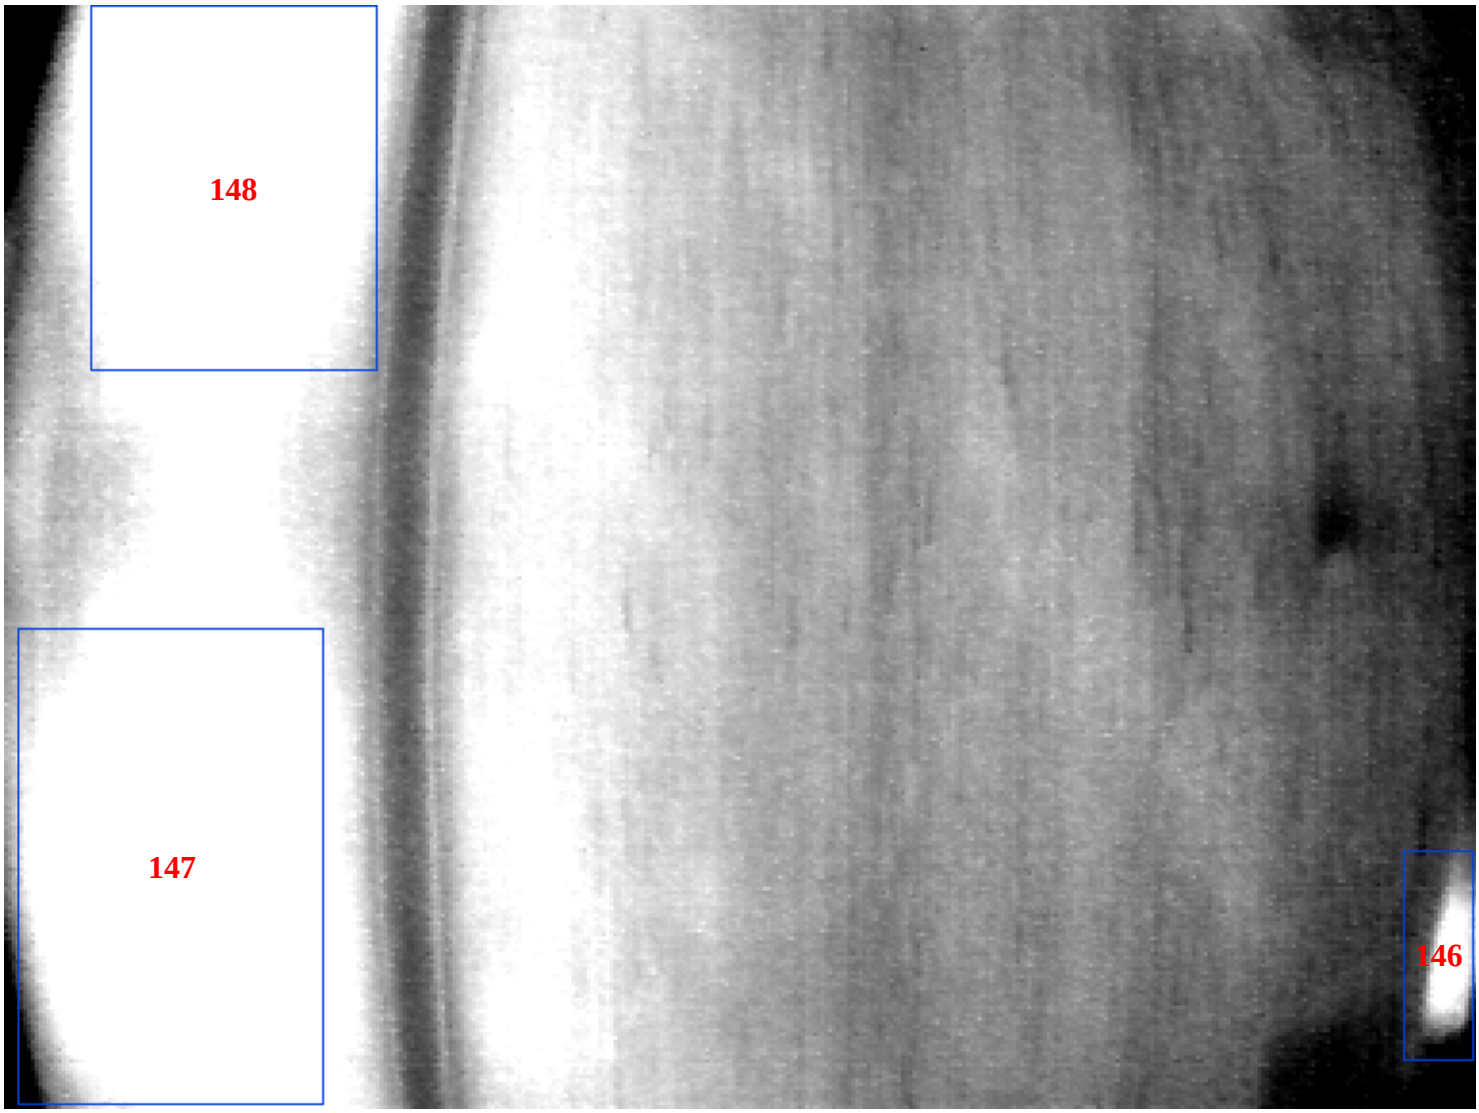
Bridge: 5002 SB Lane: 3 Image Name: 3_5584000_60964_2162.tif

| Defect # | 146 | 147 | 148 |
| Feet from Start | 160.55 | 161.38 | 167.72 |
| Feet from Right | 28.36 | 40.41 | 39.81 |
| Defect Size | 1.39 sq ft | 13.61 sq ft | 9.79 sq ft |
| Length x Width (ft) | 1.97 x 0.67 | 4.46 x 2.92 | 3.42 x 2.73 |
| Type | Delam | Delam | Delam |
