# Delaminations

Bridge: 5003 NB Lane: 1 Image Name: 1_6114000_56609_340.tif

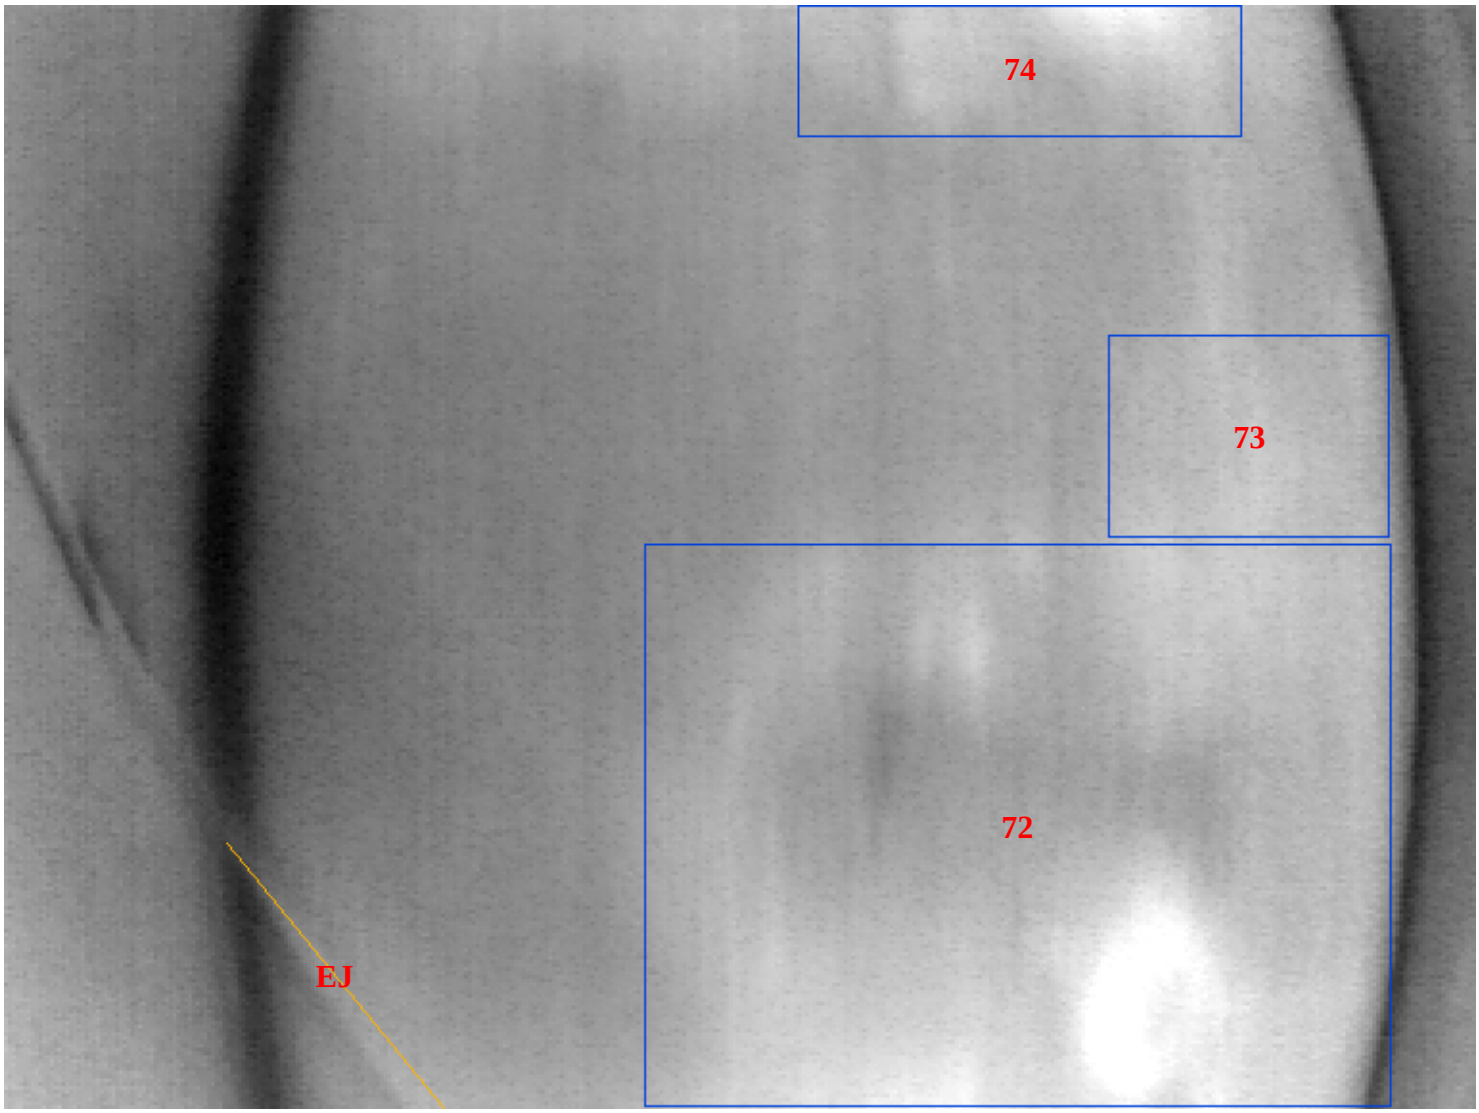
| Defect # | EJ | 72 | 73 | 74 |
| Feet from Start | 151.79 | 153.19 | 156.83 | 160.24 |
| Feet from Right | 10.86 | 4.36 | 2.16 | 4.34 |
| Defect Size | NA | 39.17 sq ft | 5.32 sq ft | 5.47 sq ft |
| Length x Width (ft) | NA | 5.27 x 7.11 | 1.90 x 2.68 | 1.24 x 4.23 |
| Type | Joint | Delam | Delam | Delam |

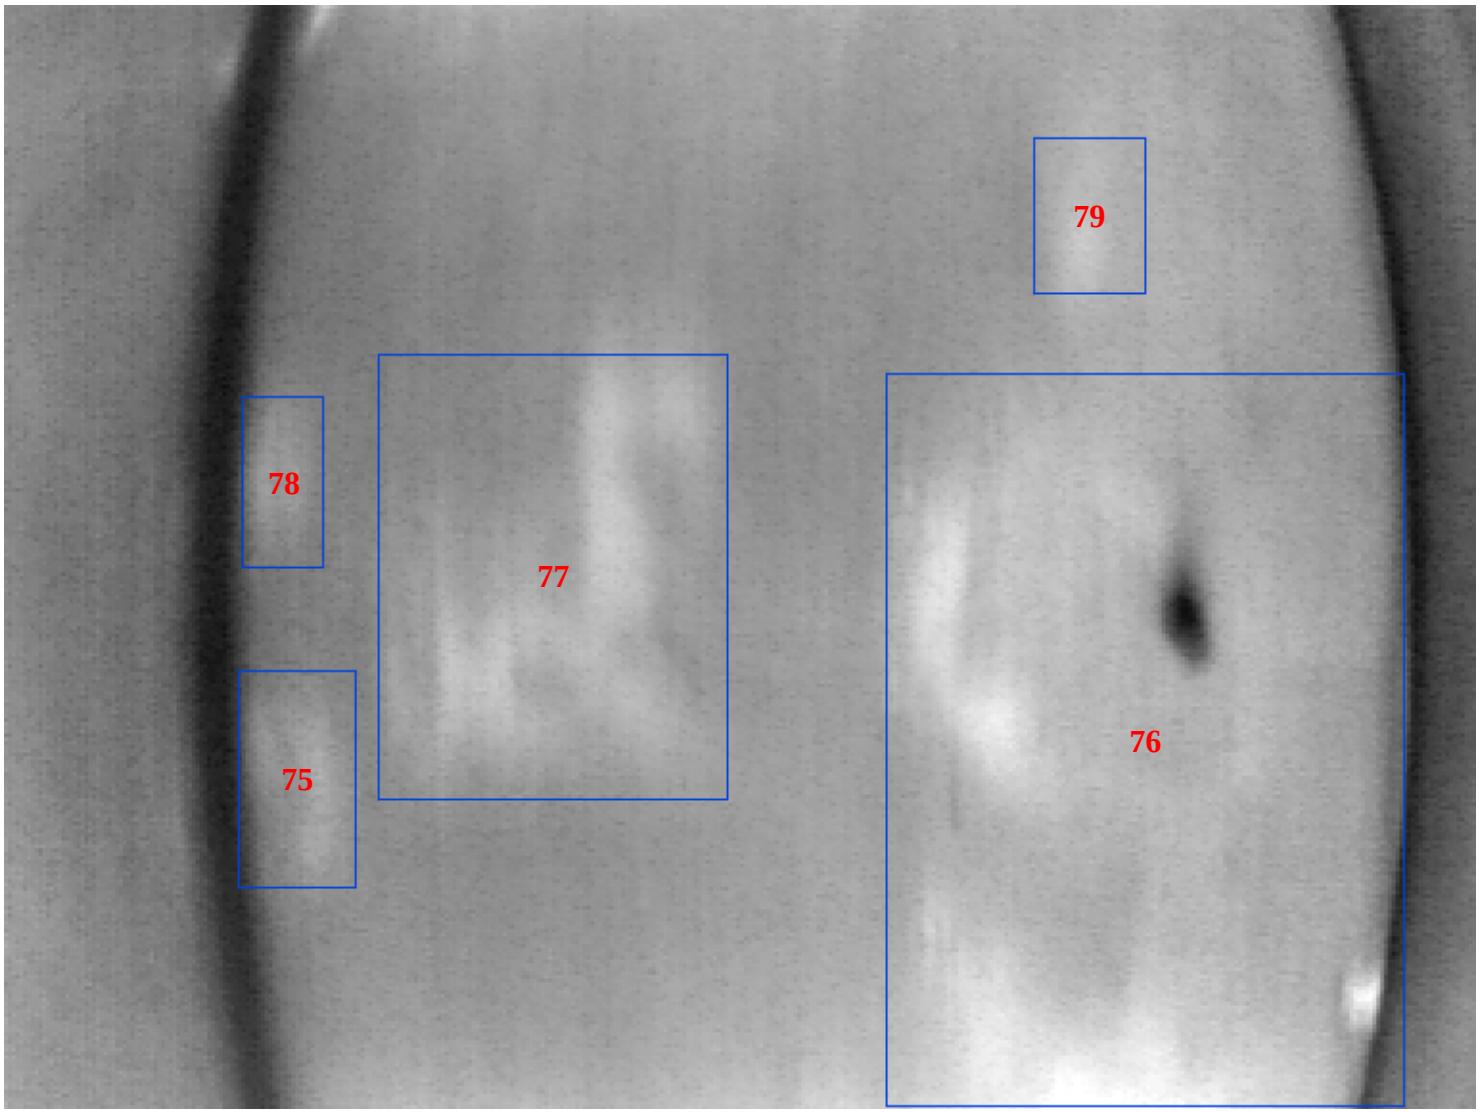
Bridge: 5003 NB Lane: 1 Image Name: 1_6337000_56589_347.tif

| Defect # | 75 | 76 | 77 | 78 | 79 |
| Feet from Start | 164.14 | 164.50 | 166.03 | 166.91 | 169.40 |
| Feet from Right | 11.21 | 3.14 | 8.78 | 11.35 | 3.67 |
| Defect Size | 2.41 sq ft | 35.46 sq ft | 14.57 sq ft | 1.32 sq ft | 1.65 sq ft |
| Length x Width (ft) | 2.04 x 1.13 | 6.86 x 4.94 | 4.17 x 3.34 | 1.61 x 0.78 | 1.47 x 1.08 |
| Type | Delam | Delam | Delam | Delam | Delam |

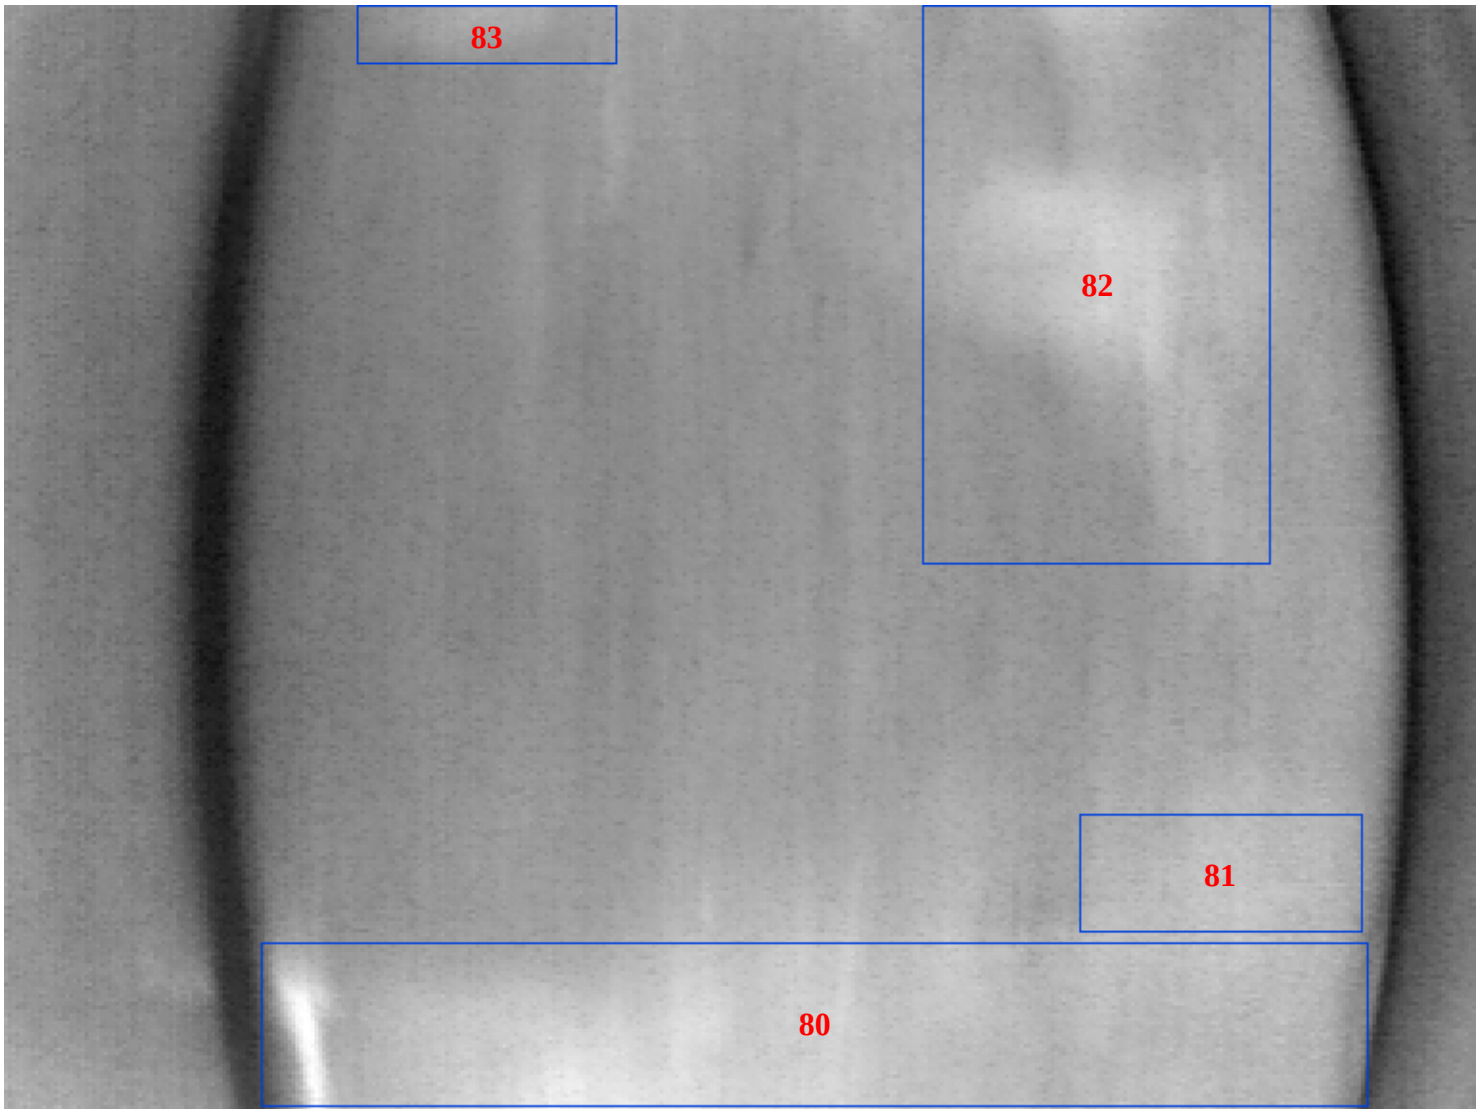
Bridge: 5003 NB Lane: 1 Image Name: 1_6555000_56589_347.tif

| Defect # | 80 | 81 | 82 | 83 |
| Feet from Start | 172.12 | 173.54 | 179.04 | 181.37 |
| Feet from Right | 6.29 | 2.42 | 3.61 | 9.41 |
| Defect Size | 16.98 sq ft | 3.13 sq ft | 18.15 sq ft | 1.44 sq ft |
| Length x Width (ft) | 1.54 x 10.54 | 1.11 x 2.70 | 5.23 x 3.32 | 0.56 x 2.48 |
| Type | Delam | Delam | Delam | Delam |

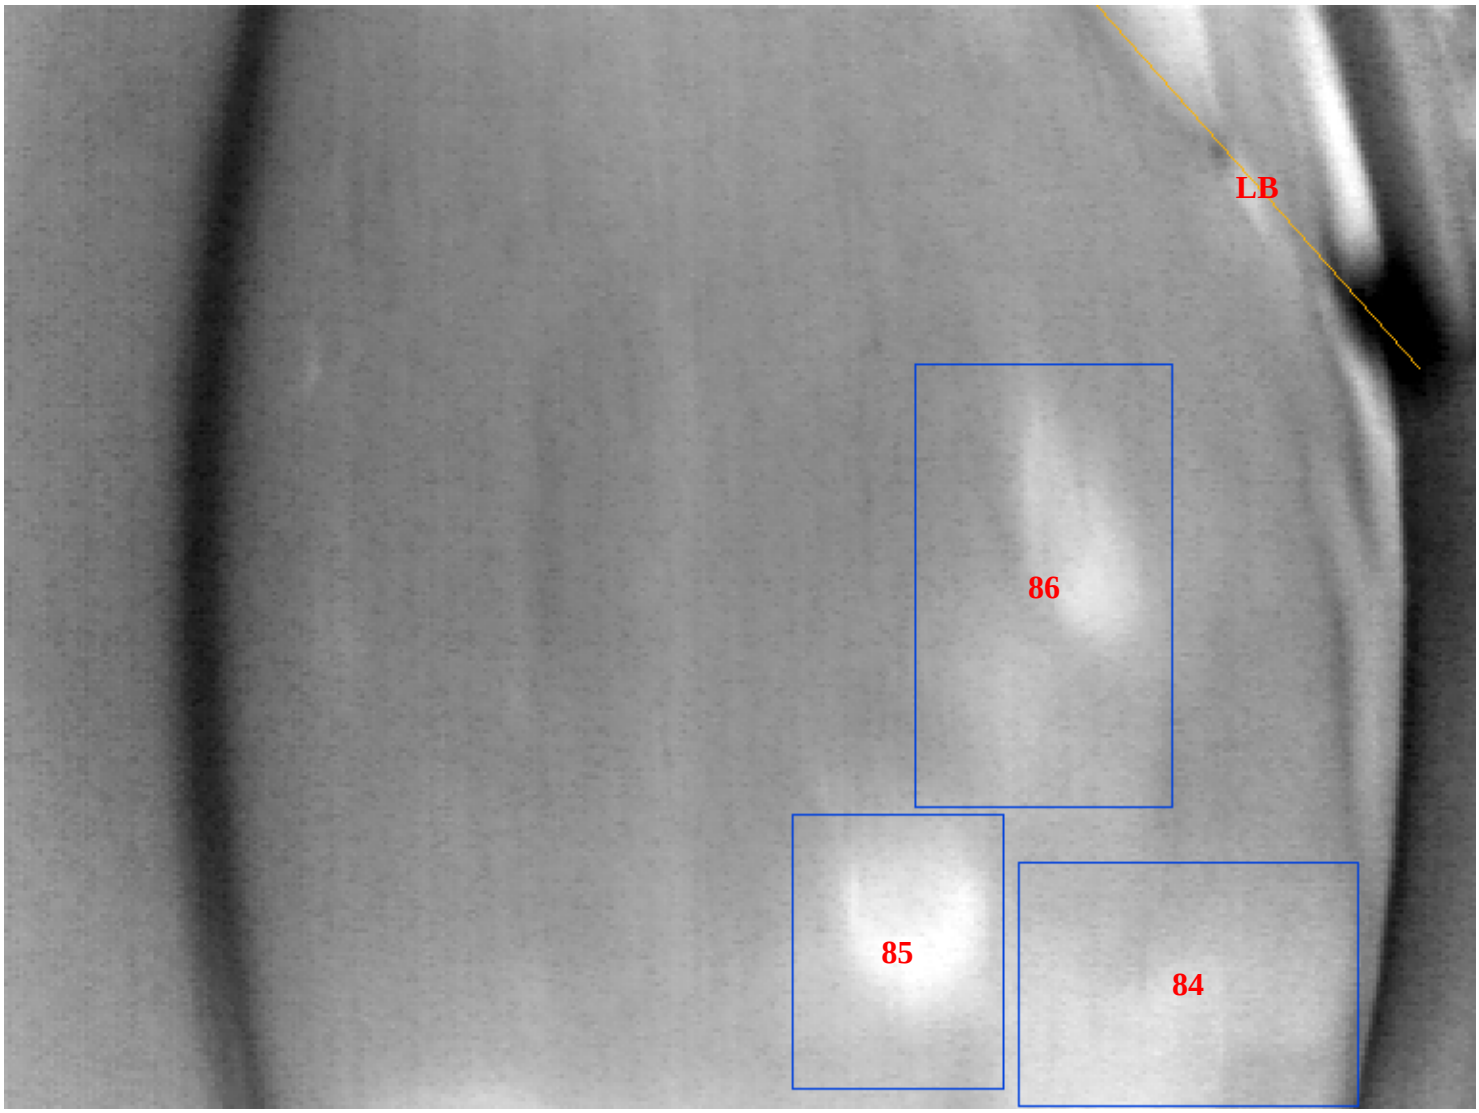
Bridge: 5003 NB Lane: 1 Image Name: 1_6776000_56589_347.tif

| Defect # | 84 | 85 | 86 | LB |
| Feet from Start | 182.92 | 183.23 | 186.65 | 190.38 |
| Feet from Right | 2.73 | 5.50 | 4.11 | 2.08 |
| Defect Size | 7.78 sq ft | 5.46 sq ft | 10.70 sq ft | NA |
| Length x Width (ft) | 2.29 x 3.24 | 2.58 x 2.02 | 4.16 x 2.46 | NA |
| Type | Delam | Delam | Delam | Lane Bound |

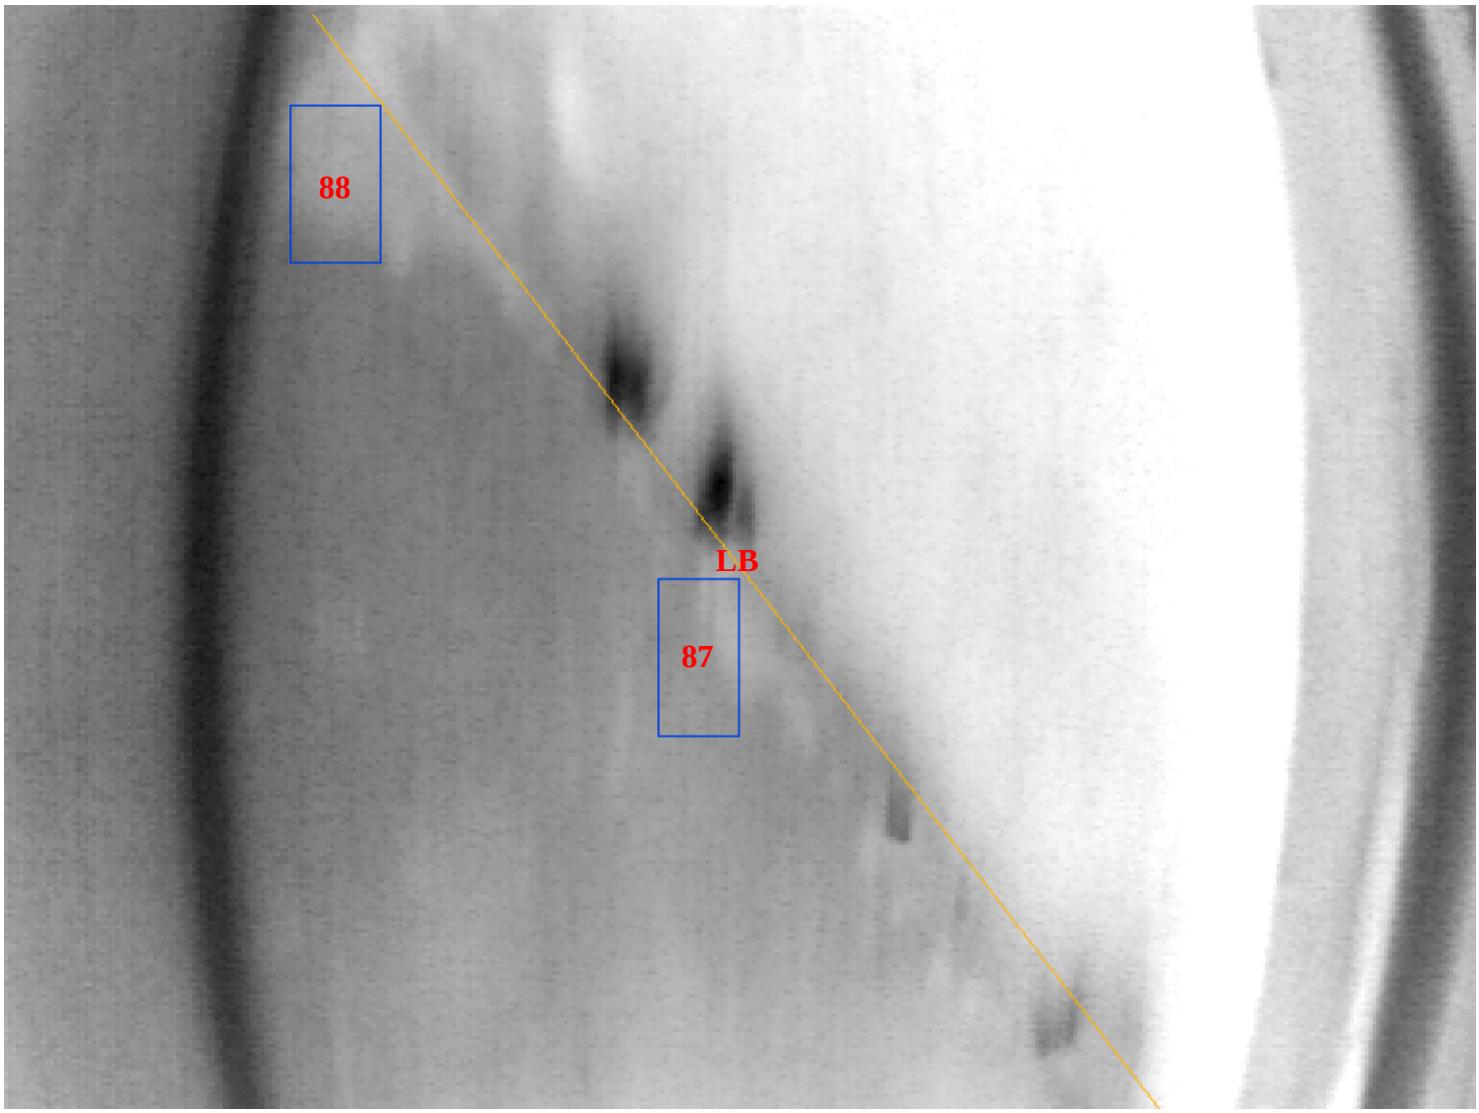
Bridge: 5003 NB Lane: 1 Image Name: 1_6994000_56589_347.tif

| Defect # | 87 | LB | 88 |
| Feet from Start | 196.26 | 197.16 | 200.68 |
| Feet from Right | 7.39 | 7.05 | 10.85 |
| Defect Size | 1.22 sq ft | NA | 1.36 sq ft |
| Length x Width (ft) | 1.49 x 0.78 | NA | 1.49 x 0.88 |
| Type | Delam | Lane Bound | Delam |

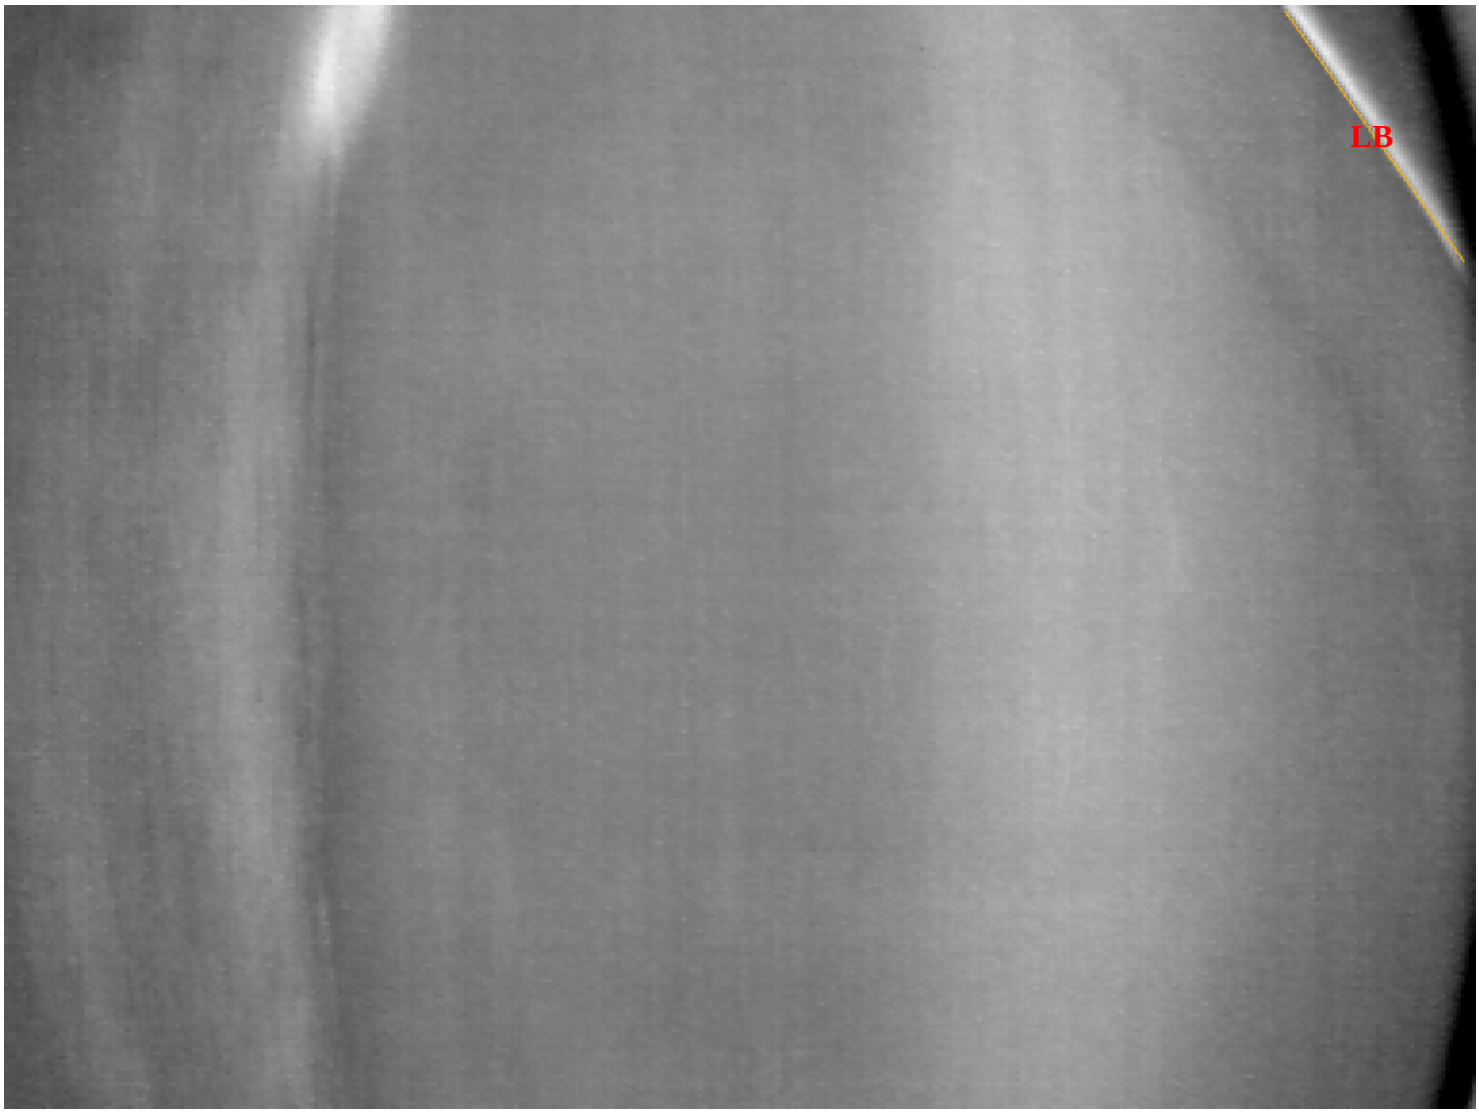
Bridge: 5003 NB Lane: 2 Image Name: 2_1737000_70503_323.tif

| Defect # | LB |
| Feet from Start | 1.38 |
| Feet from Right | 14.98 |
| Defect Size | NA |
| Length x Width (ft) | NA |
| Type | Lane Bound |

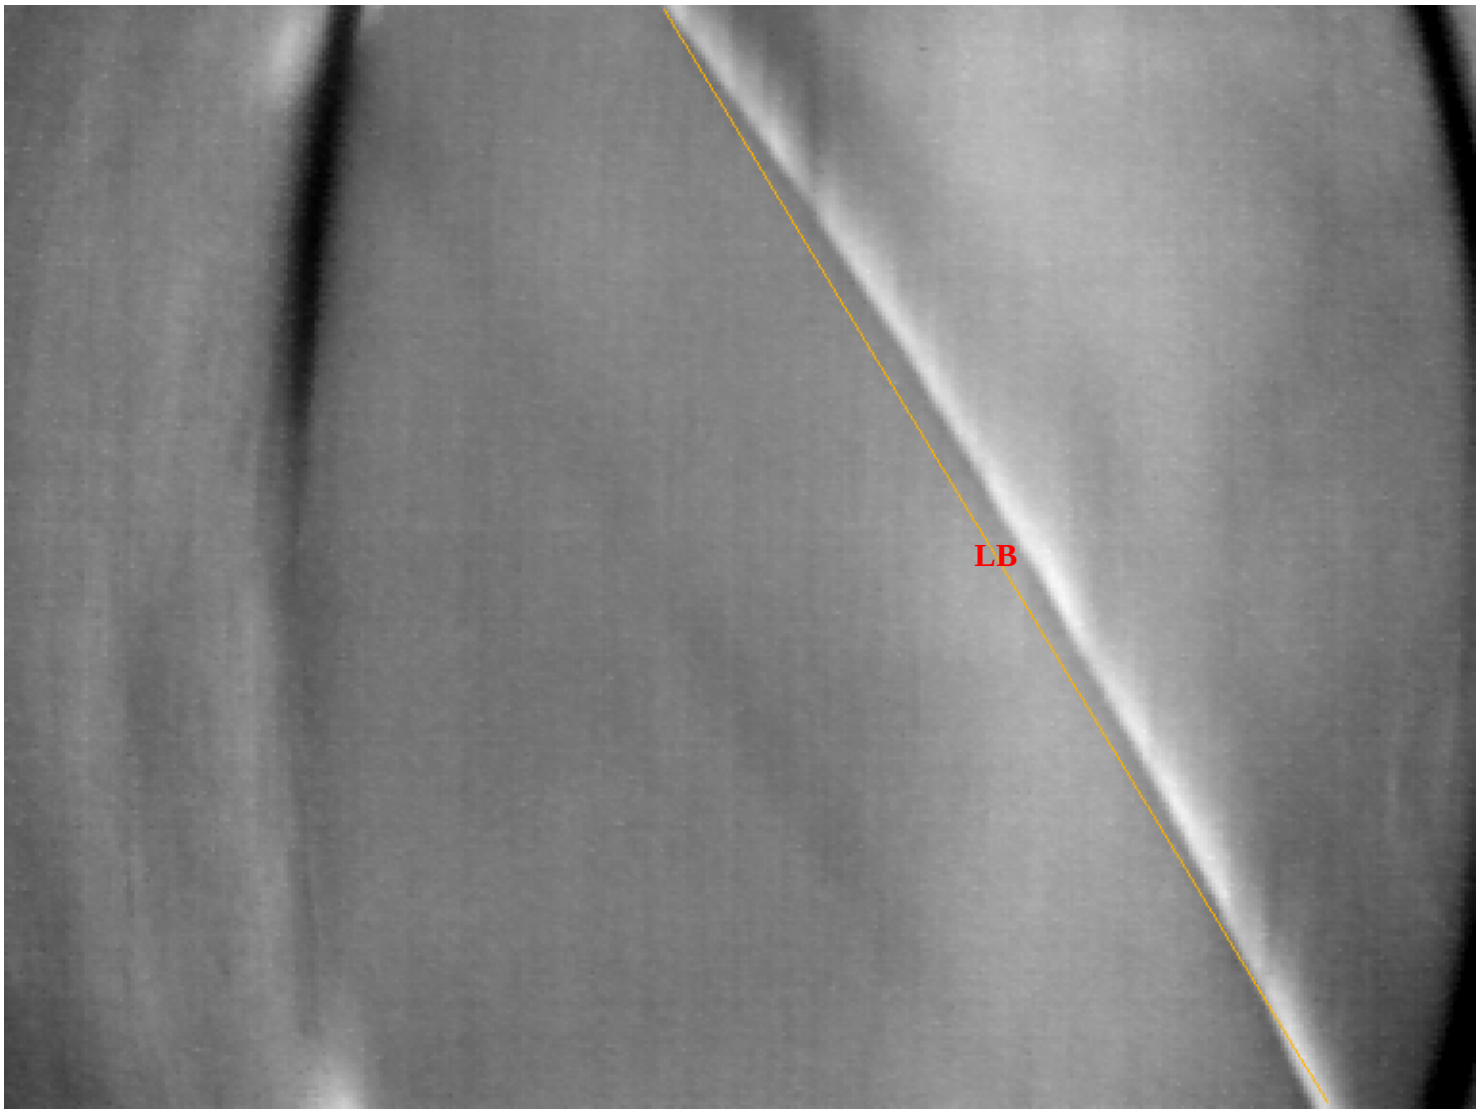
Bridge: 5003 NB Lane: 2 Image Name: 2_1912000_70503_323.tif

| Defect # | LB |
| Feet from Start | 7.74 |
| Defect Size | NA |

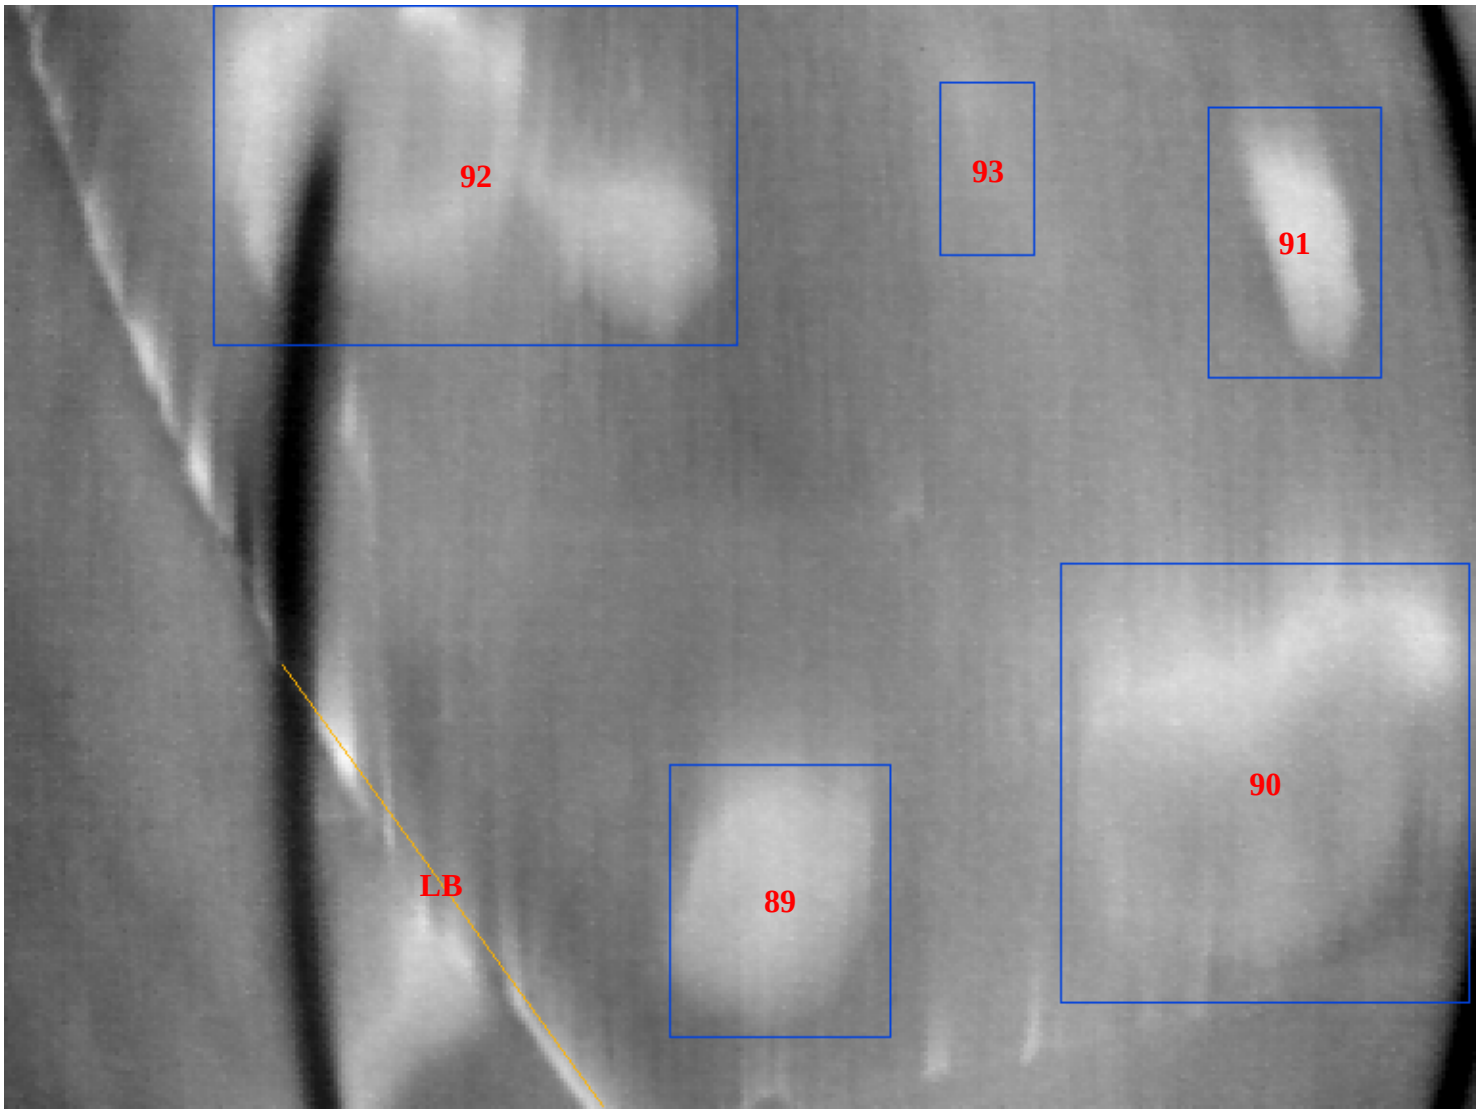
Bridge: 5003 NB Lane: 2 Image Name: 2_2085000_69308_329.tif

| Defect # | 89 | LB | 90 | 91 | 92 | 93 |
| Feet from Start | 14.50 | 14.65 | 15.60 | 20.65 | 21.28 | 21.34 |
| Feet from Right | 20.62 | 23.83 | 16.01 | 15.72 | 23.52 | 18.65 |
| Defect Size | 5.67 sq ft | NA | 16.81 sq ft | 4.41 sq ft | 16.66 sq ft | 1.55 sq ft |
| Length x Width (ft) | 2.56 x 2.11 | NA | 4.12 x 3.90 | 2.54 x 1.66 | 3.19 x 4.99 | 1.63 x 0.91 |
| Type | Delam | Lane Bound | Delam | Delam | Delam | Delam |

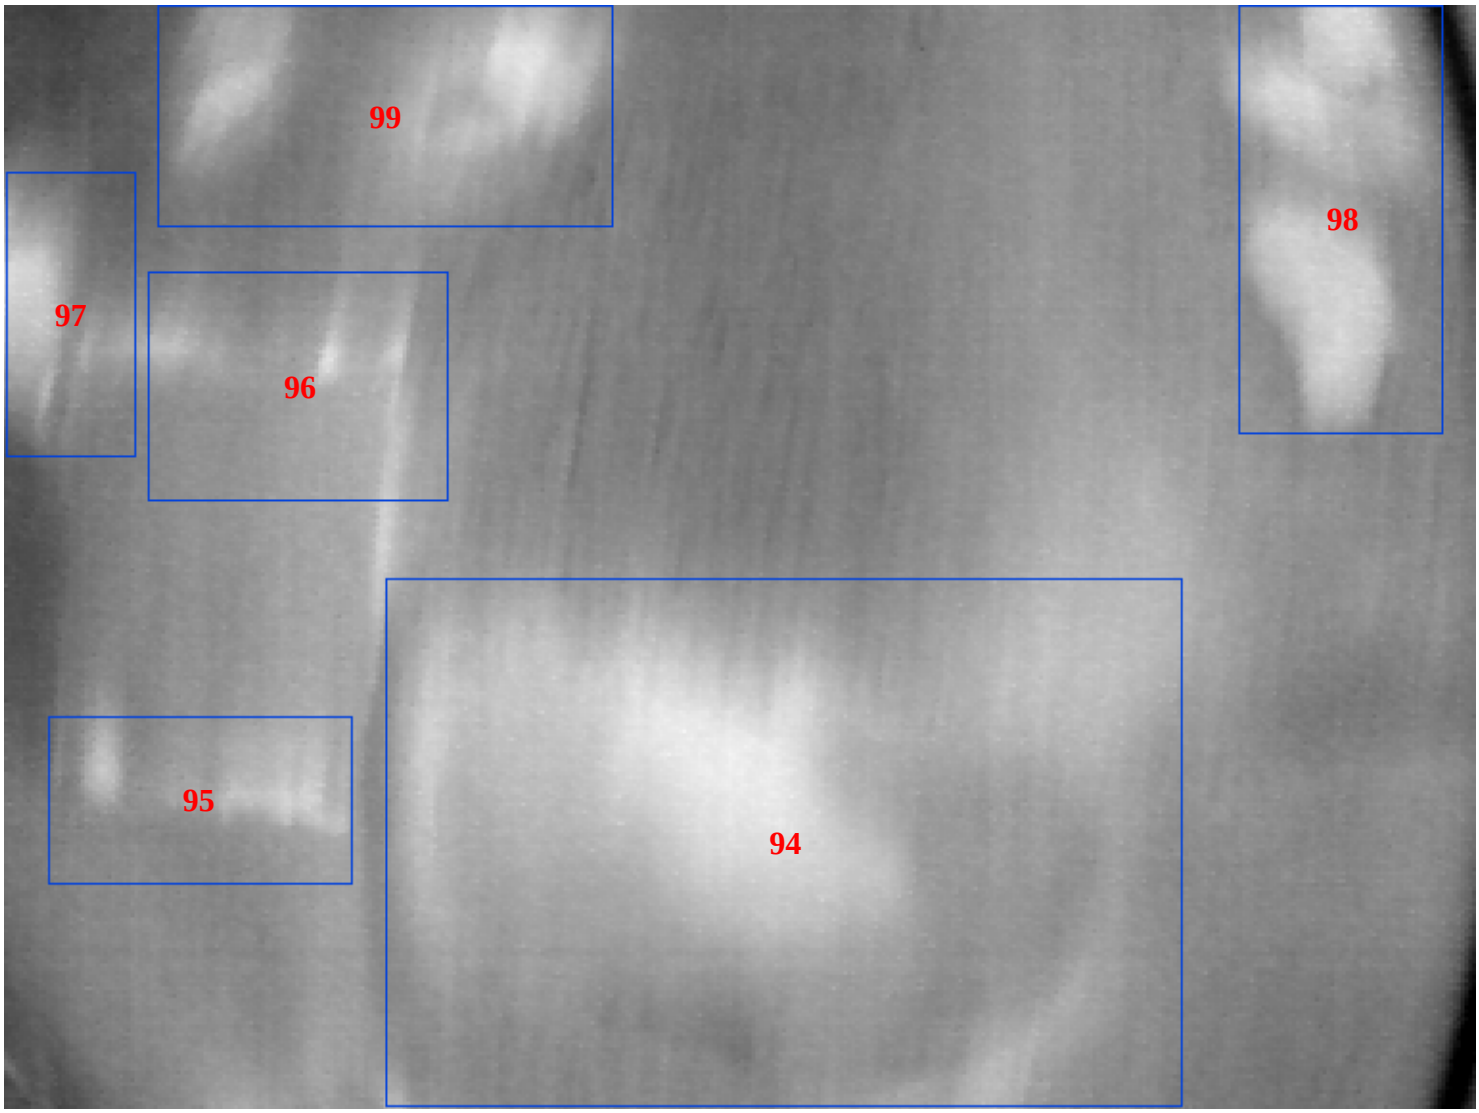
Bridge: 5003 NB Lane: 2 Image Name: 2_2261000_69308_329.tif

| Defect # | 94 | 95 | 96 | 97 | 98 | 99 |
| Feet from Start | 25.21 | 25.60 | 29.47 | 30.14 | 31.03 | 32.00 |
| Feet from Right | 20.58 | 26.13 | 25.20 | 27.36 | 15.29 | 24.37 |
| Defect Size | 39.22 sq ft | 4.78 sq ft | 6.44 sq ft | 3.46 sq ft | 8.19 sq ft | 9.43 sq ft |
| Length x Width (ft) | 4.94 x 7.58 | 1.58 x 2.90 | 2.15 x 2.86 | 2.67 x 1.24 | 4.01 x 1.95 | 2.08 x 4.34 |
| Type | Delam | Delam | Delam | Delam | Delam | Delam |

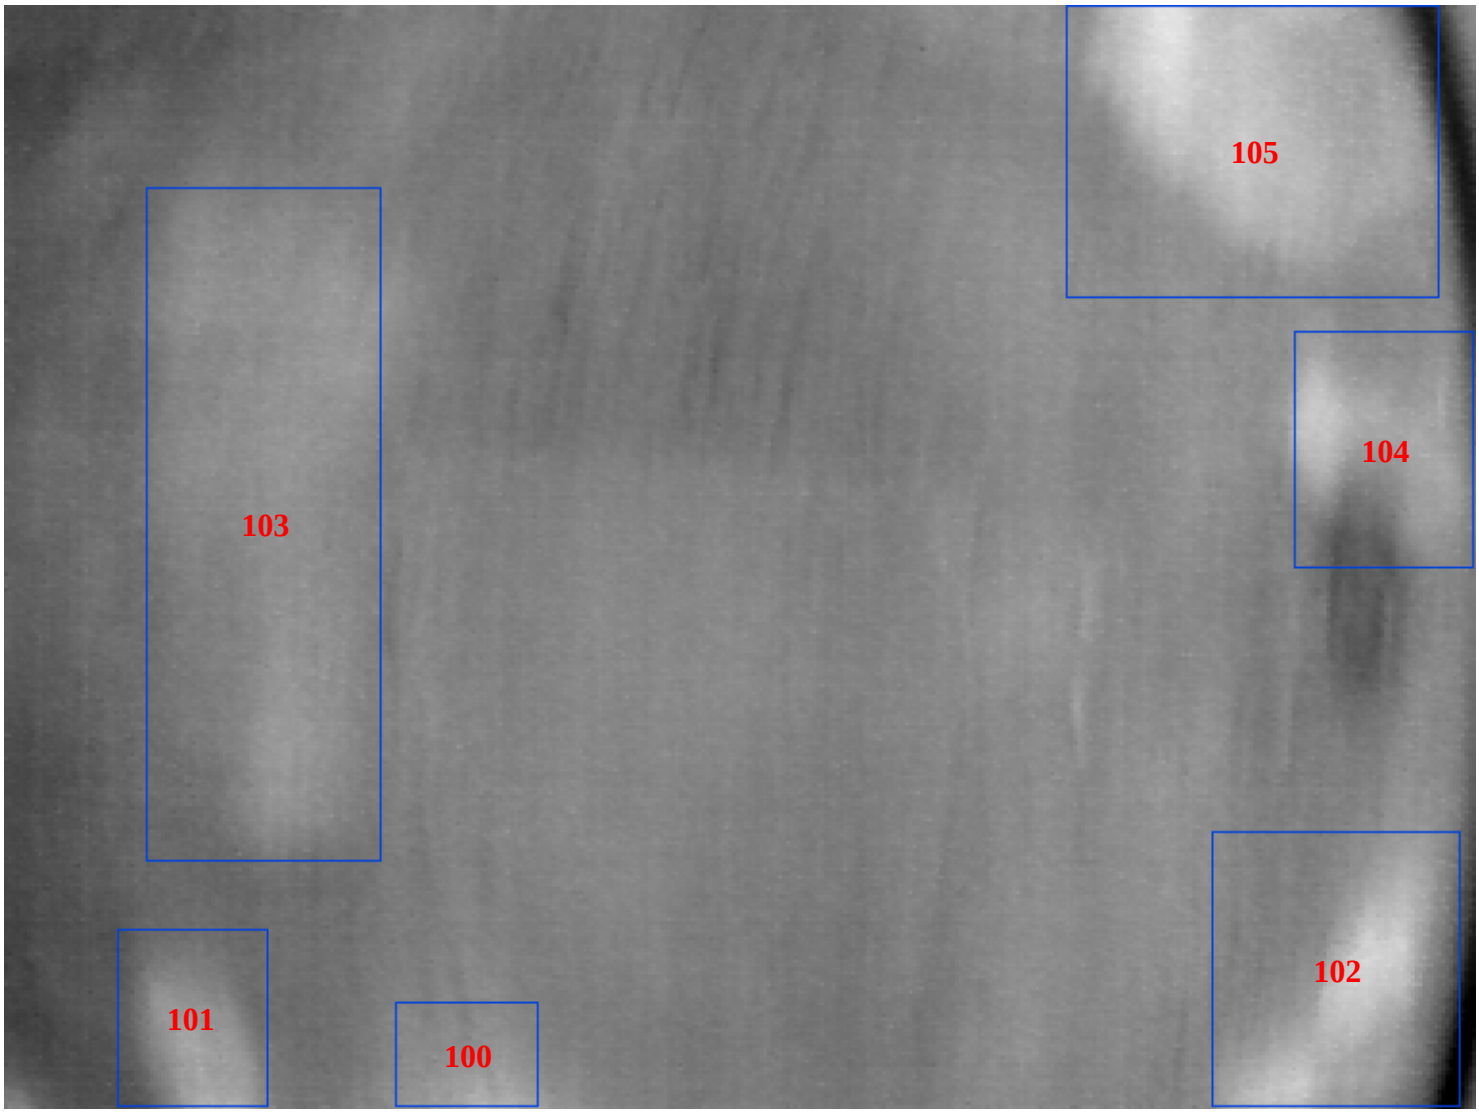
Bridge: 5003 NB Lane: 2 Image Name: 2_2440000_69308_329.tif

| Defect # | 100 | 101 | 102 | 103 | 104 | 105 |
| Feet from Start | 33.57 | 33.91 | 34.37 | 38.52 | 39.22 | 42.00 |
| Feet from Right | 23.60 | 26.20 | 15.33 | 25.53 | 14.88 | 16.12 |
| Defect Size | 1.41 sq ft | 2.51 sq ft | 6.40 sq ft | 14.79 sq ft | 3.98 sq ft | 10.19 sq ft |
| Length x Width (ft) | 0.99 x 1.37 | 1.67 x 1.44 | 2.58 x 2.37 | 6.30 x 2.24 | 2.22 x 1.71 | 2.74 x 3.55 |
| Type | Delam | Delam | Delam | Delam | Delam | Delam |

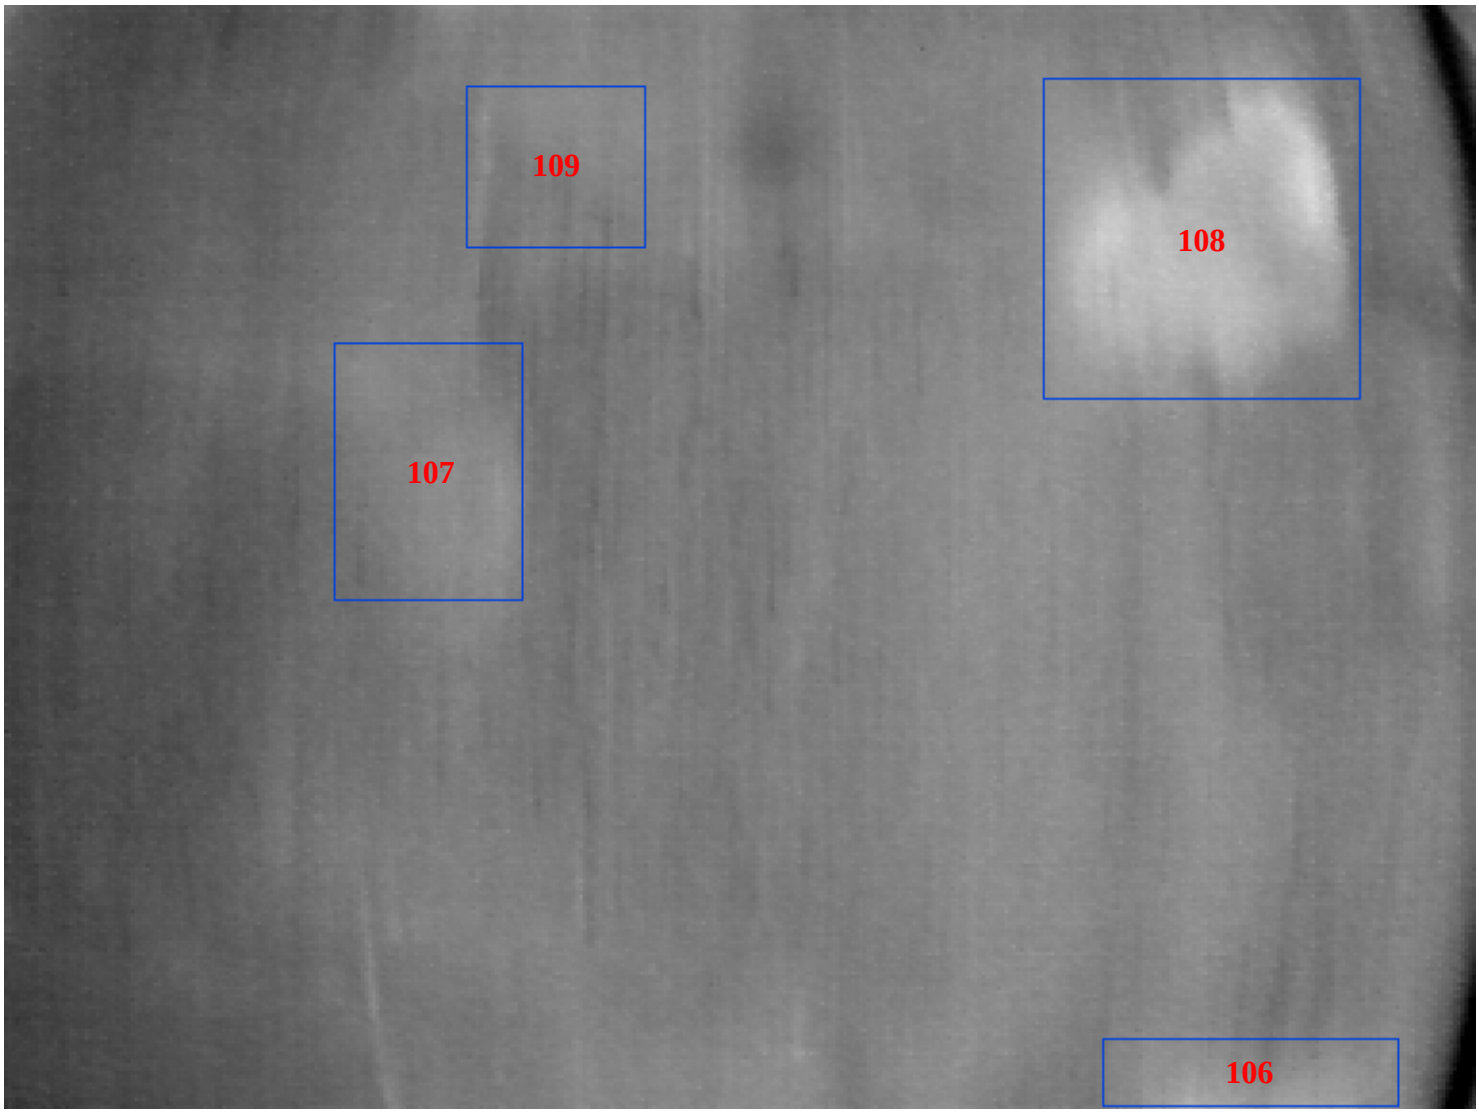
Bridge: 5003 NB Lane: 2 Image Name: 2_2620000_69308_329.tif

| Defect # | 106 | 107 | 108 | 109 |
| Feet from Start | 43.79 | 49.41 | 51.59 | 52.26 |
| Feet from Right | 16.14 | 23.96 | 16.61 | 22.75 |
| Defect Size | 1.91 sq ft | 4.57 sq ft | 9.53 sq ft | 2.73 sq ft |
| Length x Width (ft) | 0.64 x 2.83 | 2.42 x 1.80 | 3.01 x 3.03 | 1.52 x 1.71 |
| Type | Delam | Delam | Delam | Delam |
