Delaminations

Bridge: 5003 NB Lane: 2 Image Name: 2_2795000_69308_329.tif

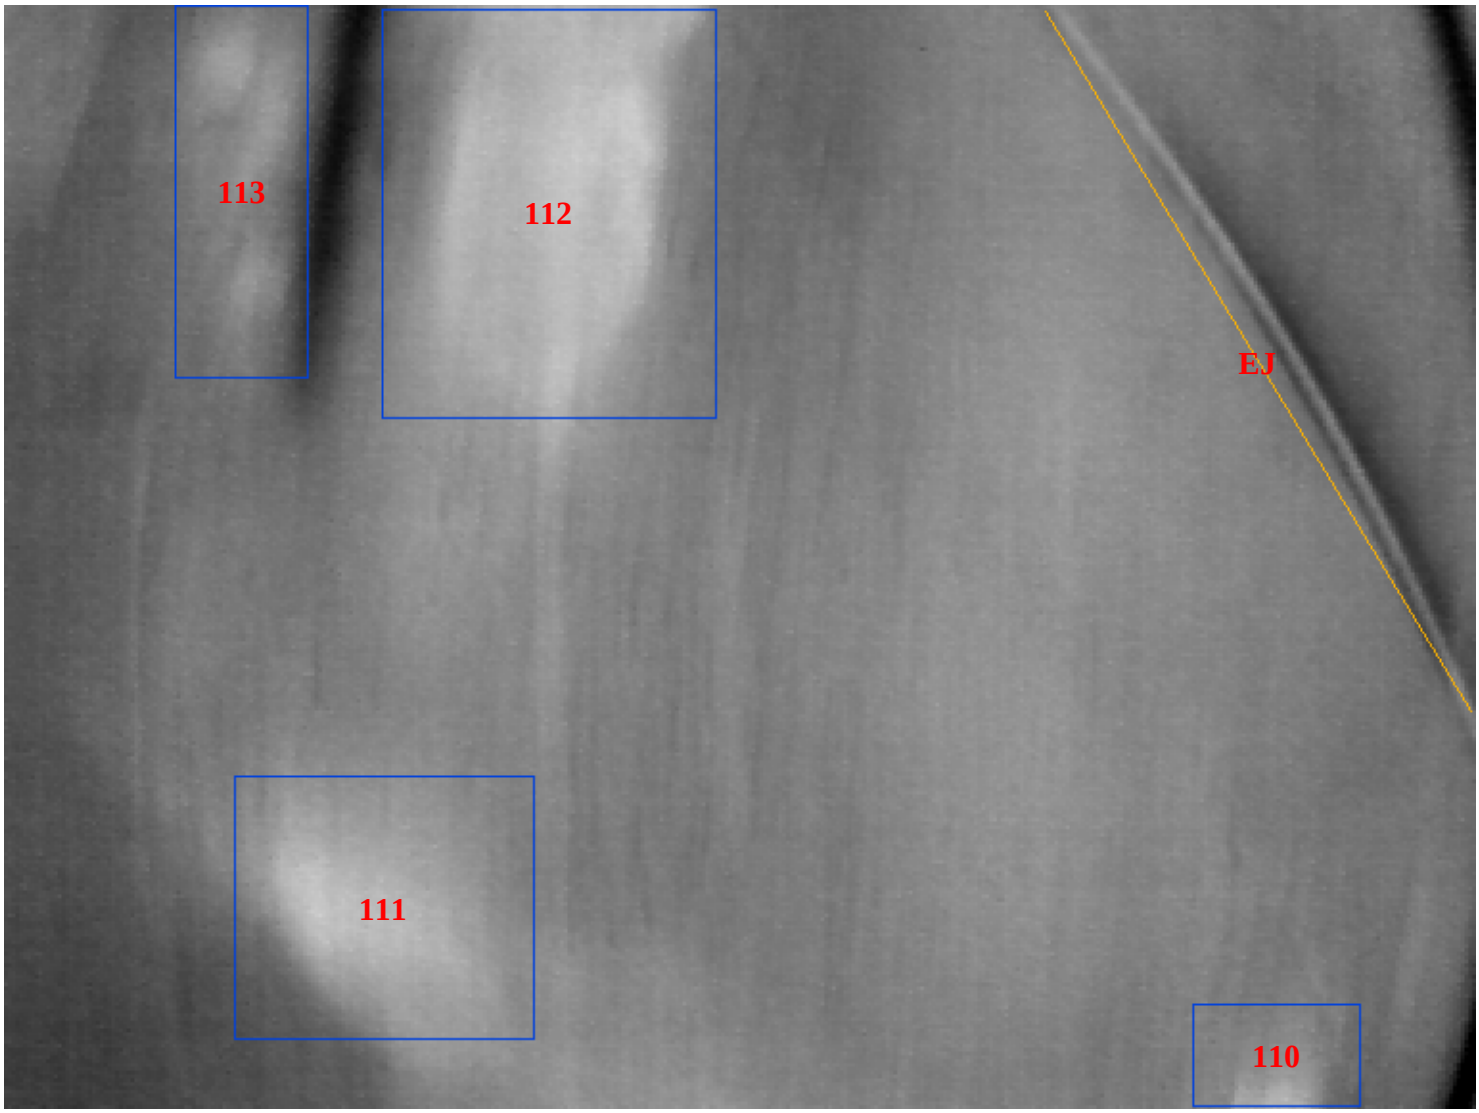
Defect #	110	111	EJ	112	113
Feet from Start	54.06	55.44	60.56	61.93	62.13
Feet from Right	15.90	24.38	16.08	22.81	25.74
Defect Size	1.62 sq ft	7.40 sq ft	NA	12.79 sq ft	4.66 sq ft
Length x Width (ft)	0.97 x 1.60	2.47 x 2.86	NA	3.83 x 3.19	3.49 x 1.28
Type	Delam	Delam	Joint	Delam	Delam

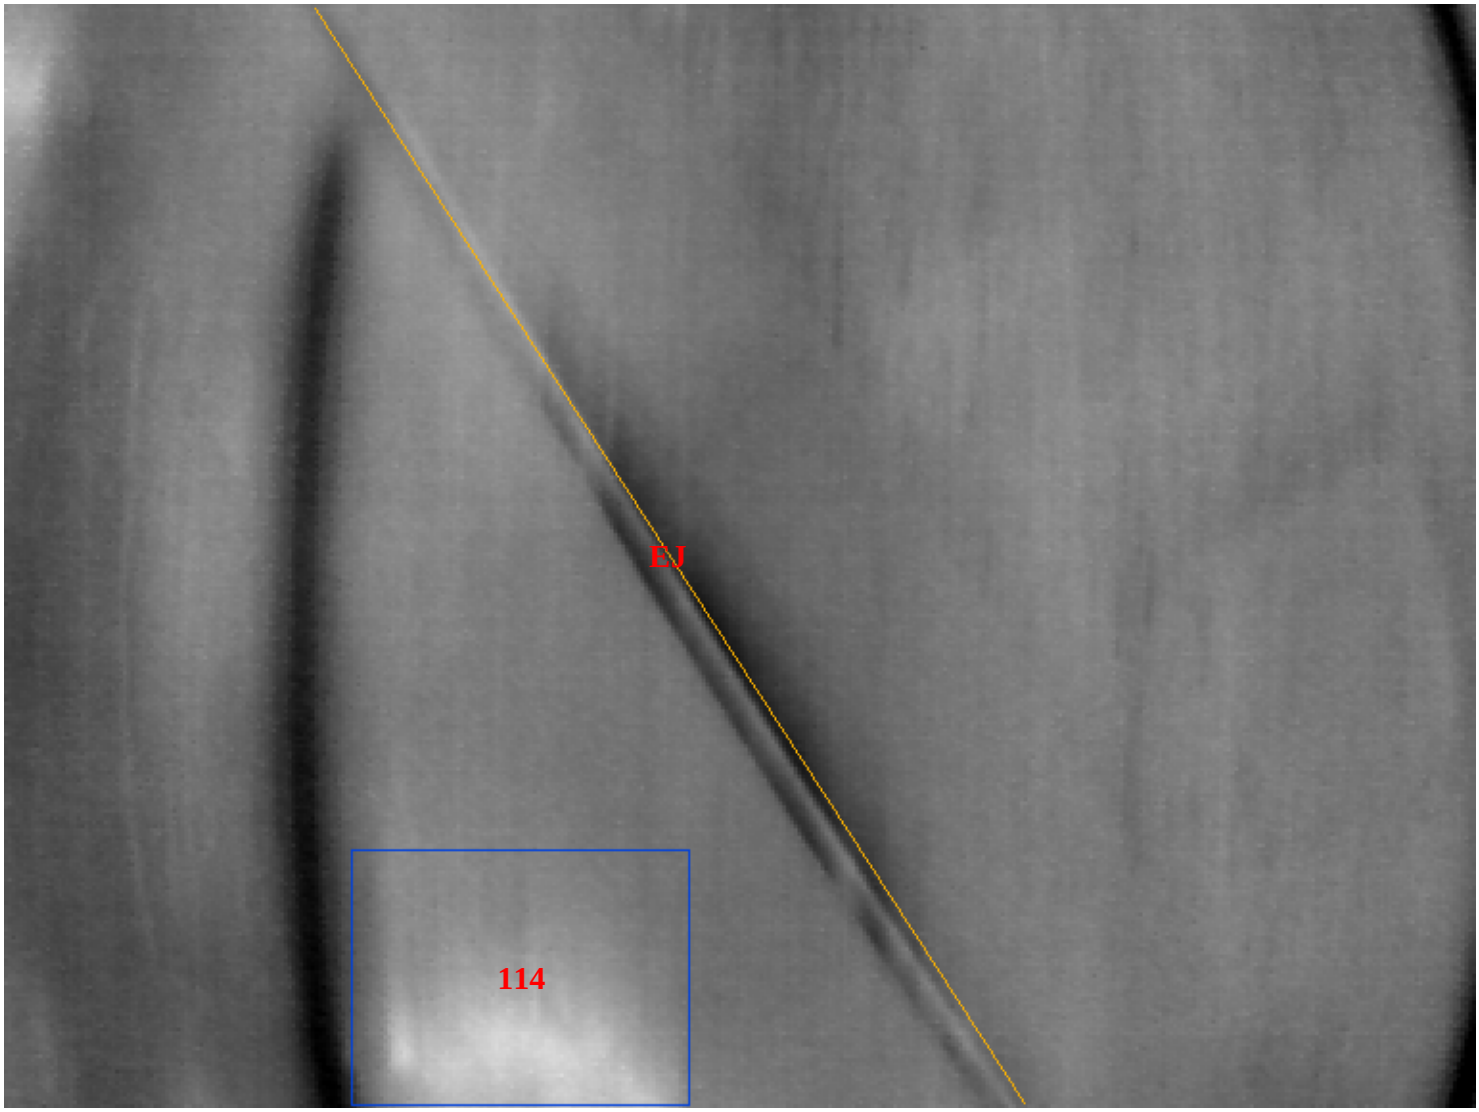
Bridge: 5003 NB Lane: 2 Image Name: 2_2972000_69308_329.tif

Defect #	114	EJ
Feet from Start	65.00	68.95
Feet from Right	23.09	21.67
Defect Size	8.10 sq ft	NA
Length x Width (ft)	2.40 x 3.23	NA
Type	Delam	Joint

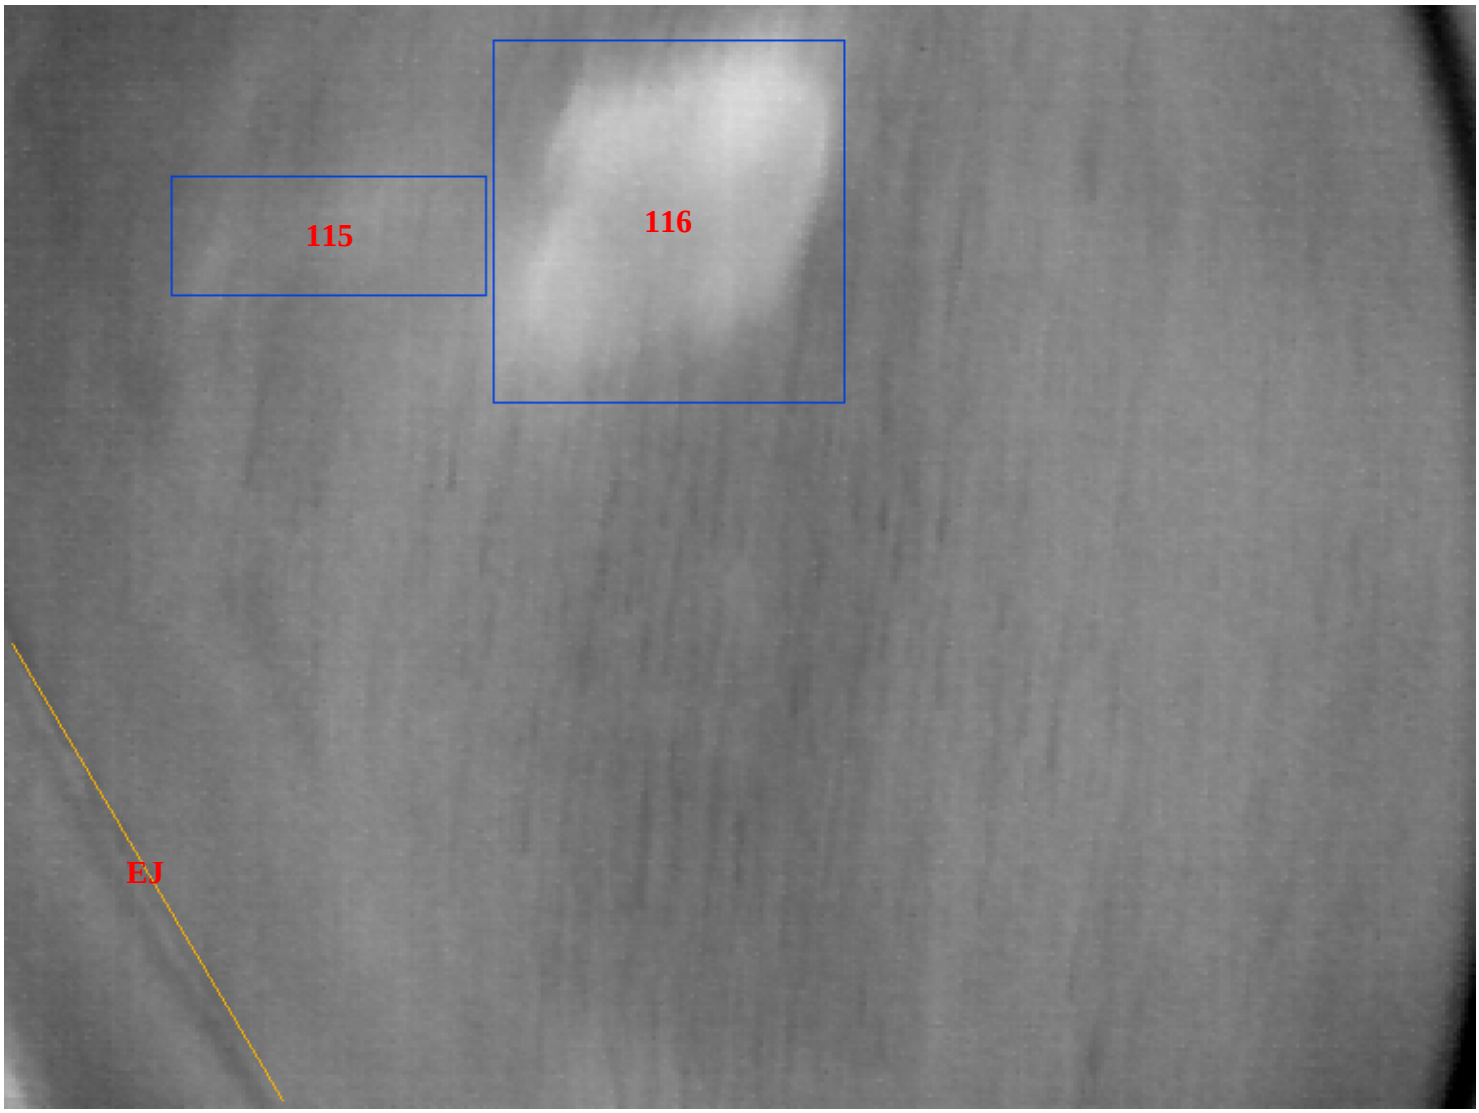
Bridge: 5003 NB Lane: 2 Image Name: 2_3147000_68883_337.tif

Defect #	EJ	115	116
Feet from Start	76.05	81.99	82.12
Feet from Right	26.64	24.91	21.67
Defect Size	NA	3.55 sq ft	11.94 sq ft
Length x Width (ft)	NA	1.13 x 3.01	3.40 x 3.35
Type	Joint	Delam	Delam

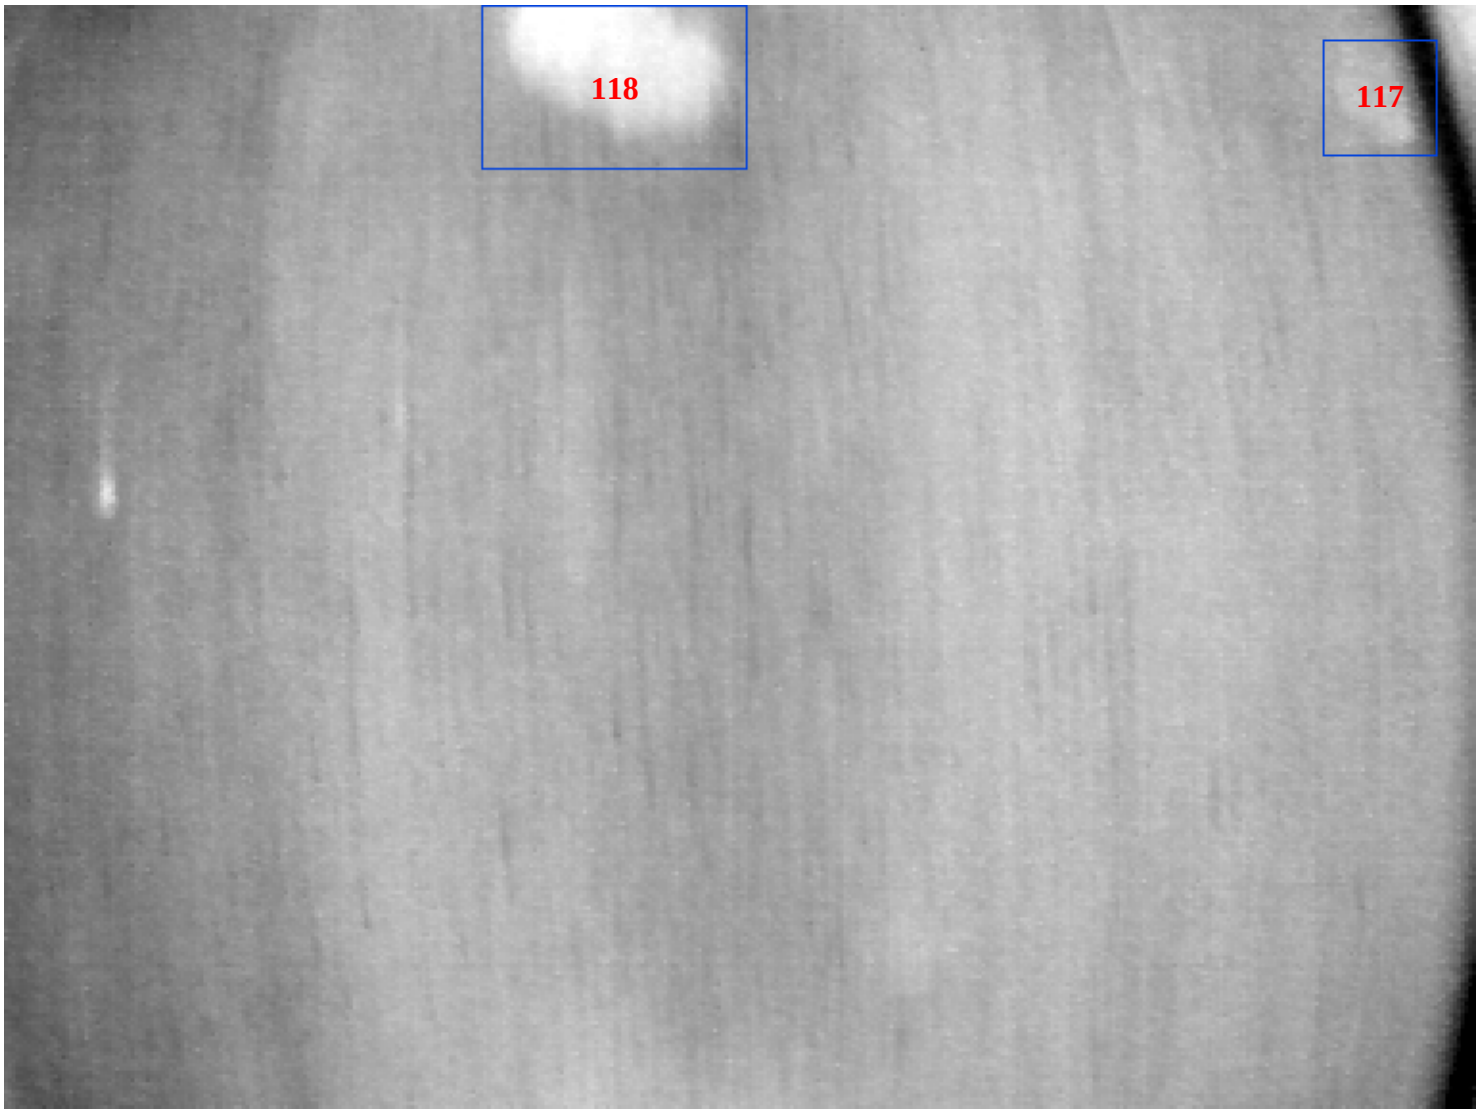
Bridge: 5003 NB Lane: 2 Image Name: 2_3323000_68883_337.tif

Defect #	117	118
Feet from Start	93.38	93.48
Feet from Right	14.91	22.19
Defect Size	1.25 sq ft	4.08 sq ft
Length x Width (ft)	1.09 x 1.09	1.54 x 2.53
Type	Delam	Delam

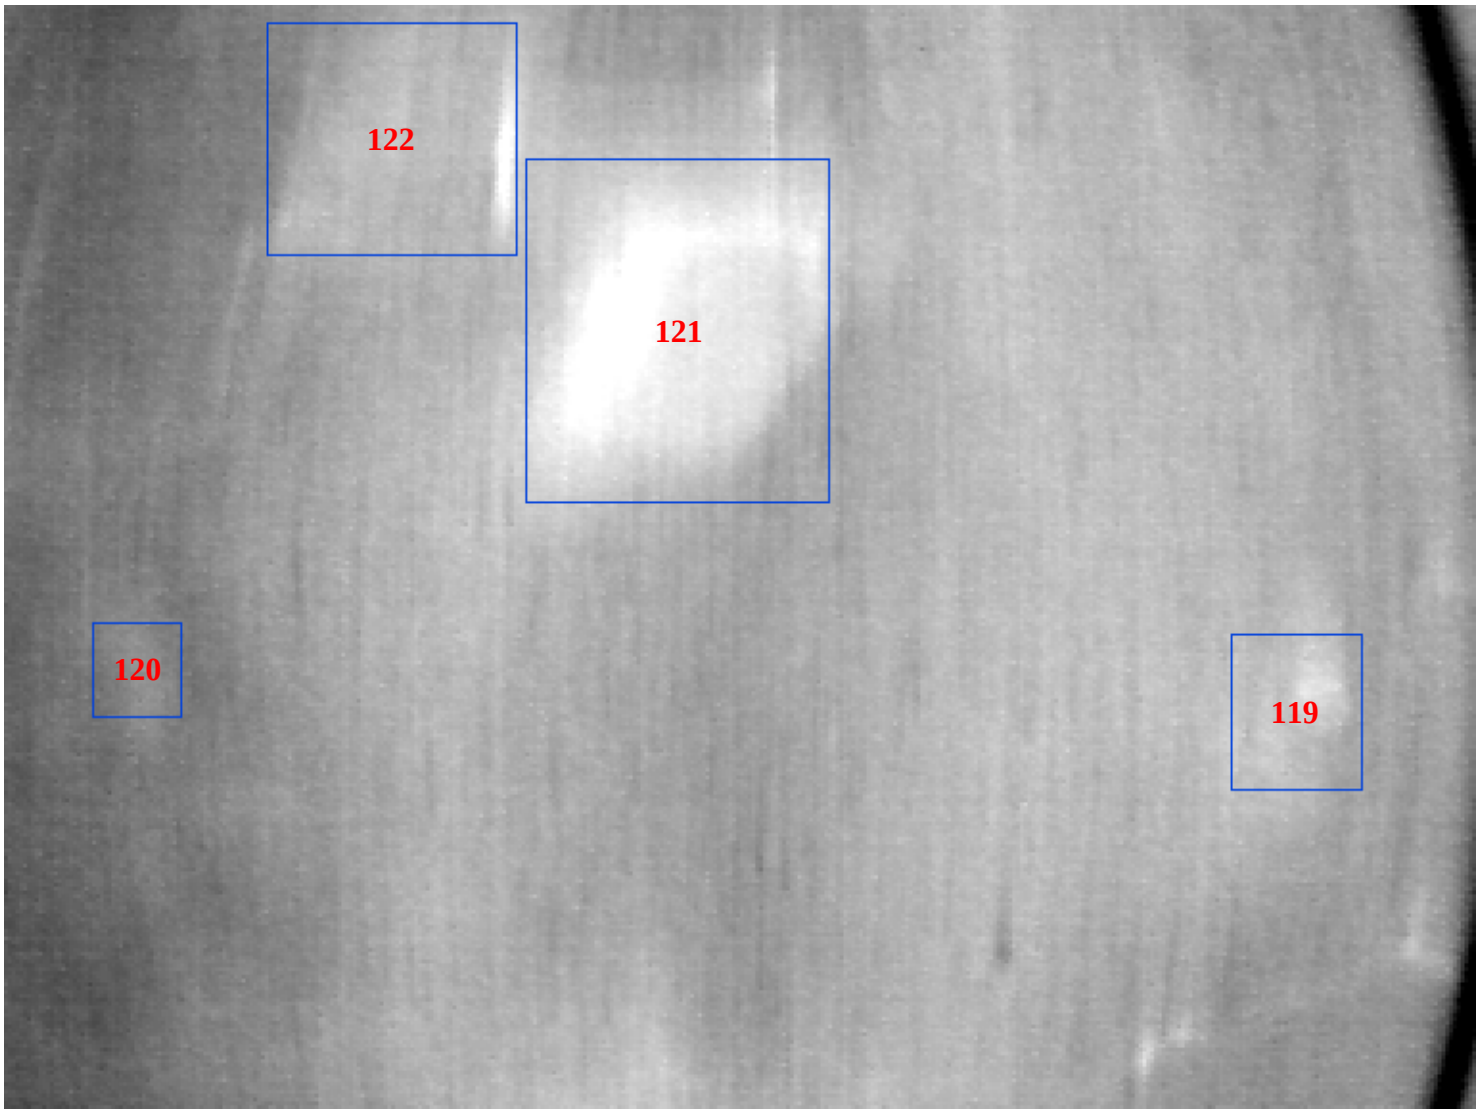
Bridge: 5003 NB Lane: 2 Image Name: 2_3504000_68883_337.tif

Defect #	119	120	121	122
Feet from Start	98.03	98.42	101.59	103.39
Feet from Right	15.70	26.73	21.59	24.31
Defect Size	1.93 sq ft	0.80 sq ft	9.78 sq ft	5.46 sq ft
Length x Width (ft)	1.47 x 1.26	0.90 x 0.86	3.22 x 2.90	2.19 x 2.39
Type	Delam	Delam	Delam	Delam

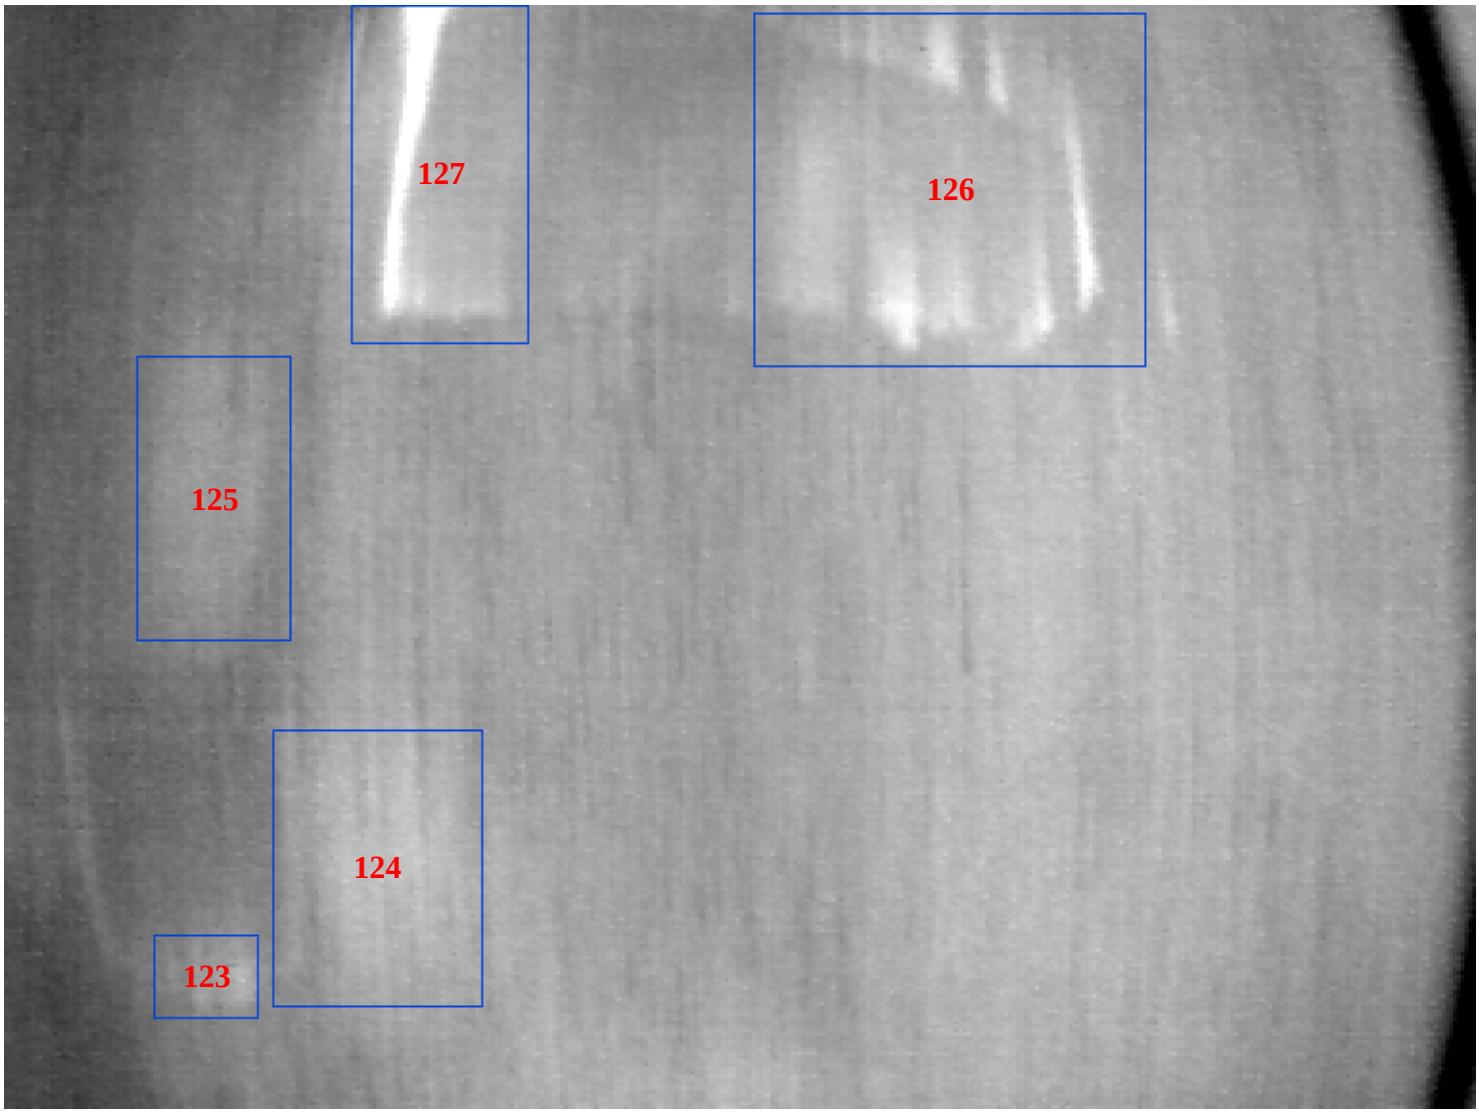
Bridge: 5003 NB Lane: 2 Image Name: 2_3690000_68883_337.tif

Defect #	123	124	125	126	127
Feet from Start	106.24	107.25	110.70	113.59	113.73
Feet from Right	26.08	24.45	26.00	19.00	23.85
Defect Size	0.83 sq ft	5.45 sq ft	4.12 sq ft	12.96 sq ft	5.62 sq ft
Length x Width (ft)	0.79 x 1.00	2.60 x 2.01	2.67 x 1.48	3.31 x 3.74	3.17 x 1.70
Type	Delam	Delam	Delam	Delam	Delam

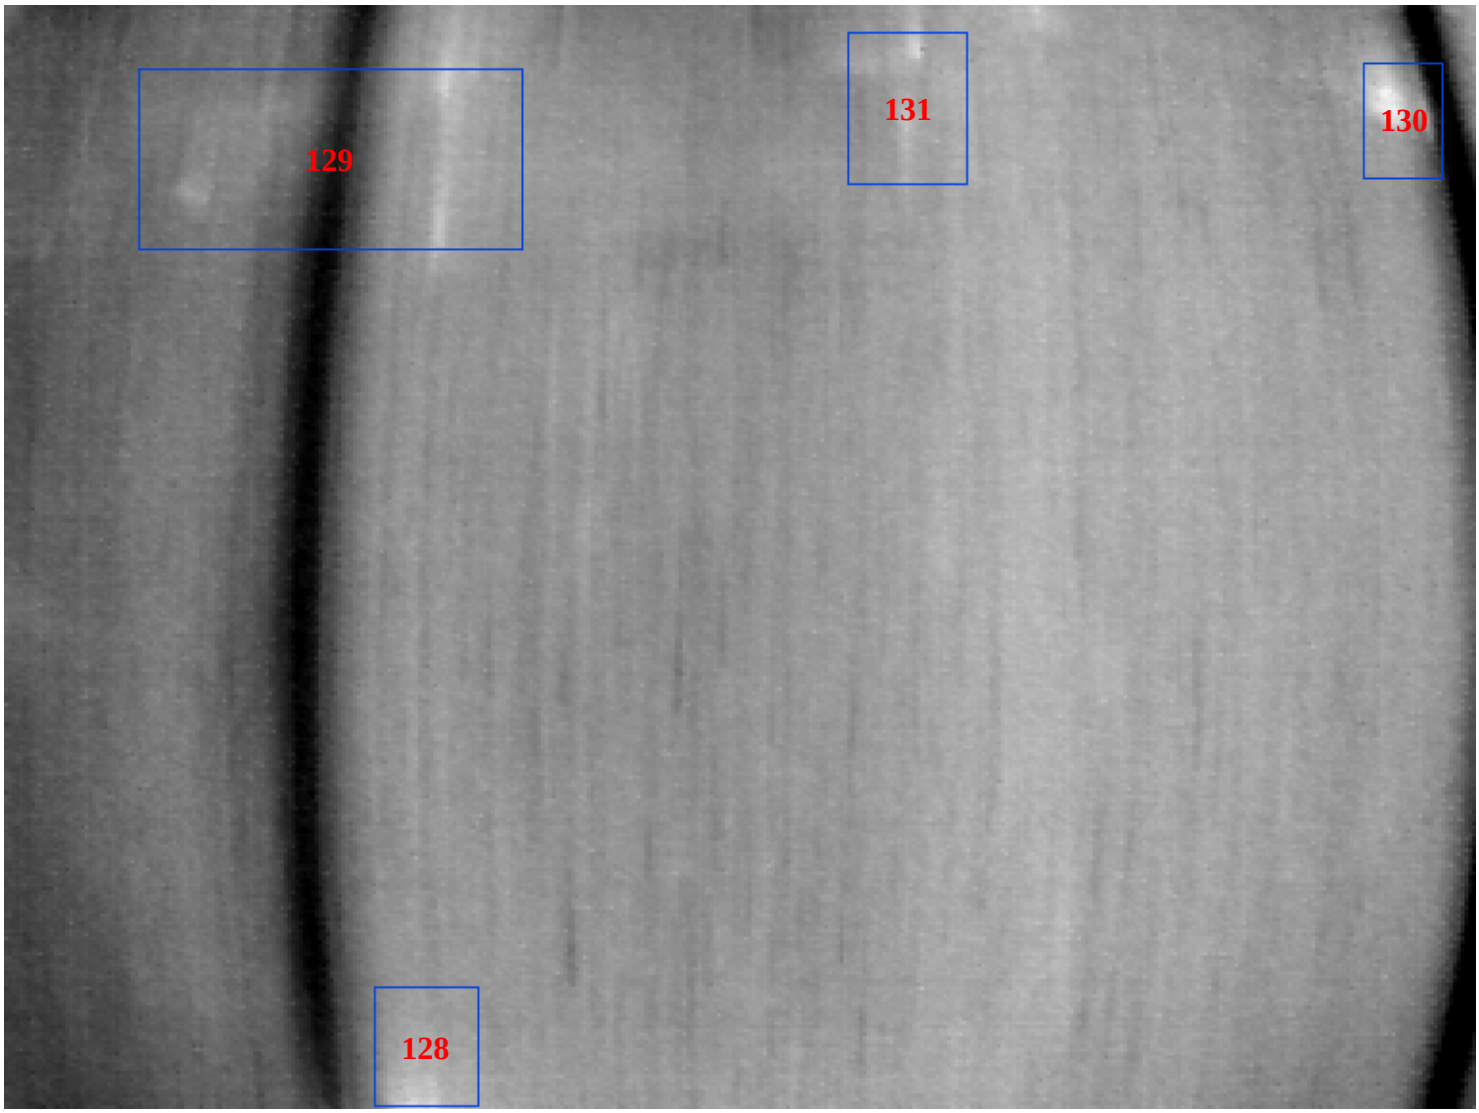
Bridge: 5003 NB Lane: 2 Image Name: 2_3872000_68883_337.tif

Defect #	128	129	130	131
Feet from Start	116.03	124.32	124.68	124.80
Feet from Right	23.98	24.89	14.69	19.40
Defect Size	1.18 sq ft	6.52 sq ft	0.88 sq ft	1.72 sq ft
Length x Width (ft)	1.13 x 1.00	1.70 x 3.66	1.09 x 0.77	1.43 x 1.15
Type	Delam	Delam	Delam	Delam

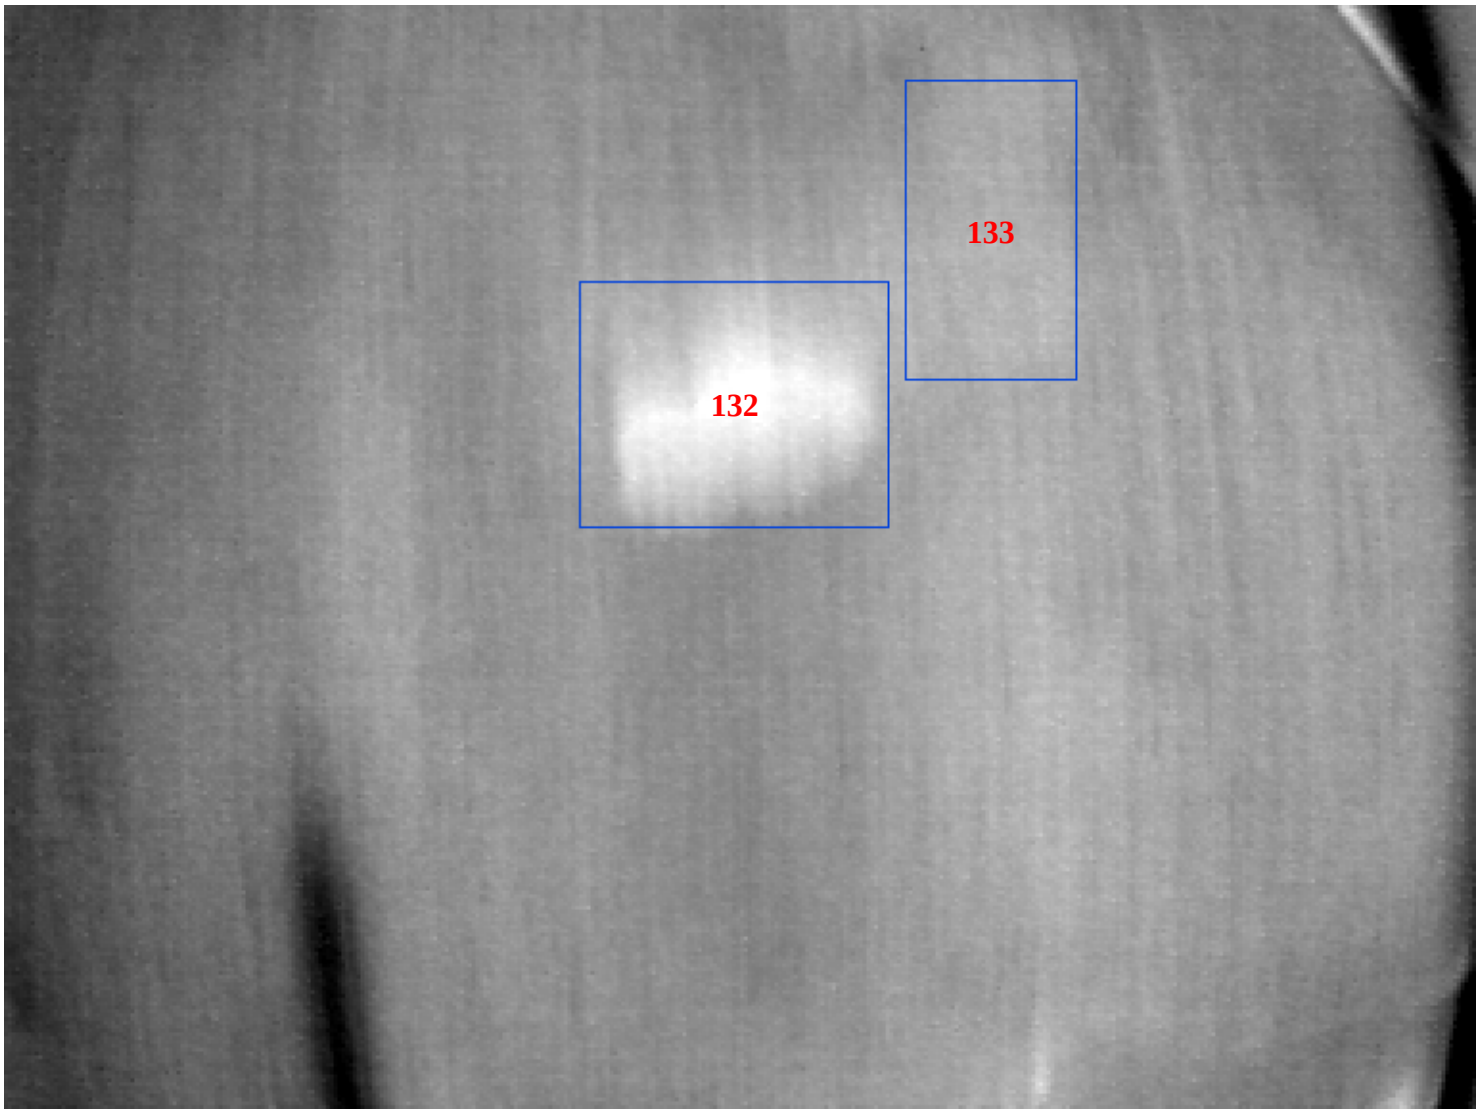
Bridge: 5003 NB Lane: 2 Image Name: 2_4052000_68761_344.tif

Defect #	132	133
Feet from Start	132.34	133.97
Feet from Right	21.05	18.61
Defect Size	7.14 sq ft	4.83 sq ft
Length x Width (ft)	2.31 x 2.95	2.81 x 1.64
Type	Delam	Delam

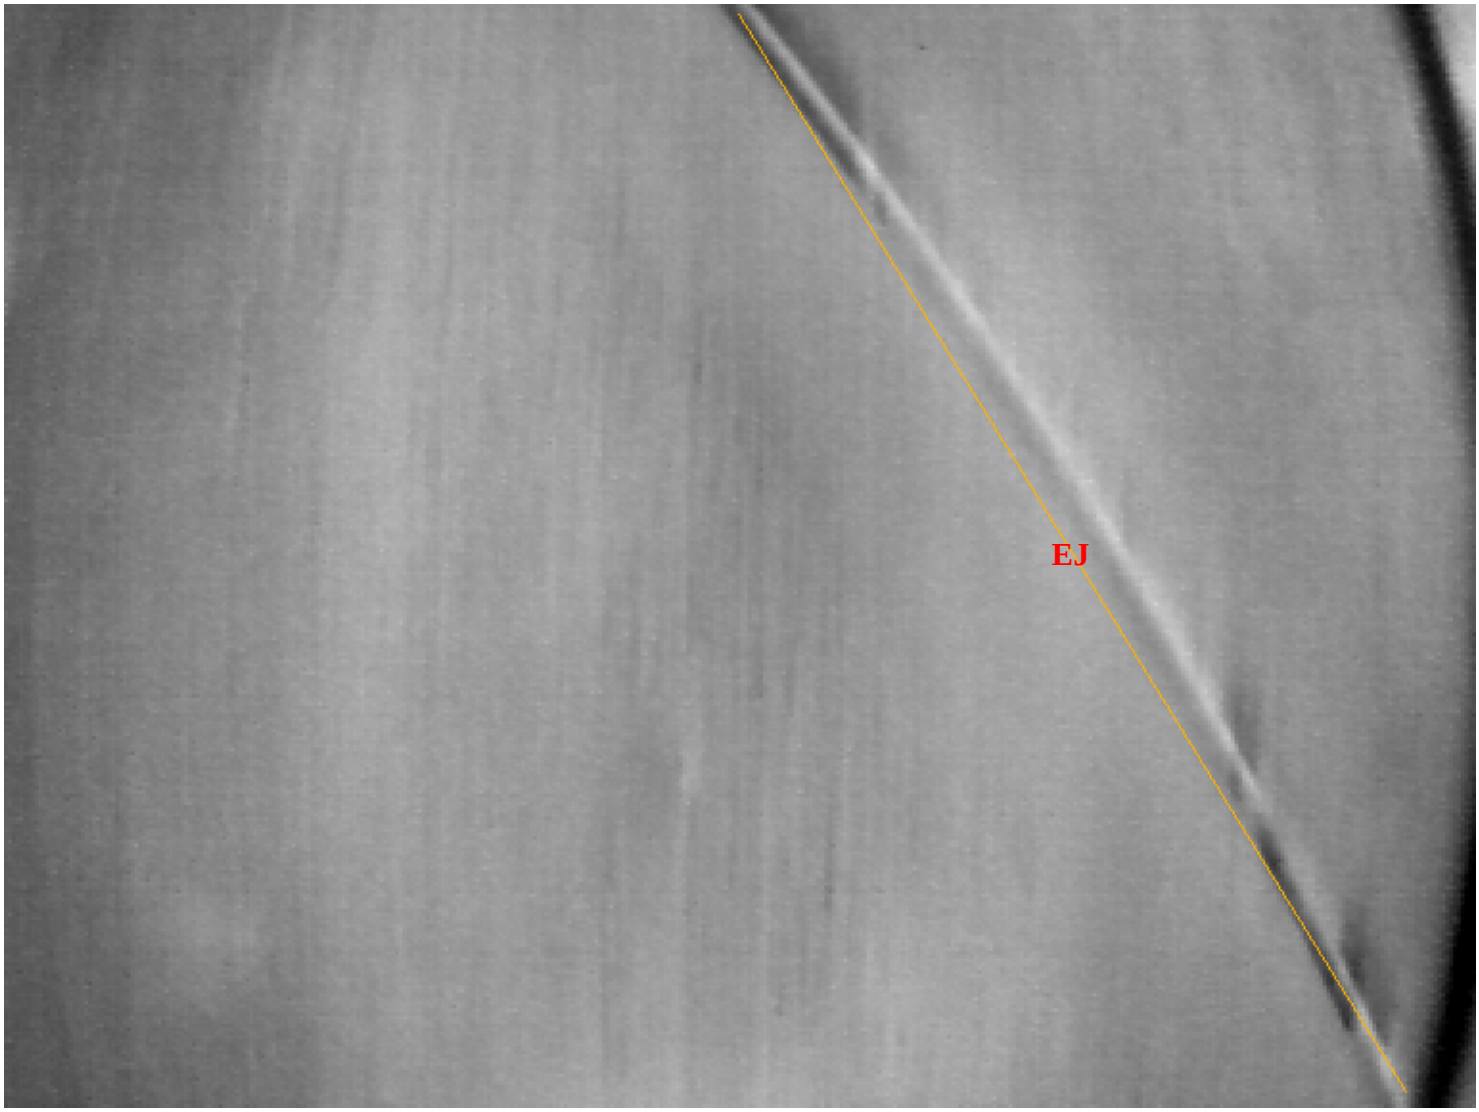
Bridge: 5003 NB Lane: 2 Image Name: 2_4239000_68761_344.tif

Defect #	EJ
Feet from Start	141.67
Feet from Right	17.85
Defect Size	NA
Length x Width (ft)	NA
Type	Joint

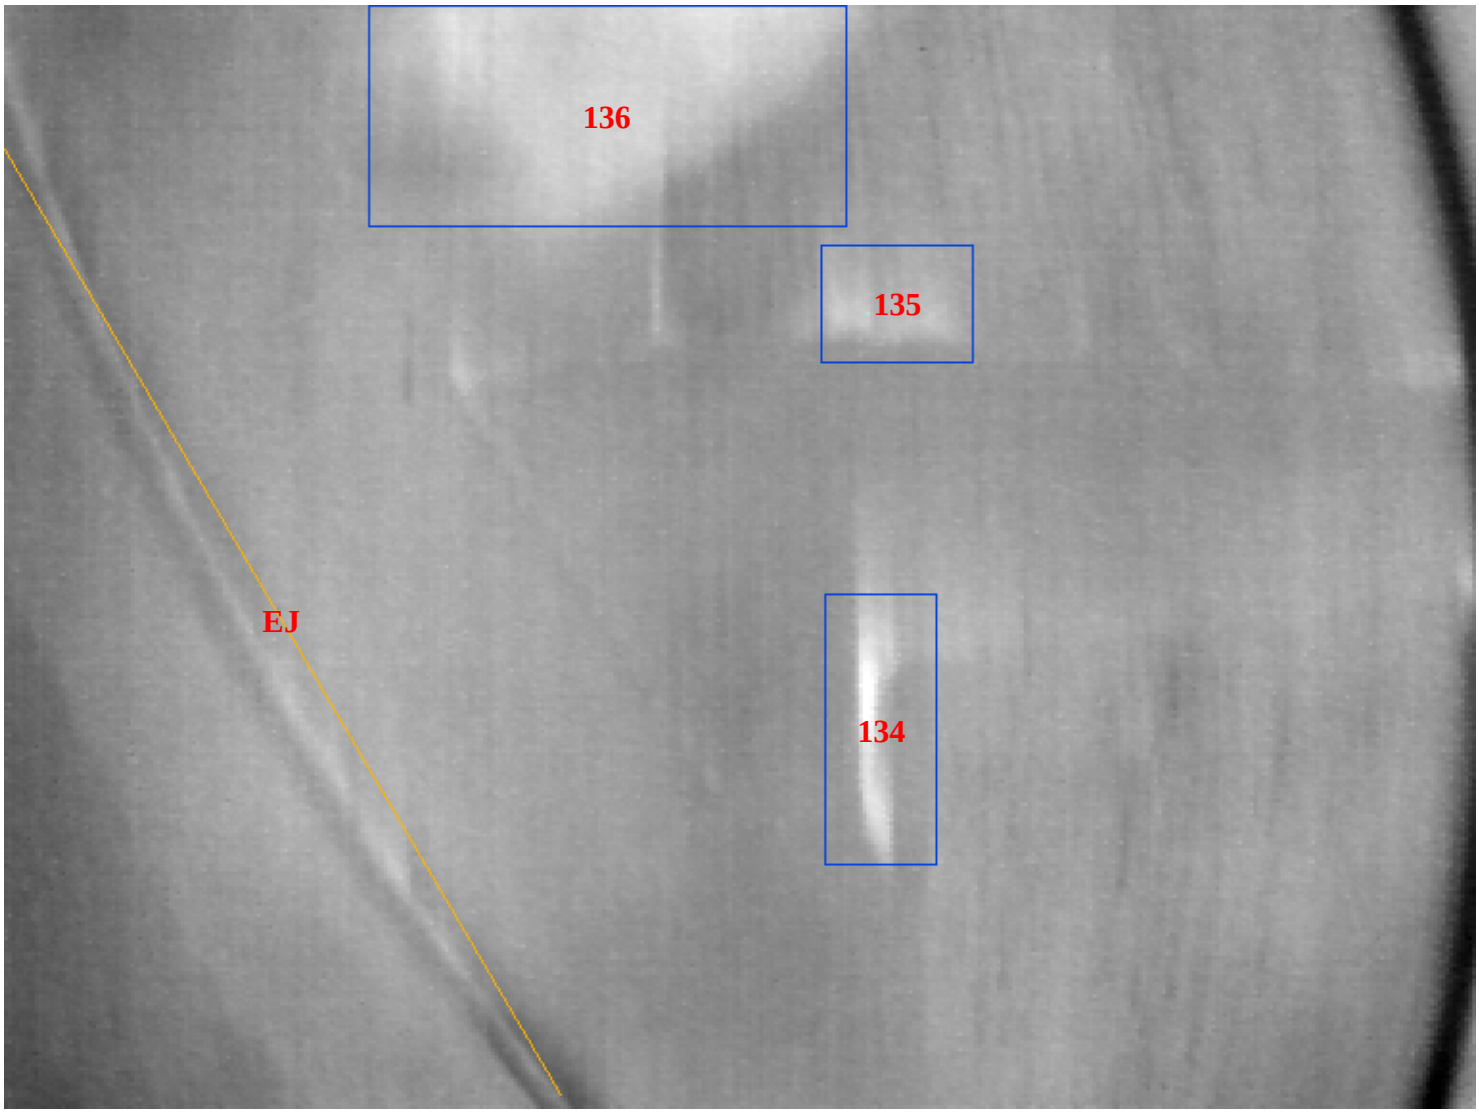
Bridge: 5003 NB Lane: 2 Image Name: 2_4418000_68761_344.tif

Defect #	134	EJ	135	136
Feet from Start	150.28	151.29	154.26	156.01
Feet from Right	19.66	25.36	19.51	22.26
Defect Size	2.86 sq ft	NA	1.69 sq ft	9.91 sq ft
Length x Width (ft)	2.54 x 1.08	NA	1.11 x 1.46	2.08 x 4.56
Type	Delam	Joint	Delam	Delam

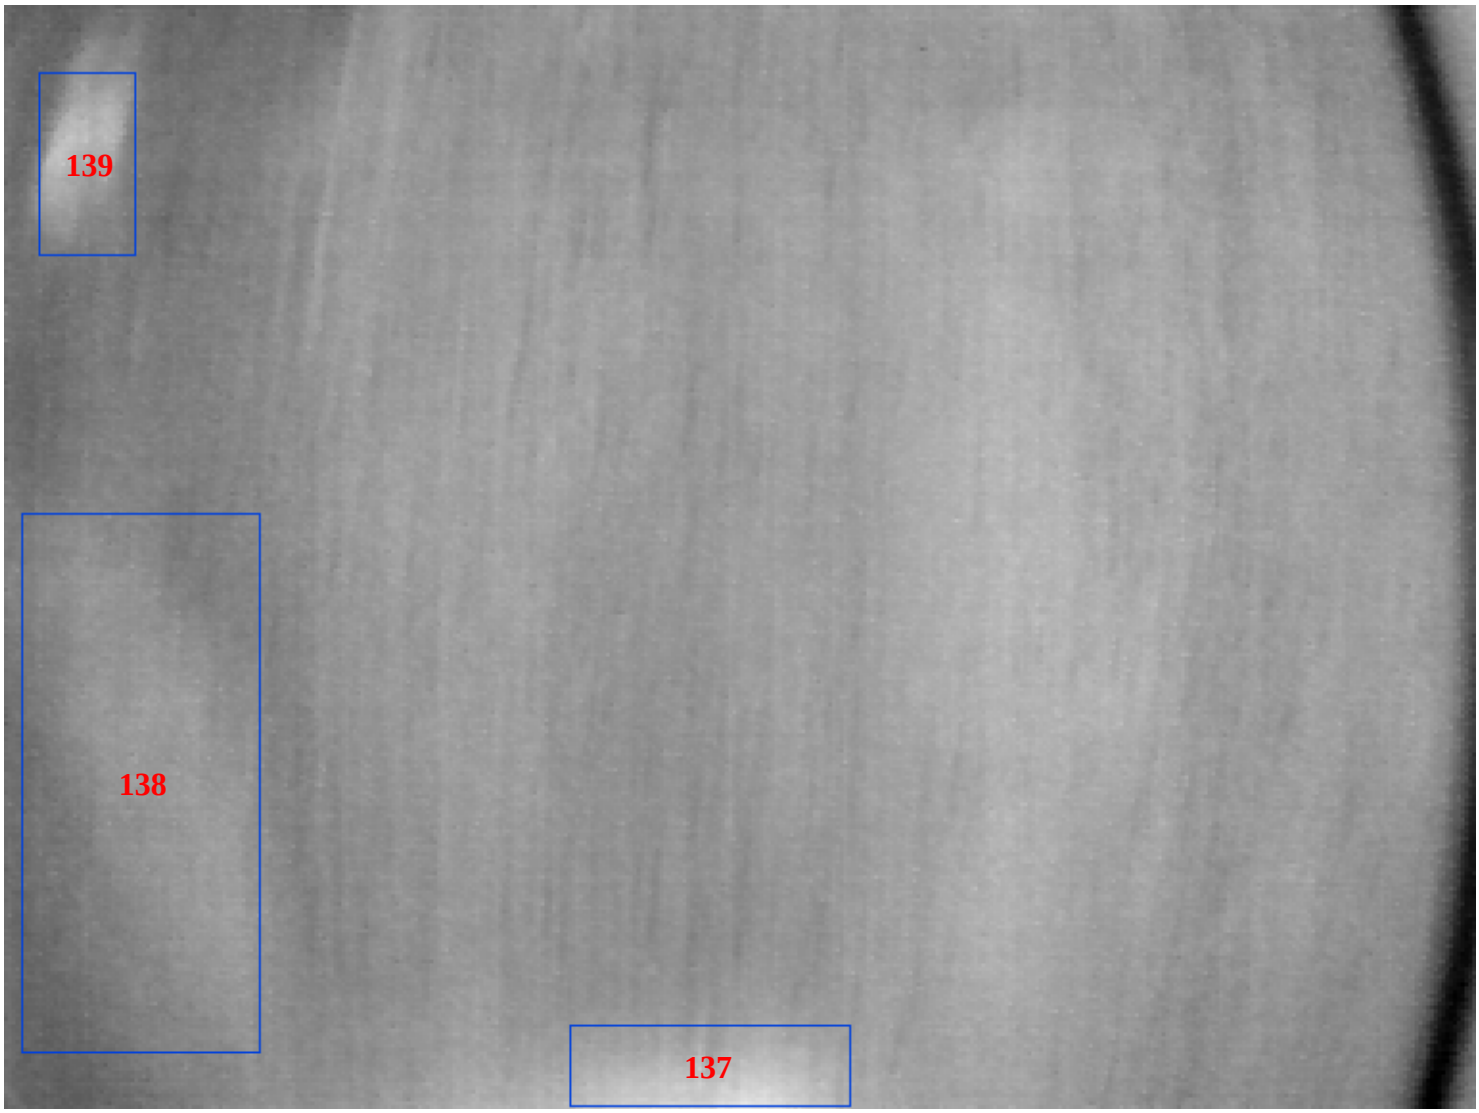
Bridge: 5003 NB Lane: 2 Image Name: 2_4598000_68761_344.tif

Defect #	137	138	139
Feet from Start	157.45	160.09	165.88
Feet from Right	21.28	26.70	27.21
Defect Size	2.16 sq ft	12.04 sq ft	1.67 sq ft
Length x Width (ft)	0.77 x 2.68	5.05 x 2.28	1.72 x 0.93
Type	Delam	Delam	Delam
