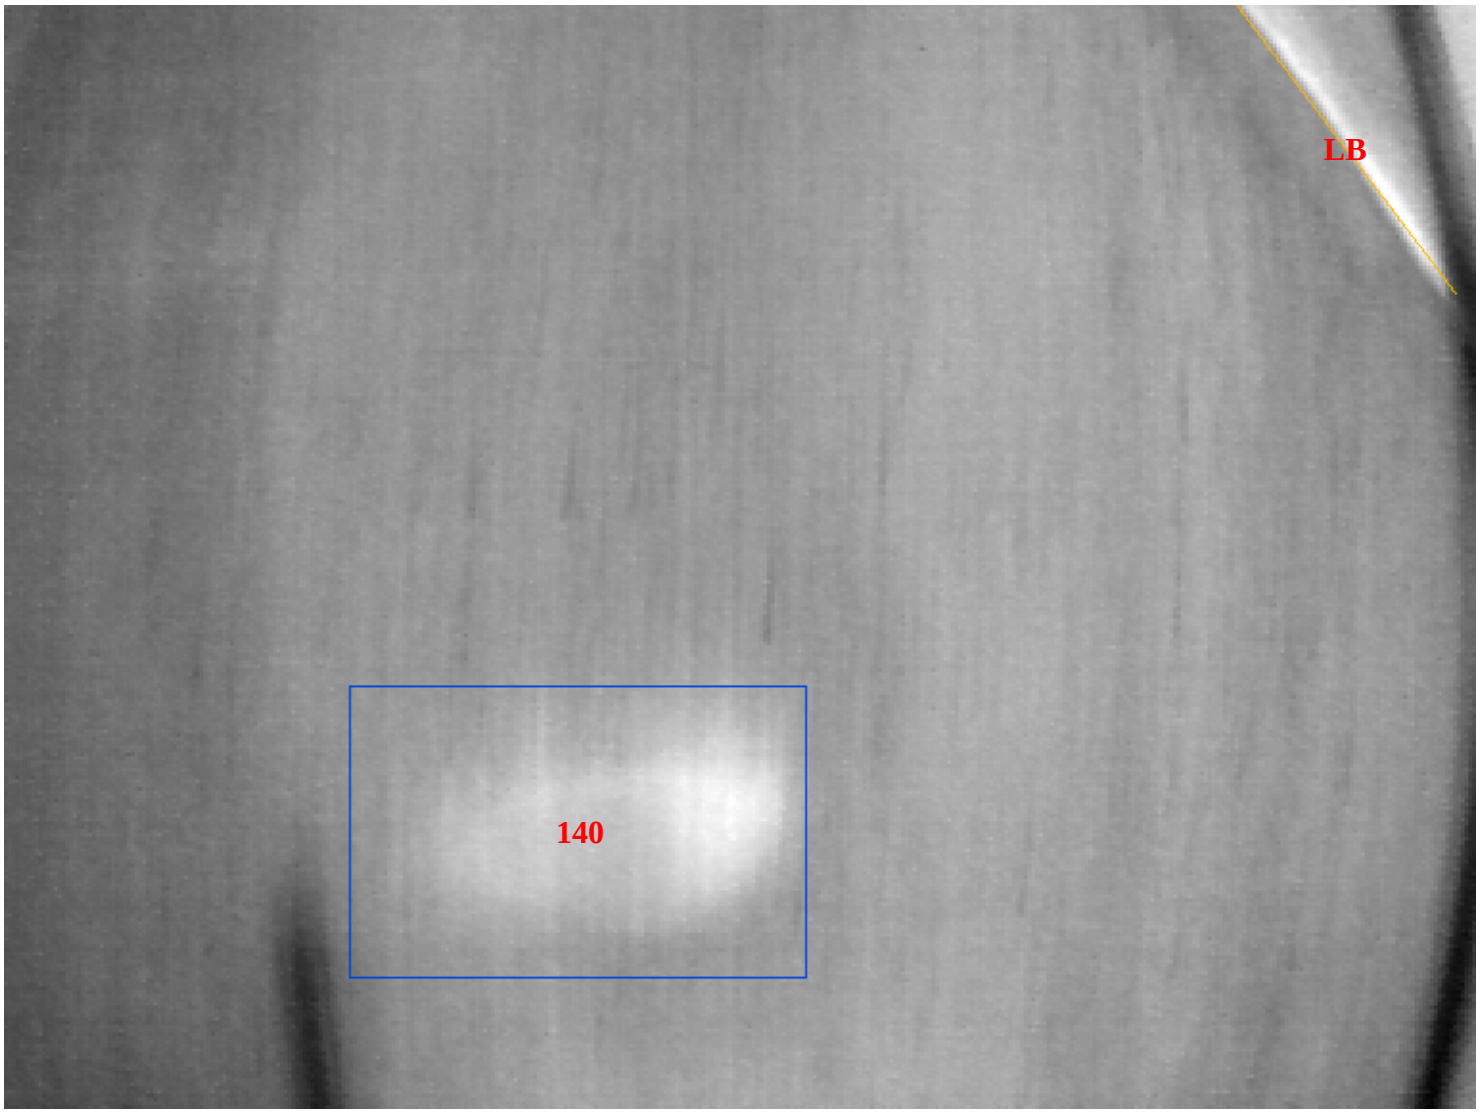
Bridge: 5003 NB Lane: 2 Image Name: 2_4957000_68761_344.tif

Defect #	140	LB
Feet from Start	180.21	186.59
Feet from Right	22.54	15.24
Defect Size	12.49 sq ft	NA
Length x Width (ft)	2.74 x 4.36	NA
Type	Delam	Lane Bound

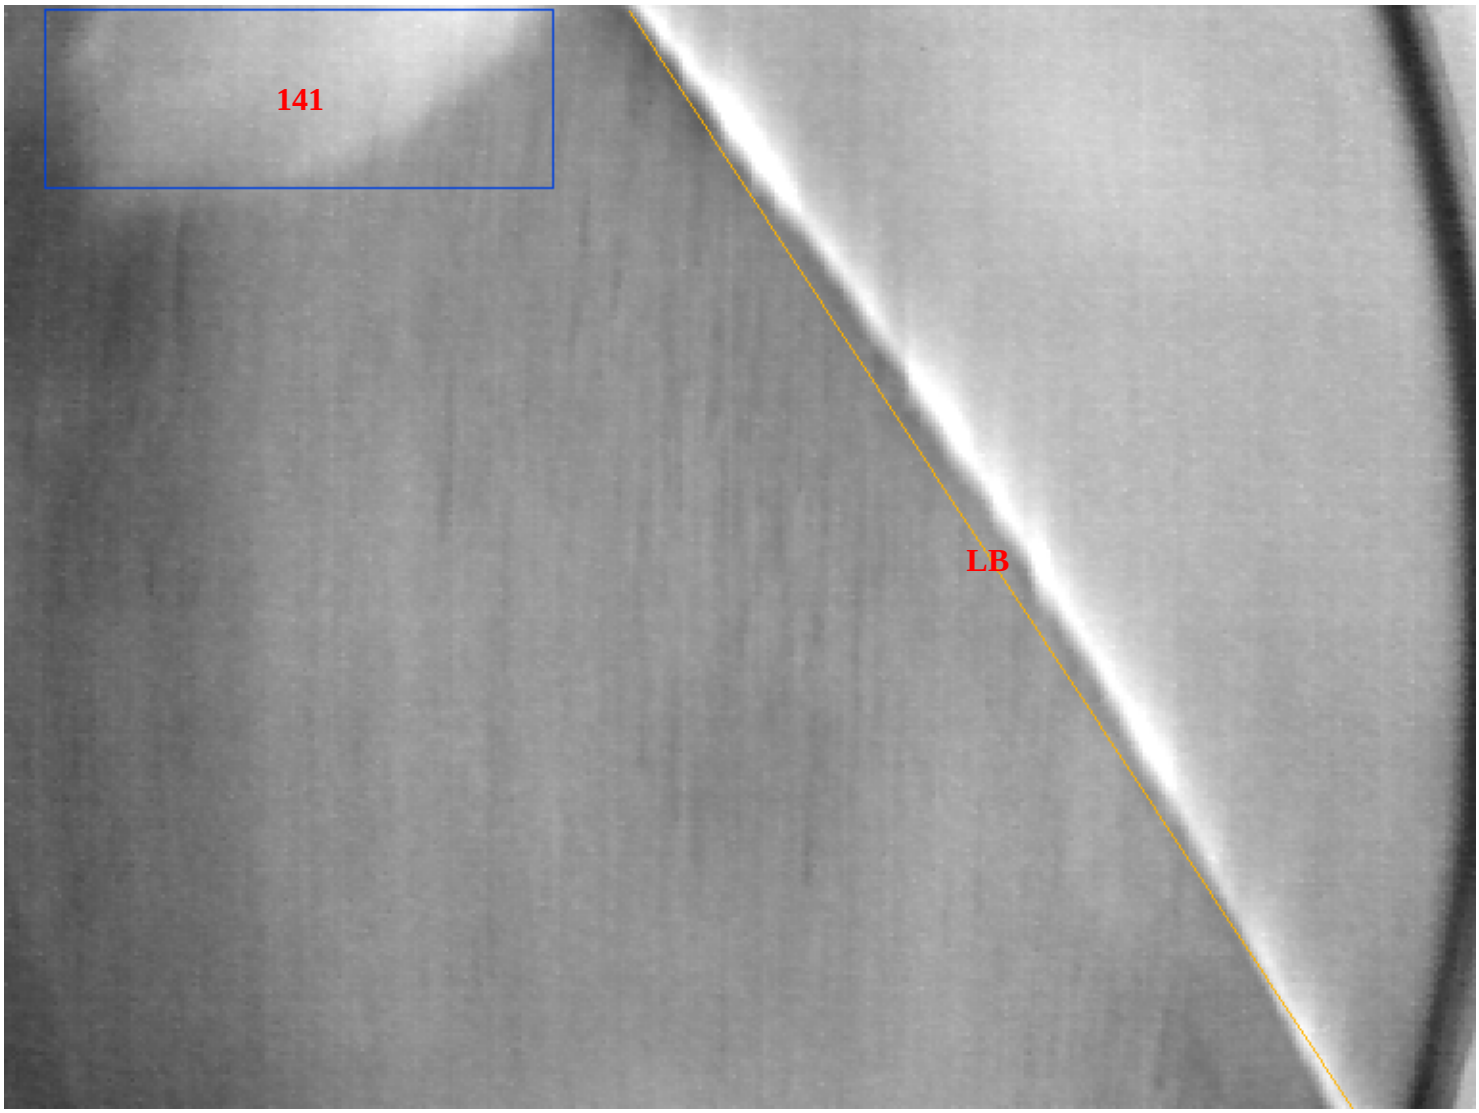
Bridge: 5003 NB Lane: 2 Image Name: 2_5143000_69045_348.tif

Defect #	LB	141
Feet from Start	193.46	197.76
Feet from Right	18.62	25.19
Defect Size	NA	8.54 sq ft
Length x Width (ft)	NA	1.68 x 4.85
Type	Lane Bound	Delam

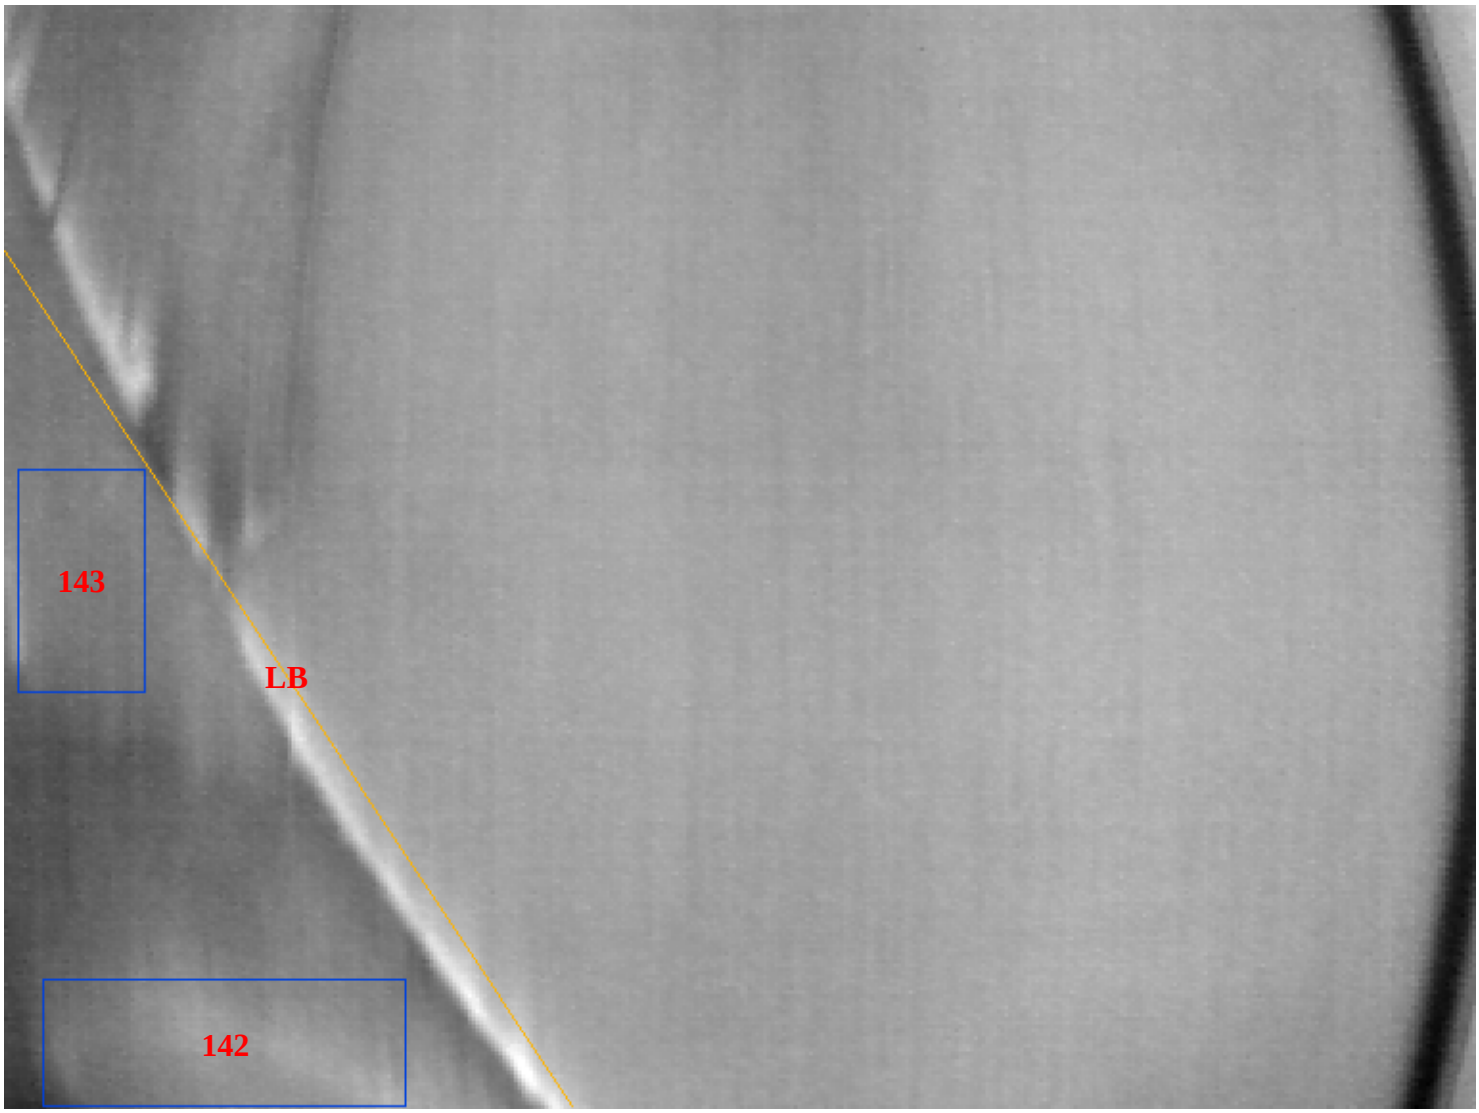
Bridge: 5003 NB Lane: 2 Image Name: 2_5320000_69045_348.tif

Defect #	142	LB	143
Feet from Start	199.12	202.53	203.44
Feet from Right	25.90	25.30	27.26
Defect Size	4.35 sq ft	NA	2.68 sq ft
Length x Width (ft)	1.20 x 3.46	NA	2.10 x 1.22
Type	Delam	Lane Bound	Delam

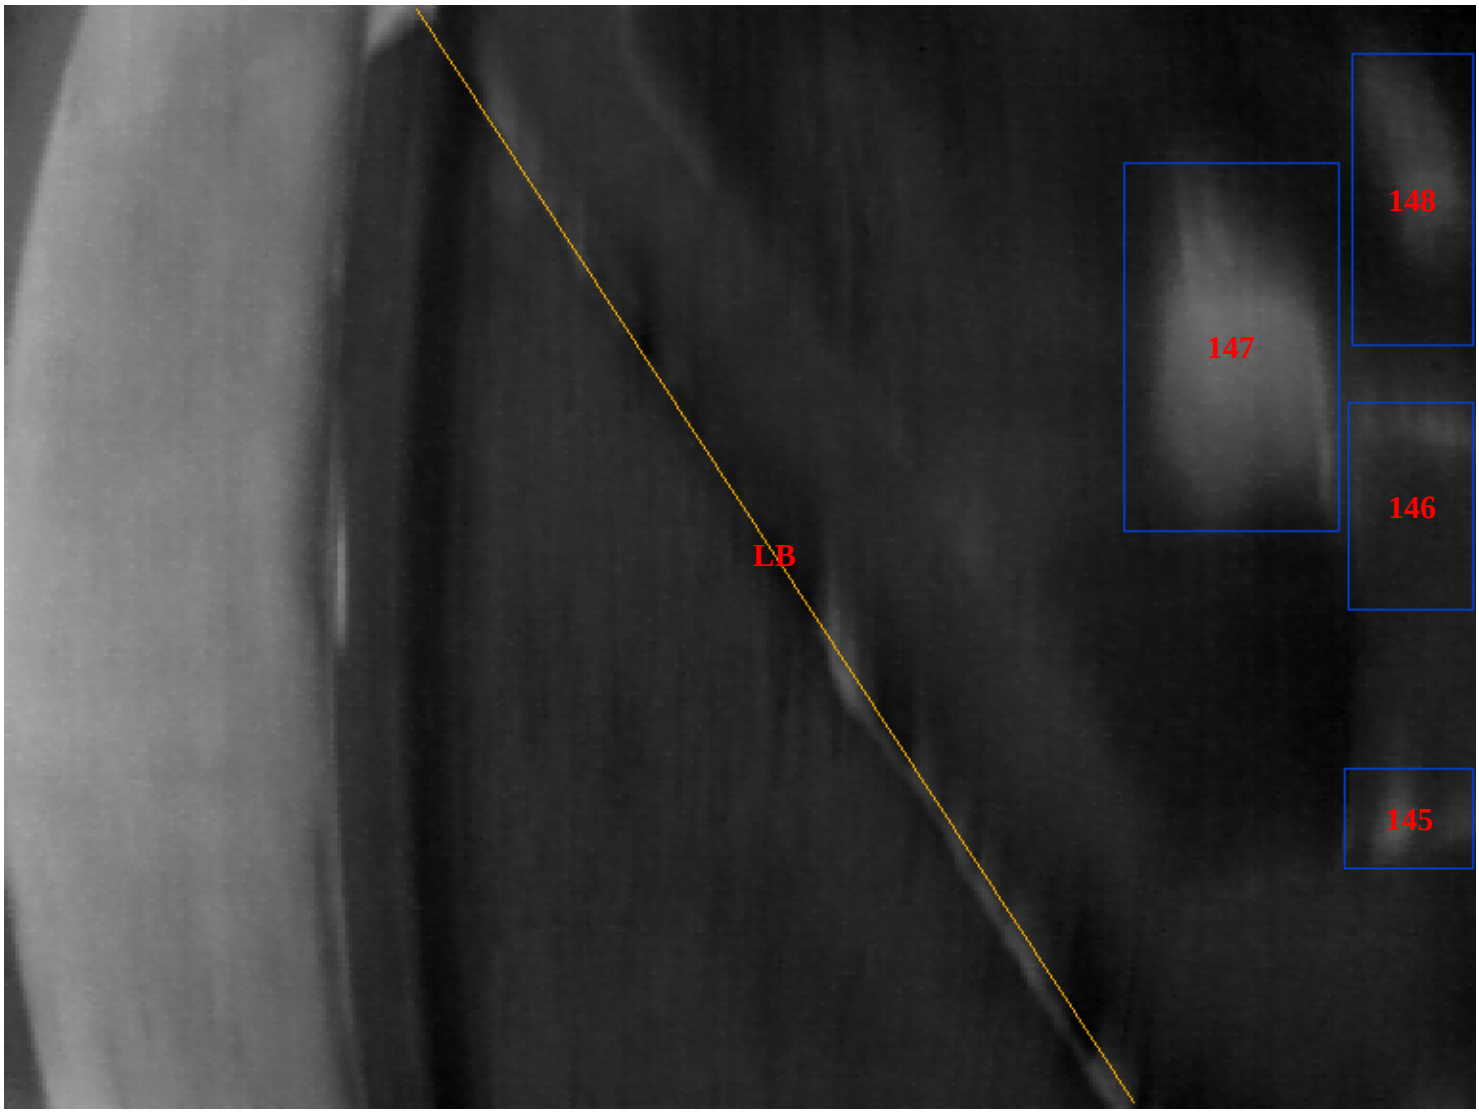
Bridge: 5003 NB Lane: 3 Image Name: 3_2503000_58007_332.tif

Defect #	145	LB	146	147	148
Feet from Start	6.82	9.28	9.74	11.22	12.60
Feet from Right	28.64	34.67	28.62	30.32	28.60
Defect Size	1.23 sq ft	NA	2.46 sq ft	7.45 sq ft	3.35 sq ft
Length x Width (ft)	0.95 x 1.24	NA	1.95 x 1.20	3.46 x 2.06	2.74 x 1.17
Type	Delam	Lane Bound	Delam	Delam	Delam

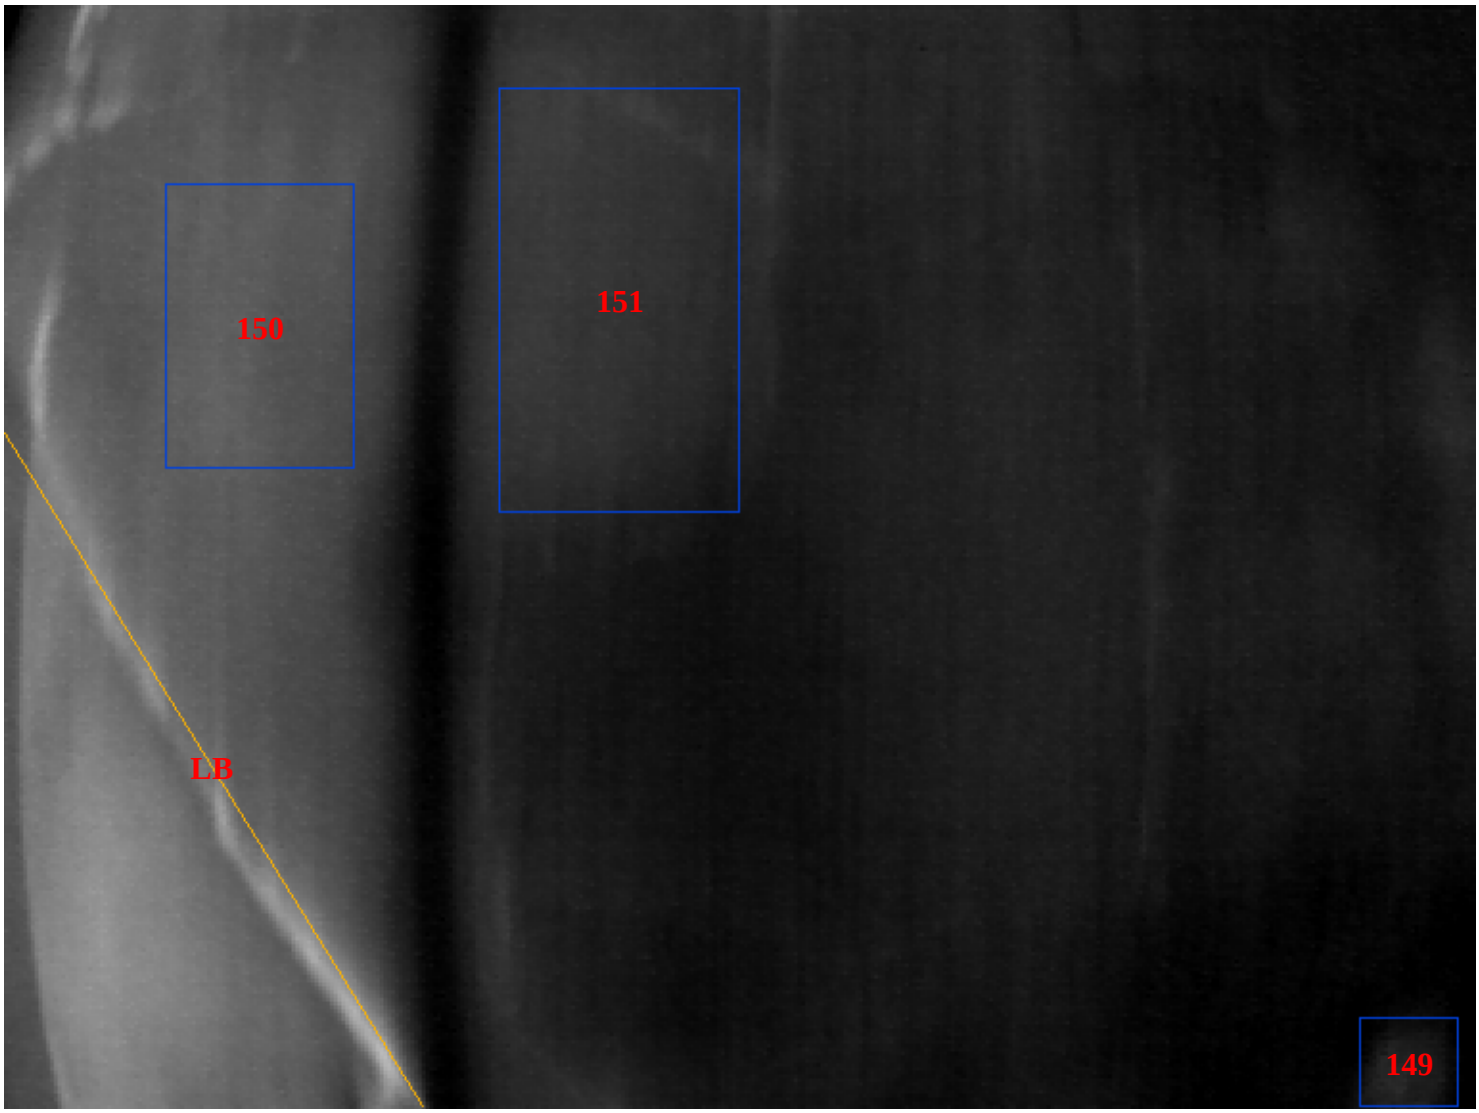
Bridge: 5003 NB Lane: 3 Image Name: 3_2713000_58007_332.tif

Defect #	149	LB	150	151
Feet from Start	14.69	17.43	21.57	21.81
Feet from Right	28.64	40.01	39.57	36.15
Defect Size	0.83 sq ft	NA	5.04 sq ft	9.56 sq ft
Length x Width (ft)	0.84 x 0.95	NA	2.67 x 1.80	3.98 x 2.30
Type	Delam	Lane Bound	Delam	Delam

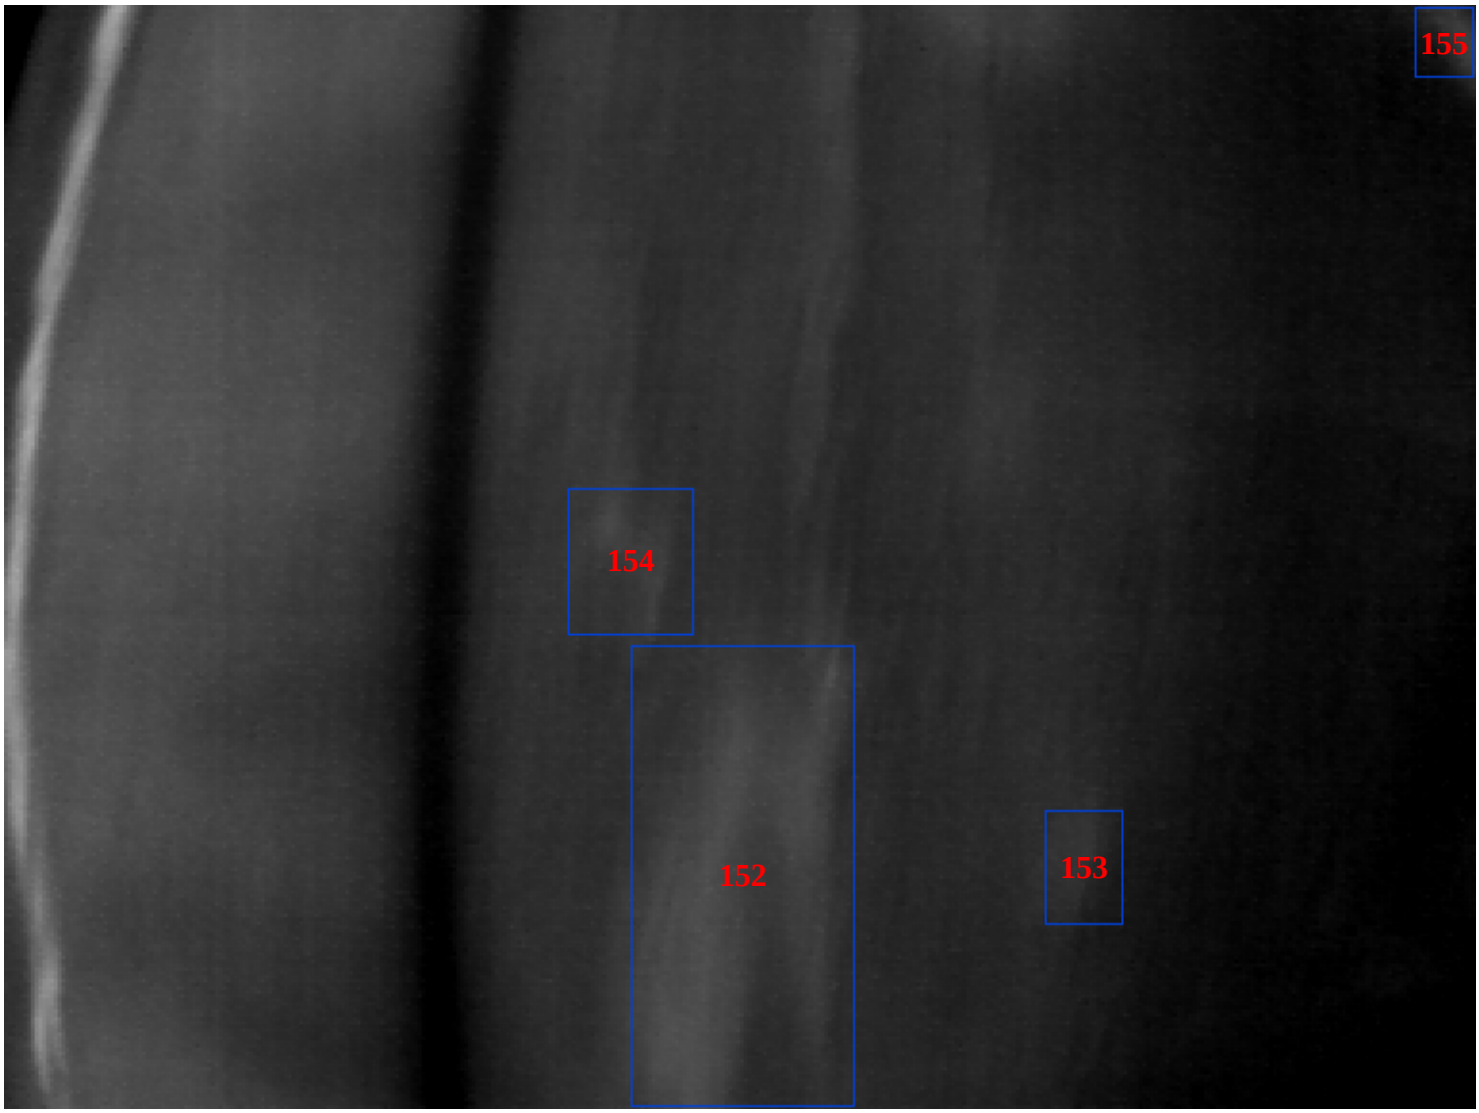
Bridge: 5003 NB Lane: 3 Image Name: 3_2926000_58007_332.tif

Defect #	152	153	154	155
Feet from Start	26.73	26.81	29.66	34.52
Feet from Right	34.97	31.73	36.04	28.30
Defect Size	9.63 sq ft	0.84 sq ft	1.74 sq ft	0.39 sq ft
Length x Width (ft)	4.32 x 2.13	1.07 x 0.75	1.38 x 1.20	0.66 x 0.57
Type	Delam	Delam	Delam	Delam

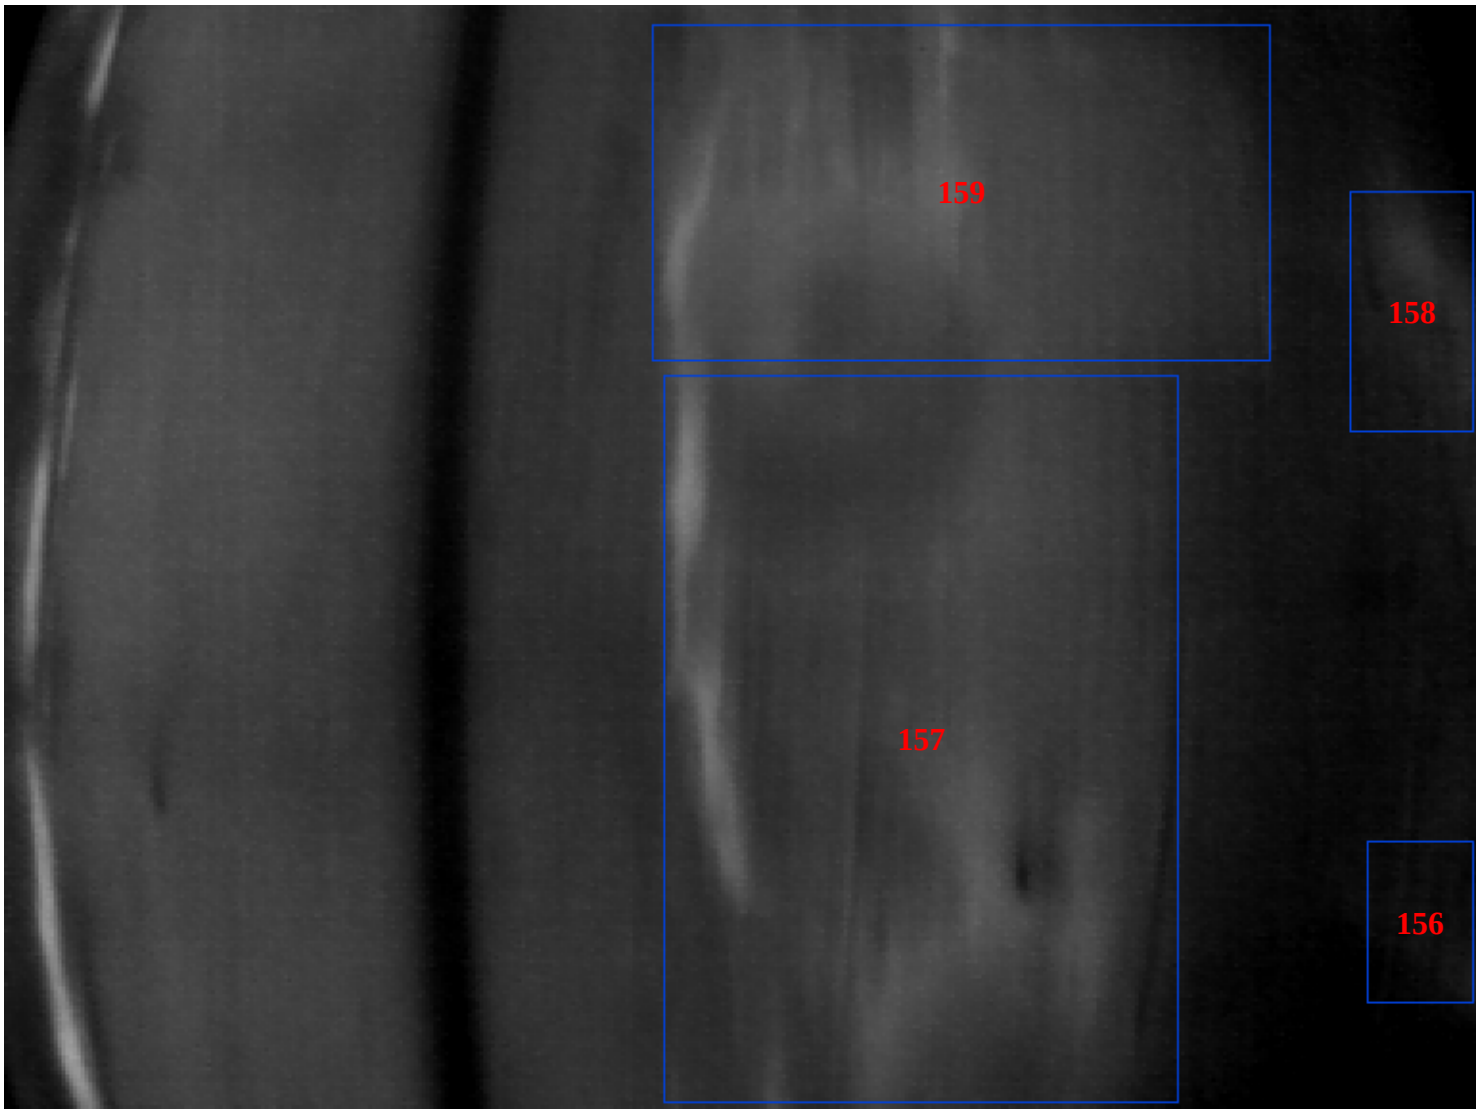
Bridge: 5003 NB Lane: 3 Image Name: 3_3137000_58007_332.tif

Defect #	156	157	158	159
Feet from Start	36.50	38.21	42.20	43.31
Feet from Right	28.53	33.28	28.61	32.89
Defect Size	1.63 sq ft	34.92 sq ft	2.80 sq ft	19.42 sq ft
Length x Width (ft)	1.52 x 1.02	6.81 x 4.90	2.26 x 1.18	3.15 x 5.89
Type	Delam	Delam	Delam	Delam

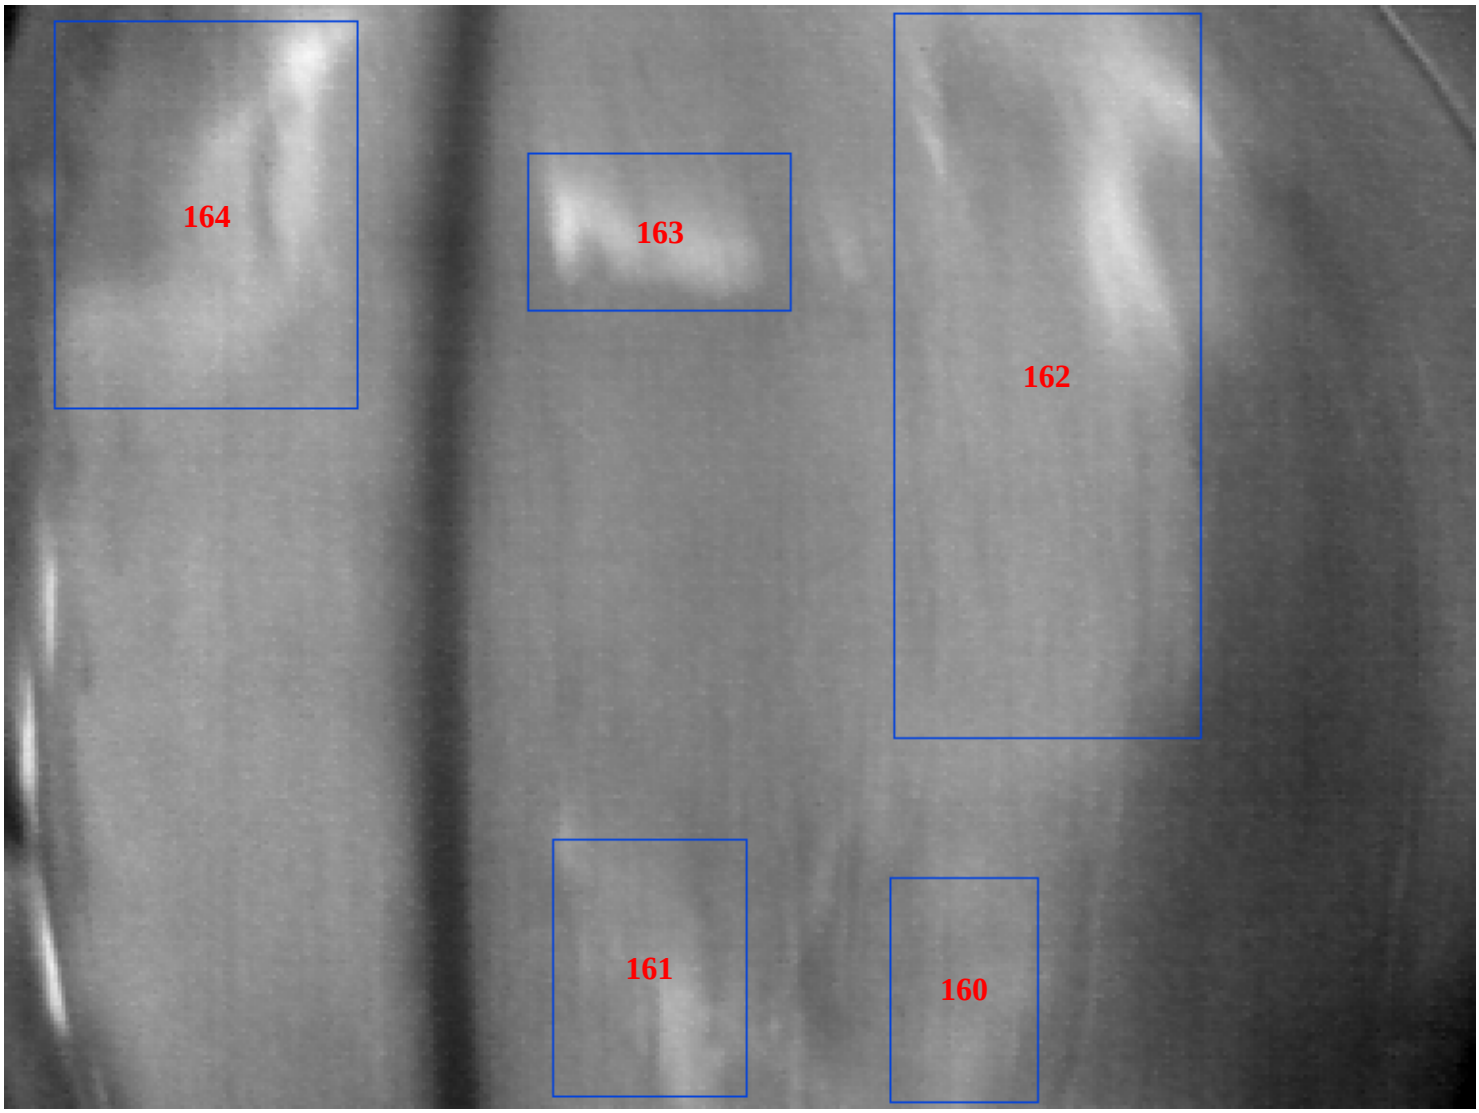
Bridge: 5003 NB Lane: 3 Image Name: 3_3355000_57824_341.tif

Defect #	160	161	162	163	164
Feet from Start	46.37	46.57	52.11	53.45	53.61
Feet from Right	32.87	35.86	32.07	35.77	40.08
Defect Size	3.14 sq ft	4.70 sq ft	20.85 sq ft	3.91 sq ft	11.03 sq ft
Length x Width (ft)	2.11 x 1.42	2.42 x 1.86	6.79 x 2.93	1.49 x 2.52	3.64 x 2.90
Type	Delam	Delam	Delam	Delam	Delam

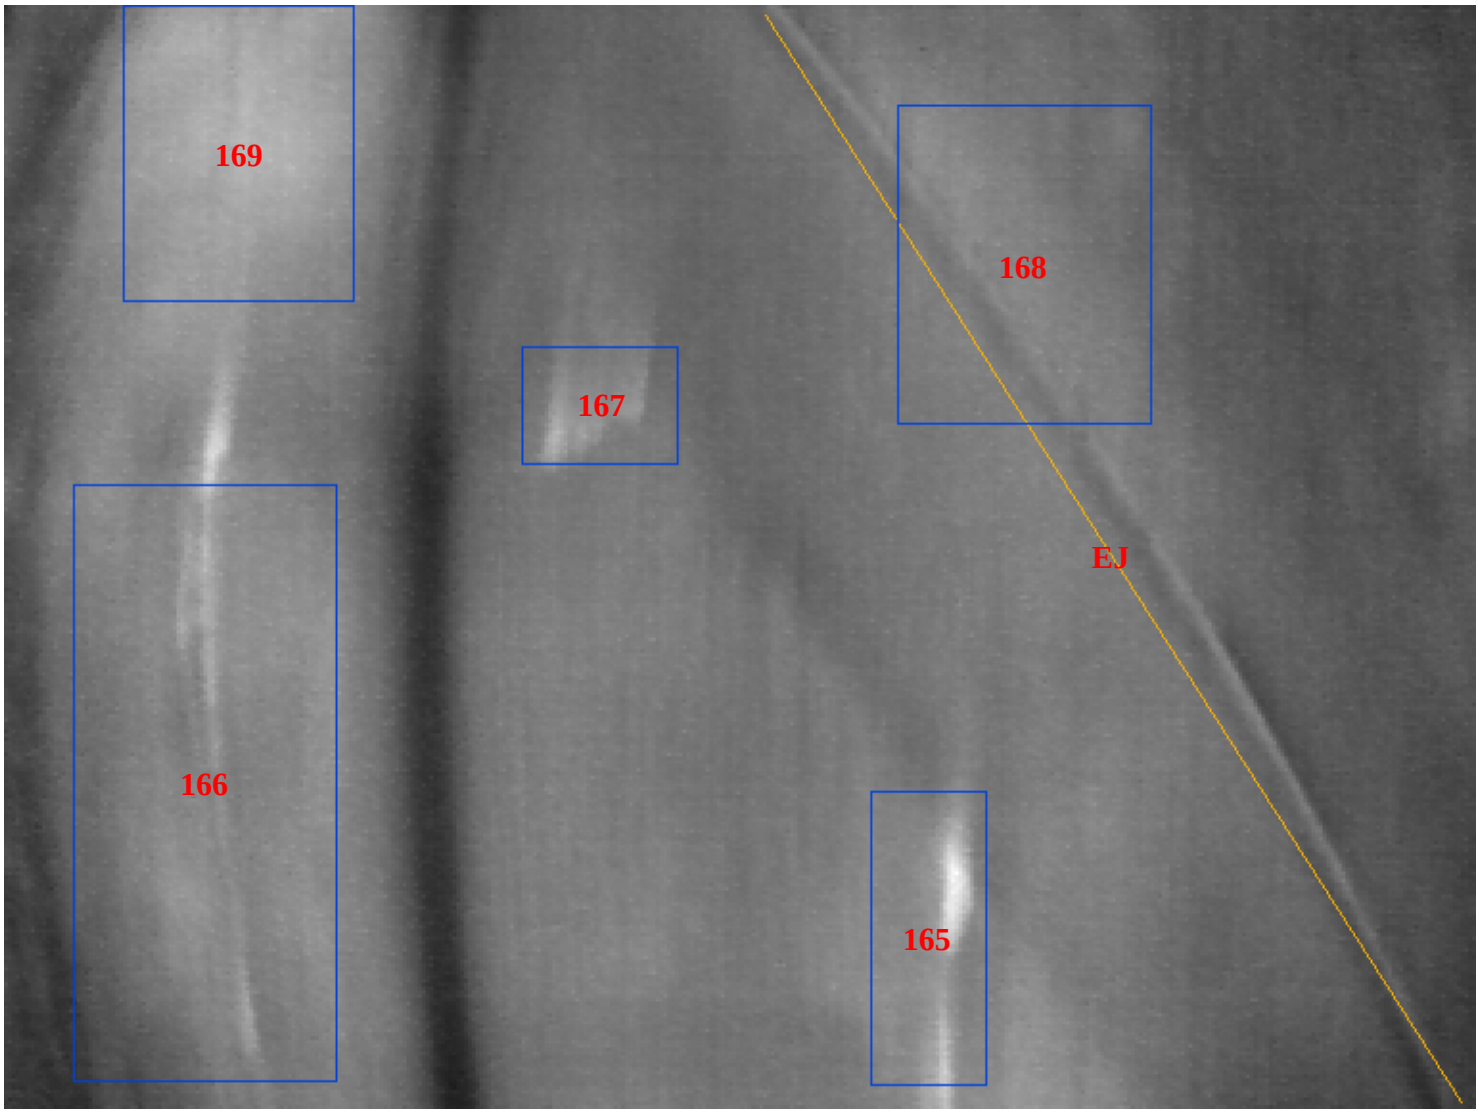
Bridge: 5003 NB Lane: 3 Image Name: 3_3569000_57824_341.tif

Defect #	165	166	EJ	167	168	169
Feet from Start	57.16	58.61	60.72	62.14	63.46	64.49
Feet from Right	33.20	40.09	31.45	36.33	32.29	39.77
Defect Size	3.21 sq ft	14.71 sq ft	NA	1.74 sq ft	7.59 sq ft	6.41 sq ft
Length x Width (ft)	2.76 x 1.11	5.59 x 2.52	NA	1.11 x 1.49	2.99 x 2.42	2.78 x 2.21
Type	Delam	Delam	Joint	Delam	Delam	Delam

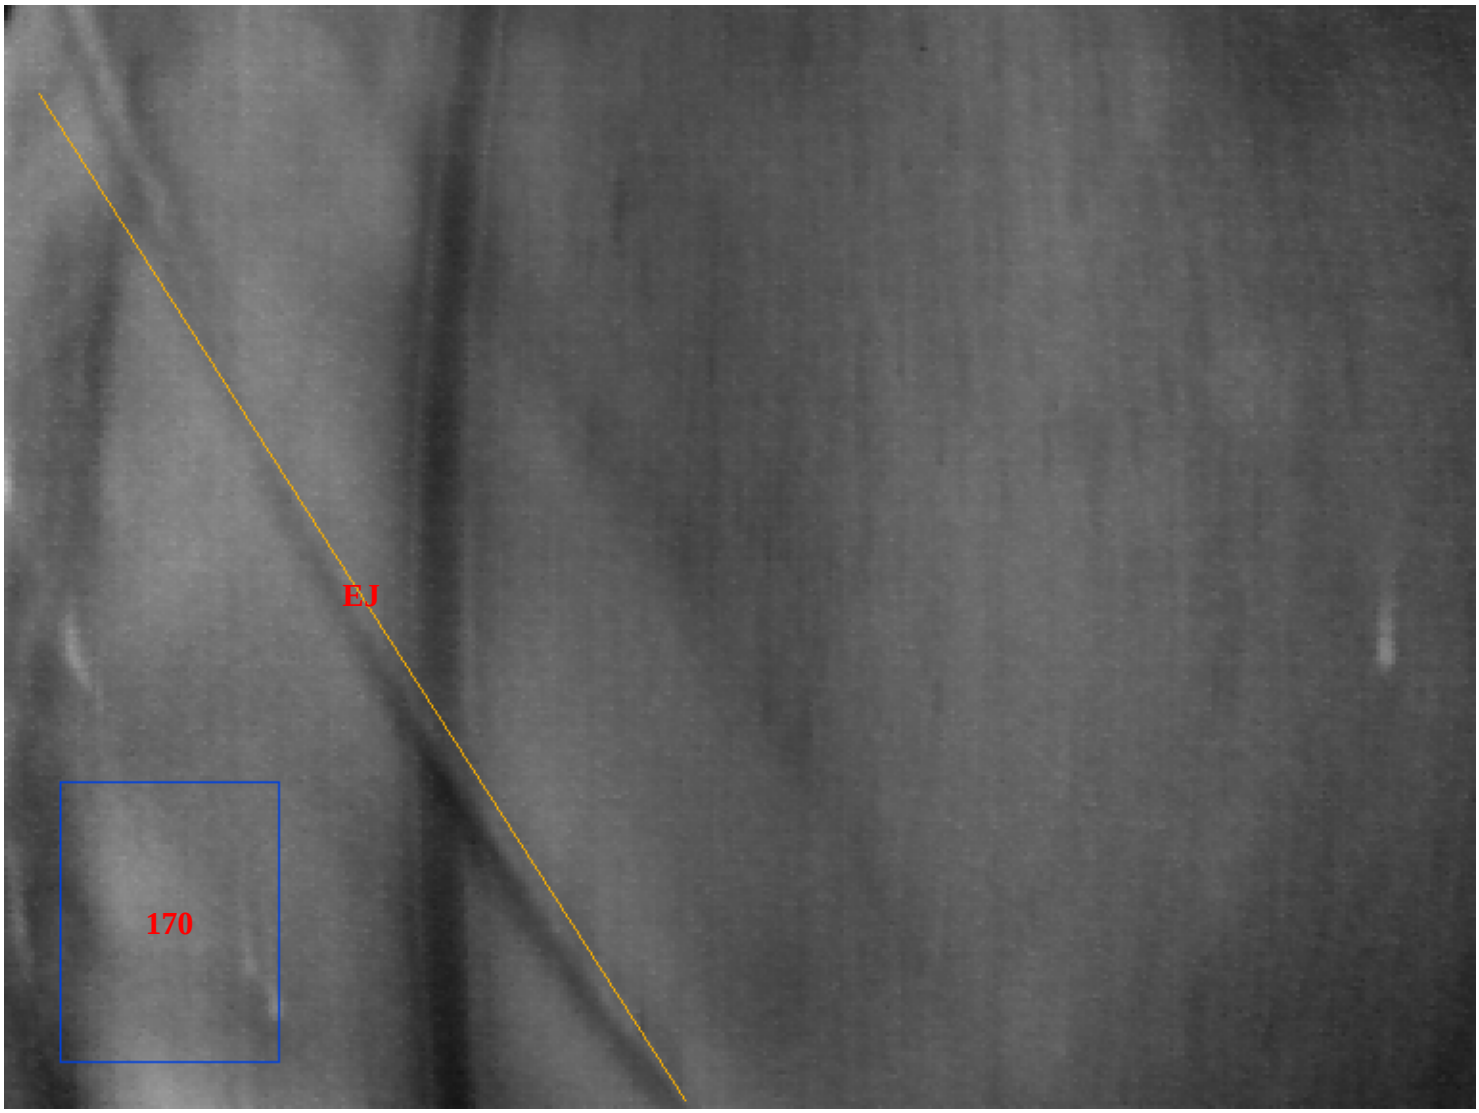
Bridge: 5003 NB Lane: 3 Image Name: 3_3783000_57824_341.tif

Defect #	170	EJ
Feet from Start	67.62	70.67
Feet from Right	40.42	38.60
Defect Size	5.78 sq ft	NA
Length x Width (ft)	2.63 x 2.10	NA
Type	Delam	Joint
