TRIMEDIA
ENVIRONMENTAL & ENGINEERING

Re: *Summary Report* – Professional Industrial Hygiene Services to Conduct a Mold Assessment at Camp Kitwen Correctional Facility in Painesdale, Michigan
TriMedia Project Number: 2018-199

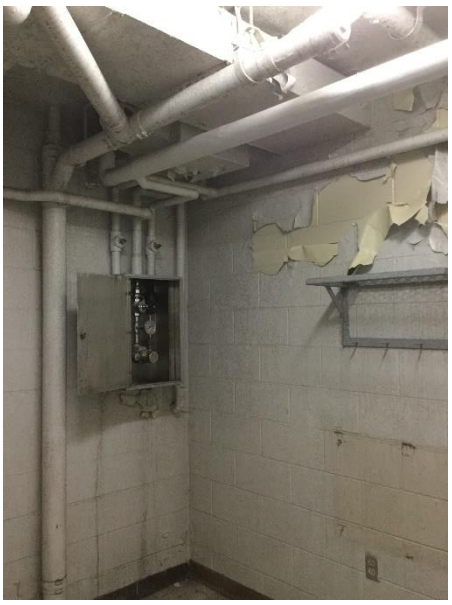
Description: Heavy mold growth and water damage in visiting area
Date: 10/9/2018 **Taken By: AGK**

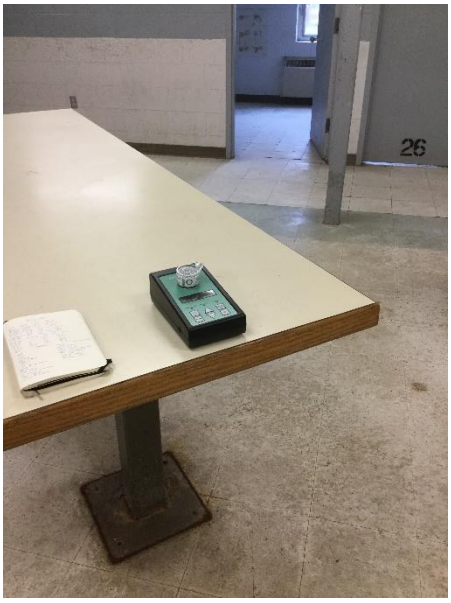
Description: Mold growth on walls
Date: 10/9/2018 **Taken By: AGK**
