SITE INSPECTION REPORT

C & H TAMARACK OPERATIONS

HUBBELL, MICHIGAN 49934

MARCH 10, 2015

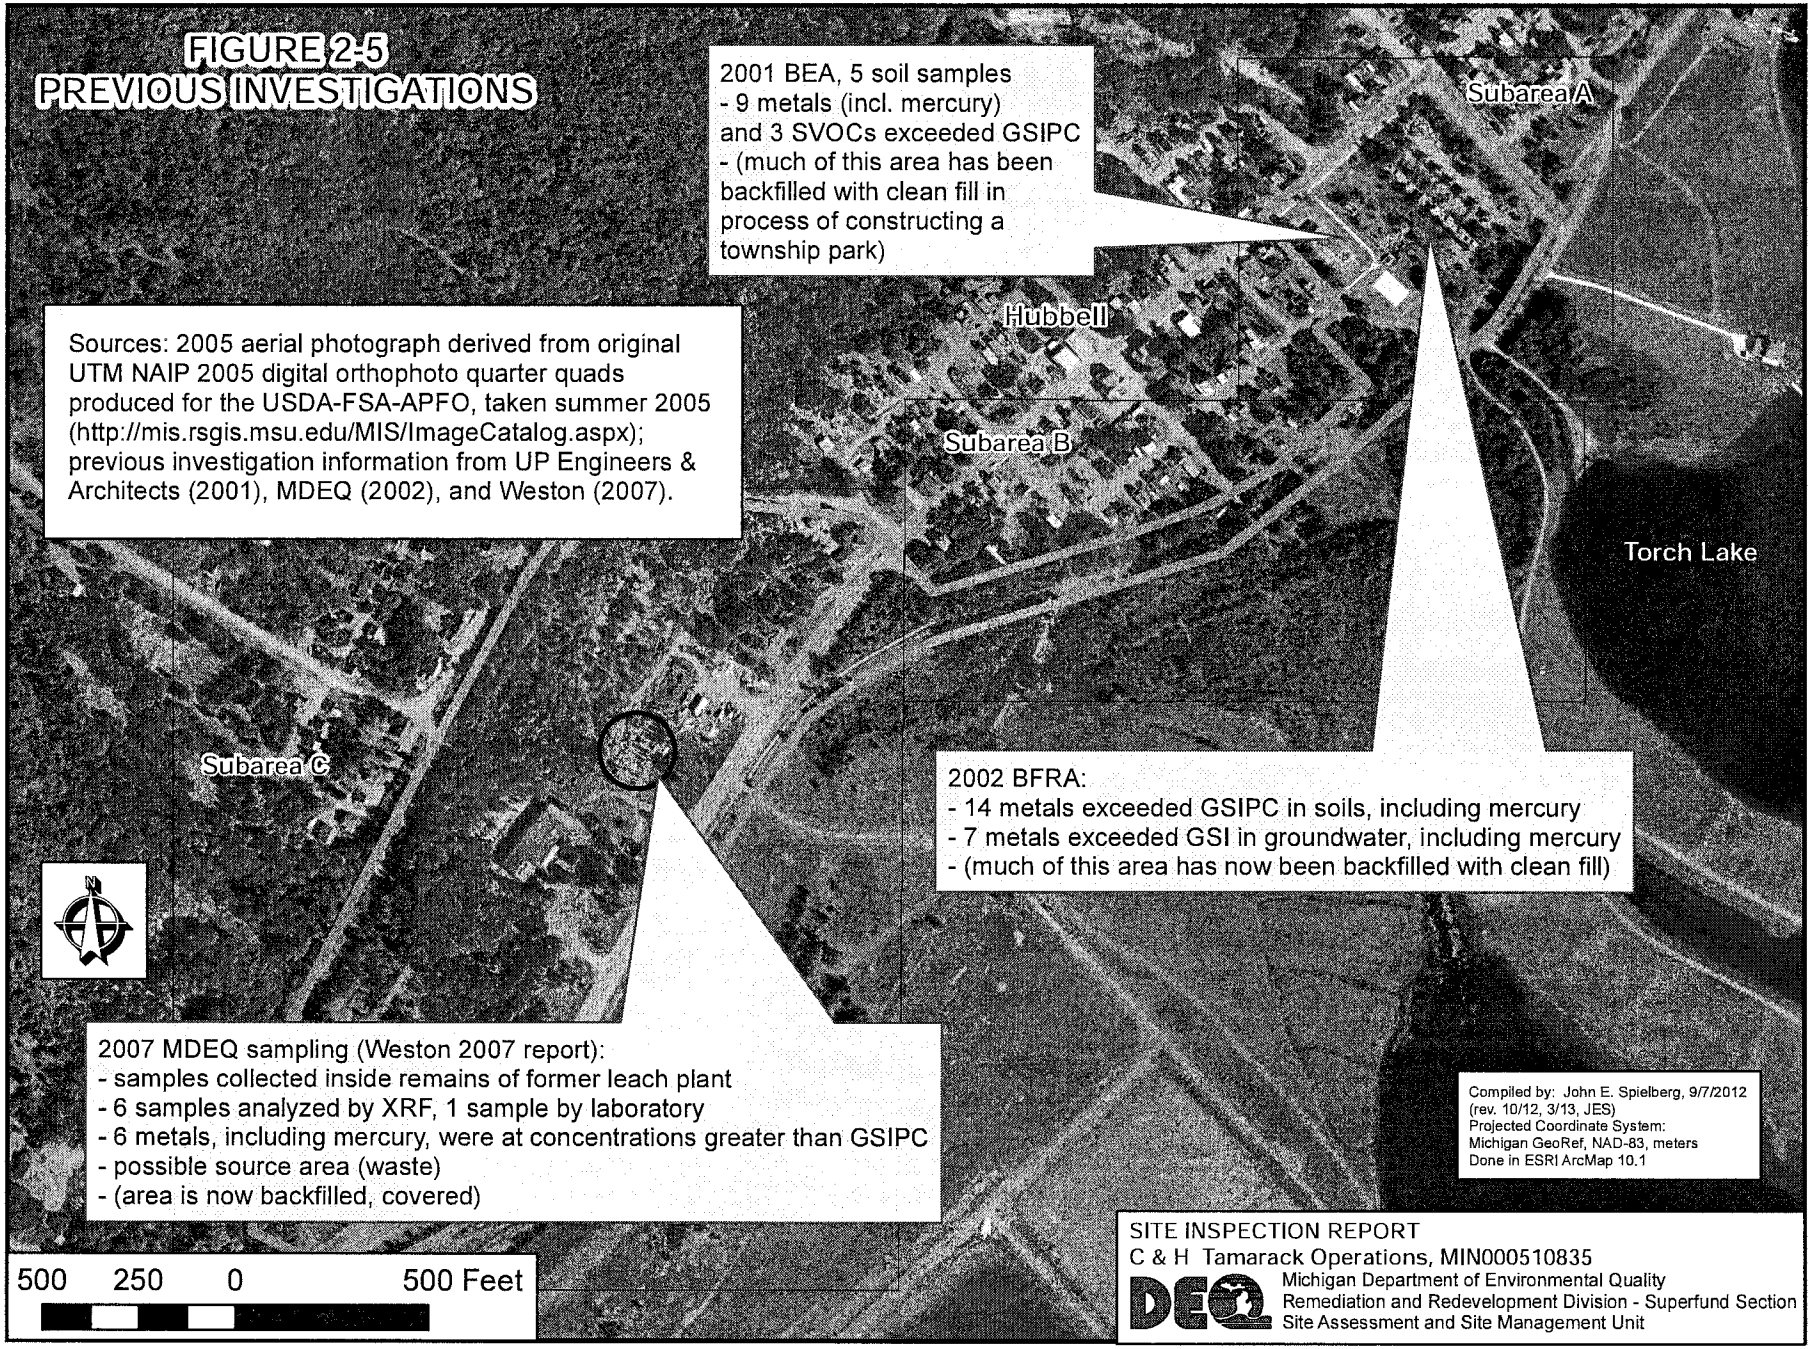
Figure 2-5: Previous Investigations

The above investigations provide documentation that source areas exist at the Site and releases to the environment have occurred at the Site. See Figure 2-5 for a summary of locations where these investigations occurred and the overall results, which demonstrate soil and groundwater contamination that poses a risk to the surface waters of Torch Lake. The table below summarizes what each investigation found:

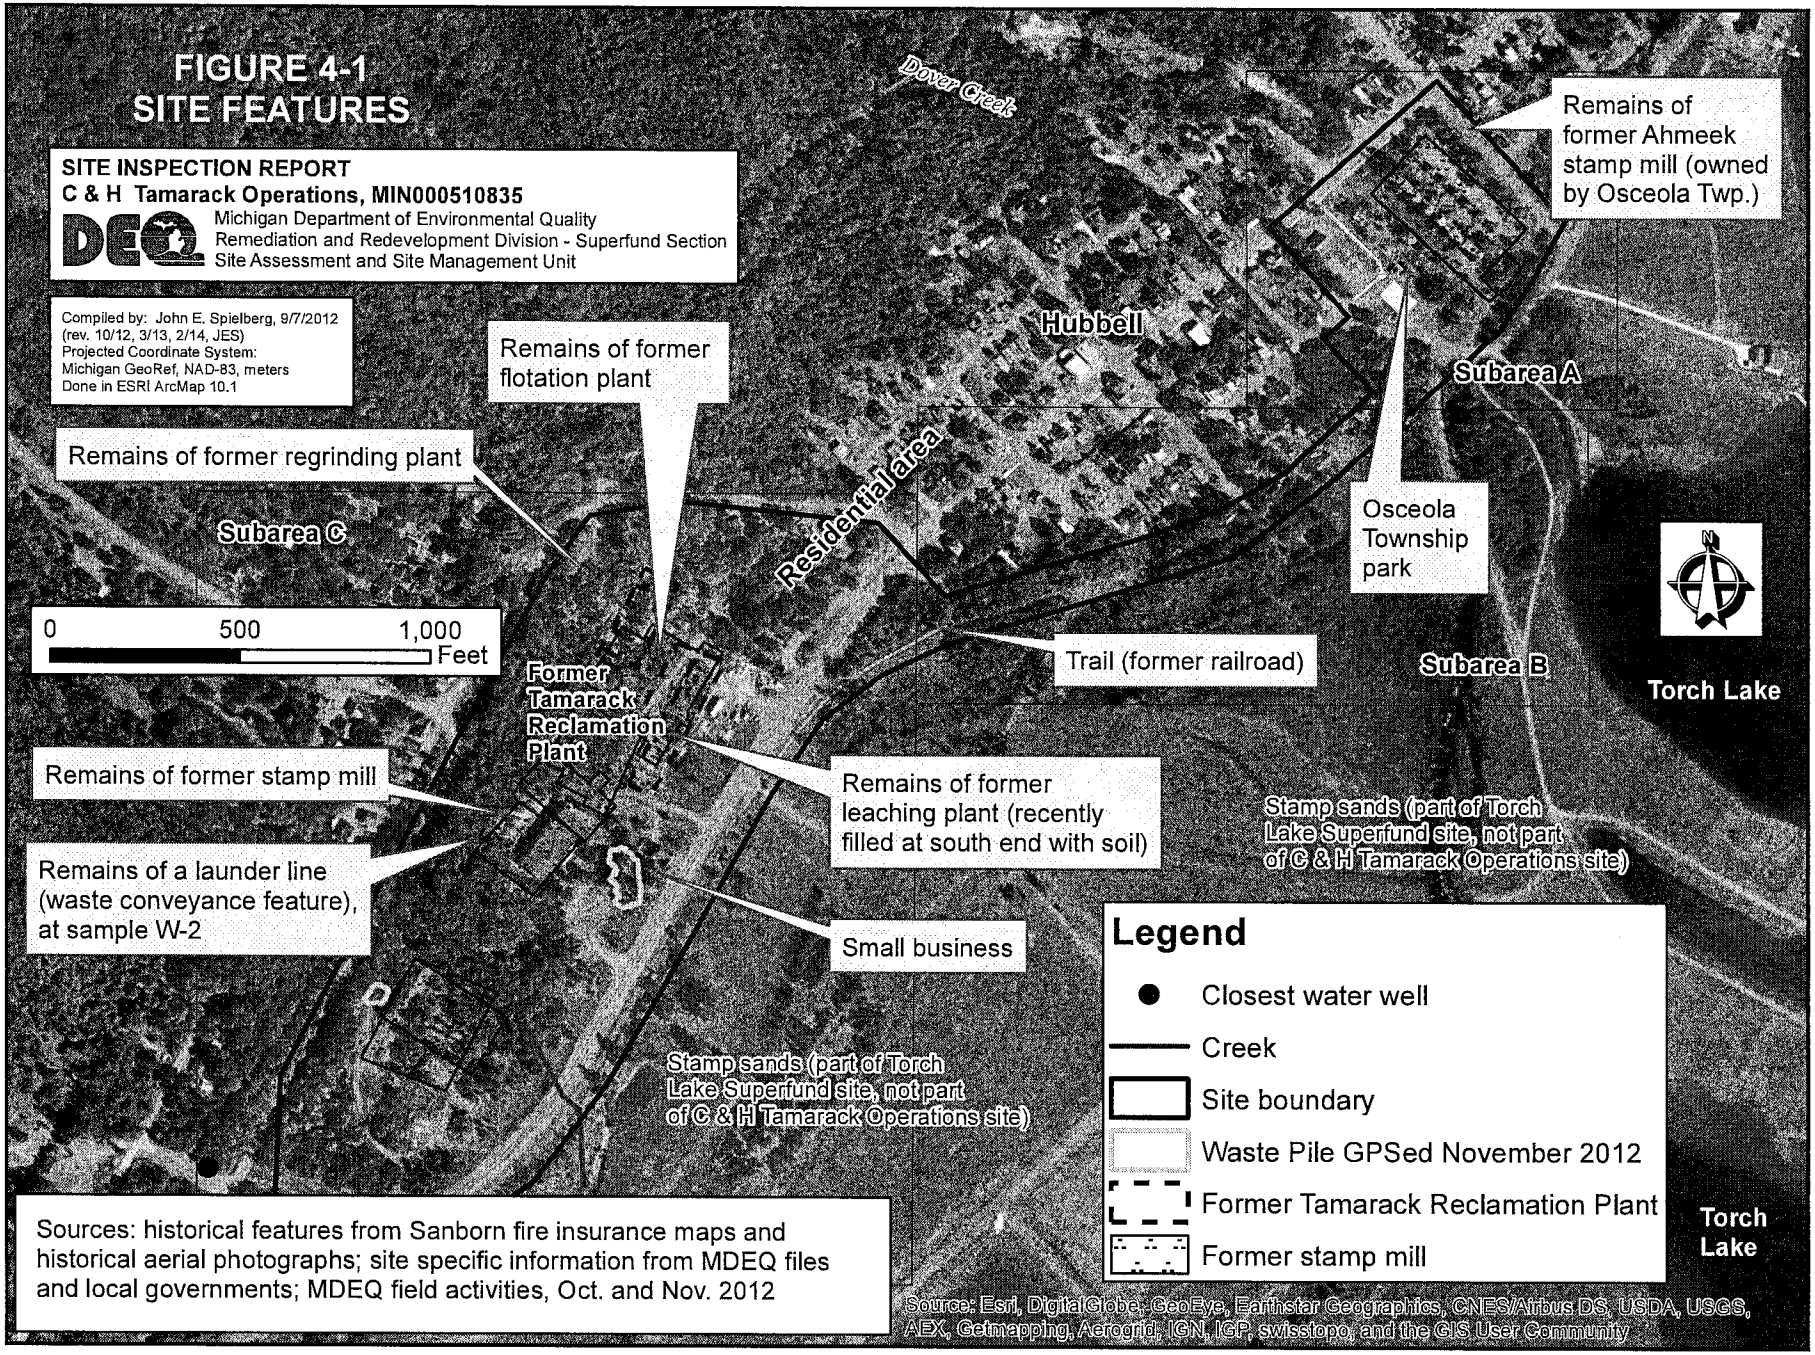
Investigation	Results
2001 BEA	All five soil samples exceeded state Groundwater Surface Water Interface (GSI) Protection Criteria (GSIPC) for nine metals and three semi-volatile organic compounds. The highest concentrations were significantly above the GSIPC. Arsenic was found up to 470 parts per million (ppm) (5.8 ppm GSIPC), copper up to 240,000 ppm (32 ppm GSIPC), and mercury up to 1.1 ppm (0.13 ppm GSIPC). The semi-volatiles carbazole, fluoranthene, and phenanthrene also exceeded GSIPC.
2002 MDEQ BFRA	MDEQ collected shallow and subsurface soil samples and groundwater samples, and conducted x-ray fluorescence (XRF) screening of surficial materials. The primary exposure pathway of concern seems to be surface water due to potential impacts from contaminated groundwater venting into Torch Lake (mostly copper, but also barium, beryllium, lead, manganese, mercury, and vanadium). Mercury, a bioaccumulative metal in surface water, was found up to 0.65 ppm in surficial soil samples, up to 250 ppm in XRF screenings, and up to 0.25 ppm in soil boring samples (0.13 ppm GSIPC). In groundwater samples, five metals including mercury were found to be significantly above background levels and all exceeded GSI levels, which are protective of surface water impacts. In addition, 23 out of 25 shallow soil samples revealed concentrations of semi-volatile or inorganic contaminants significantly above background. Ten of these samples also exceeded direct contact standards.

2005 Weston	Surface soils and standing structures were the main concern, based on contaminant concentrations at the surface above Residential Direct Contact Criteria and Particulate Soil Inhalation Criteria.
2007 Weston	The report reviewed data from the BEA, BFRA, and 2007 MDEQ sampling. Based on XRF screening results and one waste sample submitted to the MDEQ Environmental Laboratory, the former leach plant was found to contain surface soils with antimony, arsenic, copper, lead, and mercury at concentrations exceeding GSIPC. Mercury was detected at 340 ppm (0.13 ppm GSIPC).
