Technical Data Sheet

Bridge Identification:	1560440000000B043 1560440000000B044
Facility Carried:	US 10
Feature Intersected:	Sanford Lake
Location:	Sanford
County:	Midland
Region:	Bay
Year Built:	1962
Year Reconstructed:	1984, 1997
Bridge Type:	Two-Girder System
No. of Spans:	3
Deck Area:	12,547 S.F.
Paint System:	Red Lead
Paint Area:	31,500 S.F. (B04-3) 31,500 S.F. (B04-4)

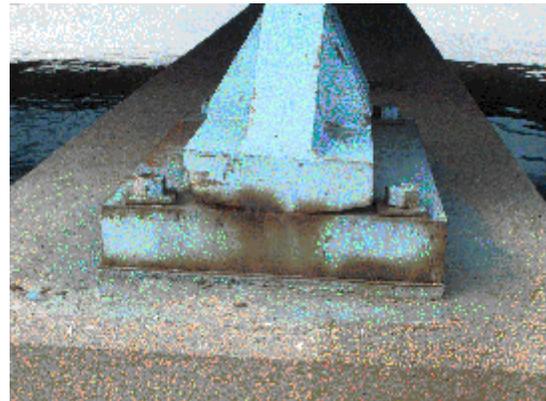
Typical Pier Bearing (25)

- ! **Bearings.**

Recommendation	Schedule
Clean bridge drainage system components (deck drains and downspouts).	6 to 12 months
Flush bridge deck joints and check for leaks.	12 months
Powerwash bridge superstructure.	12 months
Powerwash bearings and pin and hanger assemblies.	12 months
