Contribution to Michigan Geology Report - 90-4

PORT HURON STUDY
Historical Development of Hydrocarbons
and Subsequent Problems

Walter Danyluk,
Michigan Department of Natural Resources
Geological Survey Division

1990

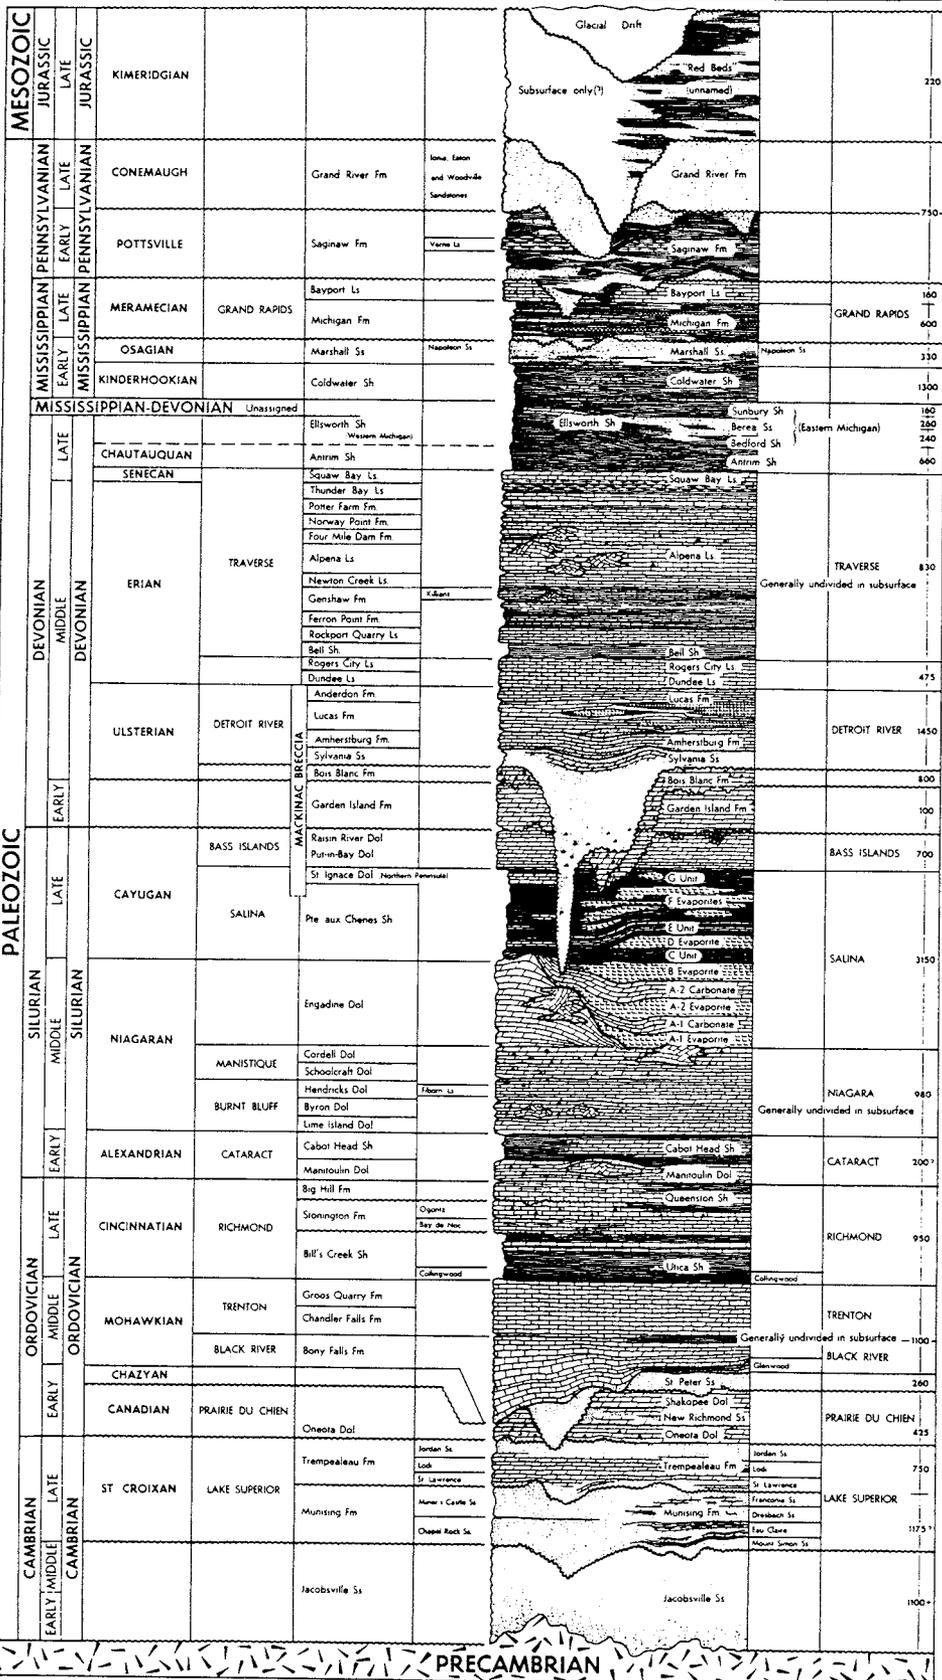
FIGURE 1. GENERALIZED SCHEMATIC OF SUBSURFACE OF PORT HURON

The old Dundee well (A) shows that if the well is not (properly) plugged, or not cased at all, or cased but corroded/damaged, fluids and gas can enter the wellbore in the Dundee, Antrim, or Glacial Drift and migrate to upper zones, or to the surface. The same can occur in old salt wells (B), except here even more formations are involved. A good portion of the Case Histories represent this scenario.

Industrial wastes injected down a disposal well (C) can migrate, or thru increased pressure force formation fluids to migrate laterally in the Detroit River formation and enter old salt wells (B), or migrate into the Dundee formation thru fractures and eventually enter old Dundee wells (A). Actual access to the well- bore is the same as described for old Dundee wells.

Deeper, more recent Niagaran wells (E) provide other potential avenues for gas/fluid migration into higher rock formations, or to the surface. Again, entry into the wellbore occurs in portions of the hole that may not be cased, cased but corroded, or impro- perly plugged. Case History 44 is an example.

Storage well (F) operations can also create potential for subsur- face/surface problems if there is leakage from the storage zone which may overpressurize surrounding rock formations and initiate or alter gas/fluid migration.

In all the cases above, migration can also occur via the annulus (space between wellbore and the casing) if it is not properly sealed.
