Management of Subsurface Landfill Fires at the Closed Kailua-Kona Landfill

Kailua-Kona, Island of Hawaii, Hawaii
By: Lindsay Mason, P.E.

County of Hawaii
Department of Environmental Management
345 Kekūanāoʻa St., Suite 41
Hilo, Hawaii 96720-4252

Element Environmental, LLC
98-030 Hekaha Street, Unit 9
Aiea, Hawaii 96701

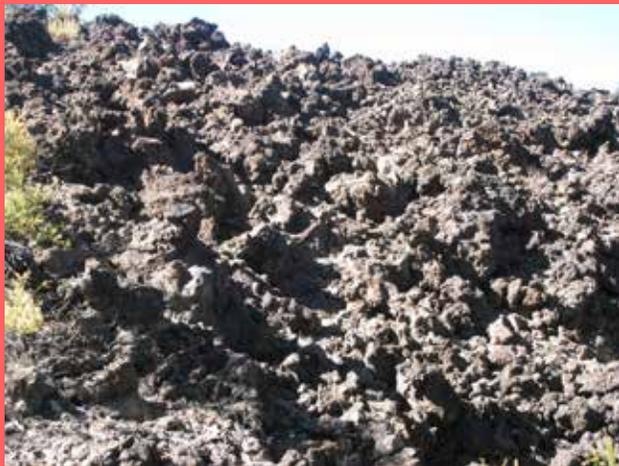
A'A Lava

- The A'a lava underlying the landfill is highly porous. A'a is formed when the lava runs fast and cools quickly resulting in a clickery looking rock.
- Local residents attest to having observed lava tubes located under the landfill. Lava tubes are formed when an active low-viscosity lava thickens and forms a "roof" over a less-viscos lava stream.
