Field Performance of Polymer Bridge Deck Overlays in Michigan

Final Report

January 2003

**Michigan Department of Transportation
Construction and Technology Division**

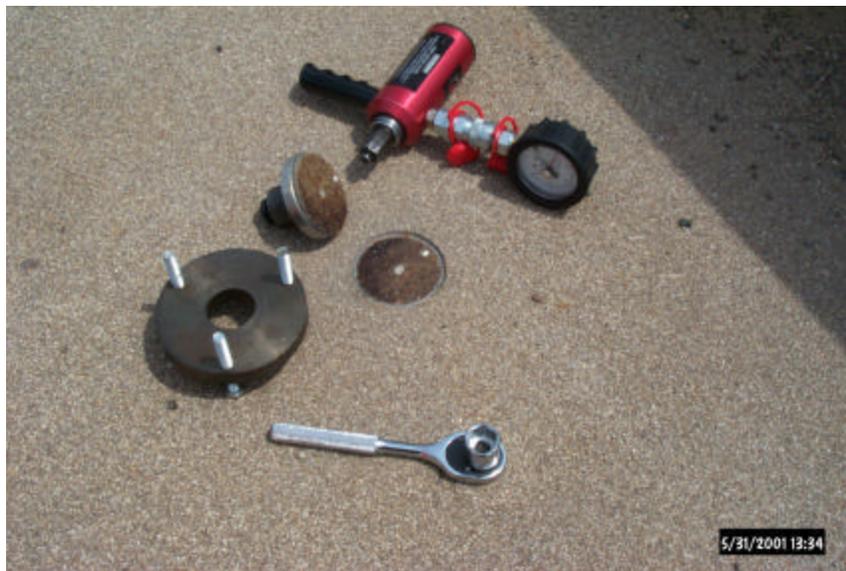
Figure 9. James Bond Test in Progress.

A survey of 37 coated bridge decks located throughout Michigan was conducted by KRC/MTU. Photographic documentation of inspections included complete mapping of each deck coating for cracking, delamination, and overall surface integrity. Bond strength testing was conducted on 2 representative deck surfaces to document the in-situ bond strength of the coating systems. The bond strength measurements were made using a James Bond (James Instruments, Inc.) in-situ bond strength tester. Figure 9 is a photo of this system after a test. The results of these measurements are given in section **JB-007 Tests** on page 28 of this report. As mentioned previously, photos taken during these surveys are contained in Appendix A under separate cover.
