Appendix A
I-696 Core Site

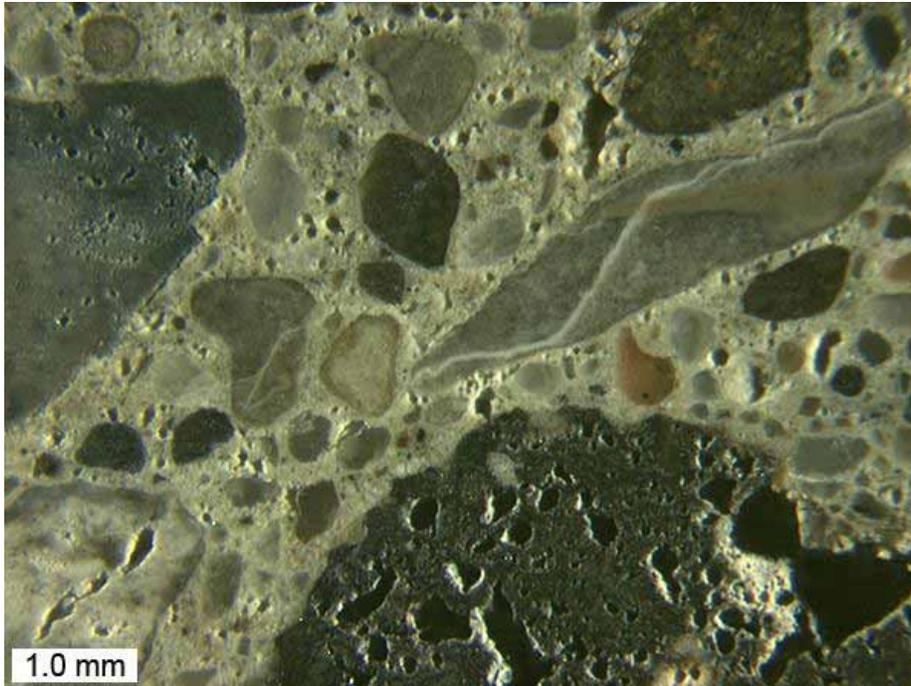
Alkali silica reaction in fine aggregate and associated cracking, before and after sodium cobaltinitrite stain, polished slab from I-696, constructed 1995, at transverse joint, top half of core A, MTU ID 696-06.

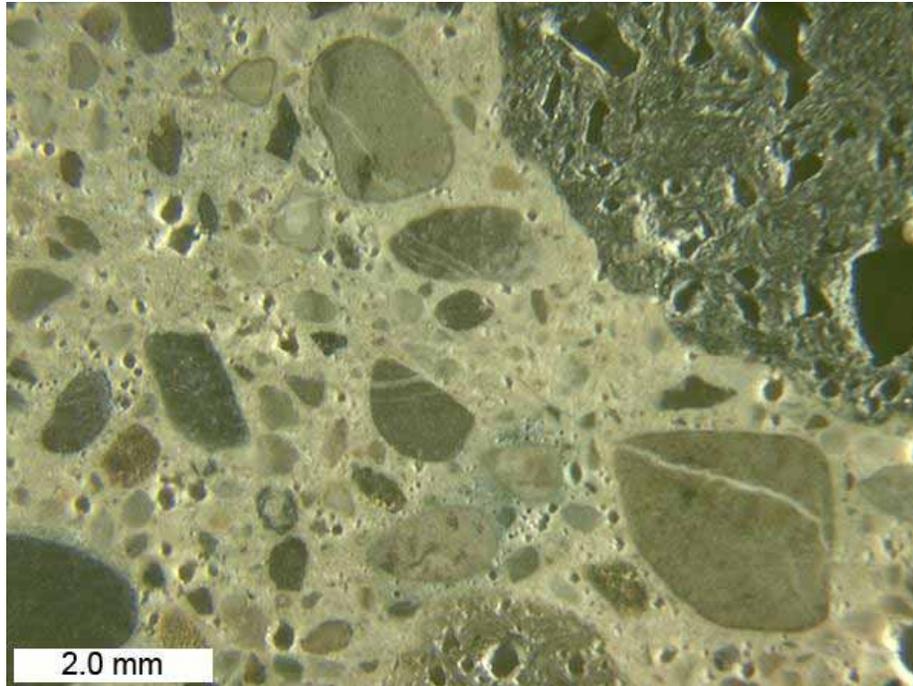
Alkali silica reaction in fine aggregate and associated cracking, before and after sodium cobaltinitrite stain, polished slab from I-696, constructed 1995, at transverse joint, top half of core A, MTU ID 696-06.

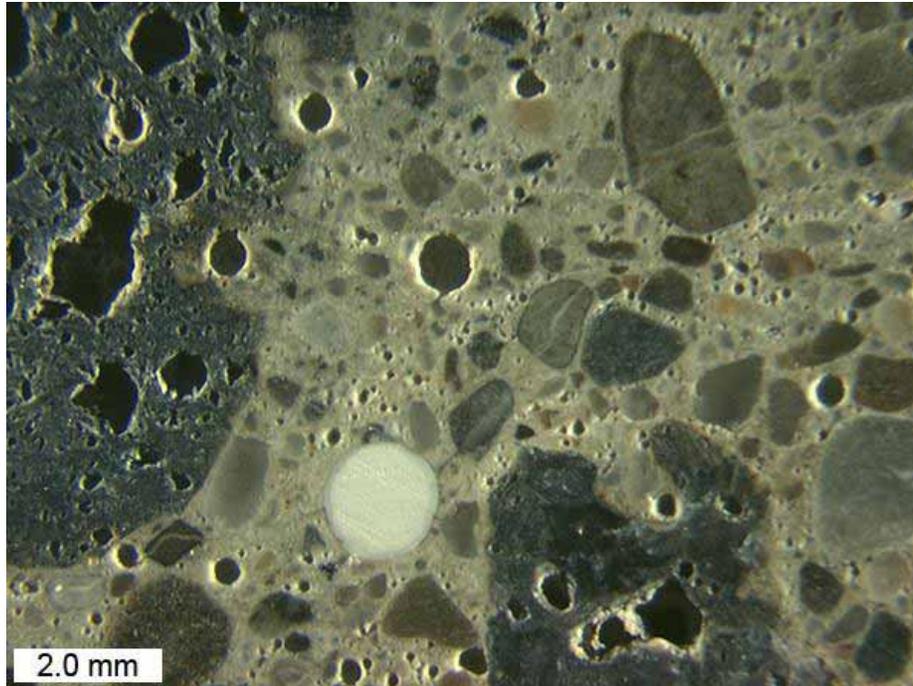
Alkali silica reaction in fine aggregate and associated cracking, before and after sodium cobaltinitrite stain, polished slab from I-696, constructed 1995, at transverse joint, top half of core A, MTU ID 696-06.

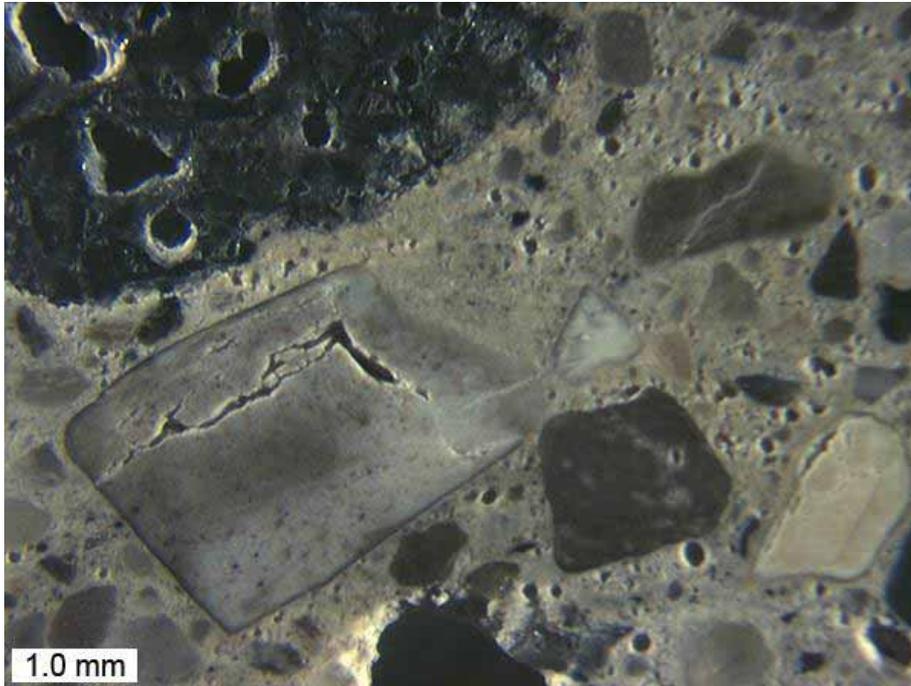
Alkali silica reaction in fine aggregate and associated cracking, before and after sodium cobaltinitrite stain, polished slab from I-696, constructed 1995, at transverse joint, bottom half of core A, MTU ID 696-06.

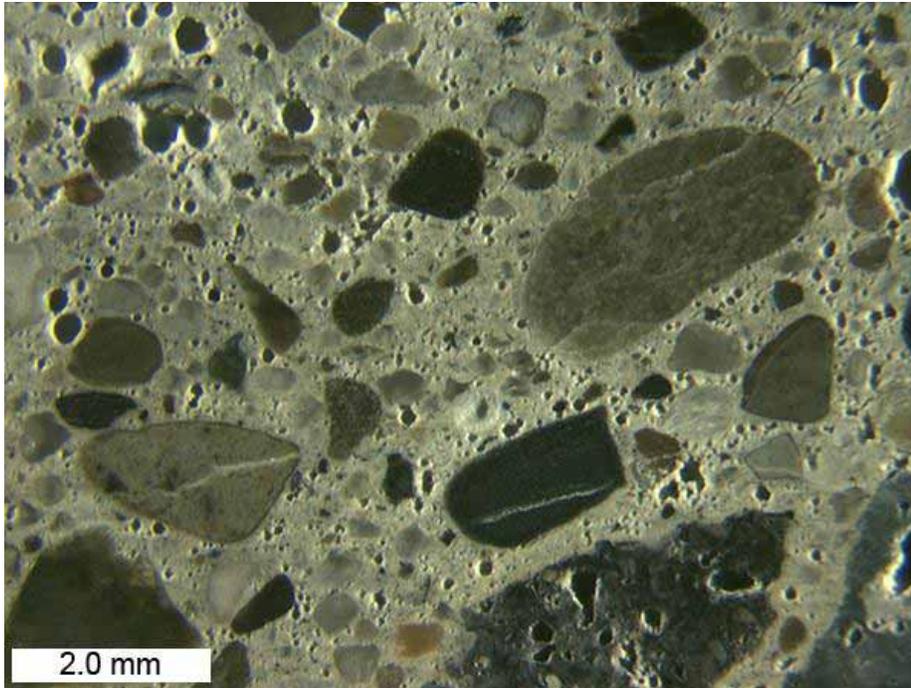
Alkali silica reaction in fine aggregate and associated cracking, before and after sodium cobaltinitrite stain, polished slab from I-696, constructed 1995, at transverse joint, bottom half of core A, MTU ID 696-06.

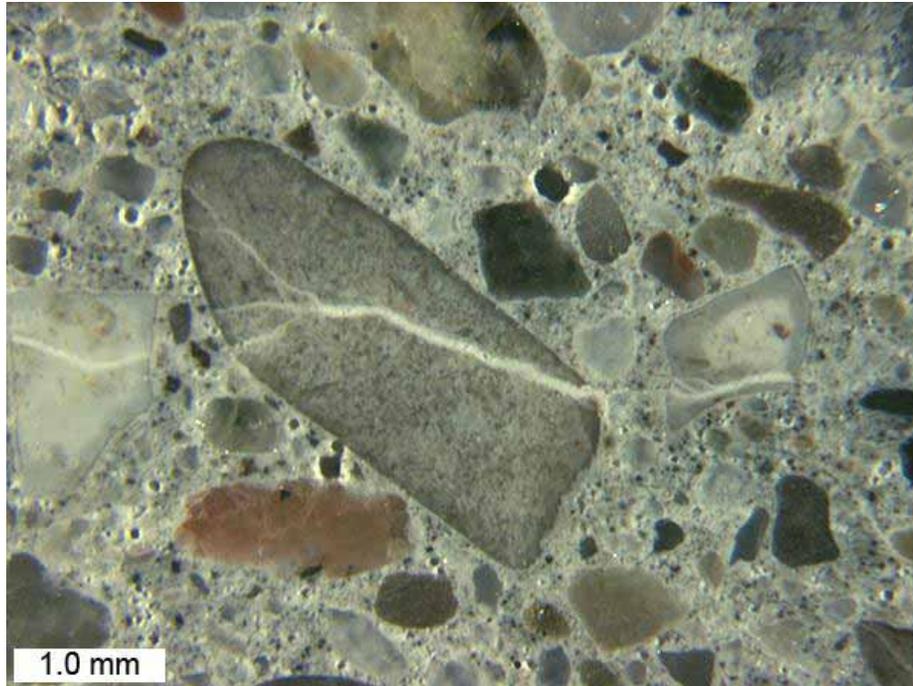
Alkali silica reaction in fine aggregate and associated cracking, before and after sodium cobaltinitrite stain, polished slab from I-696, constructed 1995, away from transverse joint, top half of core D, MTU ID 696-03.

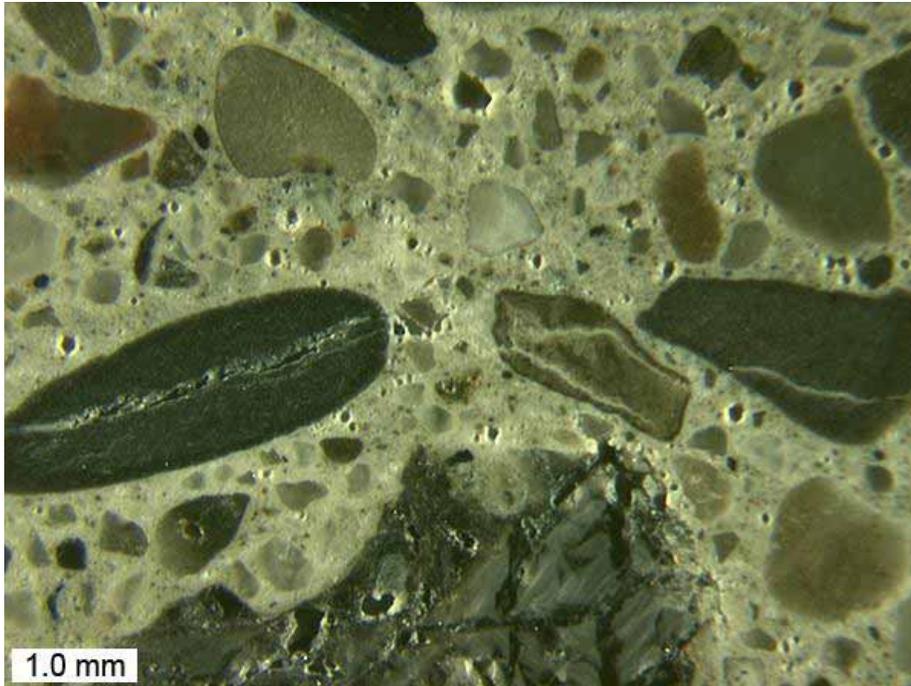
Alkali silica reaction in fine aggregate and associated cracking, before and after sodium cobaltinitrite stain, polished slab from I-696, constructed 1995, away from transverse joint, top half of core D, MTU ID 696-03.

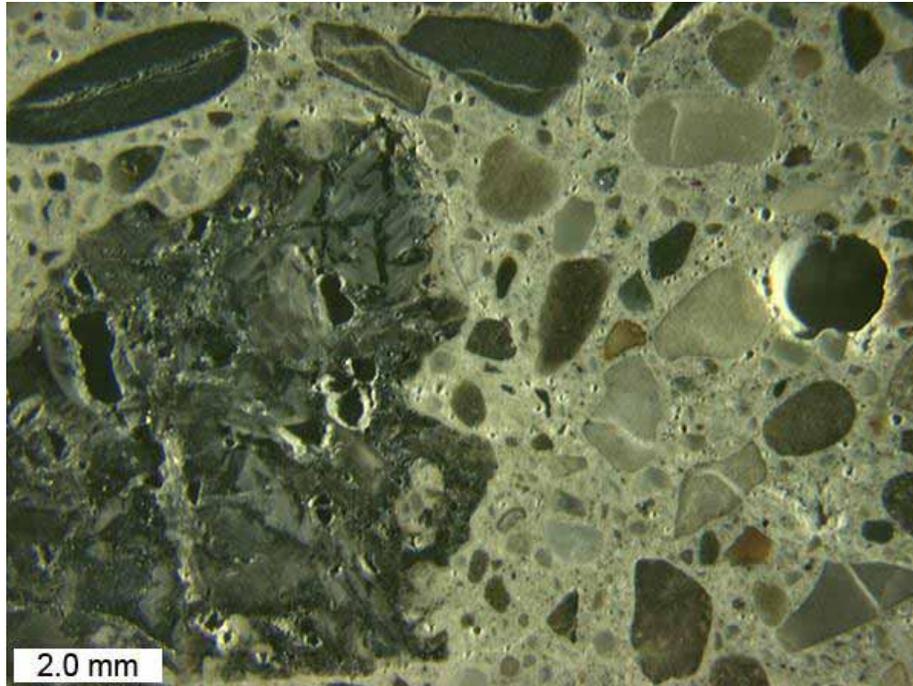
Alkali silica reaction in fine aggregate and associated cracking, before and after sodium cobaltinitrite stain, polished slab from I-696, constructed 1995, away from transverse joint, top half of core D, MTU ID 696-03.

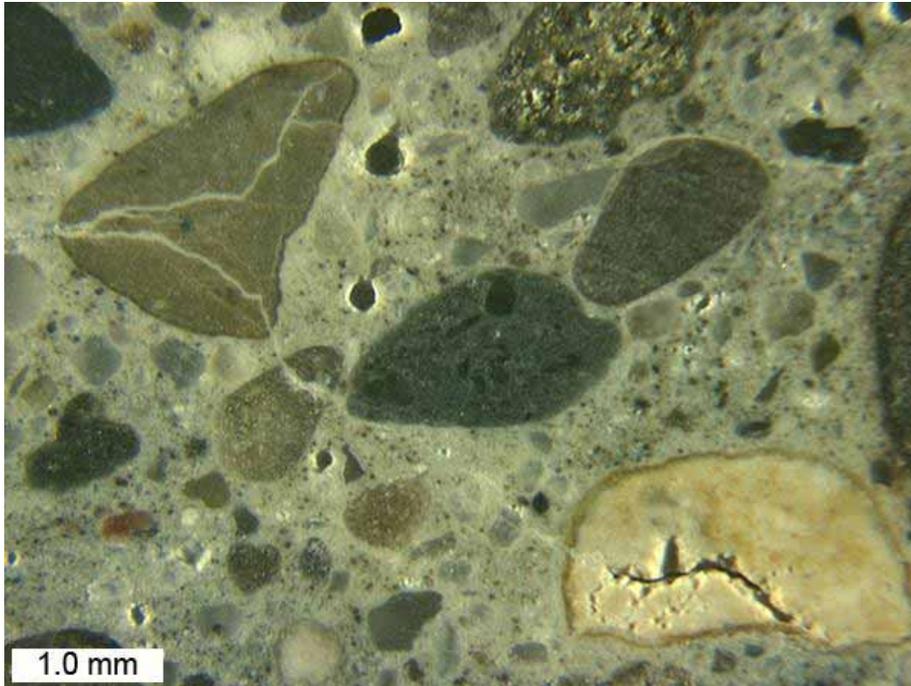
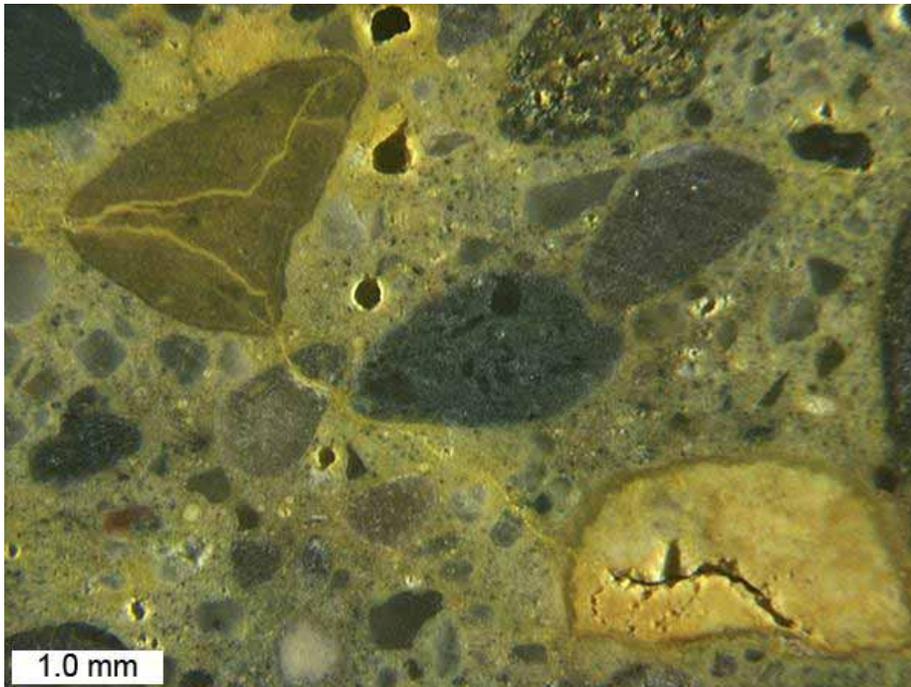
Alkali silica reaction in fine aggregate and associated cracking, before and after sodium cobaltinitrite stain, polished slab from I-696, constructed 1995, away from transverse joint, bottom half of core D, MTU ID 696-03.

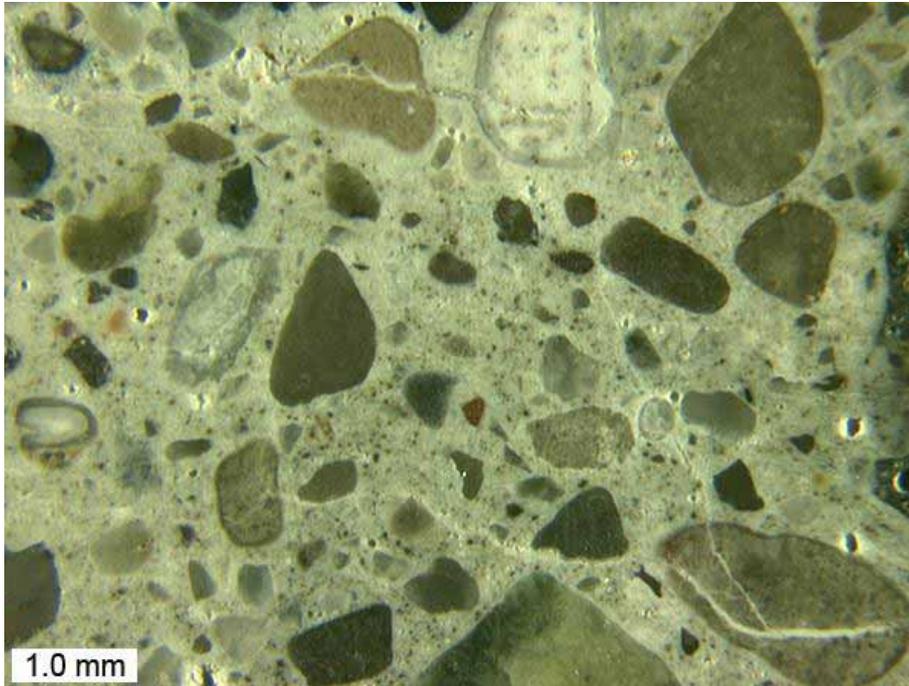
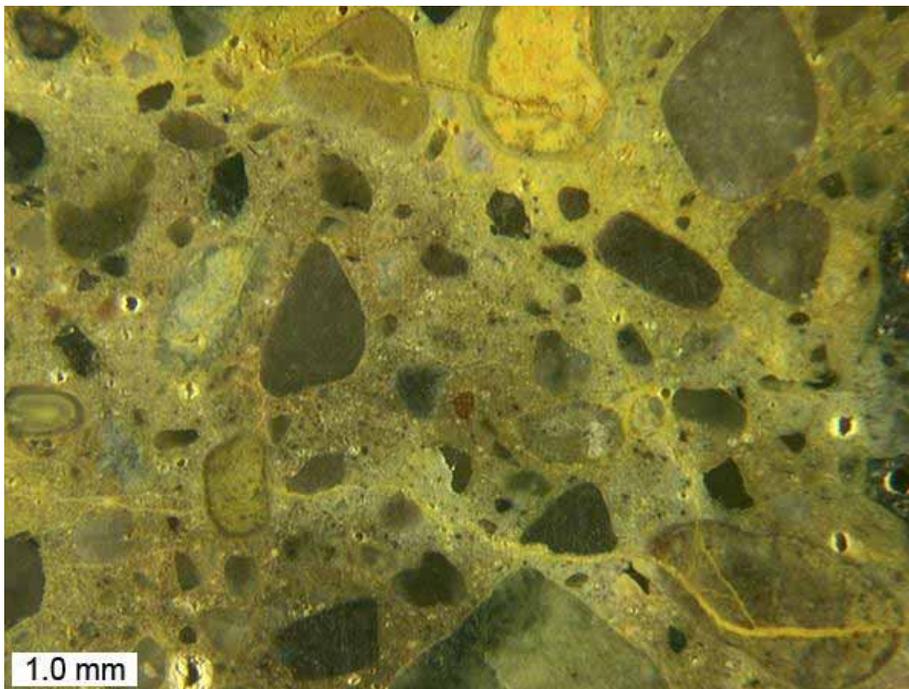
Alkali silica reaction in fine aggregate and associated cracking, before and after sodium cobaltinitrite stain, polished slab from I-696, constructed 1995, away from transverse joint, bottom half of core D, MTU ID 696-03.

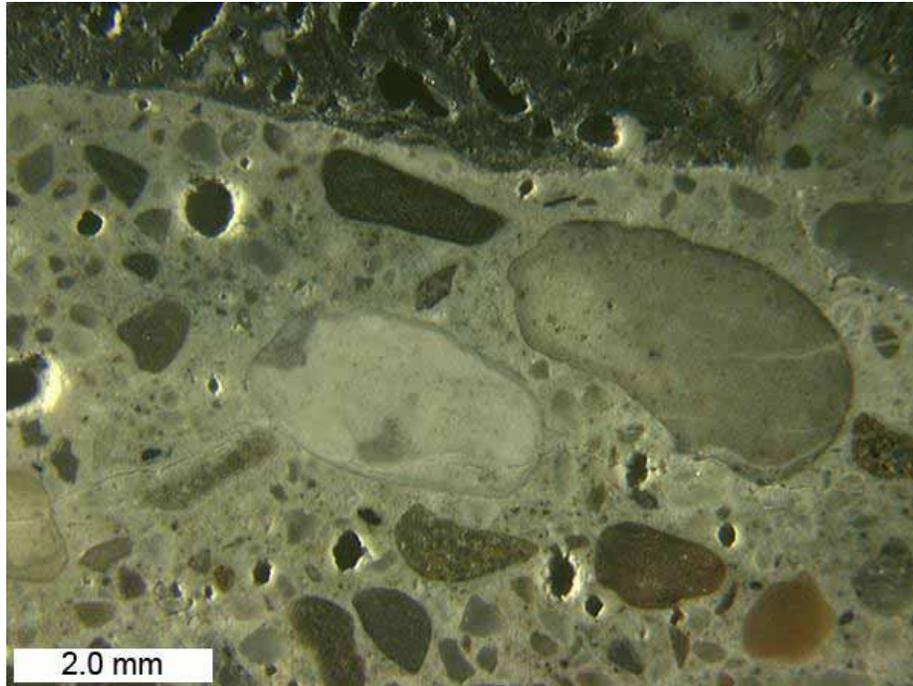
Alkali silica reaction in fine aggregate and associated cracking, before and after sodium cobaltinitrite stain, polished slab from I-696, constructed 1995, away from transverse joint, bottom half of core D, MTU ID 696-03.

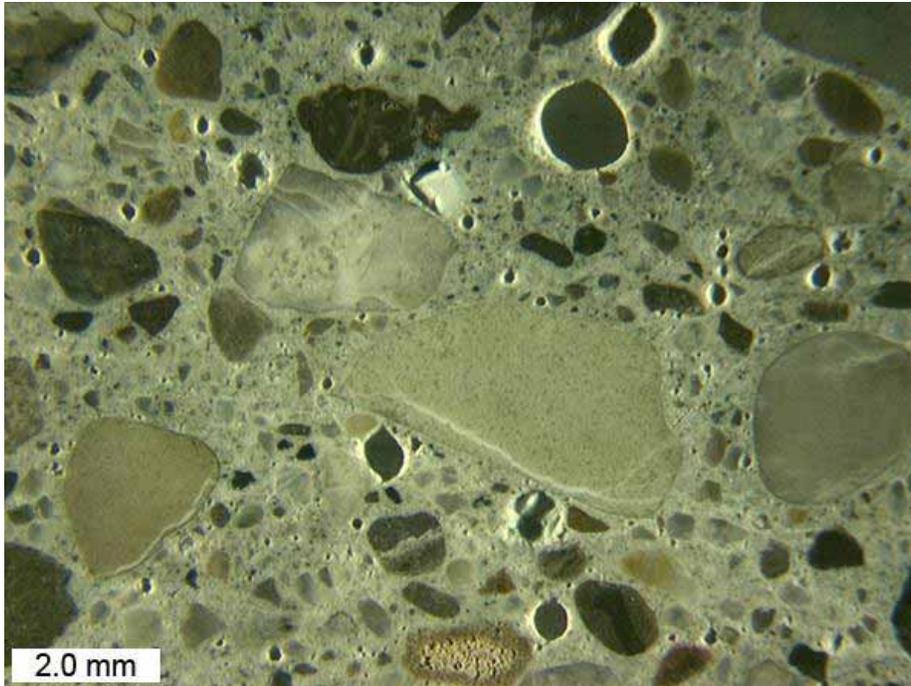
Alkali silica reaction in fine aggregate and associated cracking, before and after sodium cobaltinitrite stain, polished slab from I-696, constructed 1995, away from transverse joint, bottom half of core D, MTU ID 696-03.

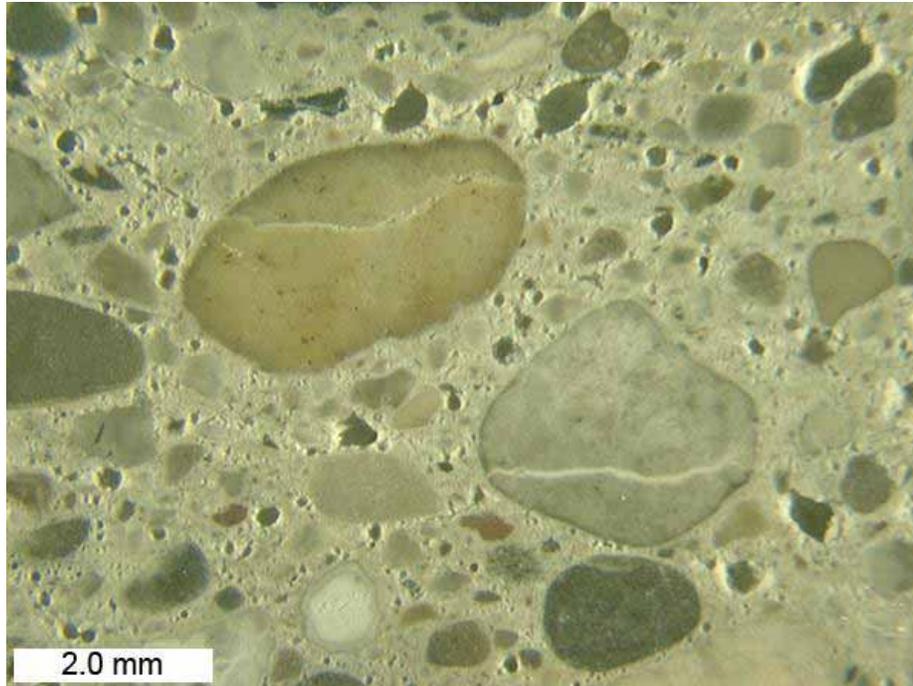
Alkali silica reaction in fine aggregate and associated cracking, before and after sodium cobaltinitrite stain, polished slab from I-696, constructed 1995, at transverse joint, top half of core A, MTU ID 696-09.

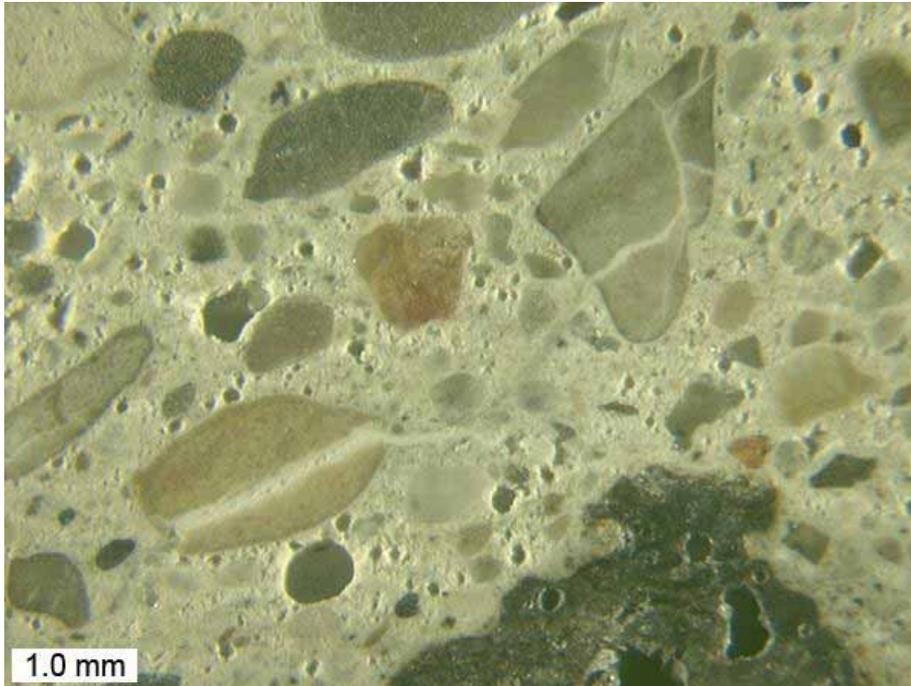
Alkali silica reaction in fine aggregate and associated cracking, before and after sodium cobaltinitrite stain, polished slab from I-696, constructed 1995, at transverse joint, top half of core A, MTU ID 696-09.

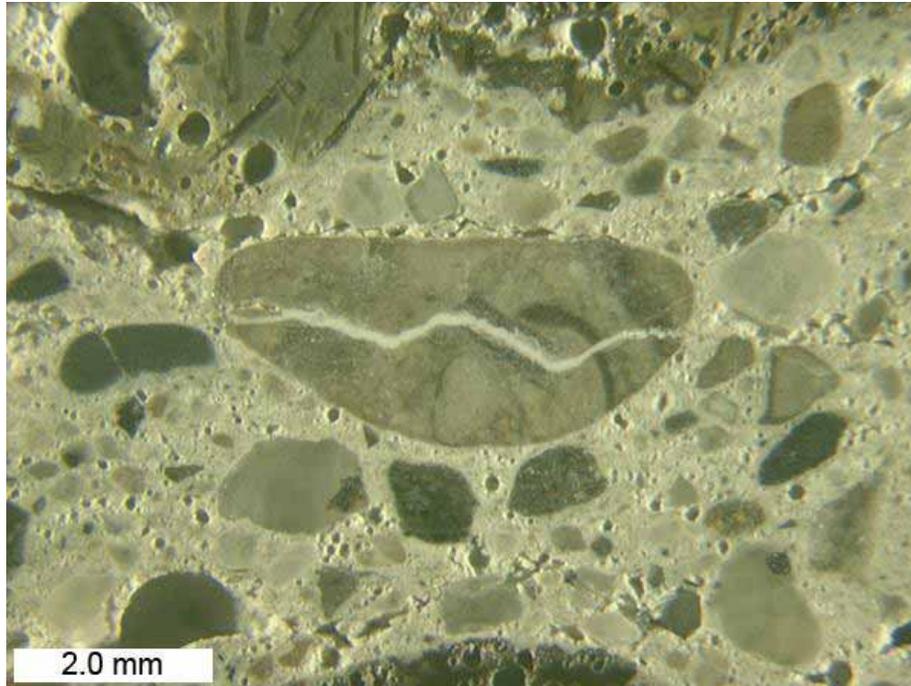
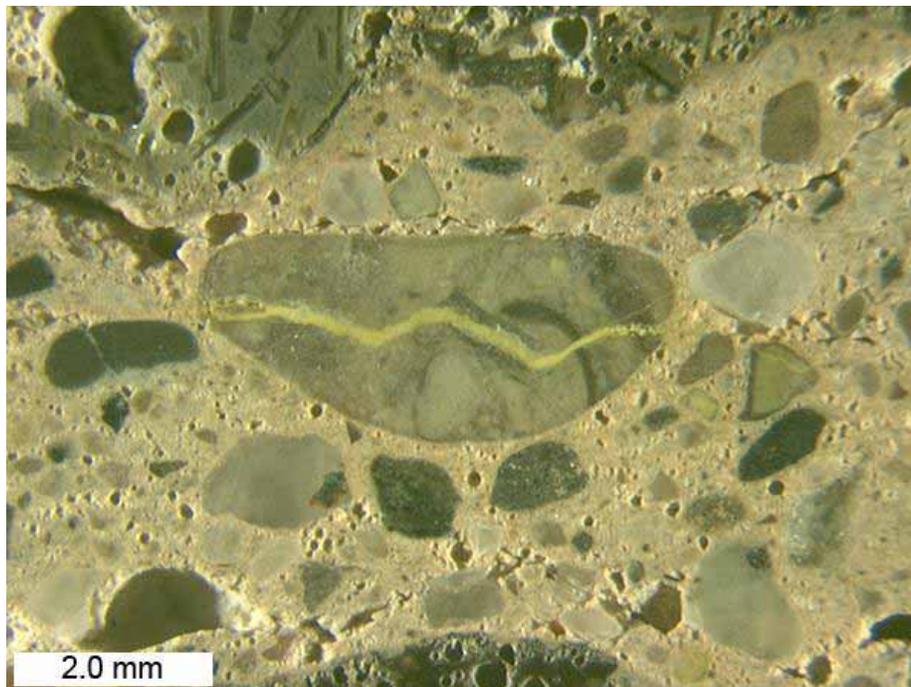
Alkali silica reaction in fine aggregate and associated cracking, before and after sodium cobaltinitrite stain, polished slab from I-696, constructed 1995, at transverse joint, top half of core A, MTU ID 696-09.

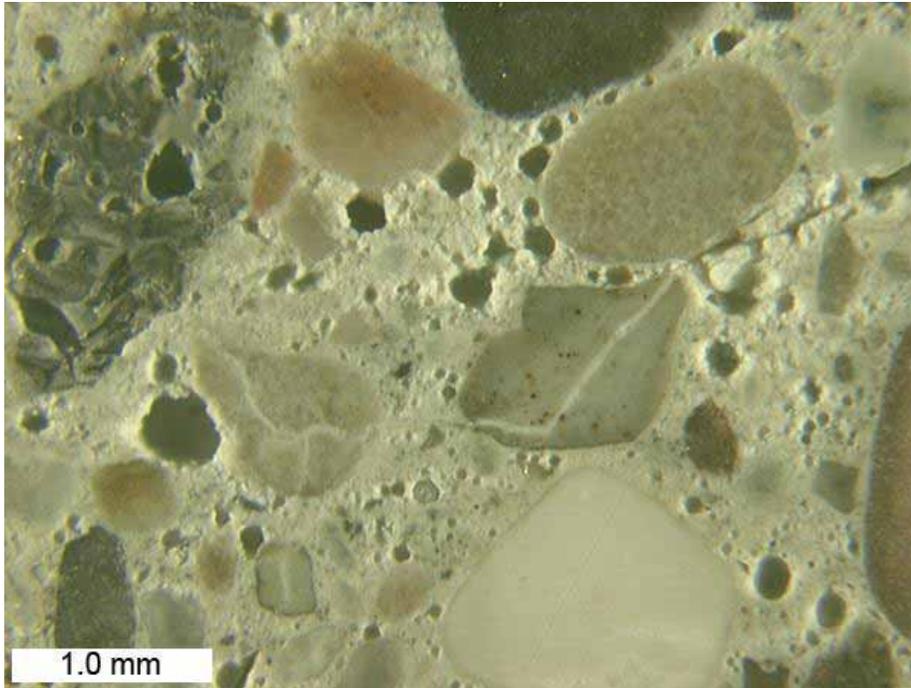
Alkali silica reaction in fine aggregate and associated cracking, before and after sodium cobaltinitrite stain, polished slab from I-696, constructed 1995, at transverse joint, top half of core A, MTU ID 696-09.

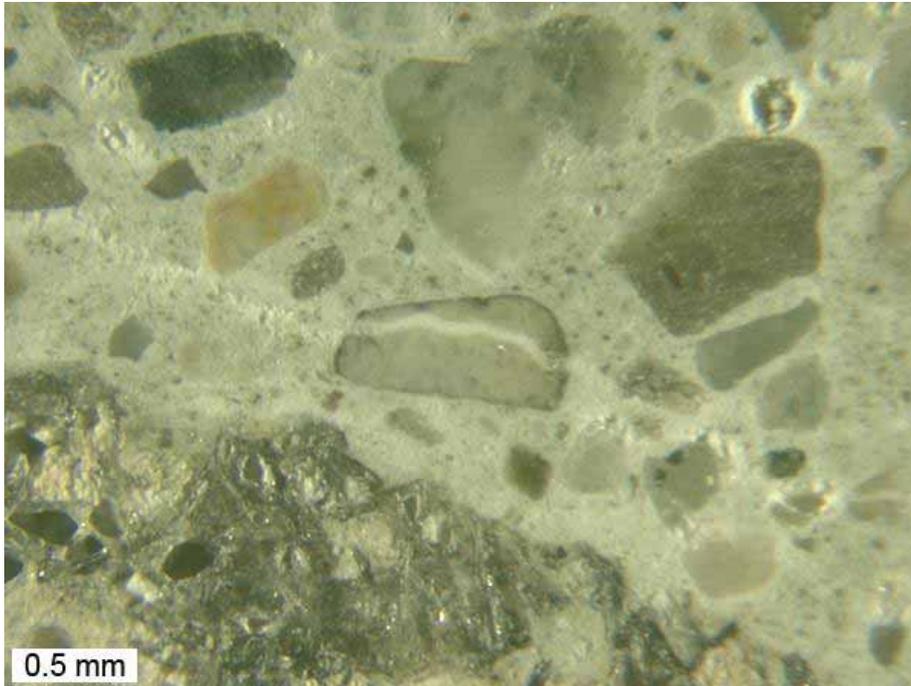
Alkali silica reaction in fine aggregate and associated cracking, before and after sodium cobaltinitrite stain, polished slab from I-696, constructed 1995, at transverse joint, top half of core A, MTU ID 696-09.

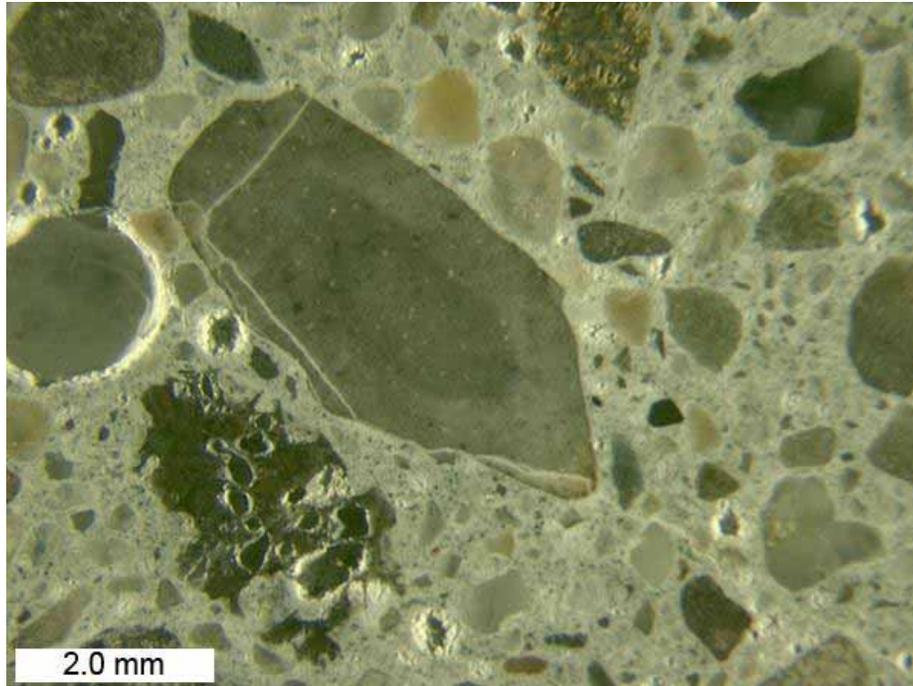
Alkali silica reaction in fine aggregate and associated cracking, before and after sodium cobaltinitrite stain, polished slab from I-696, constructed 1995, at transverse joint, bottom half of core A, MTU ID 696-09.

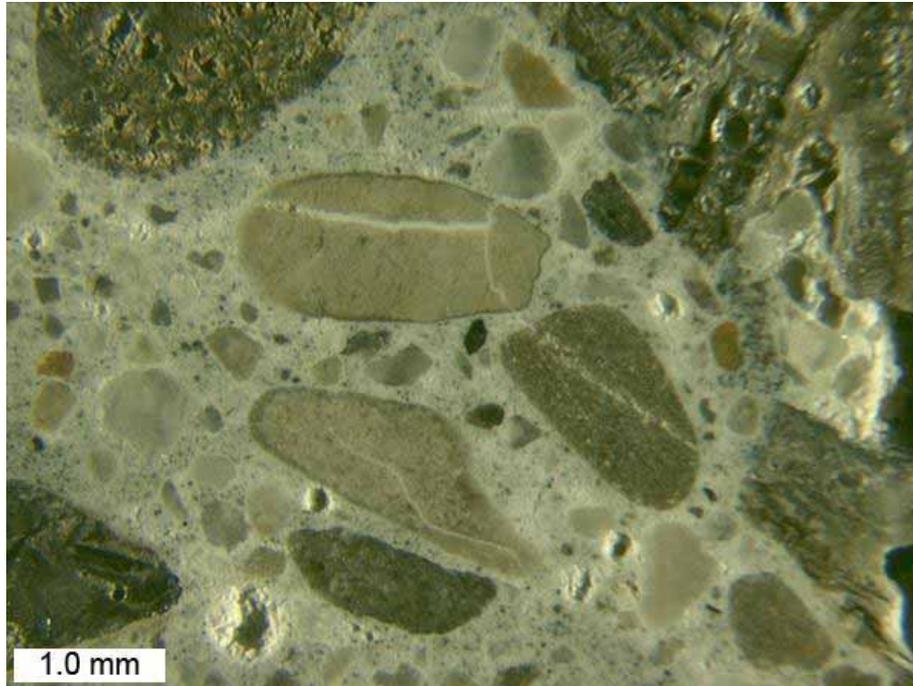
Alkali silica reaction in fine aggregate and associated cracking, before and after sodium cobaltinitrite stain, polished slab from I-696, constructed 1995, at transverse joint, bottom half of core A, MTU ID 696-09.

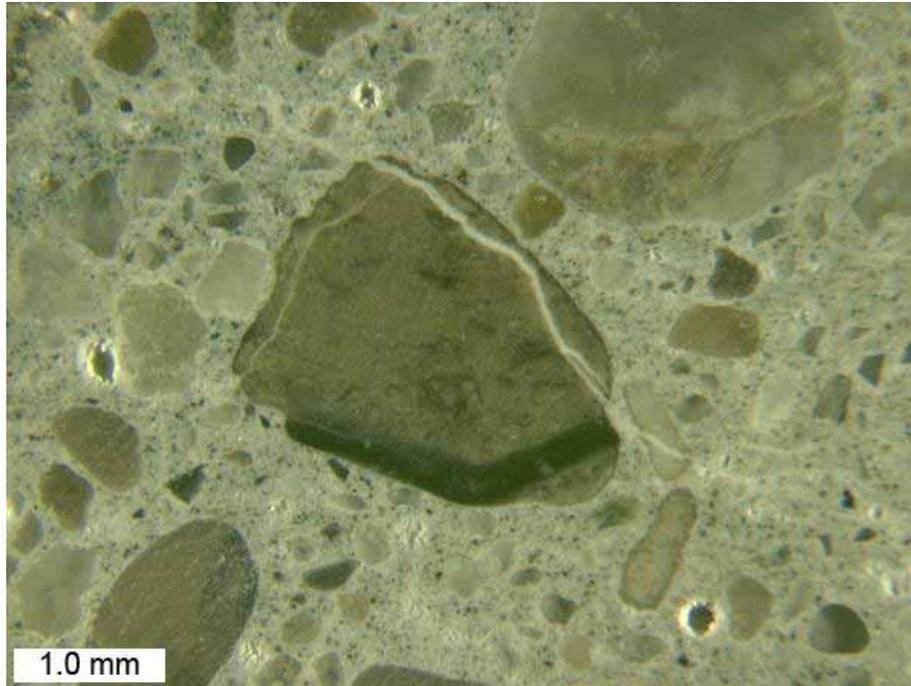
Alkali silica reaction in fine aggregate and associated cracking, before and after sodium cobaltinitrite stain, polished slab from I-696, constructed 1995, at transverse joint, bottom half of core A, MTU ID 696-09.

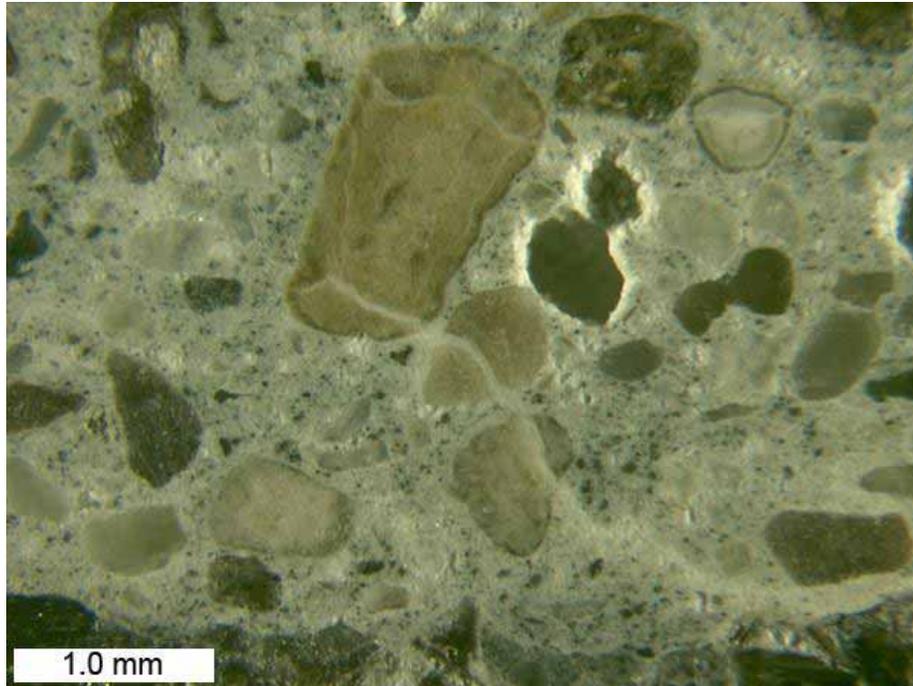
Alkali silica reaction in fine aggregate and associated cracking, before and after sodium cobaltinitrite stain, polished slab from I-696, constructed 1995, at transverse joint, bottom half of core A, MTU ID 696-09.

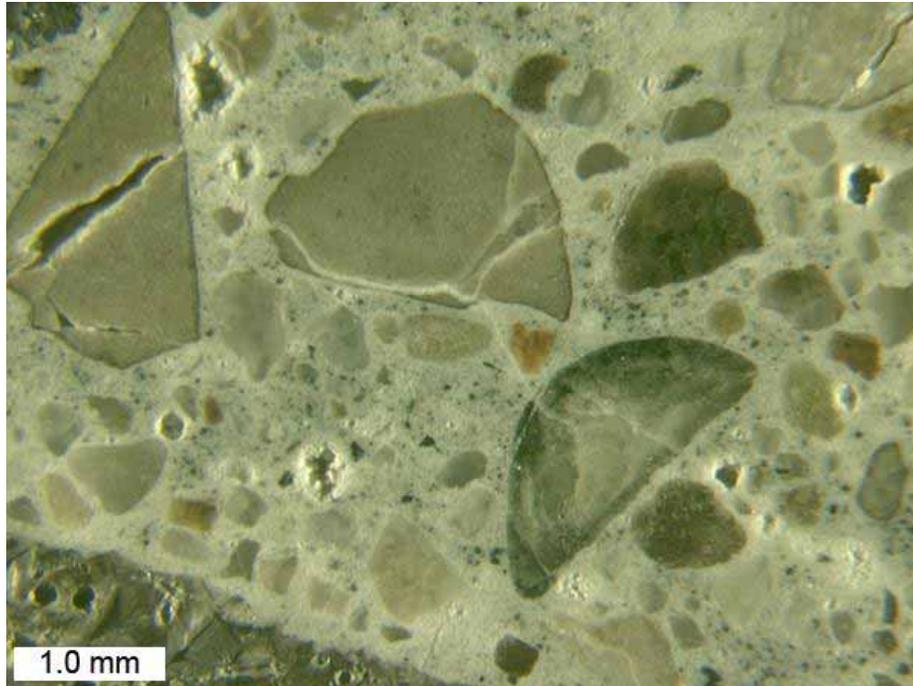
Alkali silica reaction in fine aggregate and associated cracking, before and after sodium cobaltinitrite stain, polished slab from I-696, constructed 1995, at transverse joint, bottom half of core A, MTU ID 696-09.

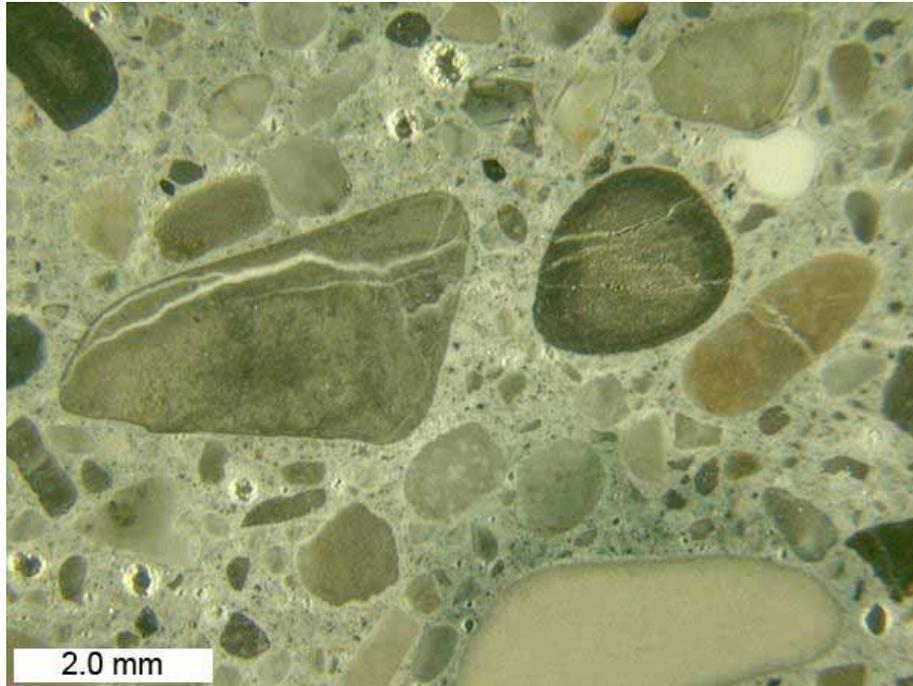
Alkali silica reaction in fine aggregate and associated cracking, before and after sodium cobaltinitrite stain, polished slab from I-696, constructed 1995, at transverse joint, bottom half of core A, MTU ID 696-09.

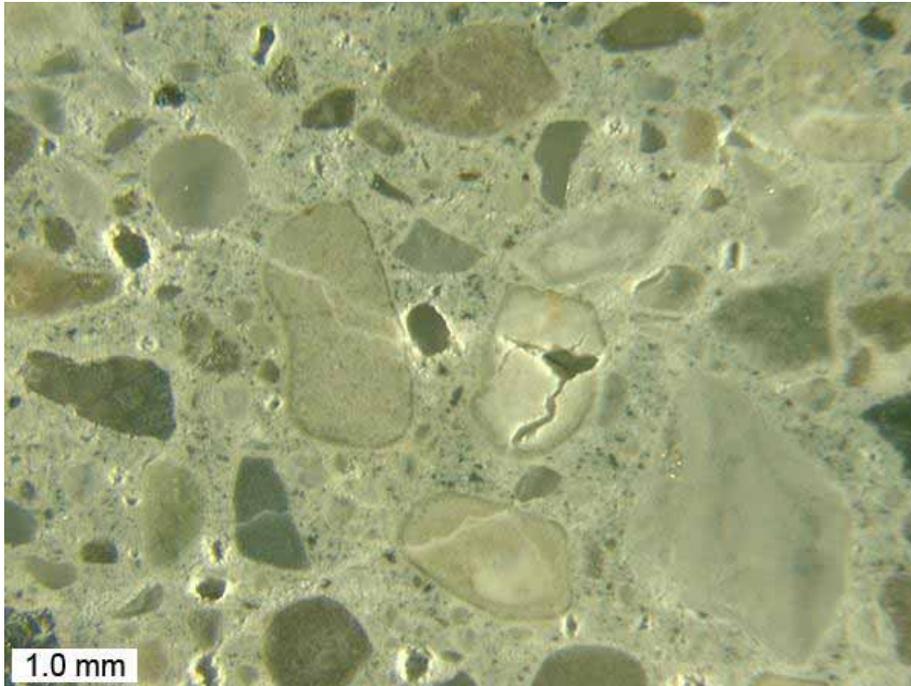
Alkali silica reaction in fine aggregate and associated cracking, before and after sodium cobaltinitrite stain, polished slab from I-696, constructed 1995, at transverse joint, bottom half of core A, MTU ID 696-09.

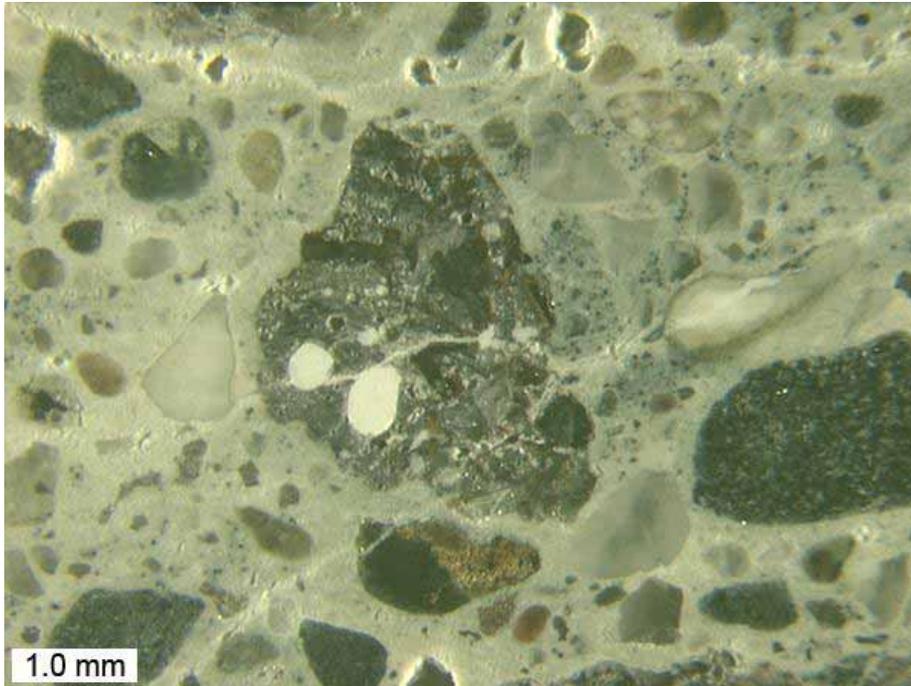
Alkali silica reaction in fine aggregate and associated cracking, before and after sodium cobaltinitrite stain, polished slab from I-696, constructed 1995, at transverse joint, bottom half of core A, MTU ID 696-09. Note voids in slag aggregate particle filled with alkali-silica reaction product.

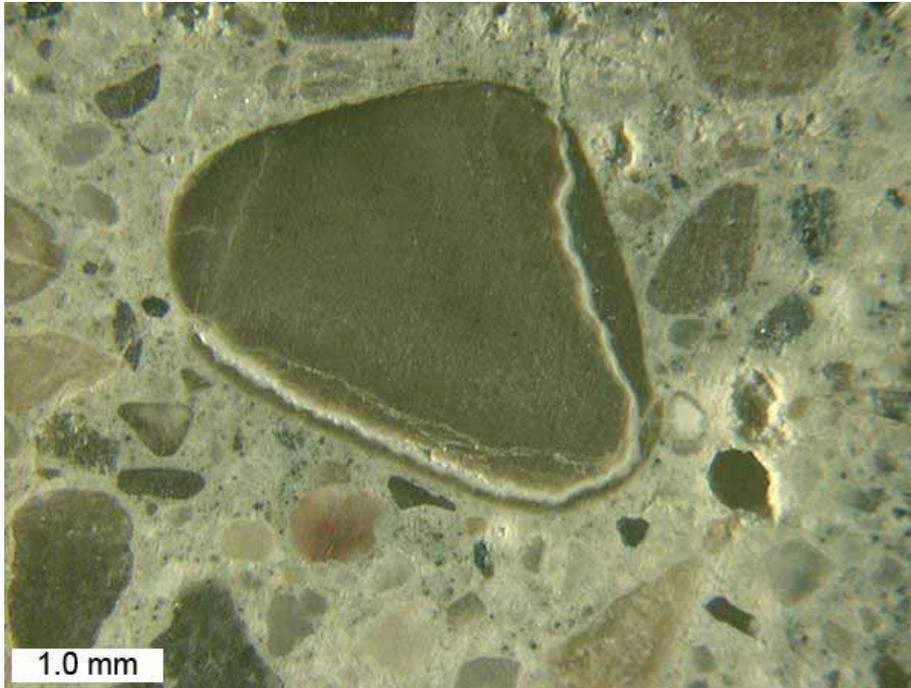
Alkali silica reaction in fine aggregate and associated cracking, before and after sodium cobaltinitrite stain, polished slab from I-696, constructed 1995, at transverse joint, bottom half of core A, MTU ID 696-09.

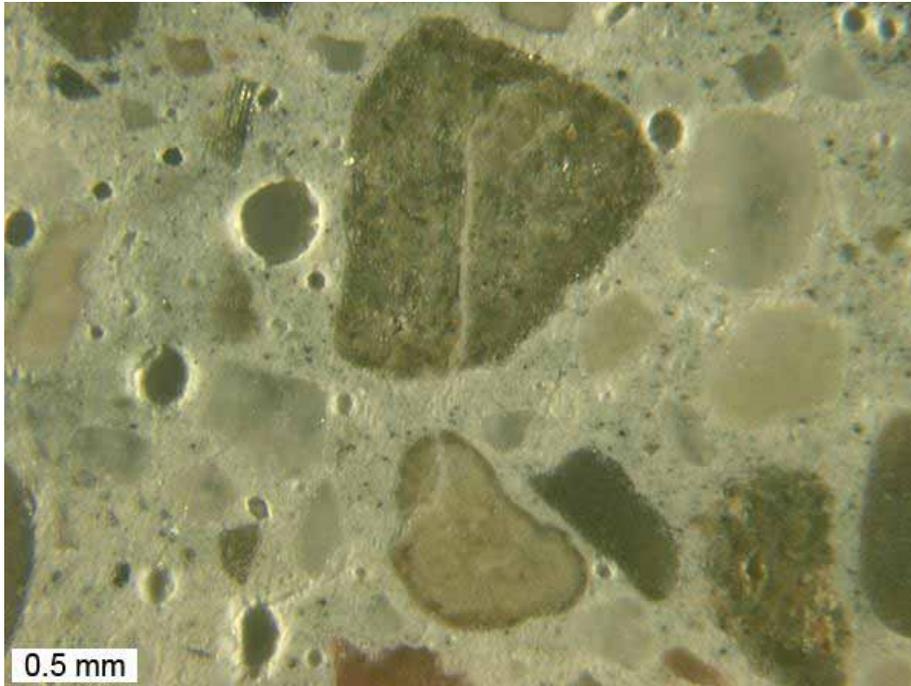
Alkali silica reaction in fine aggregate and associated cracking, before and after sodium cobaltinitrite stain, polished slab from I-696, constructed 1995, away from transverse joint, top half of core C, MTU ID 696-11.

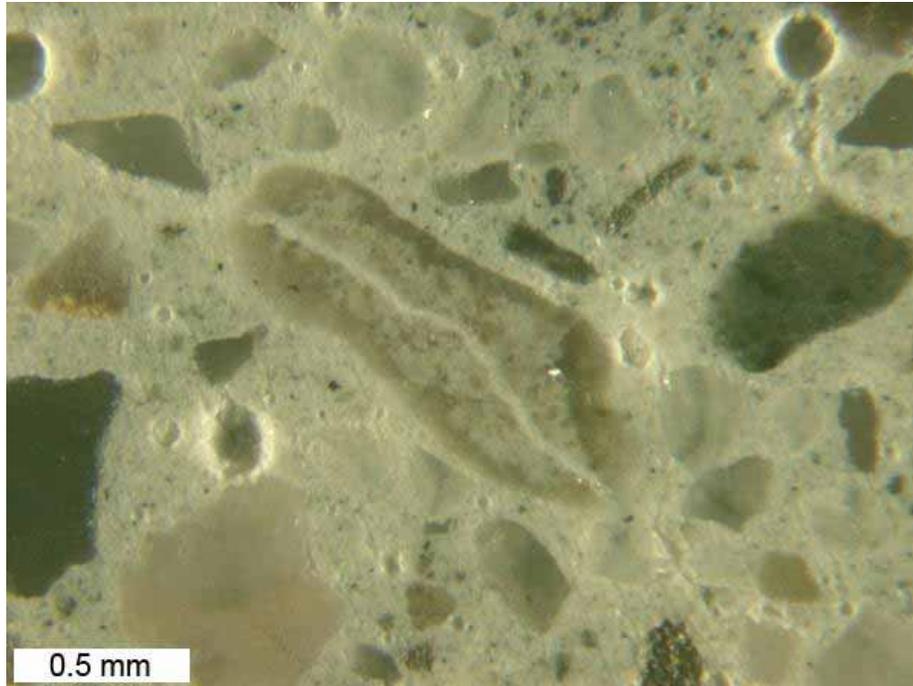
Alkali silica reaction in fine aggregate and associated cracking, before and after sodium cobaltinitrite stain, polished slab from I-696, constructed 1995, away from transverse joint, top half of core C, MTU ID 696-11.

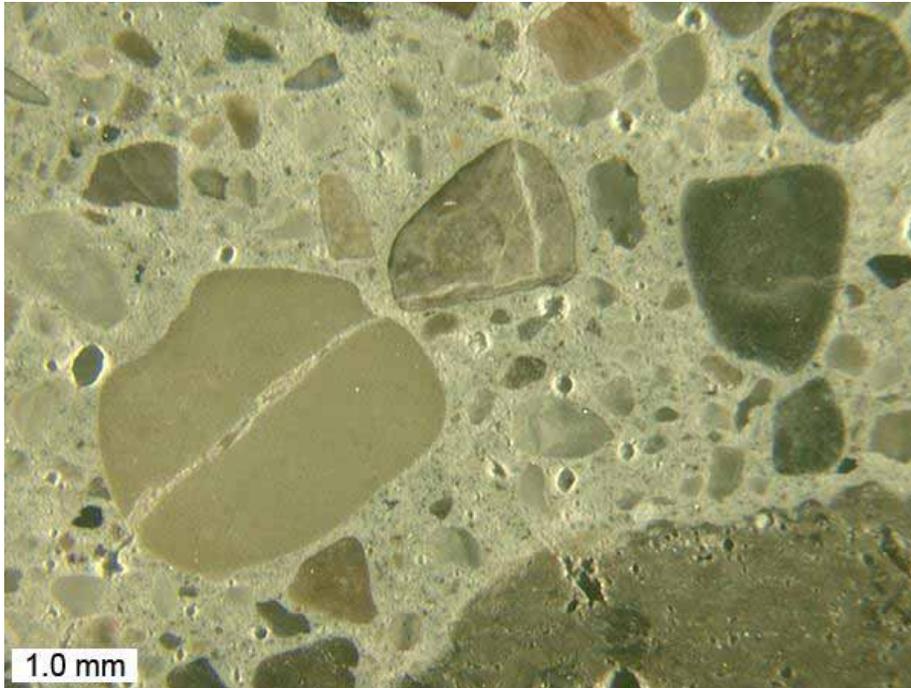
Alkali silica reaction in fine aggregate and associated cracking, before and after sodium cobaltinitrite stain, polished slab from I-696, constructed 1995, away from transverse joint, top half of core C, MTU ID 696-11.

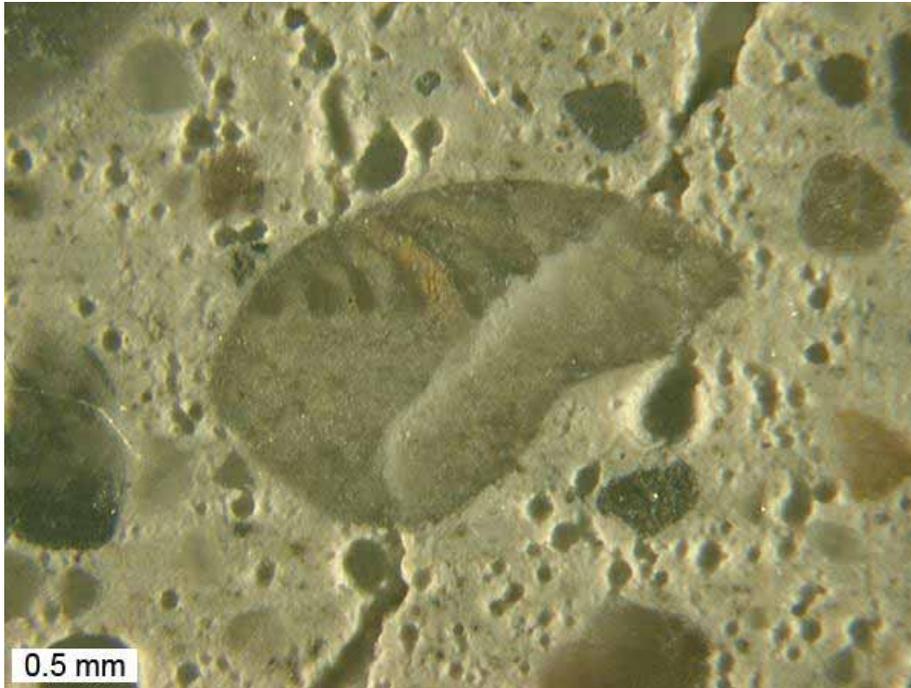
Alkali silica reaction in fine aggregate and associated cracking, before and after sodium cobaltinitrite stain, polished slab from I-696, constructed 1995, away from transverse joint, top half of core C, MTU ID 696-11.

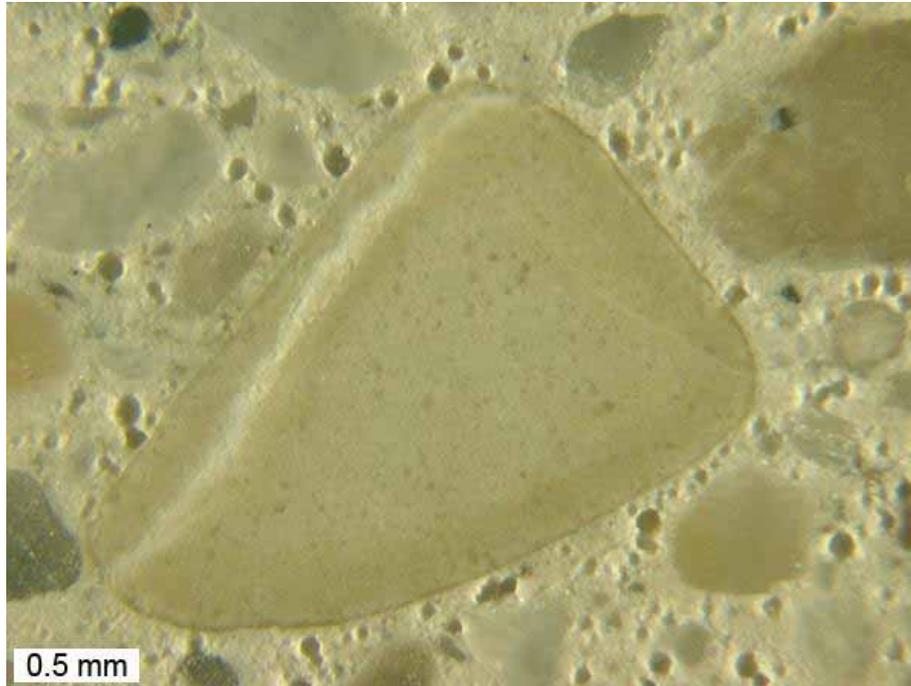
Alkali silica reaction in fine aggregate and associated cracking, before and after sodium cobaltinitrite stain, polished slab from I-696, constructed 1995, away from transverse joint, top half of core C, MTU ID 696-11.
