Appendix A
I-696 Core Site

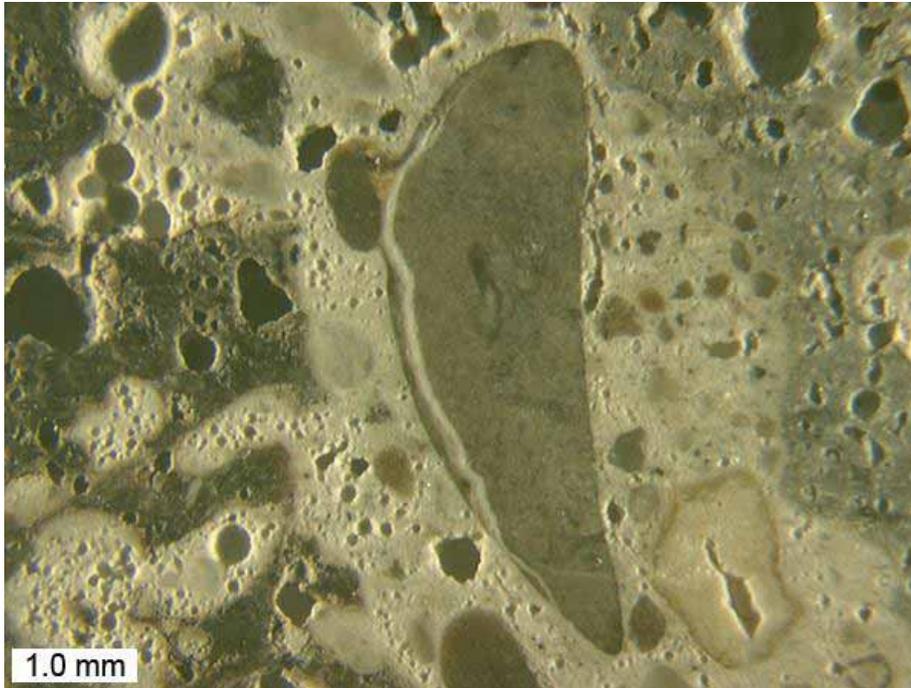
Alkali silica reaction in fine aggregate and associated cracking, before and after sodium cobaltinitrite stain, polished slab from I-696, constructed 1995, away from transverse joint, top half of core C, MTU ID 696-11.

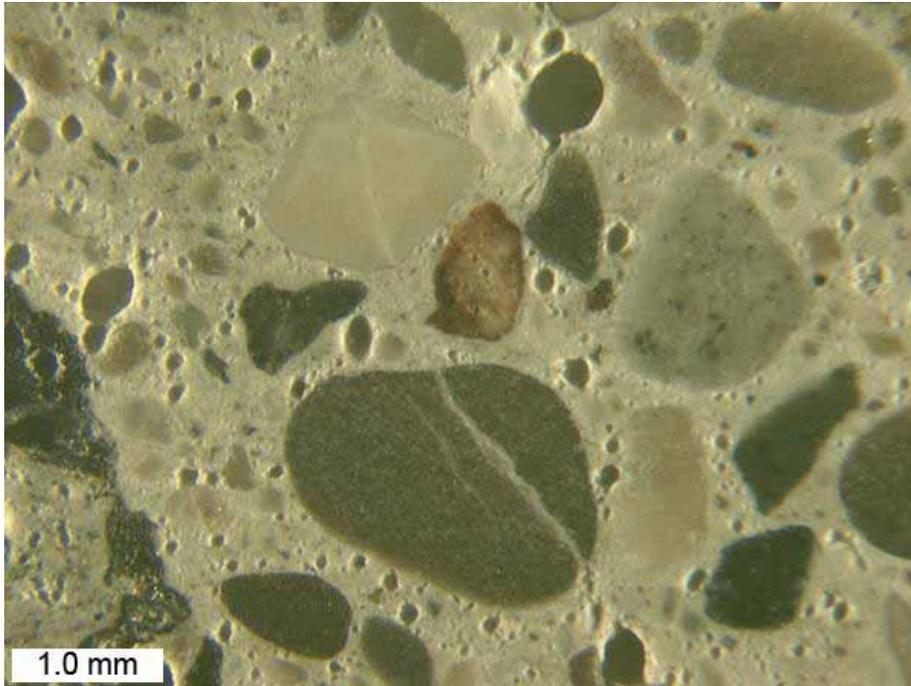
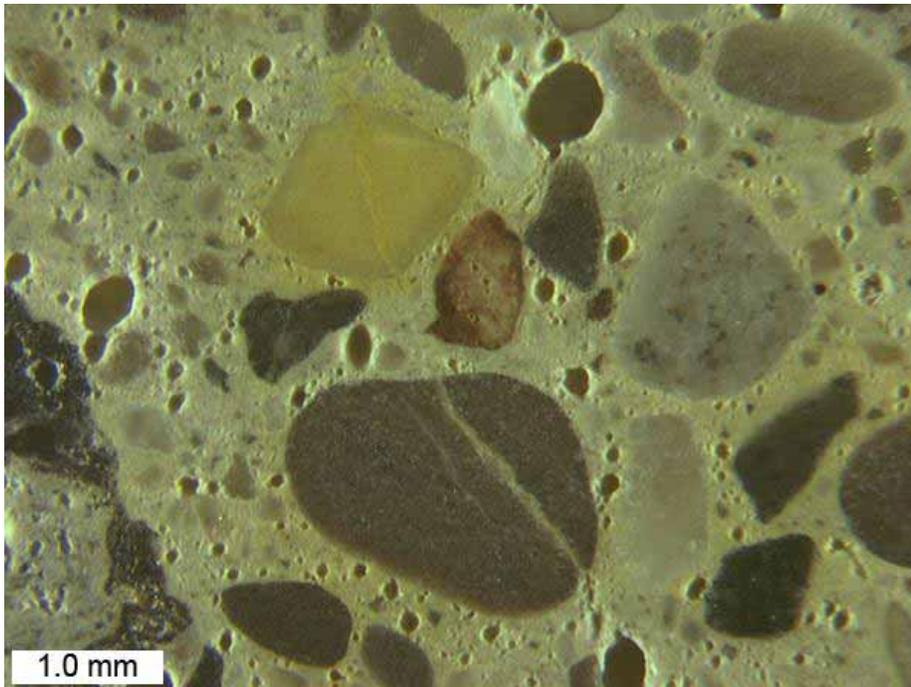
Alkali silica reaction in fine aggregate and associated cracking, before and after sodium cobaltinitrite stain, polished slab from I-696, constructed 1995, away from transverse joint, top half of core C, MTU ID 696-11.

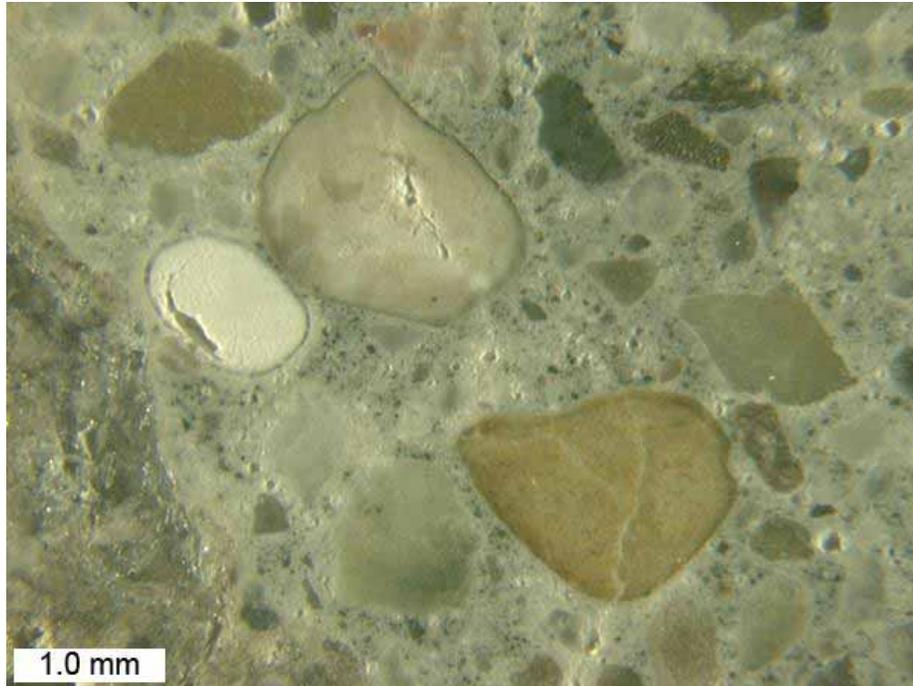
Alkali silica reaction in fine aggregate and associated cracking, before and after sodium cobaltinitrite stain, polished slab from I-696, constructed 1995, away from transverse joint, bottom half of core C, MTU ID 696-11.

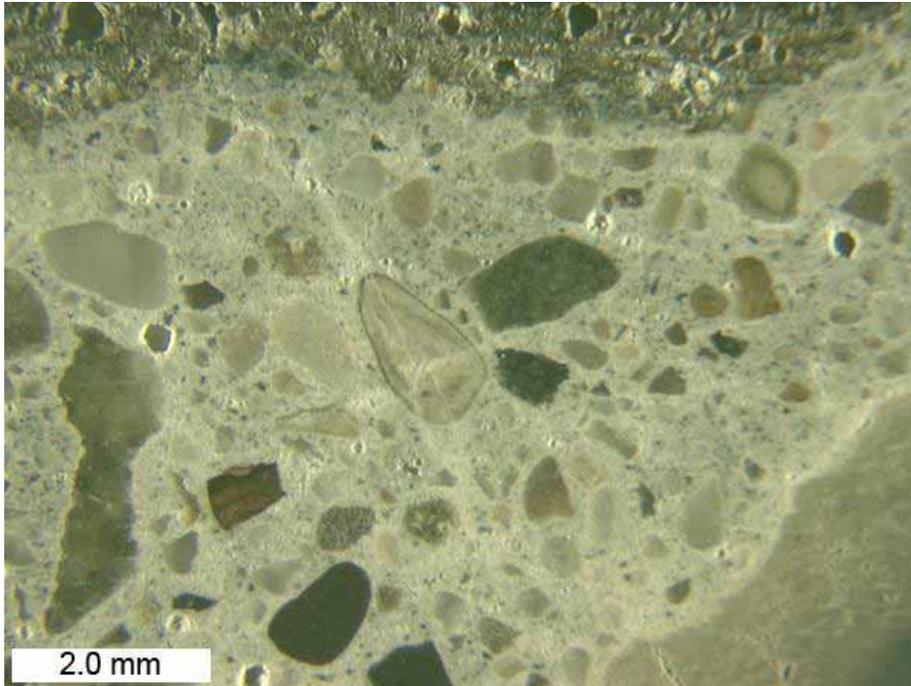
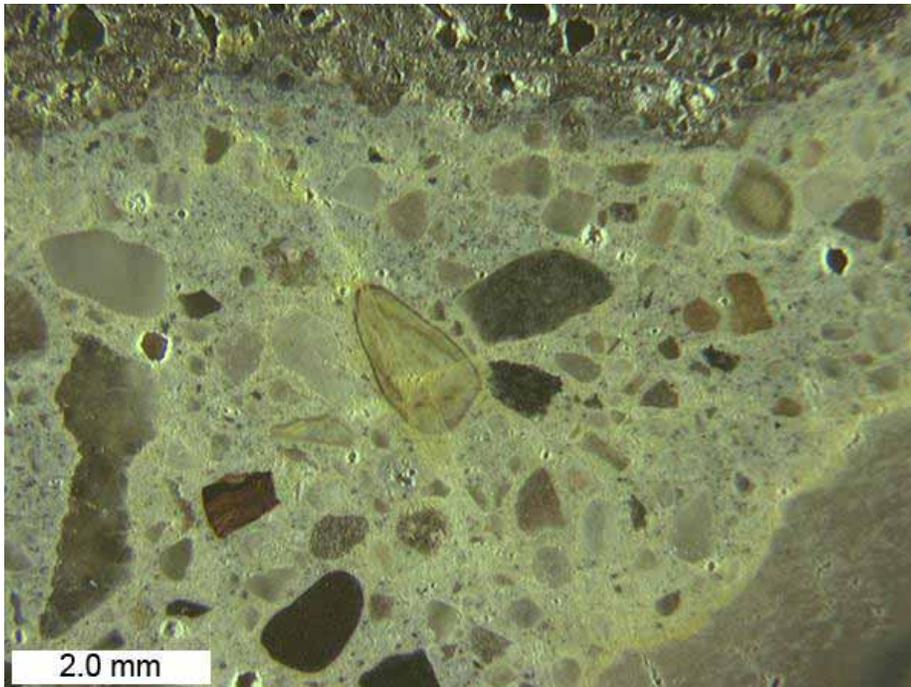
Alkali silica reaction in fine aggregate and associated cracking, before and after sodium cobaltinitrite stain, polished slab from I-696, constructed 1995, away from transverse joint, bottom half of core C, MTU ID 696-11.

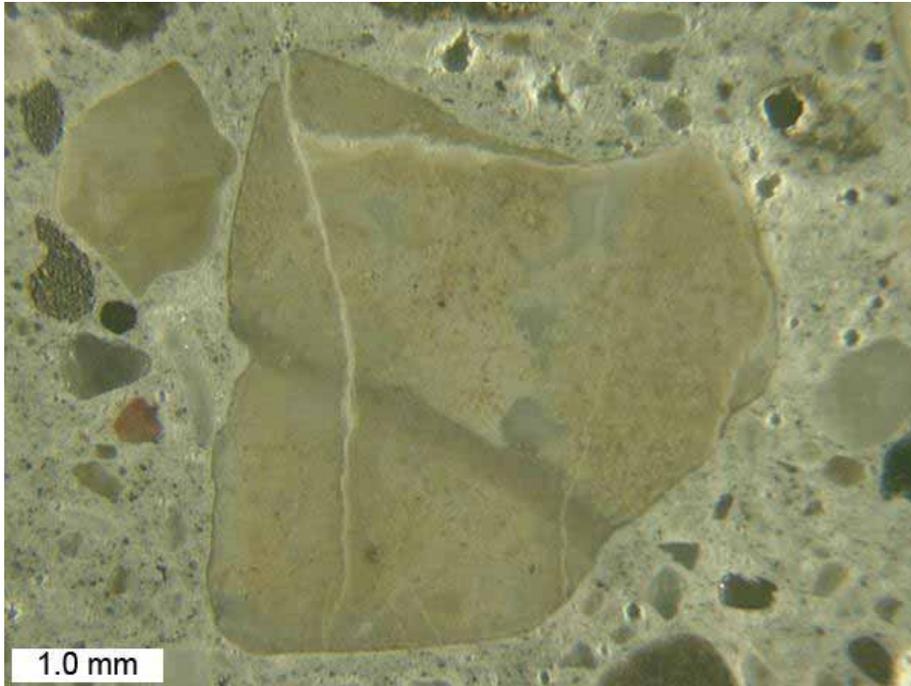
Alkali silica reaction in fine aggregate and associated cracking, before and after sodium cobaltinitrite stain, polished slab from I-696, constructed 1995, away from transverse joint, bottom half of core C, MTU ID 696-11.

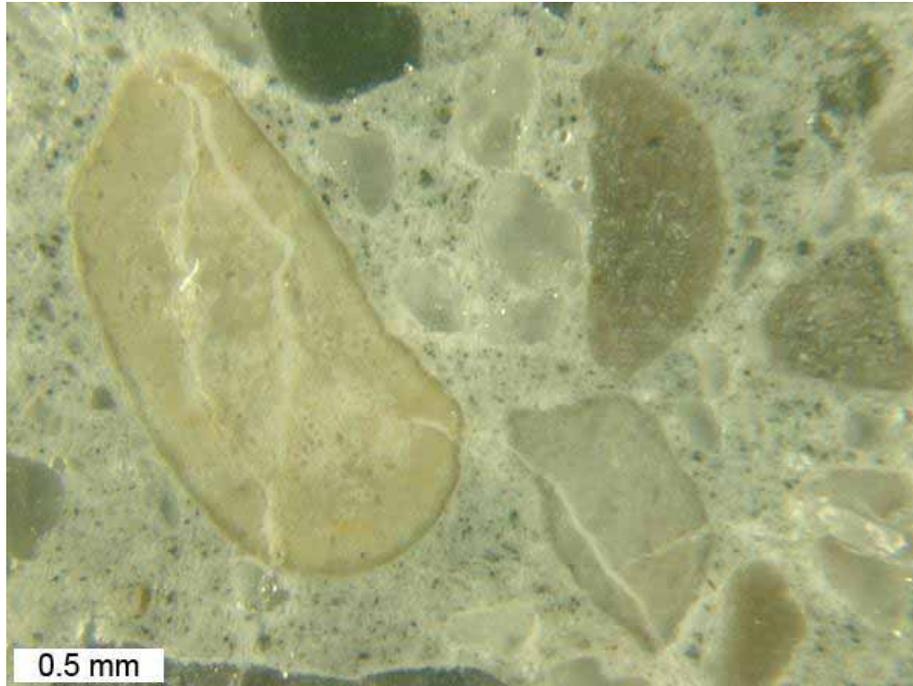
Alkali silica reaction in fine aggregate and associated cracking, before and after sodium cobaltinitrite stain, polished slab from I-696, constructed 1995, away from transverse joint, bottom half of core C, MTU ID 696-11.

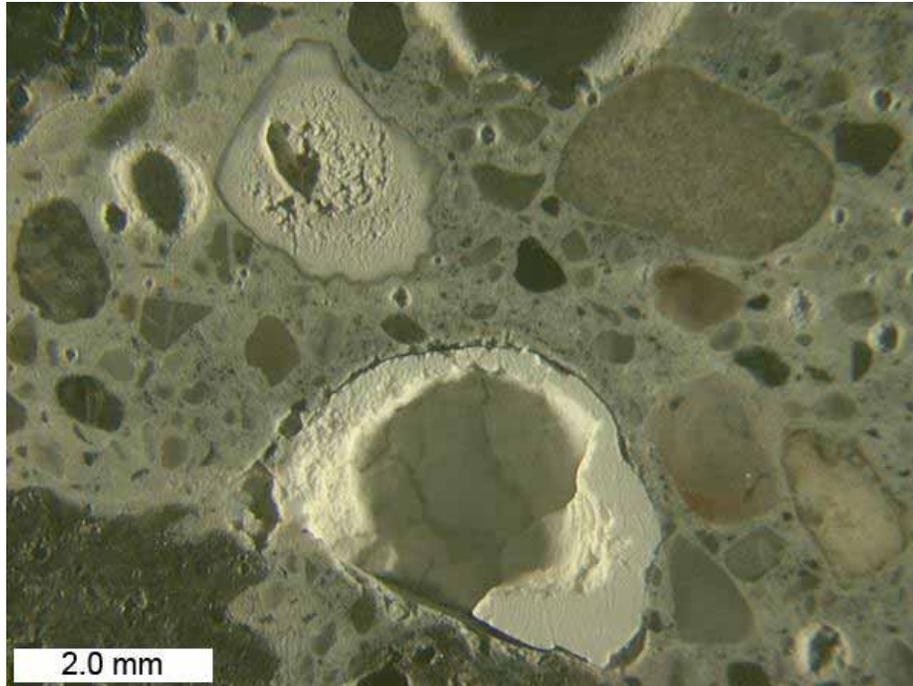
Alkali silica reaction in fine aggregate and nearby air void filled with reaction product, before and after sodium cobaltinitrite stain, polished slab from I-696, constructed 1995, away from transverse joint, bottom half of core C, MTU ID 696-11.

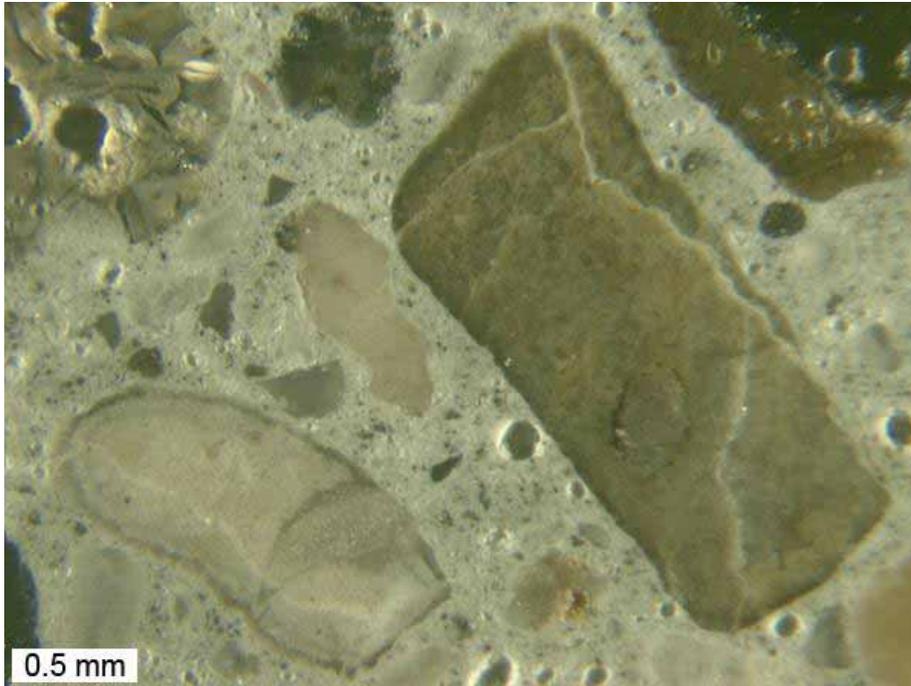
Alkali silica reaction in fine aggregate and associated cracking, before and after sodium cobaltinitrite stain, polished slab from I-696, constructed 1995, away from transverse joint, bottom half of core C, MTU ID 696-11.

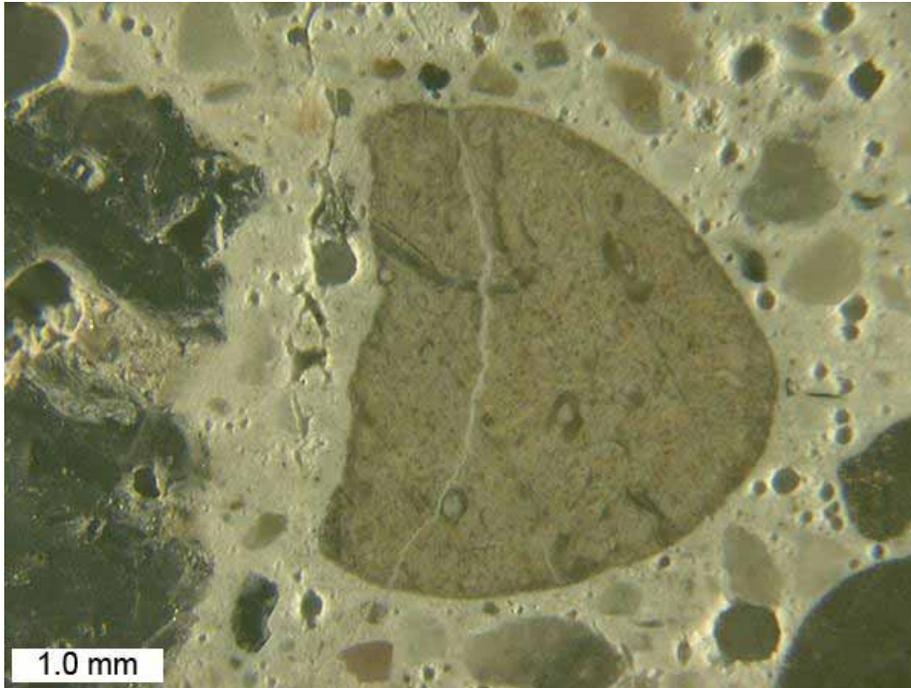
Alkali silica reaction in fine aggregate and associated cracking, before and after sodium cobaltinitrite stain, polished slab from I-696, constructed 1995, away from transverse joint, top half of core D, MTU ID 696-12.

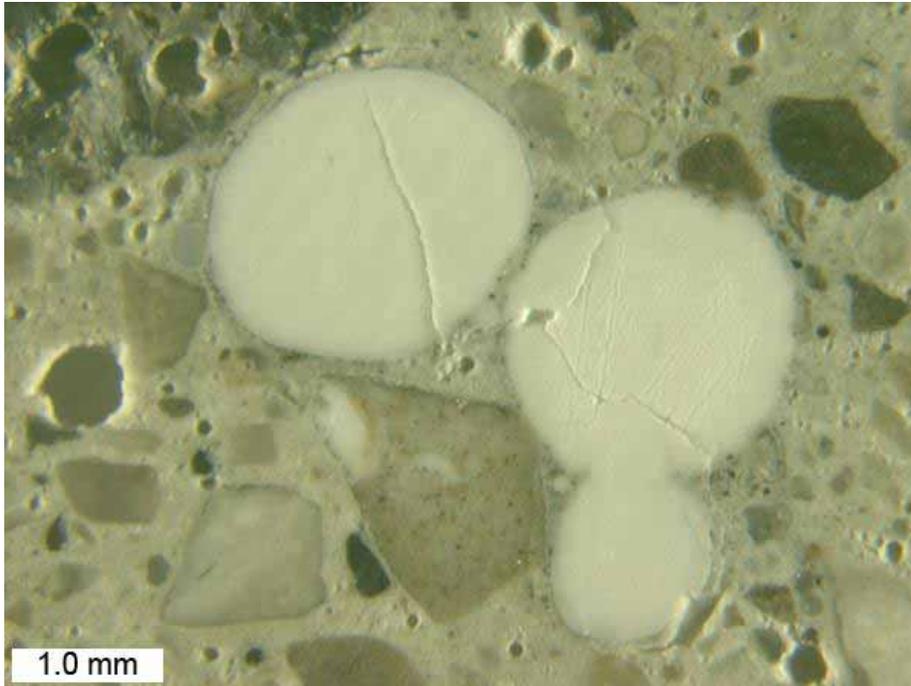
Alkali silica reaction in fine aggregate and adjacent voids filled with reaction product, before and after sodium cobaltinitrite stain, polished slab from I-696, constructed 1995, away from transverse joint, top half of core D, MTU ID 696-12.

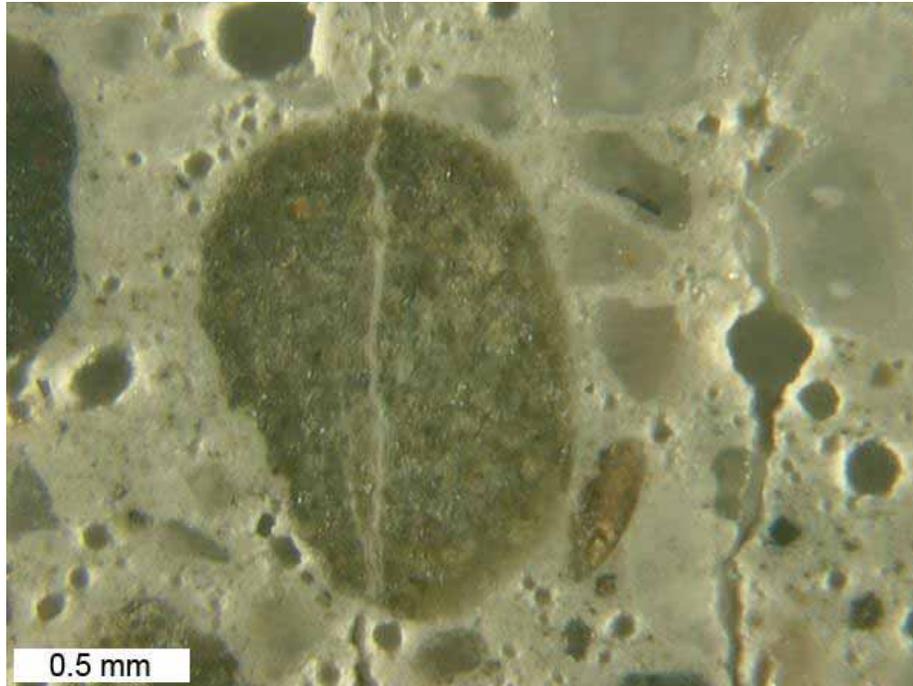
Alkali silica reaction in fine aggregate and associated cracking, before and after sodium cobaltinitrite stain, polished slab from I-696, constructed 1995, away from transverse joint, top half of core D, MTU ID 696-12.

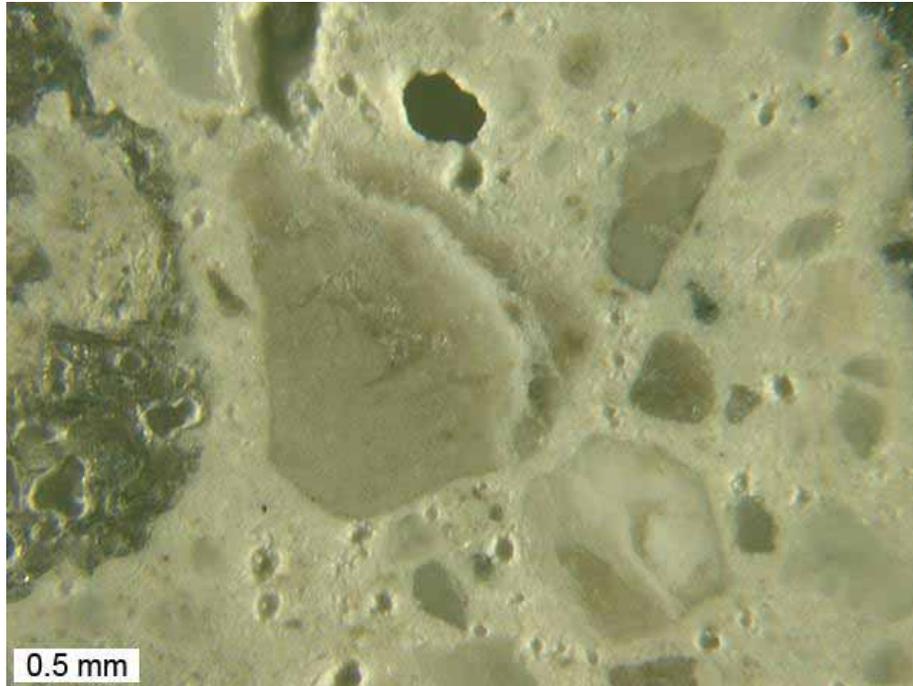
Alkali silica reaction in fine aggregate and associated cracking, before and after sodium cobaltinitrite stain, polished slab from I-696, constructed 1995, away from transverse joint, top half of core D, MTU ID 696-12.

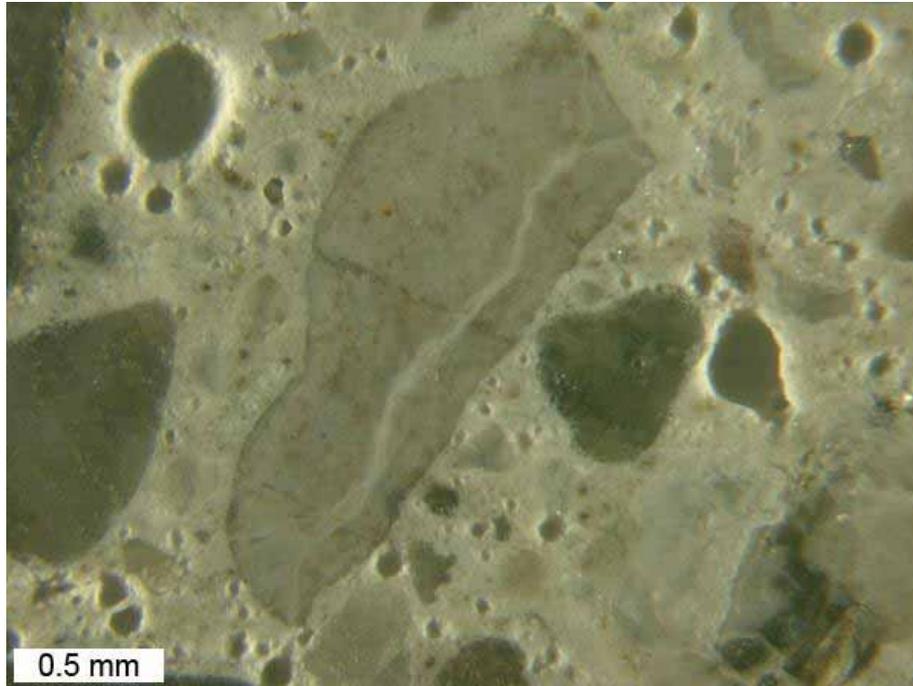
Alkali silica reaction in fine aggregate and associated cracking, before and after sodium cobaltinitrite stain, polished slab from I-696, constructed 1995, away from transverse joint, top half of core D, MTU ID 696-12.

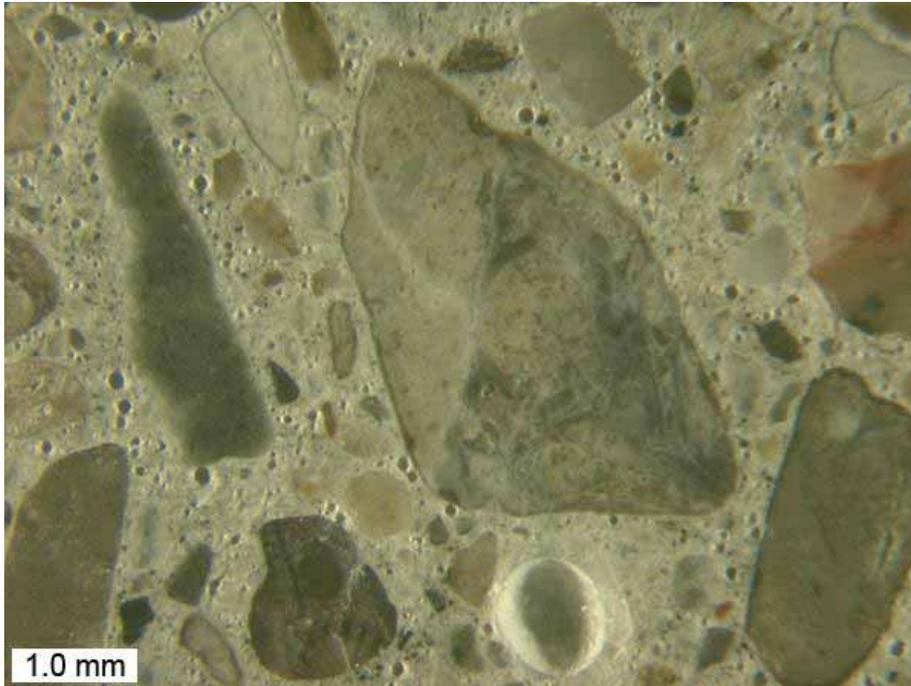
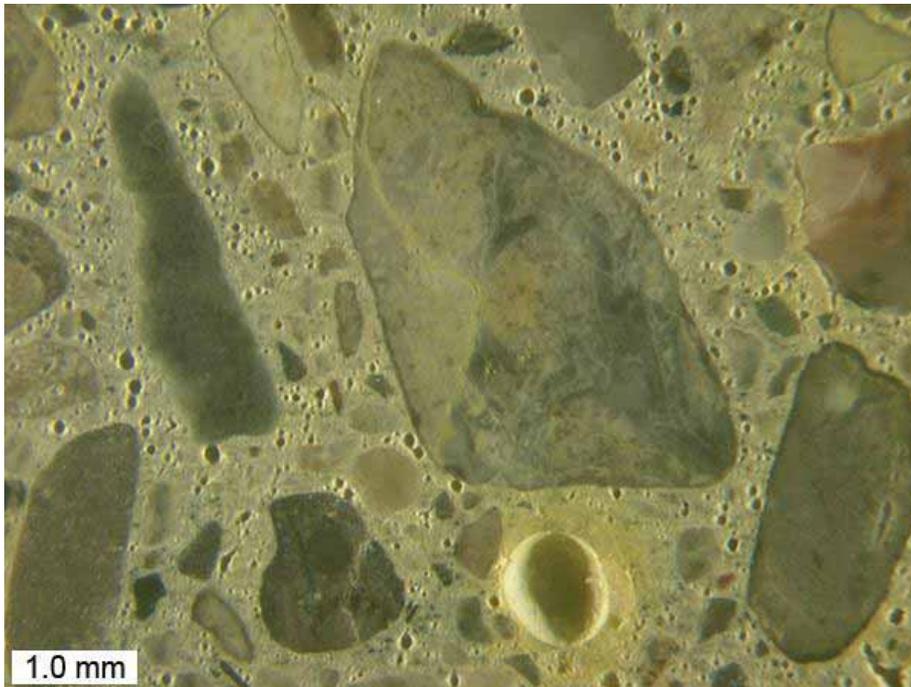
Alkali silica reaction in fine aggregate and associated cracking, before and after sodium cobaltinitrite stain, polished slab from I-696, constructed 1995, away from transverse joint, top half of core D, MTU ID 696-12.

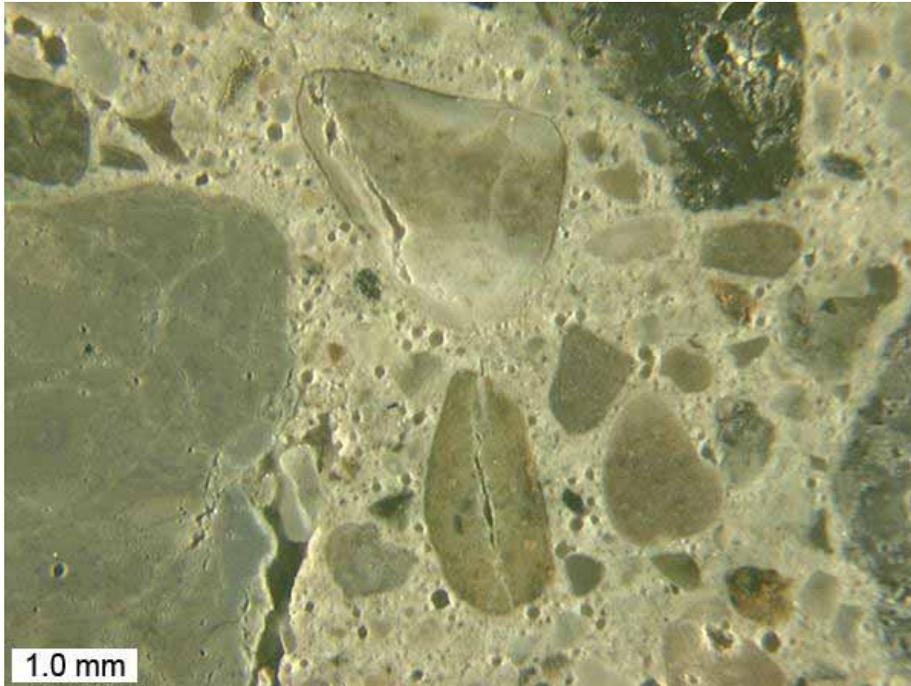
Alkali silica reaction in fine aggregate and associated cracking, before and after sodium cobaltinitrite stain, polished slab from I-696, constructed 1995, away from transverse joint, top half of core D, MTU ID 696-12.

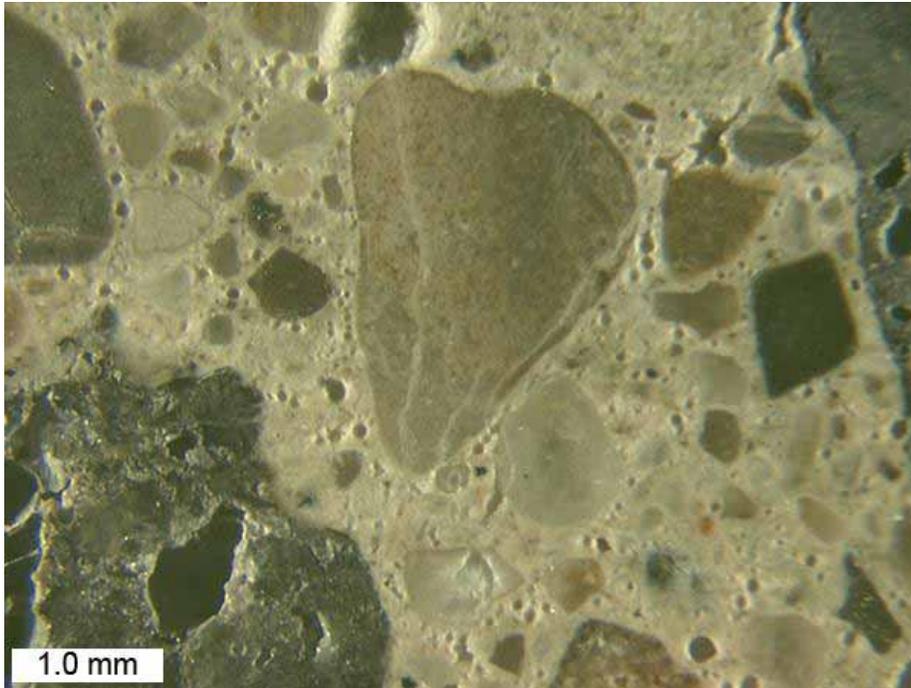
Alkali silica reaction in fine aggregate and associated cracking, before and after sodium cobaltinitrite stain, polished slab from I-696, constructed 1995, away from transverse joint, top half of core D, MTU ID 696-12.

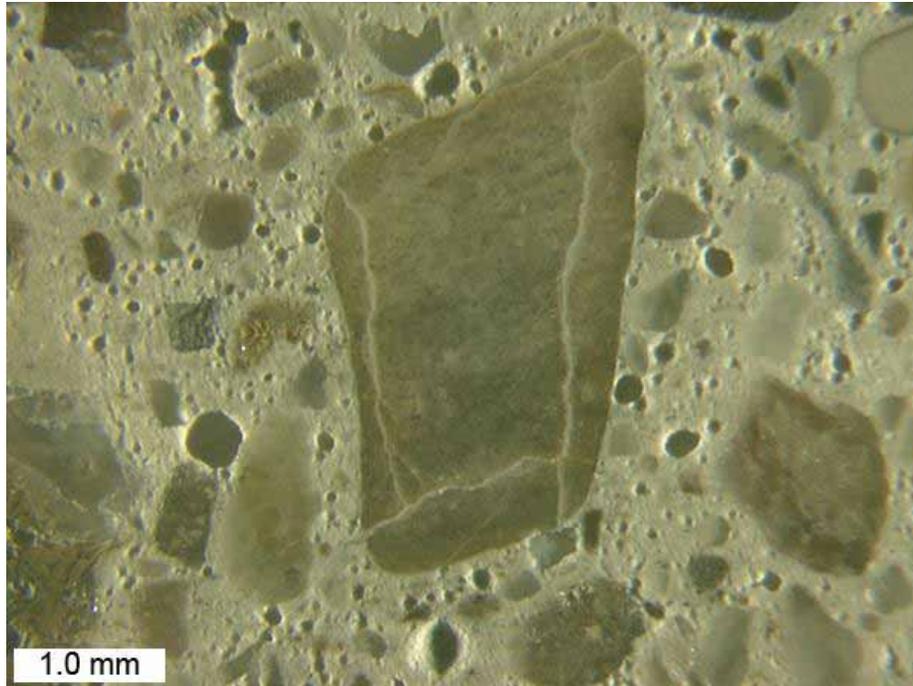
Alkali silica reaction in fine aggregate and associated cracking, before and after sodium cobaltinitrite stain, polished slab from I-696, constructed 1995, away from transverse joint, bottom half of core D, MTU ID 696-12.

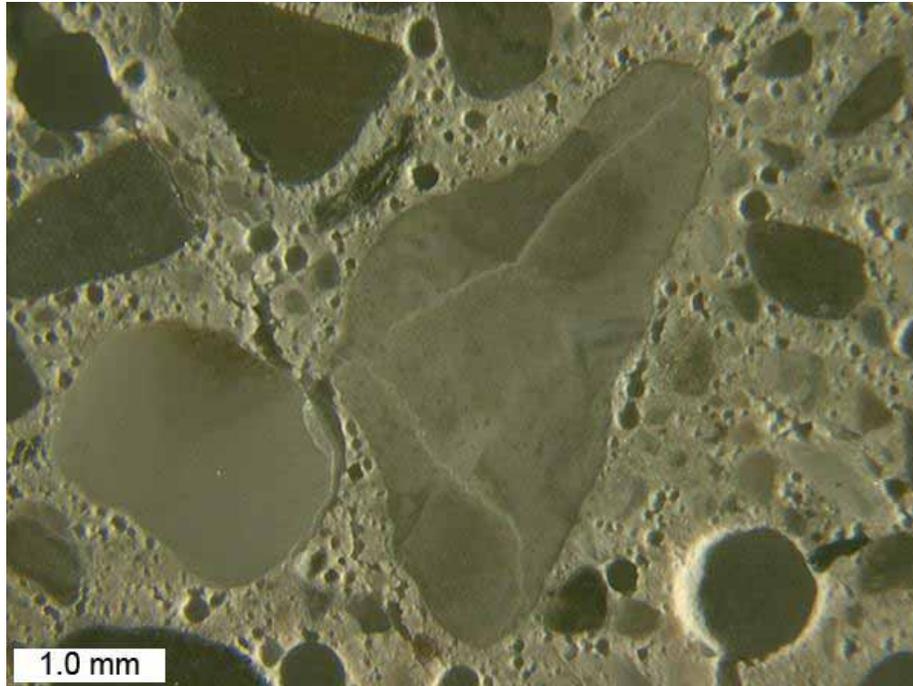
Alkali silica reaction in fine aggregate and associated cracking, before and after sodium cobaltinitrite stain, polished slab from I-696, constructed 1995, away from transverse joint, bottom half of core D, MTU ID 696-12.

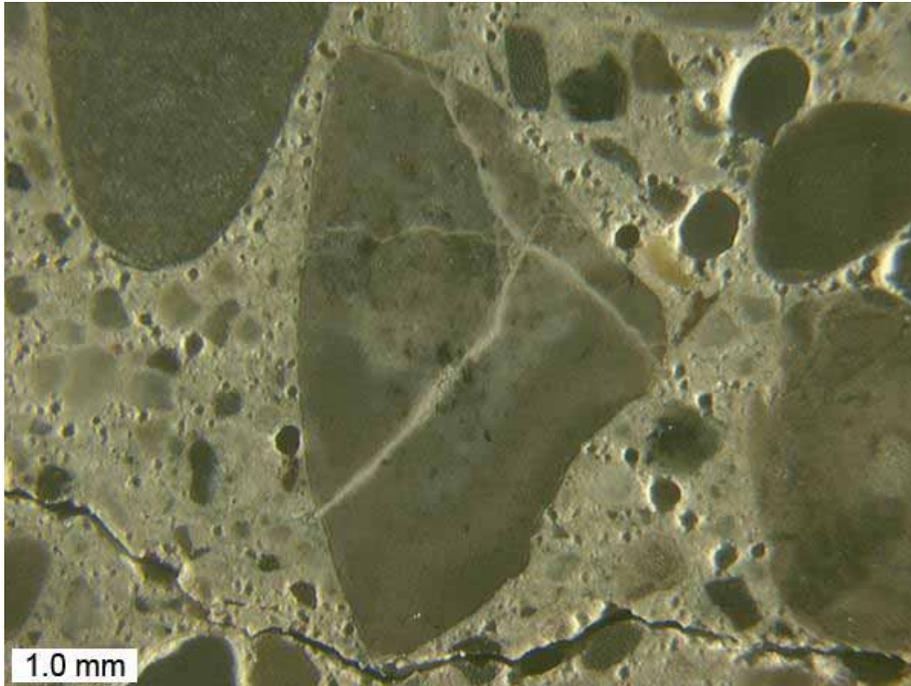
Alkali silica reaction in fine aggregate and associated cracking, before and after sodium cobaltinitrite stain, polished slab from I-696, constructed 1995, away from transverse joint, bottom half of core D, MTU ID 696-12.

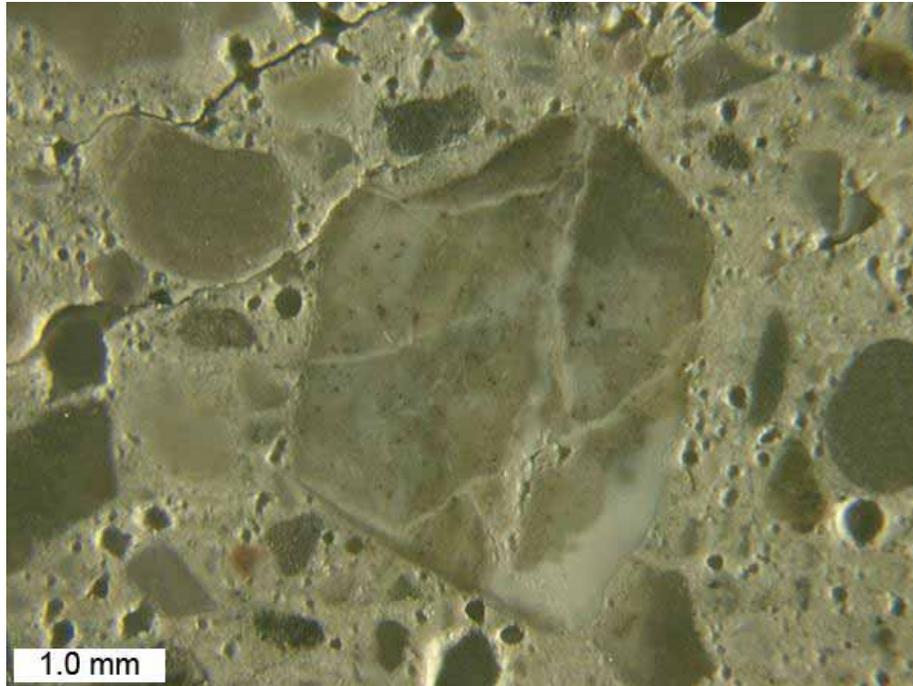
Alkali silica reaction in fine aggregate and associated cracking, before and after sodium cobaltinitrite stain, polished slab from I-696, constructed 1995, away from transverse joint, bottom half of core D, MTU ID 696-12.

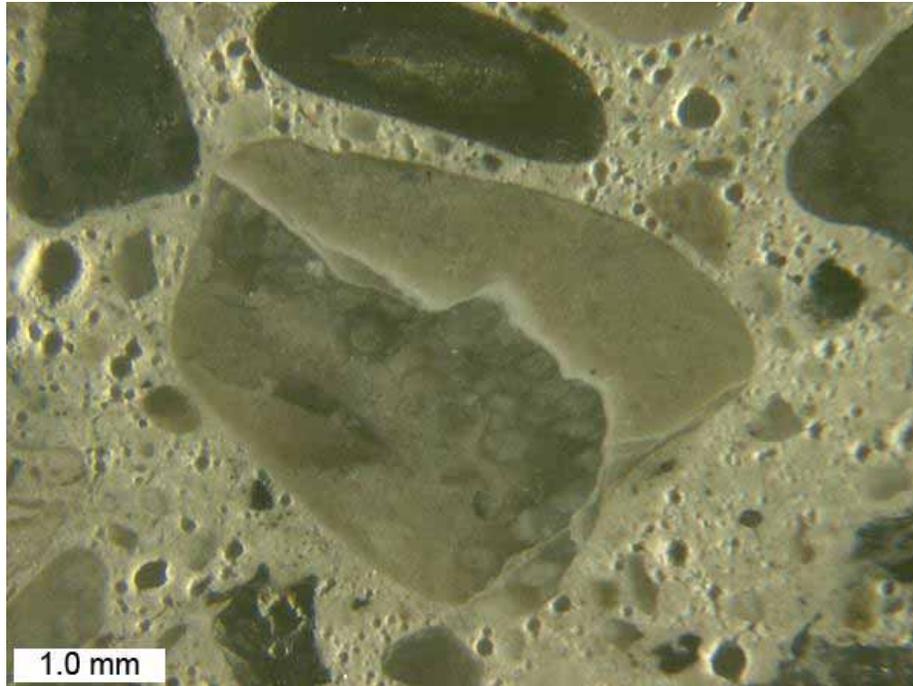
Alkali silica reaction in fine aggregate and associated cracking, before and after sodium cobaltinitrite stain, polished slab from I-696, constructed 1995, away from transverse joint, bottom half of core D, MTU ID 696-12.

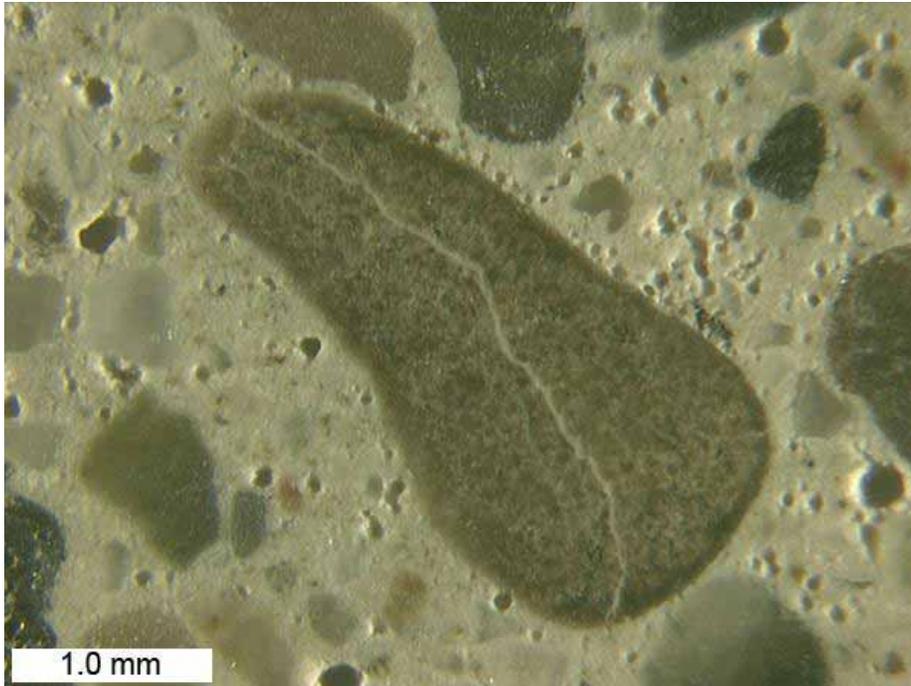
Alkali silica reaction in fine aggregate and associated cracking, before and after sodium cobaltinitrite stain, polished slab from I-696, constructed 1995, away from transverse joint, bottom half of core D, MTU ID 696-12.

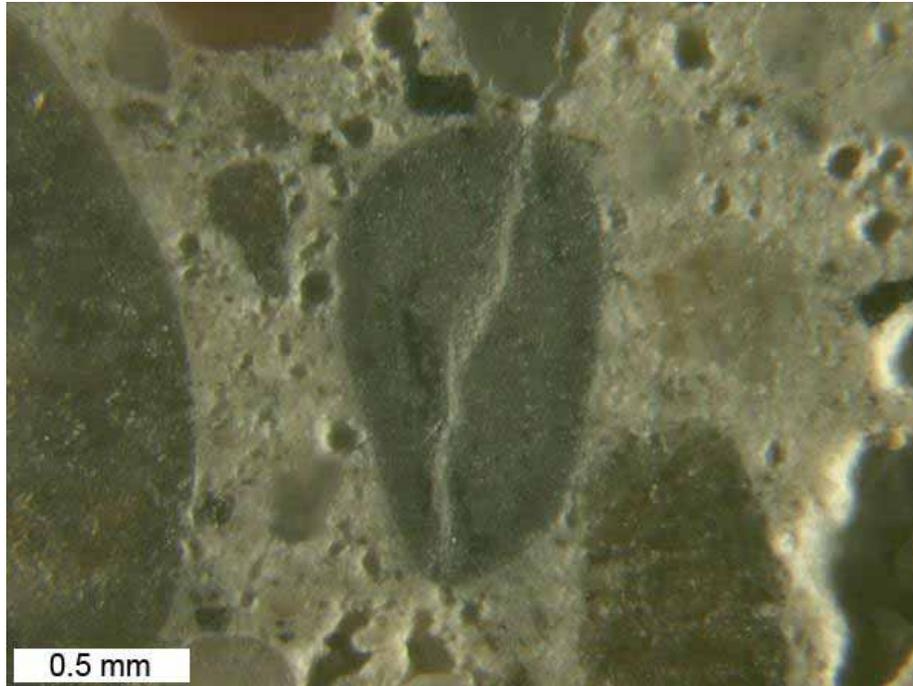
Alkali silica reaction in fine aggregate and associated cracking, before and after sodium cobaltinitrite stain, polished slab from I-696, constructed 1995, away from transverse joint, bottom half of core D, MTU ID 696-12.

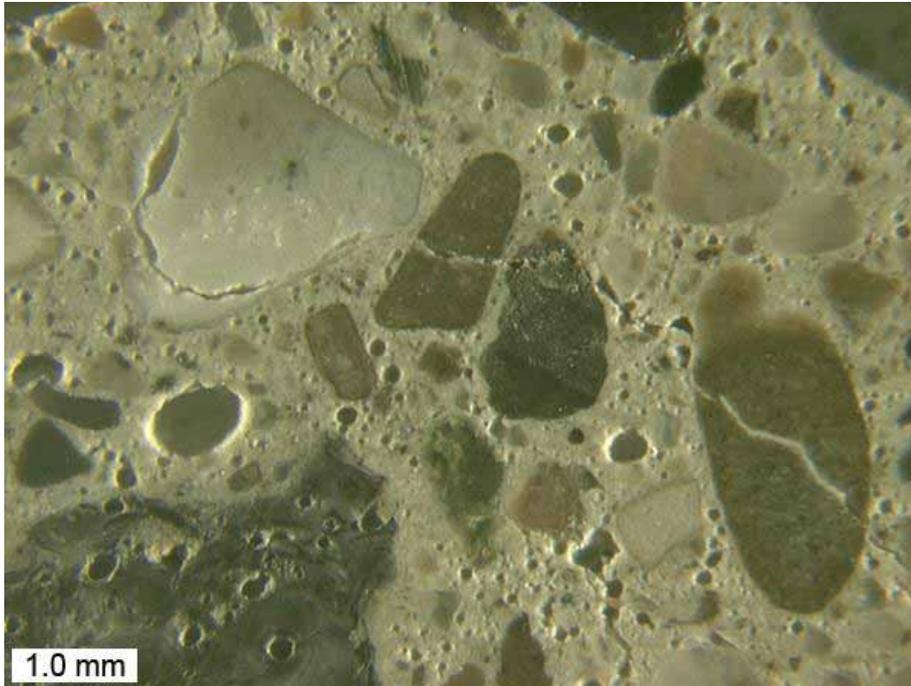
Alkali silica reaction in fine aggregate and associated cracking, before and after sodium cobaltinitrite stain, polished slab from I-696, constructed 1995, away from transverse joint, bottom half of core D, MTU ID 696-12.

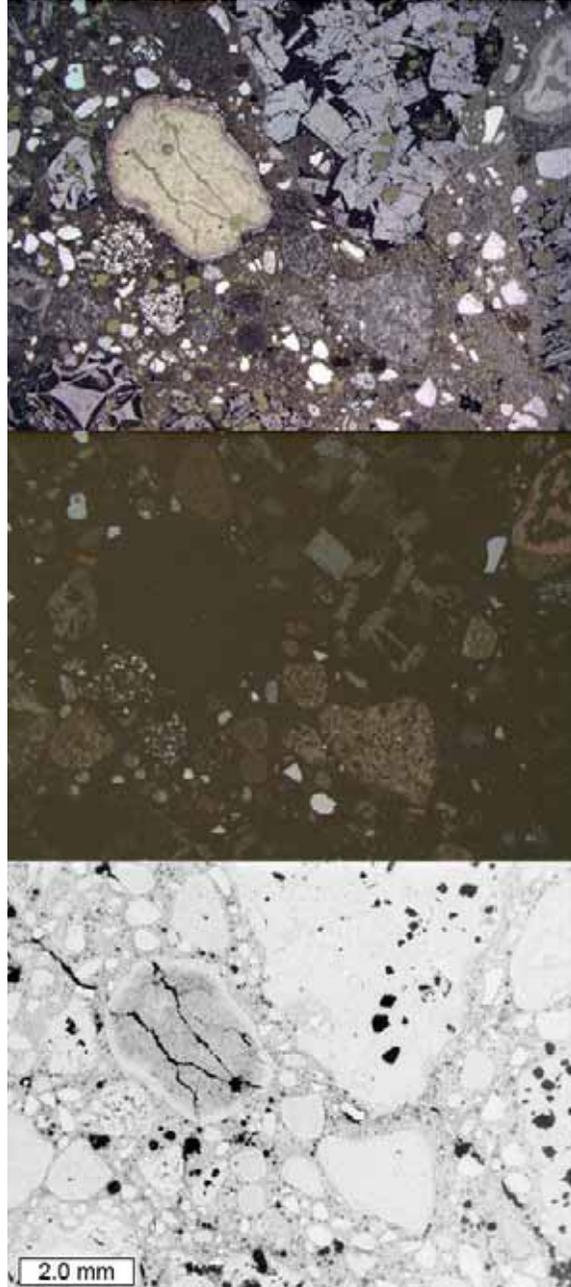
Example of chert particle exhibiting deleterious alkali-silica reaction, from thin section prepared from core from I-696, constructed 1995, away from transverse joint, MTU ID 696-03. From top to bottom: transmitted light, crossed-polars, and epifluorescent mode images.

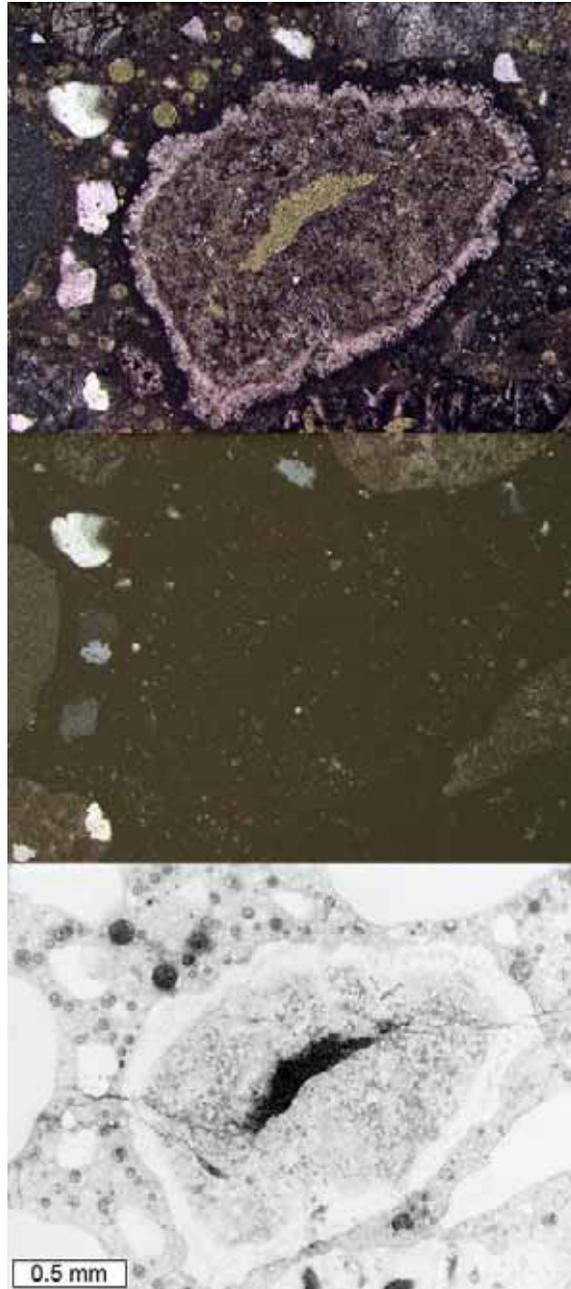
Example of chert particle exhibiting deleterious alkali-silica reaction, from thin section prepared from core from I-696, constructed 1995, away from transverse joint, MTU ID 696-03. From top to bottom: transmitted light, crossed-polars, and epifluorescent mode images.

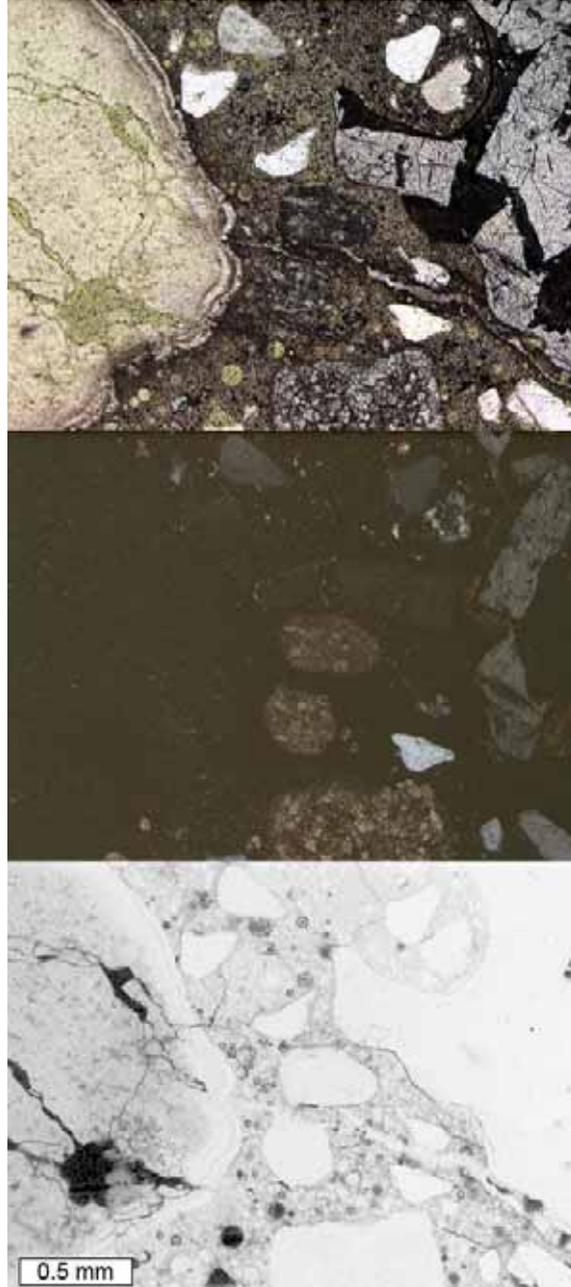
Example of chert particle exhibiting deleterious alkali-silica reaction, from thin section prepared from core from I-696, constructed 1995, away from transverse joint, MTU ID 696-03. From top to bottom: transmitted light, crossed-polars, and epifluorescent mode images.

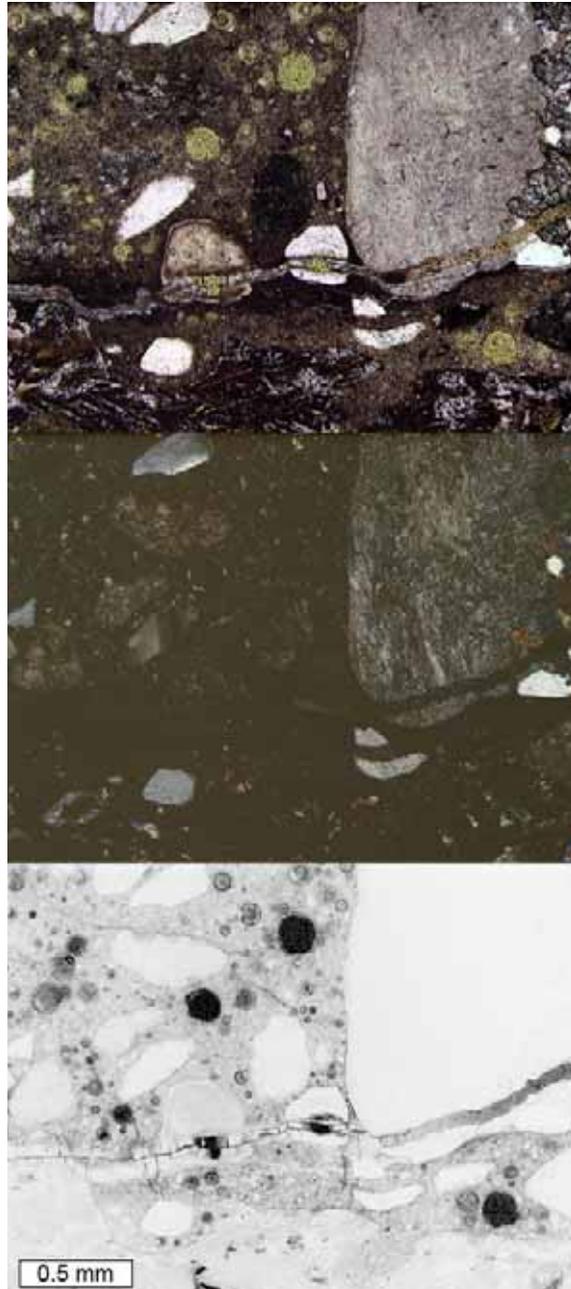
Example of chert particle exhibiting deleterious alkali-silica reaction, from thin section prepared from core from I-696, constructed 1995, away from transverse joint, MTU ID 696-03. From top to bottom: transmitted light, crossed-polars, and epifluorescent mode images.

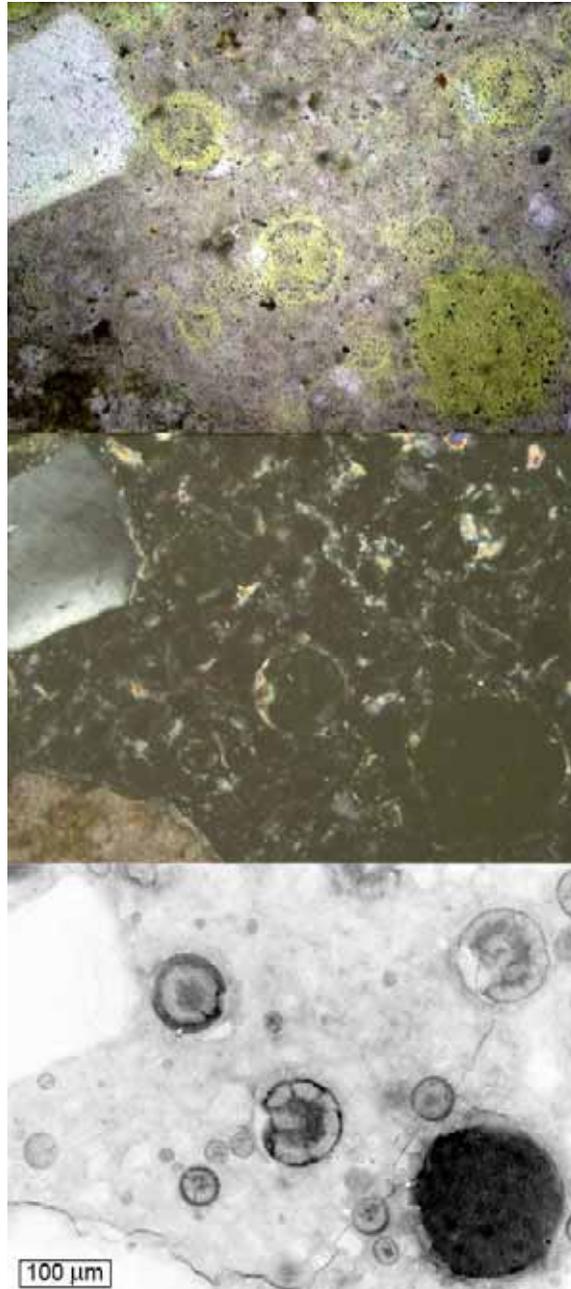
Example secondary ettringite in entrained air voids, from thin section prepared from core from I-696, constructed 1995, away from transverse joint, MTU ID 696-03. From top to bottom: transmitted light, crossed-polars, and epifluorescent mode images.

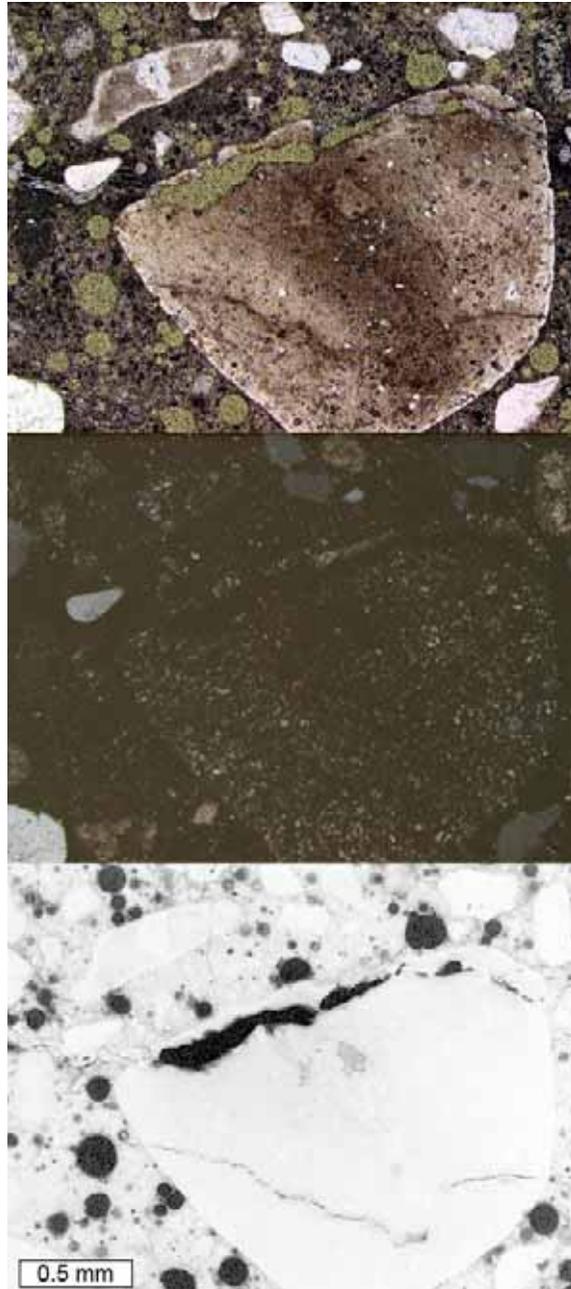
Example of chert particle exhibiting deleterious alkali-silica reaction, from thin section prepared from core from I-696, constructed 1995, away from transverse joint, MTU ID 696-12. From top to bottom: transmitted light, crossed-polars, and epifluorescent mode images.
