Appendix A
I-696 Core Site

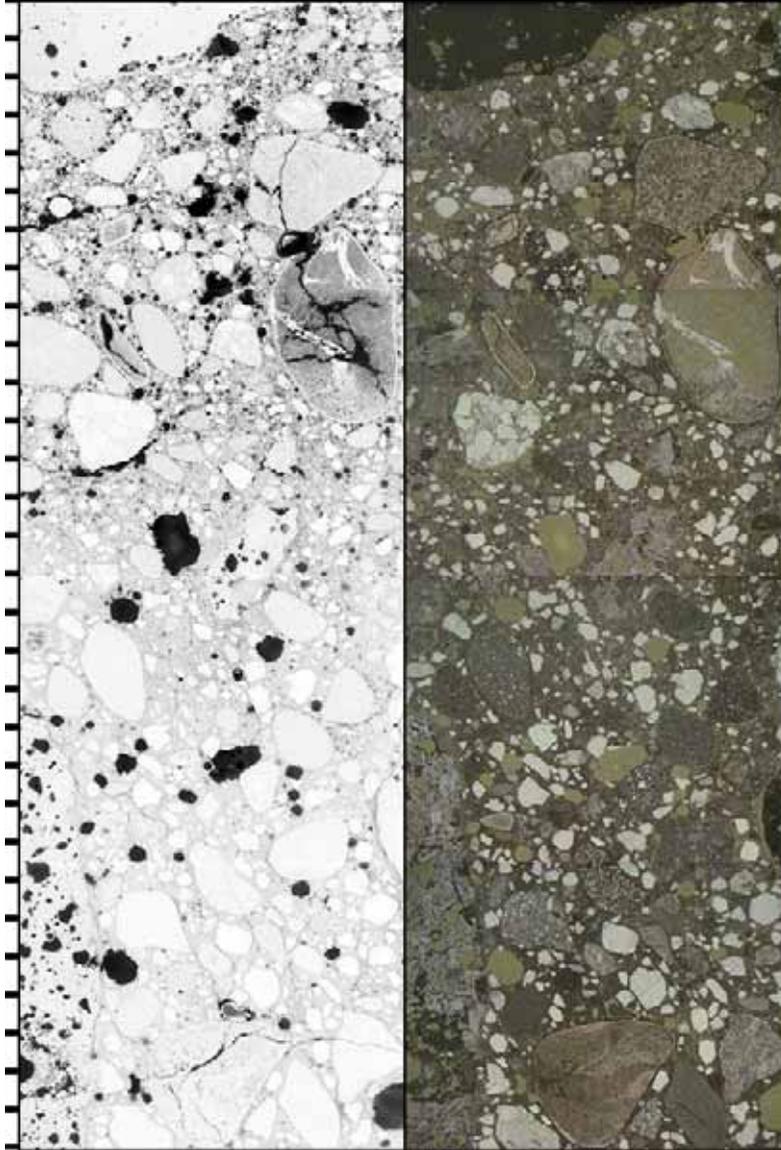
Epifluorescent mode (left) and transmitted light (right) images at transition between zone of abundant entrained air and zone without entrained air at a depth of approximately 3 inches (75 mm). Example from thin section prepared from core taken from I-696, outside lane, away from joint, MTU ID 696-03.

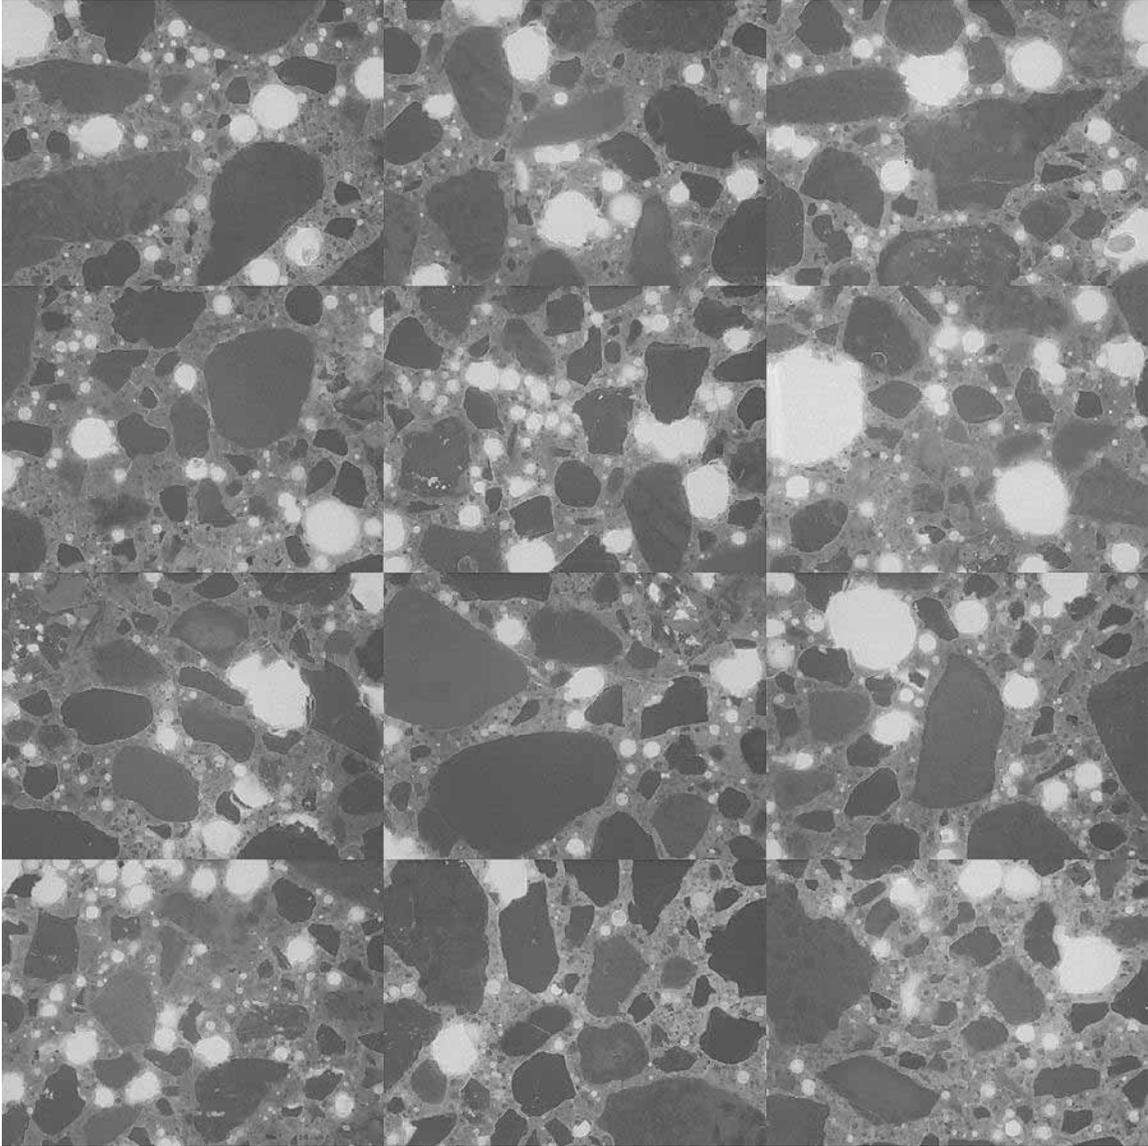
Mosaic of 12 epifluorescent mode images collected from thin sections prepared from core from I-696, constructed 1978, away from transverse joint, MTU ID 696-01 (each individual frame measures 2.612 x 1.959 mm).

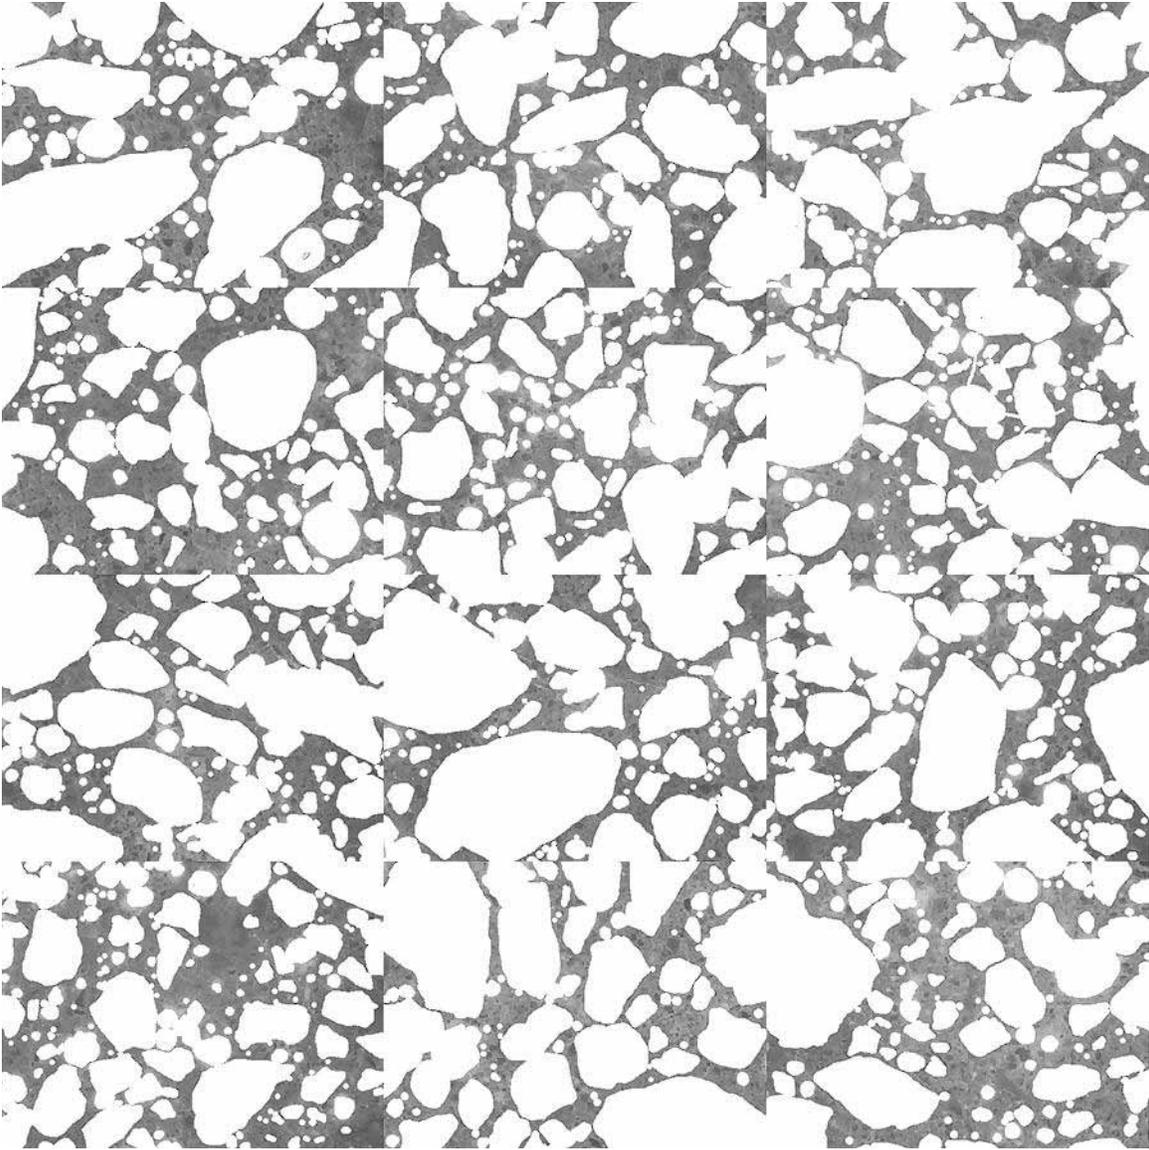
Mosaic of 12 epifluorescent mode images collected from thin sections prepared from core from I-696, constructed 1978, away from transverse joint, MTU ID 696-01, after masking out air voids and fine aggregate to isolate cement paste (each individual frame measures 2.612 x 1.959 mm).

Average cement paste pixel intensities per frame, and equivalent w/c values (as compared to 28-day moist cured mortar samples) from thin section prepared from core from I-696, constructed 1978, away from transverse joint, MTU ID 696-01.

cement paste pixel fluorescence measurements (average intensity per frame)			
67	72	80	68
78	83	66	68
70	70	81	86
equivalent w/c ($y = 0.0044x + 0.0329$)			
0.36	0.32	0.35	0.38
0.33	0.37	0.39	0.32
0.33	0.34	0.34	0.38

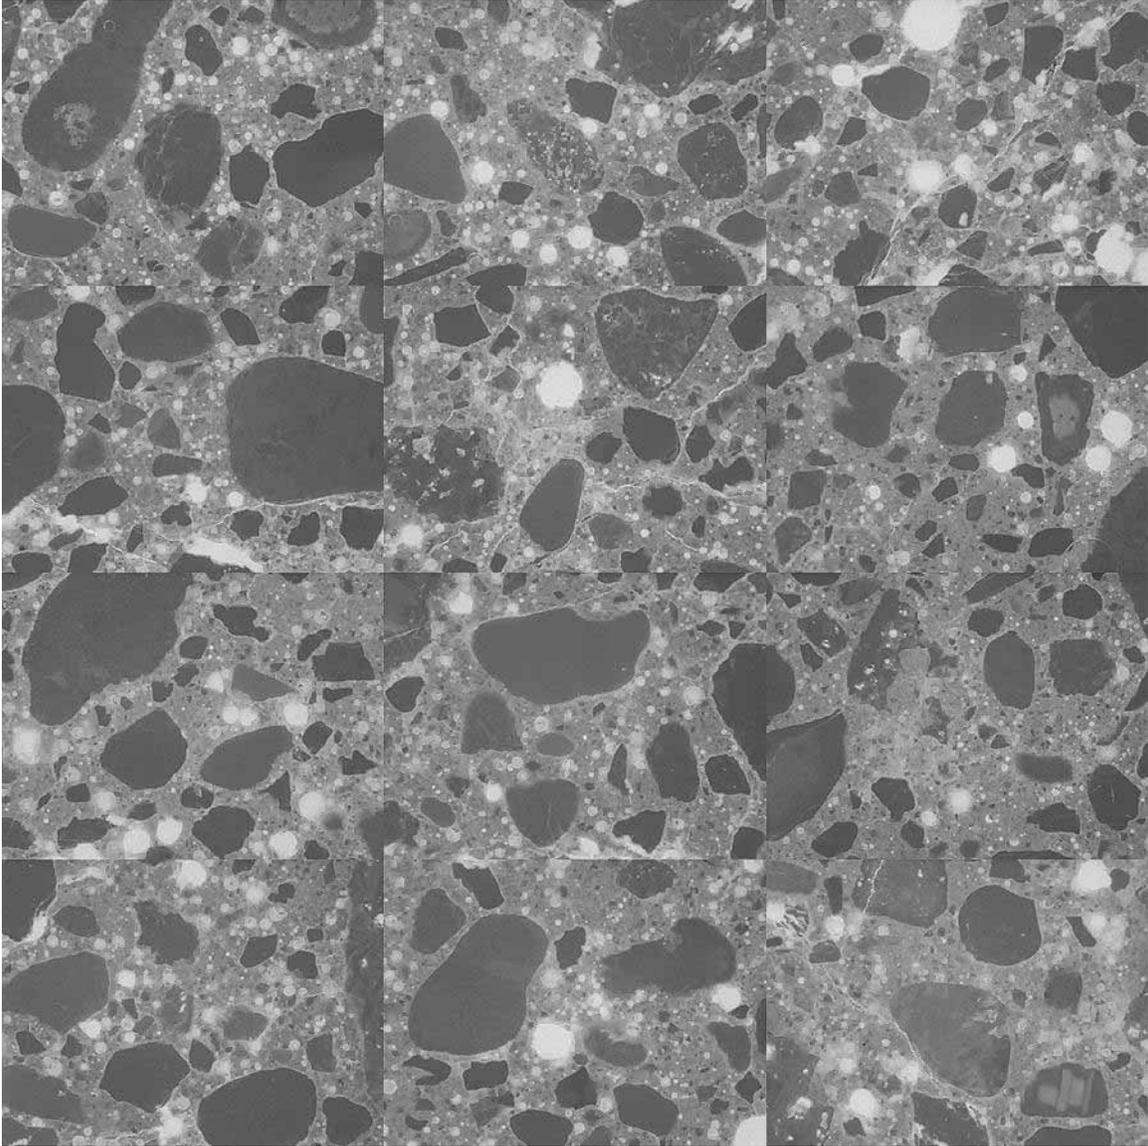
Mosaic of 12 epifluorescent mode images collected from thin sections prepared from core from I-696, constructed 1995, away from transverse joint, MTU ID 696-08 (each individual frame measures 2.612 x 1.959 mm).

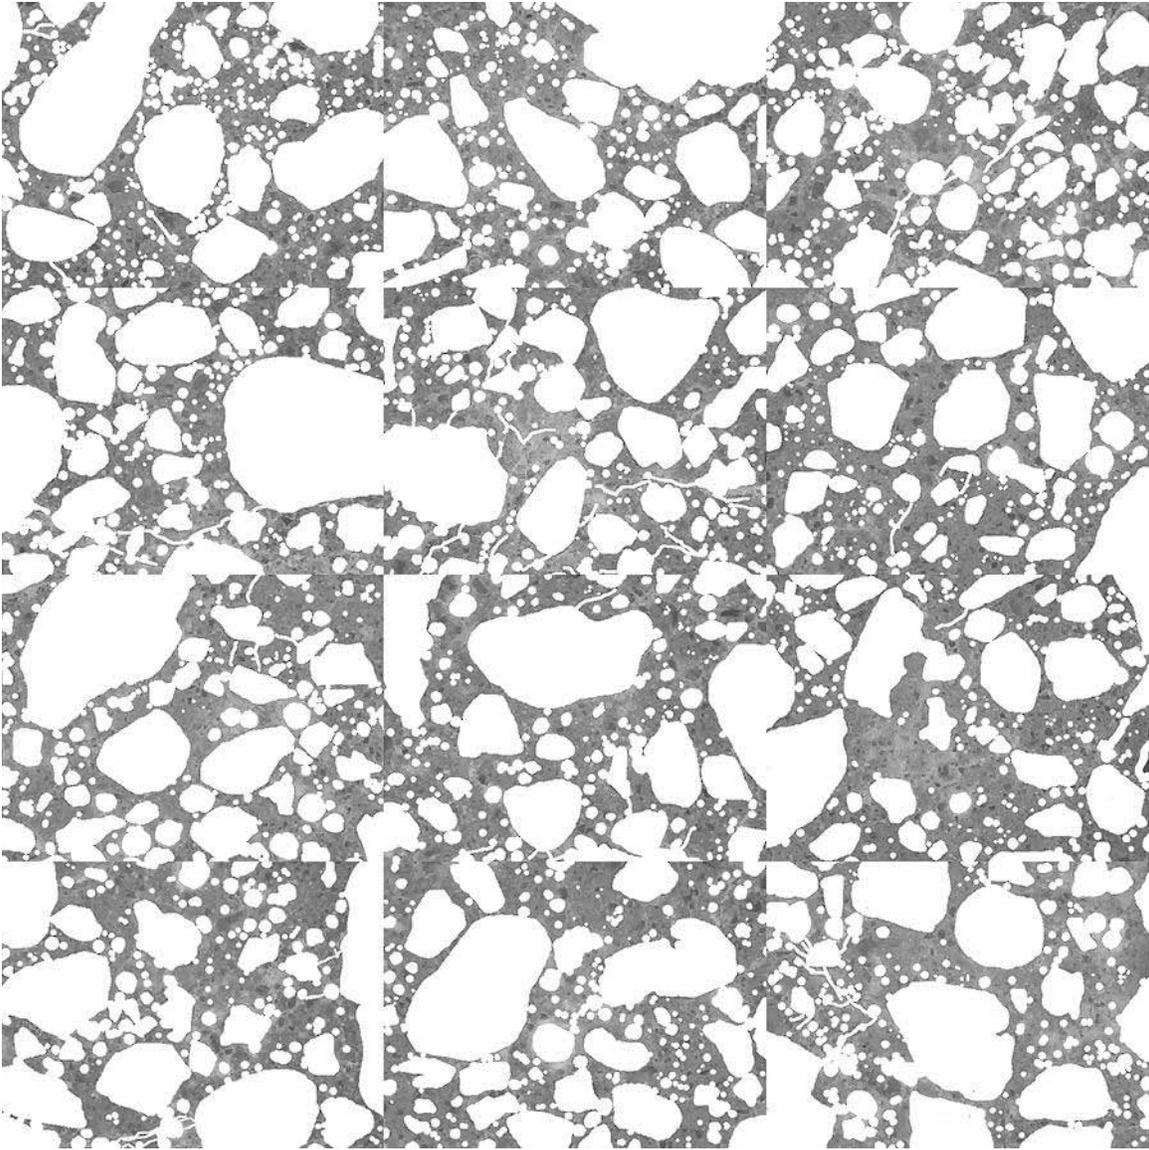
Mosaic of 12 epifluorescent mode images collected from thin sections prepared from core from I-696, constructed 1995, away from transverse joint, MTU ID 696-08, after masking out air voids and fine aggregate to isolate cement paste (each individual frame measures 2.612 x 1.959 mm).

Average cement paste pixel intensities per frame, and equivalent w/c values (as compared to 28-day moist cured mortar samples) from thin section prepared from core from I-696, constructed 1995, away from transverse joint, MTU ID 696-08.

cement paste pixel fluorescence measurements (average intensity per frame)			
75	83	80	78
81	75	82	75
73	75	75	84
equivalent w/c ($y = 0.0044x + 0.0329$)			
0.37	0.36	0.39	0.38
0.37	0.39	0.36	0.39
0.36	0.35	0.36	0.36

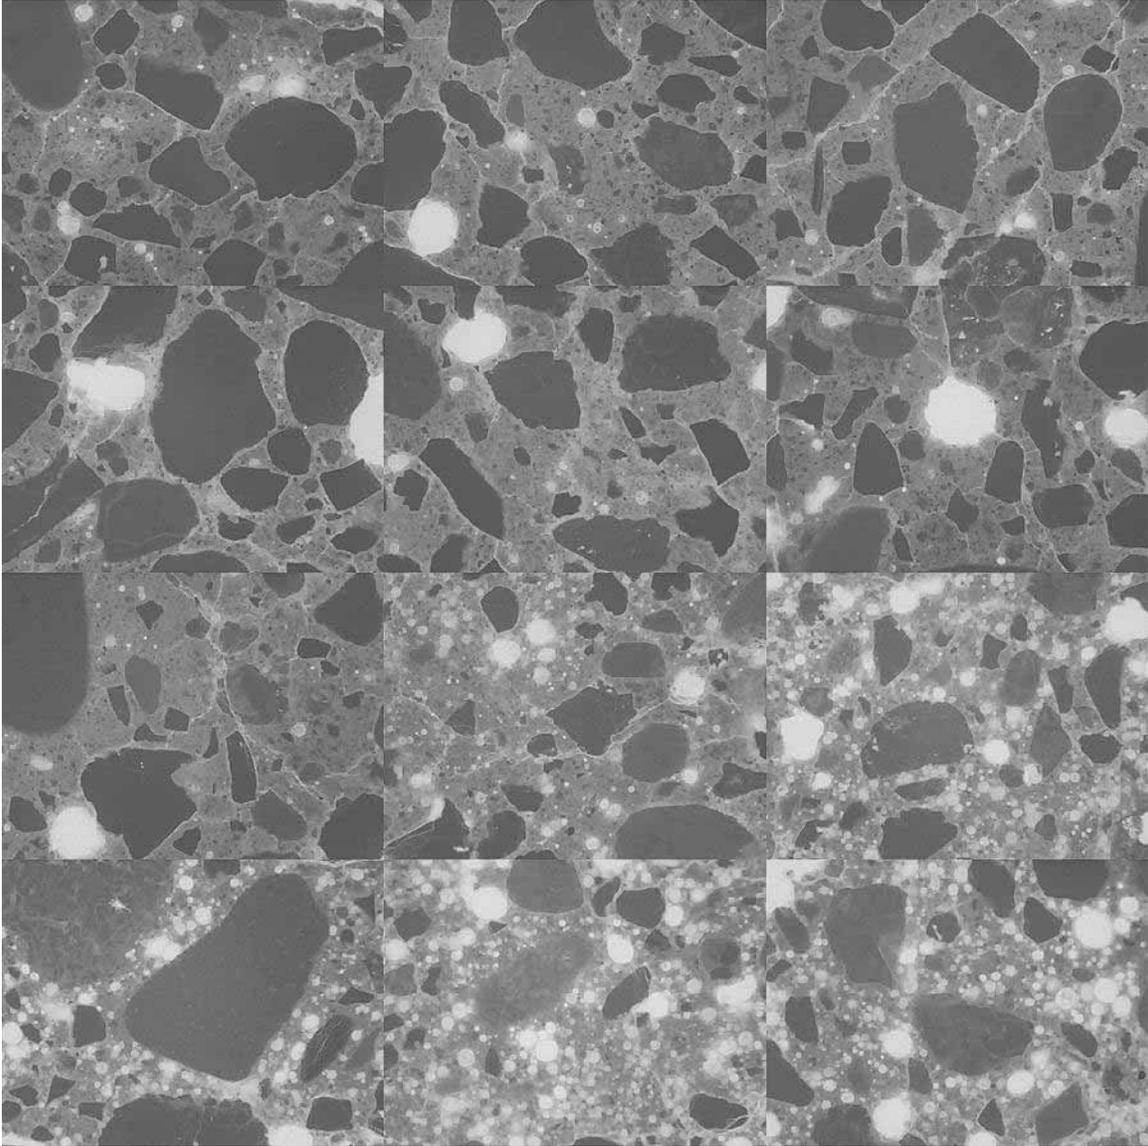
Mosaic of 12 epifluorescent mode images collected from thin sections prepared from core from I-696, constructed 1995, away from transverse joint, MTU ID 696-11 (each individual frame measures 2.612 x 1.959 mm).

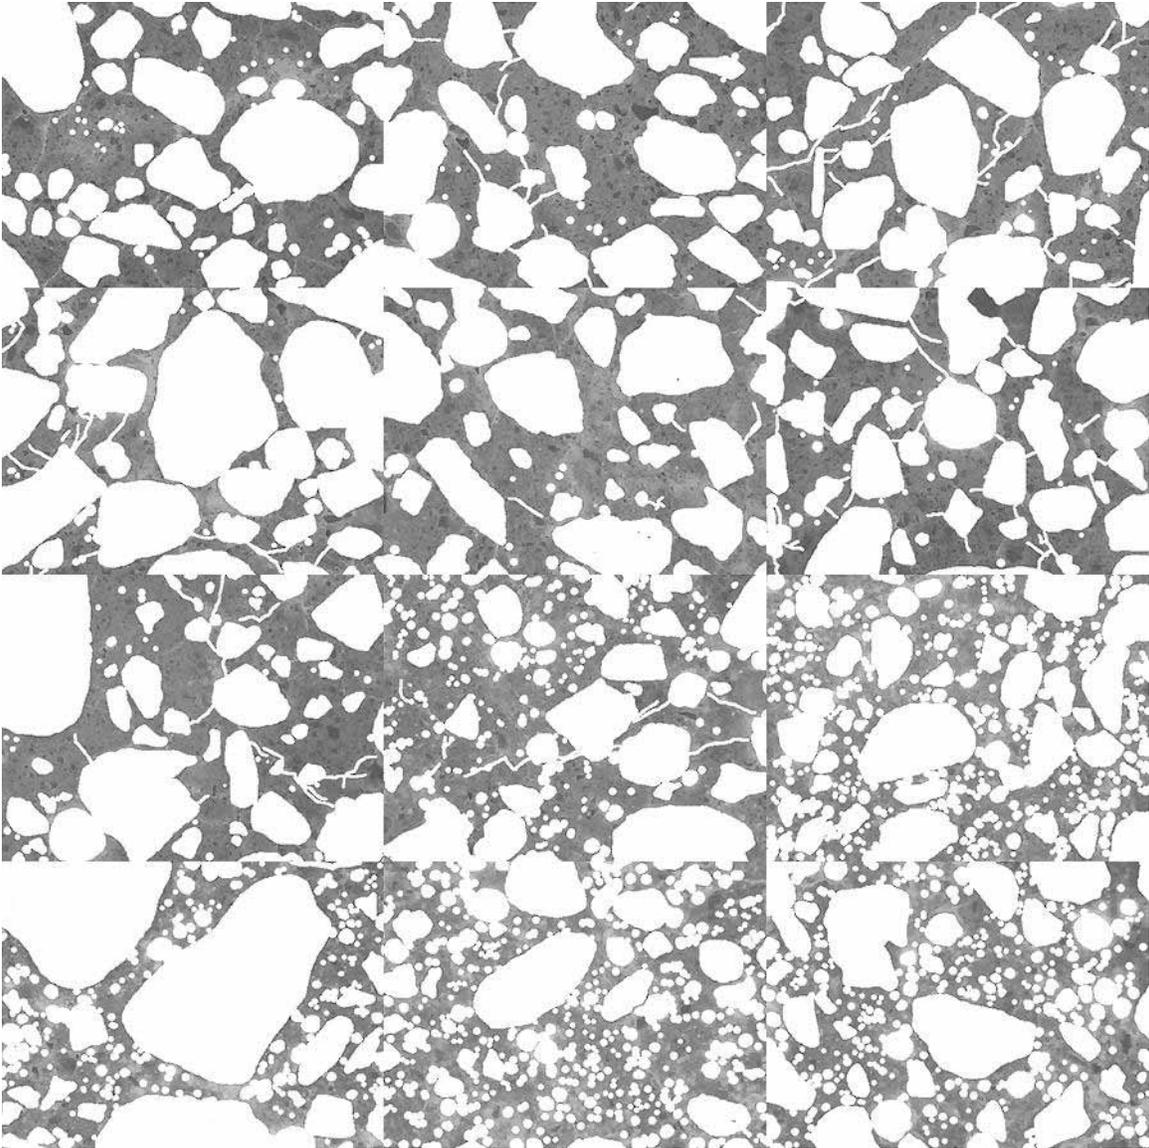
Mosaic of 12 epifluorescent mode images collected from thin sections prepared from core from I-696, constructed 1995, away from transverse joint, MTU ID 696-11, after masking out air voids and fine aggregate to isolate cement paste (each individual frame measures 2.612 x 1.959 mm).

Average cement paste pixel intensities per frame, and equivalent w/c values (as compared to 28-day moist cured mortar samples) from thin section prepared from core from I-696, constructed 1995, away from transverse joint, MTU ID 696-11.
