**DETERIORATION OF CONCRETE HIGHWAYS AND BRIDGES
CONTAINING BIG CUT PIT AGGREGATES**

Research Laboratory Division
Office of Testing and Research
Report No. 332
Research Project 59 A-19

Michigan State Highway Department
John C. Mackie, Commissioner
Lansing, June 1960

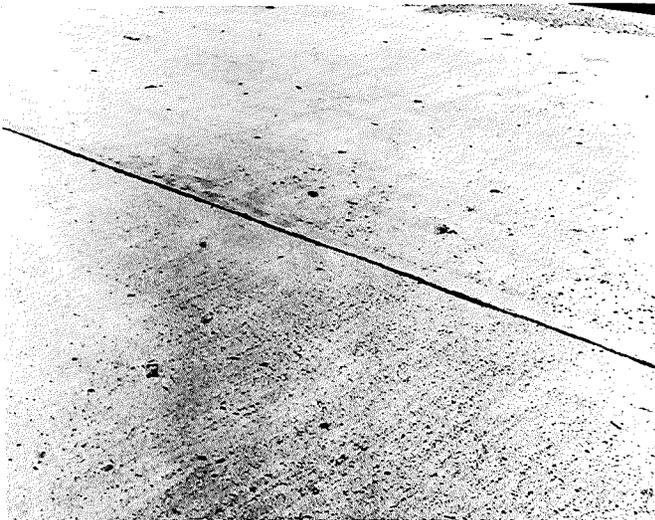
Figure 20

Constructed in 1953, this bridge is on Greenwood-Prescott Rd., 13.5 mi southeast of West Branch. Fig. 20 shows the degree of popouts on the deck surface. The break shown in Fig. 21 is along the south edge of the centerline longitudinal joint. CSB1 of 65-10-20, C1

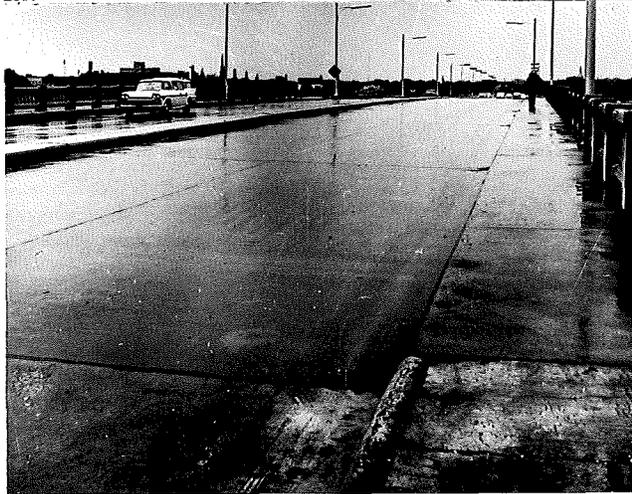
Figure 31. This 1957 bridge is on US 23 in Bay City, 0.3 mi east of the junction with M 47. All surfaces are in excellent condition, free of popouts. FGX2 of 9-15-8, C1U (09101)

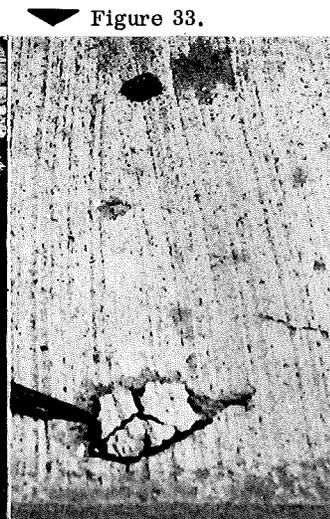
Figure 33.

This 1957 structure is in Gladwin County on M 30, 3.7 mi north of the junction with M 61. Although the general condition is good (Fig. 32) and the substructure excellent, scattered popouts are found on the deck and curbs. Cracked surface mortar is readily extracted from this concrete at popout locations (Fig. 33 before, Fig. 34 after). MB1 of 26-8-1, C2R (26032)

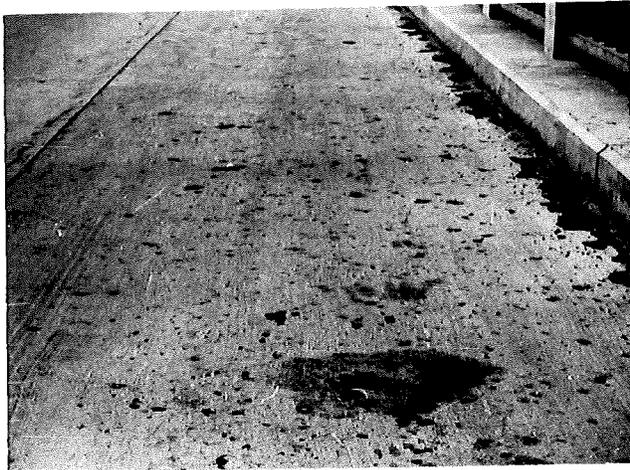
▲ Figure 44

This 1957 overpass on US 27 in Emmett County is another part of the approach system of the Macknac Bridge. Frequent popouts are found on the deck (Figs. 44, 45, and 46); the deck surface (Fig. 47) is also the site of transverse cracking at the longitudinal joint. Severe curb deterioration is visible in Figs. 48 and 49. The substructure has less frequent popouts; the wingwall is shown in Fig. 50. MX1 of 24-16-3, C1UN (24071)

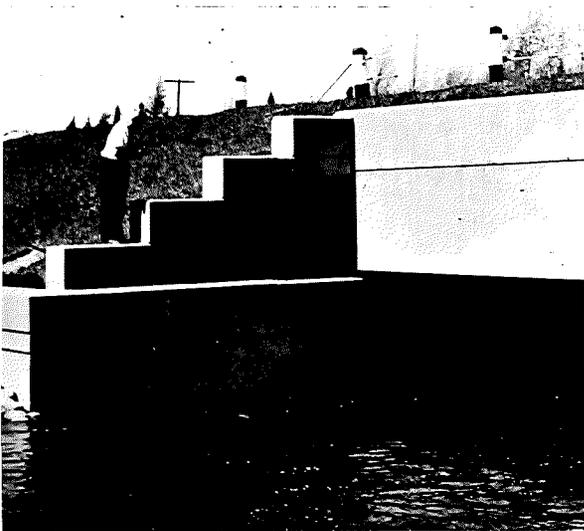
▲ Figure 52. Located on a Charlevoix County road in South Arm Twp., this bridge was built in 1958. The deck has been resurfaced with bituminous concrete, but all exposed surfaces have moderately frequent popouts. CSB1 of 15-13-24, C1R.

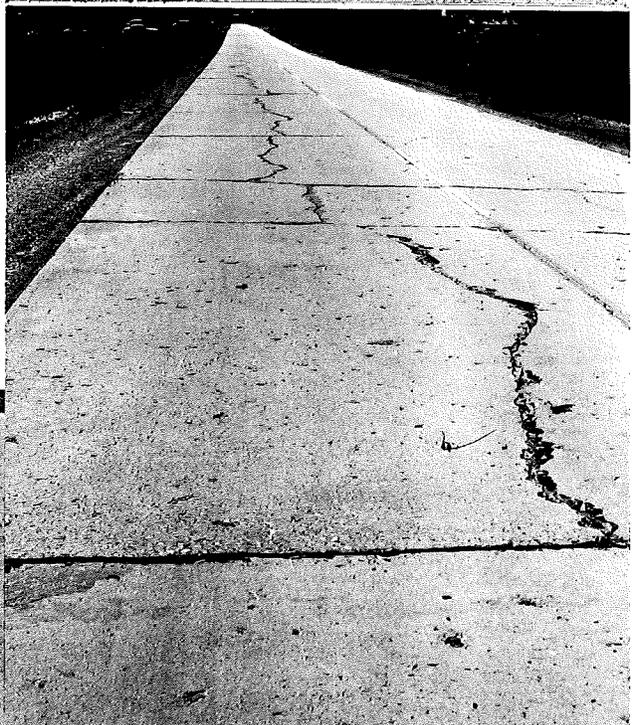
In Alpena County on M 65, from the M32 junction north 1 mi, this 1930 project has moderate popouts (Figs. 61 and 62), and in one region, extensive longitudinal cracking (Fig. 63). M 4-12, C1 (04012)

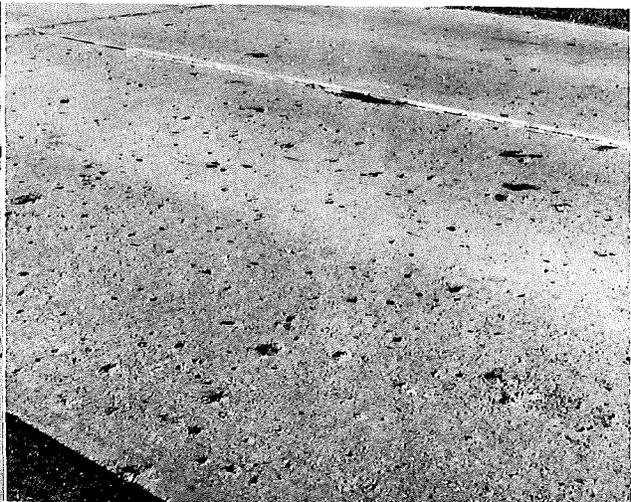
Figure 65

In Cheboygan County on US 27, from Mullett Lake northeast at the M 33 junction, this 4.2 mi 1931 project (Fig. 65) has moderately heavy popouts (Fig. 66) and areas of heavy scale (Fig. 67). F 16-19, C1 (16032)

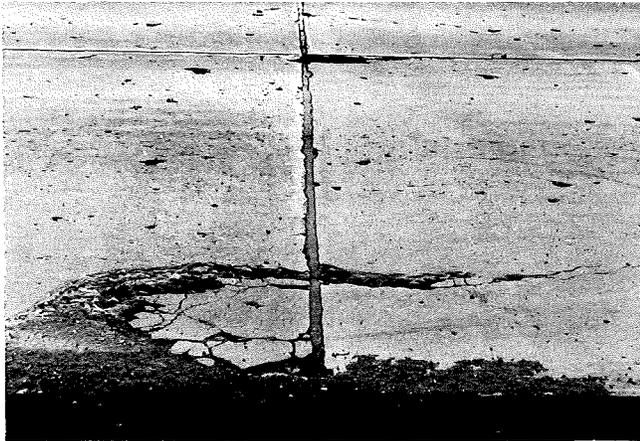
▲ Figure 71

Another 1947 project in Arenac County, 4.4 mi of M 65, from the US 23 junction north to the railroad in Twining, remains in fairly good condition, with mild deterioration as shown. M 6-27, C1 (06091)

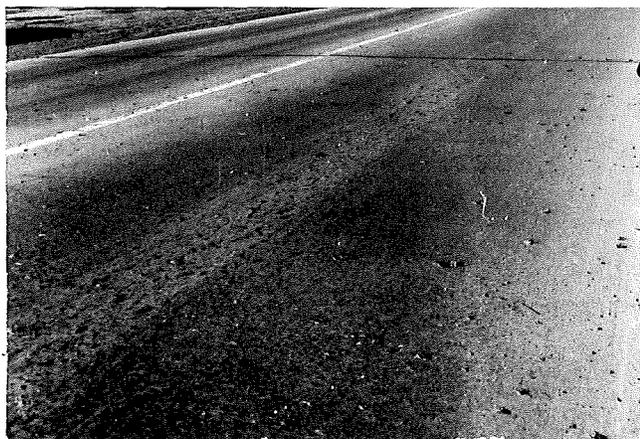
▲ Figure 73

This 1948 project in Iosco County, also on US 23, includes 0.6 mi from the M 171 junction southwest. General surface and joint conditions are illustrated. F 35-3, C9 (35032)

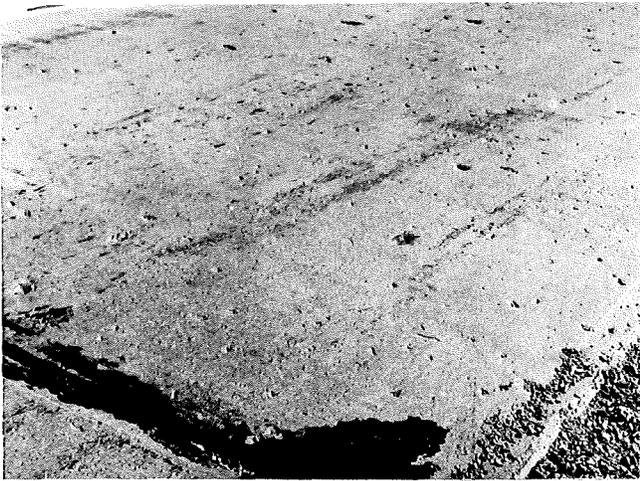
▲ Figure 75

This 1948 project comprises 0.6 mi of US 23 south from the Alpena south city limit, and features moderate popouts. M 4-4, C7 (04031)

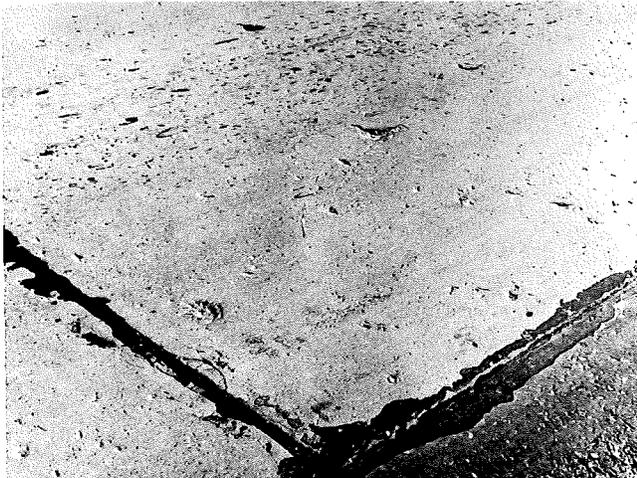
▲ Figure 77

On US 27 in Cheboygan County, this 6.5 mi 1949 project runs south from the south limit of Topinabee, with moderately heavy popouts throughout. F 16-29, C3 (16032)

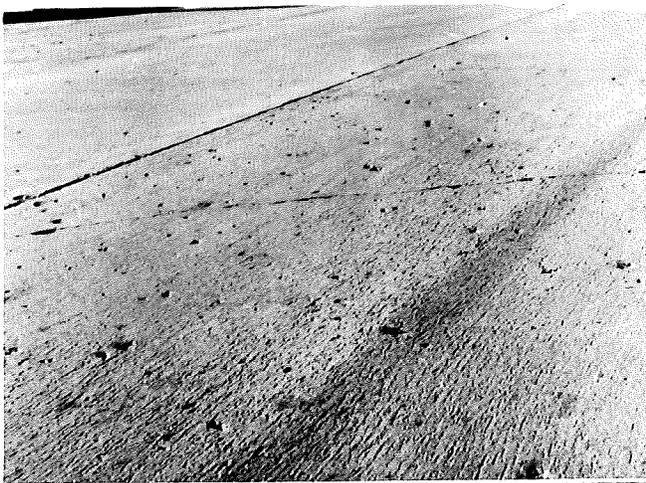
▲ Figure 80. In Arenac County at Standish, this 1950 pavement extends from the US 23 junction west for 0.4 mi. Popouts appear in fairly heavy concentration throughout the project. M 6-16, C1 (06021)

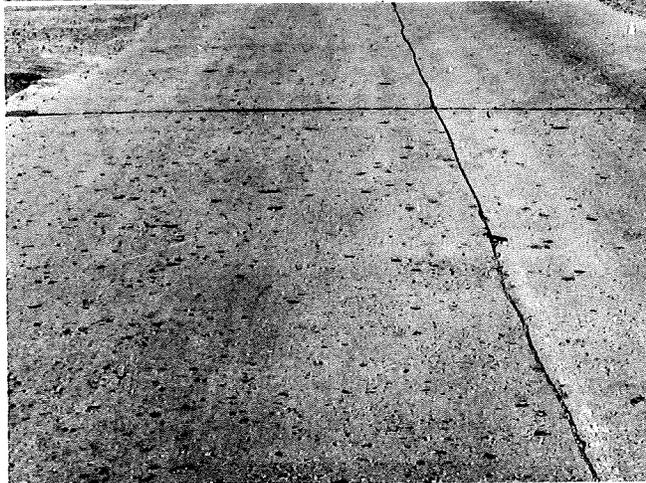
Figure 81. This 1952 project includes 0.6 mi of M 65, from the south limit of Whittemore north, with the moderate concentration of popouts shown. M 35-14, C6 (35011)

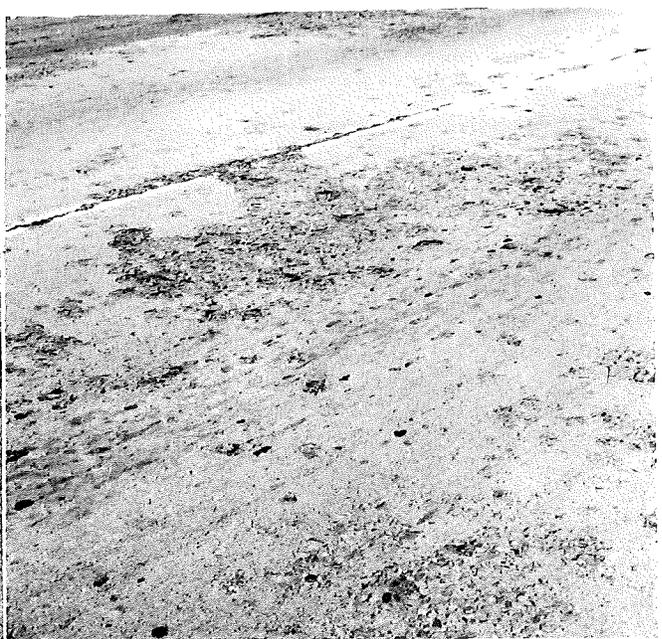
Figure 82

On US 131 at the junction with M 88 in Antrim County, this 0.2 mi 1952 project has moderate to heavy popouts and rather heavy scale. M 5-7, C5 (05071)

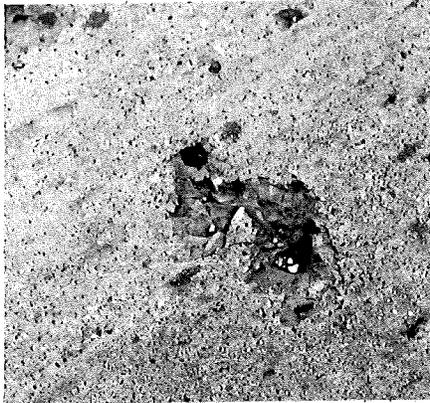
Figure 85

Located on US 23 — US 27 in Cheboygan, this 1956 project is 1.2 mi long. The entire surface is covered with heavy popouts. Note the longitudinal crack in Fig. 85. F 16-3, C2 (16033)

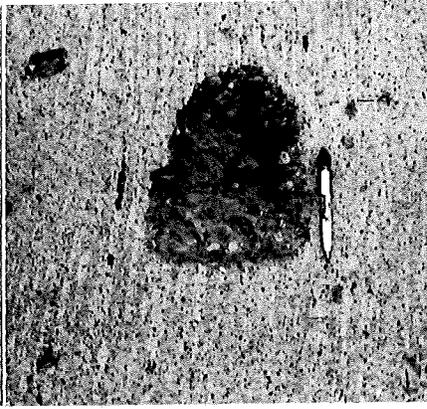
▲ Figure 86

On a south approach to the Mackinac Straits Bridge on US 31, this 1.4-mi project was built in 1957. The surface is marked with moderately heavy popouts (Fig. 89), details of which are shown in Figs. 86, 87, and 88. F 24071, C2

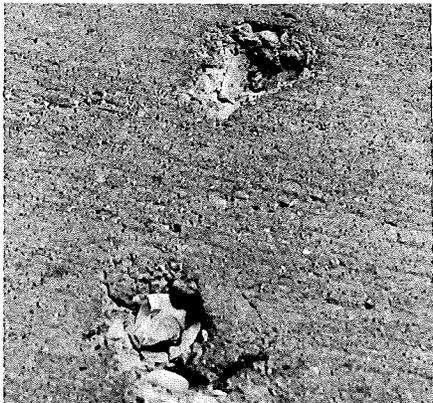
▶ Figure 90

In 1958, this 1.4 mi project was built in Arenac County, composing the intersection of M 76 and US 23 in Standish. The M 76 portion has fairly frequent popouts (Figs. 90 and 91), and large ones are scattered over the entire US 23 surface (Figs. 92 and 93). M 76: M 06011, C1; US 23: F 06072, C1
