PAVEMENT EVALUATION OF I-94 CONTROL SECTION 82021
Detroit Industrial Expressway from Rawsonville Road
(Washtenaw-Wayne County Line) to Hannan Road

Research Laboratory Division
Office of Testing and Research
Research Project R-39 F-7 (14)
Research Report No. R-465

Michigan State Highway Department
John C. Mackie, Commissioner
Lansing, July 1964

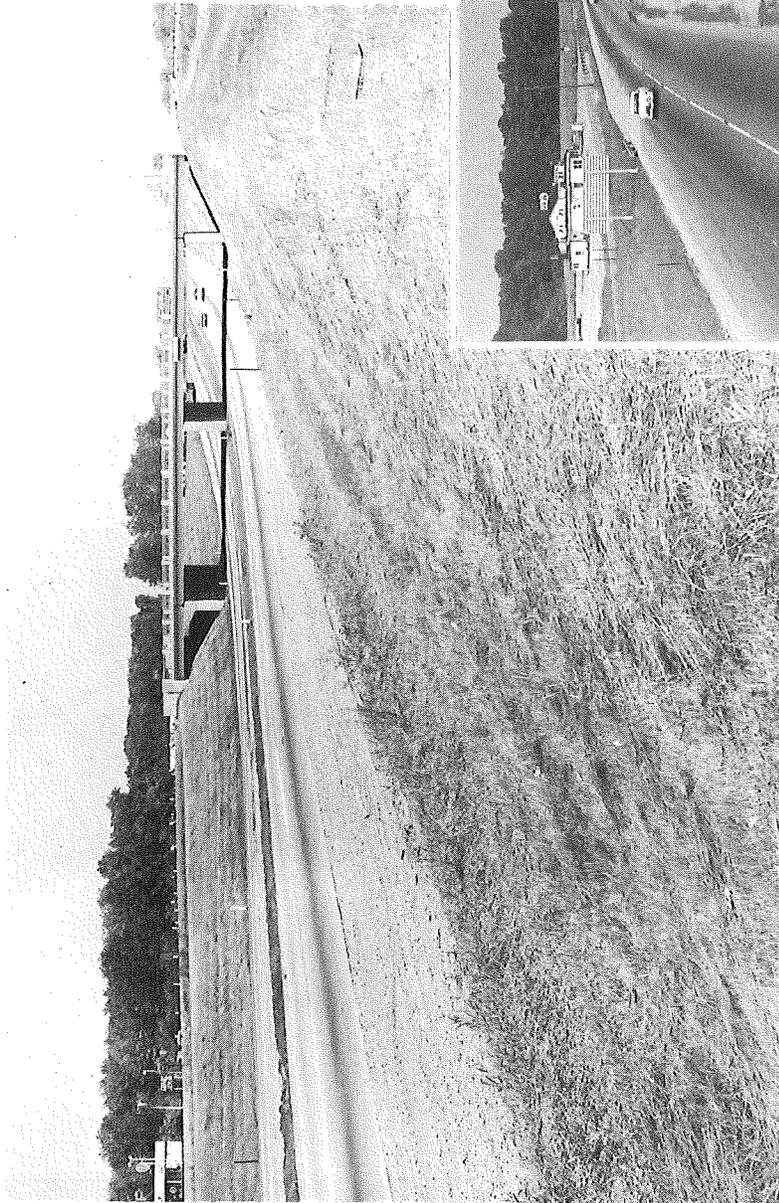
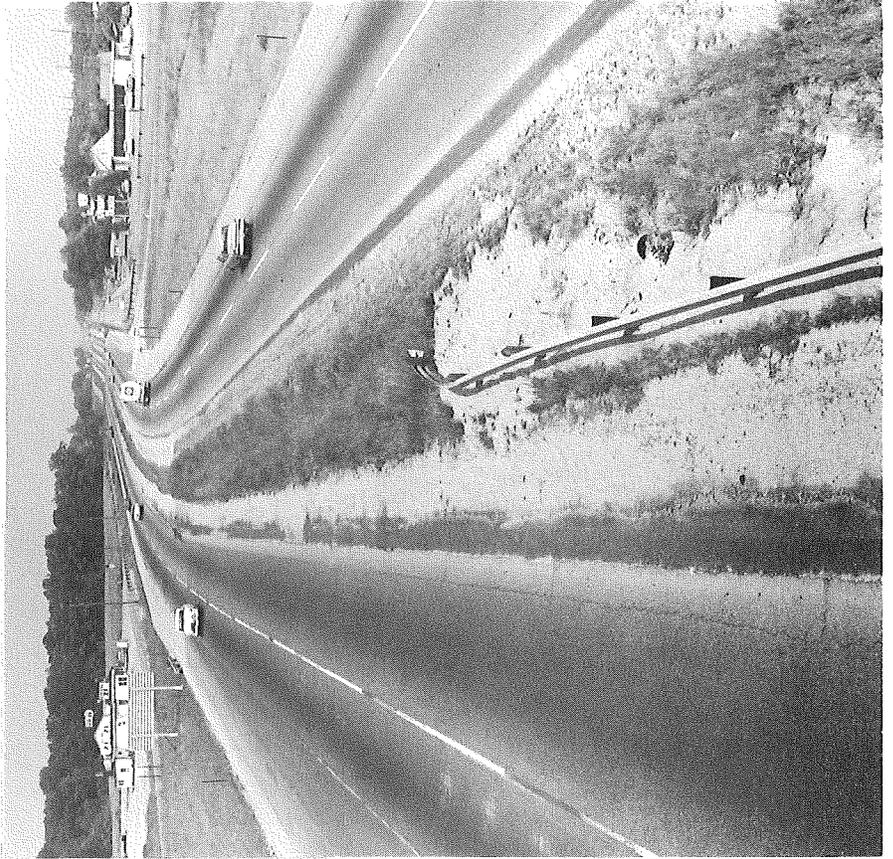
Typical general views of the widened and resurfaced 1942 pavement and the 1958 underpass pavement are shown in Fig. 1.

Figure 1. General views of the I 94 pavement looking east toward Belleville Road (above), and from Rawsonville Road (right).
