INVESTIGATION OF CONCRETE OVERRUNS
ON I 69 TWO-SPAN CONTINUOUS-TYPE BRIDGES
Pearl Beach Road Over I 69 (S11 of 12033A)

Research Laboratory Division
Office of Testing and Research
Research Project 66 F-89
Research Report No. R-621

State of Michigan
Department of State Highways
Lansing, February 1967

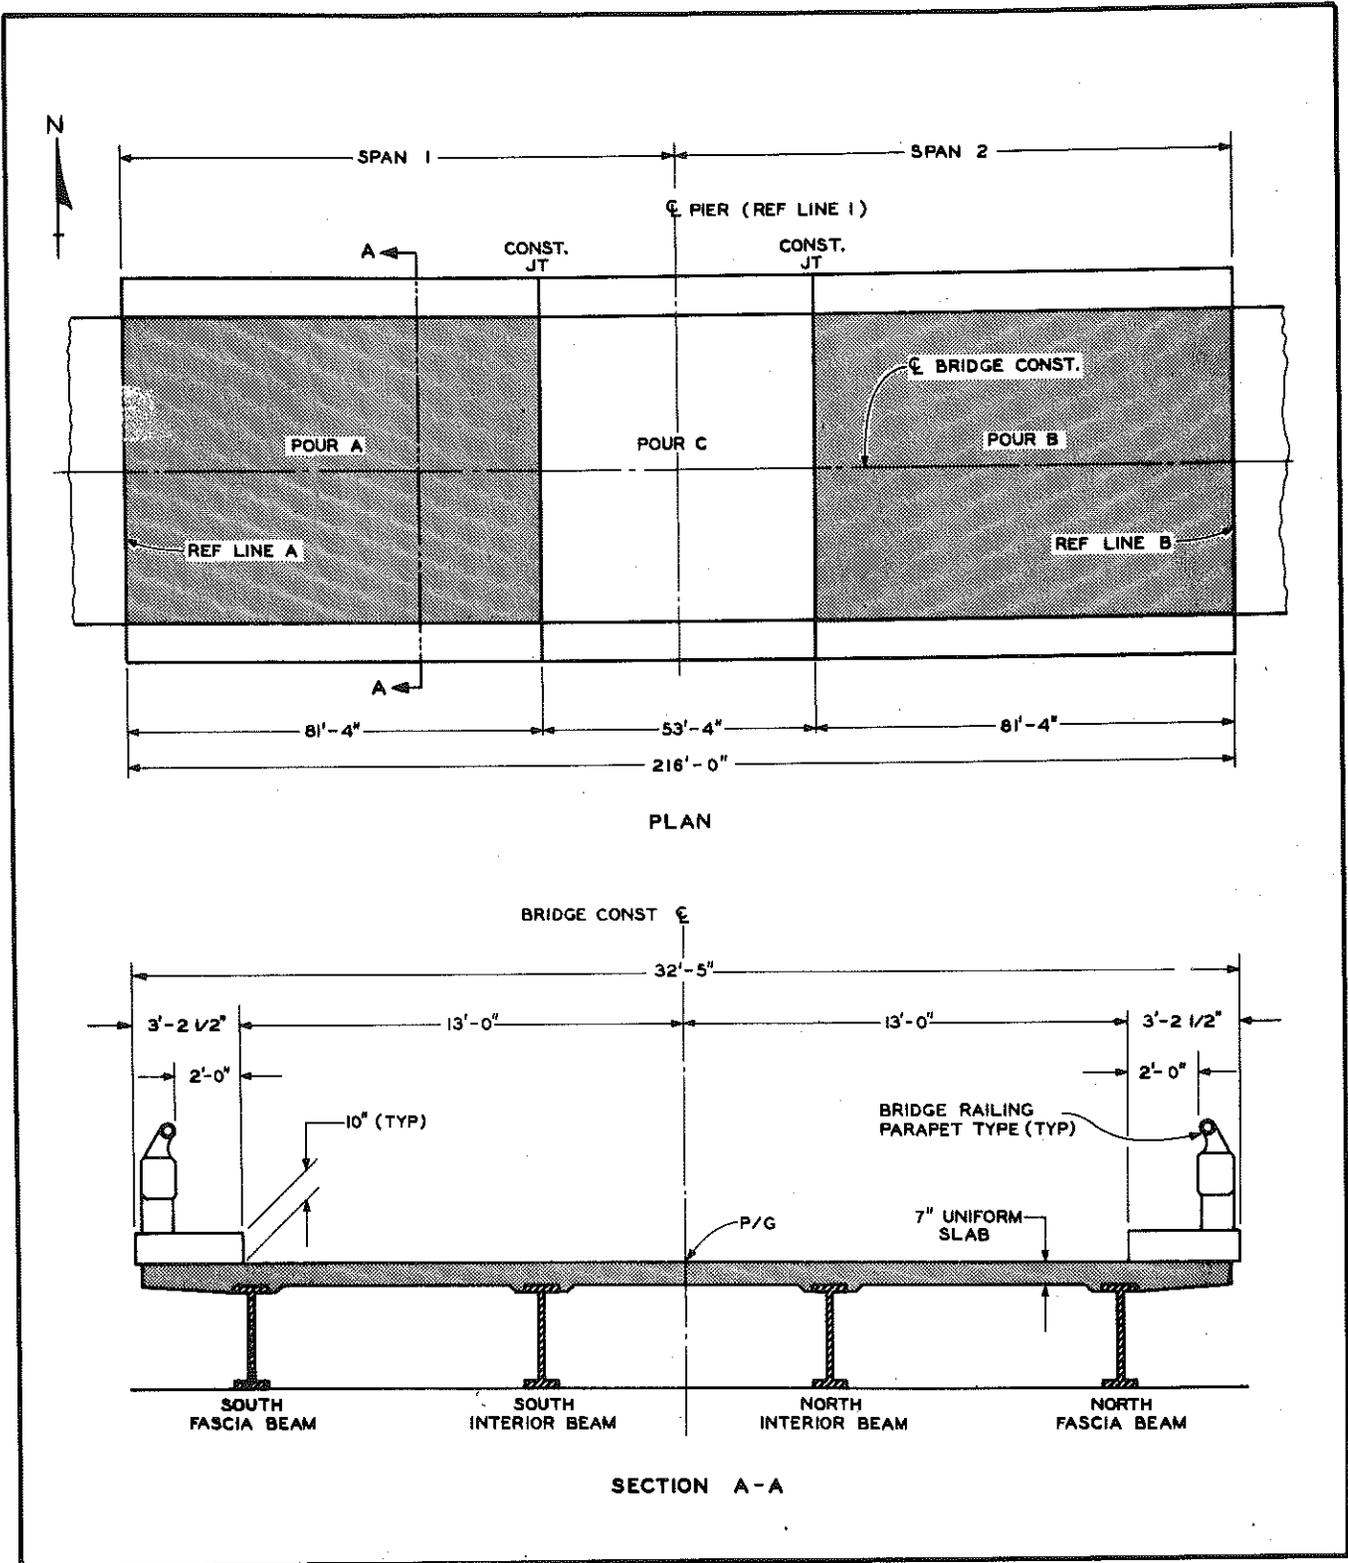
It was determined, however, that smaller overruns continued to occur after making these initial adjustments of screed elevations and joist sizes. Particularly perplexing was the occurrence of overruns in Pour C of two-span continuous bridge decks. Pour C, as indicated in Figure 1, is almost directly over the pier, where deflections are quite small. No explanation could be given for overruns occurring there, and it thus became apparent

Figure 1. Bridge plan and cross-section, indicating concrete pour locations.

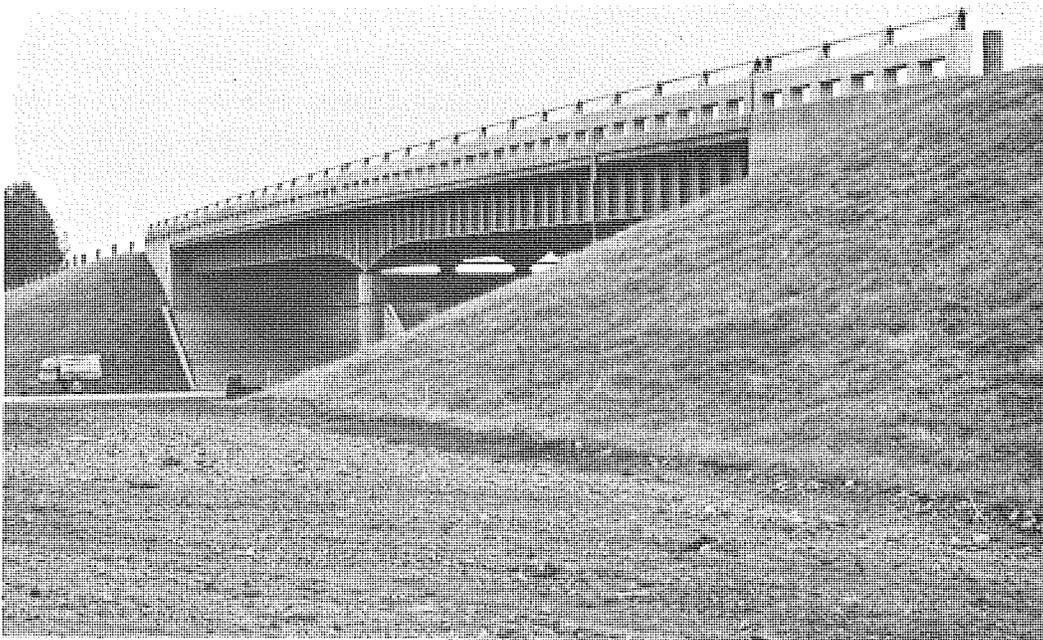
Bridge Project S11 of 12033A (Pearl Beach Road over I 69) was selected for a detailed investigation. This bridge (Fig. 2) was selected both because it was one of the first of its type constructed in Michigan, and because large overruns occurred in the deck. It was thought likely that several causes of overrun, therefore, would be exhibited here. Bridge concrete proportioning pour reports (Appendix B) indicate that Pour A in Span 1 was overrun 22.5 percent or 14.4 cu yd, and Pour C over the pier was overrun 17.2 percent or 6.4 cu yd. It should be noted that refinements have been achieved through experience in subsequent construction of this type of bridge deck.

Figure 2. Pearl River Road structure over I 69.

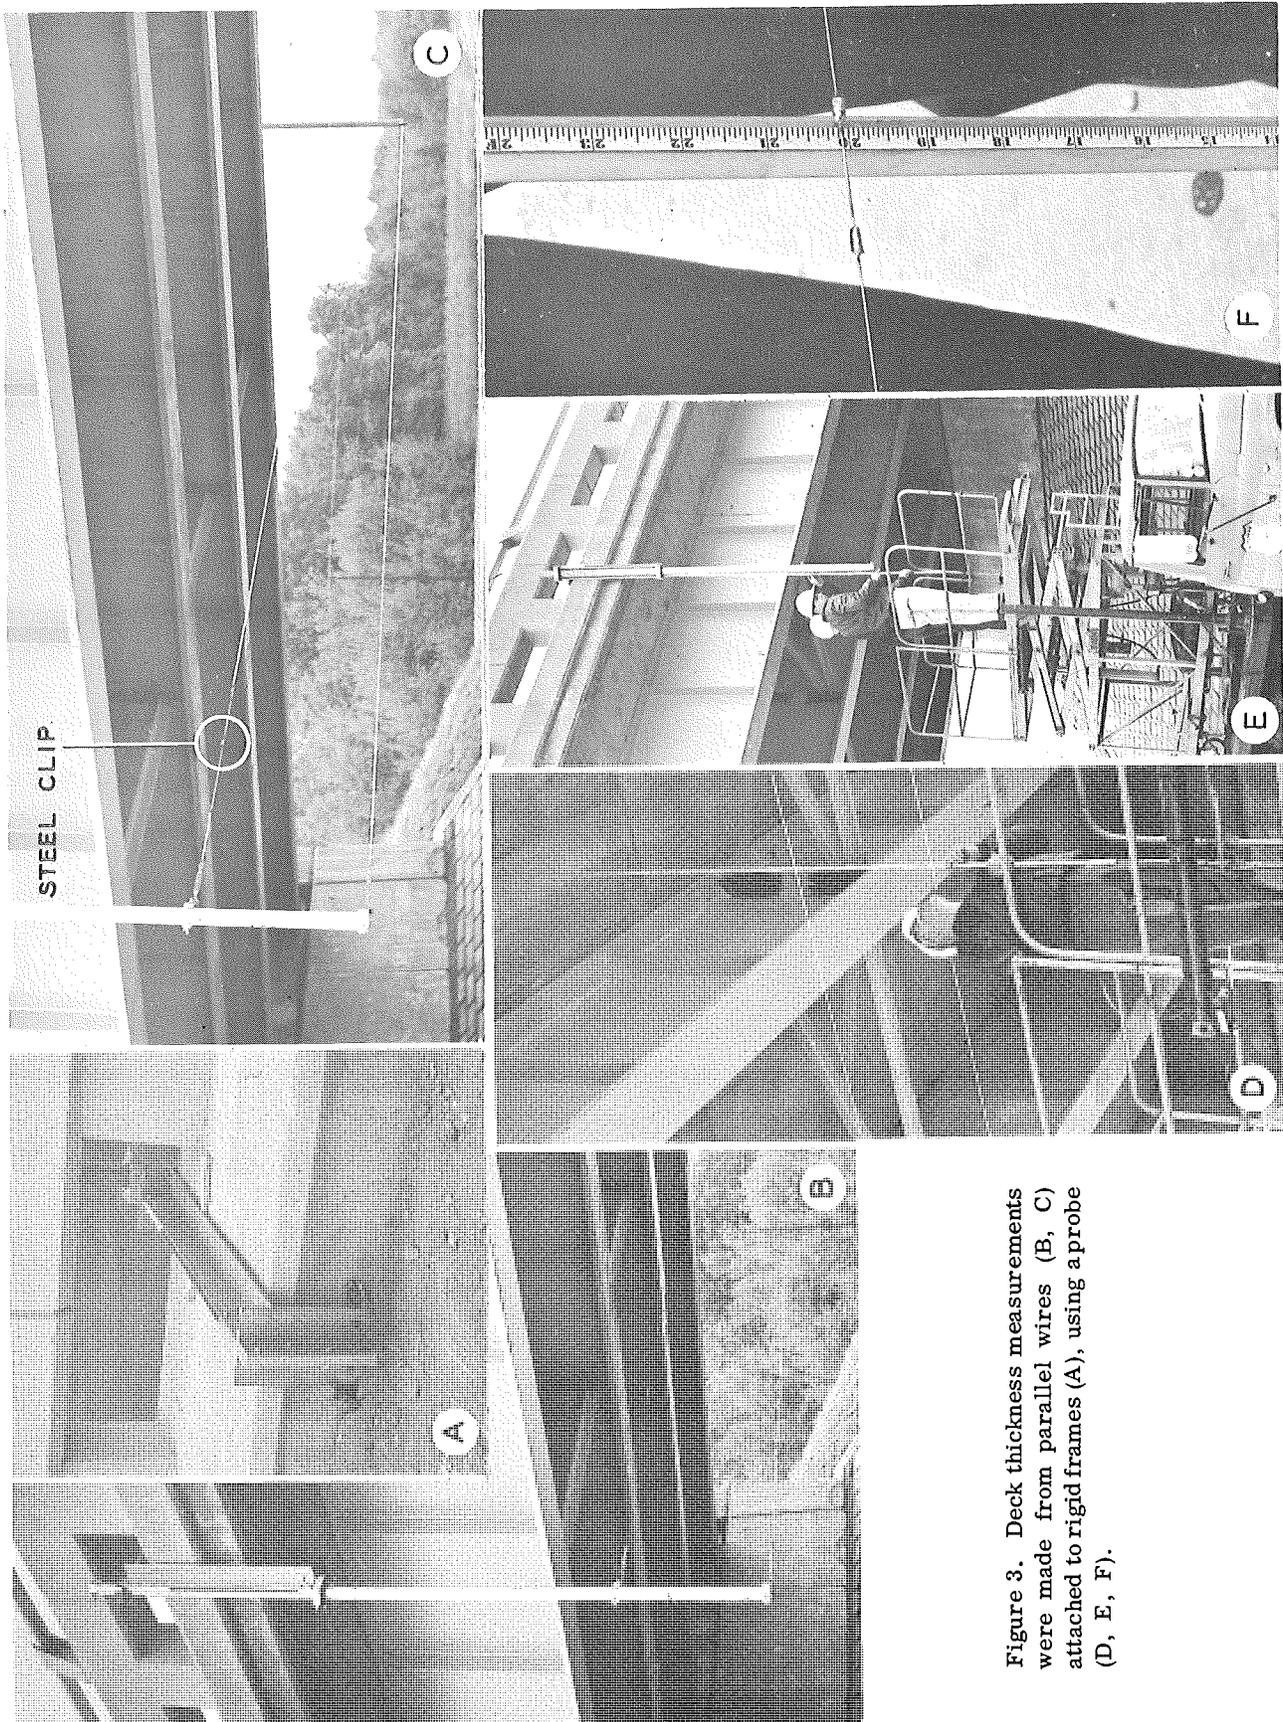
The deck on the Pearl Beach Road bridge was cross-sectioned at nine stations in Pour A and five stations in Pour C, using special direct measuring equipment constructed in the Structures Unit machine shop. The method of measurement and equipment used are illustrated in Figure 3. First, aluminum tubes were suspended from rigid frames attached to the sidewalk at both sides of the deck. Two wires were attached to the tubes below the bridge beams, and each marked with 28 steel clips at positions where thickness measurements were to be taken under the deck. Two wires were used in order to keep the measuring probe plumb. Care was exercised

Figure 3. Deck thickness measurements were made from parallel wires (B, C) attached to rigid frames (A), using a probe (D, E, F).
