OBJECTIVE V

DETAILED INVESTIGATION OF SPECIFIC TYPES OF PAVEMENT DISTRESS

Joint Failures

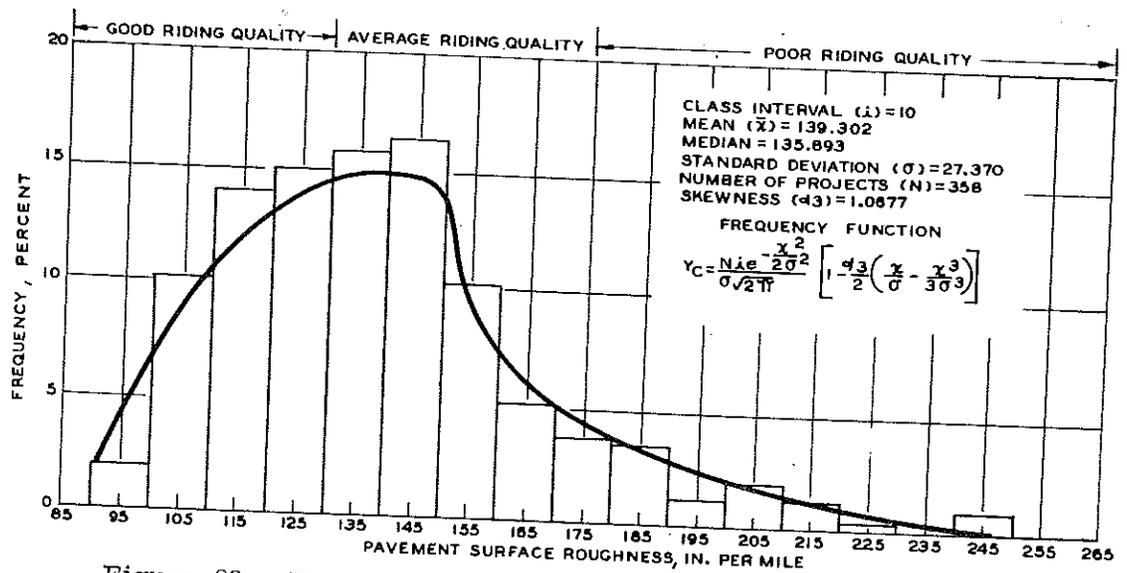
Figure 83. Frequency distribution of initial surface roughness values from rigid pavements constructed in Michigan; 1951-62.

Figure 83 shows the frequency distribution and Figure 84 the cumulative frequency distribution of initial roughness values for these 358 pavement projects. The frequency distribution is quite skewed, with a majority of projects in the good or upper average categories. The mean unweighted

initial roughness is approximately 139 inches per mile and the median approximately 136 inches per mile. "Good," "average," and "poor" categories as shown in Figures 83 and 84 for riding quality of newly constructed pavement have been established arbitrarily on the basis of roughness distributions in Michigan studies and are shown in relation to the roughness distribution.

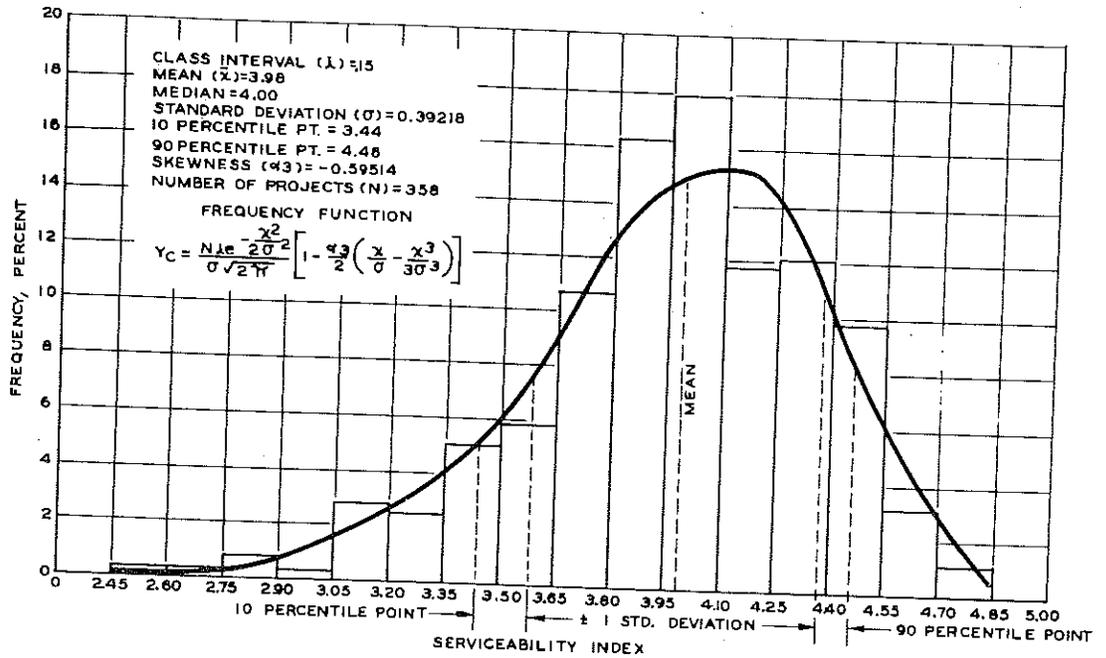
Figure 85. Frequency distribution of initial Serviceability Index values for new rigid pavement constructed in Michigan; 1951-62.

In Figures 85 and 86 the frequency distribution and the cumulative frequency distribution of the initial serviceability indices for the same projects are shown. The median index value is approximately 4.0 but the entire distribution encompasses values from 4.85 to 2.45. With these data normalized it can be anticipated that 10 percent of the projects will have an initial PSI of 4.46 or higher, 67 percent of the projects will be between 3.59 and 4.38, and 10 percent of the projects will have a PSI of 3.44 or below.

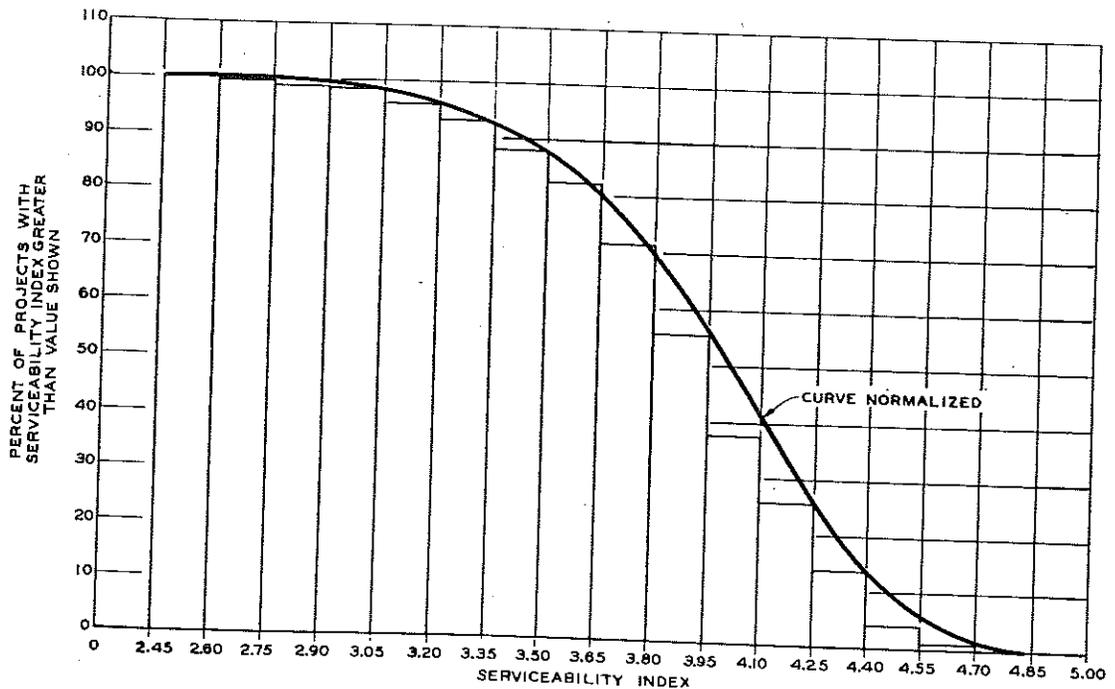
Figure 86. Cumulative frequency distribution of initial Serviceability Index values for new rigid pavement constructed in Michigan; 1951-62.

As a result of the AASHO Road Test the Present Serviceability Index has been used rather extensively by state highway departments as a means of evaluating pavements. The largest and overriding factor in this index is pavement roughness and while certain condition survey factors are incorporated into the index, their effect on the index is almost negligible. This study has indicated that if structural performance of the pavement is to be evaluated, the Present Serviceability Index performs poorly. The reason for this is that initial roughness plays such a predominant part in the Index that initial PSI values, as shown previously in Figure 86, range from 2.45 to 4.85. With this range in PSI values for newly constructed pavements it

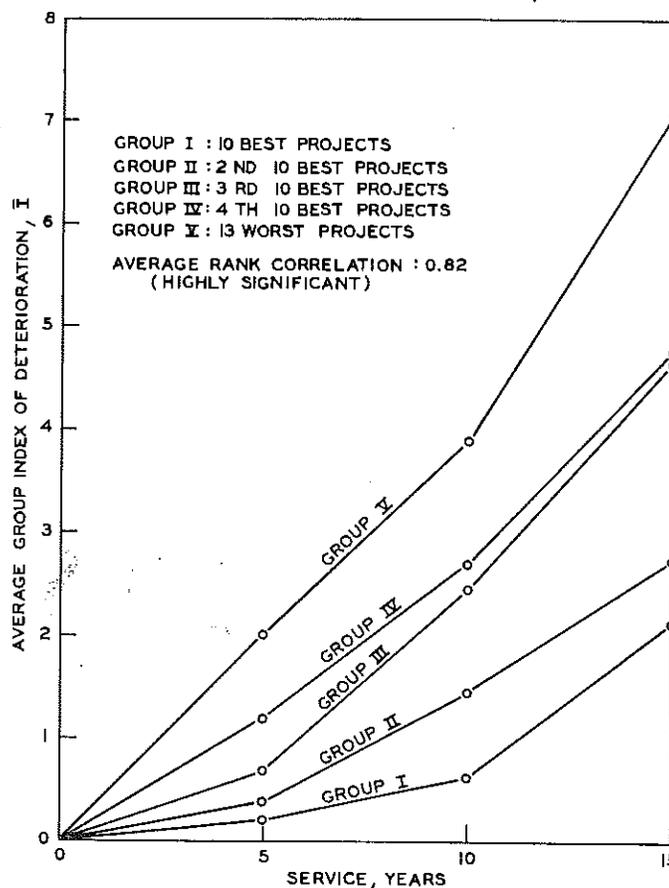
Figure 87. Five-year structural deterioration index as a predictor of future performance.

Another method of indicating the ability to "predict" performance from condition surveys is shown in Figure 87 where the project performance at the end of five years is divided into five groups and then the individual group performance is observed at the end of ten and fifteen years of service. A

statistical comparison indicates the same thing: The average rank correlation is 0.82 which is highly significant thereby substantiating the predicting power of condition survey variables in estimating future deterioration.

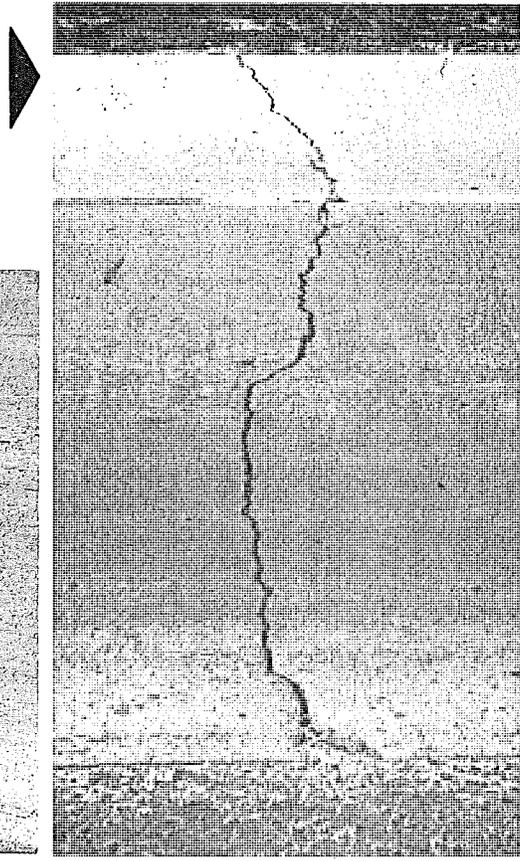
Figure A1. Transverse crack. In this case the crack is quite wide indicating that the longitudinal reinforcing steel has probably broken.

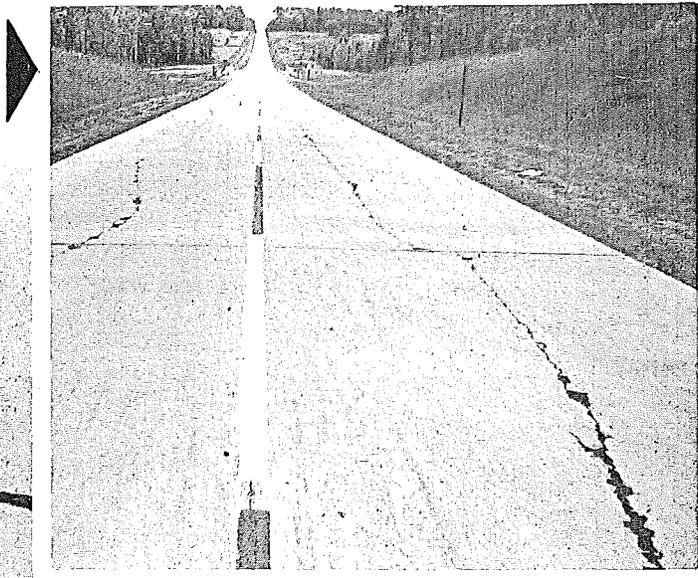
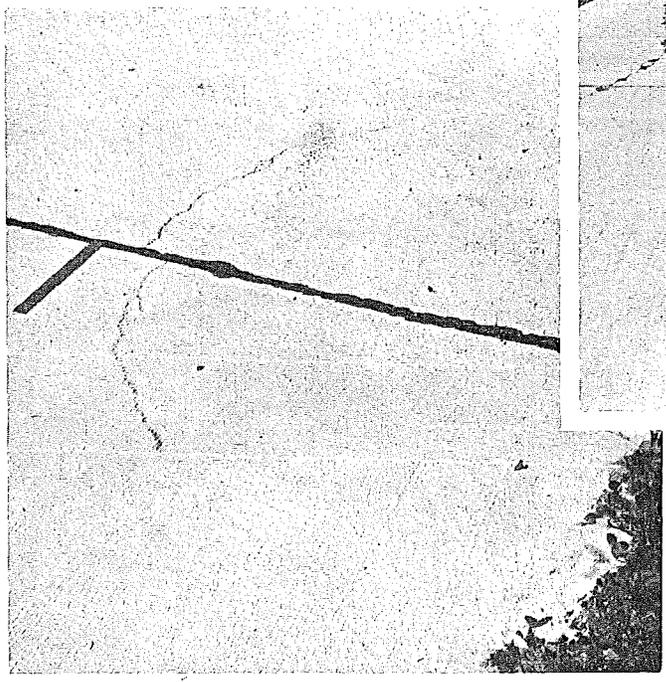
Figure A4. Infiltration crack. A short crack following a course approximately parallel to the centerline and starting from either a transverse joint or a transverse crack. Sometimes known also as a "restraint crack" or "crowfoot crack."
