A REPORT ON THE CAUSE OF DETERIORATION  
OF SECTIONS OF FLEXIBLE I 94 PAVEMENT

E. C. Novak, Jr.

Research Laboratory Section  
Testing and Research Division  
Research Project 77 TI-433  
Research Report No. R-1081

Michigan State Highway Commission  
Peter B. Fletcher, Chairman; Carl V. Pellonpaa,  
Vice-Chairman; Hannes Meyers, Jr., Weston E. Vivian  
John P. Woodford, Director  
Lansing, February 1978

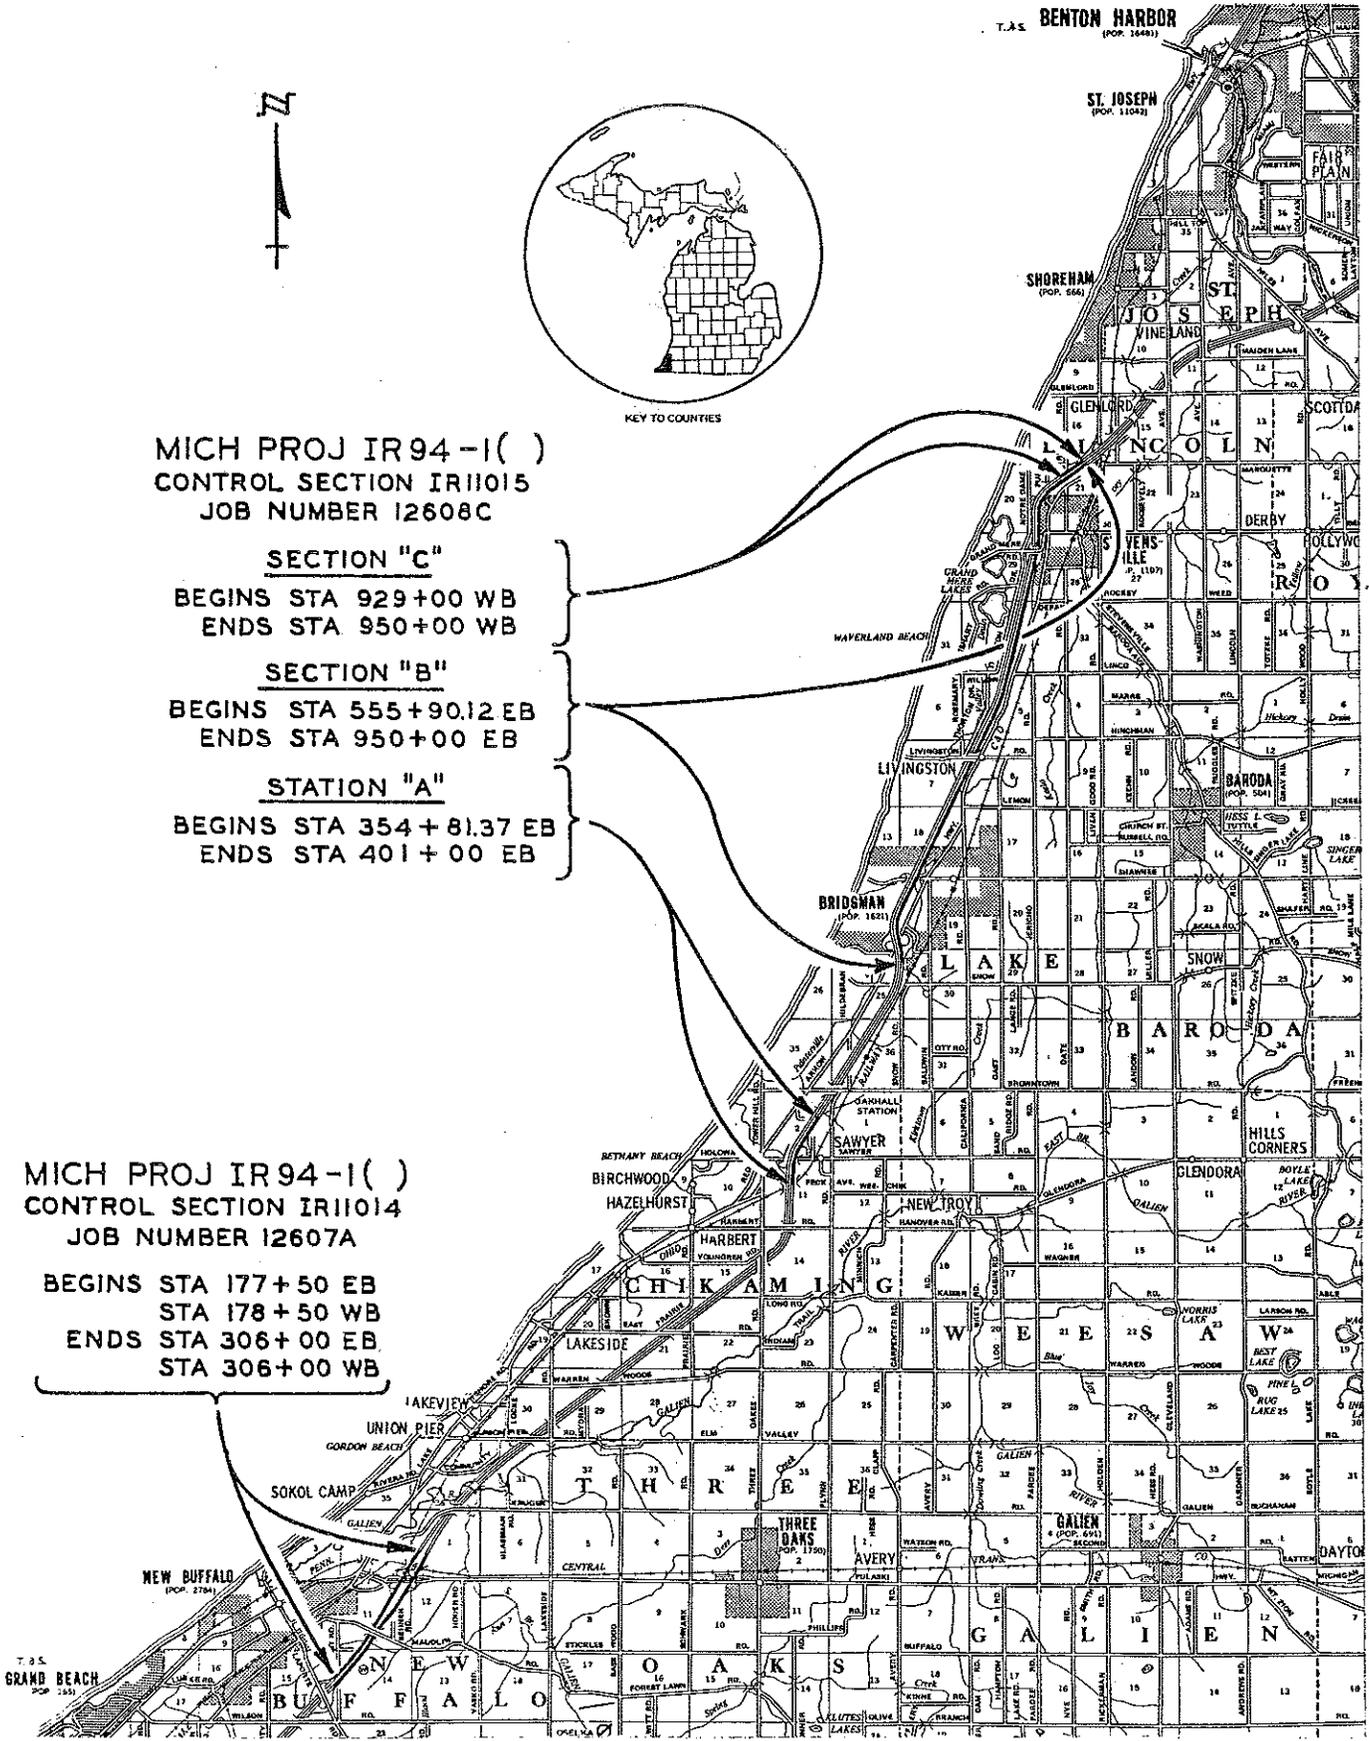
Figure 1. Recommended for reconstruction sections, I 94.

As a result of Mr. Luther's letter K. A. Allemeier requested that the Research Laboratory perform sufficient study of the sections of I 94 indicated in Figure 1 to determine the cause of deterioration of these sections and in particular the cause of rutting.

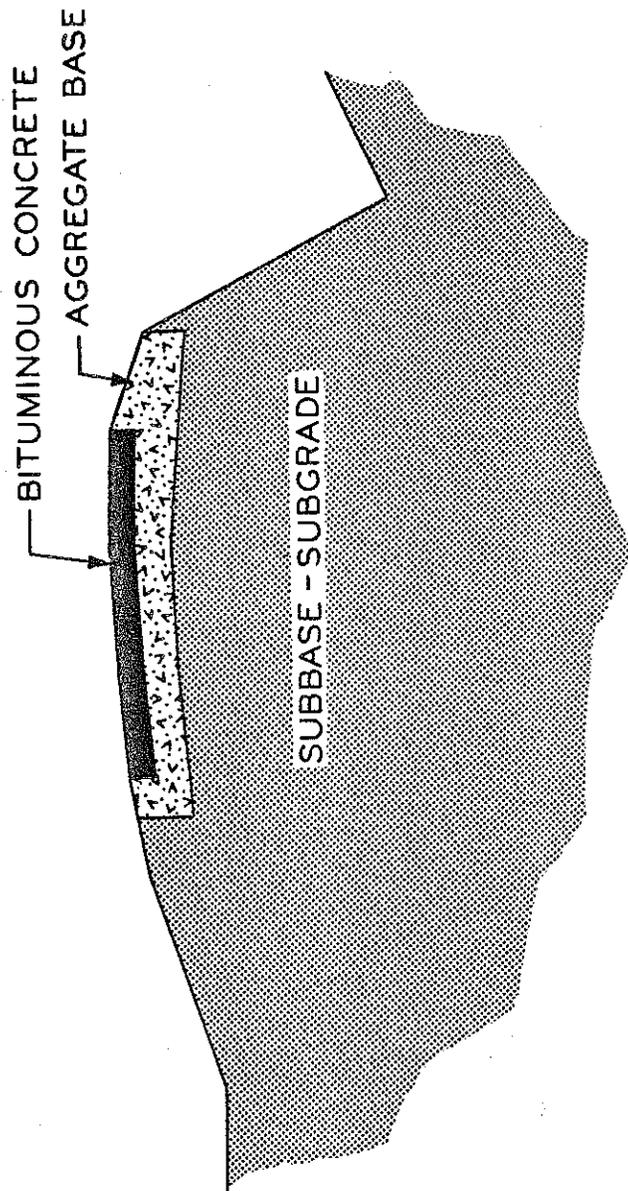
Figure 8. Cross-section of eastbound I 94 at Station 228+00.

Pavement Layer	Rut Depth, in.	
	LWP	RWP
Bituminous Concrete	0.05	0.075
Aggregate Base		
Subbase		
Depth to H <sub>2</sub> O

Pavement Layer	Thickness, in.
	RWP
Bituminous Concrete	5
Aggregate Base	10-1/4
Subbase	---
Depth to H <sub>2</sub> O	> 7 ft from pavement surface

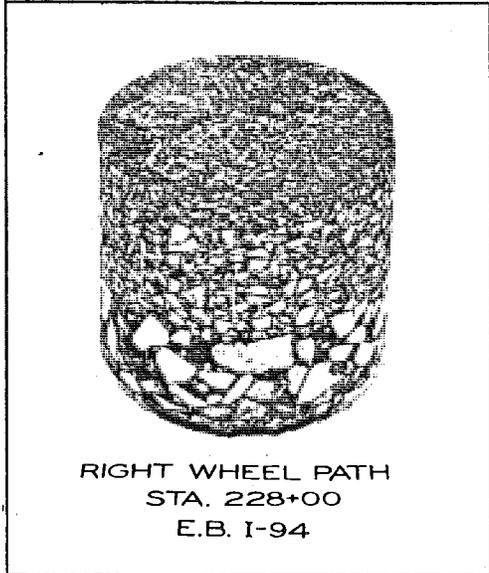
▲ Shallow rutting of RWP.

▶ Core taken from RWP.

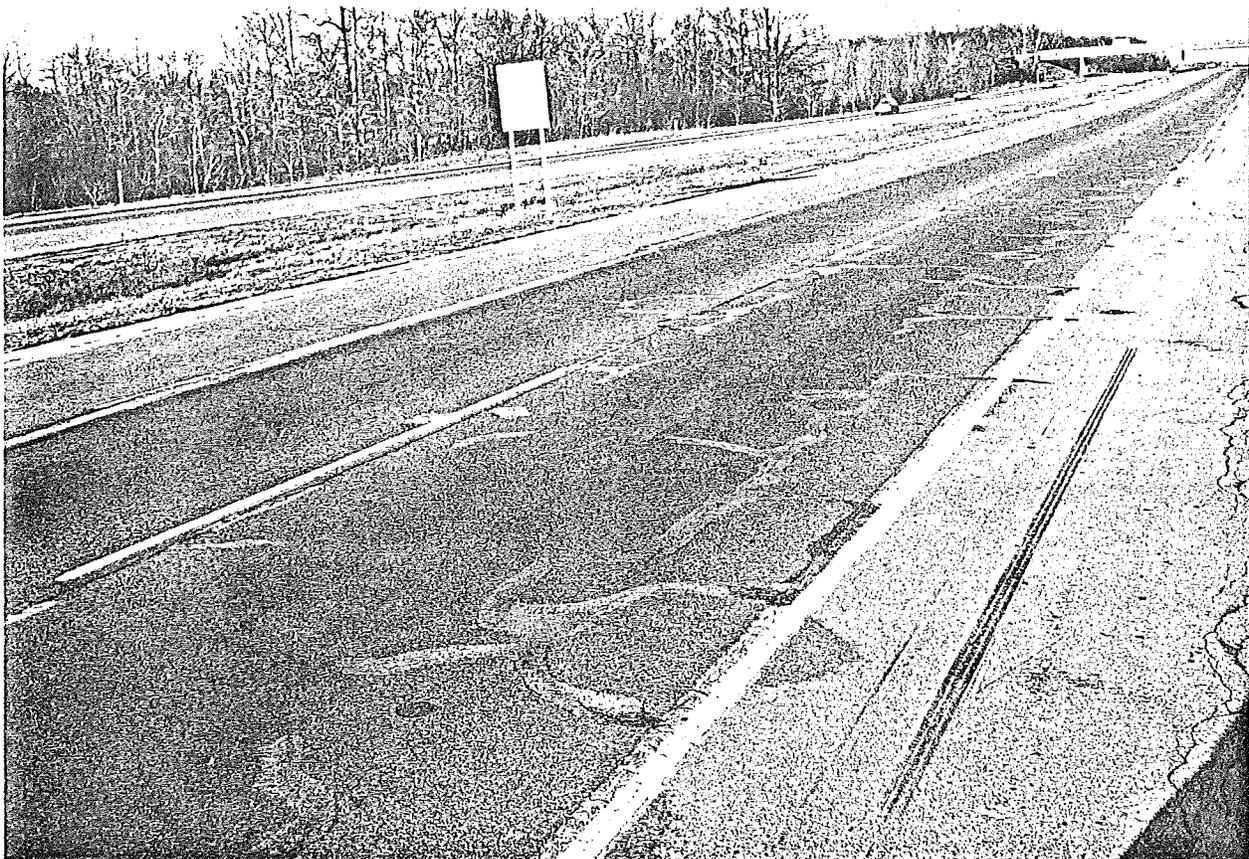
Figure 8a. General view of test area.

RIGHT WHEEL PATH  
STA. 228+00  
E.B. I-94

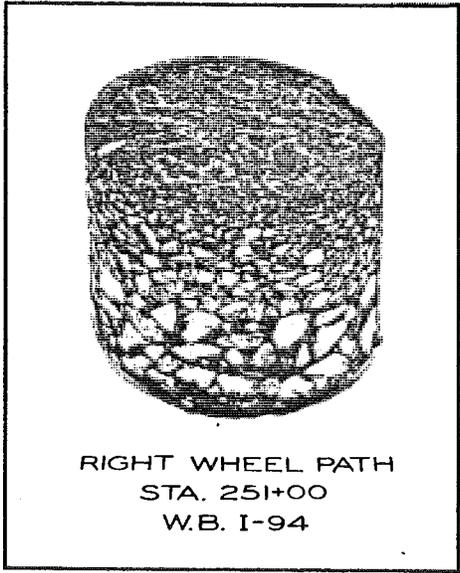
▲ No rutting, but slight pumping of base fines.

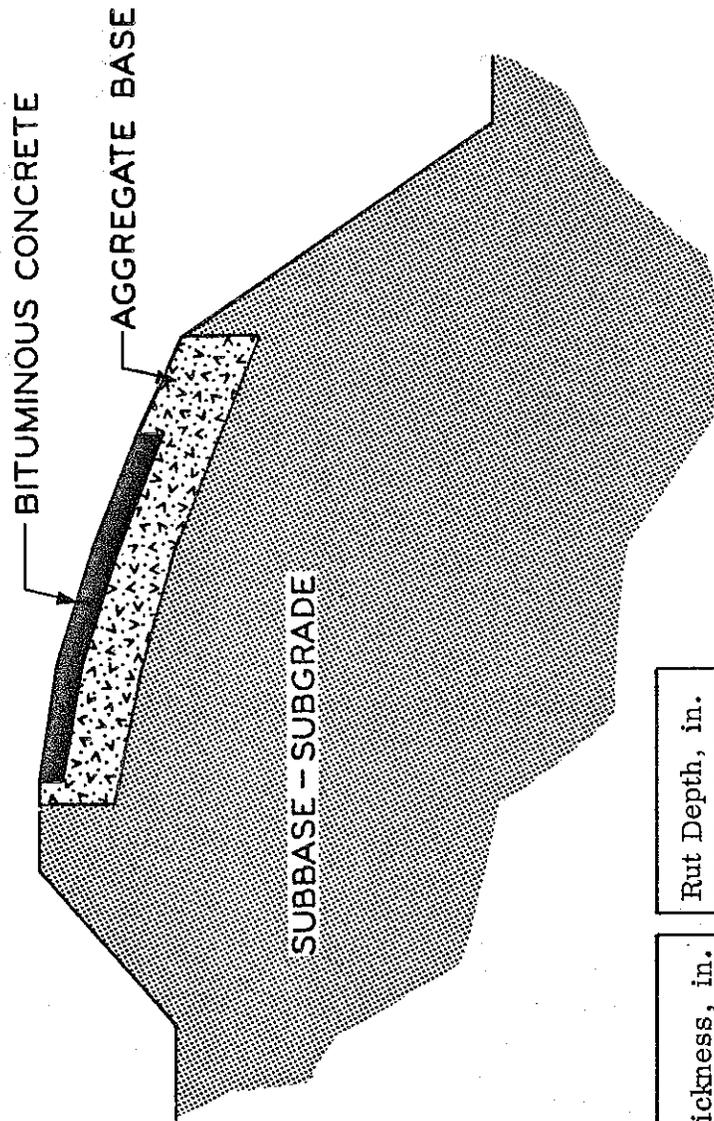
Figure 12. Cross-section of eastbound I 94 at Station 574+00.

Pavement Layer	Thickness, in.		Rut Depth, in.	
	RWP		LWP	RWP
Bituminous Concrete	4-1/2		0.20	0.225
Aggregate Base	12-1/2			
Subbase	---			
Depth to H <sub>2</sub> O	> 7 ft from pavement surface

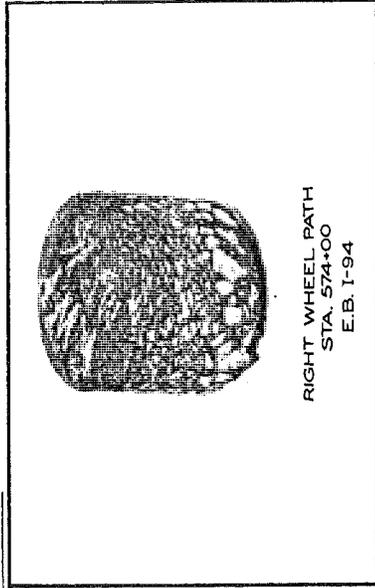
Indicates moderate rutting of the RWP.

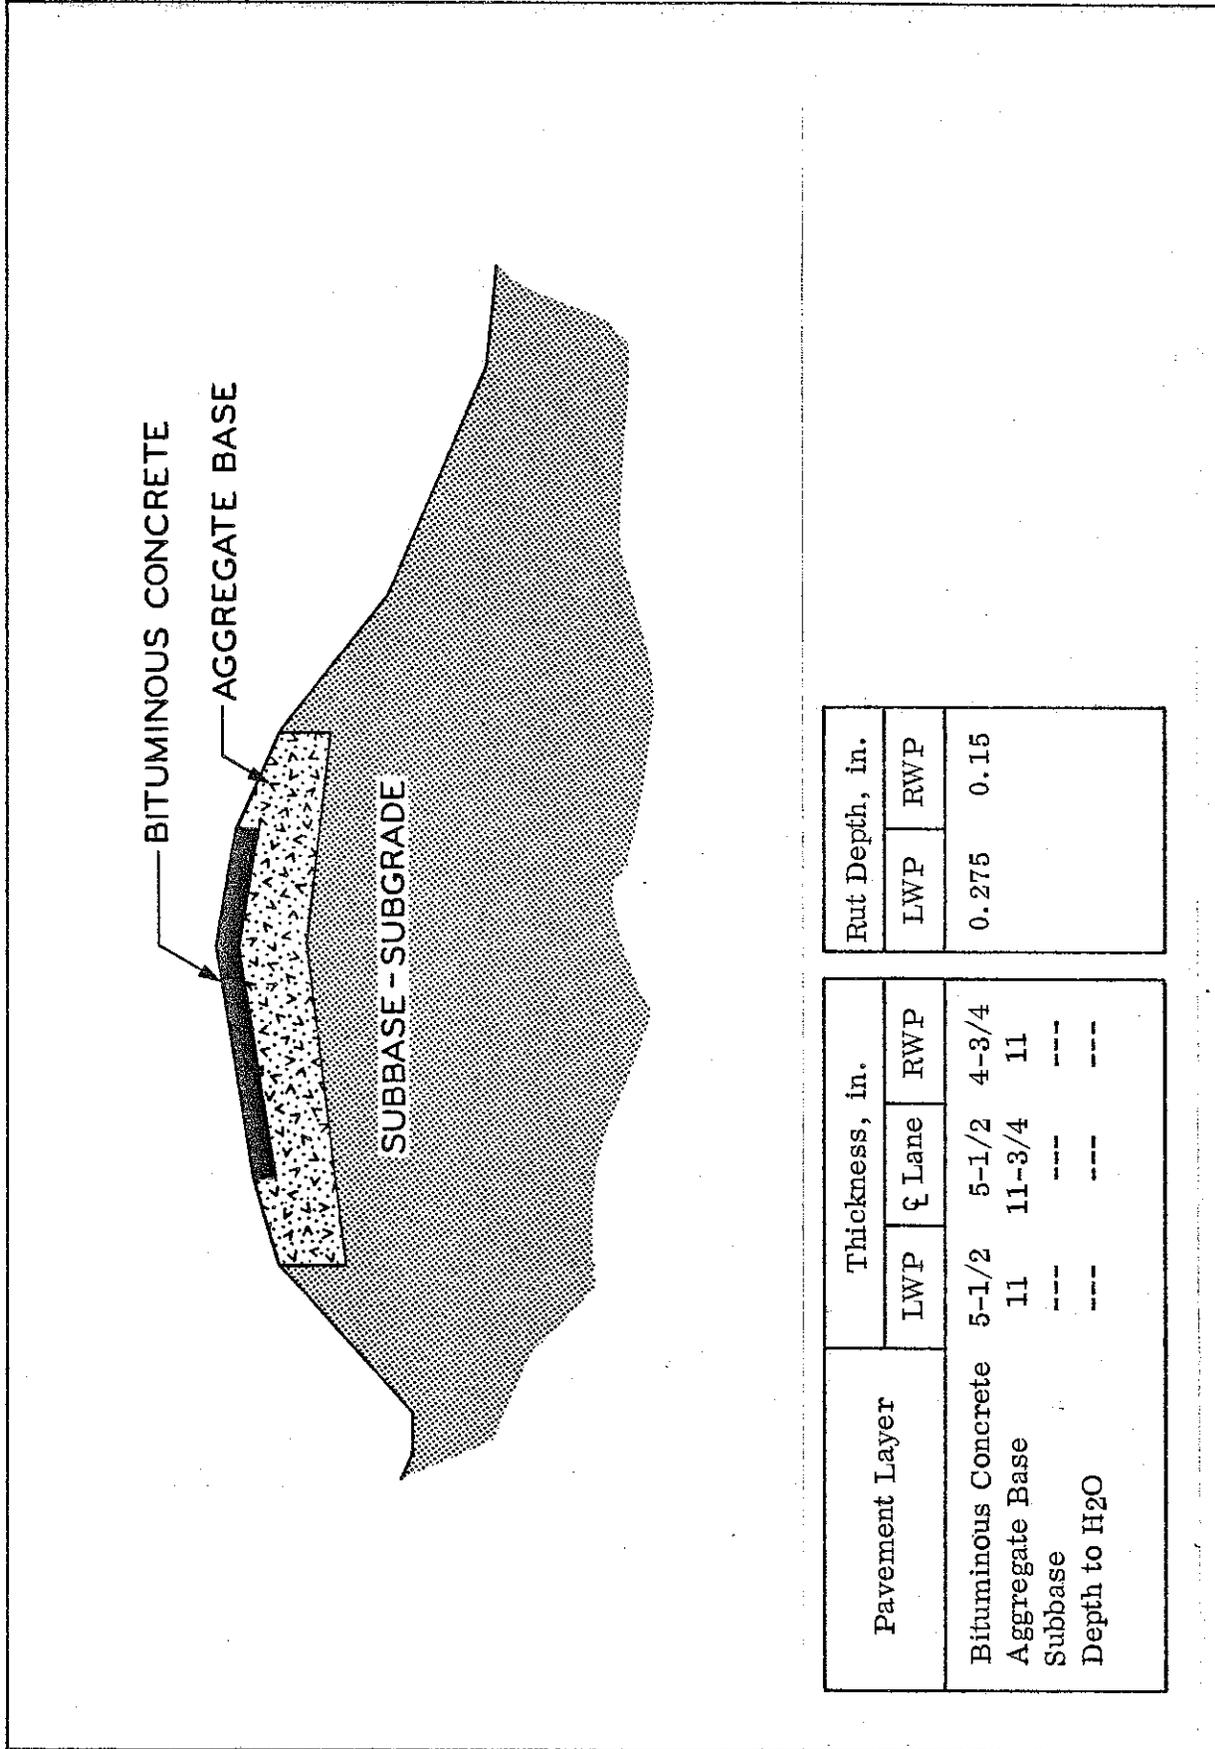
Figure 13. Cross-section of westbound I 94 at Station 592+00.

It was also noted that in uncracked areas, cutting bituminous samples was much more difficult than it was for cracked areas. Figures 13a and 16a indicate that comparatively higher asphalt contents exist in uncracked sections of pavement. Tentatively, the excellent performance of the uncracked pavement sections is attributed to higher bitumen content. Bituminous test results are needed to confirm this conclusion. The thickness of the bituminous concrete varies within a range of 4-1/4 to 5 in. which compares well with the 4-1/2 in. design thickness.

Pavement Layer	Thickness, in.			Rut Depth, in.	
	LWP	½ Lane	RWP	LWP	RWP
Bituminous Concrete	5-1/2	5-1/2	4-3/4	0.275	0.15
Aggregate Base	11	11-3/4	11		
Subbase	---	---	---		
Depth to H2O	---	---	---

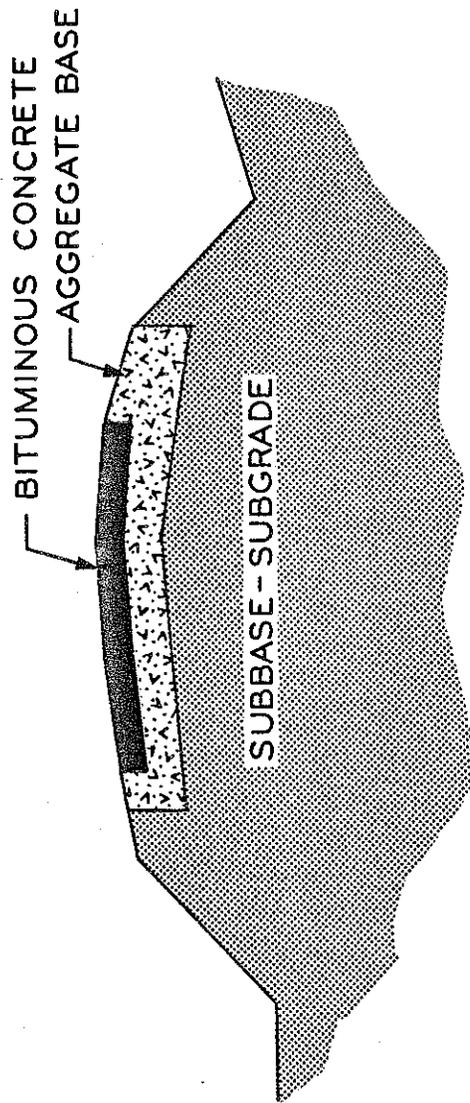
Figure 14. Cross-section of eastbound I 94 at Station 592+00.

The thickness of the base plus select subbase is 1 to 3 in. thinner than the 12 in. design thickness, with the actual average thickness being a little over 10 in. Pumping of fines from the base has reduced its thickness in the wheelpaths as illustrated by results obtained at Sta. 592+00 and 746+00 (Figs. 14 and 17). It was noted that the aggregate base was of higher density and more difficult to dig in those areas where the base was the primary cause of distress. This is attributed to increased coarse aggregate interlock that results as the fines are removed by pumping.

Pavement Layer	Thickness, in.			Rut Depth, in.	
	LWP	¢ Lane	RWP	LWP	RWP
Bituminous Concrete	5	5	4-3/4	0.925	0.25
Aggregate Base	7-3/4	9	9-1/4		
Subbase	---	-	---		
Depth to H <sub>2</sub> O	> 5 ft from pavement surface

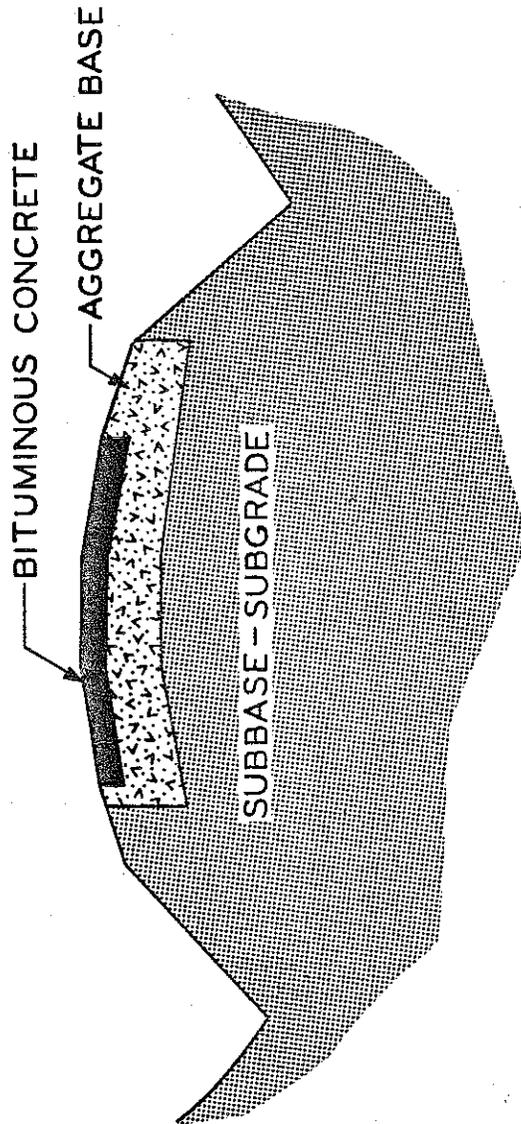
Figure 15. Cross-section of eastbound I 94 at Station 712+00.

Pavement Layer	Thickness, in.			Rut Depth, in.	
	LWP	±Lane	RWP	LWP	RWP
Bituminous Concrete	5	5	4-3/4	0.35	0.70
Aggregate Base	10	10	9-1/2		
Subbase	--	--	---		
Depth to H <sub>2</sub> O	> 4 ft from pavement surface

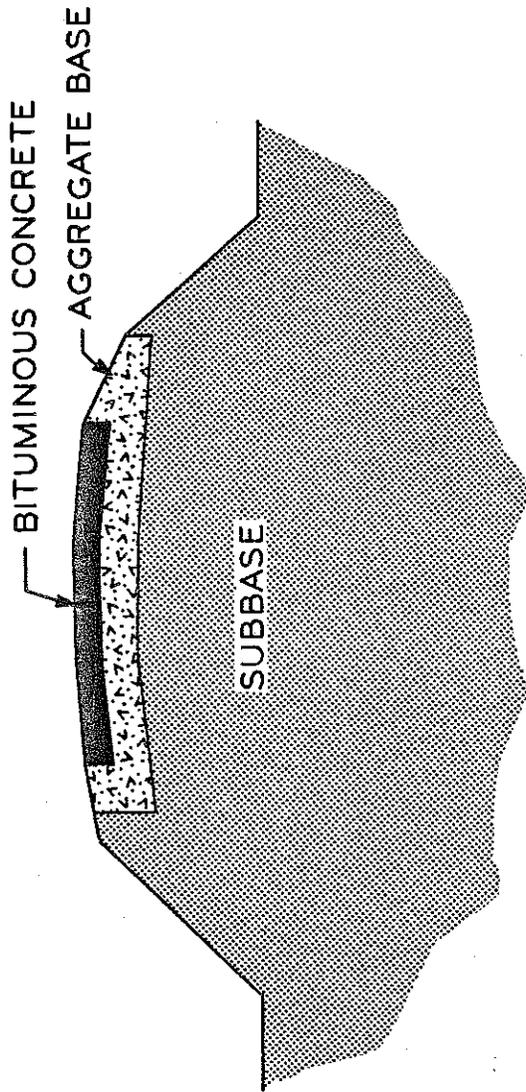
Figure 16. Cross-section of eastbound I 94 at Station 720+00.

Pavement Layer	Thickness, in.			Rut Depth, in.	
	LWP	℄ Lane	RWP	LWP	RWP
Bituminous Concrete	5	5	4-3/4	0.225	0.275
Aggregate Base	9-3/4	9-1/2	8-3/4		
Subbase	---	---	---		
Depth to H <sub>2</sub> O surface	> 4 ft from pavement surface

In areas where the bituminous concrete is not crack susceptible, such as at Sta. 720+00 (EB) the high fines content of the base gravel has not detrimentally influenced pavement performance; i.e., the pavement is not rutted or cracked. In adjacent areas with the same base material, Sta. 712+00 and 746+00, the crack susceptible bituminous concrete has cracked, admitted water to the base, and has initiated rutting and softening with its associated alligator cracking of the bituminous concrete.

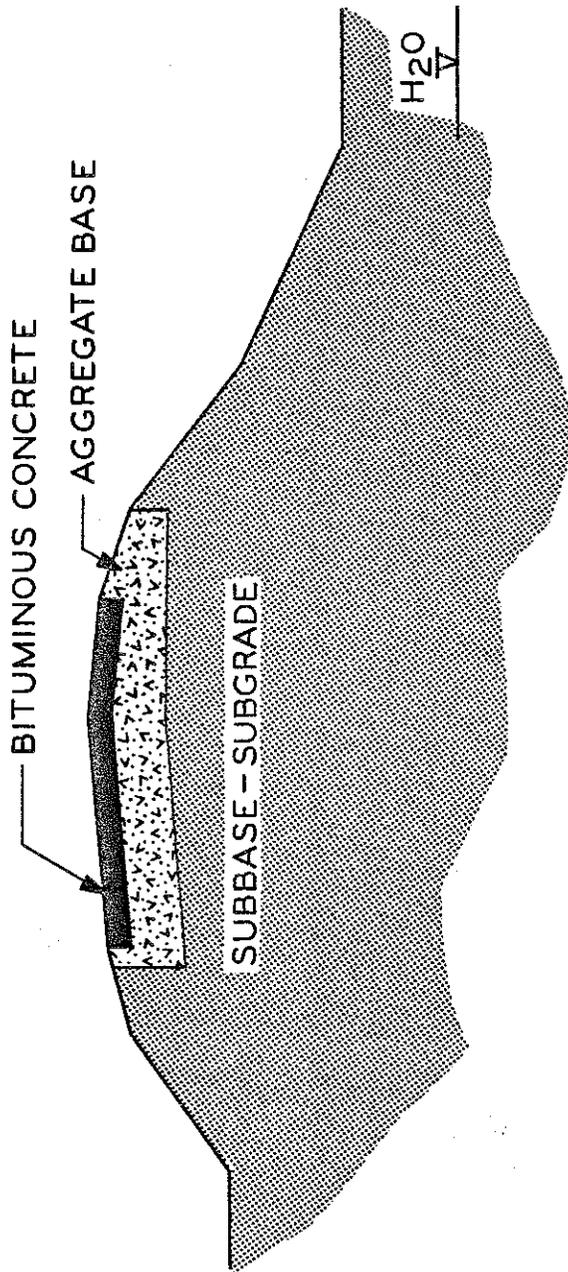
Figure 17. Cross-section of eastbound I 94 at about Station 746+00.

Pavement Layer	Thickness, in.			Rut Depth, in.	
	LWP	¢ Lane	RWP	LWP	RWP
Bituminous Concrete	5	5	4-1/2	0.35	1.15
Aggregate Base	11-1/4	10-1/2	8-1/2		
Subbase	---	---	---		
Depth to H <sub>2</sub> O	> 4 ft from pavement surface

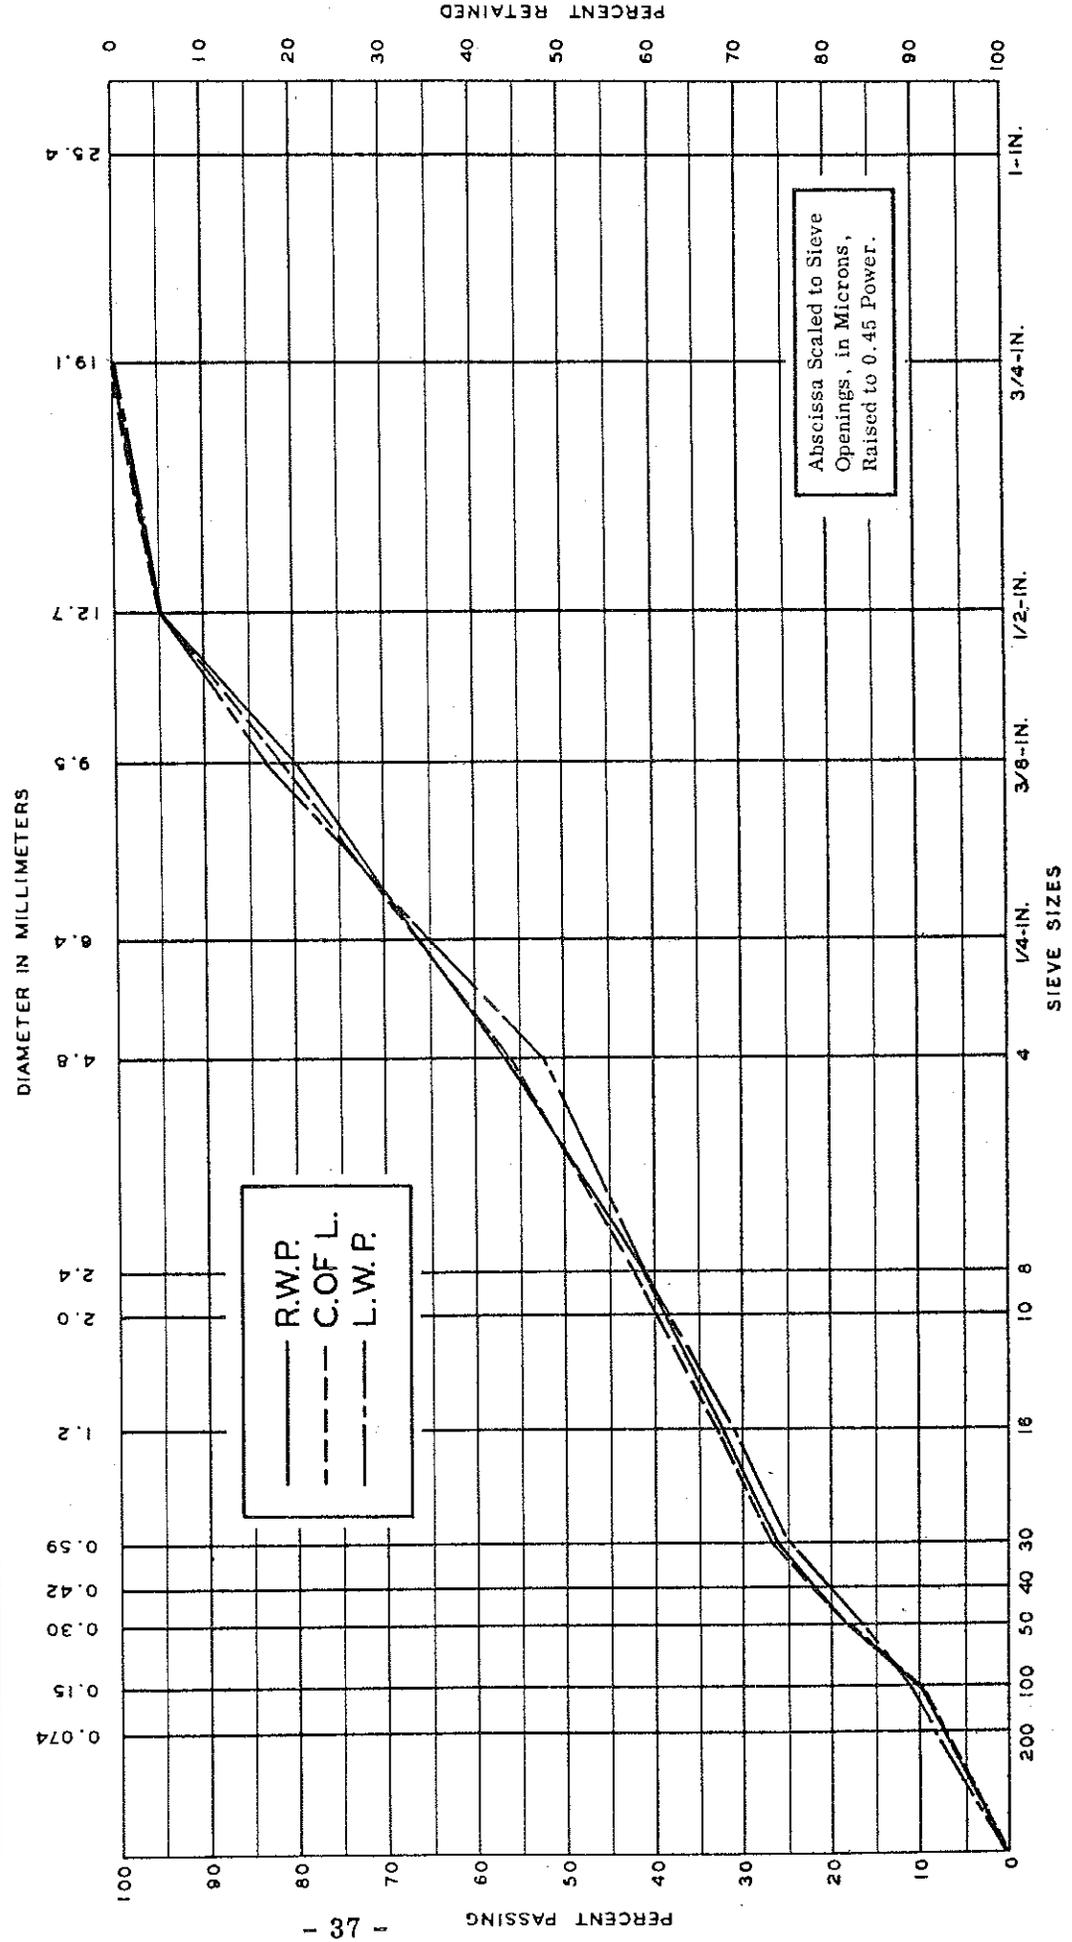
Figure 19. Gradation of base samples from Station 254+00 (EB).

All bases tested have a loss-by-washing content in excess of 7 percent and many are in the 11 to 12 percent range. Figures 18 to 25 show that they also have very dense gradations. These two characteristics combine to give a base which is generally extremely stable when less than 90 percent water saturated. However, when over 90 percent water saturated, and subject to freeze-thaw action, volume change and softening (loss of strength) occurs. The volume change is responsible for some of the wheelpath rutting, while softening is responsible for the alligator cracking.

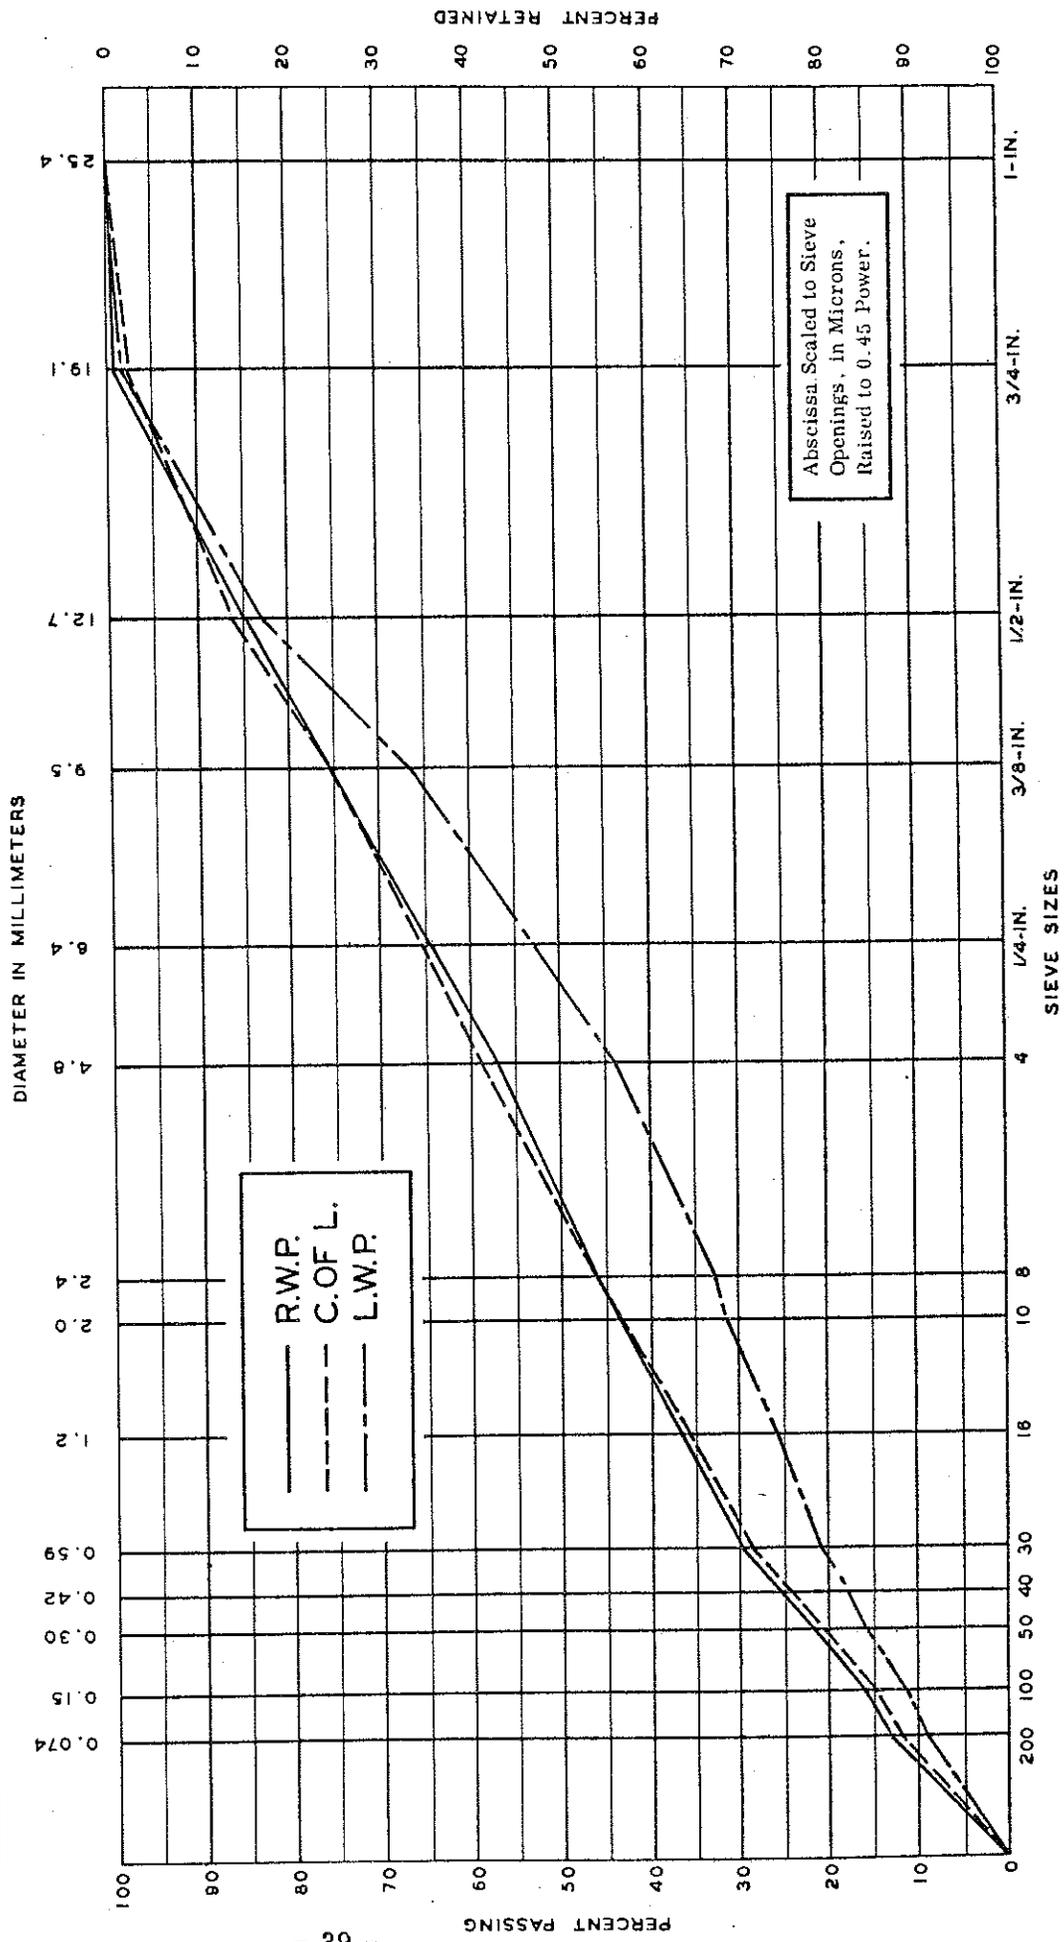
Figure 21. Gradation of samples from Station 592+00 (EB).

Some of the base is exhibiting severe degradation characteristics. In reviewing gradations for Sta. 592+00 (EB and WB) and to a lesser extent Sta. 746+00 (EB) it will be noted that the left wheelpath base samples are finer than are the right wheelpath samples. This has caused an increased rutting of the left wheelpath compared to the right (Figs. 13, 14, and 17). The left wheelpath does receive a greater total number of load repetitions than does the right because of the lane changes made by the heavy truck traffic. Normally, the right wheelpath ruts more because of the lower lateral support hence lower stability in the right wheelpath. The tendency to degrade could be alleviated by bituminous stabilization.
