**CONTINUOUSLY REINFORCED CONCRETE
PAVEMENT IN MICHIGAN
A HISTORICAL SUMMARY**

J. E. Simonsen

**Research Laboratory Section
Testing and Research Division
Research Projects 61 F-64,
57 F-46, and 73 F-129
Research Report No. R-1120**

**Michigan Transportation Commission
Hannes Meyers, Jr., Chairman; Carl V. Pellonpaa,
Vice-Chairman; Weston E. Vivian, Rodger D. Young,
Lawrence C. Patrick, Jr., William C. Marshall
John P. Woodford, Director
Lansing, June 1979**

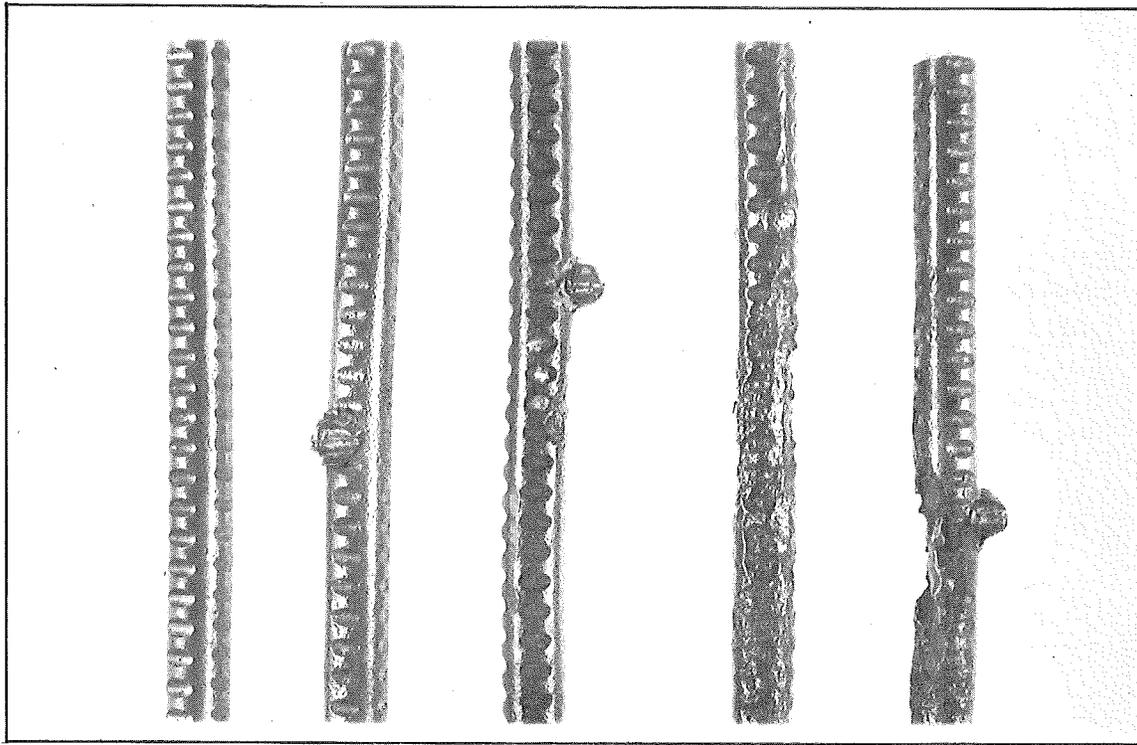
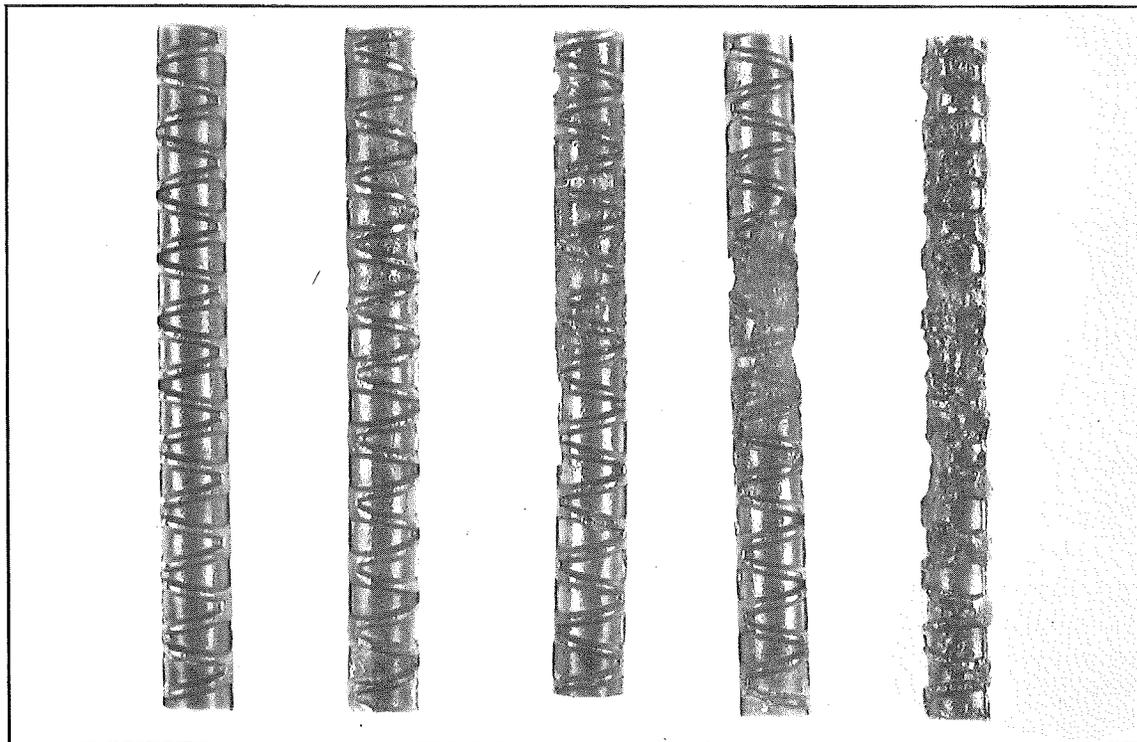
Figure 1A. Steel samples showing the five stages of corrosion.

Index	Definition
1	No corrosion. Discoloration of the surface of the bar may have occurred.
2	Mild corrosion. Scattered minute pitting of the bar surface.
3	Moderate corrosion. Concentrated pitting of the bar surface with pit depths up to approximately 1/32 in., and/or the beginning of slight uniform reduction of the bar diameter.
4	Severe corrosion. Concentrated pitting of the bar surface with pit depths greater than approximately 1/32 in., and/or uniform reduction of the bar diameter up to approximately 25 percent.
5	Critical corrosion. Deep concentrated pitting of the bar surface, and/or uniform reduction of the bar diameter from over approximately 25 percent to failure of the bar.

The five stages of corrosion are illustrated in Figure 1A, for both deformed wires and deformed bars. To determine the corrosion index for the steel samples each bar was visually examined independently by three different persons. Since the rating scale is subject to interpretation, the three ratings did not agree in all cases. Where two of the three observers were in agreement the index number, which was assigned by the two observers, was used. In cases where all three observers assigned a different index to the same sample the middle index number was used to indicate the corrosion.

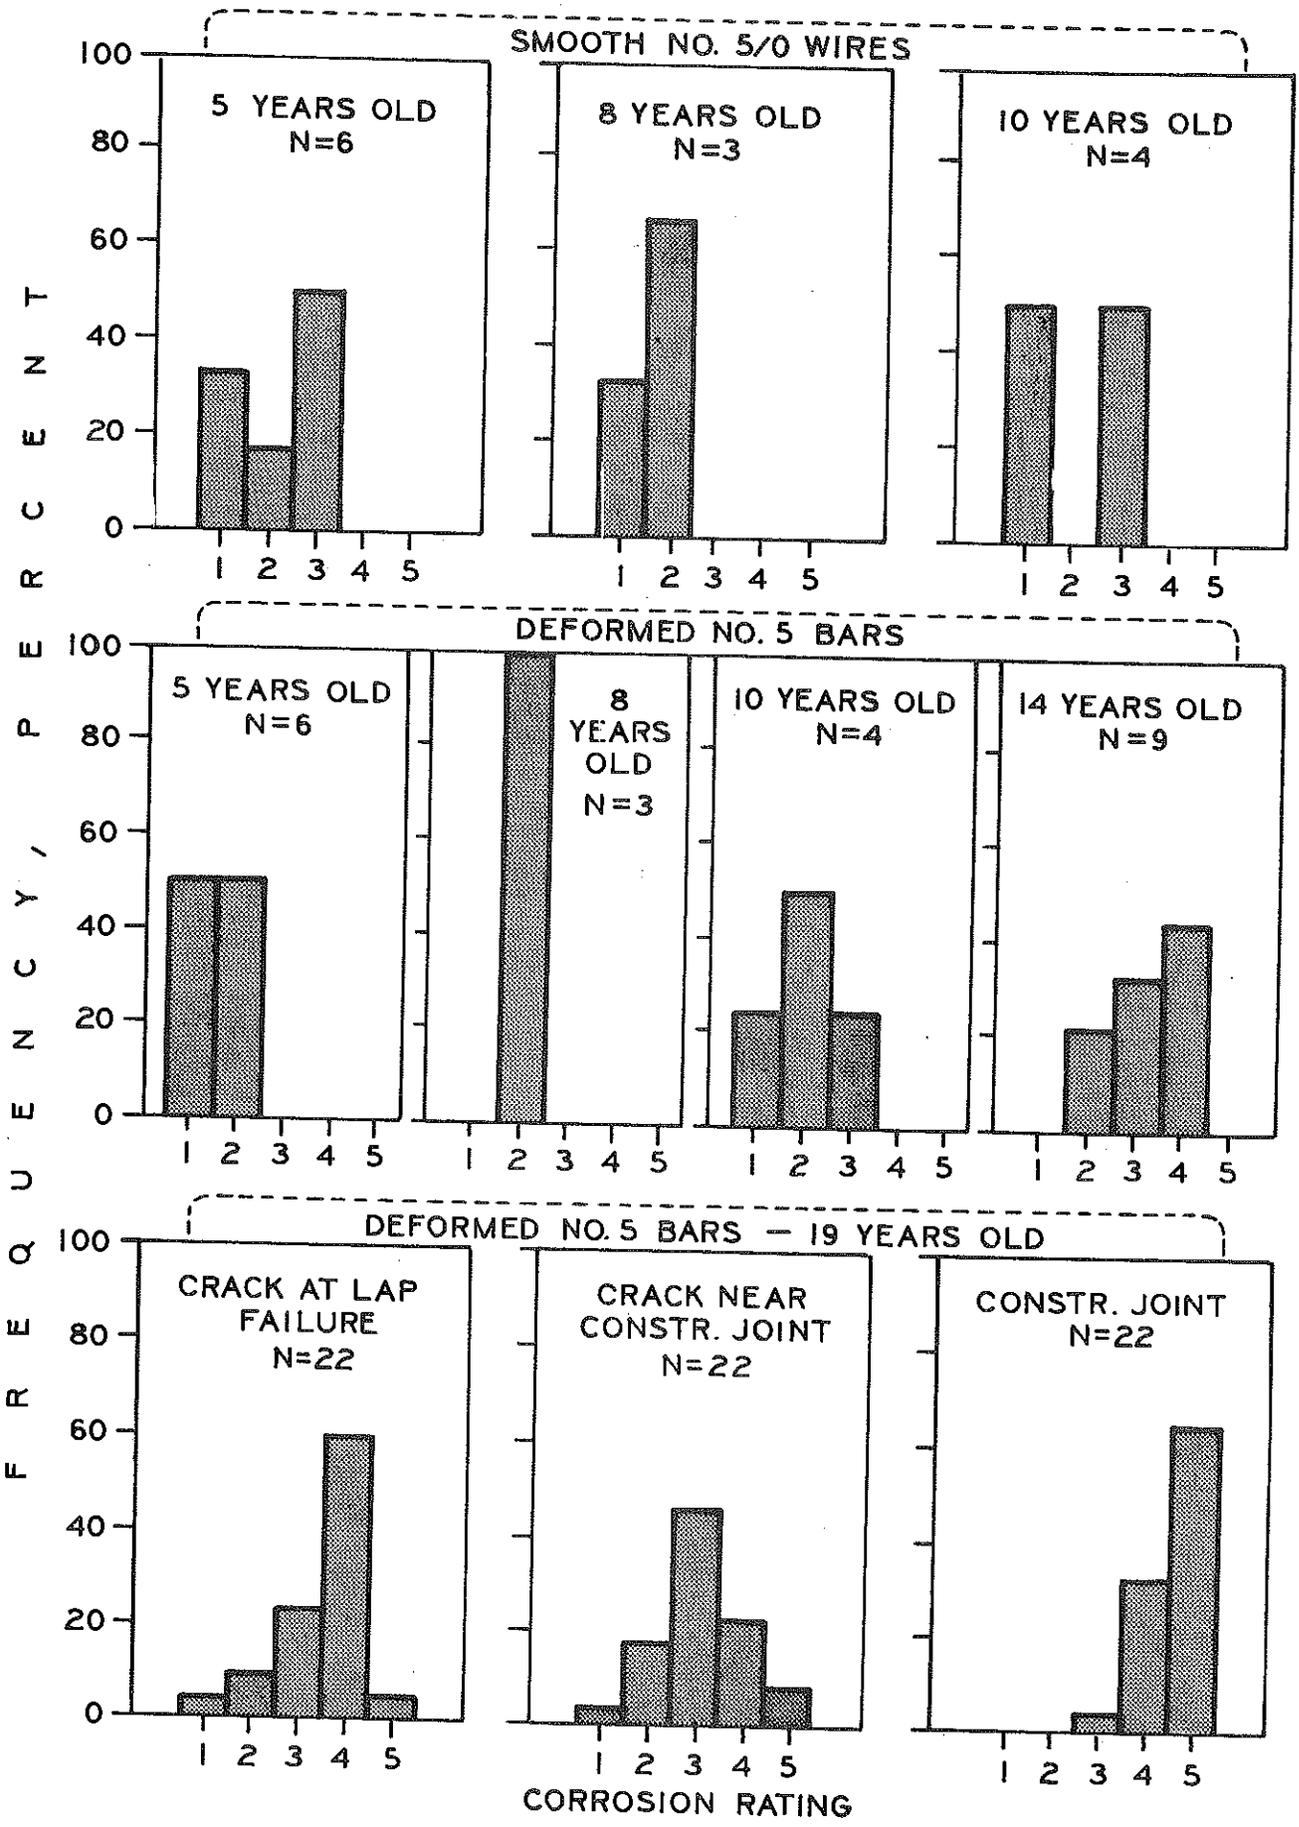
The corrosion ratings of the three sets of samples from the smooth welded wire mesh section are shown on the top portion of Figure 2A. As can be noted, none of the samples in the three age brackets were rated higher than 3 or 'moderately corroded.' Since the use of this type of reinforcement was discontinued in the early sixties no further study of its corrosion was made.

The corrosion of the deformed bar samples from cores is shown on the middle portion of Figure 2A. Both the five and eight year old samples were rated in the 1 and 2 categories, whereas, in the 10 year old samples one sample was given a rating of 3. Of the 14 year old samples 22, 34, and 44 percent were rated 2, 3, and 4, respectively. Thus, the steel samples removed from cores indicate that corrosion increases with time as would be expected.

In order to determine the corrosion at a crack across a lane, steel samples were removed from two repair areas in 1977. The percentage of bars with a given rating number is shown on the bottom portion of Figure 2A. As can be seen, after 19 years of service a large percentage of bars show corrosion ratings of 4 and 5. At the construction joint, 96 percent were rated in the 4 and 5 categories. The condition of the pavement area from which the steel was removed is shown in Figures 3A, 4A, and 5A for the lap failure, crack near construction joint, and for the construction joint, respectively.

Figure 2A. Corrosion ratings of 5 to 10-year old smooth No. 5/0 wires and of 5 to 19-year old deformed No. 5 bars.

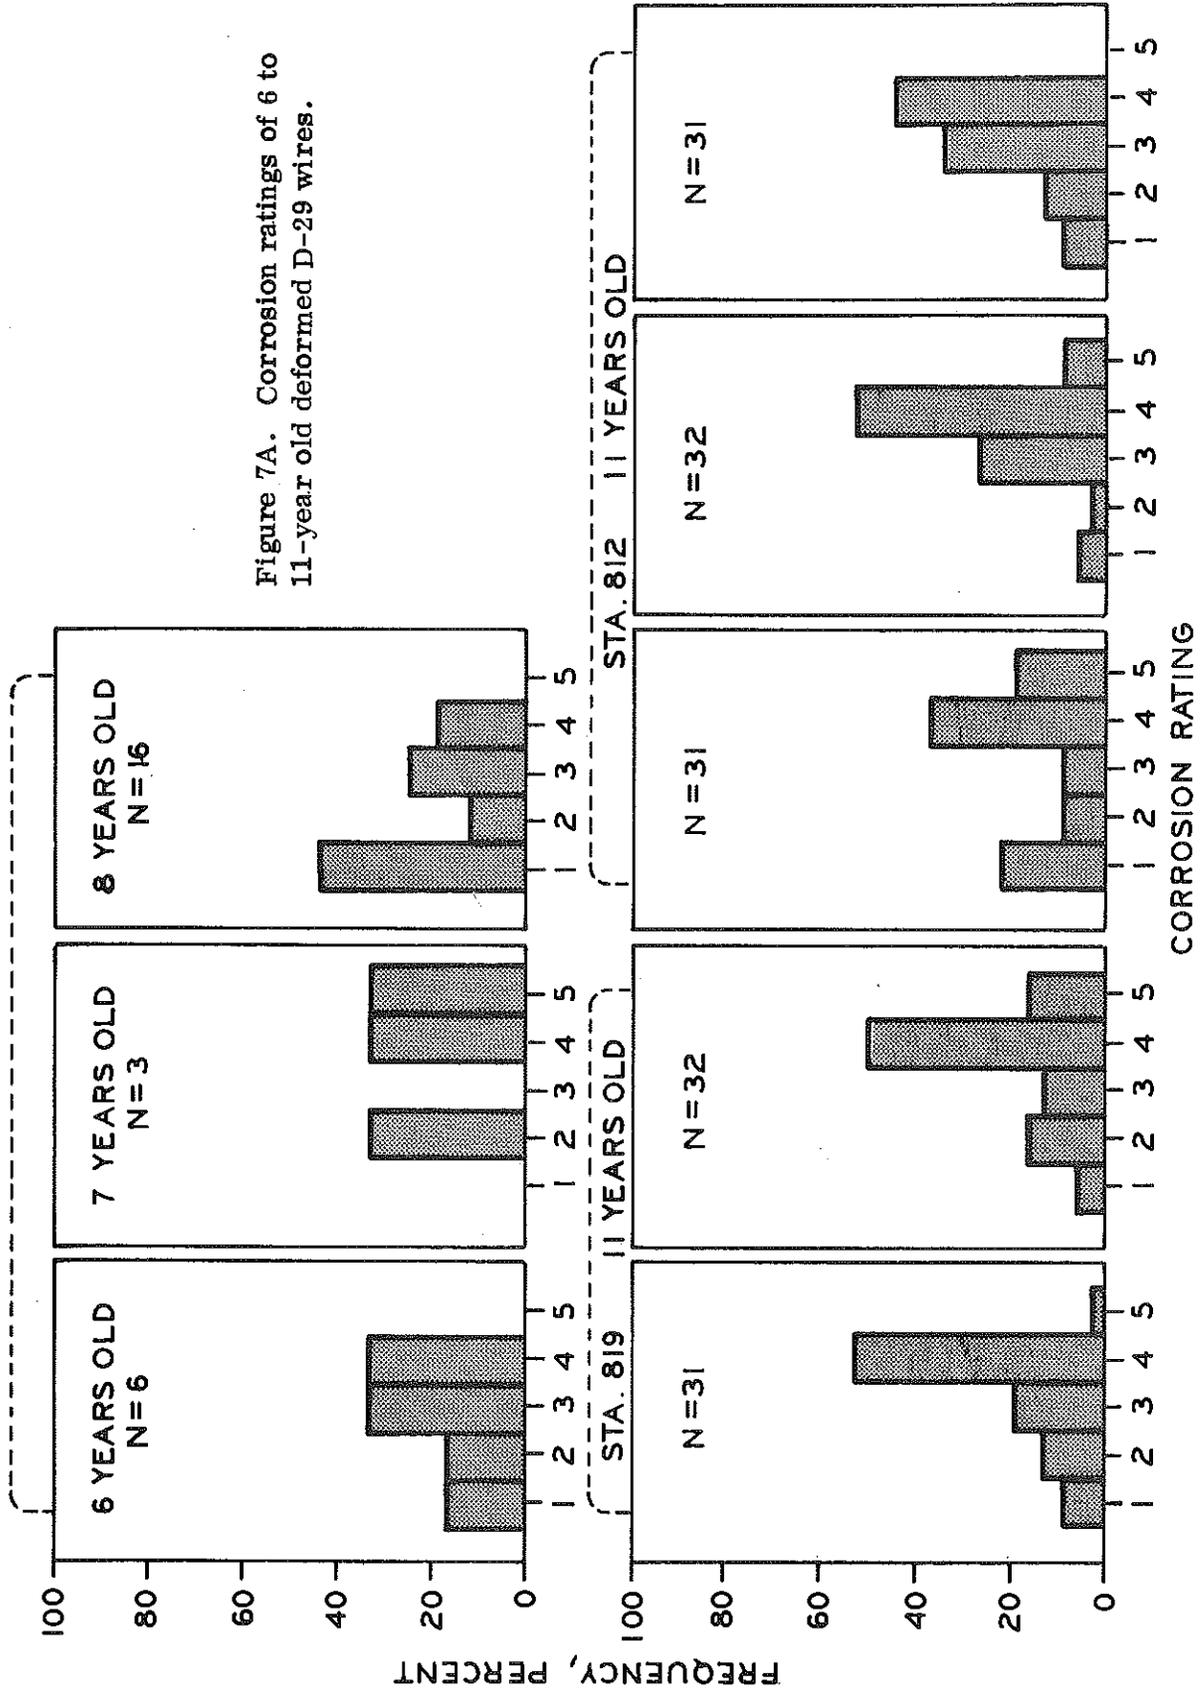
Figure 7A. Corrosion ratings of 6 to 11-year old deformed D-29 wires.

of Figure 7A for steel samples of deformed wire six, seven, and eight years old. On the lower left portion of Figure 7A is the results of wire samples removed from two consecutive cracks at the repair at Station 819 and the results from three consecutive cracks at Station 812 are shown on the bottom portion of Figure 7A. The condition of the pavement, from which the samples were removed, is shown on Figures 8A and 9A before repairs were made.

As shown on the graphs for six, seven, and eight year old samples, 28 percent of the samples were rated 4 and 5 (severe and critical corrosion). For the samples removed from consecutive cracks at Station 819 and 812 58 percent of the samples were rated 4 or 5. Thus, the degree of corrosion has apparently increased during the four year period since the first samples were taken.

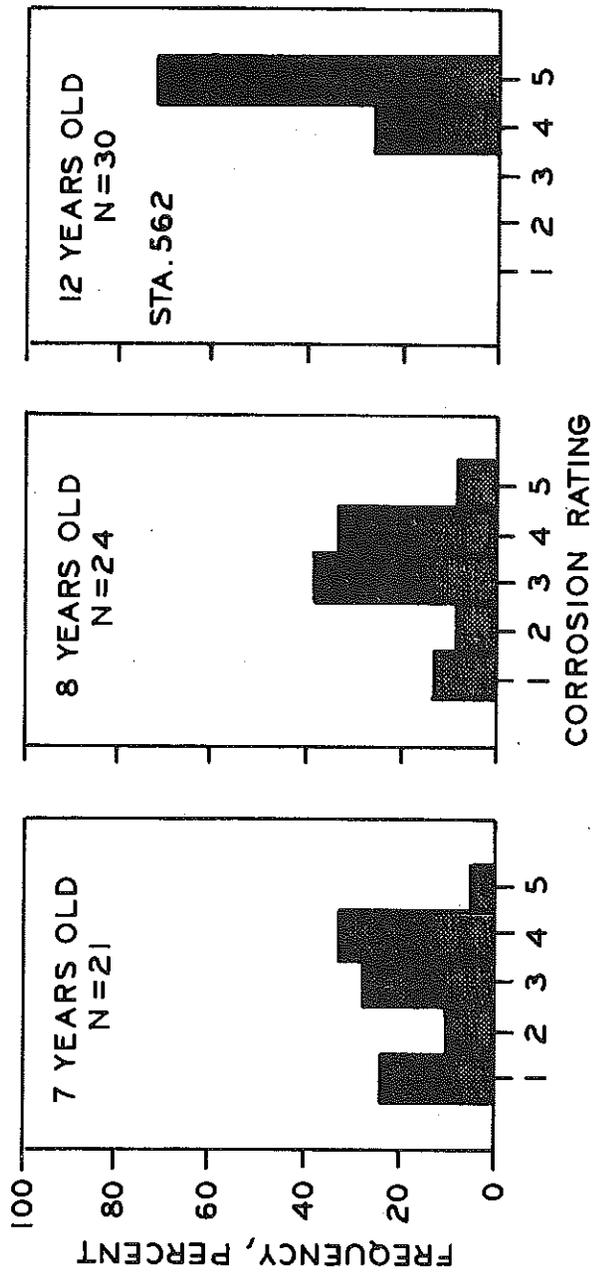
The corrosion ratings of deformed bar samples are shown on Figure 10A. For the seven and eight year old samples about 40 percent were rated 4 and 5. The 30 bars removed from a repair at Station 562 were all rated 4 and 5. The tensile test results are shown on Figure 11A. The bars are randomly numbered and two bars were broken during removal. The samples are from the middle lane of a three-lane pavement and the traffic lane had been repaired two years earlier. As shown on the graph, 85 percent of the bars had tensile strengths below the guaranteed minimum, and the tensile strength of four bars was below the minimum yield strength.

Figure 10A. Corrosion rating of 7 to 12-year old deformed No. 5 bars.

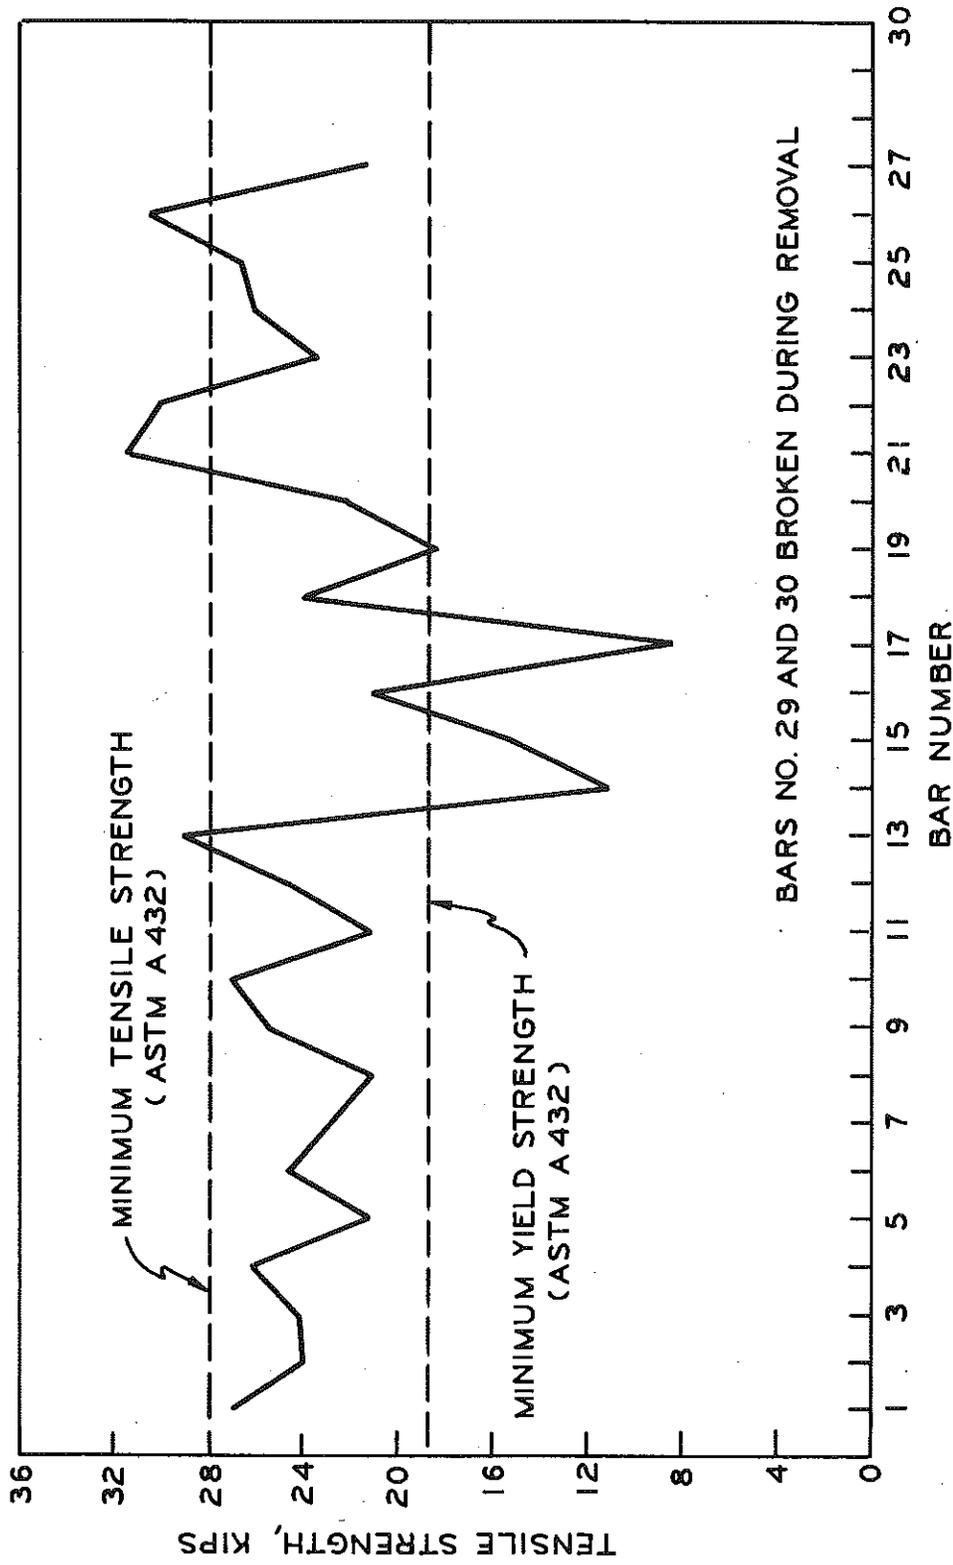
Figure 11A. Tensile strength of deformed No. 5 bars after 12 years service (Sta. 562).

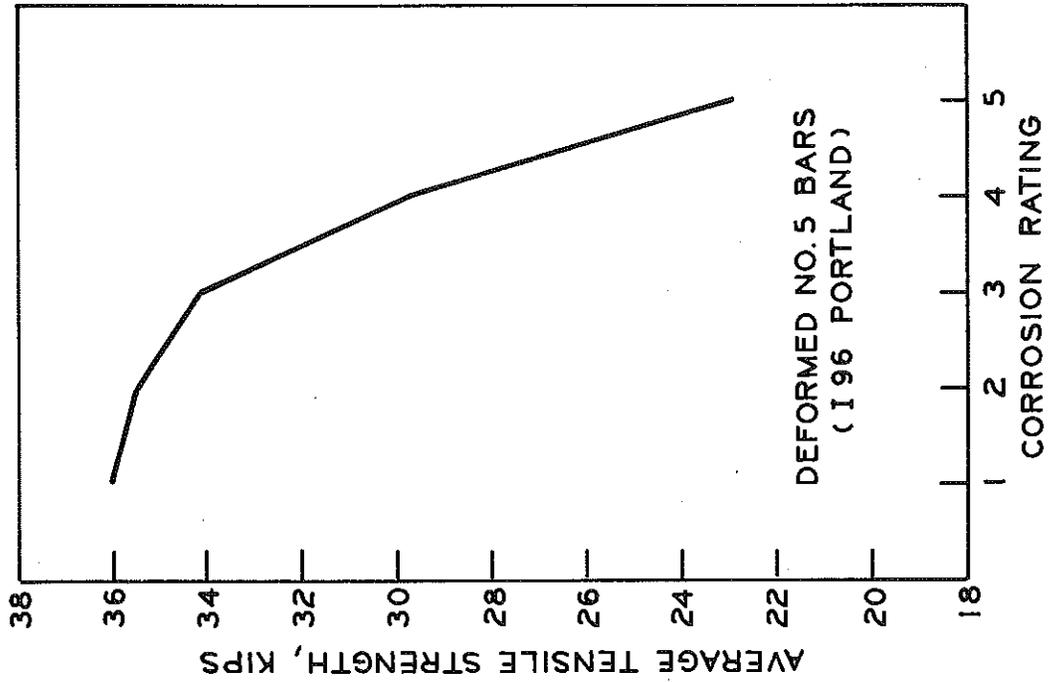
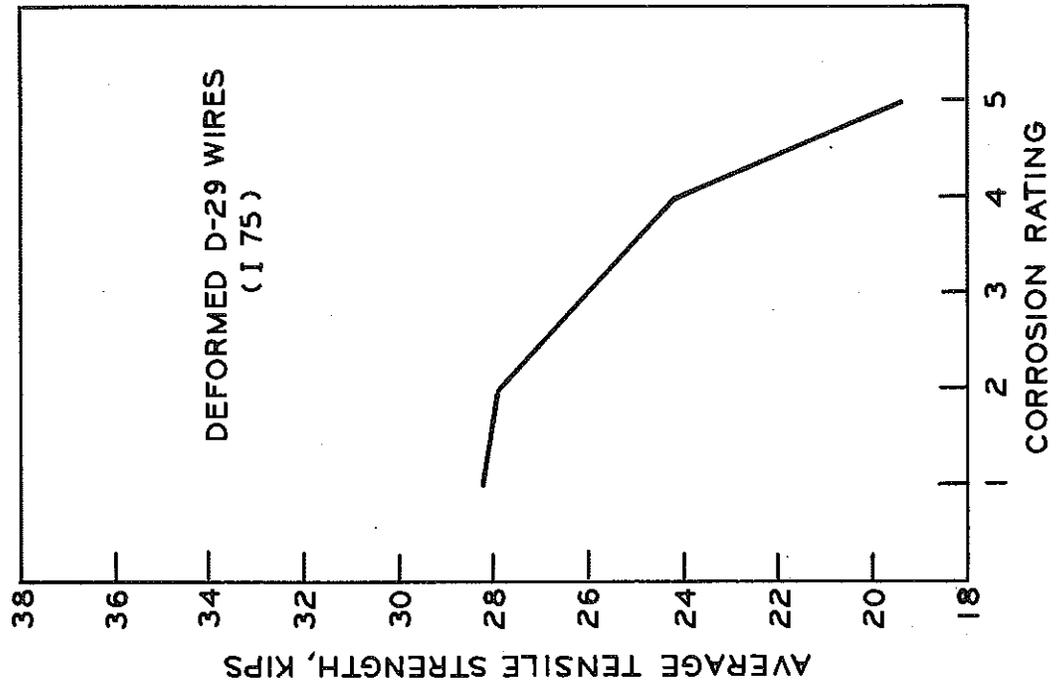
The relationship between average tensile strengths and corrosion ratings is shown in Figure 12A. On the basis of the graphs, it can be seen that corrosion ratings of 1 and 2 have little influence on the bar strengths. A rating of 3 still does not affect the strength significantly. However, ratings of 4 and 5 show much greater reductions in strength. A deformed wire

Figure 12A. Relationship of tensile strength and corrosion ratings of deformed No. 5 bars from I 75 and I 96.

with a 5 corrosion rating has, on the average, lost 32 percent of its ultimate tensile strength compared to one with a rating of 1 (no corrosion). For the bars from I 96 near Portland an average loss of 36 percent in tensile strength had occurred for bars with a 5 rating compared to bars with a 1 rating.

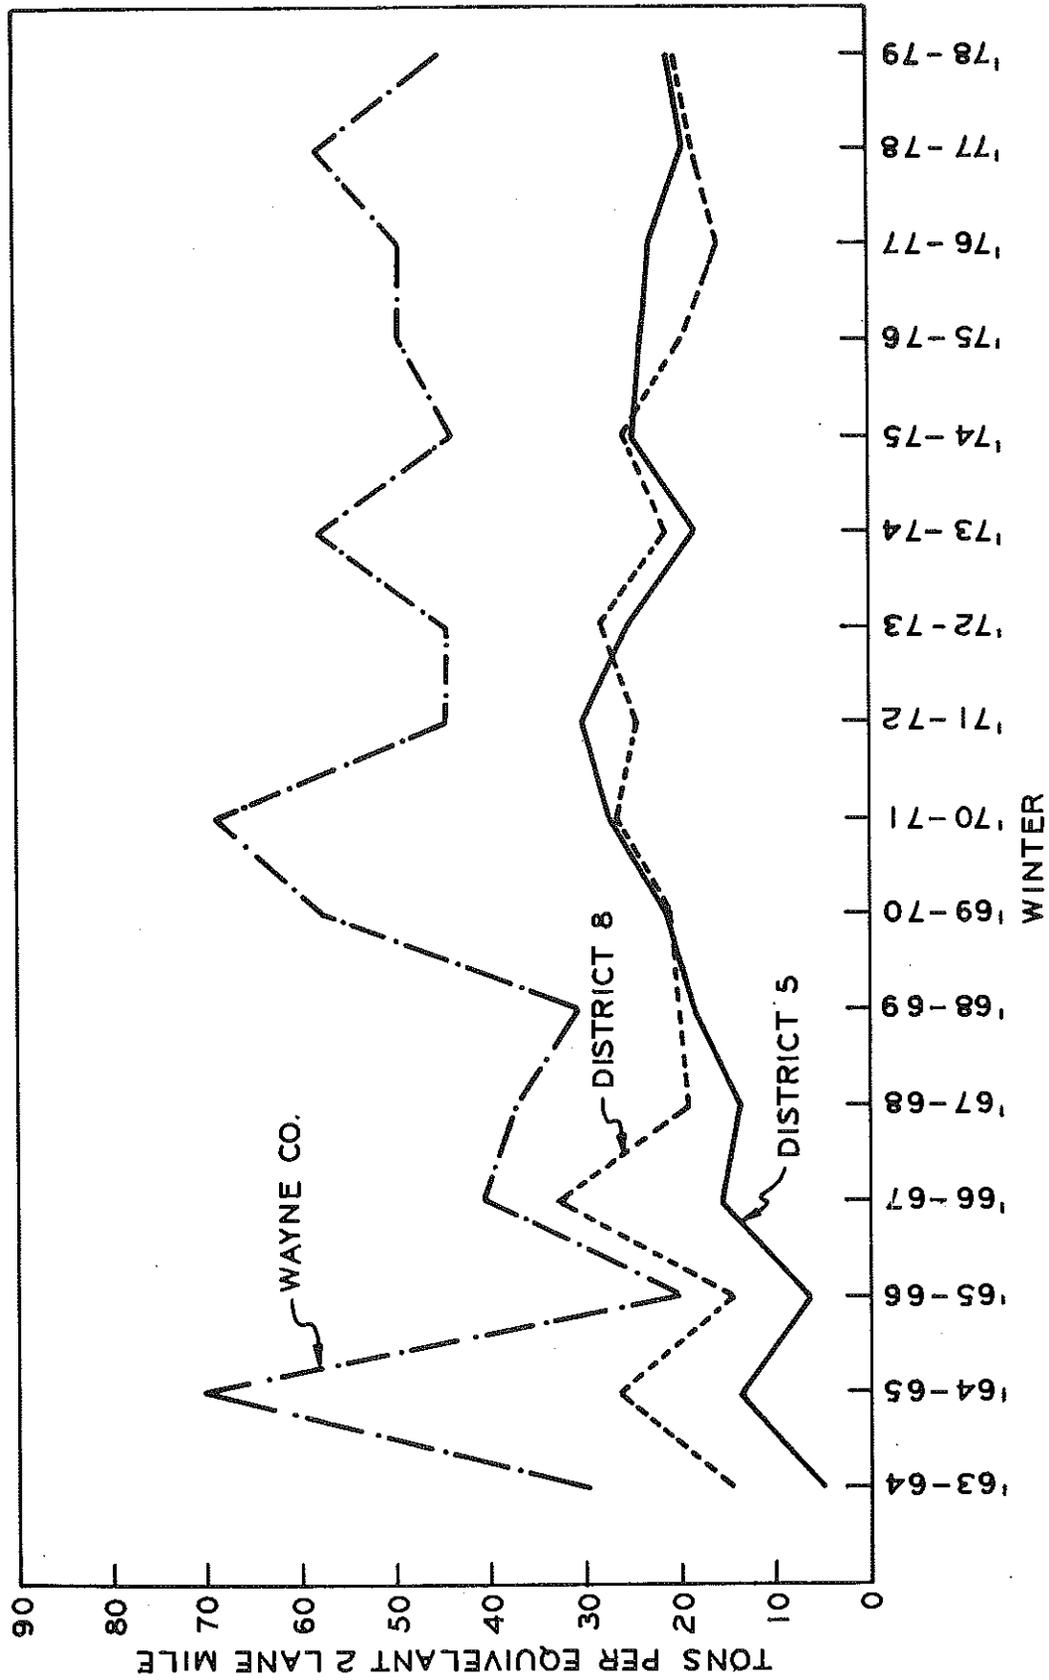
Another factor that is very significant in the corrosion of the reinforcement is the use of salt for removing snow and ice from the pavement. The amount of salt applied per equivalent two-lane mile of pavement in the areas from which steel samples have been examined is shown in Figure 13A for the winters 1963 through 1979. The average tonnage applied per year per equivalent two-lane mile in Wayne County and in Districts 5 and 8, is 47, 19, and 22, respectively.

Figure 13A. Tons of salt applied per equivalent two-lane mile in Wayne County and in Districts 5 and 8 (from Maintenance Division records).
