EVALUATION OF WEATHERING STEEL
IN A DETROIT FREEWAY ENVIRONMENT
-SECOND EIGHT-YEAR STUDY-

G. L. Tinklenberg

Research Laboratory Section
Materials and Technology Division
Research Project 62 G-122
Research Report No. R-1277

Michigan Transportation Commission
William C. Marshall, Chairman;
Rodger D. Young, Vice-Chairman;
Hannes Meyers, Jr., Carl V. Pellonpaa,
Shirley E. Zeller, William J. Beckham, Jr.
James P. Pitz, Director
Lansing, August 1986

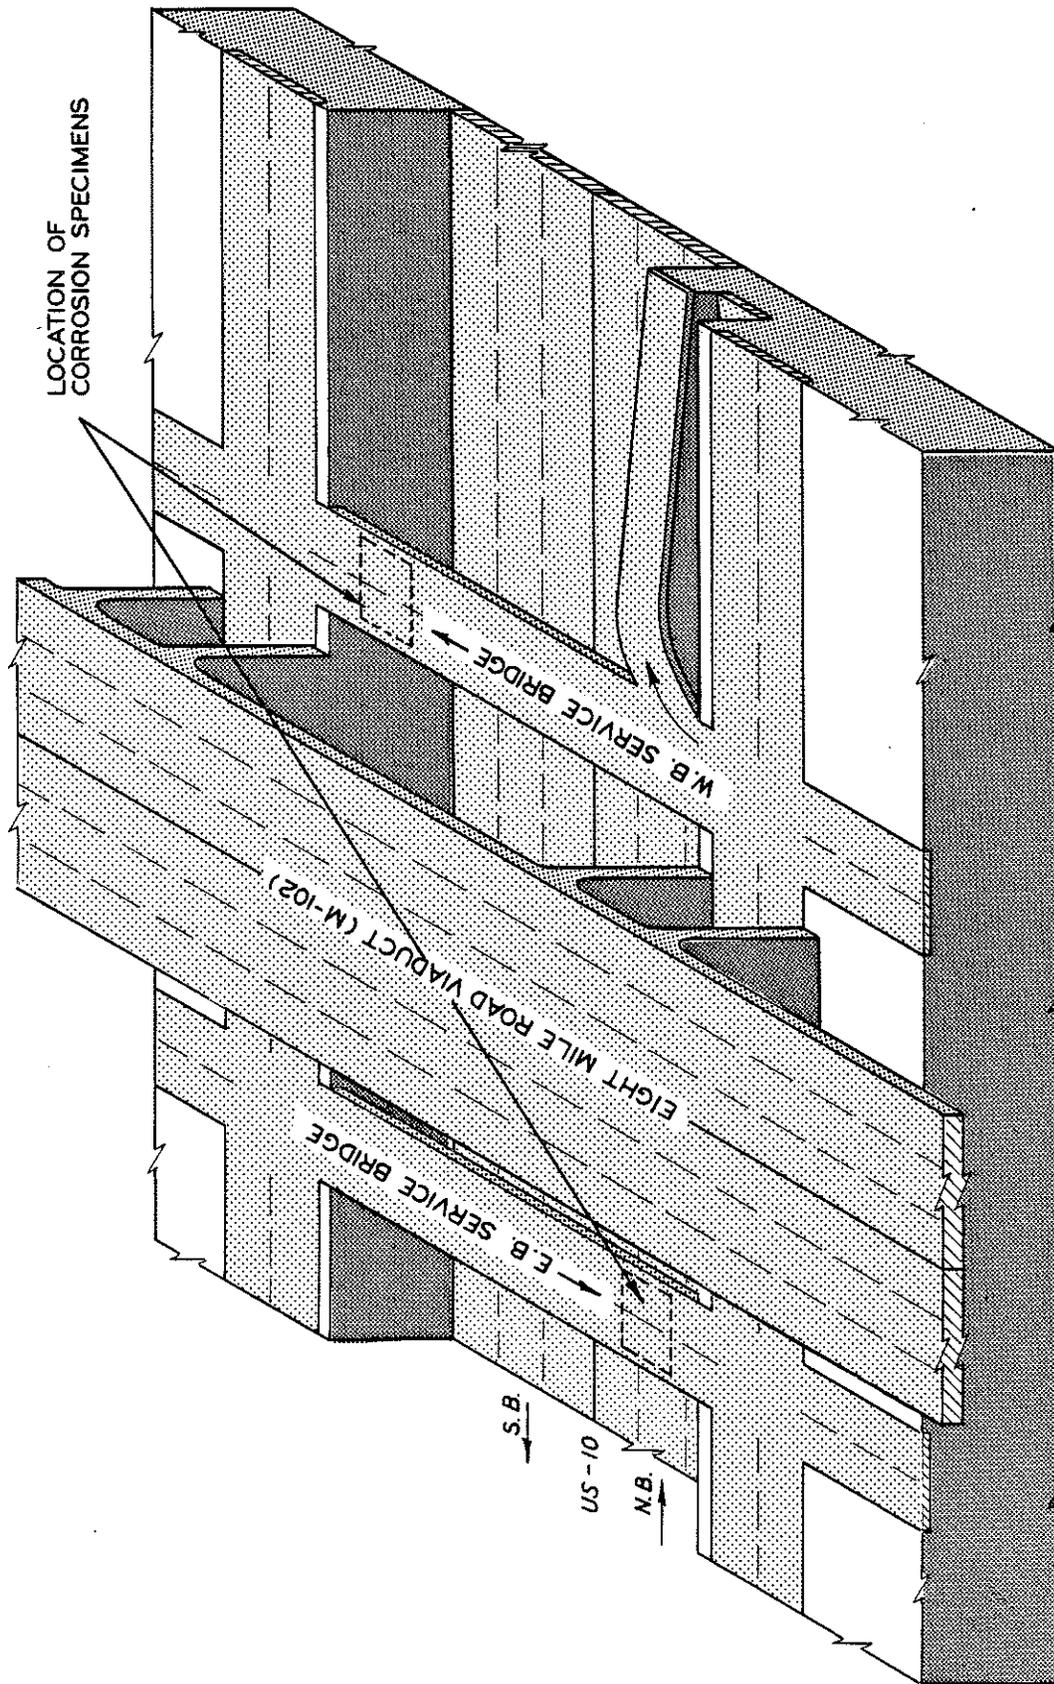
Figure 1. Complex intersection at the Eight Mile Road and the John Lodge Expressway; note location of corrosion specimens.

2) On the westbound 8 Mile Rd service road bridge over Southbound US 10. These panels were about 15 ft from a vertical retaining wall (Fig. 1).

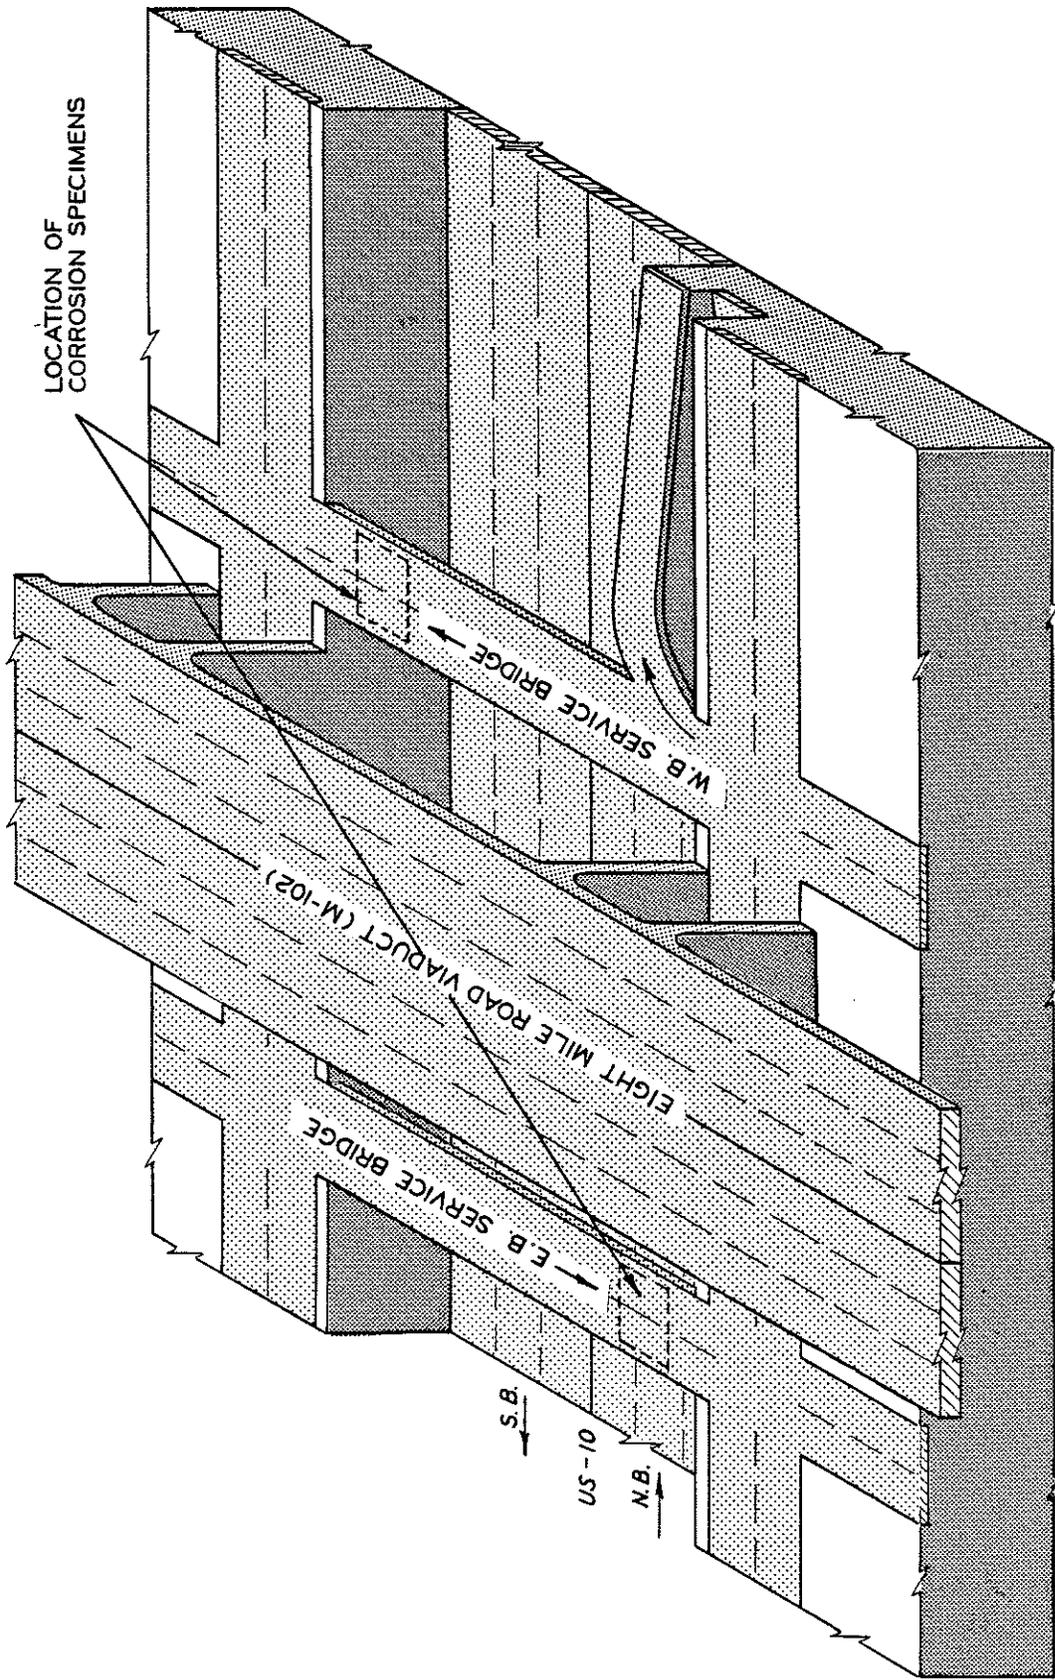
Figures 1 to 4 illustrate the racks and panels (with location of each rack) that will be removed after 2, 4, 8 and 16 years on the Westbound Service Bridge above the southbound (SB) and northbound (NB) lanes of the expressway and on the Armory Roof (AR).

Figure 1. Complex intersection at the Eight Mile Road and the John Lodge Expressway; note location of corrosion specimens.
