***A-588 BRIDGE MOUNTED SIGN
FAILURE INVESTIGATION***

CONSTRUCTION AND TECHNOLOGY DIVISION

A-588 BRIDGE MOUNTED SIGN FAILURE INVESTIGATION

**TESTING AND RESEARCH SECTION
CONSTRUCTION AND TECHNOLOGY DIVISION
RESEARCH PROJECT TI - 1976
RESEARCH REPORT R-1408**

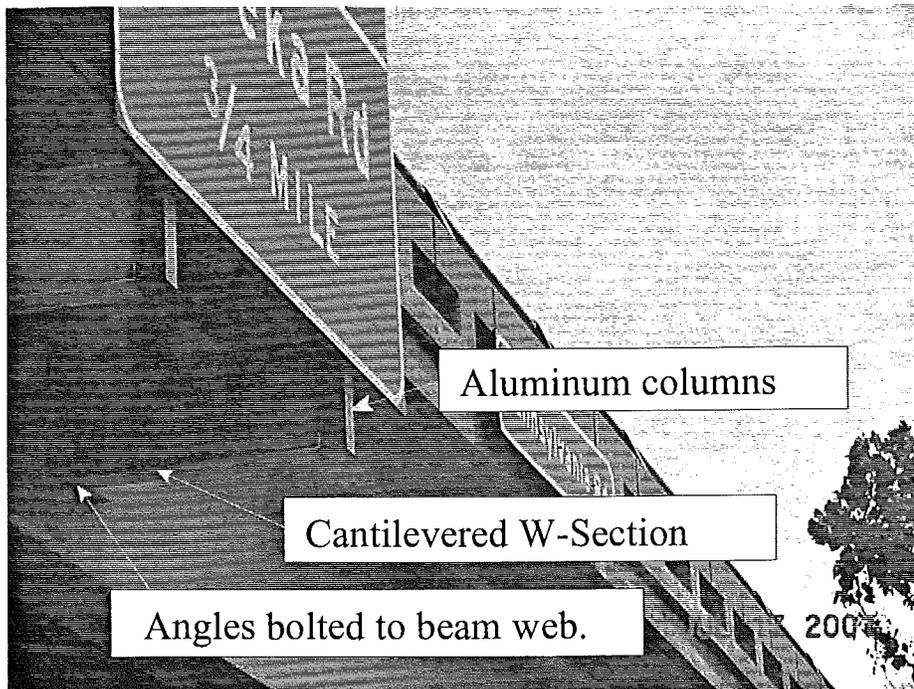
The sign was supported from the bridge using a bolted connection detailed according to Sign Standard Plan VIII-820E. This detail uses a W-section steel beam that is bolted to and cantilevers from the web of a steel bridge fascia beam. An example of this type of sign support is shown in Figure 1.

Figure 1 - Typical bolted sign connection, Type C or D.
