# CAUSES & CURES FOR PRESTRESSED CONCRETE I-BEAM END DETERIORATION

AUGUST 2002

WAYNE STATE  
UNIVERSITY

TESTING AND RESEARCH SECTION  
CONSTRUCTION AND TECHNOLOGY DIVISION  
RESEARCH REPORT NO. RC-1412

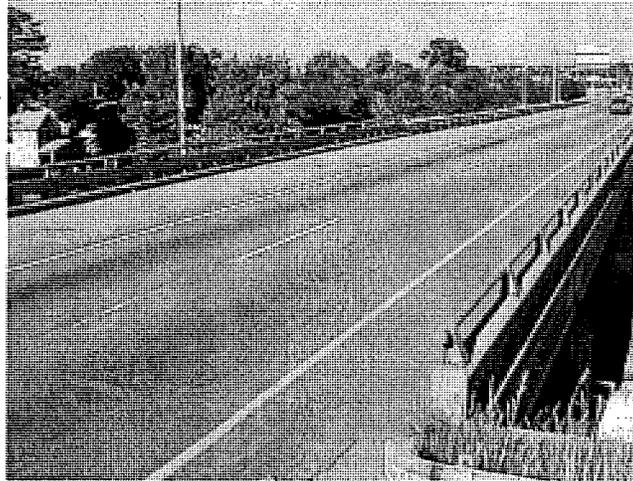
The deck is overlaid with asphalt (see Photo 3-9)

**Photo 3-9. General view of the deck**

Minor cracks and some spalls are noted along construction joints. Cracking, scaling and some rust stains are noted at the barriers.

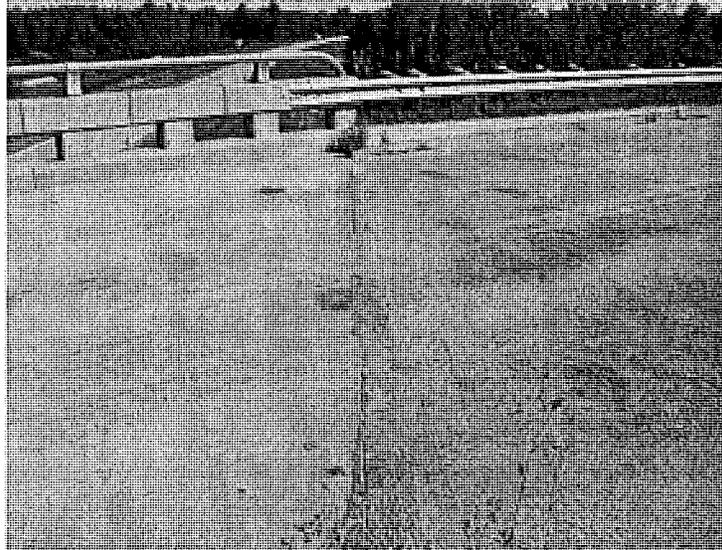
The concrete deck of the main span is in good condition. Both approaches have asphalt patches and potholes. The construction joints are partially broken as it shown in Photo 3-60.

**Photo 3-60. Construction joint between deck and approach**
