## **APPENDIX A: PHOTOGRAPHS**

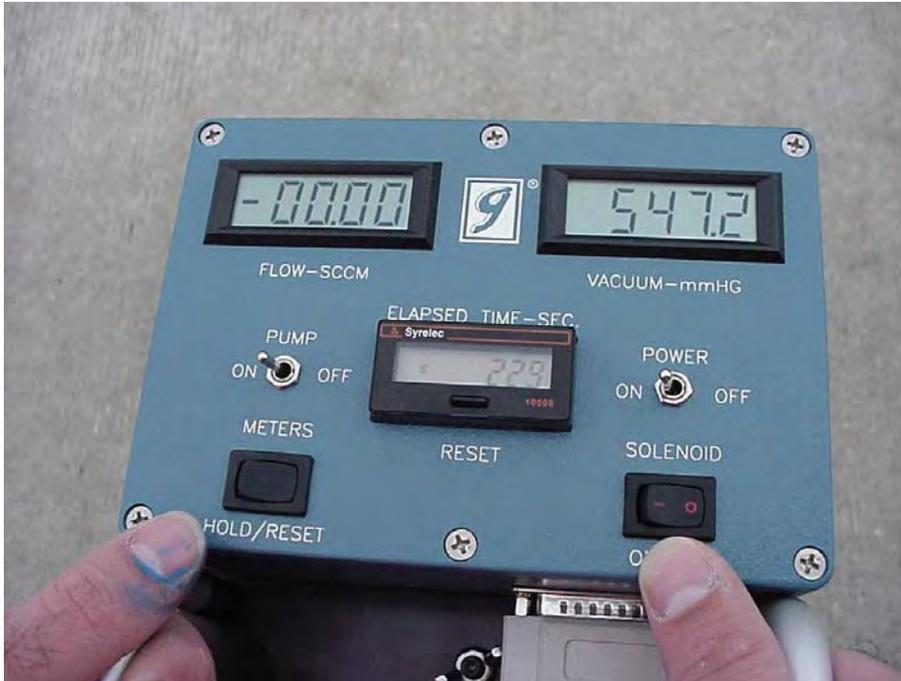
Air permeability apparatus control panel.  
Photo taken during permeability testing of Site 0, US-23 SB.

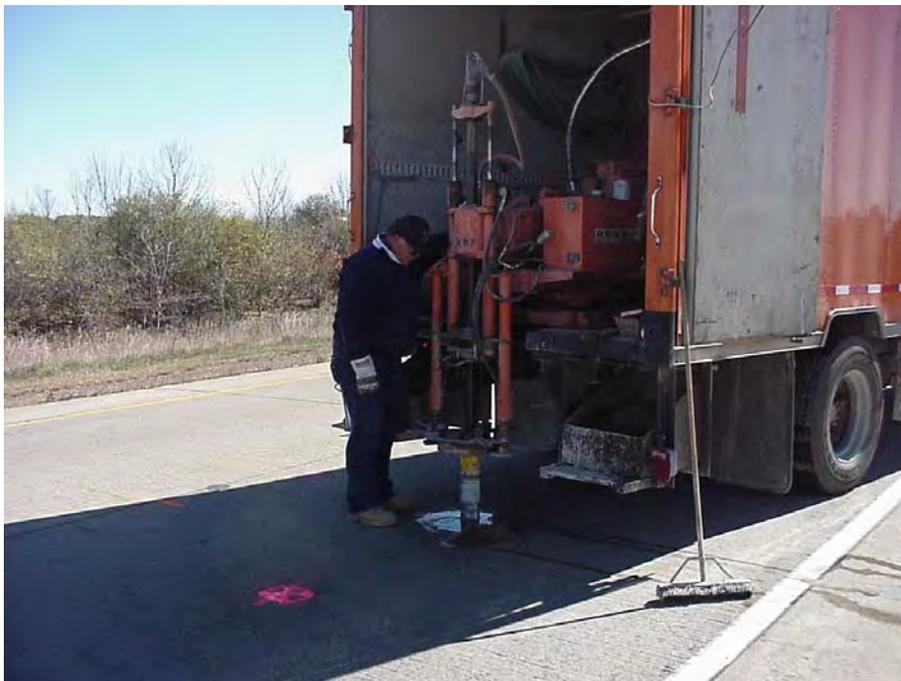
MDOT coring rig and technician during coring of Site 0, US-23 SB.

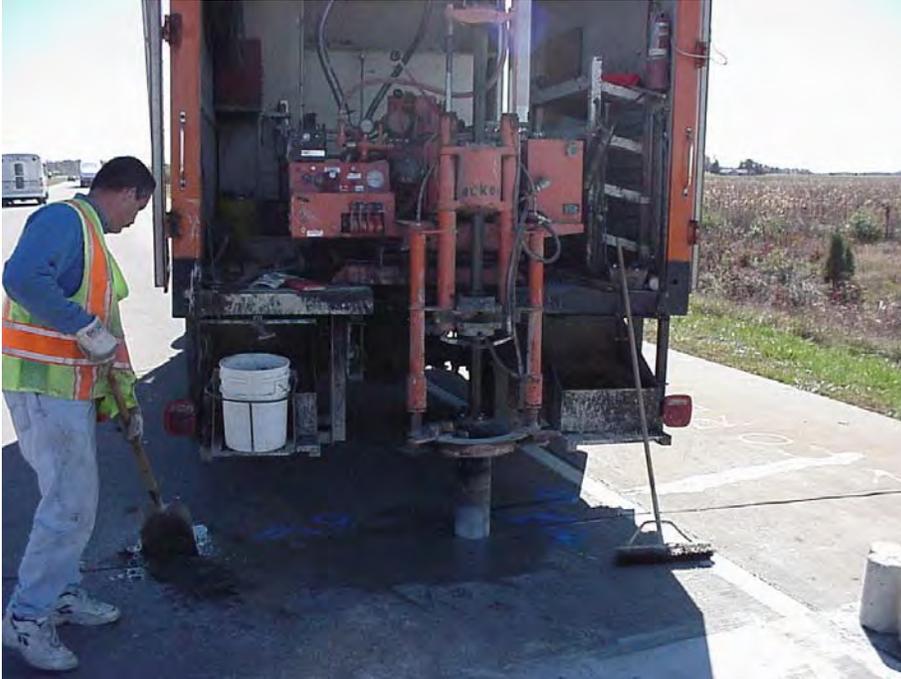
The void from the previous core is filled with a plug (lower right) and mortar while the current core is being taken. Photo taken at Site 1, US-23 SB.

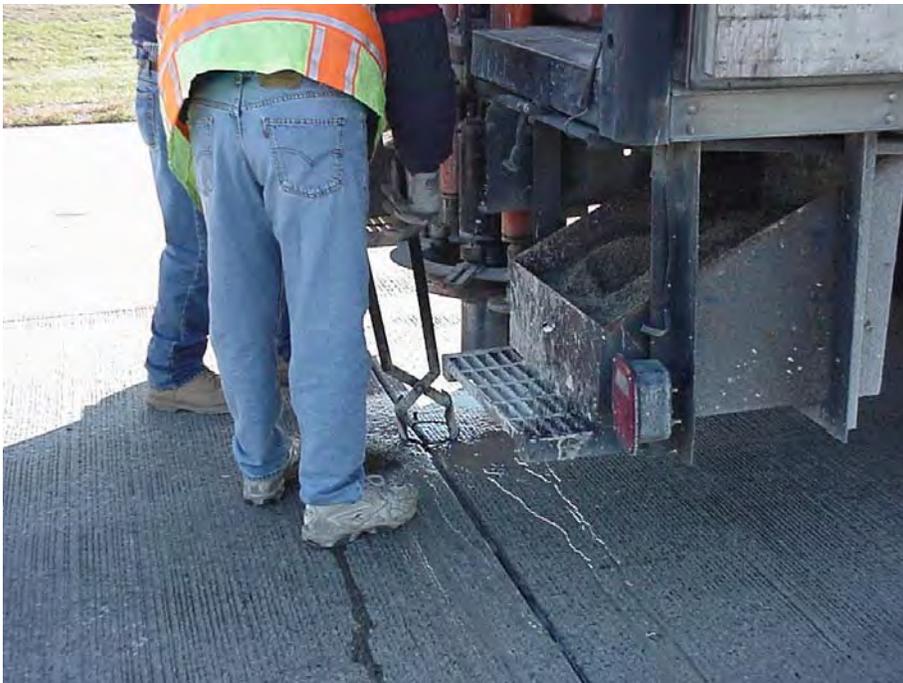
Lower drilling unit used to core the pavement slabs at Site 2, US 23 SB.

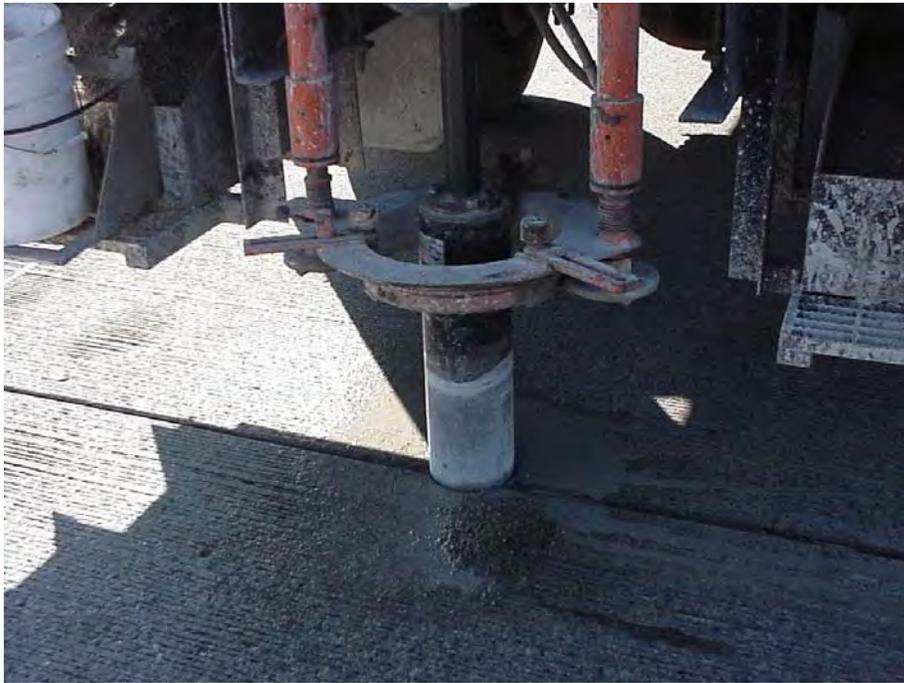
A six-inch joint core is extracted after being drilled. Photo taken at Site 2, US-23 SB.

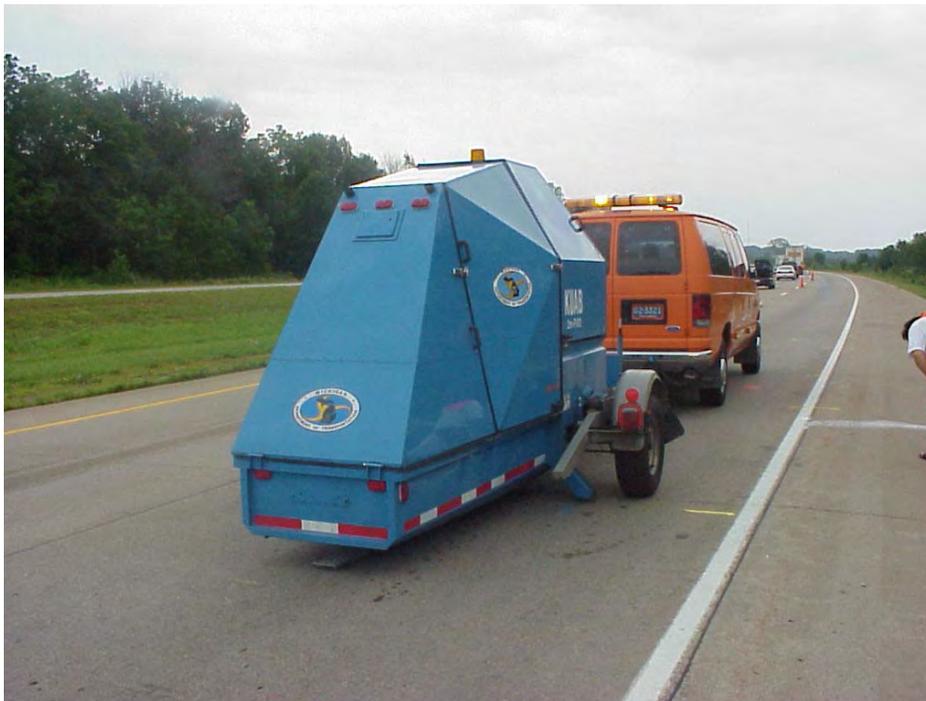
FWD Testing Machine from MDOT. Photo taken at Site 4A, US-23 SB.

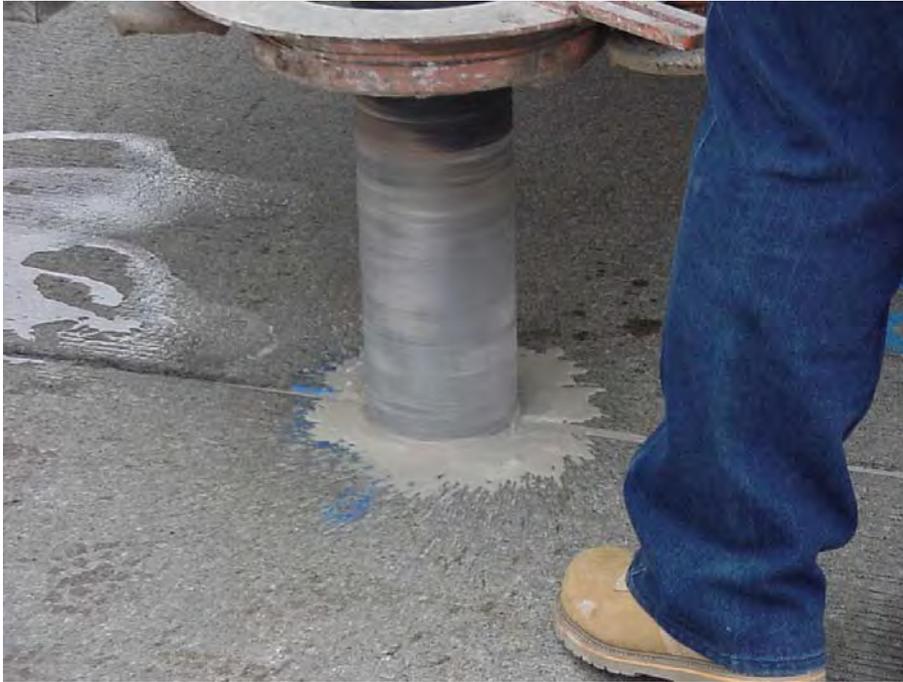
Site 0: US-23 Southbound, Section A of MDOT Aggregate Study.  
Lower Unit of coring apparatus used to take six-inch core from pavement joint.

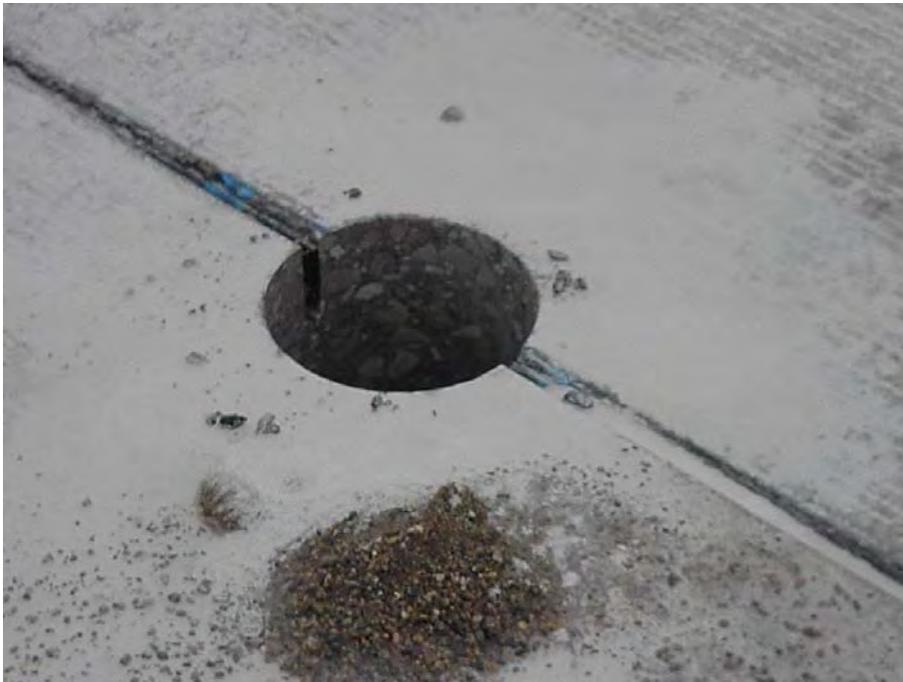
Site 0: US-23 Southbound, Section A of MDOT Aggregate Study.  
Void left from extraction of six-inch core from the pavement joint.

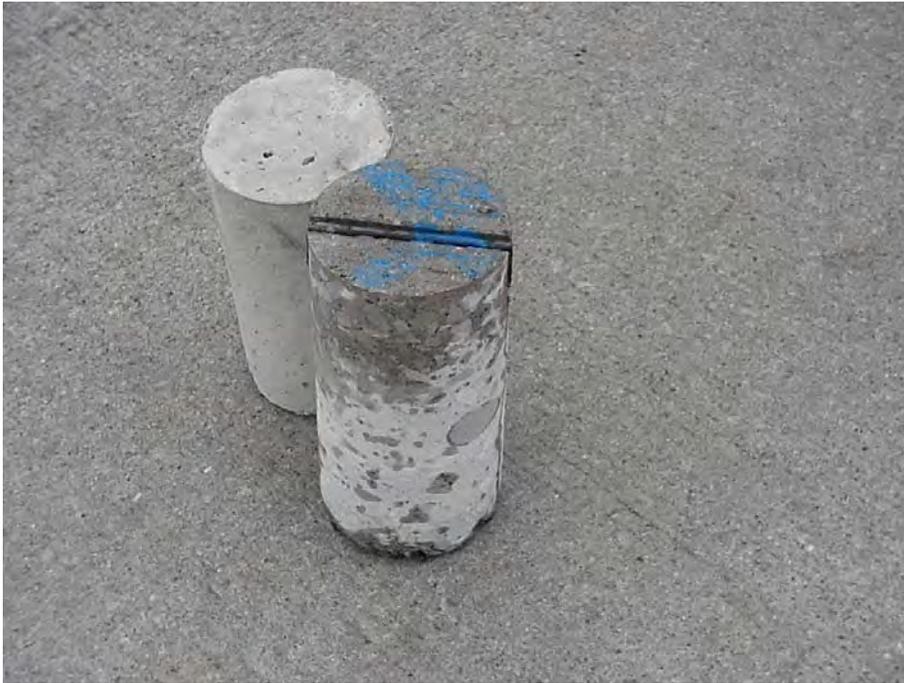
Site 0: US-23 SB, Section A of MDOT Aggregate Study. Six-inch core extracted from pavement joint. Petrographic analysis will be done on the six-inch core.

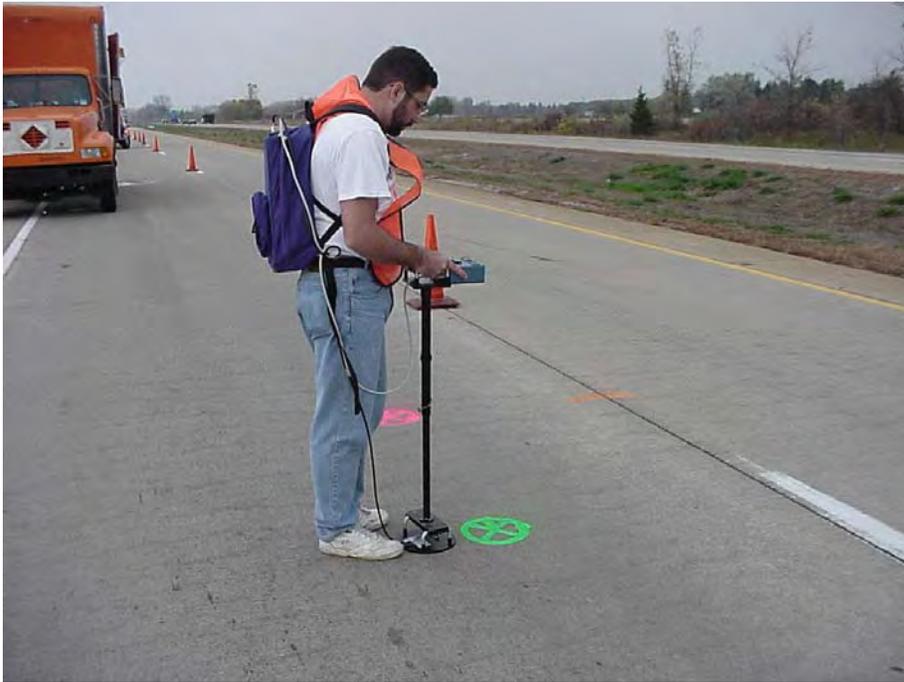
Site 0: US-23 SB, Section A of MDOT Aggregate Study.  
Permeability testing using the air permeability field apparatus.

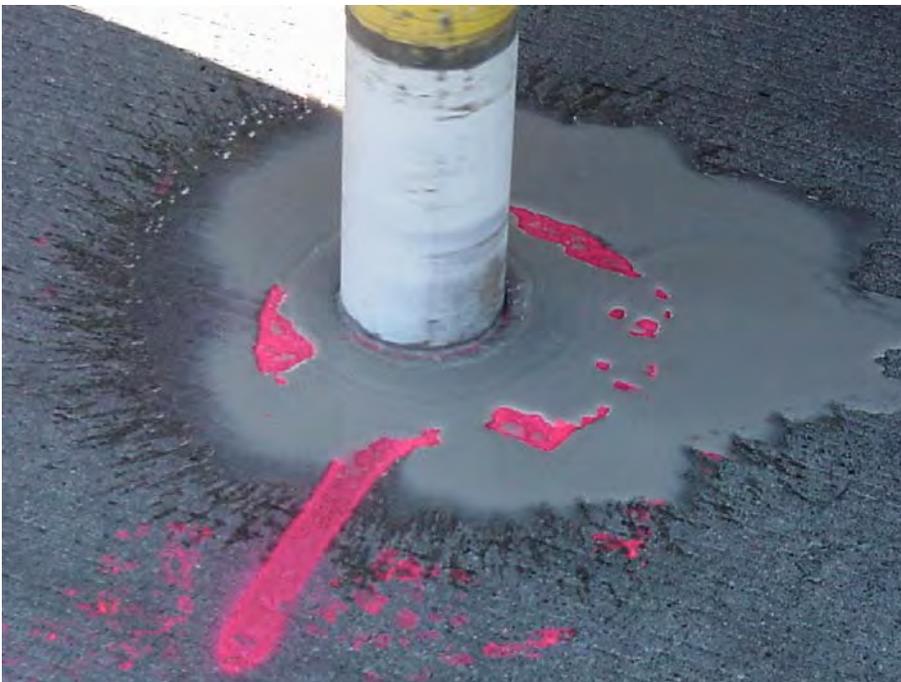
Site 0: US-23 SB, Section A of MDOT Aggregate Study.  
Coring process for the four-inch core used for permeability and linear traverse testing.

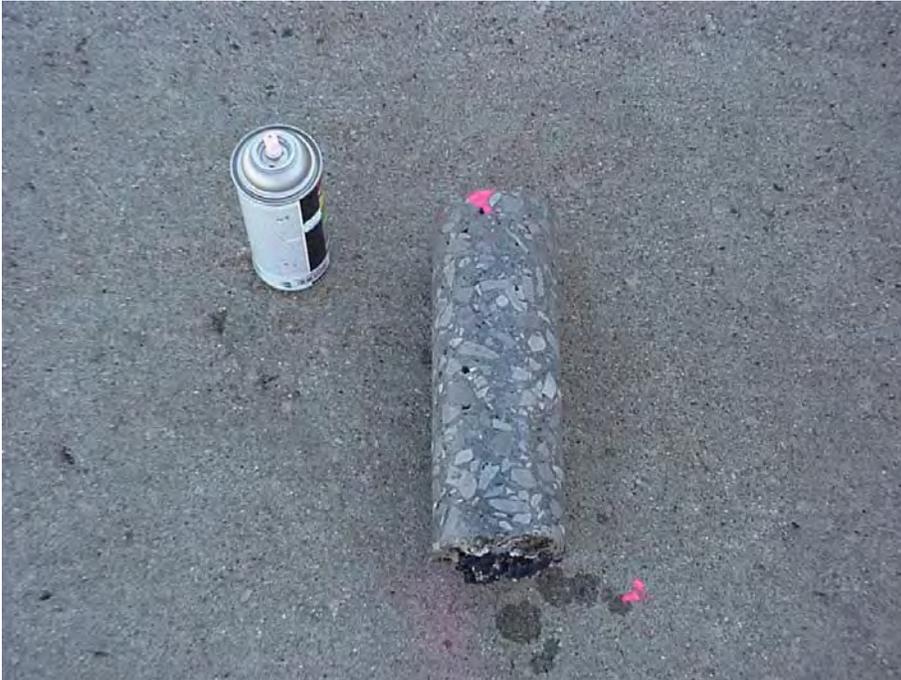
Site 0: US-23 SB, Section A of MDOT Aggregate Study.  
Four-inch core used for permeability and linear traverse testing.

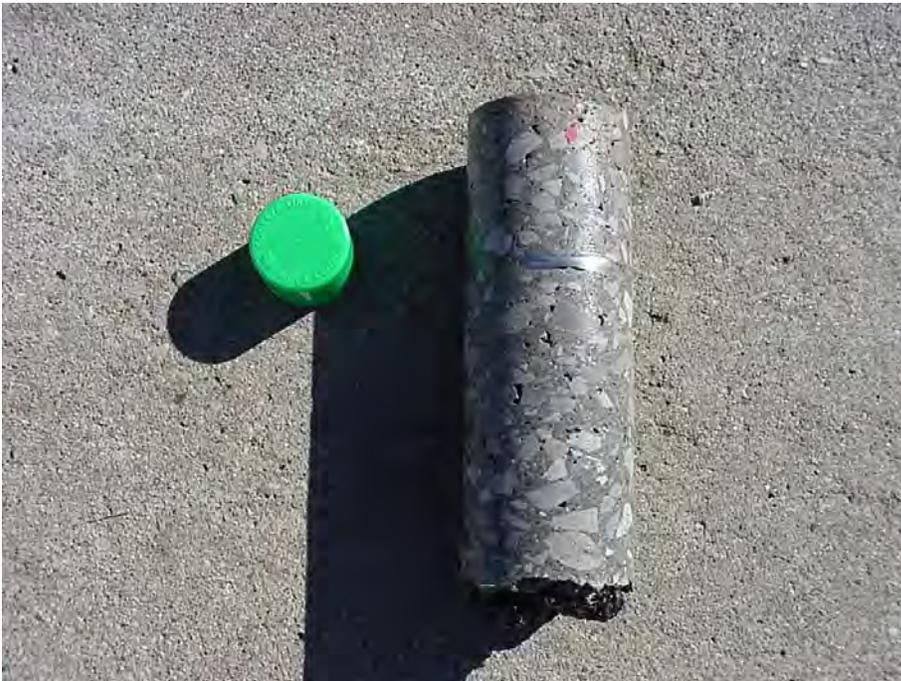
Site 0: US-23 SB, Section A of MDOT Aggregate Study. Four-inch core used for compressive strength testing. Note the reinforcing steel in the upper portion of the core.

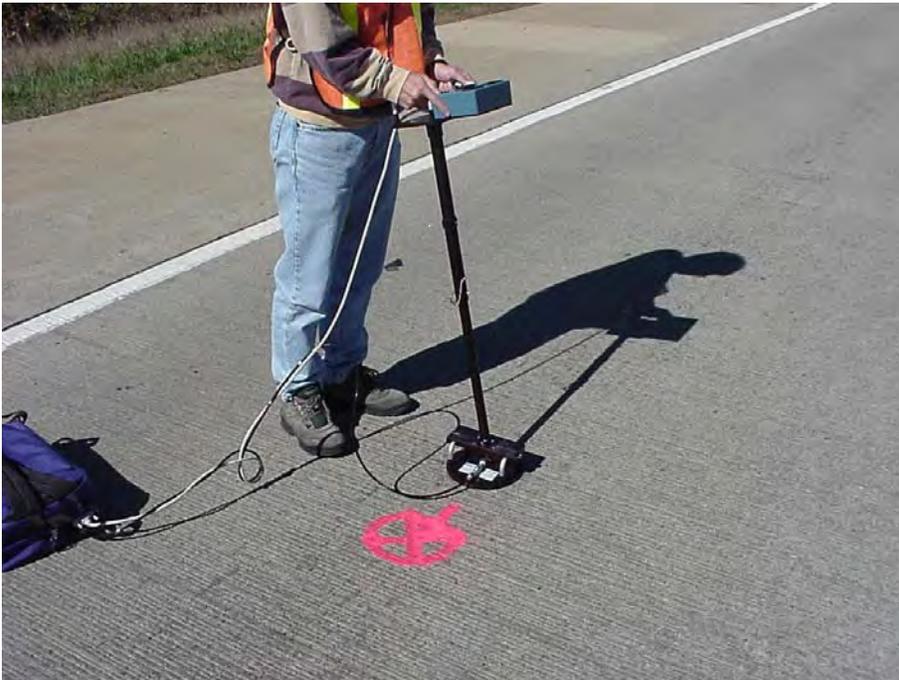
Site 1: US-23 SB, Section B of MDOT Aggregate Study.  
Permeability testing using the air permeability field apparatus.

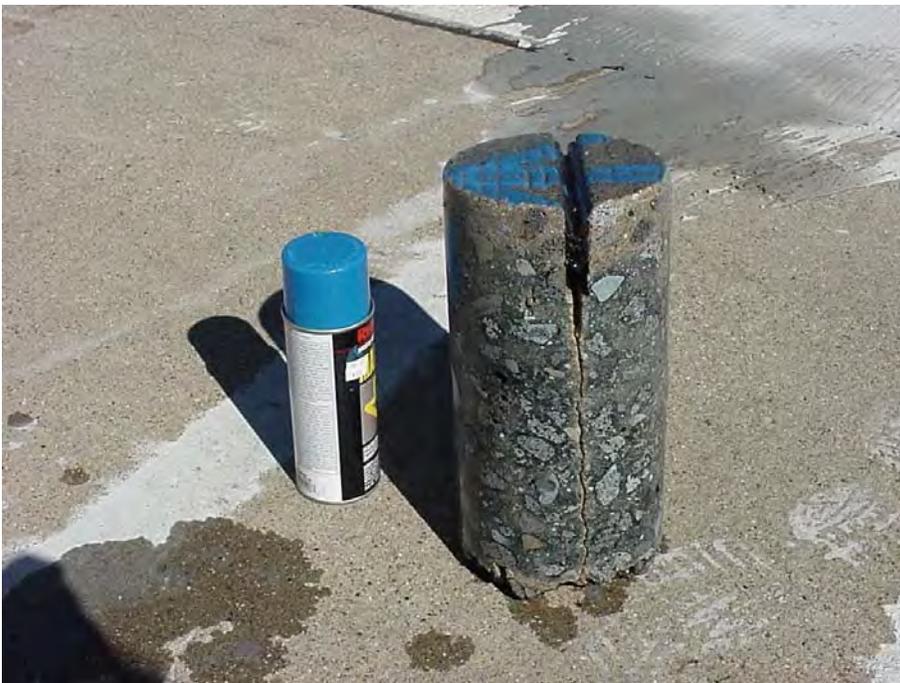
Site 1: US-23 SB, Section B of MDOT Aggregate Study. Six-inch core extracted from pavement joint. Petrographic analysis will be done on the six-inch core.

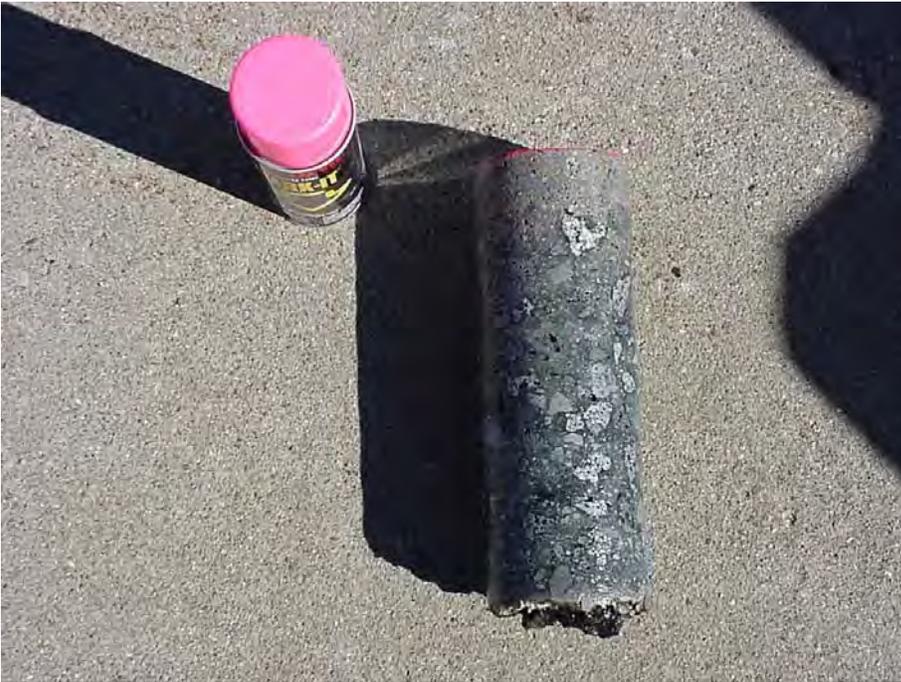
Site 1: US-23 SB, Section B of MDOT Aggregate Study.  
Four-inch core used for permeability and linear traverse testing.

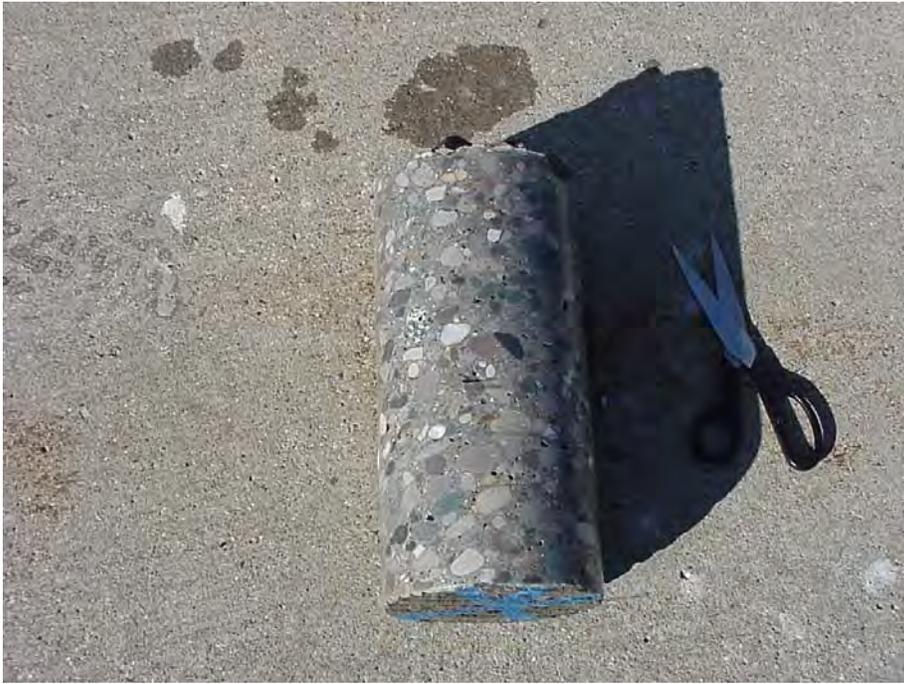
Site 2: US-23 SB, Section C of MDOT Aggregate Study. Six-inch core extracted from pavement joint. Petrographic analysis will be done on the six-inch core.

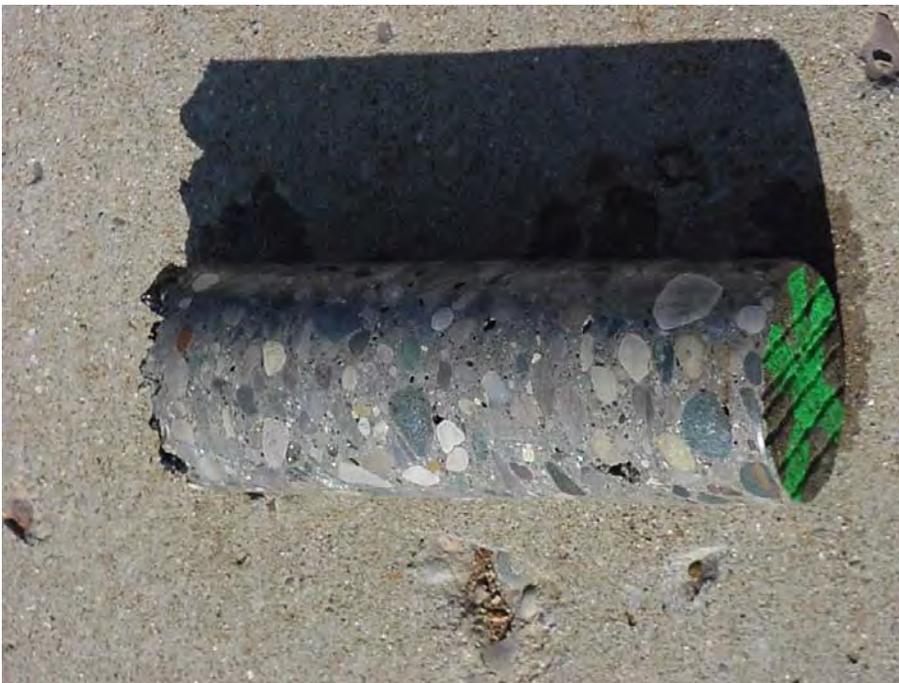
Site 2: US-23 SB, Section C of MDOT Aggregate Study. Four-inch core used for permeability and linear traverse testing.

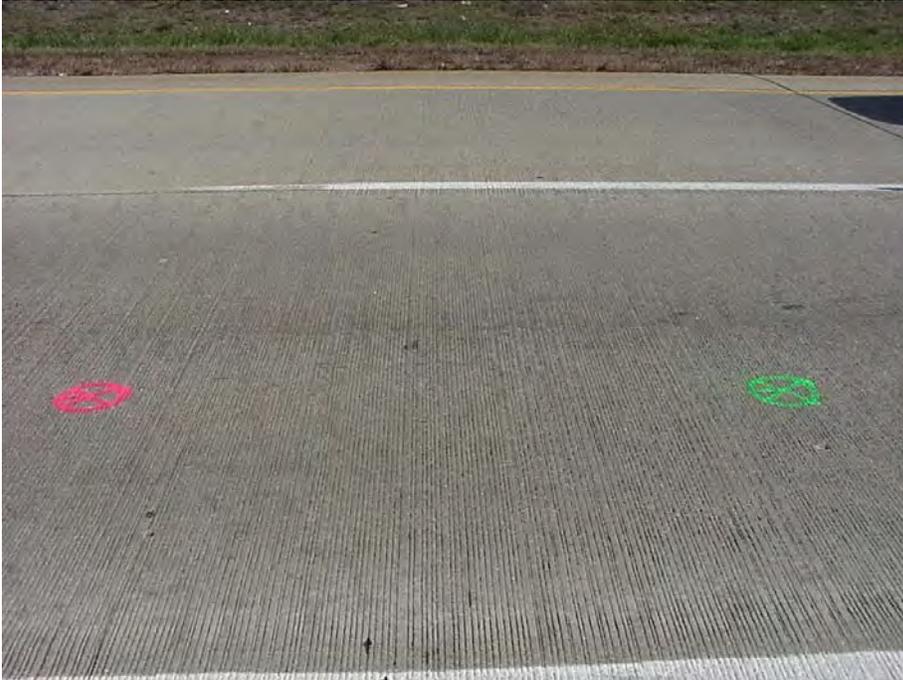
Site 3: US-23 SB, Section D of MDOT Aggregate Study. Surface of traveling lane showing the position of the cores taken to test compressive strength (green), permeability, and air void spacing (pink).
