APPENDIX B: TEST SITE INSPECTION DATA

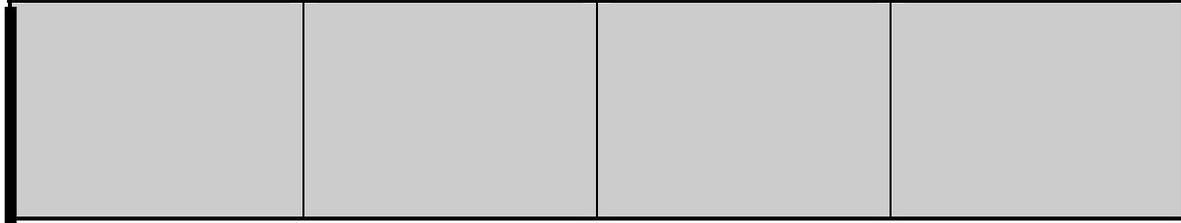
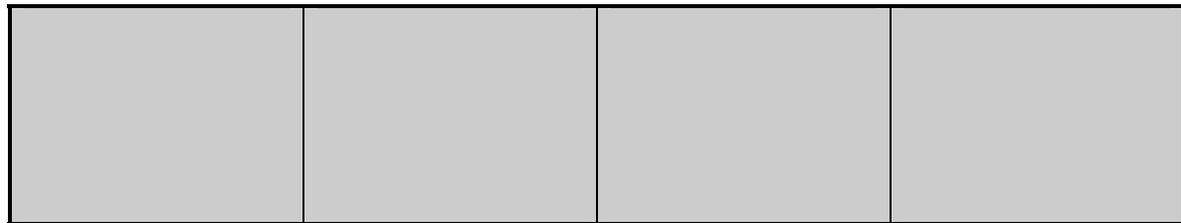
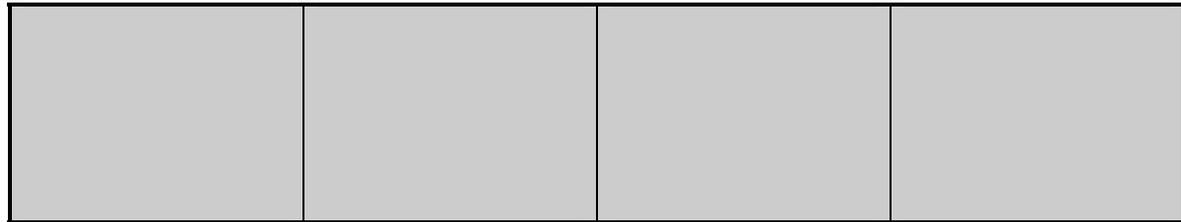
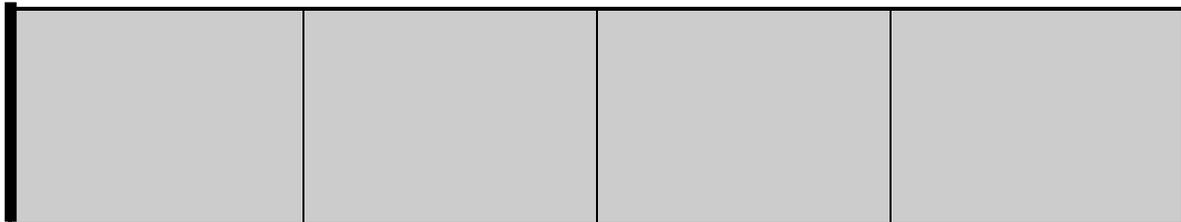
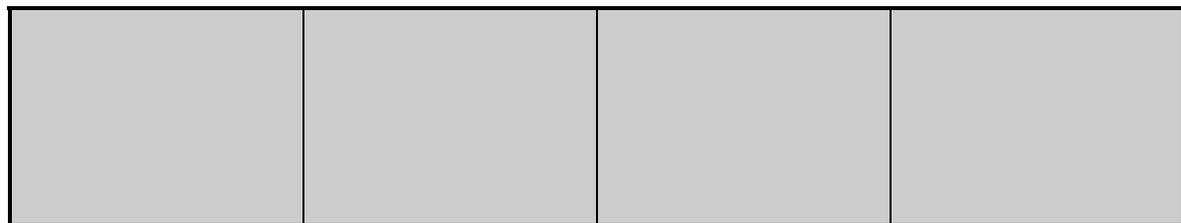
COMMENTS: Lane-shoulder dropoff; polished agg in wheelpath; popouts; lane-lane faulting; tar and chip repair throughout the entire site (especially near longitudinal joint); natural gravel pavement

COMMENTS: General comments apply; Chip and seal repairs extensive along longitudinal joint; Polished agg (severe) in wheelpath; Popouts: ~ 2.5 per m²

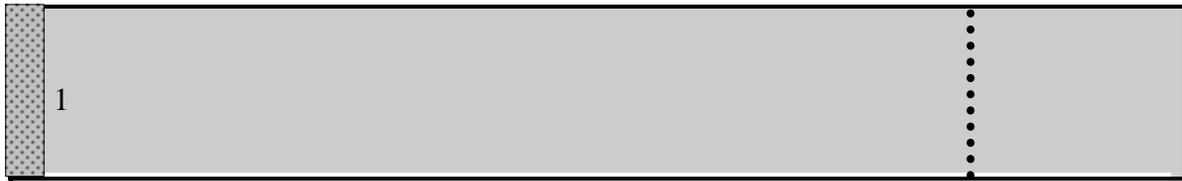
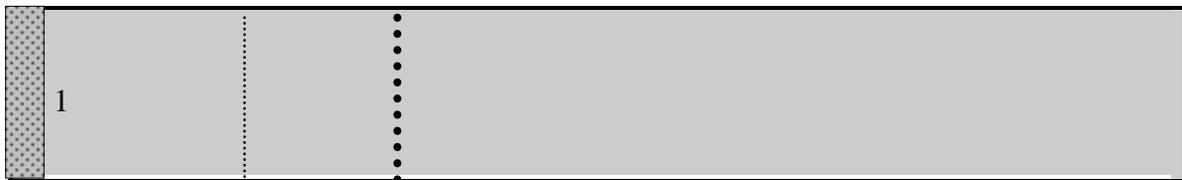
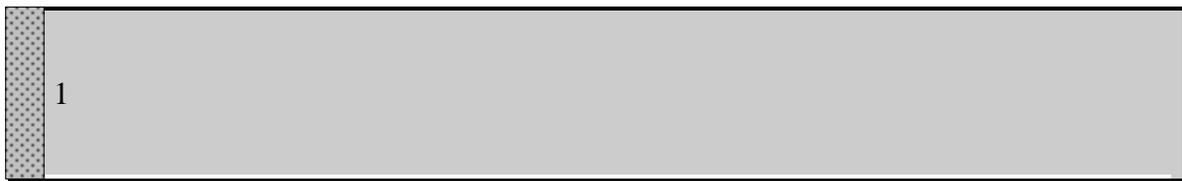
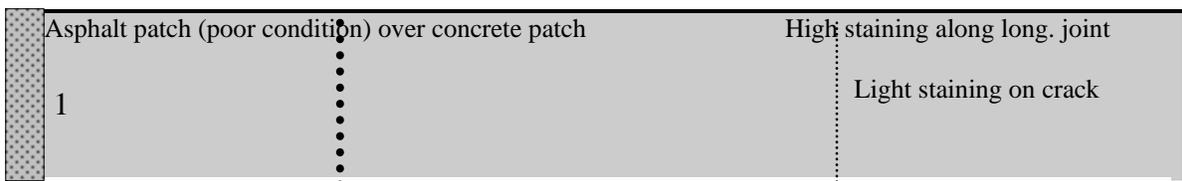
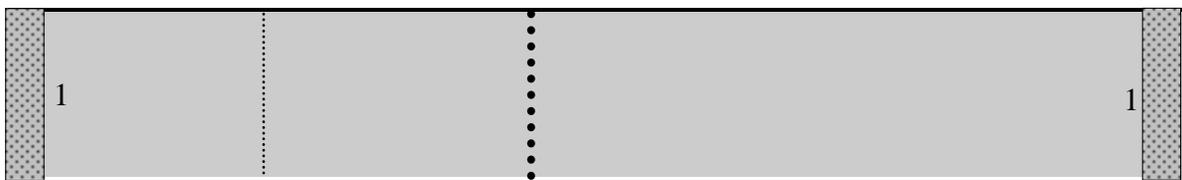
COMMENTS: Longitudinal joint is completely spalled and asphalt repaired in many spots; high steel in a few areas; large amount of polished aggregate; many popouts throughout site; large amount of small, tight cracks (possibly old shrinkage cracks)

COMMENTS: Shrinkage-like cracking which is very tough to see, predominantly transverse; Polished agg (severe) in wheelpath; Popouts: ~ 2-3 per m²

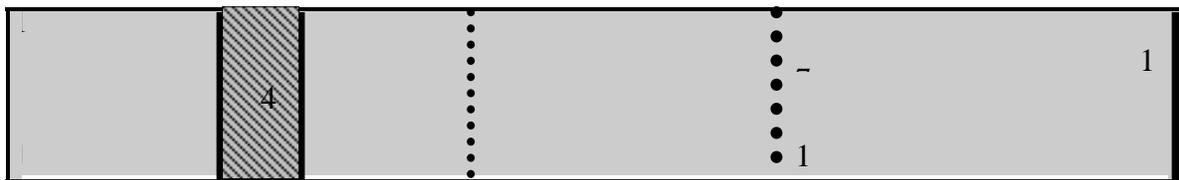
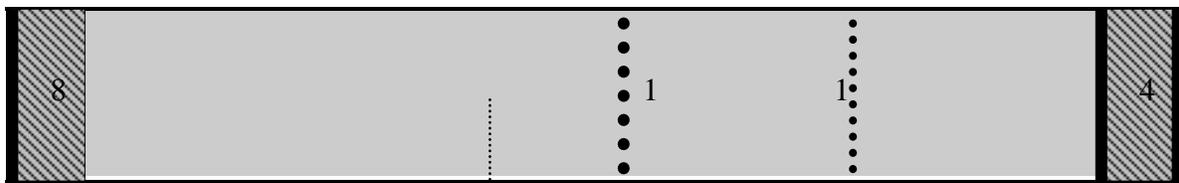
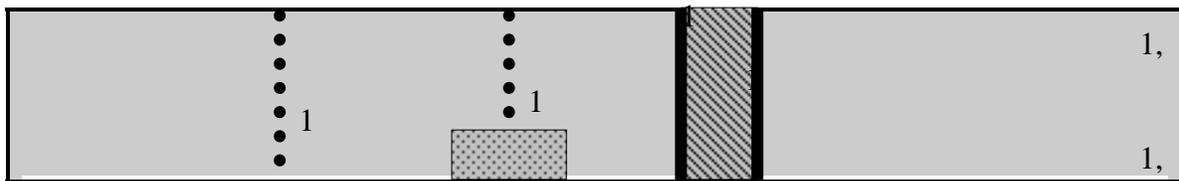
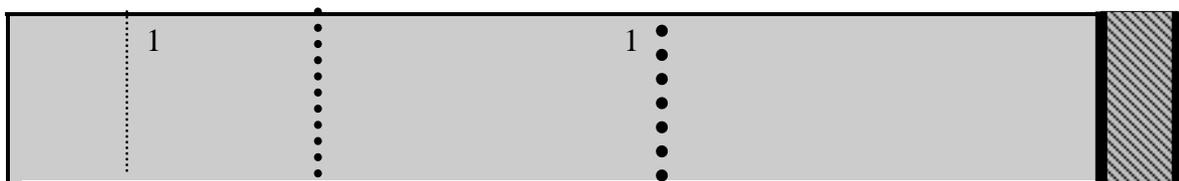
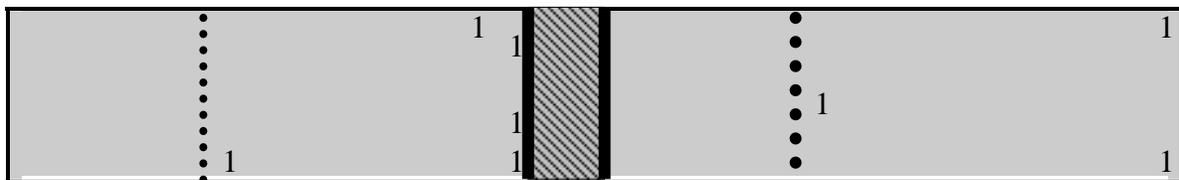
COMMENTS: Polished agg and tiny cracks (possibly old shrinkage cracking) throughout site

COMMENTS: Shrinkage-like cracking which is very tough to see, predominantly transverse; Popouts: ~ 3 per m²

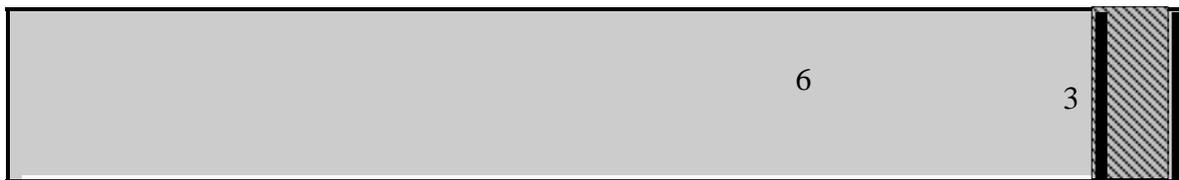
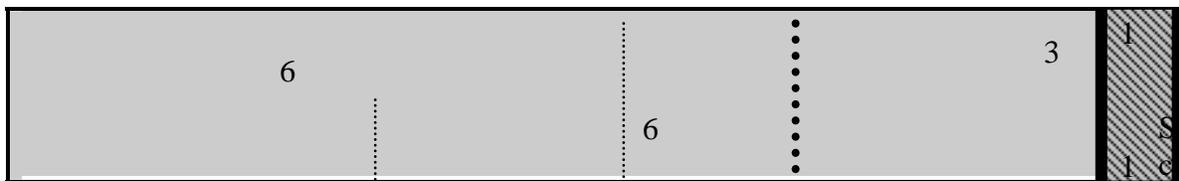
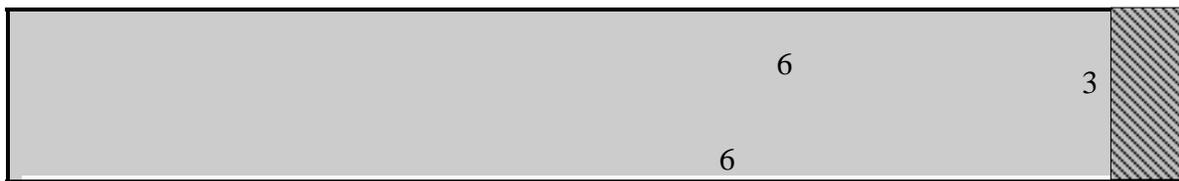
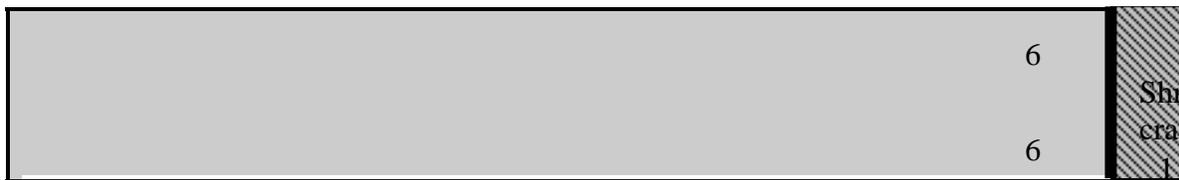
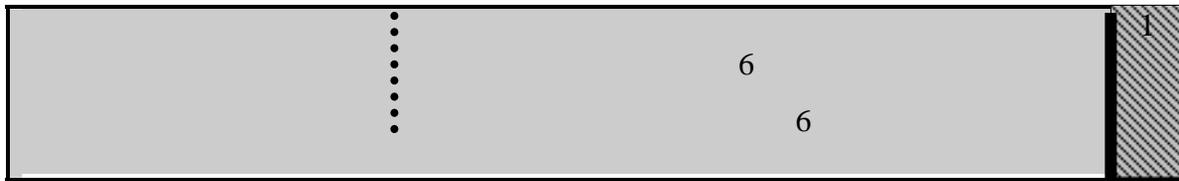
COMMENTS: Entire site is diamond ground, shrinkage cracking throughout site (tough to see due to surface texture after grinding)

COMMENTS: Shrinkage-like cracking throughout slab; Popouts: ~ 1.5 per m² - could be due to diamond grinding; joint before patch is completely missing sealant.

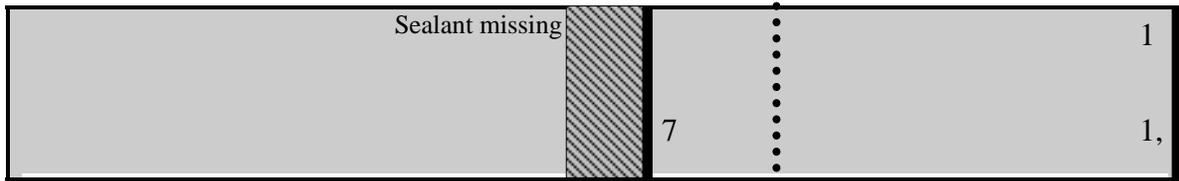
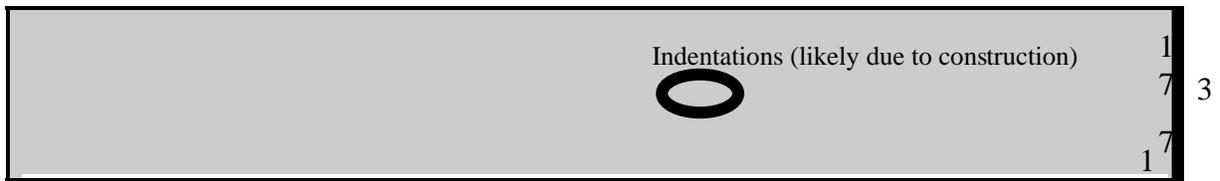
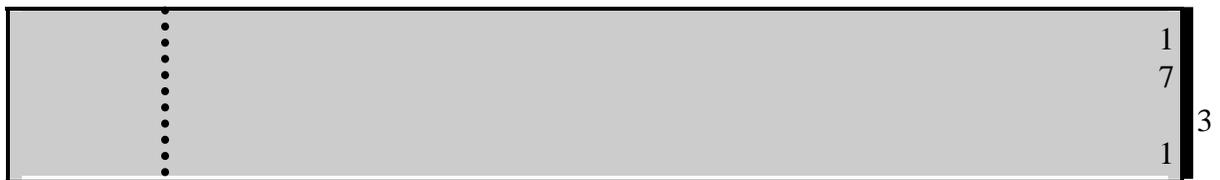
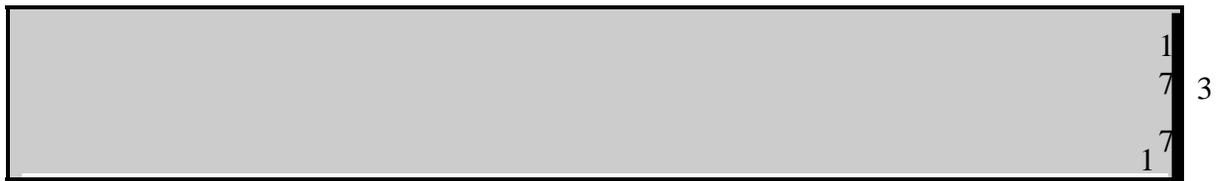
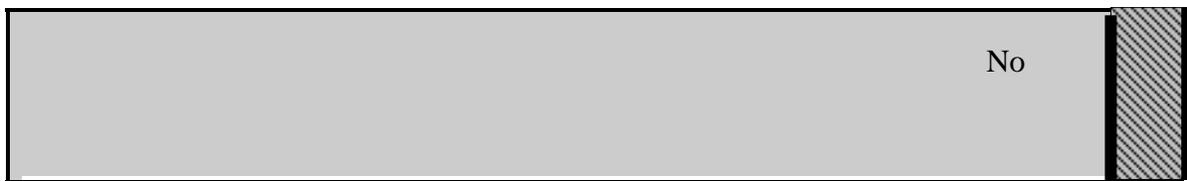
COMMENTS: Large amount of shrinkage cracking and polished agg throughout site

COMMENTS: Shrinkage-like cracking throughout slab; Popouts: ~ 0.5 per m²; Polished agg in wheelpath
