# **APPENDIX A**

## **JACK PARKER'S INTERIM REPORT DECEMBER, 2002**

1. PURPOSE OF THIS REPORT: This is a response to a request by Michigan Dept of Transportation to evaluate the effects that an old gypsum mine beneath I-196 might have on the stability of that highway - in both near and long terms.

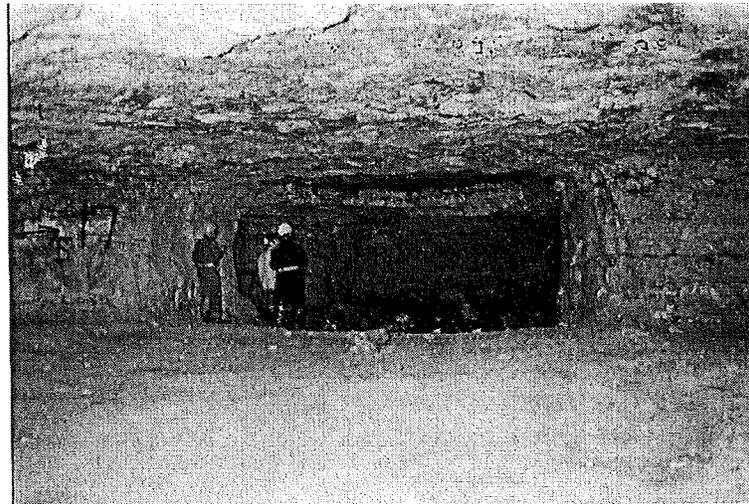
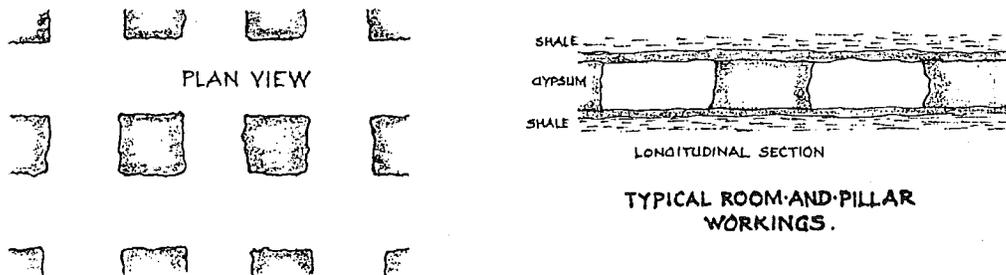
Figure 1. Photograph and illustration of room and pillar workings of the number 2 seam.

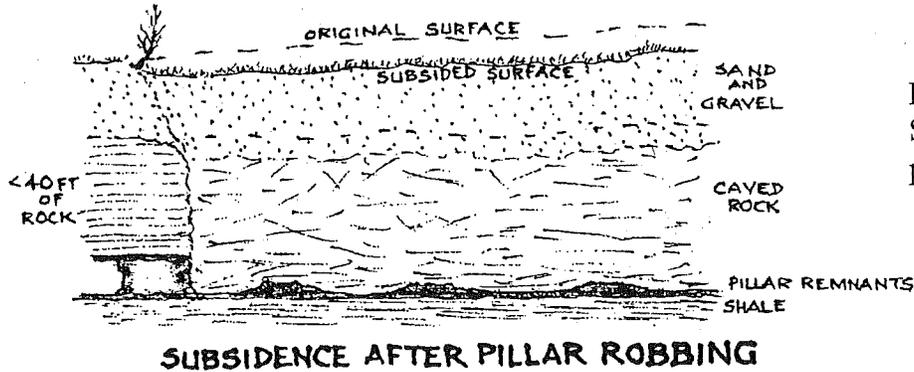
If most of it is rock and the thickness is not great (say 40 ft or less) subsidence may be as much as 70% of mined height - 7 or 8 feet.

Figure 2.  
Subsidence after pillar removal.

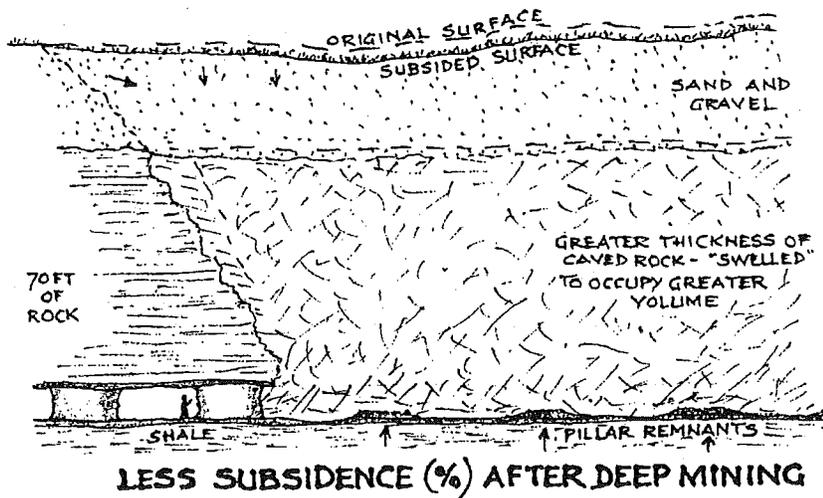
If most of it is rock but it is thicker - the rock will "swell", i.e., fall in a jumbled state, taking up more space - then the amount of subsidence will be less, say 40%, or 4 ft.

Figure 3. Less subsidence after pillar removal.

Adjacent to these falls some rock and much of the adjacent soil, sand and gravel will slump sideways into the subsidence basin, as shown in the above sketches. Thus there will be some subsidence beyond the limits of the underground collapse.

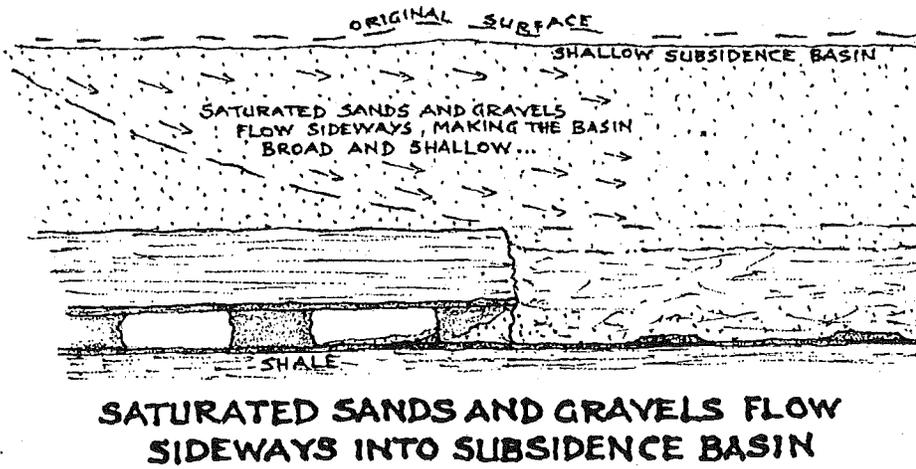
Thick sand and gravel will flow, or slump, especially when wet, so the basin may be broad and the limits may be indistinct.

Figure 4. Subsidence with material flowing into openings.

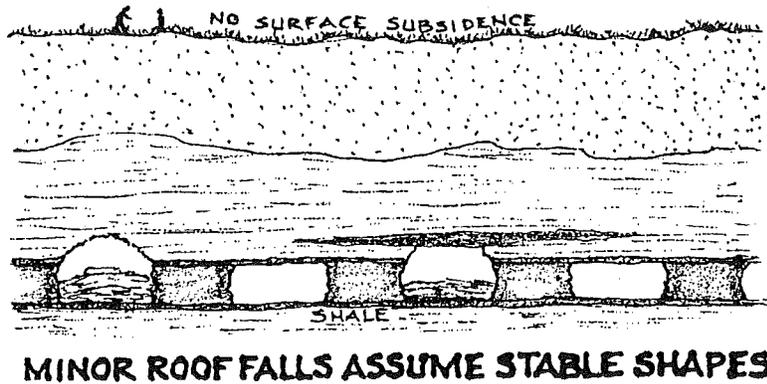
A small failure at shallow depth, say an intersection of two mine openings, may develop a natural arch or may go up to a stable roof horizon (such as the #1 gypsum above #2).

Figure 5. Minor roof falls assume stable conditions.

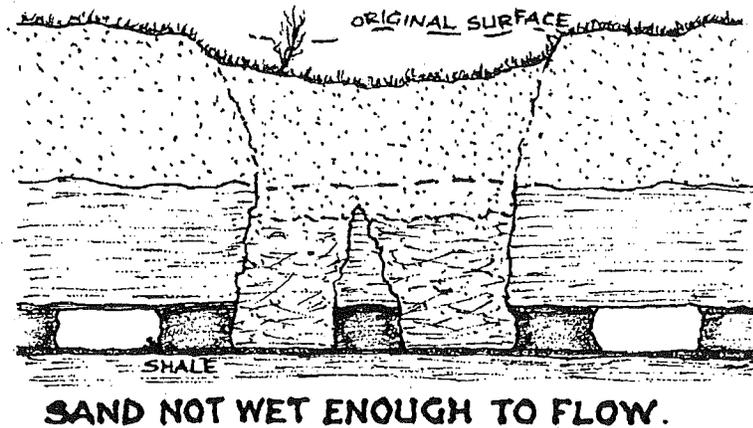
Several such failures may coalesce and go on up to top of bedrock, the base of sand and gravel. The fallen rock will partly fill the void but sand and gravel may fall in too, creating a well-defined "sinkhole" at surface.

Figure 6. Roof collapse without material flow.

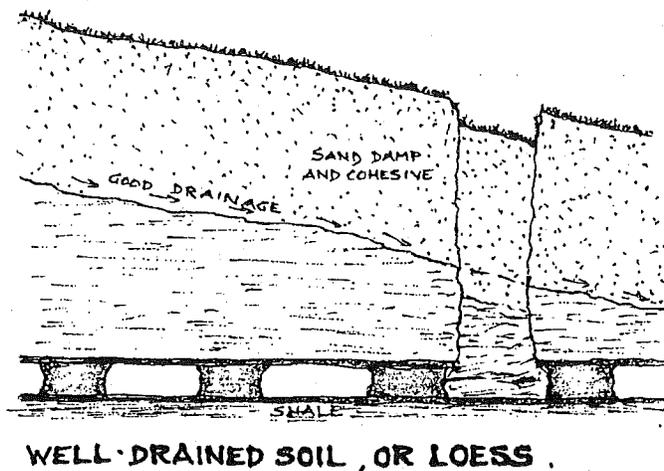
In loess soils and sands which is damp and cohesive, the sinkhole may have steep sides, like a chimney, whereas if it is saturated with water it may flow into the mine like liquid mud, and spread over wide areas, leaving a wide, shallow basin at surface.

Figure 7. Development of well-defined sinkhole.
