APPENDIX D

Selected Site Photos

It is recognized that a visual record of a pavement section's condition is invaluable. Thus, this appendix is included to provide a brief overview of each test section. The photos presented for each test section include a site overview, photos of typical distresses in the section, and highlights of notable features on the site, such as clogged edge drain outlets.

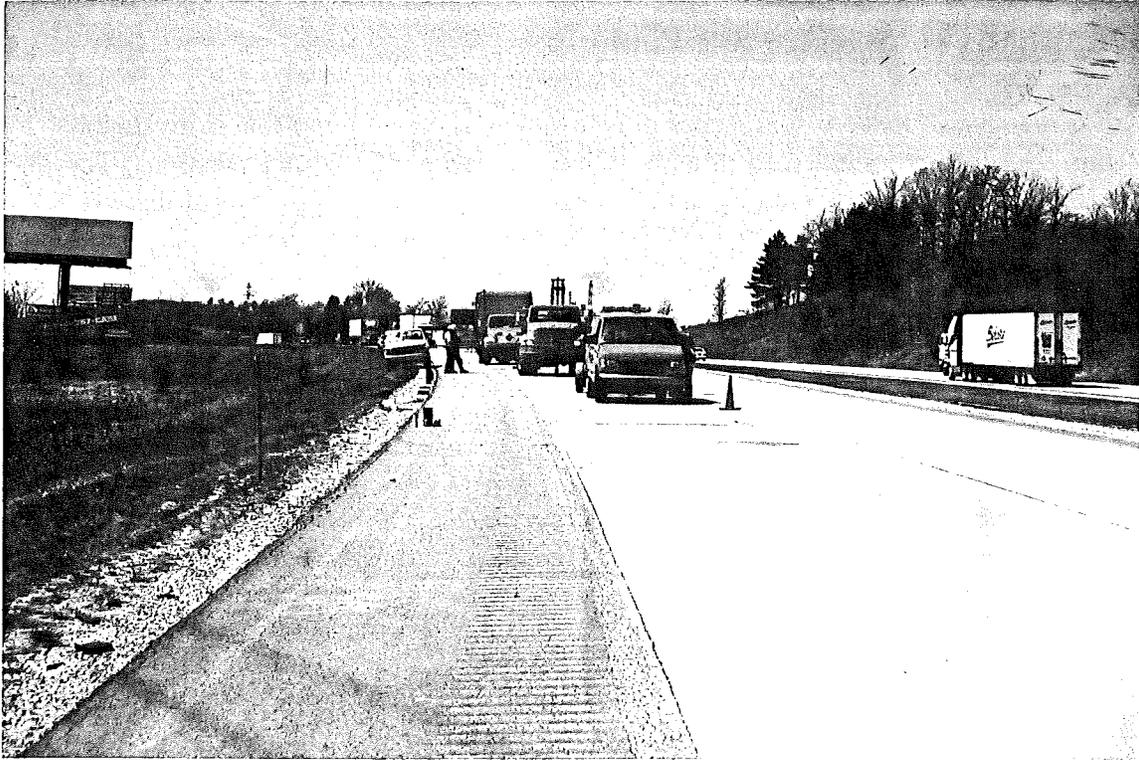
Photo C1. An overview of CSN# 11017-32516A (Section A), EB looking west. The 14 ft widened truck lane design and asphalt shoulder can be seen.

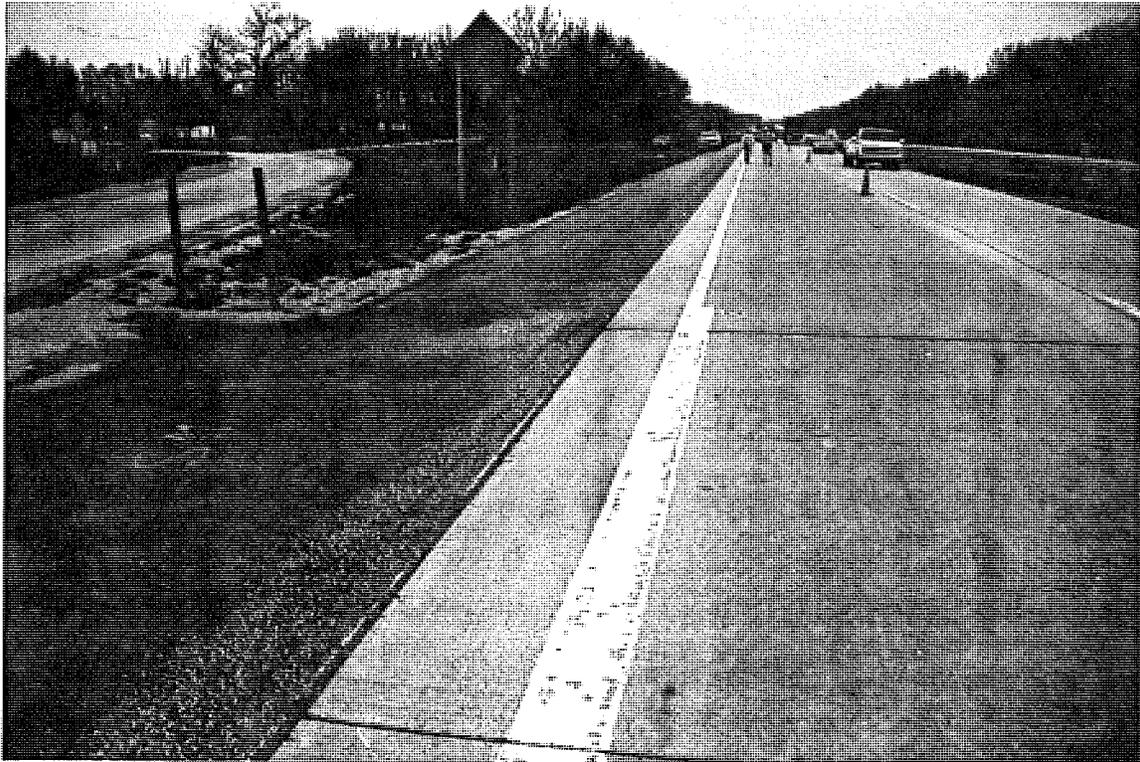
Photo C5. An overview looking west on CSN# 11017-32516A (Section C), EB. This section has a 14 ft widened truck lane and an asphalt shoulder. Transverse joint spacing varies from 15 to 17 ft.

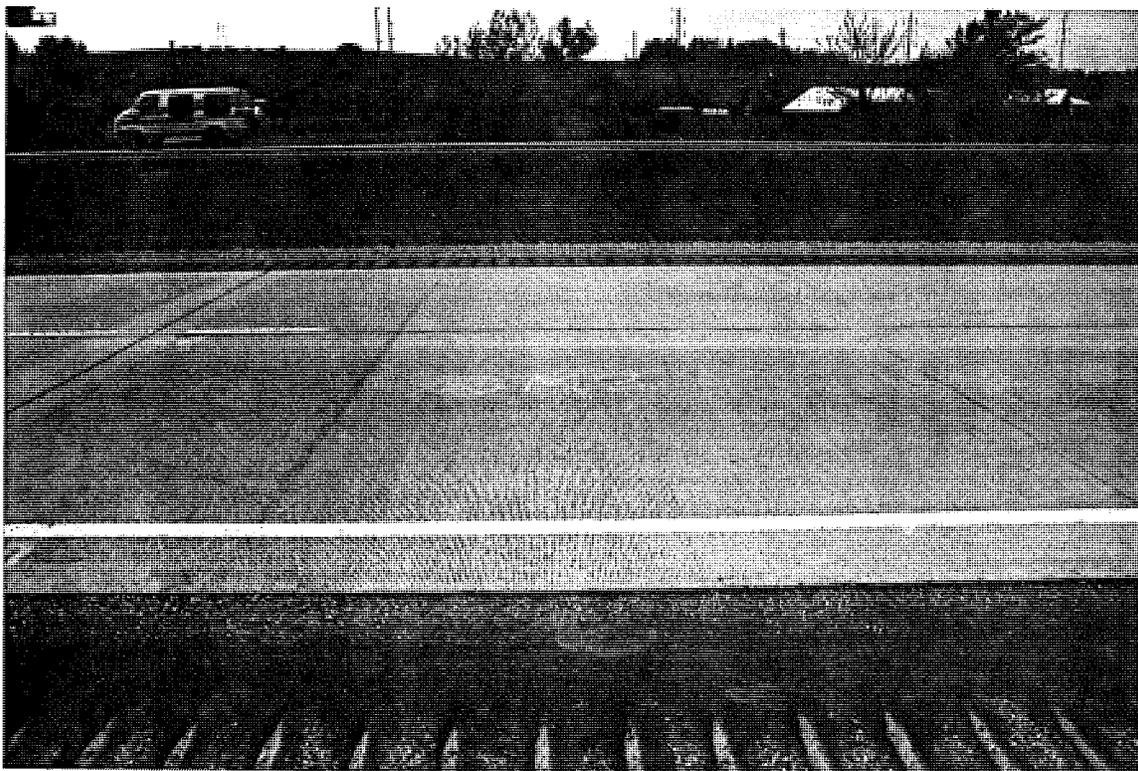
Photo C10. A view of a typical uncracked slab in CSN# 11017-32516A (Section D) WB. This section has 15 ft joint spacing, 14 ft widened truck lane, and asphalt shoulders.

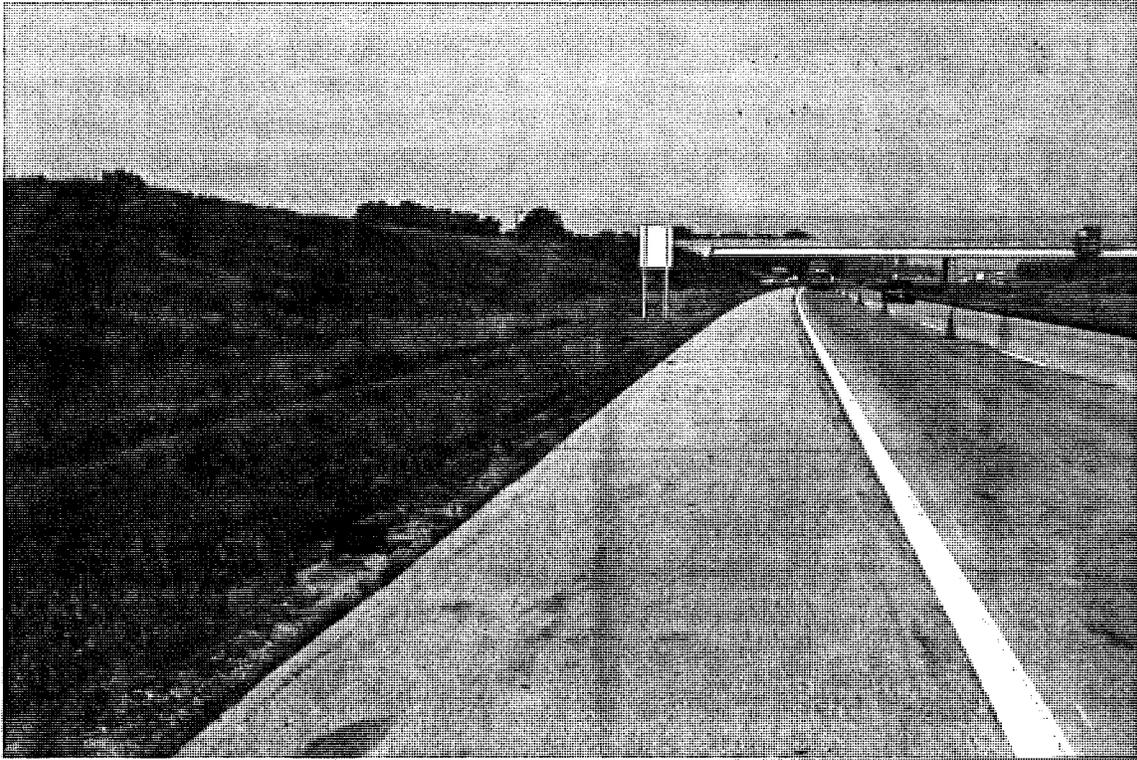
Photo C13. An overview of CSN# 19042-24680A (Section B) EB looking west. This section has 41 ft slabs and concrete shoulders with no intermediate joints.

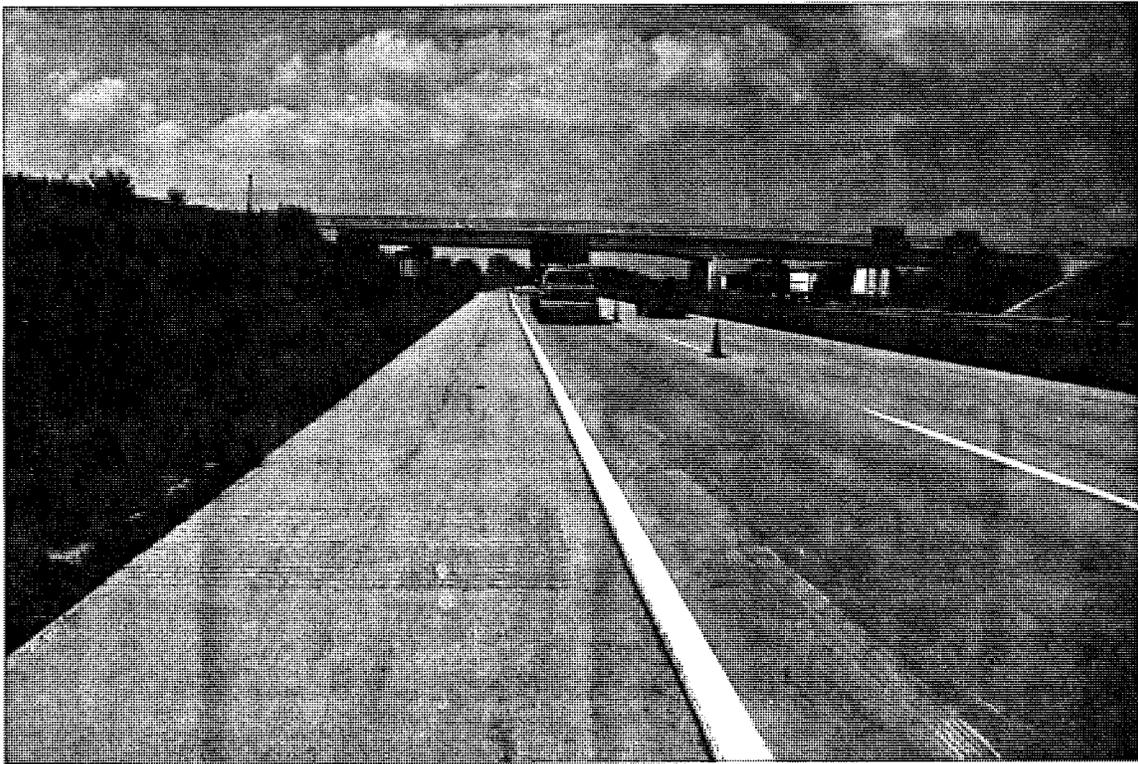
Photo C17. A overview looking west on CSN# 19042-02233A (Section C) EB. Slabs are 41 ft long. The concrete shoulder slabs have the same length.

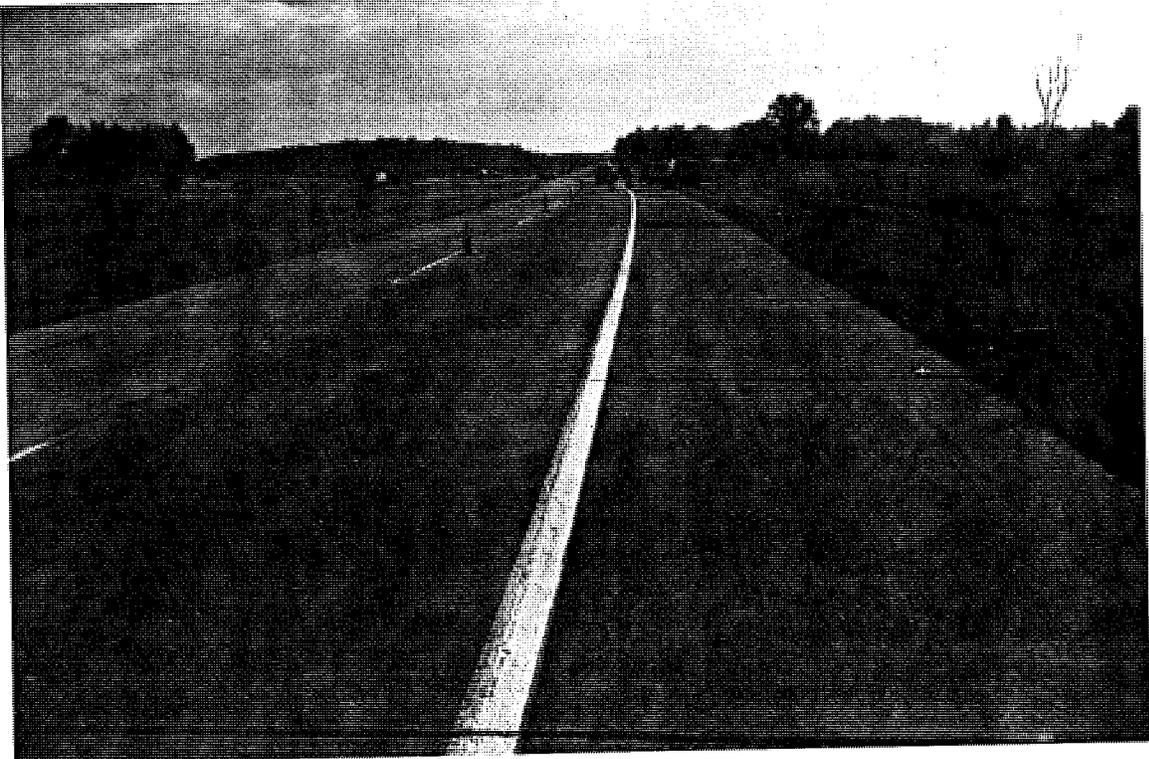
Photo C21. An overview looking east along CSN# 19043-02234A, EB, showing the third point intermediate shoulder joints. The slabs in the driving lanes are 41 ft long.

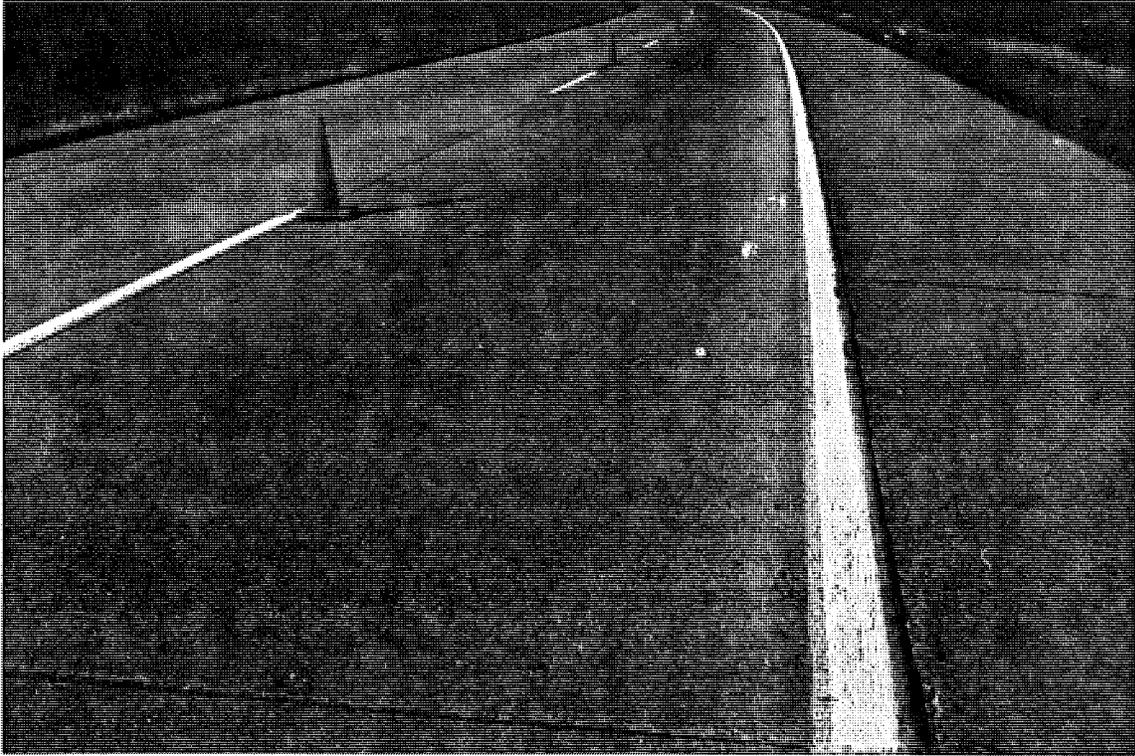
Photo C25. An overview of the end of the test section of CSN# 19043-02234A WB, looking west. This section has 41 ft joint spacings in the driving lanes, but only 14 ft joint spacing in the shoulders.

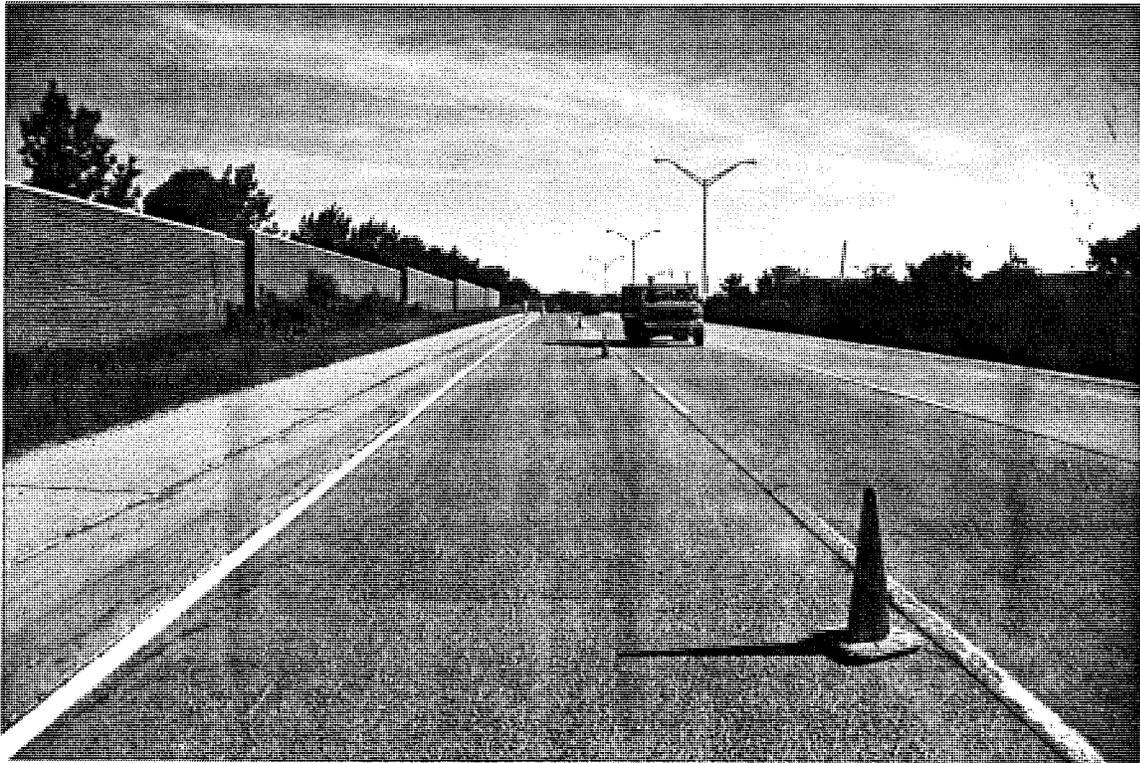
Photo C29. An overview looking north on CSN# 25132-06582A SB. This photo shows the 3 lanes of traffic and the third point intermediate shoulder joints. The slab length is 44 ft in the driving lanes.

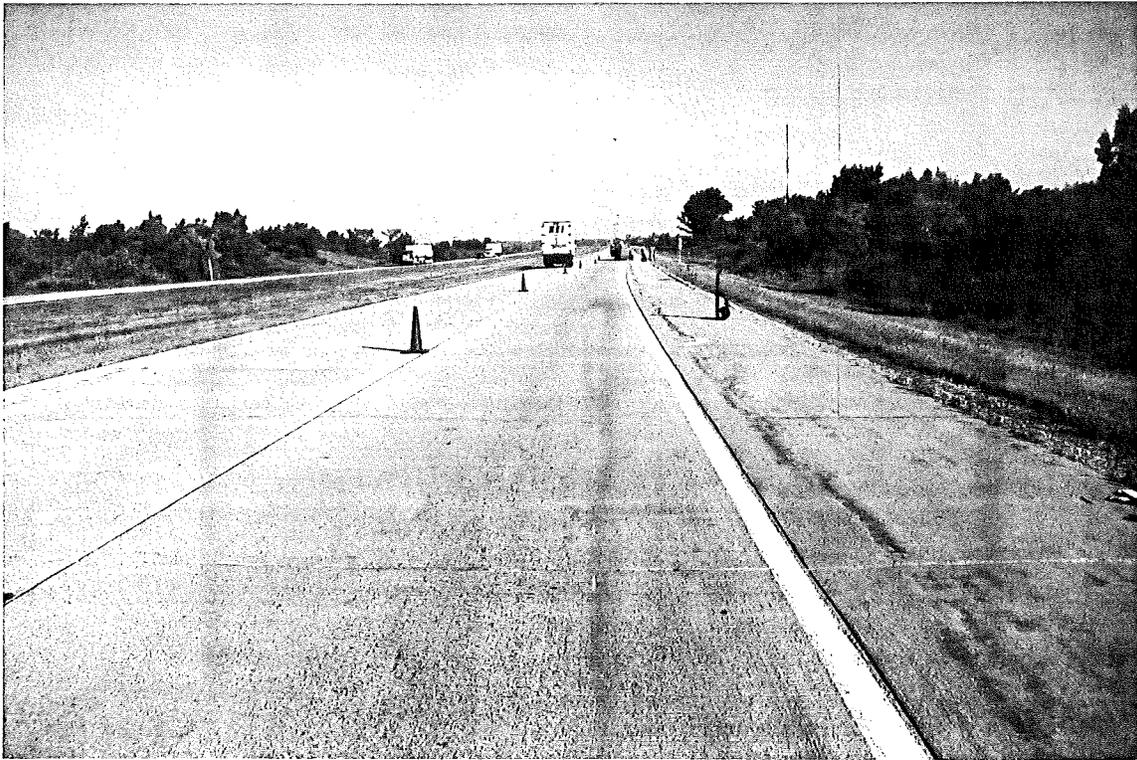
Photo C33. An overview looking west on CSN# 44044-18804 WB, showing the intermediate shoulder joints. Slabs in the driving lanes are 41 ft long. Swamp vegetation in the ditches can be seen on the right side of the photo.

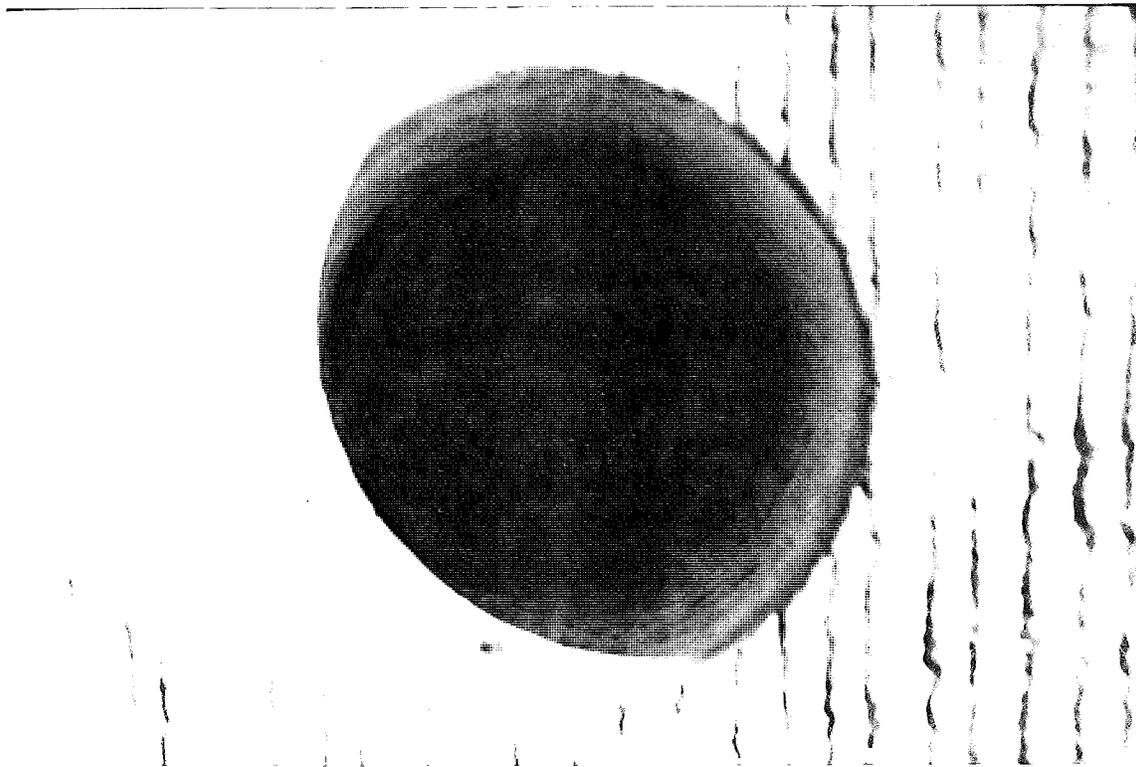
Photo C36. A close-up of a corehole on CSN# 44044-18804A WB, showing the OGDC base course.

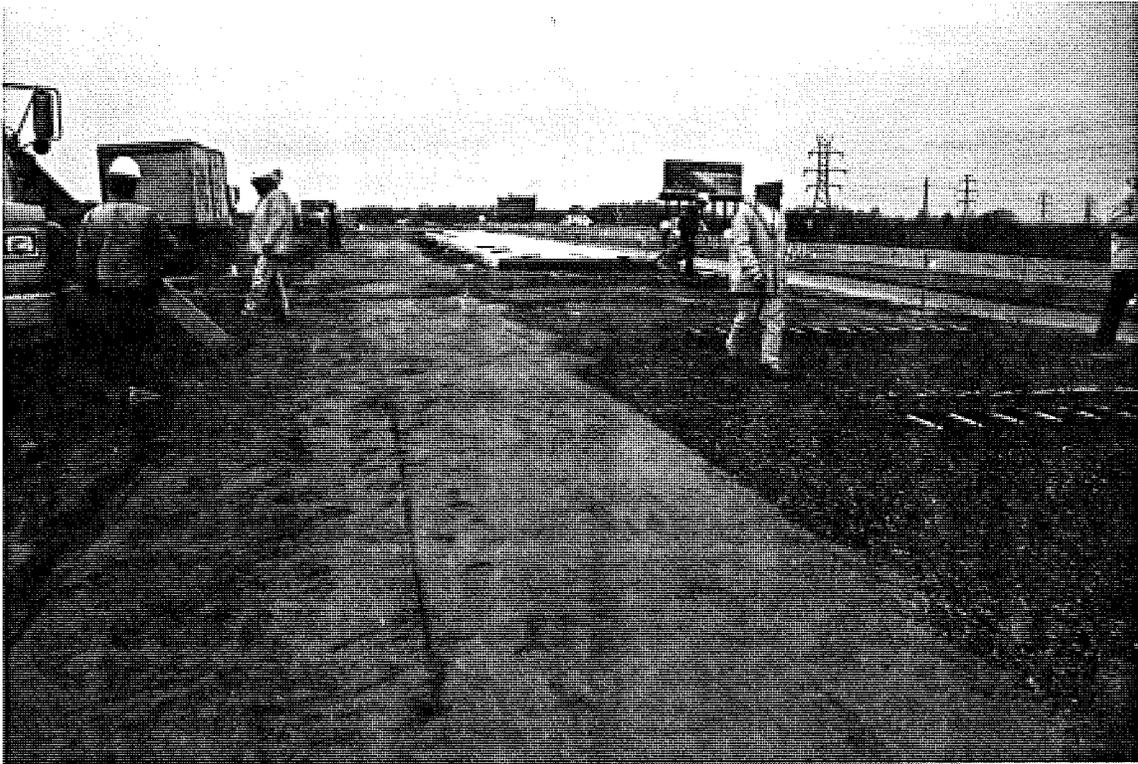
Photo C37. An overview of CSN# 47065-28215A WB looking west, just prior to paving. The open graded drainage course and dowel cages are visible.

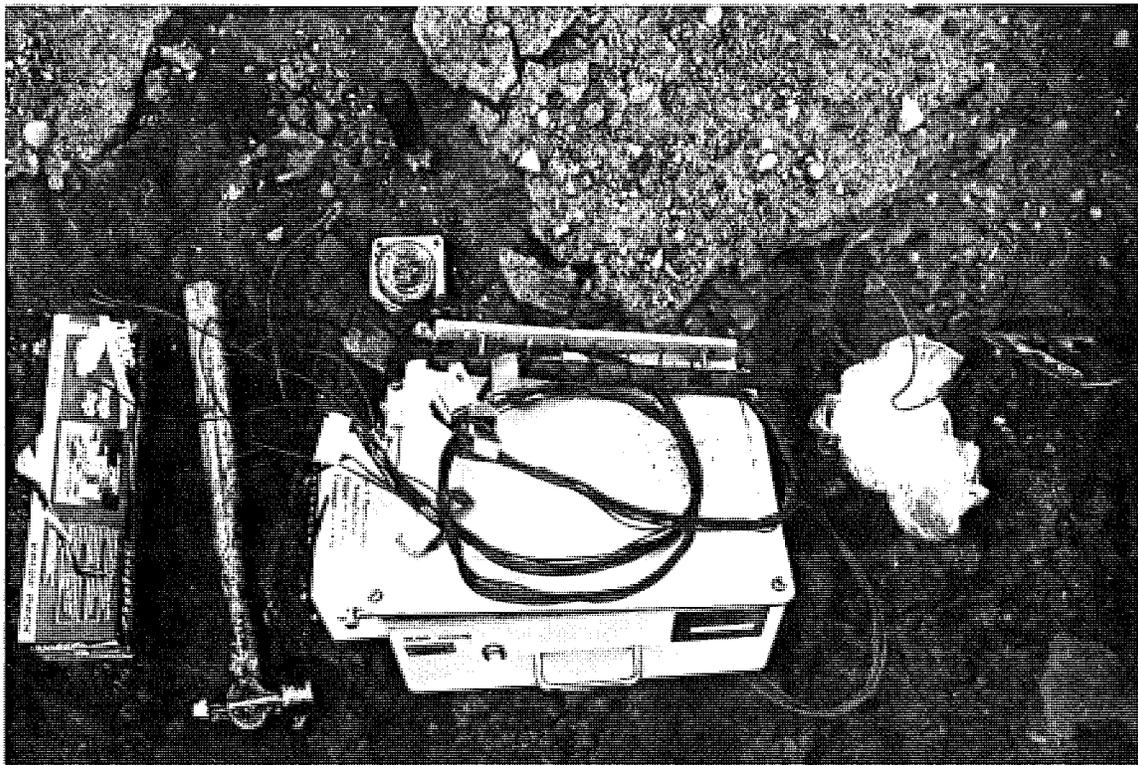
Photo C38. A view of the temperature profile instrumentation prior to installation in the slab in CSN# 47065-28215A WB. The gray box is the data-acquisition system. Lying on the box is the thermocouple rig, with thermocouples spaced in one inch increments.

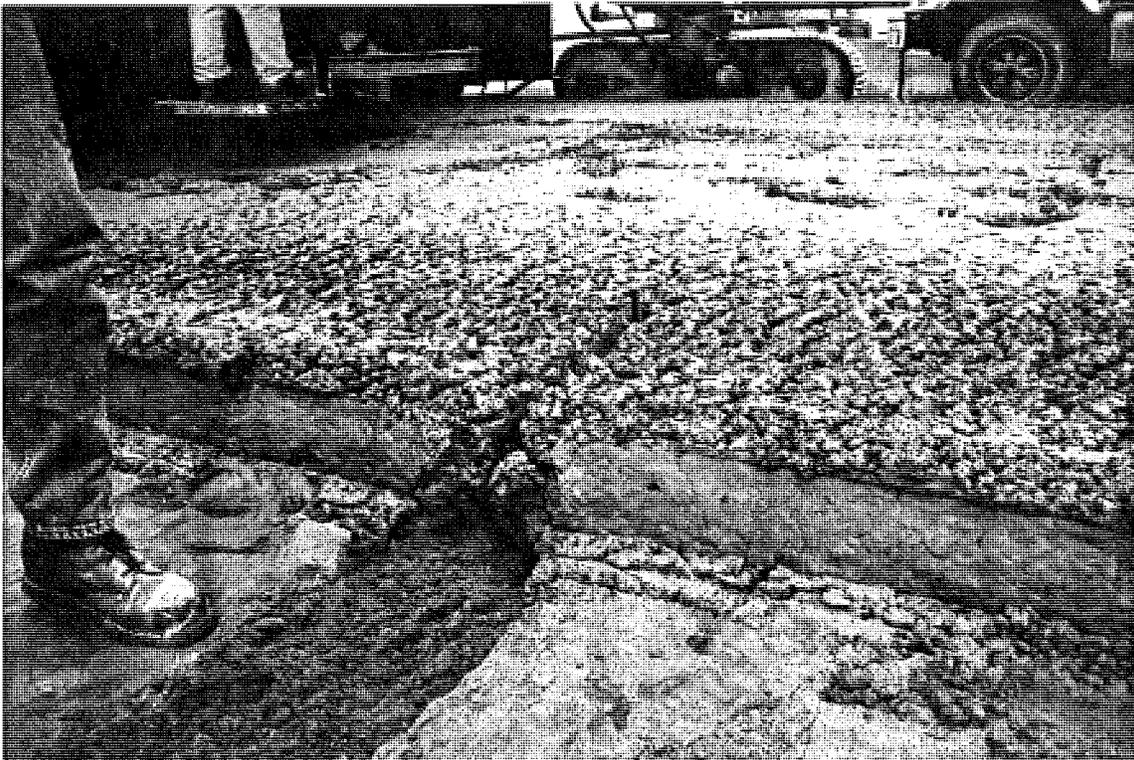
Photo C39. A view of the thermocouple rig immediately after installation in CSN# 47065-28215A WB. The rig is installed between paving lifts, and the cables are buried to protect them from damage during the second paver pass.

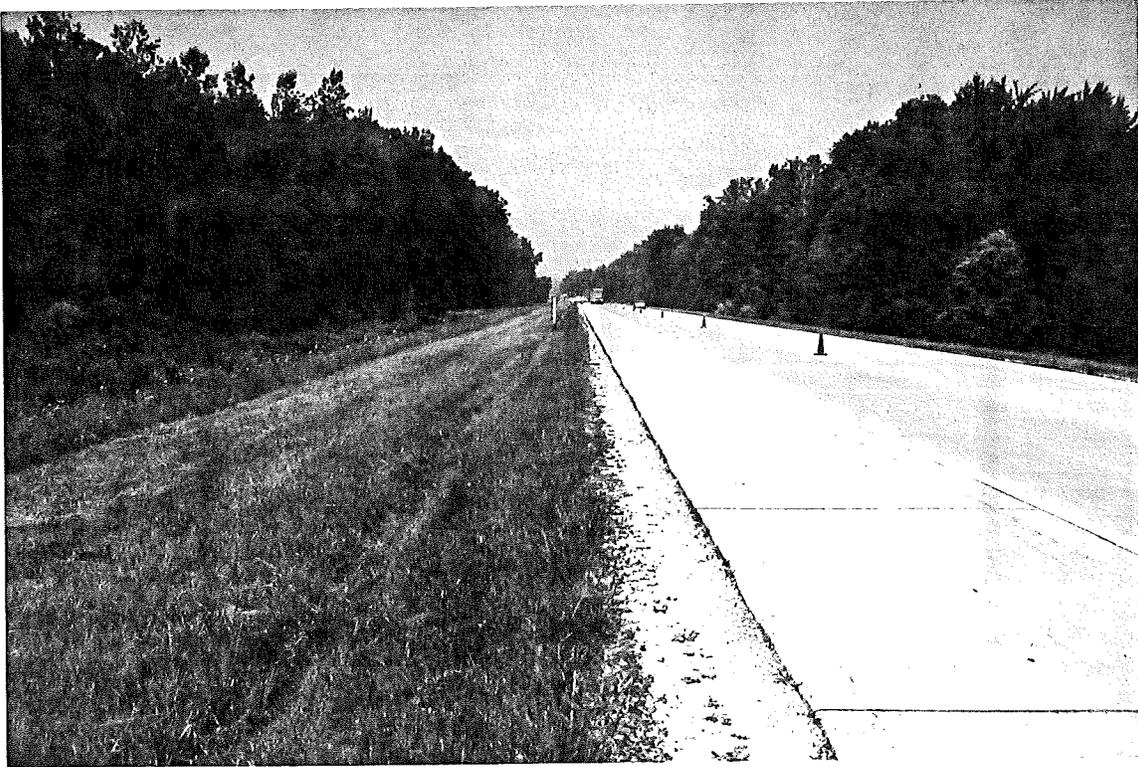
Photo C41. An overview looking west showing intermediate shoulder joints on CSN# 77023-21586A EB. The slabs in the driving lanes are 41 ft long.

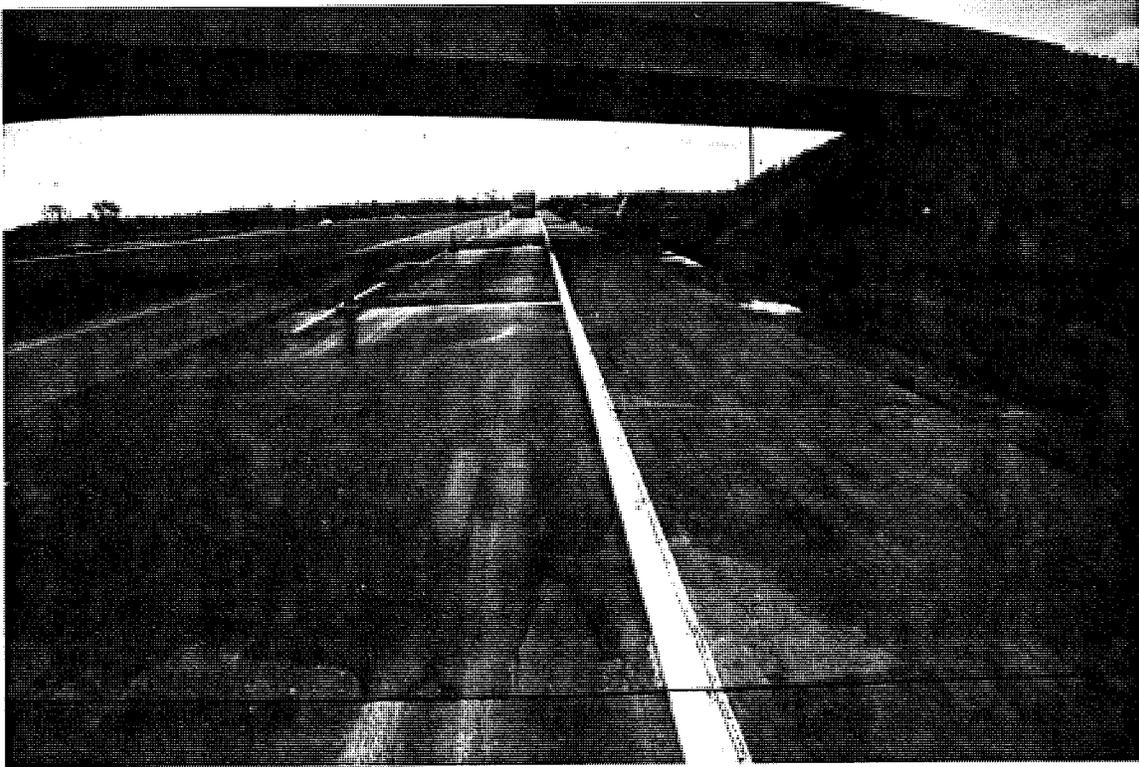
Photo C49. An overview looking east on CSN# 77024-17988A (Section B), EB. The third point intermediate shoulder joints can be seen. Slabs are 41 ft long in the driving lanes.

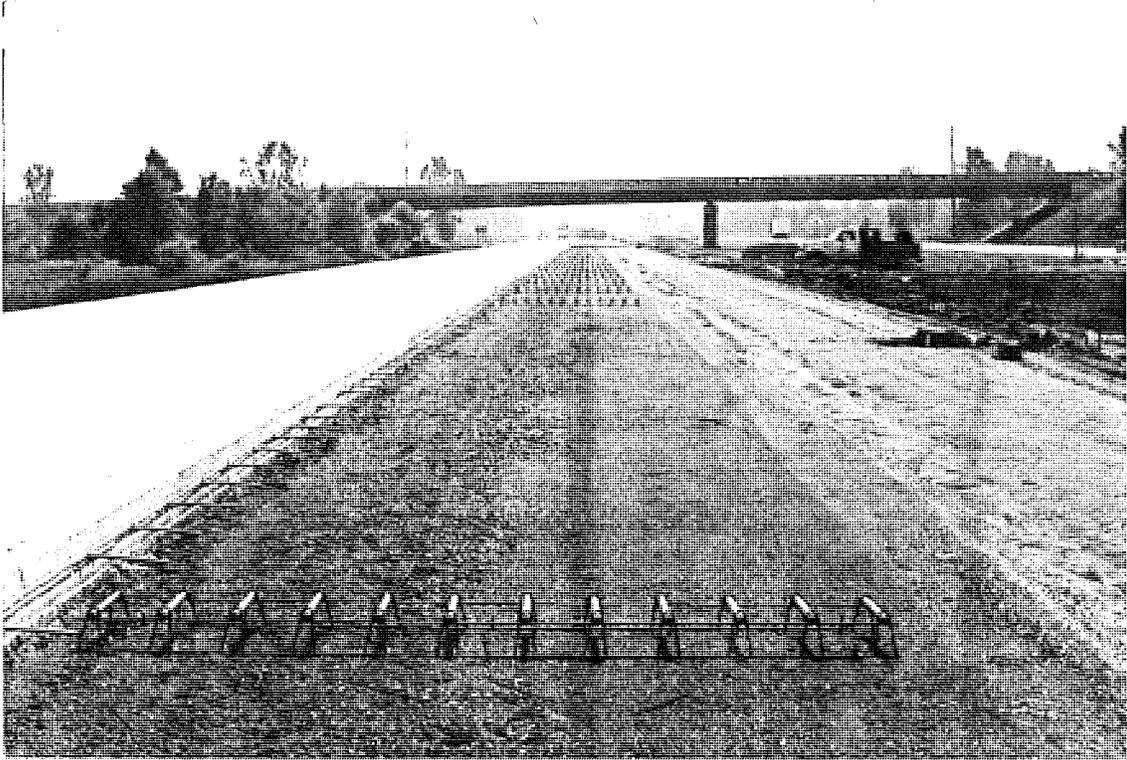
Photo C53. An overview of CSN# 82291-37305A NB looking south. Three dowel baskets have been removed to allow for study of load transfer efficiency with and without dowel baskets.

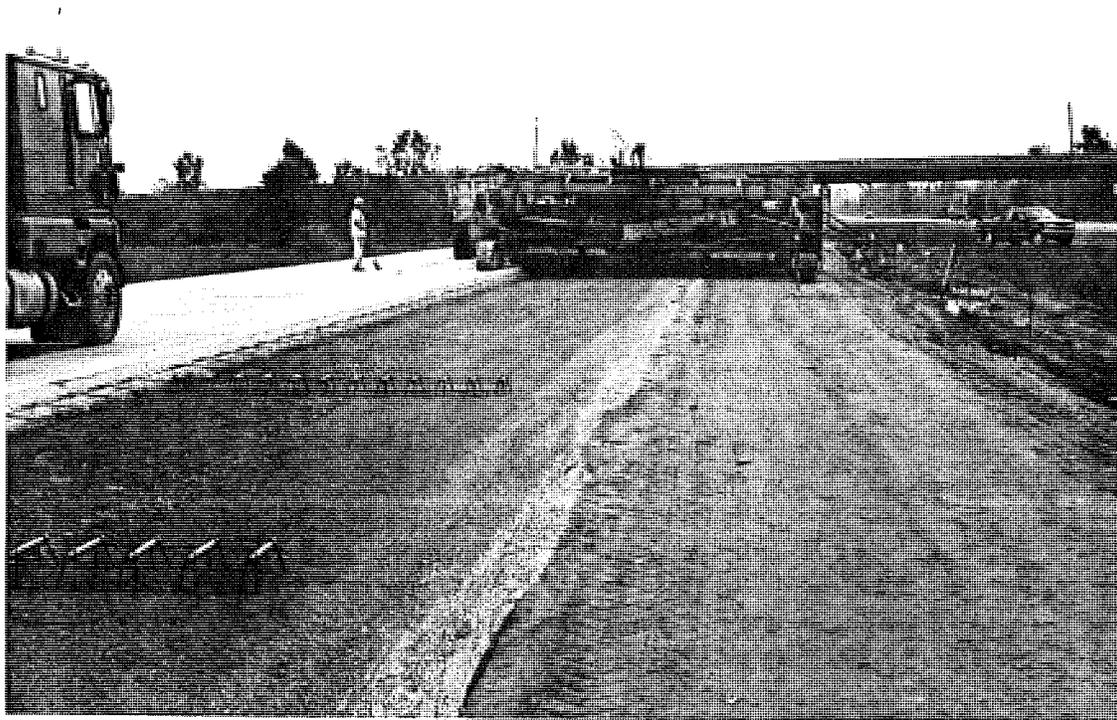
Photo C54. A view of CSN# 82291-37305A NB looking south as the paving train advances toward the removed dowel section. A thermocouple rig is to be installed in the slab near the location where yellow caution tape is seen.

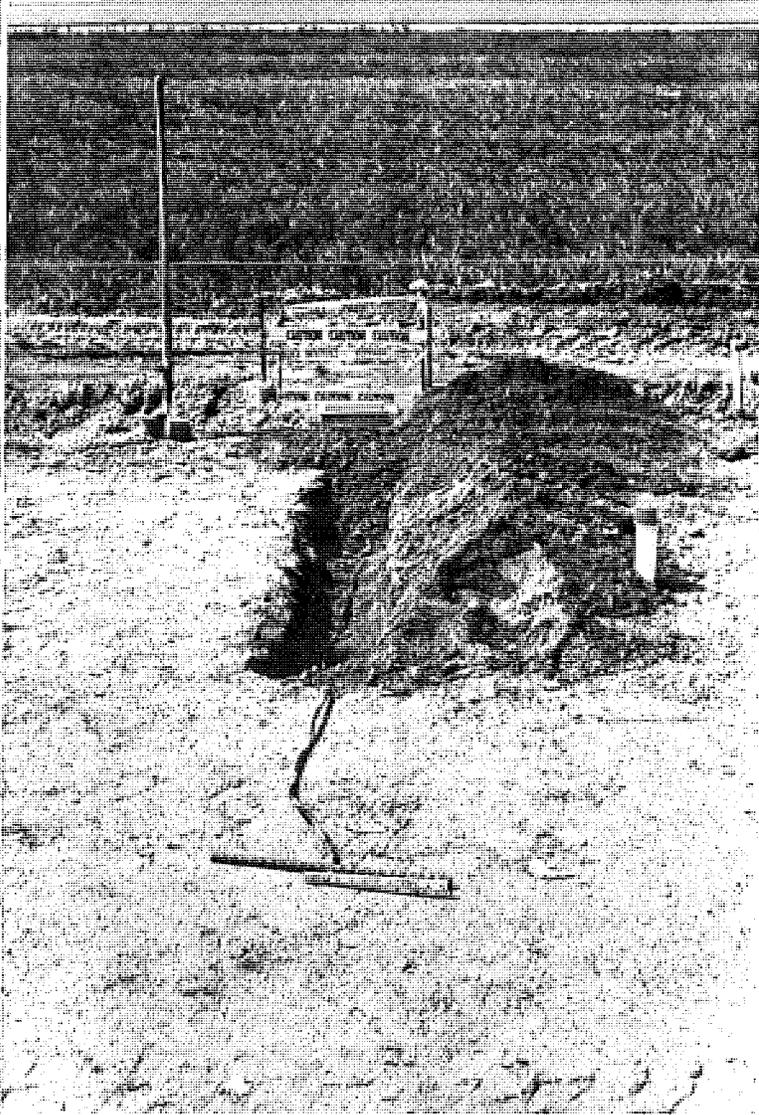
Photo C55. A view of the thermocouple rig on CSN# 82291-37305A NB prior to installation.
